Fort Lauderdale Police Headquarters Project Update

June 3, 2025

CAM #25-0630 EXHIBIT 3 Page 1 of 28

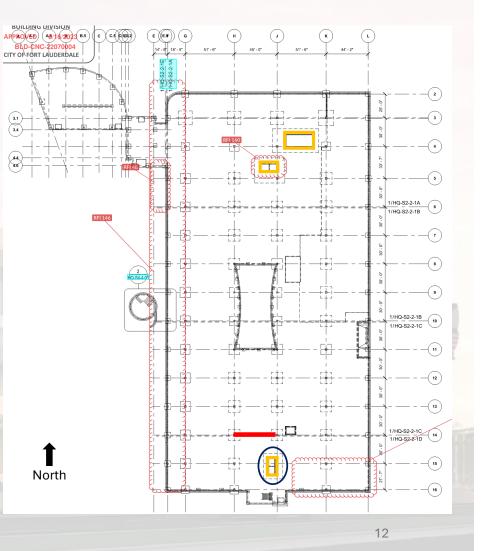
- 1. Shear Wall Capacities
 - Finding
 - The Southern-most Reinforced Concrete Core Wall is Not Code-compliant for Strength Between Levels 1 and 2
 - Possible rectification
 - Adding a Properly Designed Full-height Shear Wall (i.e., from foundation to roof) with an Accompanying Foundation on Gridline 14 Between Gridlines H and J
 - Timeframe for Rectification
 - As Soon as Possible (0 to 2 months)
 - Timeframe Set Due to Hurricane Season
 - Should be Completed Before the Building is Occupied (i.e., after construction)

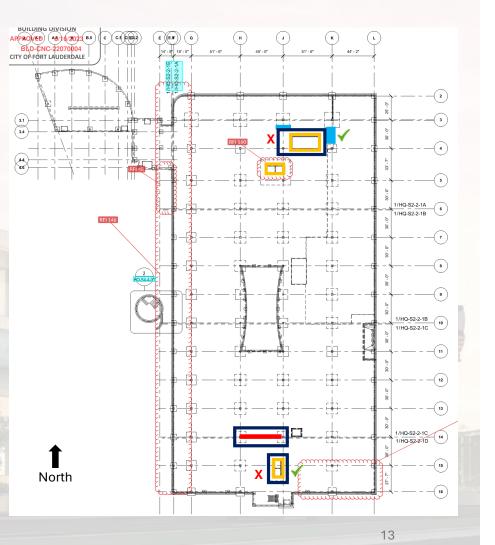
2. Shear Wall Foundations

- Finding
 - The Design Capacity of the Mat Foundations for the Concrete Shear Walls Around the North Stair Shaft and the South Elevator Shaft is Exceeded Under Full Design Wind Loads and are therefore Not Code-compliant.
- Possible rectification
 - Adding the Shear Wall in Item 1 to the Building can Rectify Conditions Related to the South Elevator Shaft.
 - Attaching the Mat Footing for the North Stair Shaft to its Surrounding Isolated Spread Footings can Rectify the Sliding Capacity Condition.
- Timeframe for Rectification
 - Same as for Shear Walls

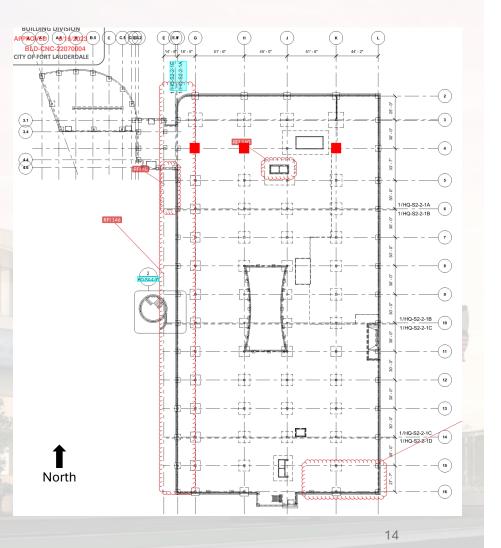
- 3. Column Foundations
 - Finding
 - Bearing Stress Under the Three Isolated Footings on Gridline 4 Exceeds the Allowable Soil Design Bearing Capacity and are Not Code-compliant.
 - Possible Rectification
 - Enlarge the Footings
 - Timeframe for Rectification
 - Before Building Occupation

AECOM/TT has informed WJE that the roof live load currently shown on the drawings (30 psf) is higher than the minimum required by code (20 psf) and will update the drawings for the lower live load. WJE can re-check the foundations with the reduced loads.

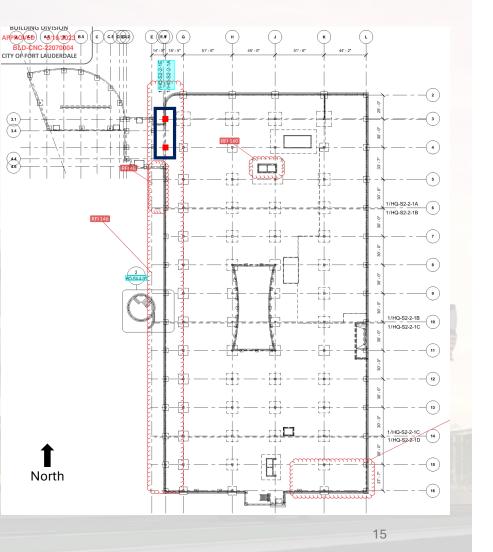
- 4. Side Bearing Capacities
 - Finding
 - Bearing Stress in the Slide Bearings on Gridline F Exceeds the Manufacturer's Published Allowable Capacity Under Full Design Loads.
 - Possible rectification
 - Replace Bearings with Higher Capacity Bearings.
 - Timeframe for Rectification
 - Before Building Occupation

AECOM/TT has acknowledged issue with slide bearings and has indicated that these bearings will be replaced with higher capacity bearings.

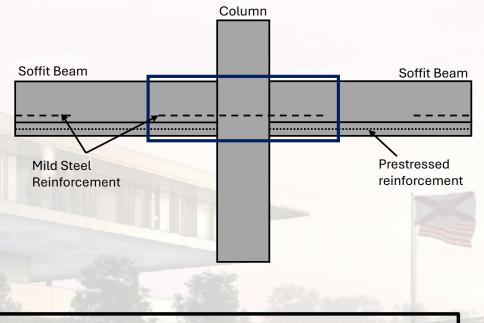
- 5. Structural Integrity Code Provisions
 - Finding
 - Detail Used to Provide Continuity of Bottom Reinforcement is Not Addressed in Appliable Building Code.
 - Note: This Building System is Widely Used within the South Florida Market.
 - Possible Rectification
 - Structural Engineer of Record to Provide Calculations, Results of Load Tests, or Other Valid Engineering Documentation which Demonstrate that this Type of Connection is Adequate to Develop Continuity of Bottom Reinforcement
 - Timeframe for Rectification
 - Before Building Occupation

Resolution of this issue is ongoing. A meeting with the Building Division of DSD, AECOM/TT, and WJE is being coordinated to discuss and resolve this issue.

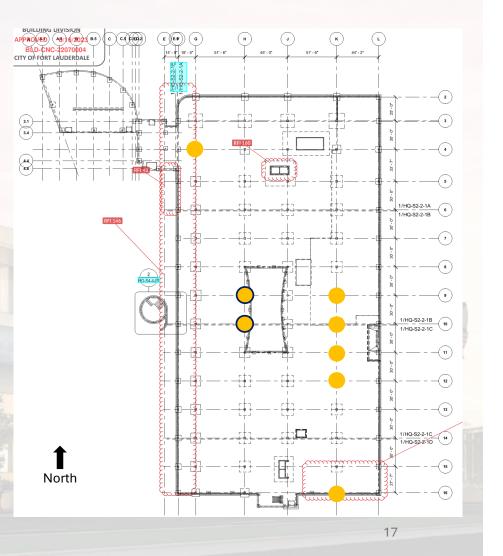
6. Column Axial-Flexural Capacities

- Finding
 - Based on WJE Analysis, 24 Columns were Overstressed (under full design load) for Combined Axial and Flexural Loading and thus are Not Strictly Code-compliant. Only 8 of Those Columns were Overstressed by More Than 10%.
- Possible Rectification
 - Strengthen the Columns that are Overstressed More Than 10%
- Timeframe for Rectification
 - Before Building Occupation

AECOM/TT agrees with WJE that strengthening of the 16 columns overstressed less than 10% is not necessary. AECOM/TT and WJE will work towards a resolution on the other 8 columns.

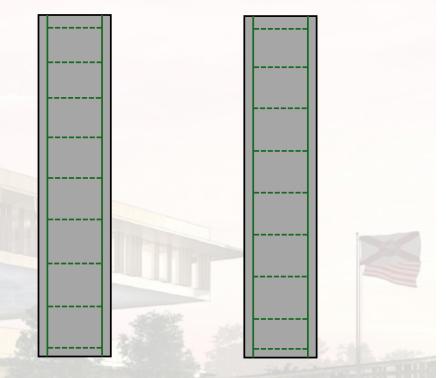
7. Column Shear Capacities

- Finding
 - Up to 50 Columns were Found Not to be Strictly Code-compliant for Shear Due to Ties Spaced more Widely than d/2.
- Possible Rectification
 - We do <u>Not</u> Believe Strengthening of these Columns is Necessary (See Graphic).
- Timeframe for Rectification
 - Before Building Occupation

ACI 318-14 requires tie spacing less than "d/2" to include strength of ties in the capacity.

d/2 ~ 10 ¾" for most 24" square columns EOR specified tie spacing of 12" maximum

AECOM/TT agrees with WJE that strengthening of these columns is not necessary.

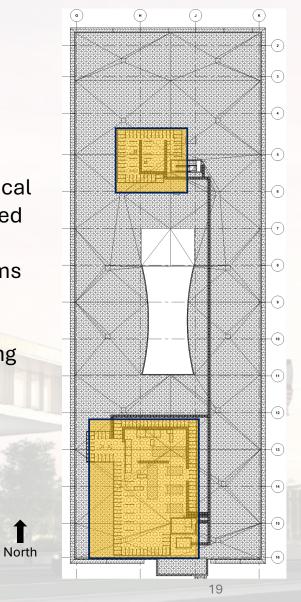
8. Roof Beam Capacities

- Finding
 - There is a Discrepancy on the Drawings Regarding which Mechanical Loads Should be Used at the Roof. If One Set of Loads that is Called Out are Used, Some of the Roof Beams May Not have Sufficient Strength, if the Other Load Set is Used, it is Possible that the Beams would have Minimum Required Strength.
- Possible rectification
 - Clarify Intended Loading on Drawings. If Necessary, After Clarifying Loading, Strengthen the Beams.
- Timeframe for Rectification
 - Before the Building is Fully Loaded

Current live load on drawings is 150 psf. AECOM/TT has informed WJE that this load is outdated and will be reduced to 75 psf and the drawings updated. WJE can recheck the finding for these reduced loads.

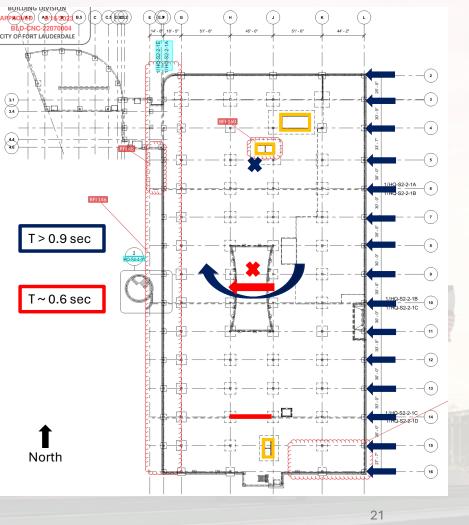
10.Building Period

- Finding
 - Fundamental Period of Vibration (twisting mode) of the Building is Greater than 0.9 Seconds
 - Significantly Larger than Typical Concrete Shear Wall Buildings having No More than Three Stories.
 - While this Condition Does Not Violate any Code-prescribed Performance Limitations, it is Not Standard Practice to Design Structures to Perform this Way.
- Possible Rectification
 - Adding an Appropriately Designed Full-height Shear Wall to the Structure (as previously described in Item 1) Will Rectify this Condition.

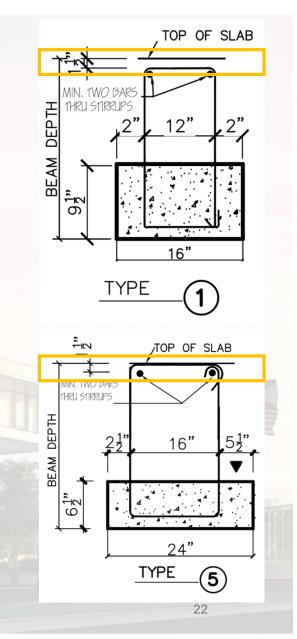
11.Concrete Cover Depth

- The Precast Concrete Shop Drawings Inconsistently Indicate the Amount of Cover Depth Provided in the Soffit Beams. In Some Cases, the Cover Depth is Indicated to Satisfy Minimum Code Cover Requirements, and in Others it Does Not.
- Required Response
 - The Structural Engineer of Record Should Confirm and Document which Cover Depth was Used in the Design of the Soffit Beams.
 - If Cover Depth is Not Sufficient, Rectifications May be Required.

AECOM/TT is working on gathering documentation to show that the appropriate cover depth was maintained during construction.
