The lot at 716 Bryan Place (AKA SW 4th Place) in Fort Lauderdale currently has the structure that was once part of the property now up on wood blocks and steel about 5' off the ground. Although it is always best to try and reuse a structure for both historic and ecological value, this particular structure was allowed to be moved, and then left to deteriorate and is now in a state that would make it totally unfeasible to reuse.

716 SW 4th Place, Fort Lauderdale, FL

Detailed Building and Site Condition Assessment

Property Address: 716 SW 4th Place
Fort Lauderdale, FL 33312
Inspection Date: May 2, 2013

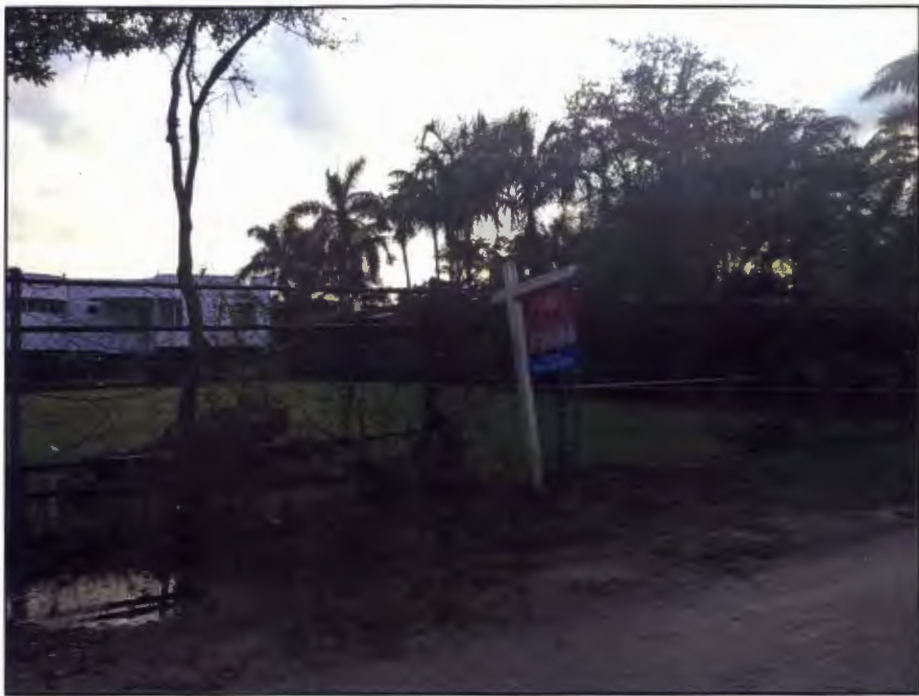
View from the street

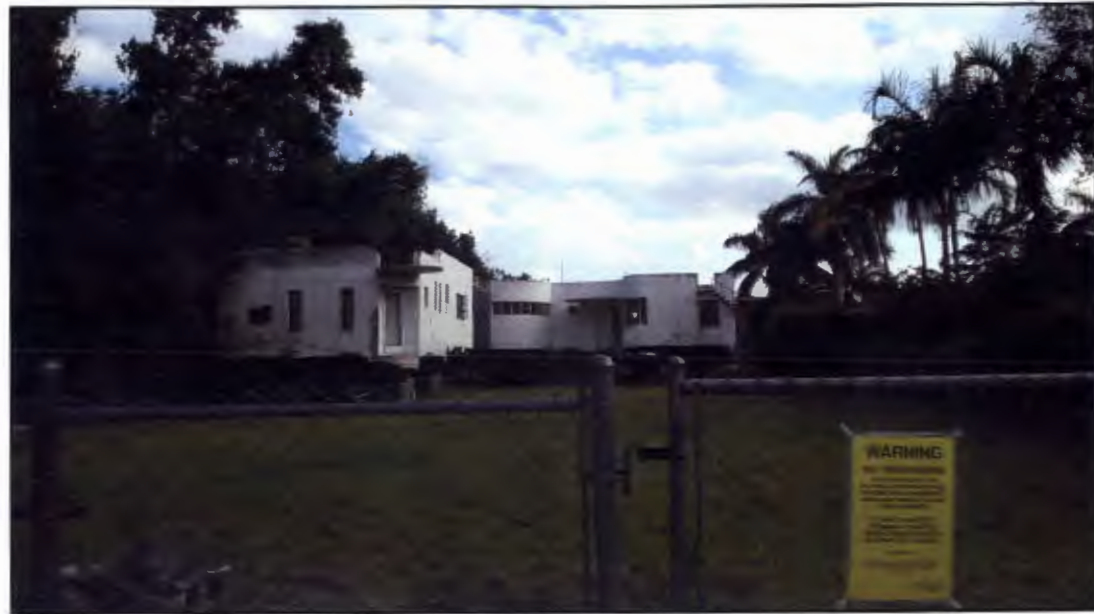
View from the street

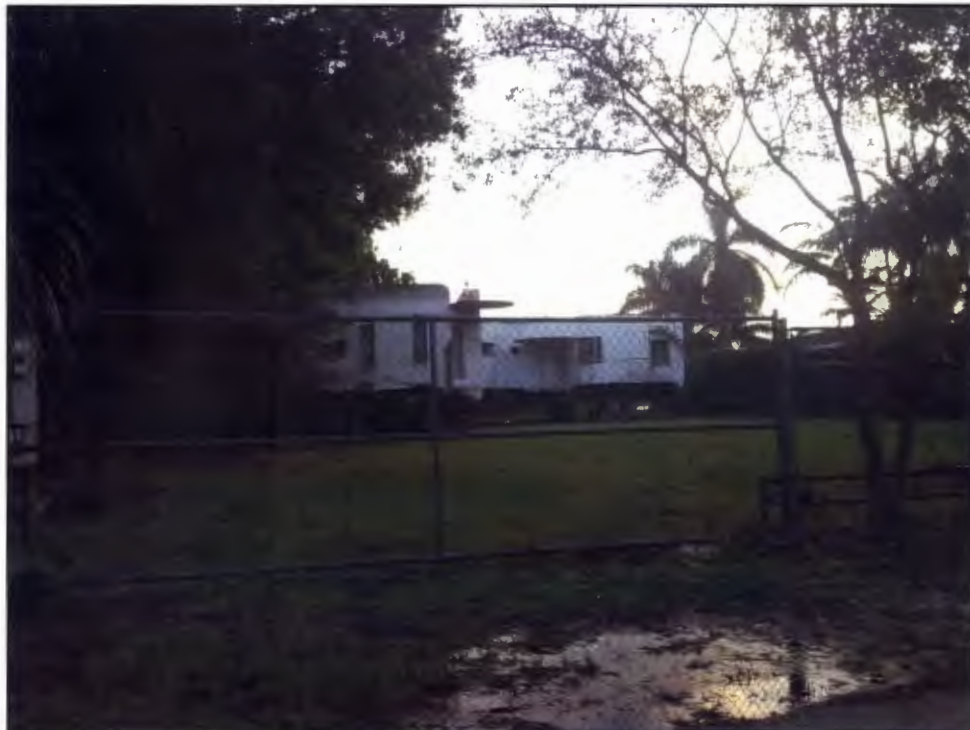
View from the street

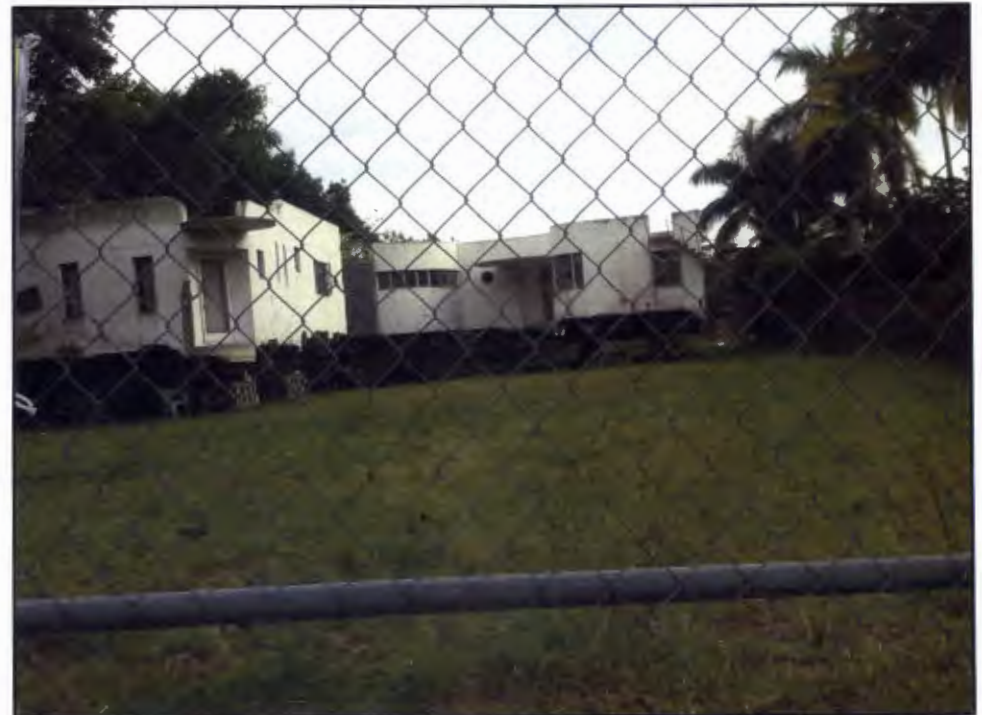
View from the street- note chair under structure

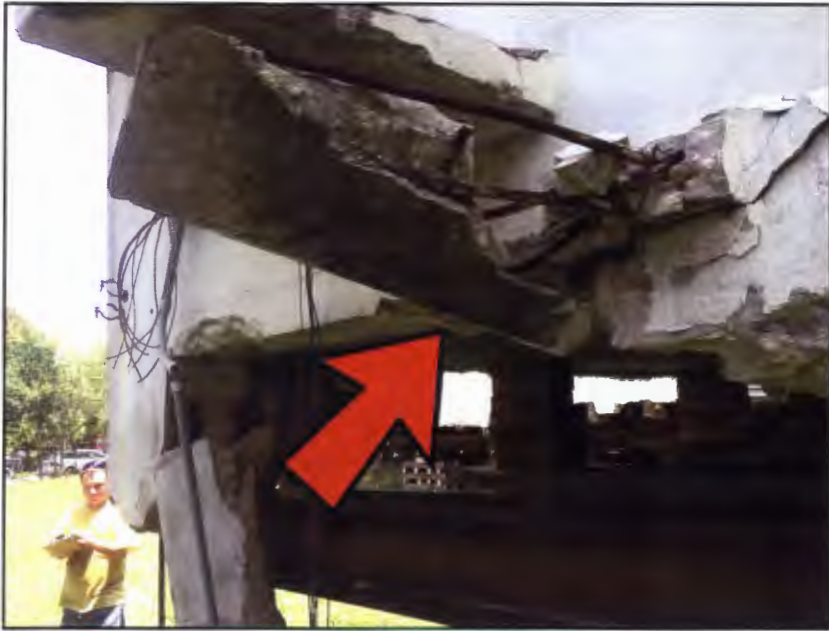
Falling Concrete

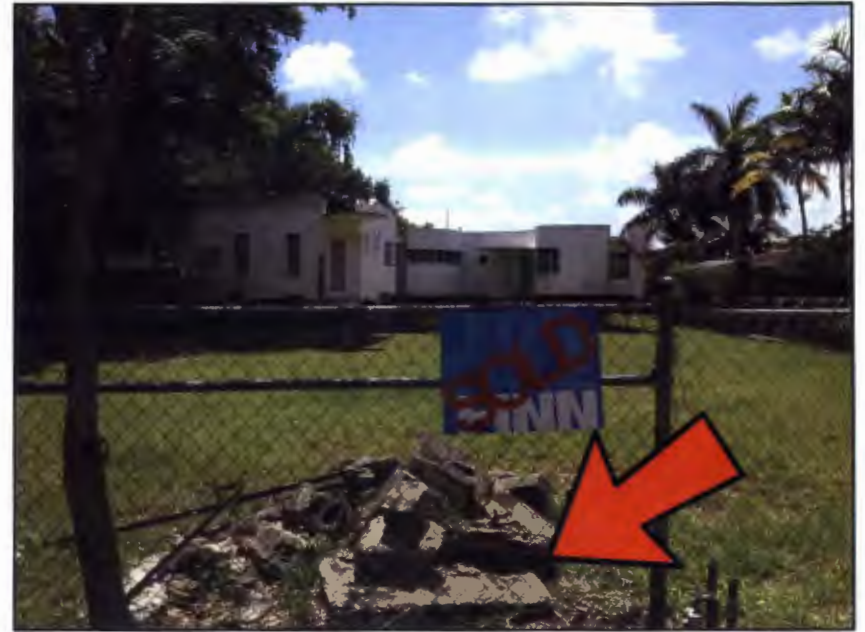
Past chunks of concrete that have fallen off.

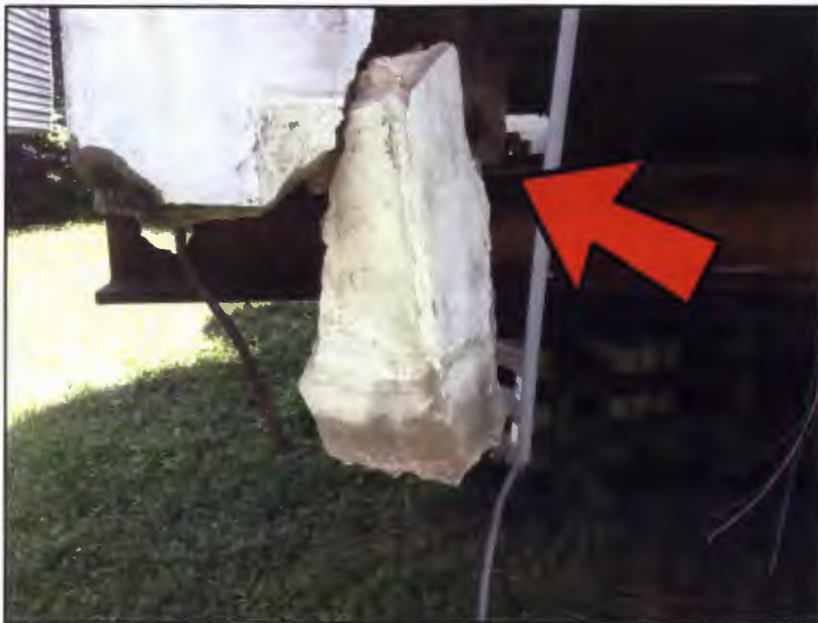
Large chunks falling off.

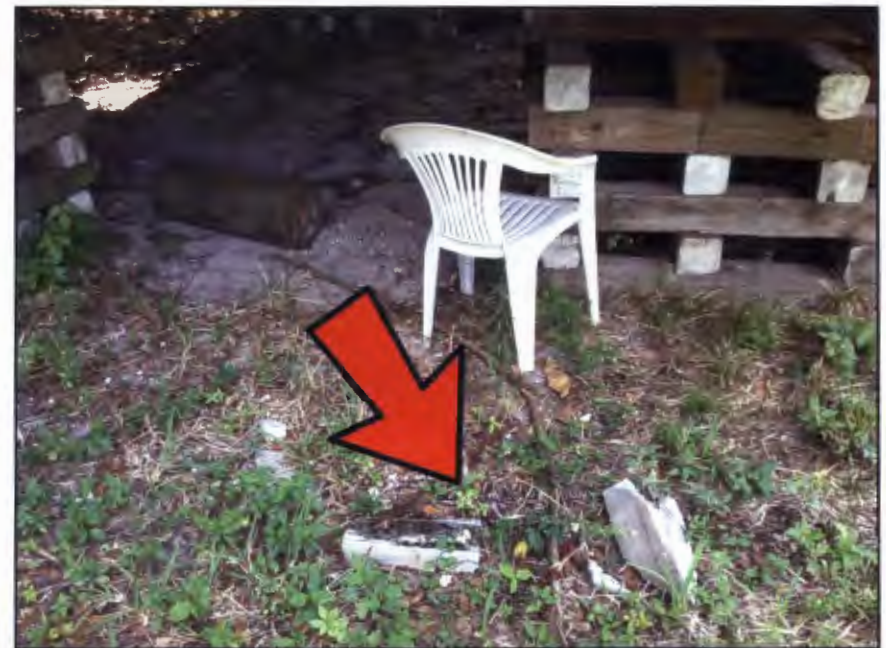
Vagrant hangout with chunks of concrete that have recently fallen off.

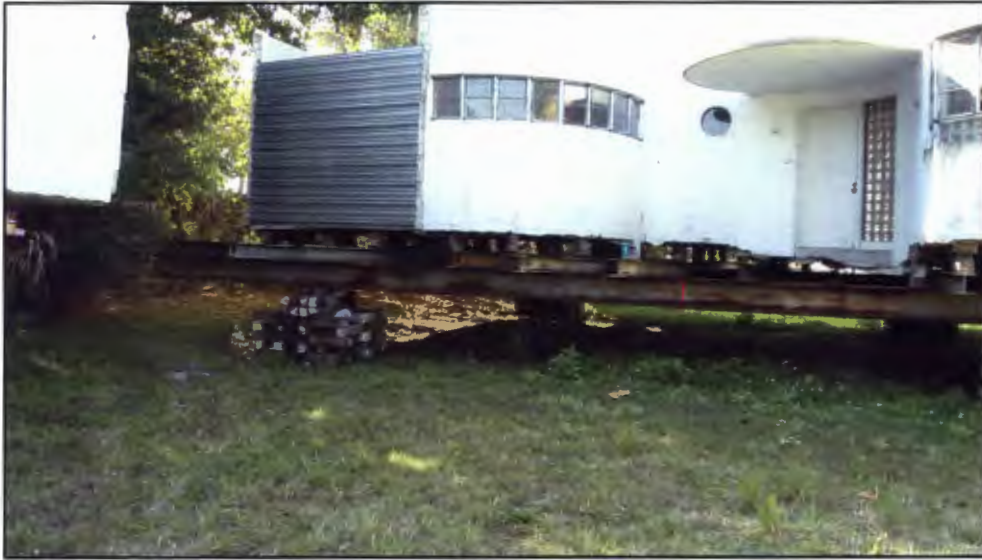
Home cut in half- View from front yard

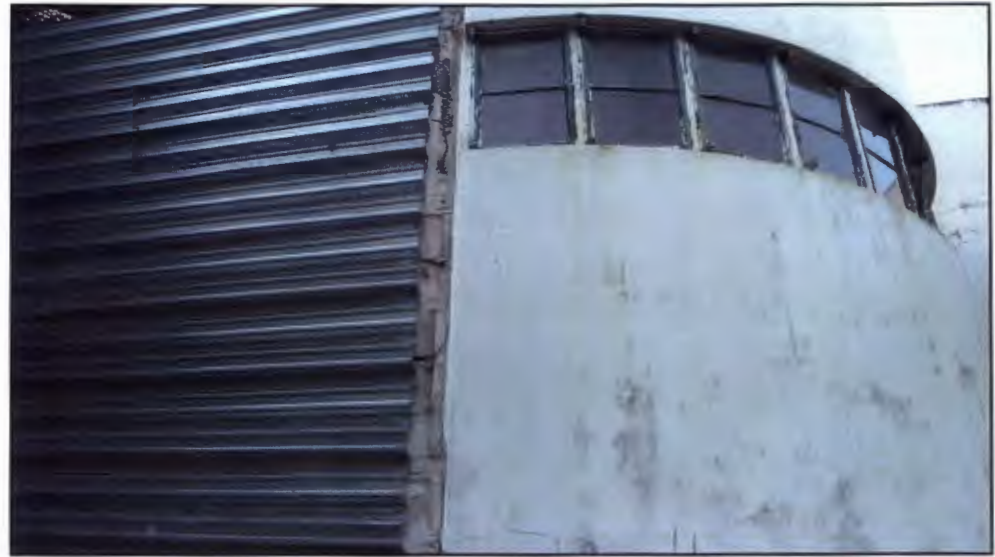
House cut in half

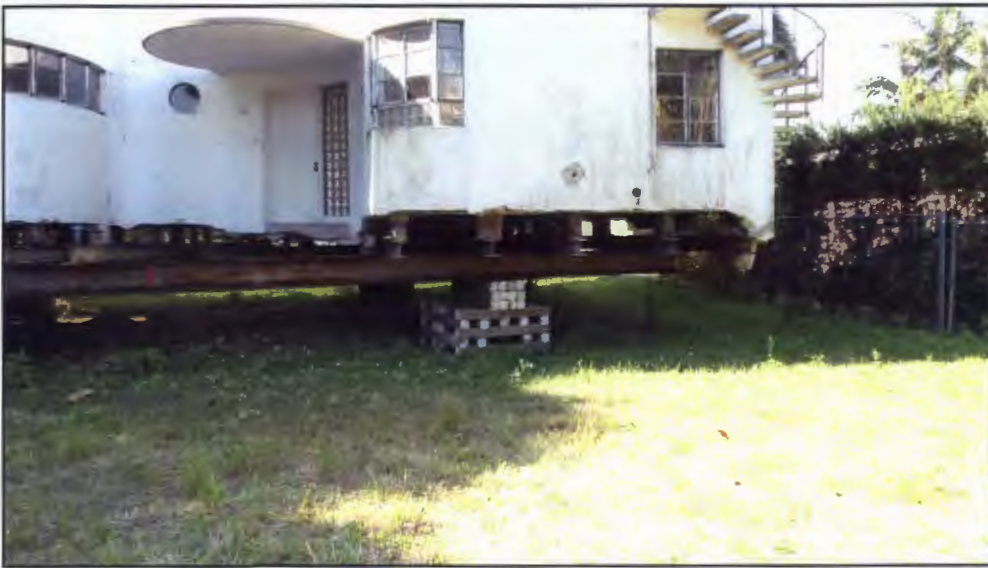
Unsafe stairs and all around wall cracking and rusting

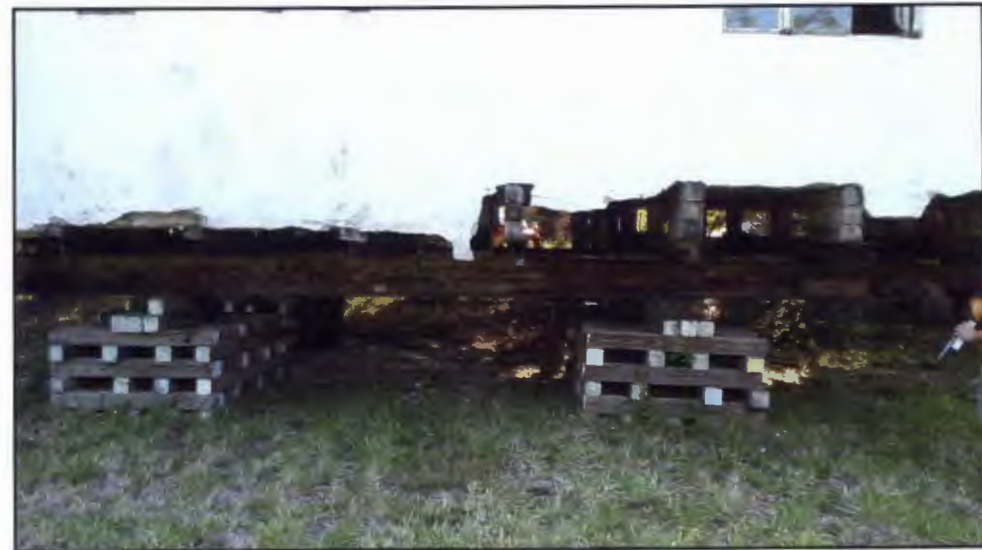
Wood supports starting to fail

The structure has been divided and raised off foundation and is currently set upon steel I-Beams held up by wood blocking supports. The structure has sat in this arrangement for many years. It appears as though the wooden support blocks have started to settle into the loose/non-compacted soil foundation beneath them. Deterioration of the wooden support blocks is also an issue contributing to the instability and deflection of the structure. A North-South crack in the foundation on the east side of the main structure is accompanied by a visible deflection of the slab. There are several long cracks in the ground and roof slab.

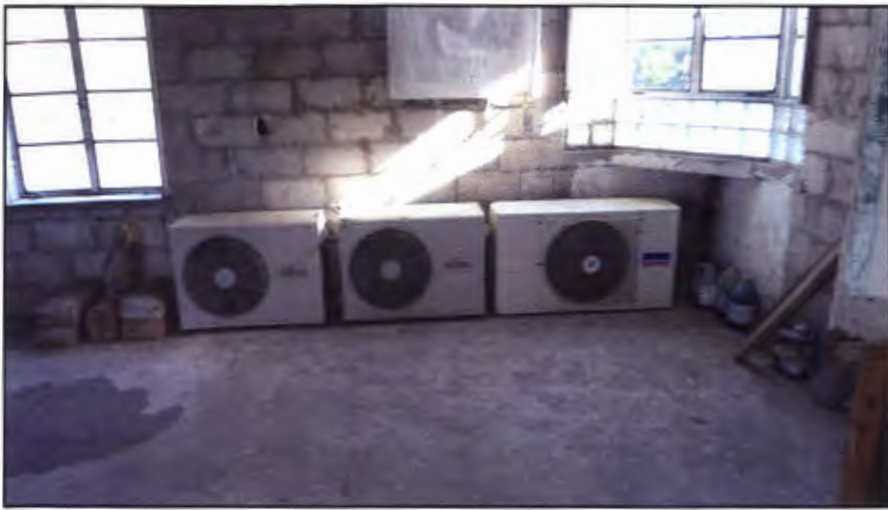
Block construction- not poured as previously stated

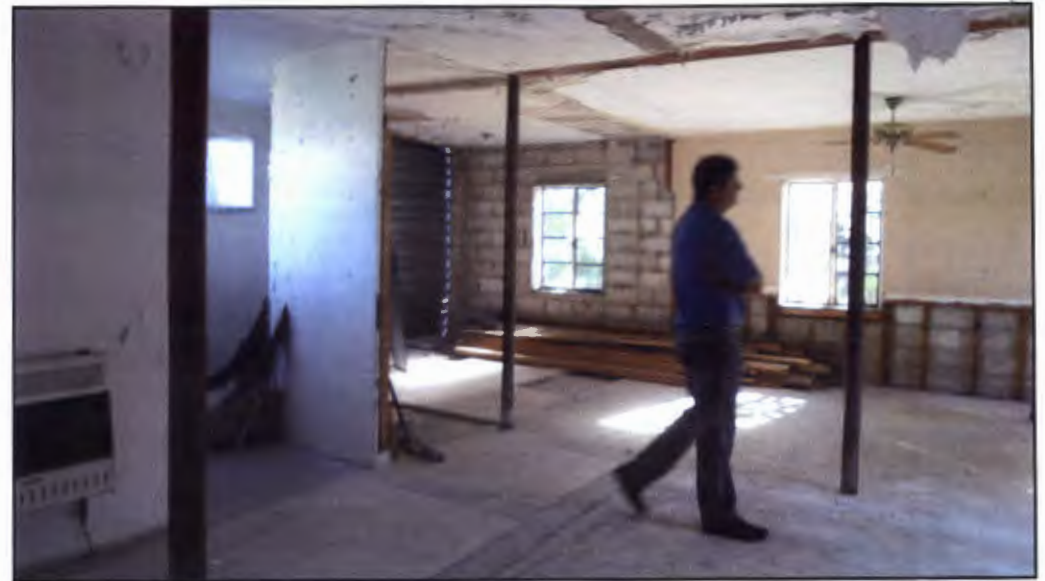
- Roof cannot support itself like modern roofs (note steel columns). No feasible floor plan could be used in this building.
- Exterior walls need to be saw cut on 24 to 36" centers [per engineer] and steel reinforced and restuccoed so the entire building would have a "new" stucco thus further removing the historical look.

Interior with required supports to hold up roof

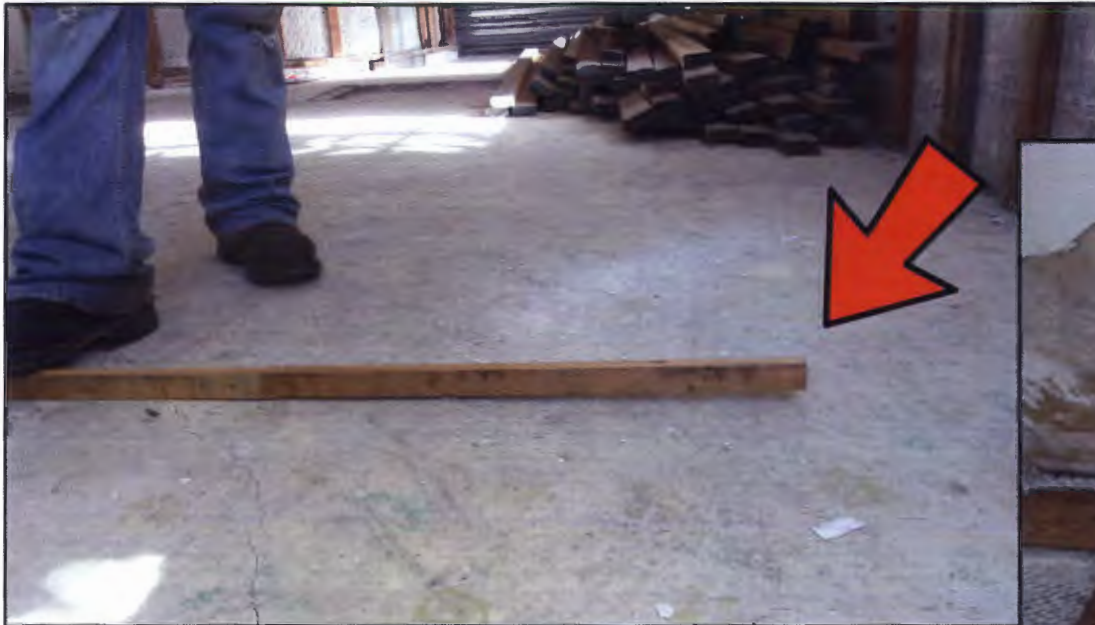
Floor cracked and falling

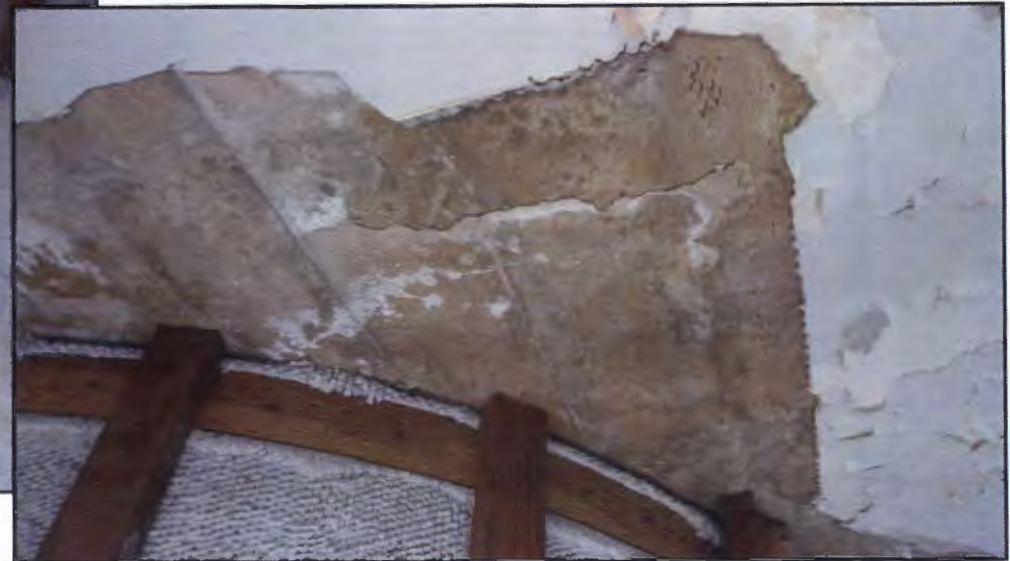
Looks like plaster but roof concrete is splitting.

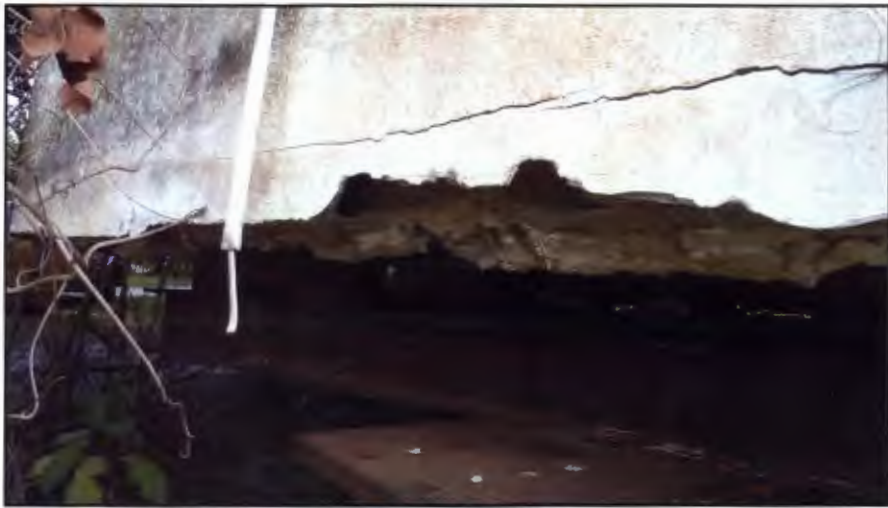
Chunks falling off of building

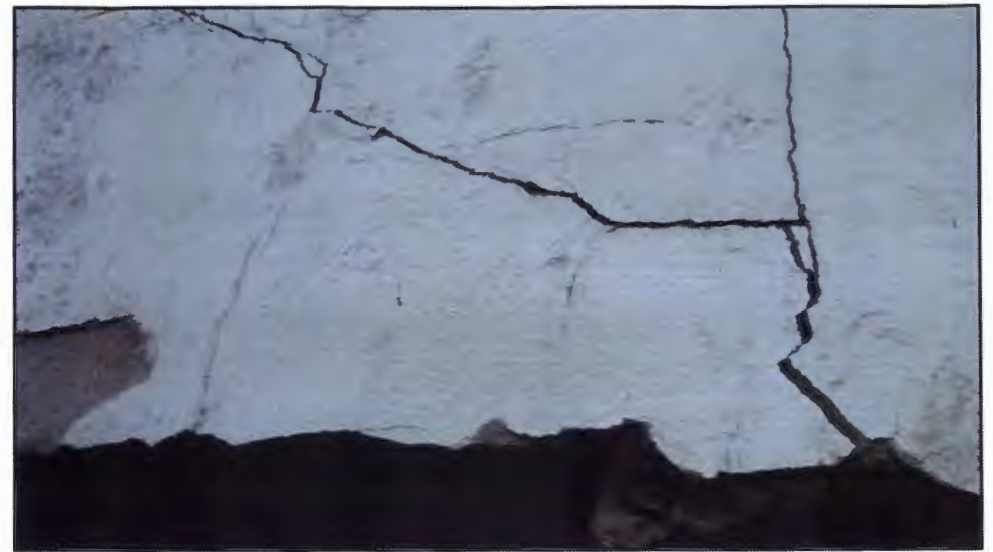
Deep Structural Wall cracks with pieces falling off

Due to being built of all concrete, there is very little flexibility for structural deflection. Sitting upon temporary supports and an unstable sandy foundation has caused many vertical and horizontal cracks in supporting CMU walls around entire structure. All of the cracks need to be repaired. After sitting for approximately 8 years without having them sealed, salty water has intruded and caused oxidation (rusting) of the rebar in many locations.

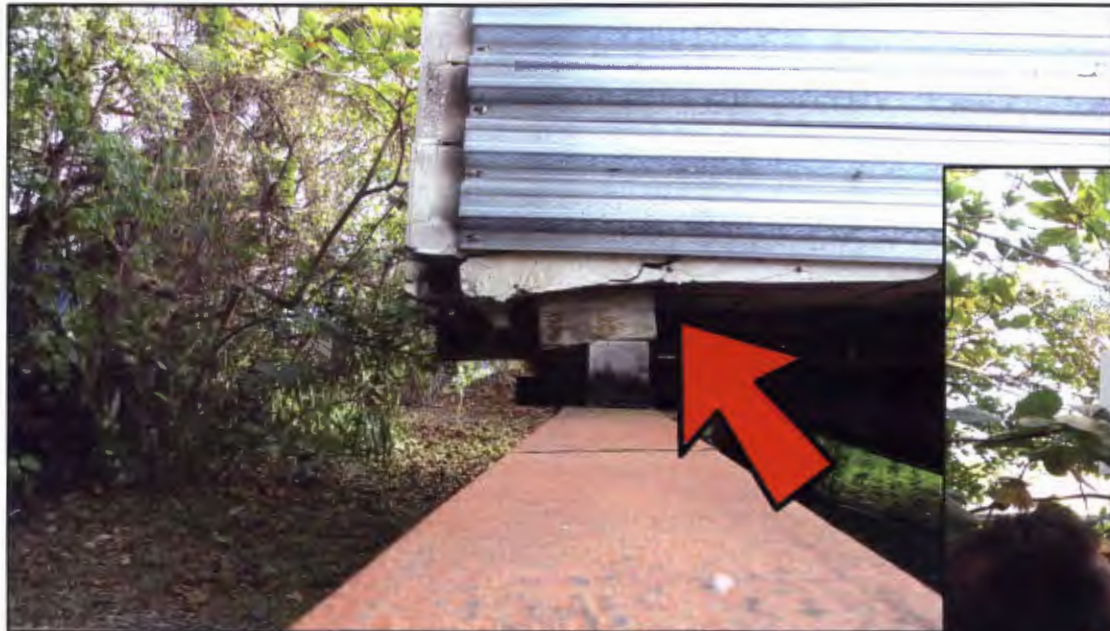
East foundation cracking and falling off

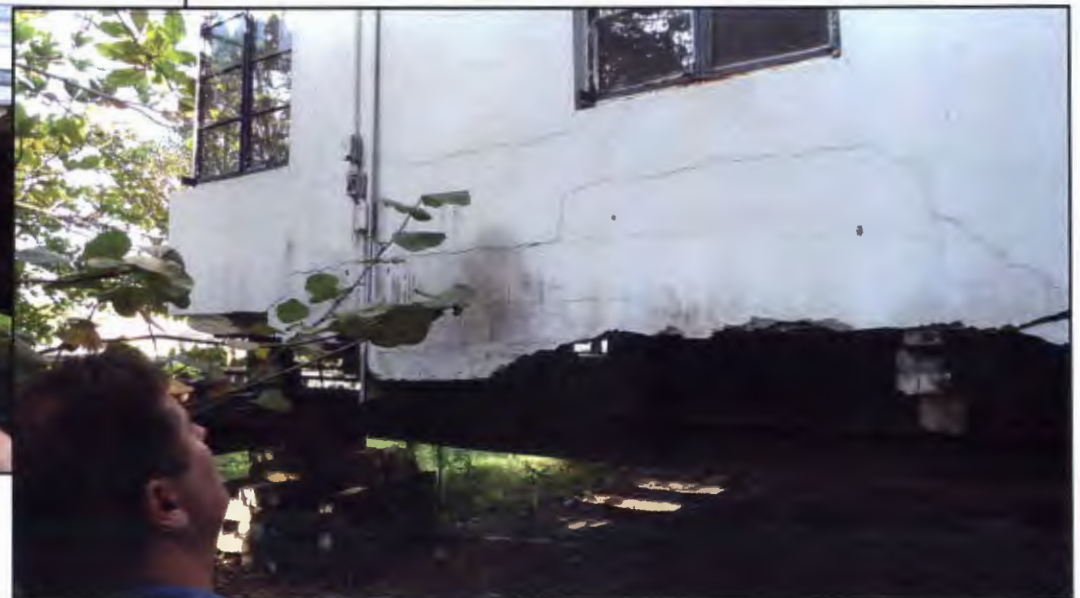
East Wall cracking to point of windows breaking.

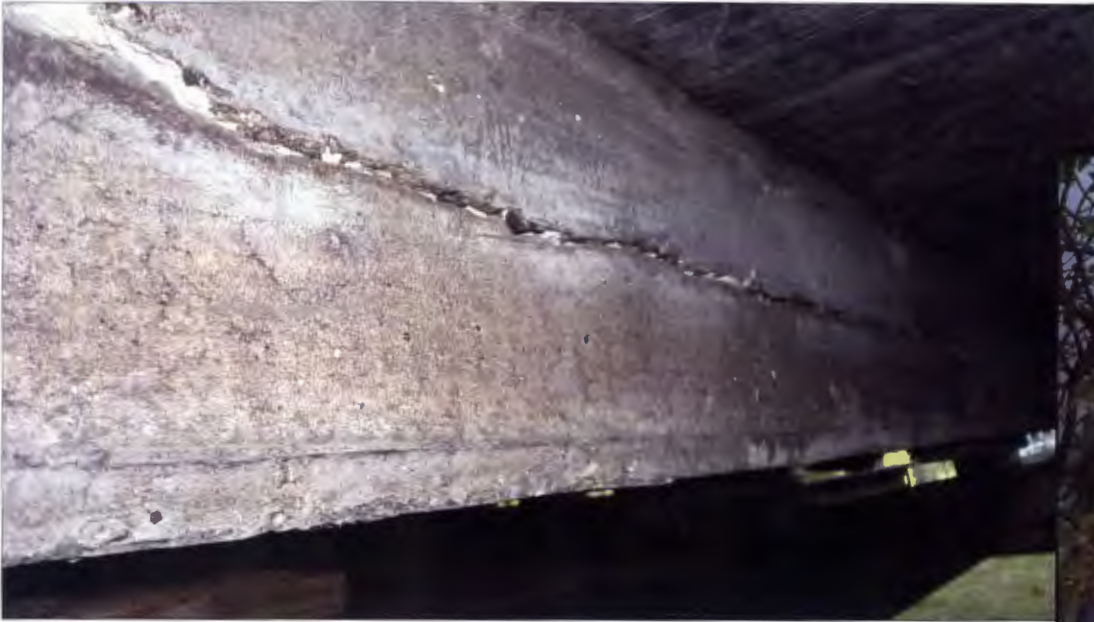
Major grade beam crack

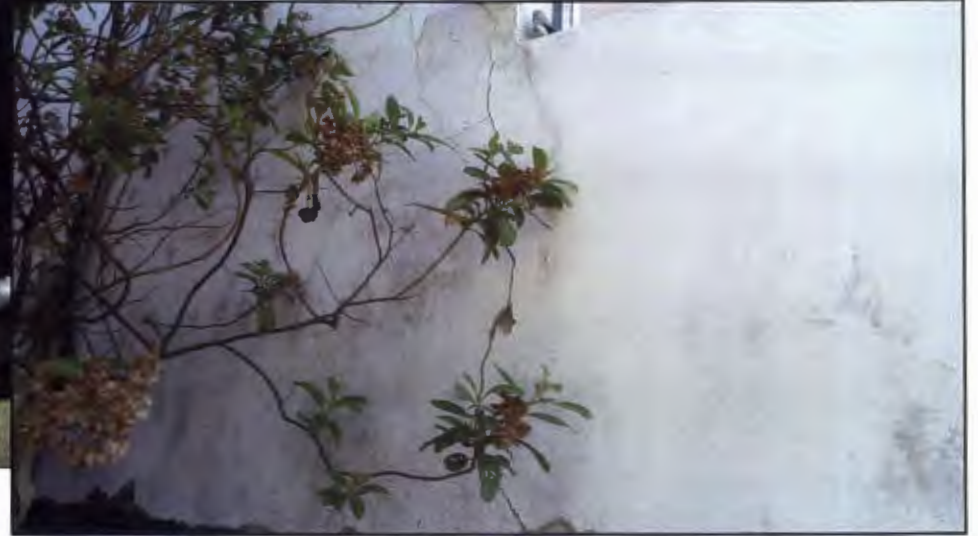
Major Wall Crack

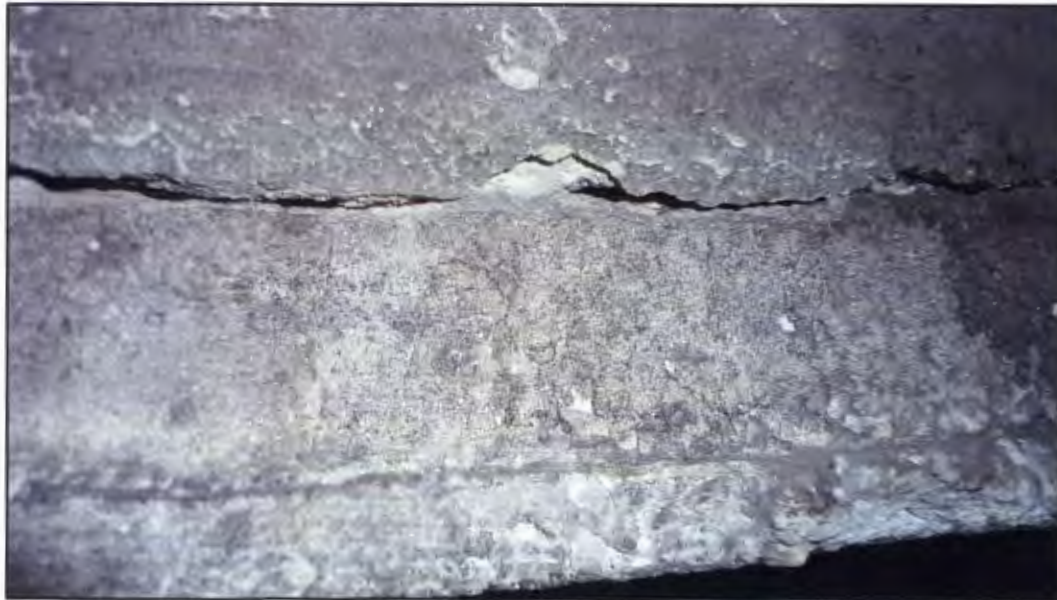
Major grade beam crack 2

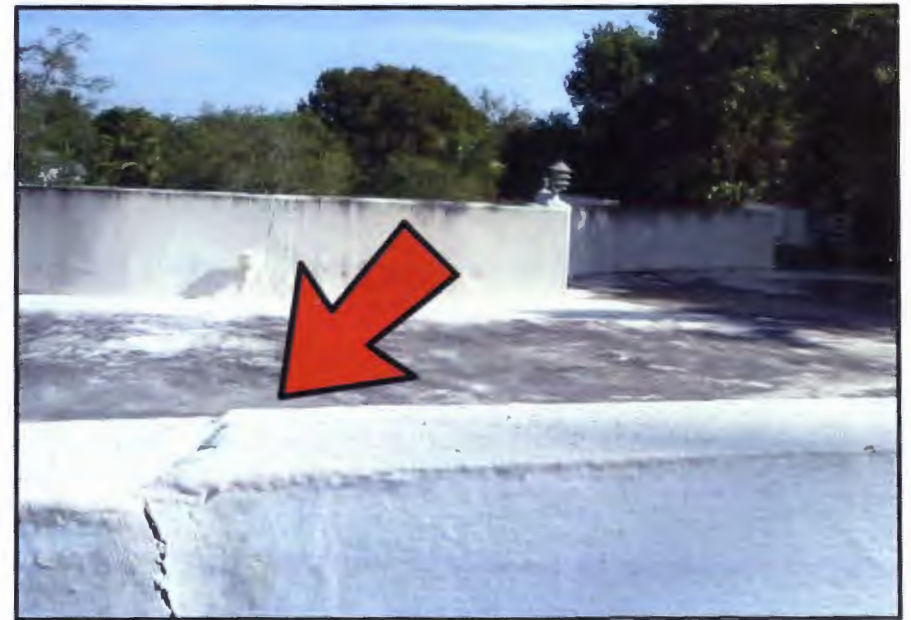
Major Wall Separation

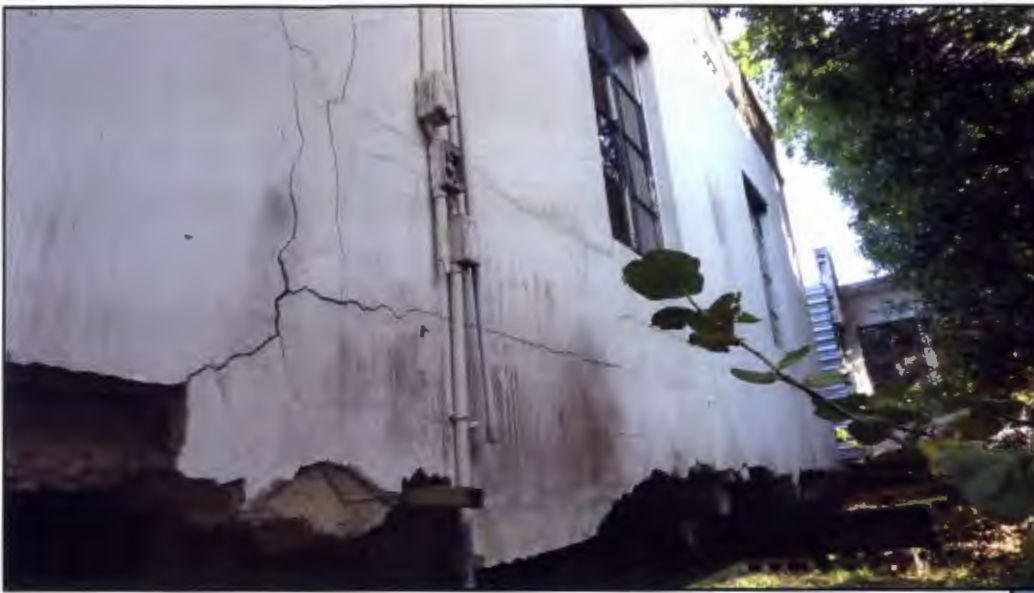
Foundation Cracking and large parts falling off

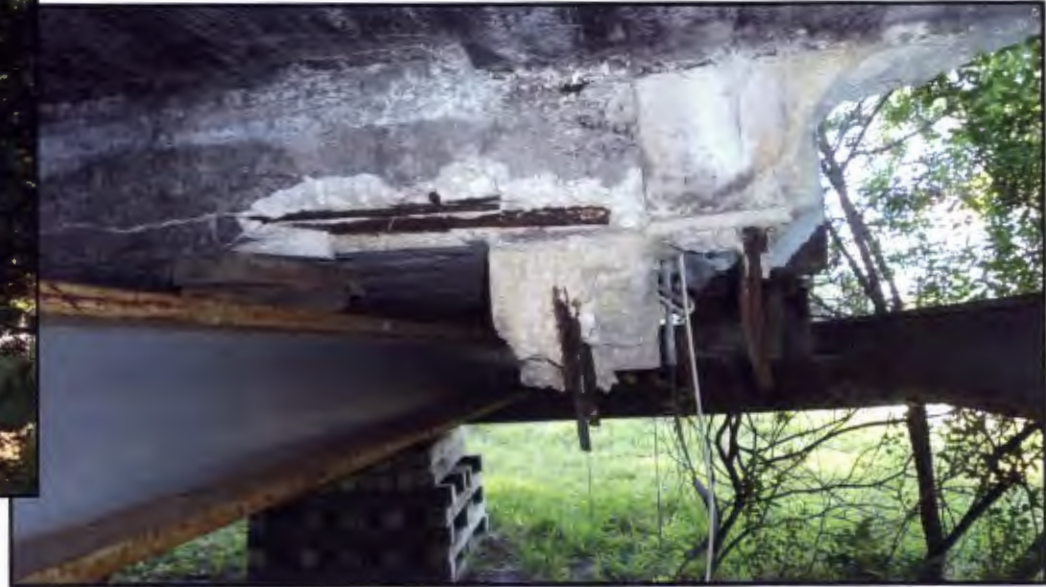
Foundation Cracks/ Parts Falling off

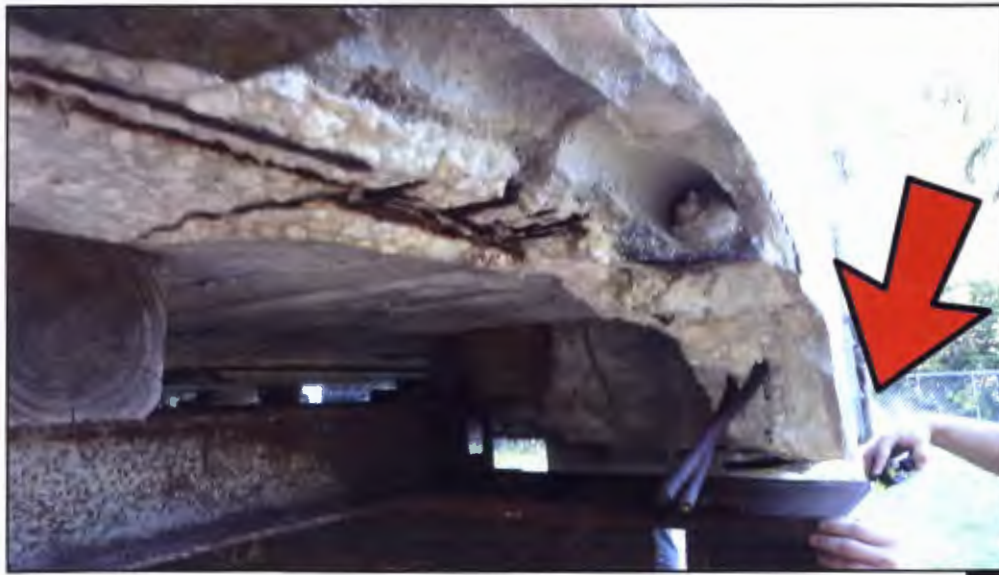
Foundation pulling away from wall

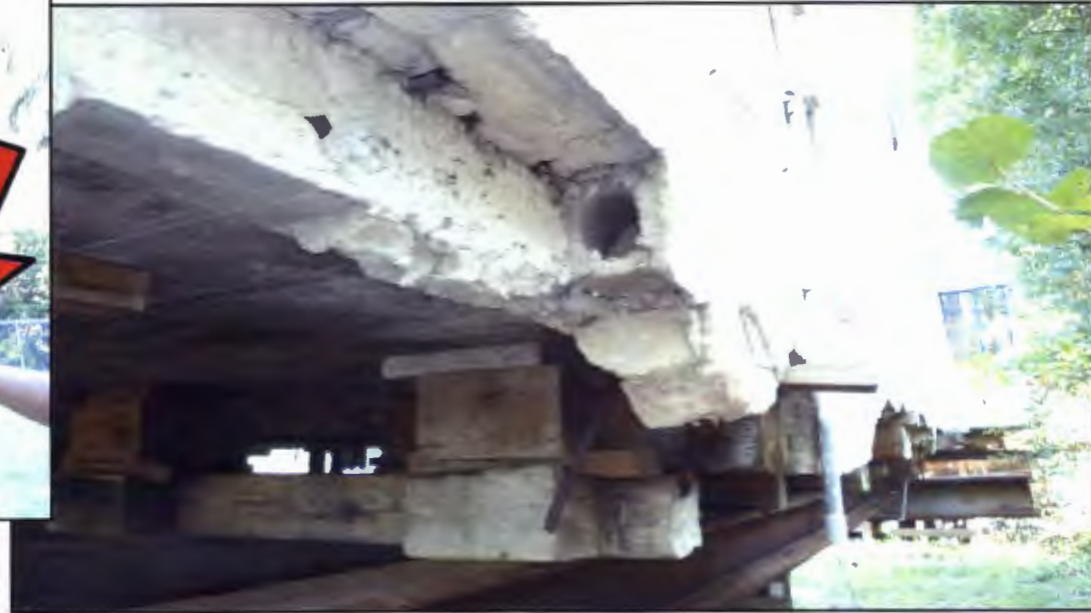
Foundation Cracks/ Parts falling off

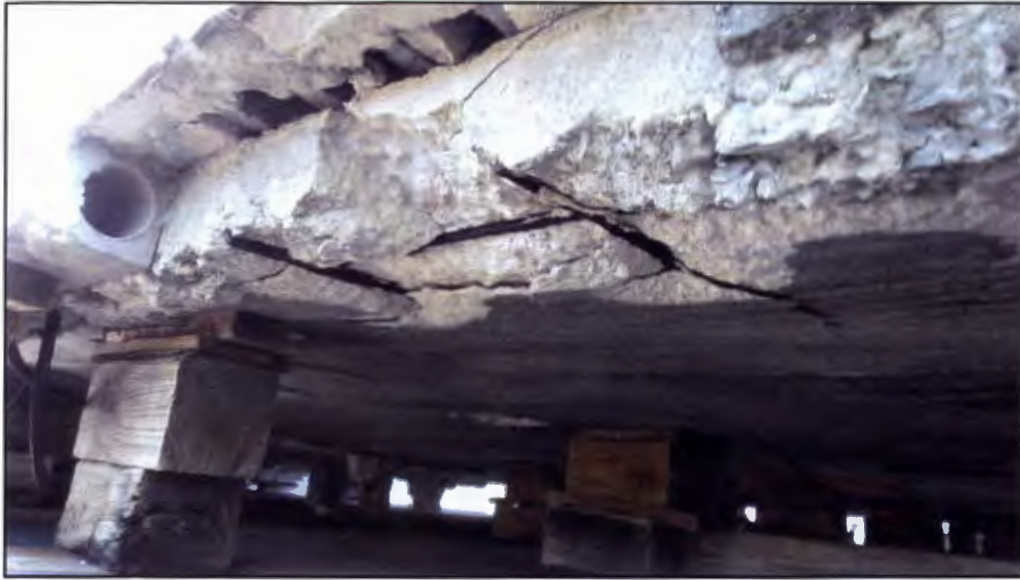
Foundation sprawling and wall and floor separated

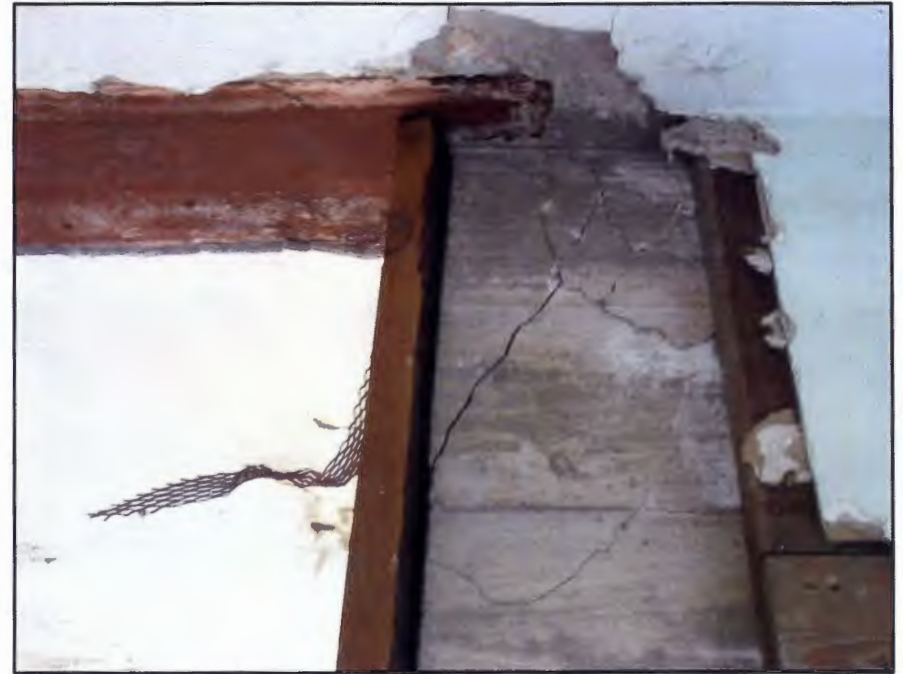
Major cracks in support beams

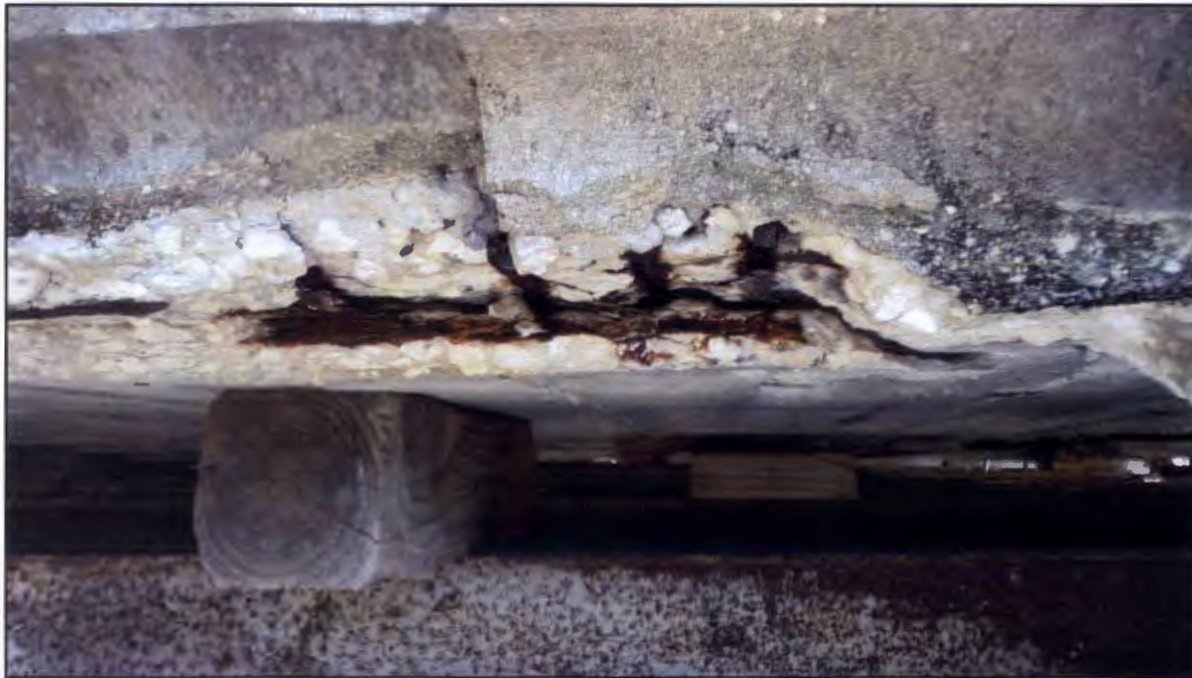
Major cracks in foundation

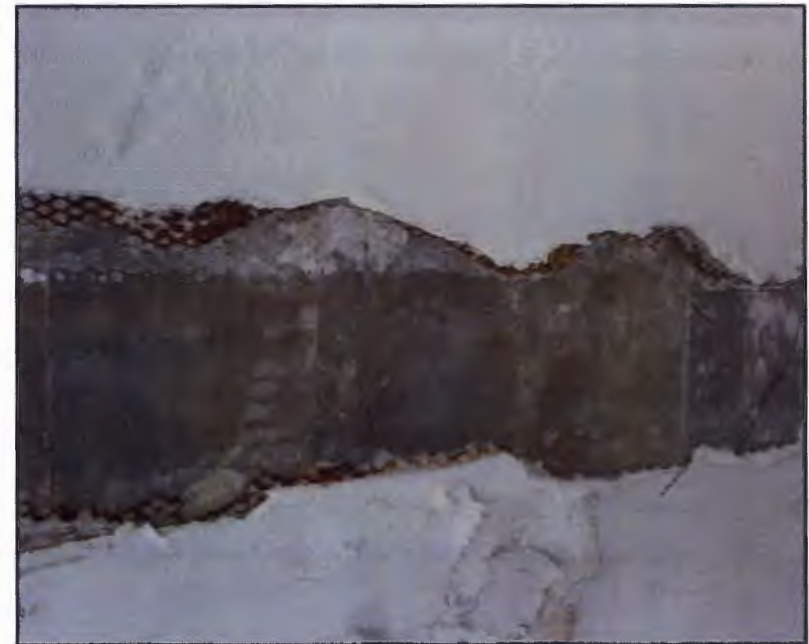
Ceiling cracking where walls were removed
8 years ago

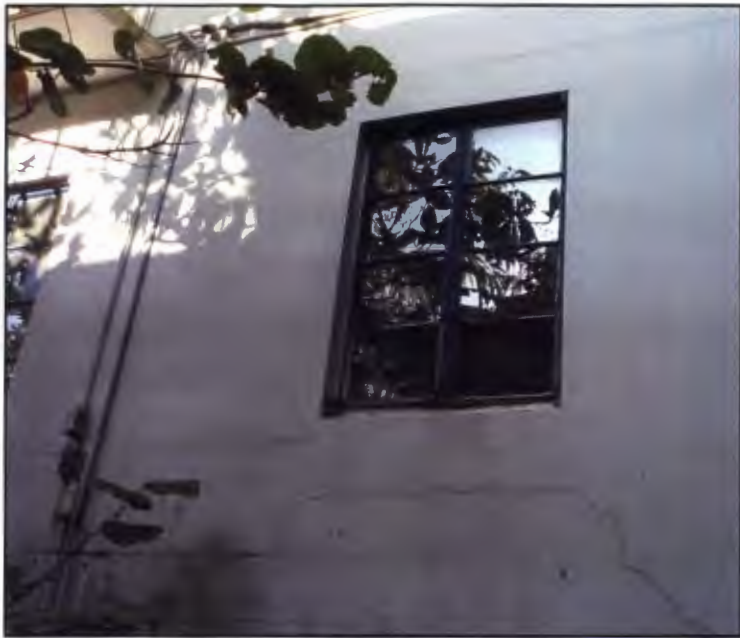
East wall Cracking

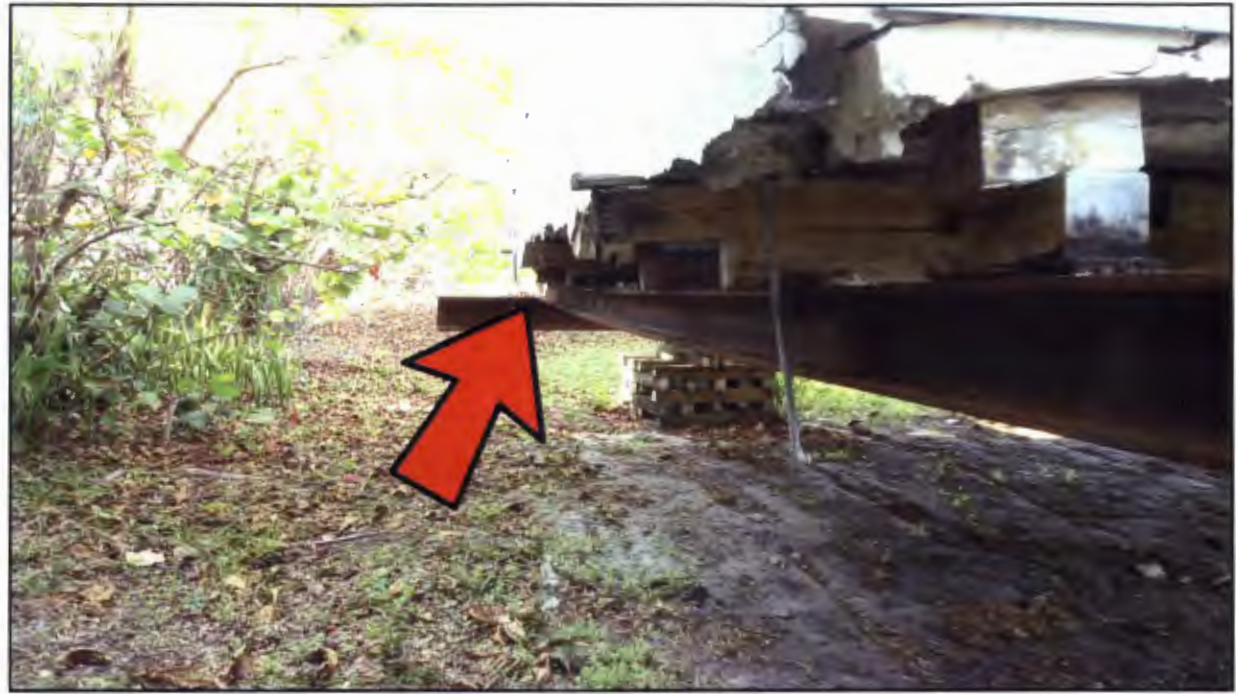
East side bowing under stress and cracked foundation and wall

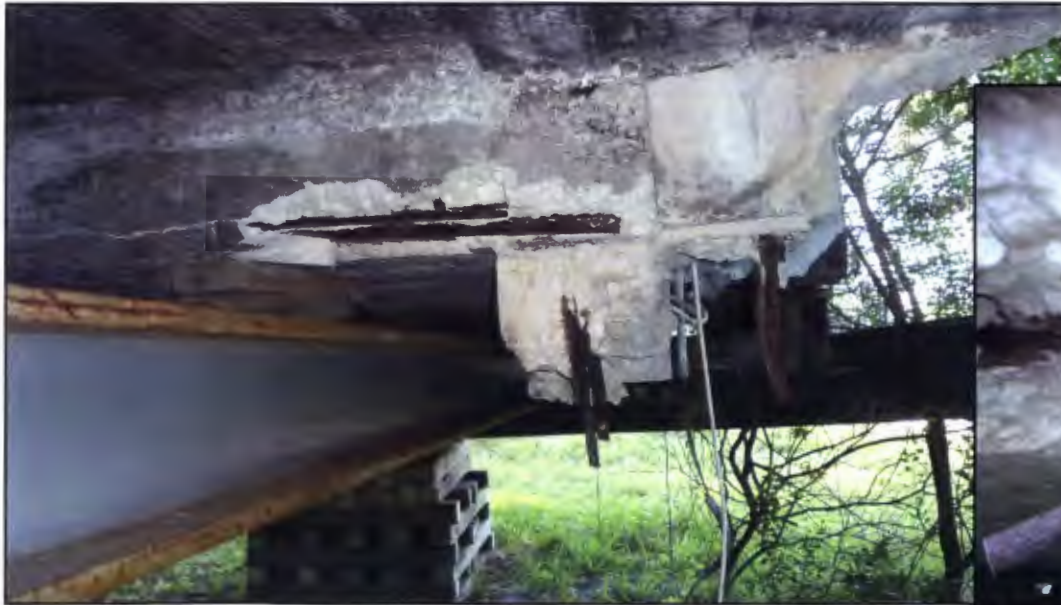
Foundation Cracking and parts falling off

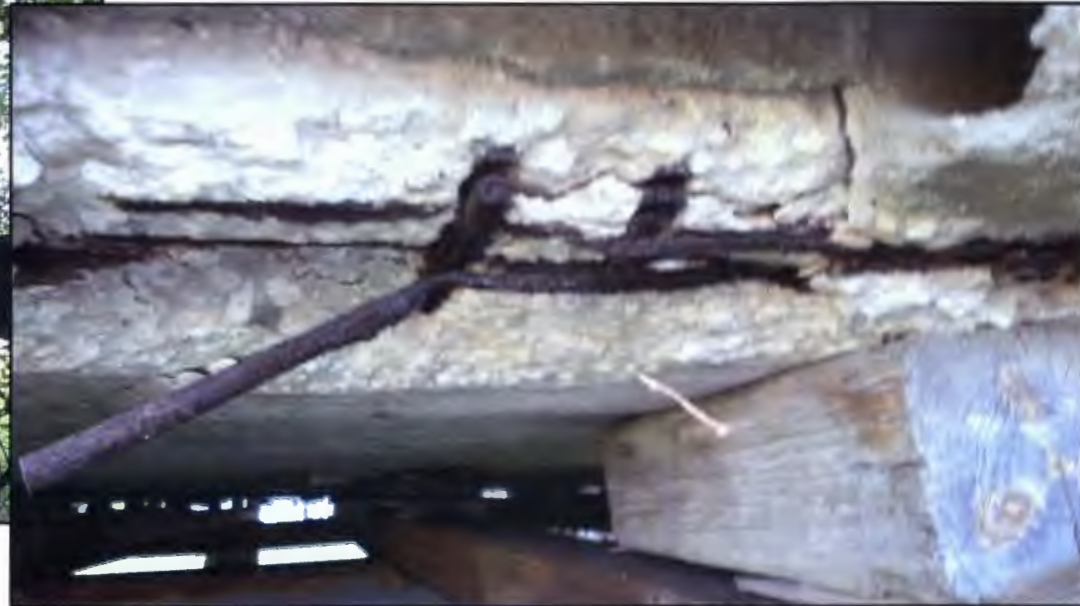
Floor Cracking and falling off

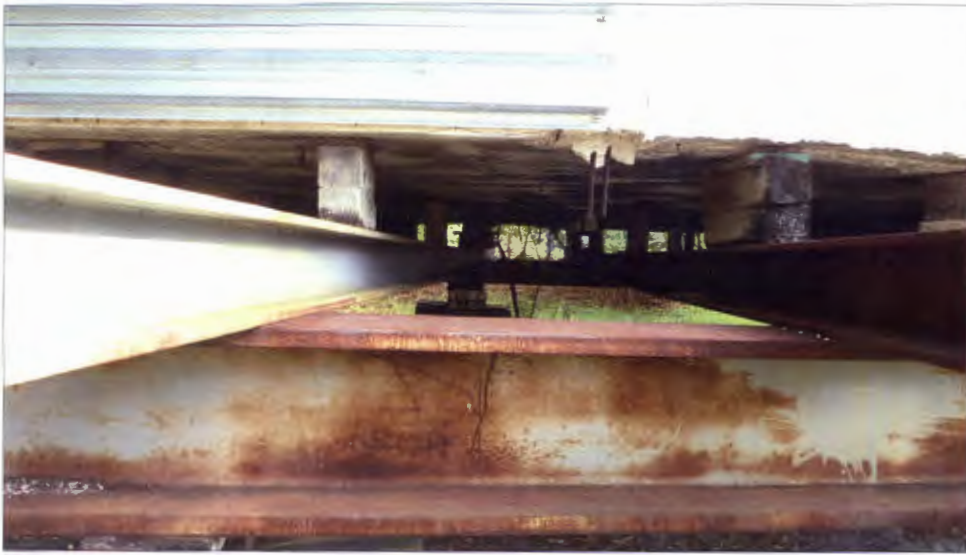
More bending of the steel over time
