The lot at 716 Bryan Place (AKA SW 4th Place) in Fort Lauderdale currently has the structure that was once part of the property now up on wood blocks and steel about 5' off the ground. Although it is always best to try and reuse a structure for both historic and ecological value, this particular structure was allowed to be moved, and then left to deteriorate and is now in a state that would make it totally unfeasible to reuse.

716 SW 4th Place, Fort Lauderdale, FL

Detailed Building and Site Condition Assessment

Property Address: 716 SW 4th Place
Fort Lauderdale, FL 33312
Inspection Date: May 2, 2013

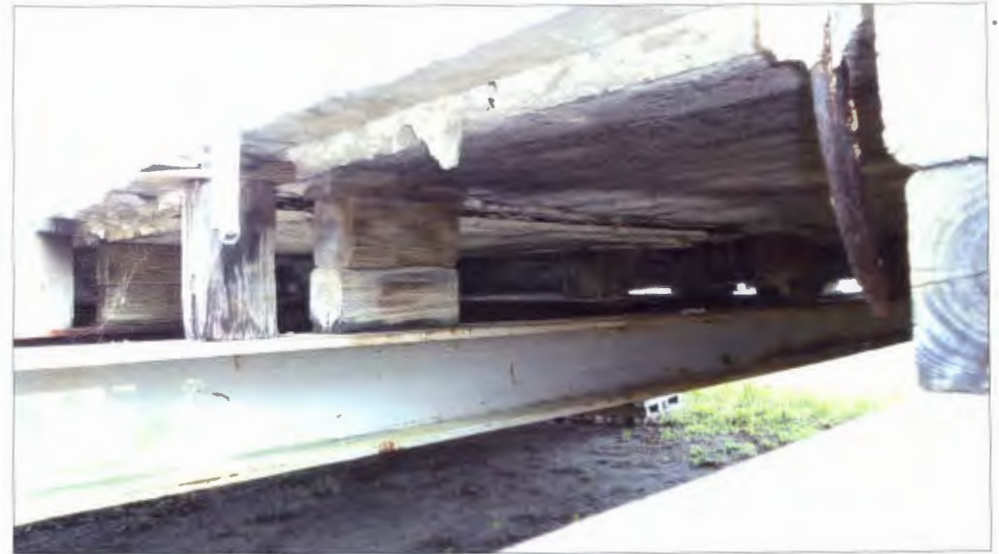
Rebar rusting

Visual observations from the underside of the concrete slab shows the points where it was cut away from its foundation piles during the initial movement. All the cut piles have exposed steel rebar causing them to corrode for many years in the salty environment. Major corrosion can be seen on the visibly exposed rebar. Corrosion to this extent may have also jeopardized the structural integrity of the adjacent rebar that cannot be seen by the naked eye. It is likely more structural damage will be endured if this building was to be set again on a new foundation.

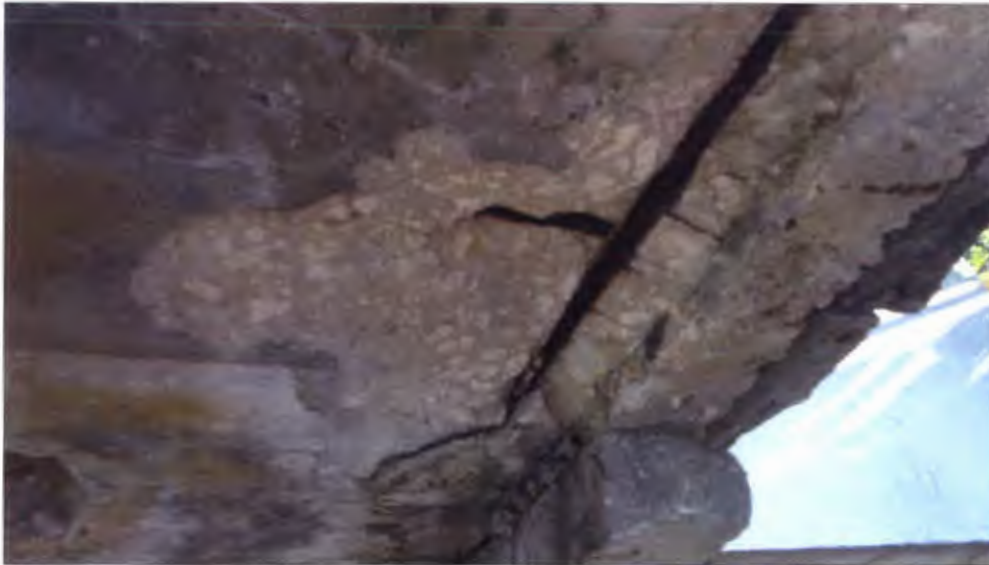
Rusting rebar breaking up concrete

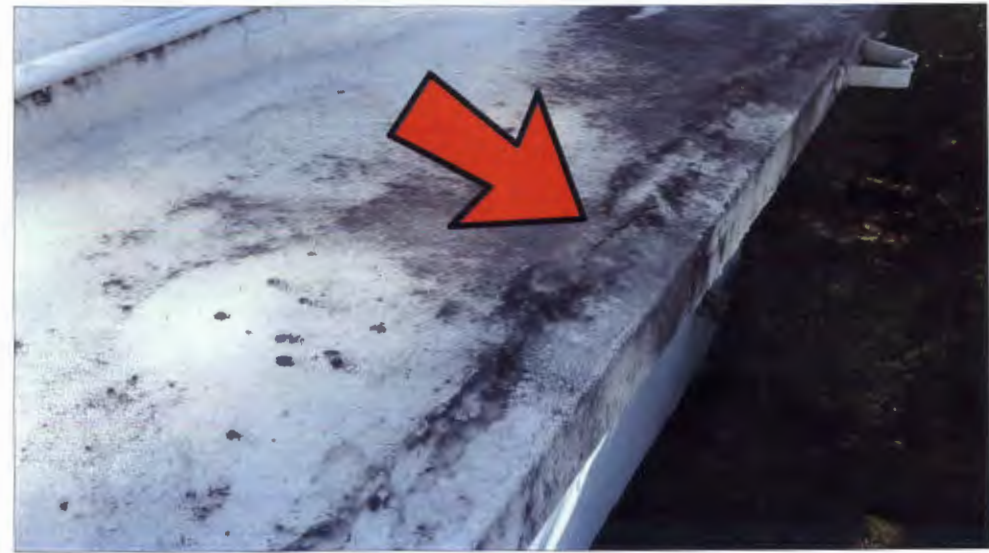
Roof edge separating

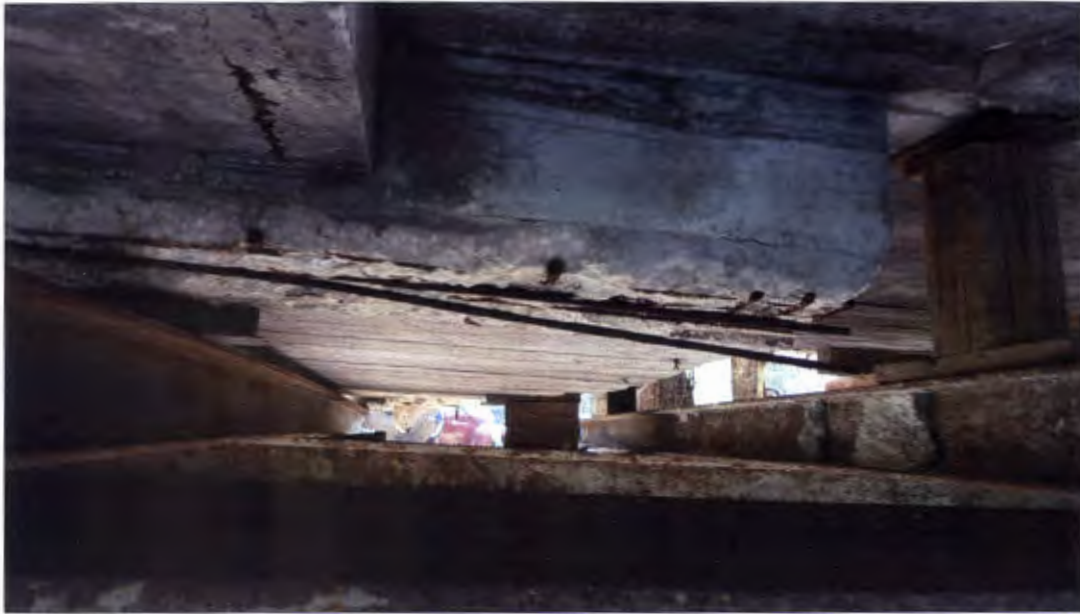
Rusting rebar on the floor

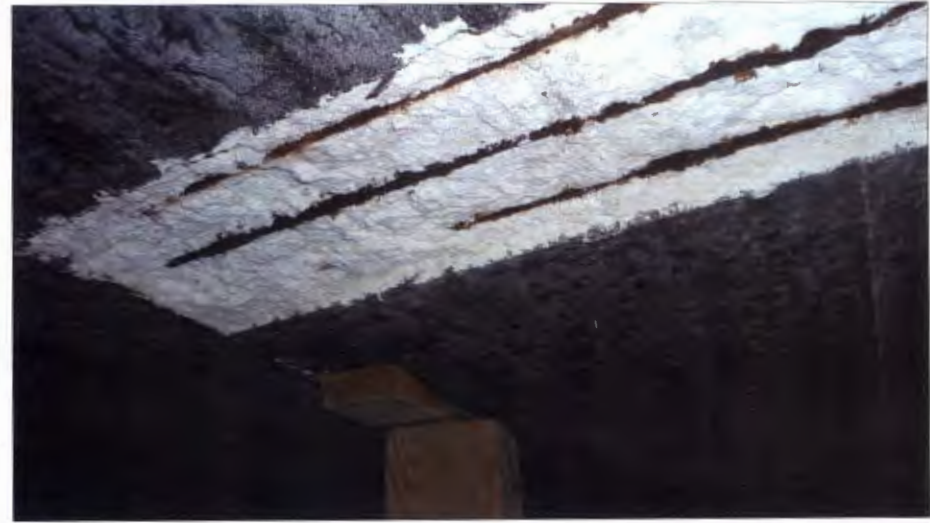
Test area rusted rebar

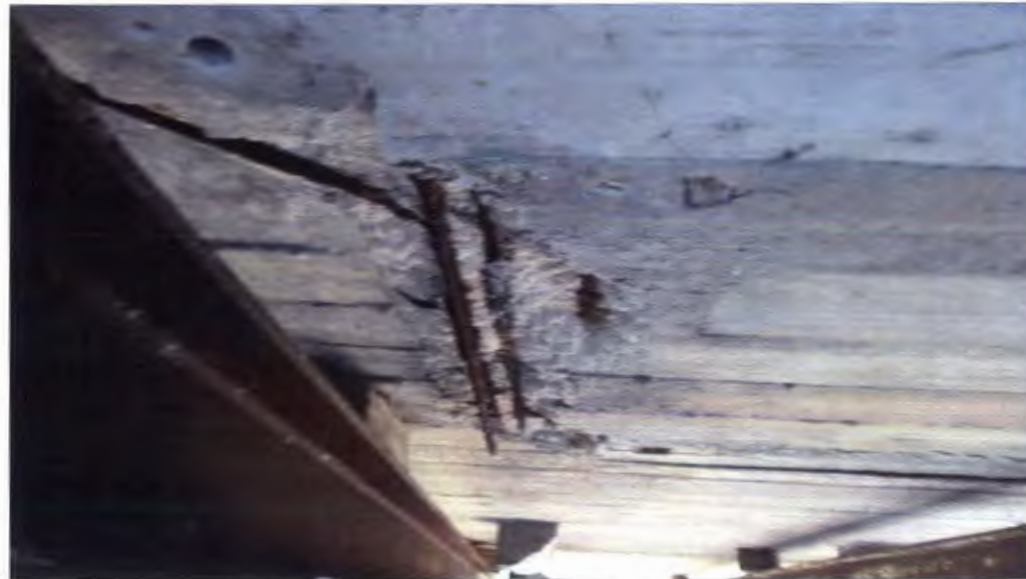
Rusting rebar

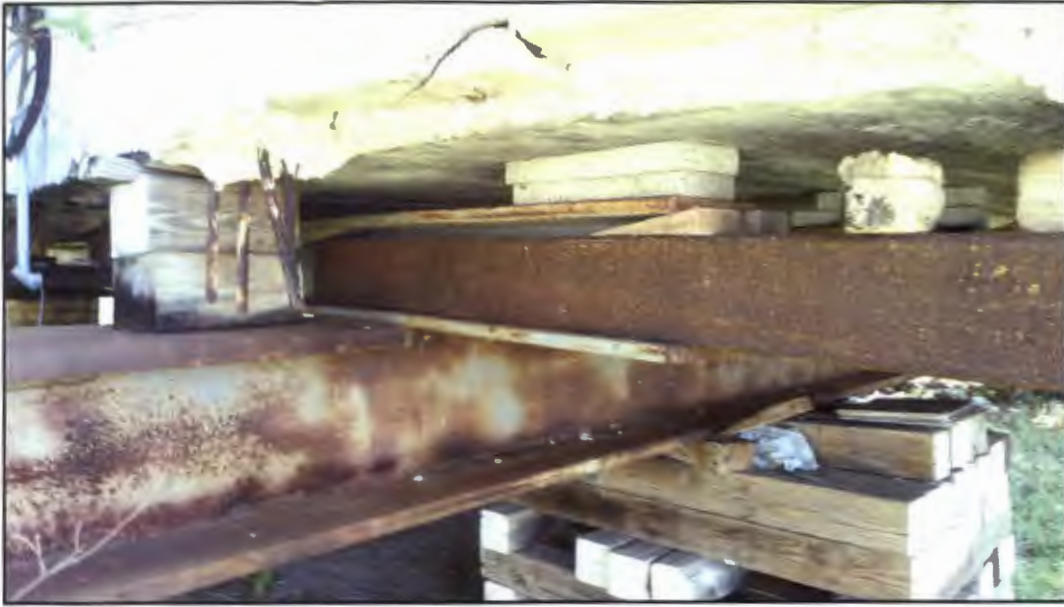
Unsafe Beam Extensions causing the cracks to get worse

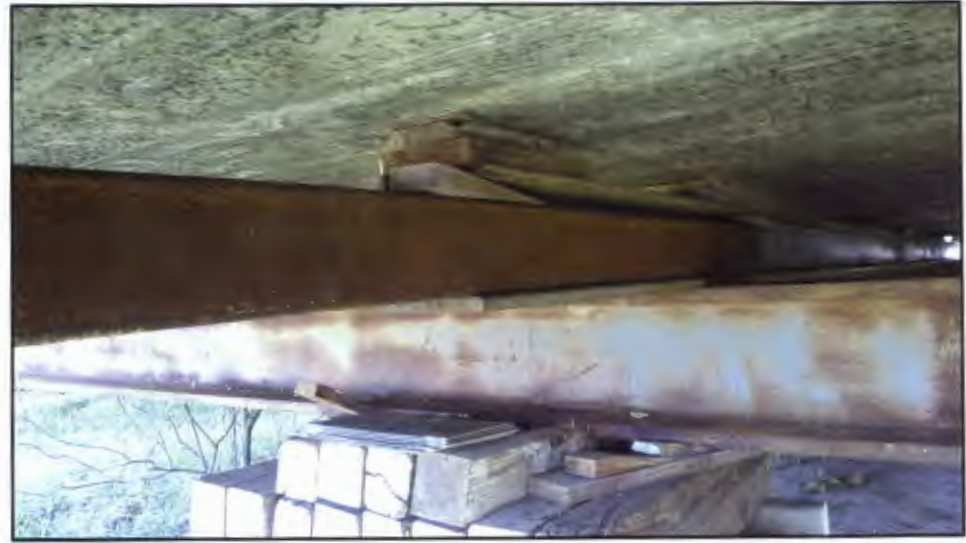
Unsafe Beam Extensions

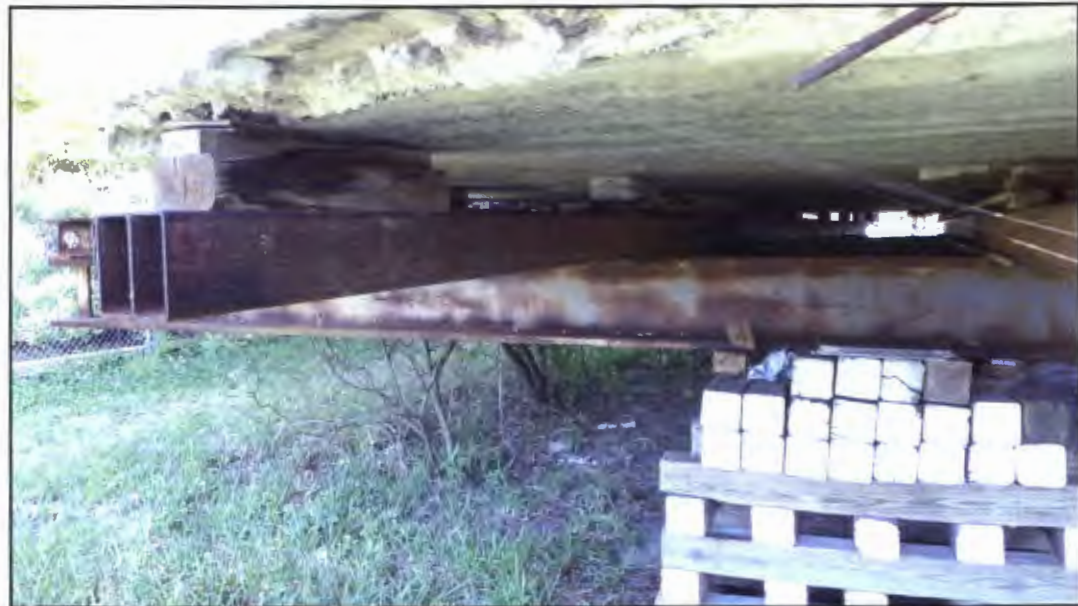
Unsafe Beam Extensions 2
