**TO:** Honorable Mayor and Members of the Fort Lauderdale City Commission  
**FROM:** Rickelle Williams, City Manager *RW*  
**DATE:** May 5, 2025  
**SUBJECT:** New Police Headquarters — Phase 2 Peer Review

Draft Report

April 22, 2025  
WJE No. 2024.4855.0

**Fort Lauderdale Police Headquarters**  
WJE Peer Review, Phase 2 – Building Structural Design Peer Review

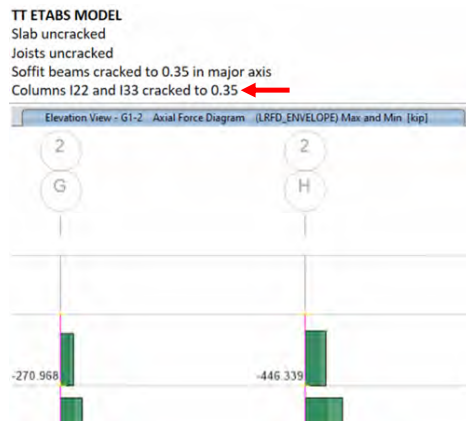
Figure 3. Image from the file "2025311\_FLPH Column H-2 and J-2 Validation.pdf" (dated March 11, 2025) prepared by the SEOR which indicates that they used a flexural stiffness modifier of 0.35 for reinforced concrete columns along Gridline 2

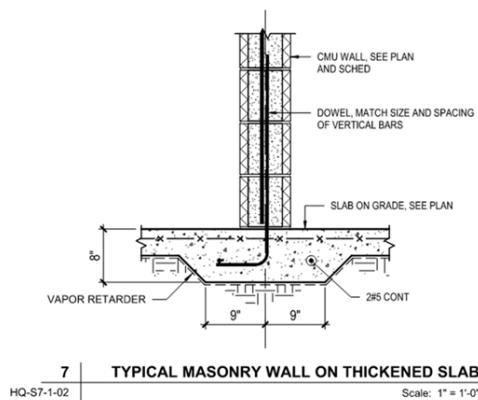
Figure 4. Detail 7 from Sheet HQ-S7-1-02 which shows CMU wall bearing on thickened slab-on-ground. Note that there is a vapor retarder under the slab-on-ground supporting the partition masonry walls

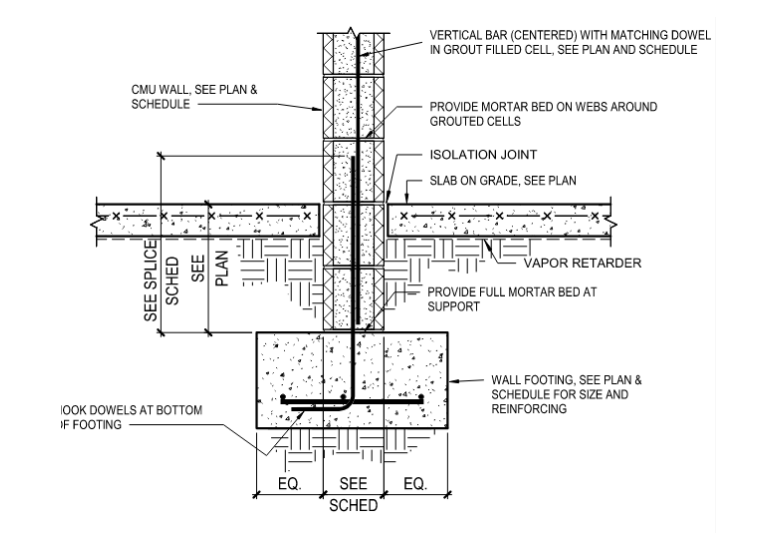
Figure 5. Detail 2 from Sheet HQ-S6-1-03 which shows CMU wall foundation for wall footings that have WF# designation on the foundation plans. Note that the vapor retarder under the slab-on-ground does not pass under the wall footing

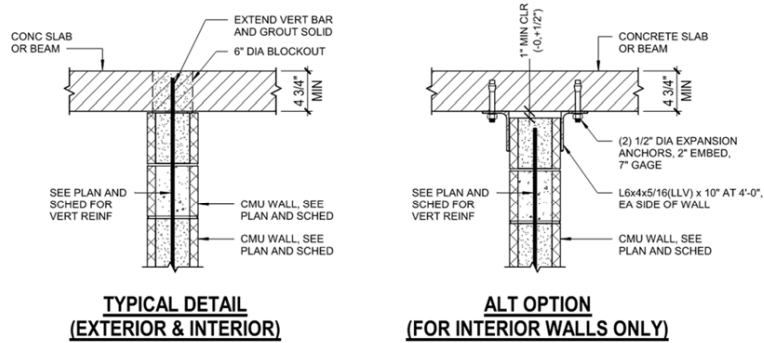
6 | **TYPICAL TOP OF WALL BRACING - CONCRETE STRUCTURE**  
 HQ-S7-1-02 | Scale: 1" = 1'-0"

- None of the connections of the partition masonry walls (i.e., not including the bearing wall in the community room and the masonry core wall in the main structure) to the diaphragm shown in the structural drawings (Detail 6 of Sheet HQ-S7-1-02) or noted in the special inspection reports (i.e., PTA anchors) satisfy ACI 318-14 Section 12.5.3.7. In other words, these connections do not satisfy the shear-friction provisions of ACI 318, which invalidates the masonry walls as code-compliant contributors to lateral resistance.

Figure 7. Detail 6 of Sheet HQ-S7-1-02 which shows two options for connecting the partition CMU walls to the elevated slabs or beams

For the reasons outlined above, we recommend that the SEOR reevaluate the adequacy of the FLPHQ without considering the partition masonry walls as part of the lateral force-resisting system. Note that WJE has *not* considered these partition masonry walls as contributing to the lateral force-resisting system when evaluating the FLPHQ and developing our findings. If the SEOR abandons the approach of attempting to use the partition masonry walls as part of the lateral force-resisting system, then adding the full-height shear wall and rectifying the foundations as noted above in Items 1 and 2, and properly designing them for predicted demands is expected to be sufficient to resolve Item 15.

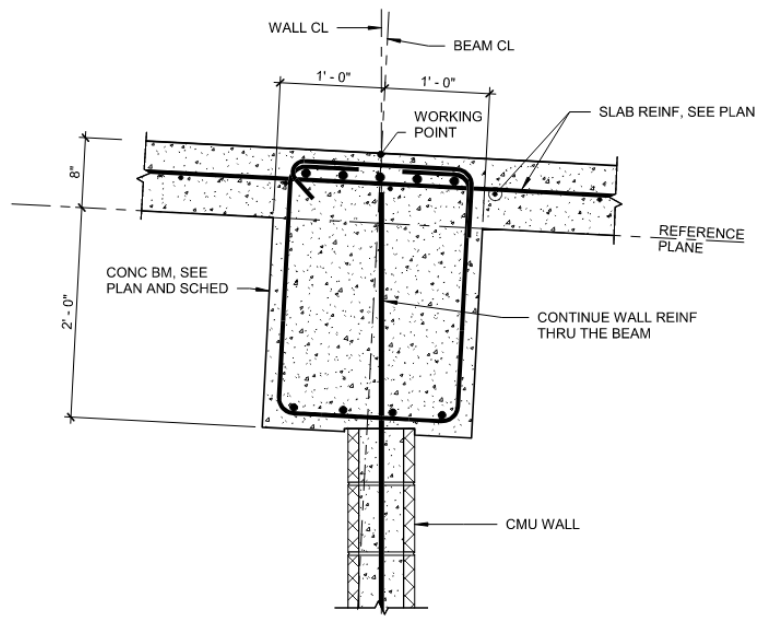
Figure 11. Detail 3 from Sheet HQ-S4-3-04, dated November 15, 2023 showing connection between top of CMU wall and reinforced concrete beam overhead in Area E. Note that the vertical wall reinforcement is well-anchored above the CMU wall to permit shear forces from the diaphragm to be transferred into the wall through shear friction

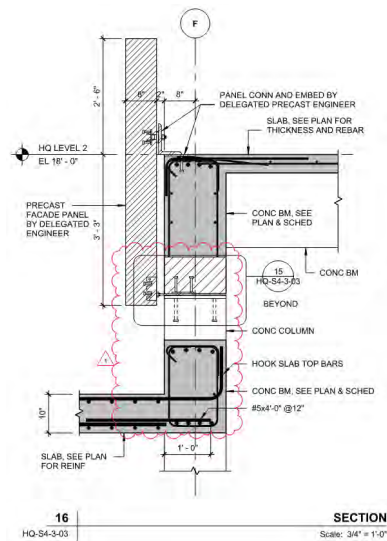
4. **Slide Bearing Capacity.** The bearing stress in the slide bearings on Gridline F (adjoining the community room and lobby area to the main structure of the FLPHQ) exceeds the manufacturer's published allowable capacity when subjected to design loads. Since the design demand exceeds the manufacturer's published design capacity, these bearings are not code-compliant. This condition can be rectified by replacing the existing bearings with a higher-capacity system. Replacement of the bearings may also require rectifications at the top of the stub column below the bearing to accommodate the size and thickness of the new bearing. This rectification should be completed before the building is occupied (0 to 6 months). We also recommend that the SEOR comments on the ranges of temperature and exposure conditions which the slide bearings will be subjected to and how those ranges will affect bearing performance. The SEOR should also provide the peak lateral displacement expected across the slide bearing under factored design level loads and/or thermal temperature differences for review.

Figure 12. Section through joint between Area E and the main building of the FLPHQ showing the lower beam from Area A the stub column above, and the upper beam from the main building of the FLPHQ. The slide bearing is located at the top of the stub column

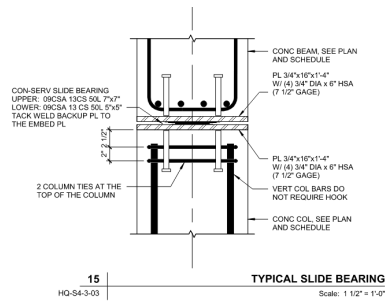
Figure 13. Detail of slide bearing noting the manufacturer (Con-Serv) and the size of the lower portion of the bearing (5 inches by 5 inches)

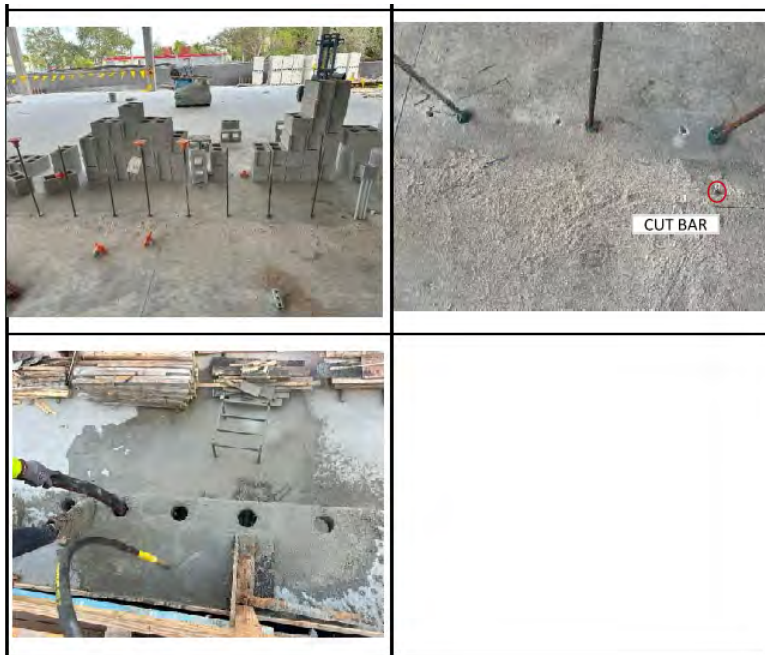
Figure 16. Photographs from Threshold Inspection Report No. 073 showing bars doweled 3 inches into slab-on-ground after original bars were mislocated (top photographs), and filling of grouted cells (bottom photograph)

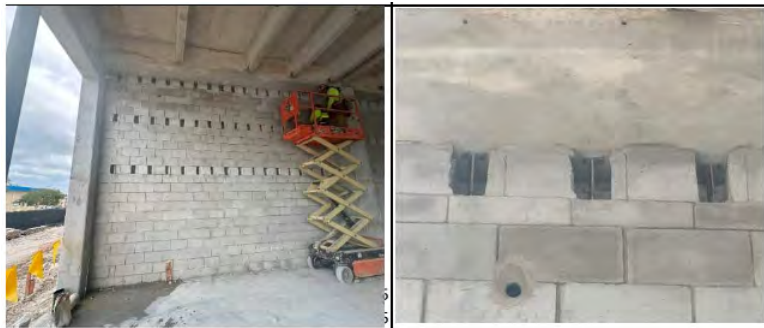
Figure 17. Photographs from Threshold Inspection Report No. 081. Left photograph shows overall wall construction on first story at one location. Right photograph shows the PTA anchors at the top of the wall. Note that two screws are used to connect each anchor to the above element

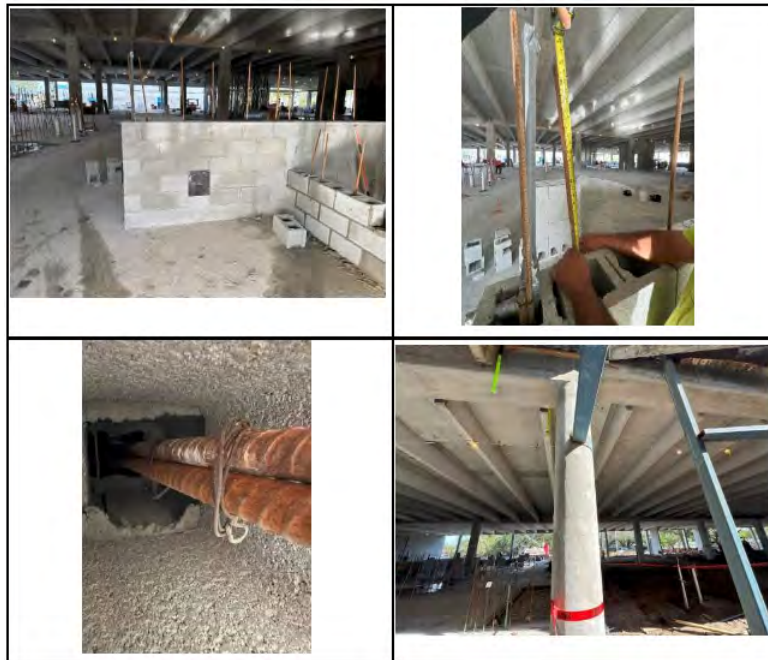
Figure 18. Photographs from Threshold Inspection Report No. 084. Upper photographs and lower right photograph appear to be of the first story prior to full installation of CMU walls. Note the lack of shoring indicating that the CMU walls were not constructed as bearing walls

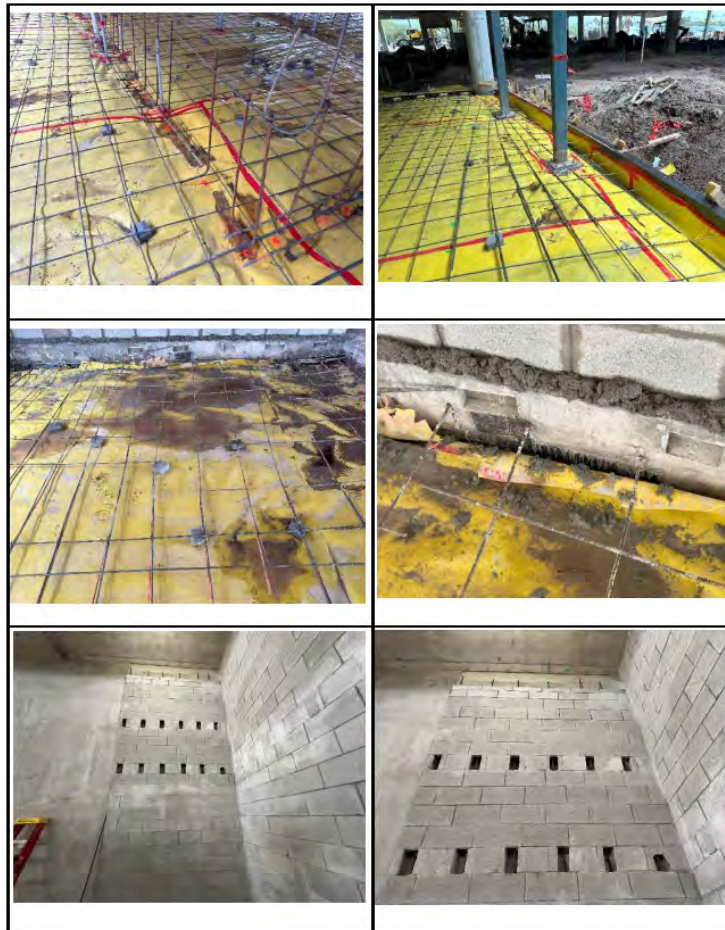
Figure 19. Photographs from Threshold Inspection Report No. 087 showing issue noted by inspector at thickened slab under CMU wall in upper left photograph and reinforcement not extending to the bottom of the slab above in the bottom two photographs

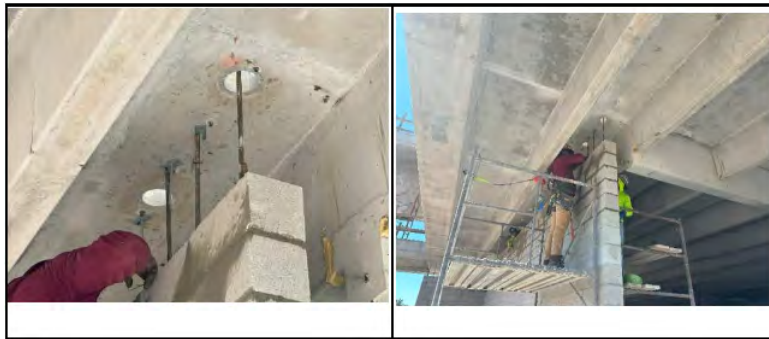
Figure 20. Photographs from Threshold Inspection Report No. 099 showing issue noted by inspector at top of "HQ Level 3 South CMU wall". Note PTA anchors and connection of vertical masonry bars to above slab in left image. Note that the bars are generally spliced to anchors attached to the slab with screws

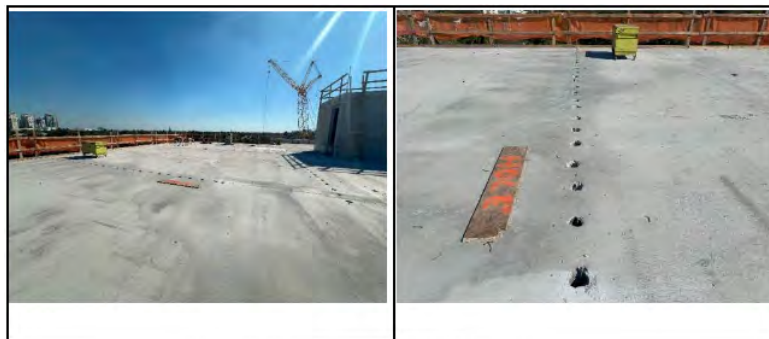
Figure 21. Photographs from Threshold Inspection Report No. 101. While not clearly stated in the report, these images are believed to be of the third floor slab

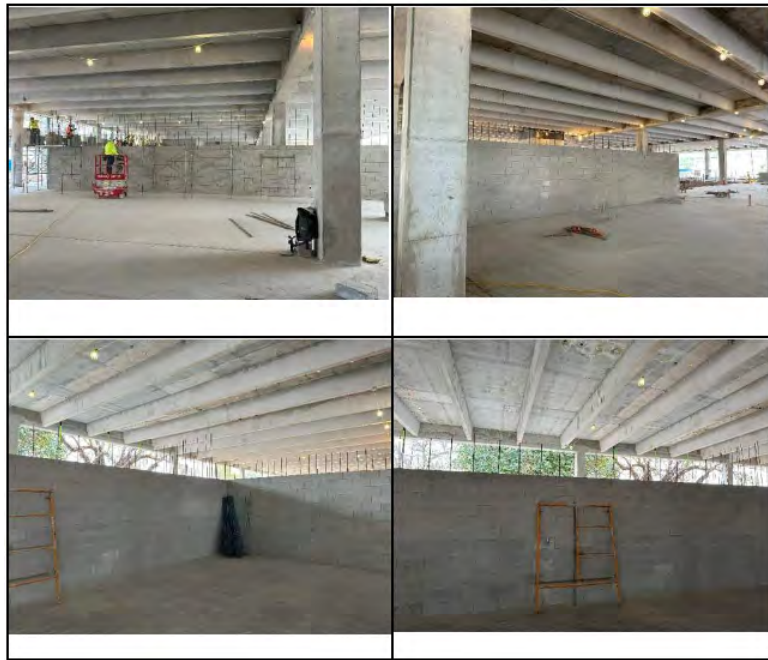
Figure 22. Photographs from Threshold Inspection Report No. 103 showing first story CMU walls under construction. Note the lack of shoring indicating that the CMU walls were not constructed as bearing walls

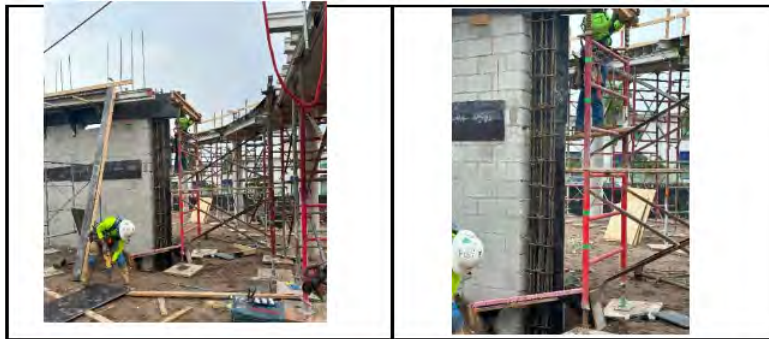
Figure 23. Photographs from Threshold Inspection Report No. 105 showing CMU wall in Area E under construction. Since the wall is being constructed prior to the roof structure, this CMU wall will take load from the roof structure as a bearing wall

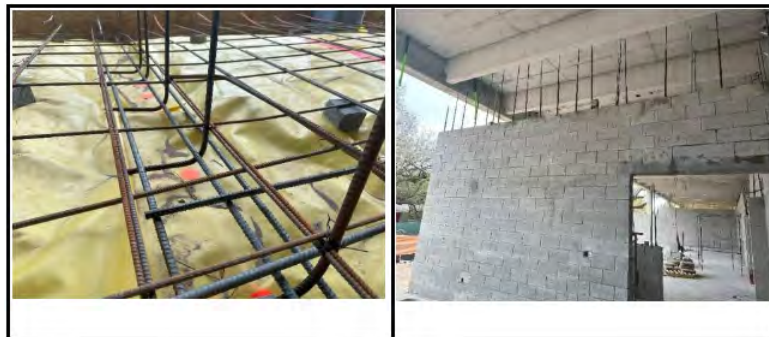
Figure 24. Photographs from Threshold Inspection Report No. 107. The photograph on the left shows hooked dowels at a thickened slab location under a wall. The inspector noted that the dowels needed to be shifted downwards. The photograph on the right shows a CMU wall in the first story under construction. Note that no shoring of the structure above is present, indicating that the CMU wall was not constructed as a bearing wall

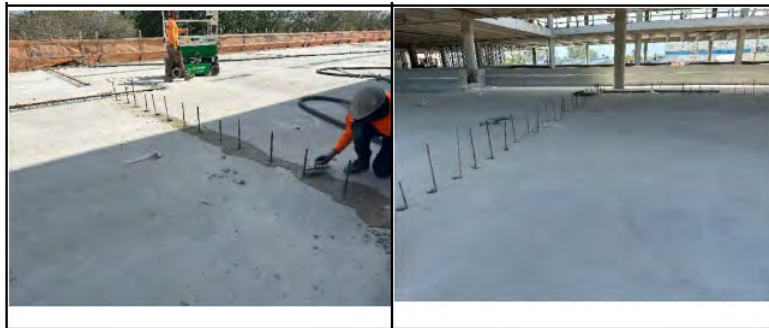
Figure 25. Photographs from Threshold Inspection Report No. 109 showing dowels extending through cored holes in slab. These dowels appear to be from the CMU wall below

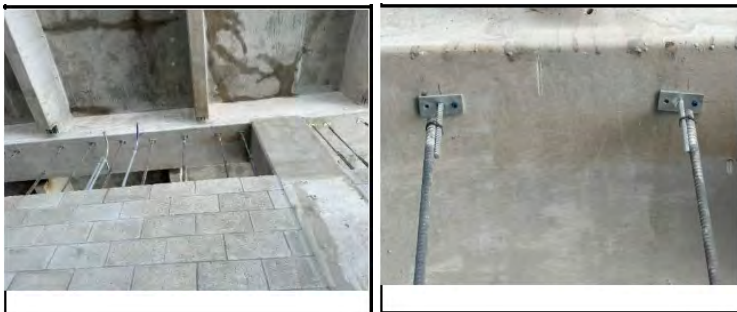
Figure 26. Photographs from Threshold Inspection Report No. 123 showing PTA connectors at bottom of soffit beam with only one screw attaching the plate of the anchor to the soffit beam

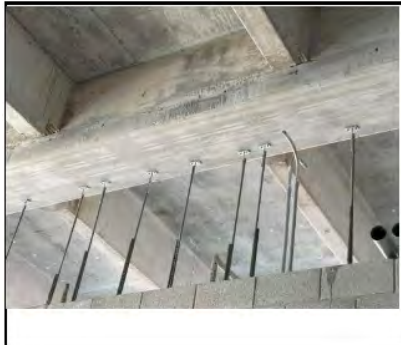
Figure 27. Photograph from Threshold Inspection Report No. 125 showing PTA connectors at bottom of soffit beam with the two screws attaching the plate of the anchor to the soffit beam

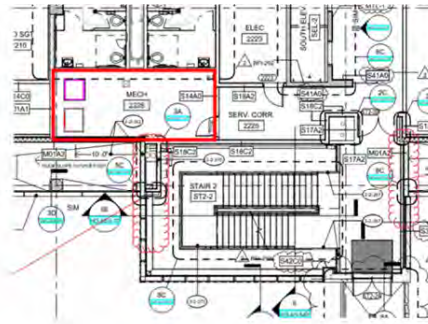
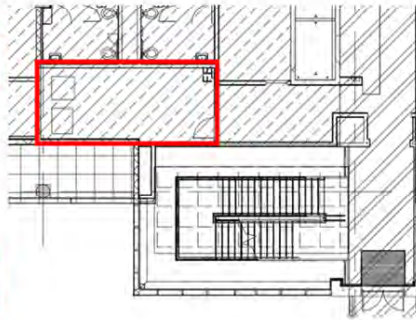
14. **Mechanical Equipment.** In addition to the loading discrepancy noted in Item 8 above regarding equipment weight versus uniform live loads, there is an area bounded by Gridlines H, J, 14, and 16 on Level 2 that is designated in the architectural drawings, but not in the structural drawings, as

Figure 30. Possible inconsistency between architectural drawings (top) and structural drawings (bottom) regarding the location of mechanical equipment. Note that the architectural drawings designate Room 2226 on Level 2 as a mechanical room; however, the structural drawings indicate that a General live load rather than a Mechanical live load was used to design that area

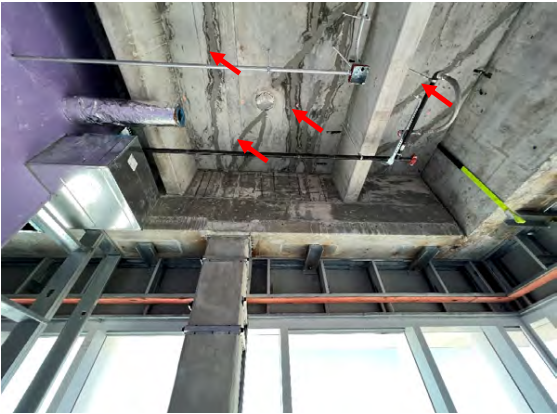
Figure 33. Example of cracks (see red arrows) in the reinforced concrete slab (at the roof) which have been repaired

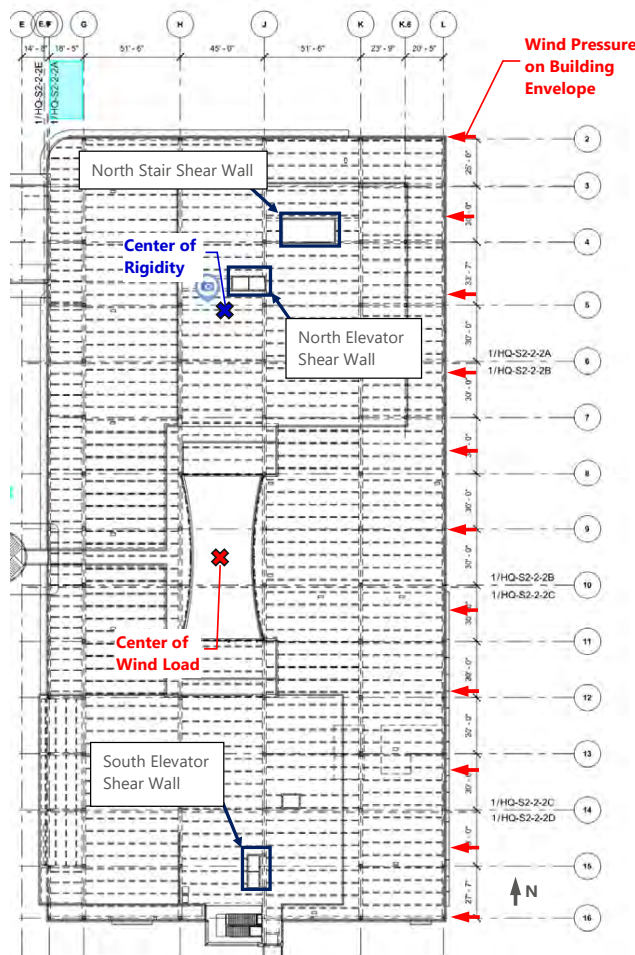
10. **Building Period.** Due to the relatively small length of shear wall in the southern half of the main building of the FLPHQ, the fundamental period of vibration of the building is over 0.9 seconds (which is significantly larger than typical concrete shear wall buildings having no more than three stories). The fundamental mode also corresponds with a twisting response of the structure. While this condition does not violate any code-prescribed performance limitations, it is not standard practice to design structures to perform this way. Adding an appropriately designed full-height shear wall (i.e., from foundation to roof) to the structure (as previously described) will rectify this condition.

Figure 34. Plan view of FLP HQ showing the approximate locations of the center of rigidity and east-west wind loads. Due to eccentricity between the two, the structure twists

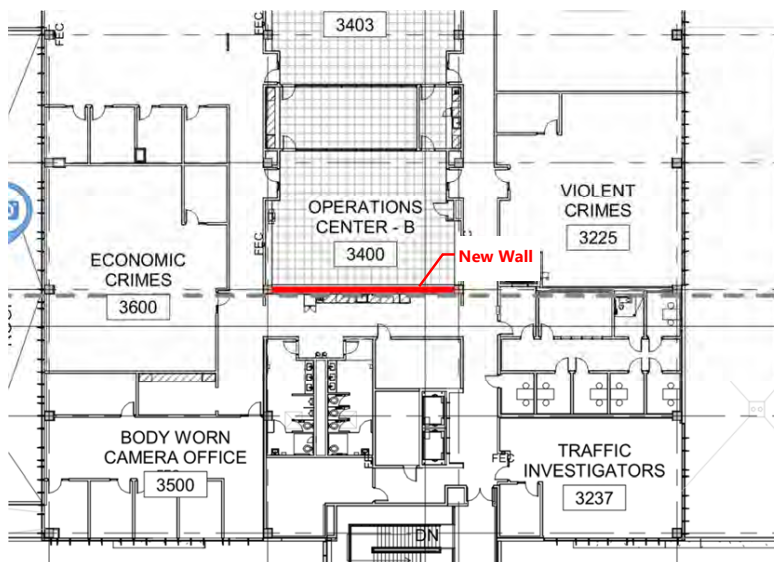
1. **Shear Wall Capacities.** The southern-most reinforced concrete core wall is not code-compliant for one-way shear strength or flexural strength between Levels 1 and 2. Adding a properly designed full-height shear wall (i.e., from foundation to roof) with an accompanying foundation to the structure on Gridline 14 between Gridlines H and J can rectify this condition. Rectification of this condition should be carried out *as soon as possible* (0 to 2 months) and should be completed before the building is occupied. Note that, contrary to the position of the SEOR, we do *not* believe that the concrete masonry unit (CMU) partition walls are a reliable part of the lateral load-resisting system. We have provided other findings related to the use of these CMU walls in the Documentation section below.

Figure 40. One potential location for the proposed new reinforced concrete shear wall

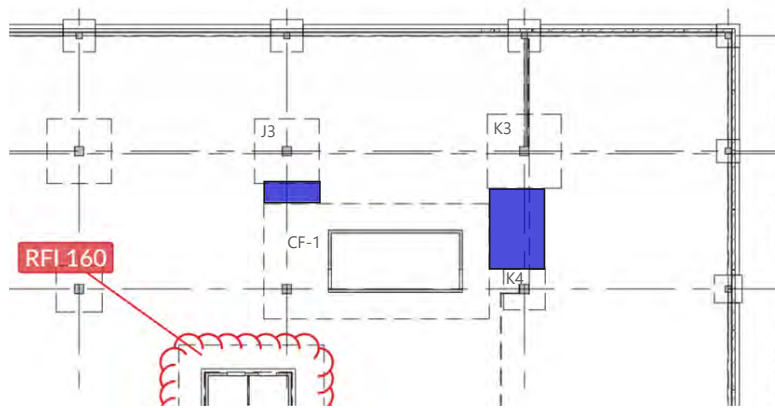
2. **Foundation Capacities at Shear Walls.** The mat foundations for the concrete shear walls around the north stair shaft (designated as CF-1 on the structural drawings) and the south elevator shaft (CF-3) all have lateral demands that exceed the allowable design capacity under design wind loads in the east-west direction and are therefore not code-compliant. Adding the aforementioned shear wall to the building can rectify conditions related to the south elevator shaft but not the sliding exceedance at the north stair shaft. Attaching mat footing CF-1 to its surrounding isolated

footings can rectify the sliding condition. Rectifications to the foundations should take place at the same time as those for the shear walls.

Figure 41. Conceptual rectification of sliding deficiency of mat footing CF-1. The mat footing is attached to nearby isolated footings (J3, K3, and K4) with new reinforced concrete (shown in blue font)
