**SUBJECT:** Police Headquarters WJE Clarification Letter – Phase 2 Peer Review Report – Life Safety Category

**Draft Report**

WJE No. 2024.4855.0

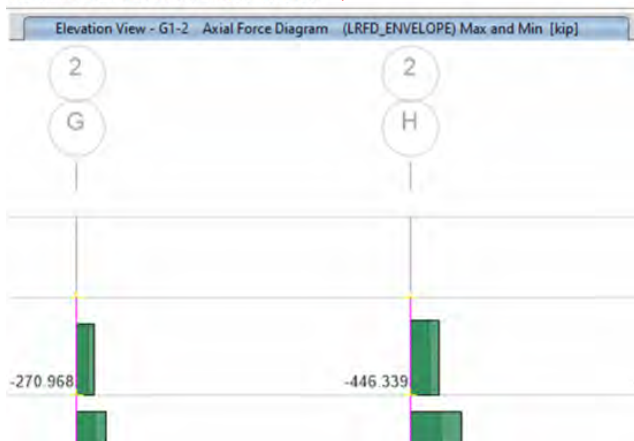
Soffit beams cracked to 0.35 in major axis

Columns I22 and I33 cracked to 0.35

Figure 3. Image from the file "2025311\_FLP Column H-2 and J-2 Validation.pdf" (dated March 11, 2025) prepared by the SEOR which indicates that they used a flexural stiffness modifier of 0.35 for reinforced concrete columns along Gridline 2

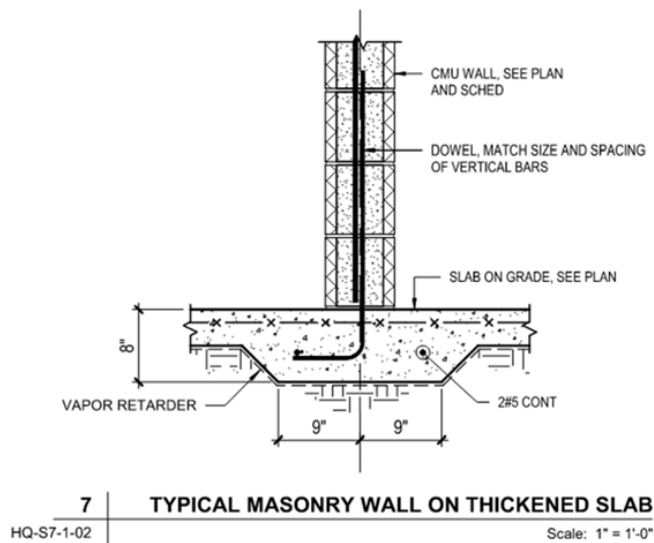
Figure 4. Detail 7 from Sheet HQ-S7-1-02 which shows CMU wall bearing on thickened slab-on-ground. Note that there is a vapor retarder under the slab-on-ground supporting the partition masonry walls

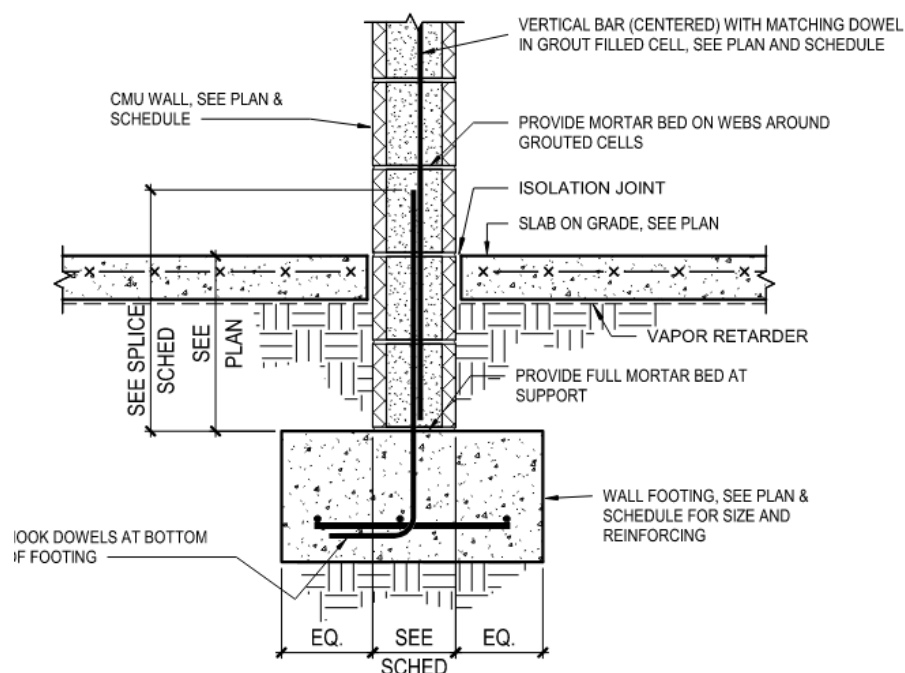
Figure 5. Detail 2 from Sheet HQ-S6-1-03 which shows CMU wall foundation for wall footings that have WF# designation on the foundation plans. Note that the vapor retarder under the slab-on-ground does not pass under the wall footing

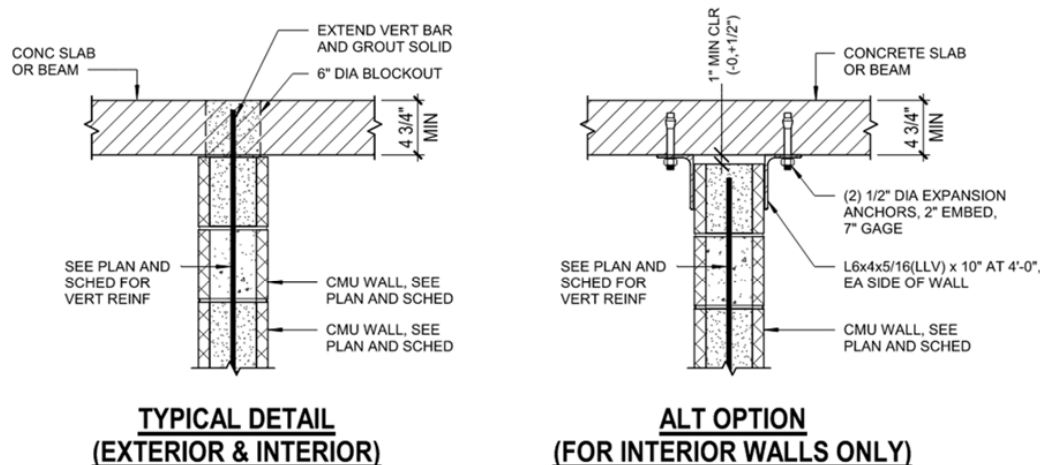
**6** | **TYPICAL TOP OF WALL BRACING - CONCRETE STRUCTURE**  
 HQ-S7-1-02 | Scale: 1" = 1'-0"

None of the connections of the partition masonry walls (i.e., not including the bearing wall in the community room and the masonry core wall in the main structure) to the diaphragm shown in the structural drawings (Detail 6 of Sheet HQ-S7-1-02) or noted in the special inspection reports (i.e., PTA anchors) satisfy ACI 318-14 Section 12.5.3.7. In other words, these connections do not satisfy the shear-friction provisions of ACI 318, which invalidates the masonry walls as code-compliant contributors to lateral resistance.

Figure 7. Detail 6 of Sheet HQ-S7-1-02 which shows two options for connecting the partition CMU walls to the elevated slabs or beams

For the reasons outlined above, we recommend that the SEOR reevaluate the adequacy of the FLPHQ without considering the partition masonry walls as part of the lateral force-resisting system. Note that WJE has *not* considered these partition masonry walls as contributing to the lateral force-resisting system when evaluating the FLPHQ and developing our findings. If the SEOR abandons the approach of attempting to use the partition masonry walls as part of the lateral force-resisting system, then adding the full-height shear wall and rectifying the foundations as noted above in Items 1 and 2, and properly designing them for predicted demands is expected to be sufficient to resolve Item 15.

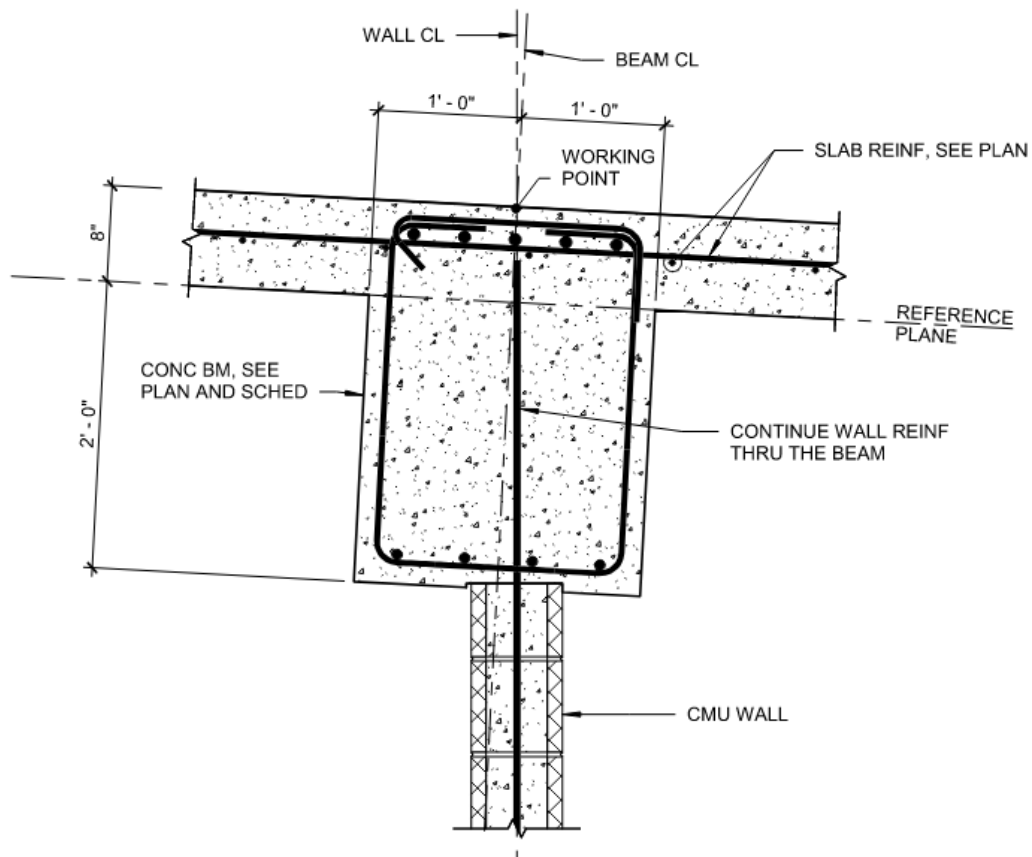
Figure 11. Detail 3 from Sheet HQ-S4-3-04, dated November 15, 2023 showing connection between top of CMU wall and reinforced concrete beam overhead in Area E. Note that the vertical wall reinforcement is well-anchored above the CMU wall to permit shear forces from the diaphragm to be transferred into the wall through shear friction

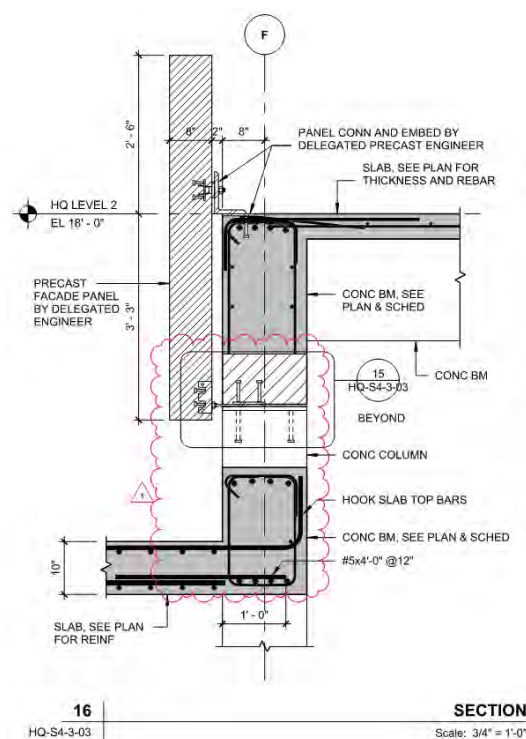
4. **Slide Bearing Capacity.** The bearing stress in the slide bearings on Gridline F (adjoining the community room and lobby area to the main structure of the FLPHQ) exceeds the manufacturer's published allowable capacity when subjected to design loads. Since the design demand exceeds the manufacturer's published design capacity, these bearings are not code-compliant. This condition can be rectified by replacing the existing bearings with a higher-capacity system. Replacement of the bearings may also require rectifications at the top of the stub column below the bearing to accommodate the size and thickness of the new bearing. This rectification should be completed before the building is occupied (0 to 6 months). We also recommend that the SEOR comments on the ranges of temperature and exposure conditions which the slide bearings will be subjected to and how those ranges will affect bearing performance. The SEOR should also provide the peak lateral displacement expected across the slide bearing under factored design level loads and/or thermal temperature differences for review.

Figure 12. Section through joint between Area E and the main building of the FLPHQ showing the lower beam from Area A the stub column above, and the upper beam from the main building of the FLPHQ. The slide bearing is located at the top of the stub column

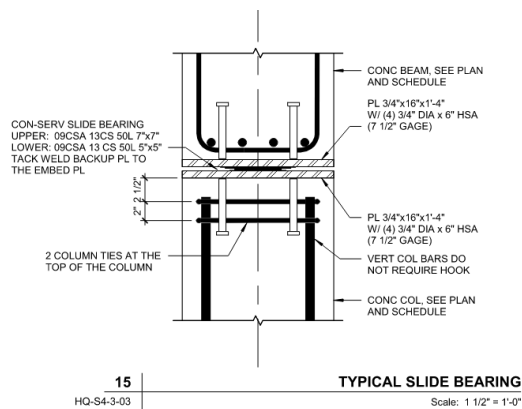
Figure 13. Detail of slide bearing noting the manufacturer (Con-Serv) and the size of the lower portion of the bearing (5 inches by 5 inches)

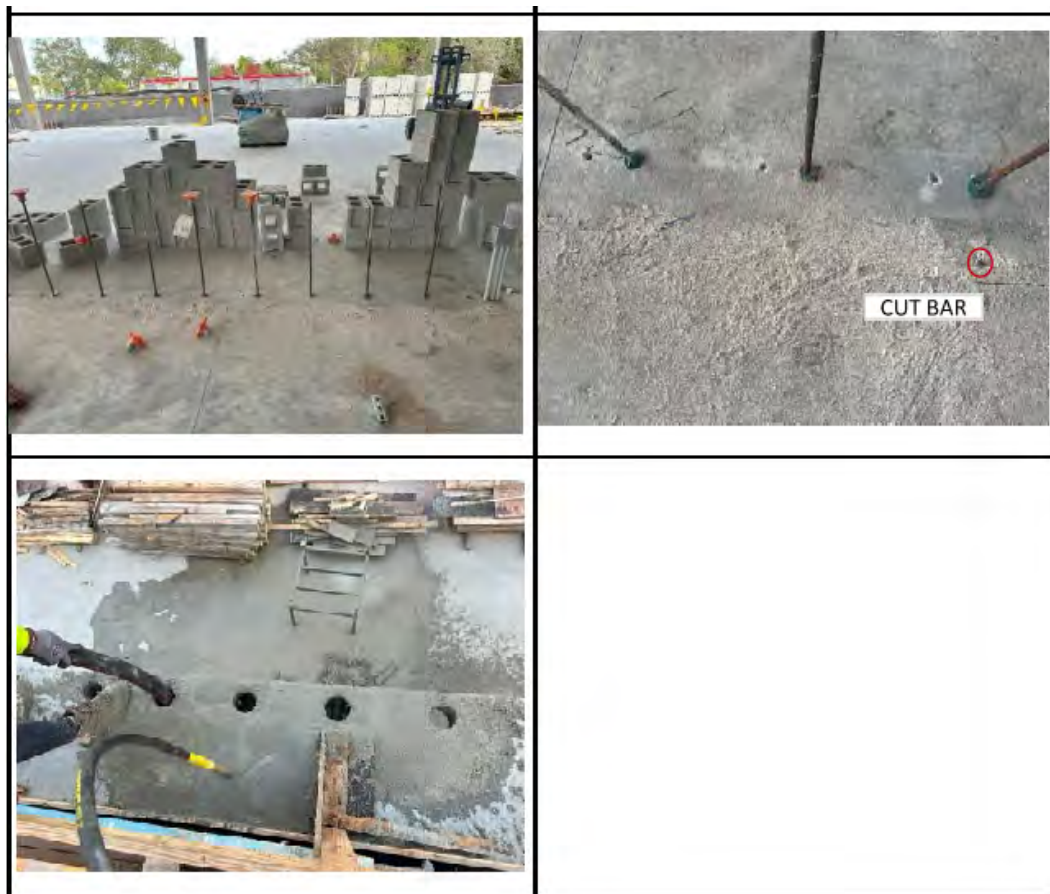
Figure 16. Photographs from Threshold Inspection Report No. 073 showing bars doweled 3 inches into slab-on-ground after original bars were mislocated (top photographs), and filling of grouted cells (bottom photograph)

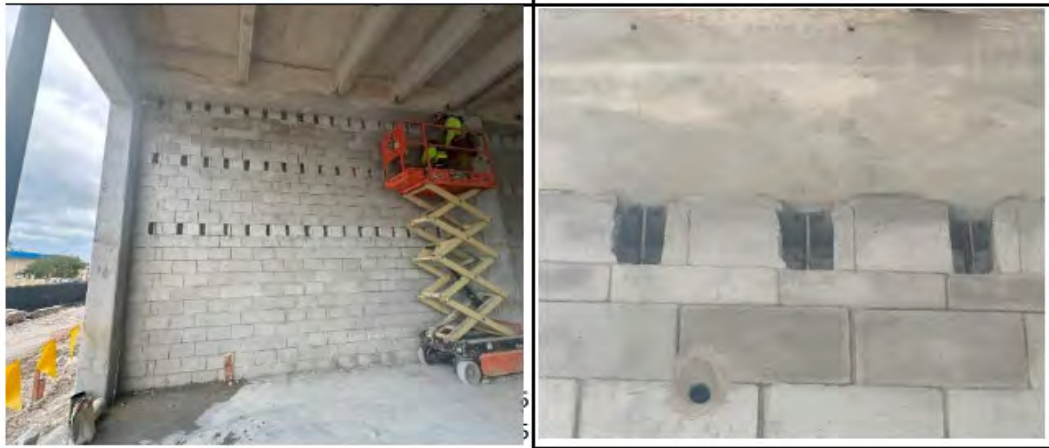
Figure 17. Photographs from Threshold Inspection Report No. 081. Left photograph shows overall wall construction on first story at one location. Right photograph shows the PTA anchors at the top of the wall. Note that two screws are used to connect each anchor to the above element

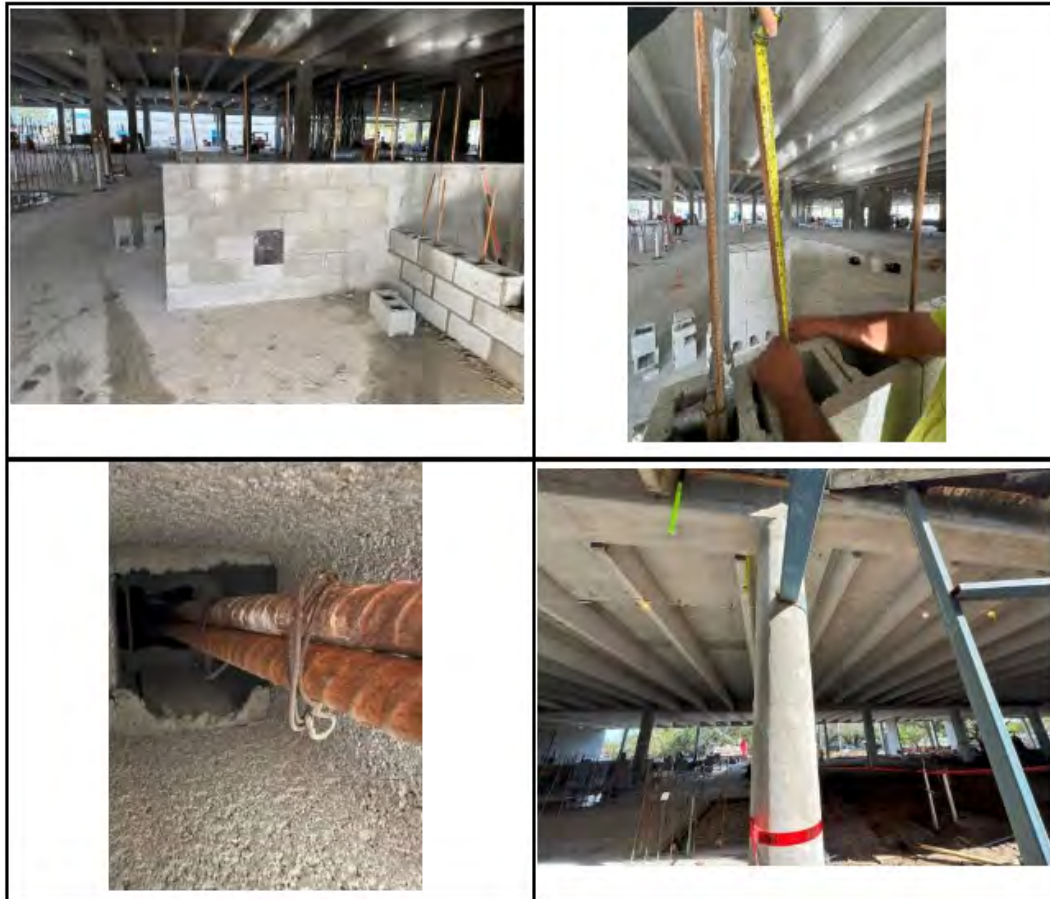
Figure 18. Photographs from Threshold Inspection Report No. 084. Upper photographs and lower right photograph appear to be of the first story prior to full installation of CMU walls. Note the lack of shoring indicating that the CMU walls were not constructed as bearing walls

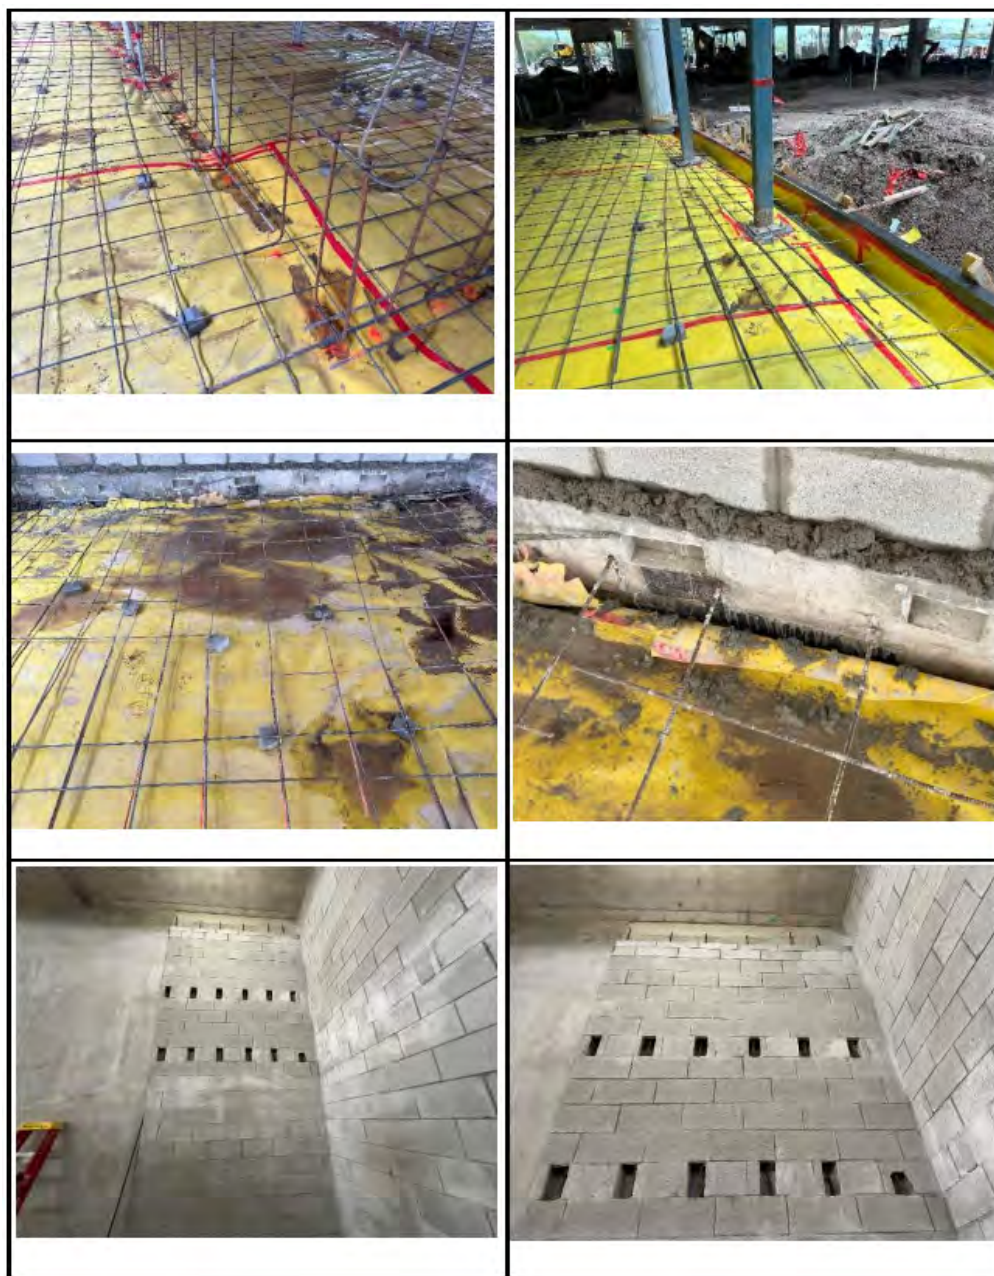
Figure 19. Photographs from Threshold Inspection Report No. 087 showing issue noted by inspector at thickened slab under CMU wall in upper left photograph and reinforcement not extending to the bottom of the slab above in the bottom two photographs

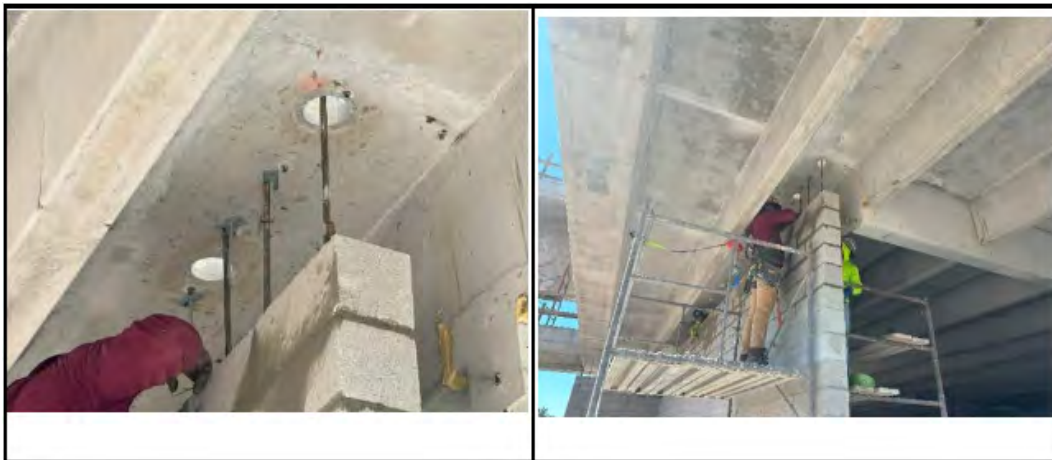
During our review of the special inspection reports, we also observed that the PTA anchors used to connect the partition masonry walls to the above floors were not oriented orthogonal to the walls, as shown on the anchor manufacturer's website. Accordingly, we recommend that the SEOR comment on which orientation of the anchors is appropriate and provide documentation from the anchor manufacturer supporting the use of that orientation.

Figure 20. Photographs from Threshold Inspection Report No. 099 showing issue noted by inspector at top of "HQ Level 3 South CMU wall". Note PTA anchors and connection of vertical masonry bars to above slab in left image. Note that the bars are generally spliced to anchors attached to the slab with screws

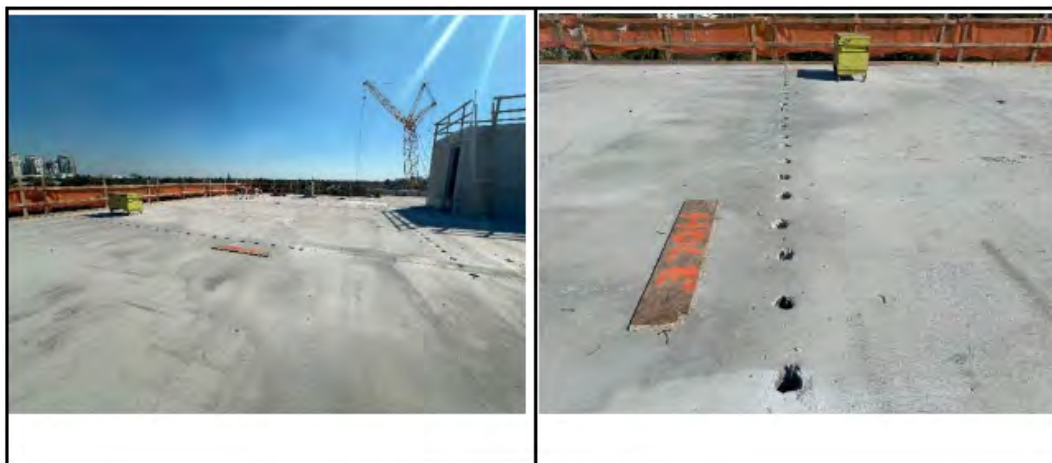
Figure 21. Photographs from Threshold Inspection Report No. 101. While not clearly stated in the report, these images are believed to be of the third floor slab

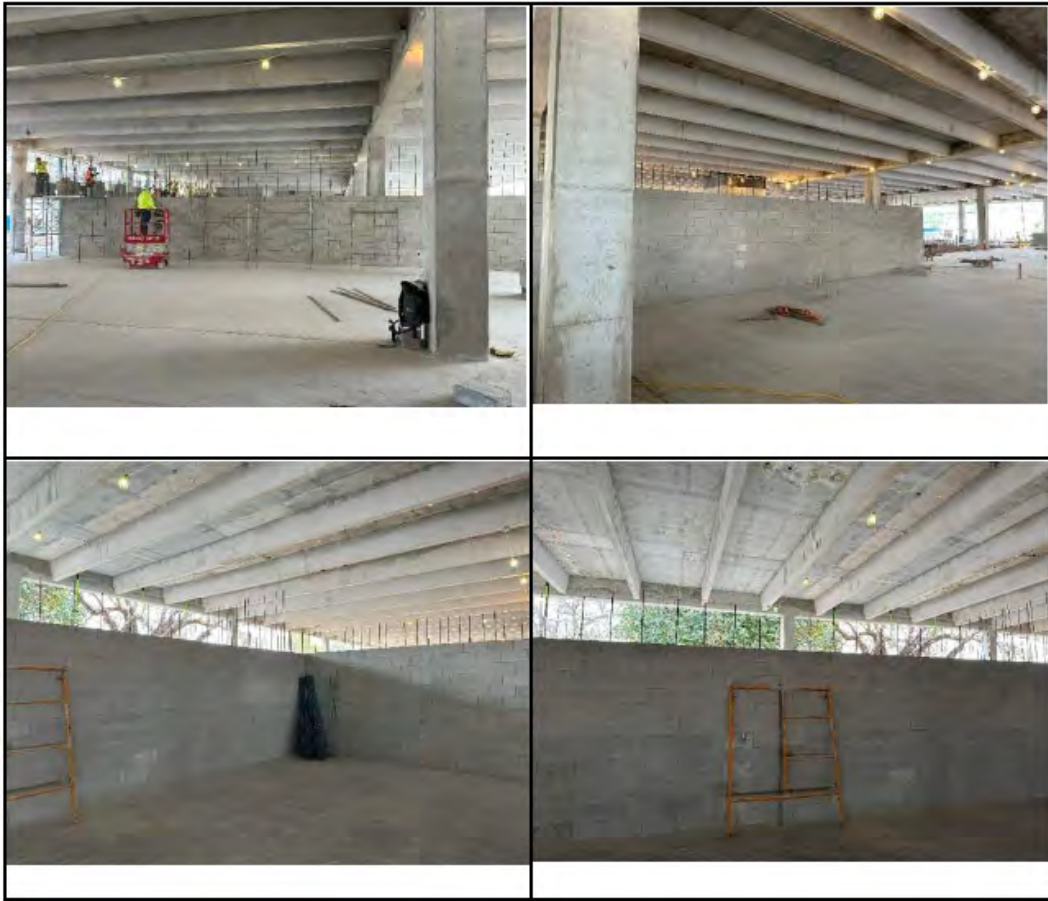
Figure 22. Photographs from Threshold Inspection Report No. 103 showing first story CMU walls under construction. Note the lack of shoring indicating that the CMU walls were not constructed as bearing walls

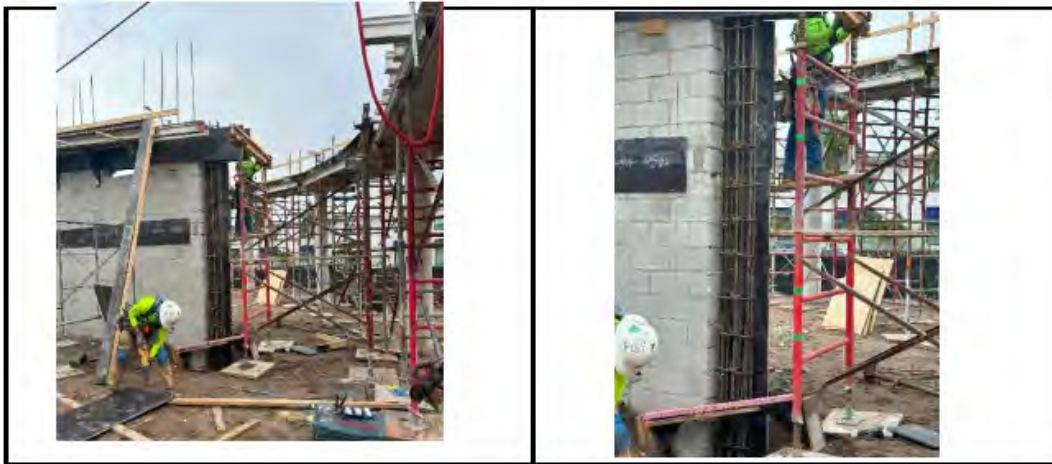
Figure 23. Photographs from Threshold Inspection Report No. 105 showing CMU wall in Area E under construction. Since the wall is being constructed prior to the roof structure, this CMU wall will take load from the roof structure as a bearing wall

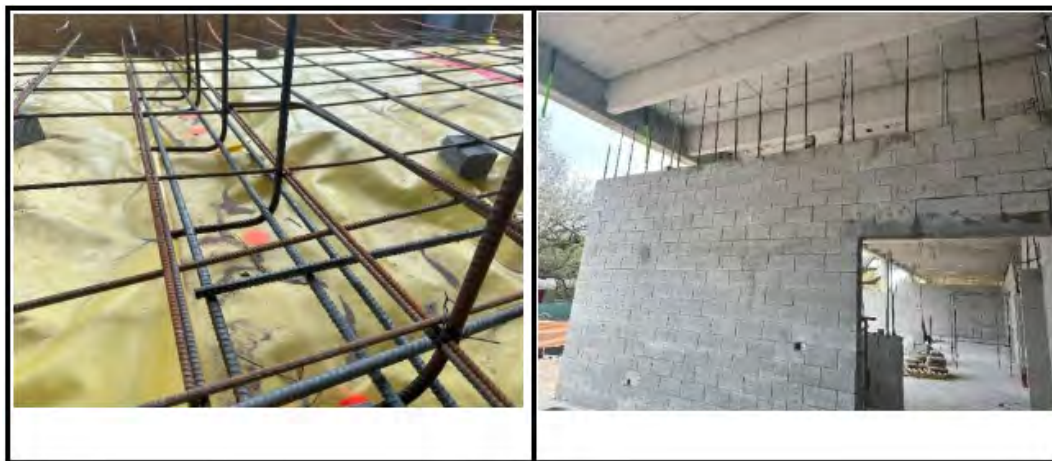
Figure 24. Photographs from Threshold Inspection Report No. 107. The photograph on the left shows hooked dowels at a thickened slab location under a wall. The inspector noted that the dowels needed to be shifted downwards. The photograph on the right shows a CMU wall in the first story under construction. Note that no shoring of the structure above is present, indicating that the CMU wall was not constructed as a bearing wall

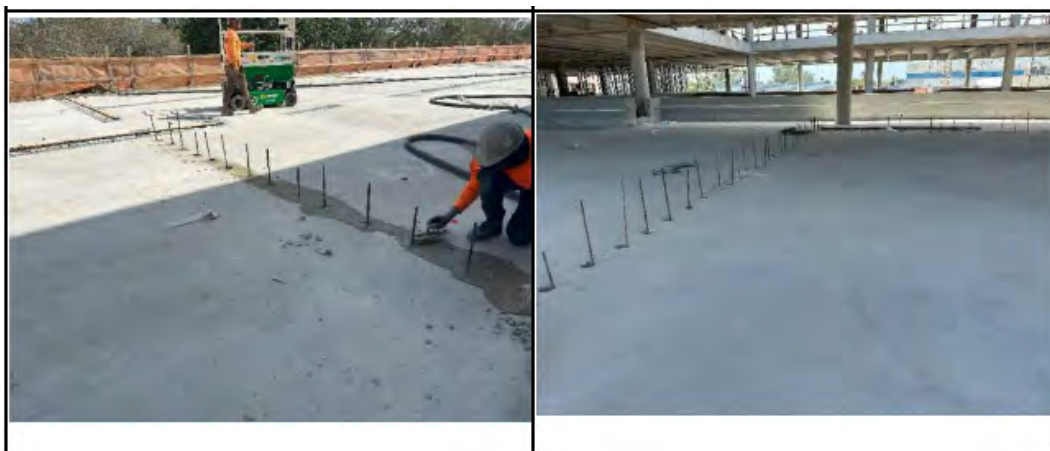
Figure 25. Photographs from Threshold Inspection Report No. 109 showing dowels extending through cored holes in slab. These dowels appear to be from the CMU wall below

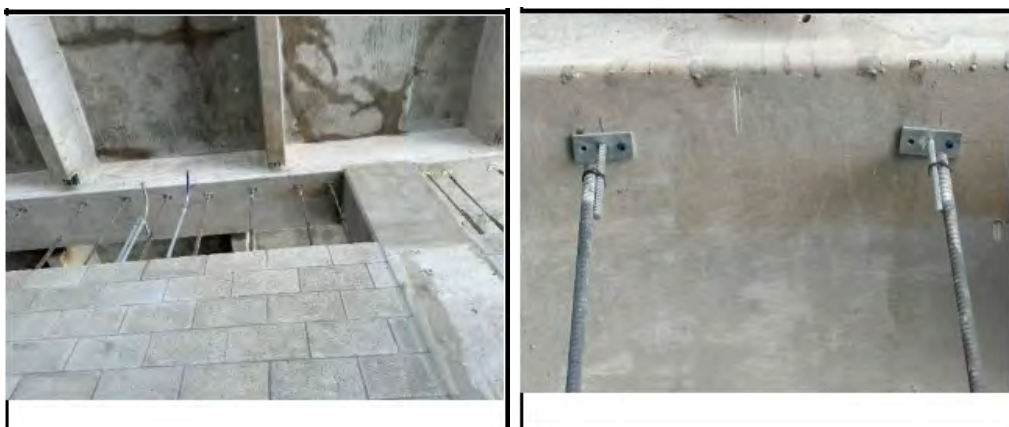
Figure 26. Photographs from Threshold Inspection Report No. 123 showing PTA connectors at bottom of soffit beam with only one screw attaching the plate of the anchor to the soffit beam

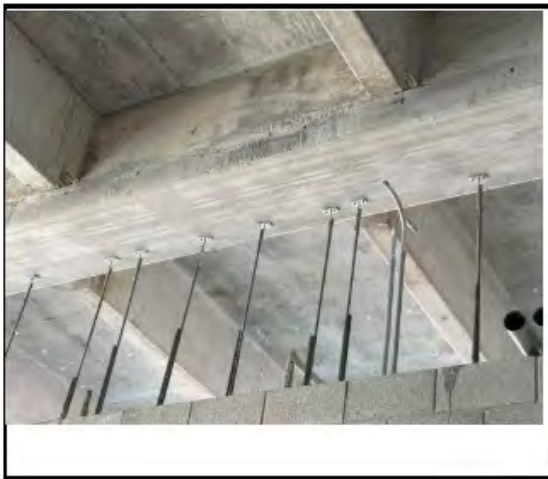
Figure 27. Photograph from Threshold Inspection Report No. 125 showing PTA connectors at bottom of soffit beam with the two screws attaching the plate of the anchor to the soffit beam

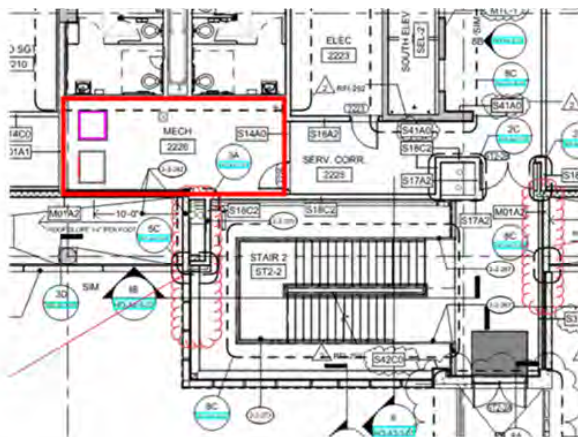
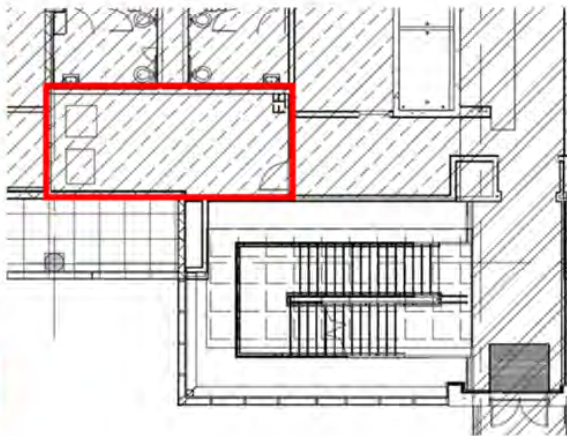
14. **Mechanical Equipment.** In addition to the loading discrepancy noted in Item 8 above regarding equipment weight versus uniform live loads, there is an area bounded by Gridlines H, J, 14, and 16 on Level 2 that is designated in the architectural drawings, but not in the structural drawings, as

Figure 30. Possible inconsistency between architectural drawings (top) and structural drawings (bottom) regarding the location of mechanical equipment. Note that the architectural drawings designate Room 2226 on Level 2 as a mechanical room; however, the structural drawings indicate that a General live load rather than a Mechanical live load was used to design that area

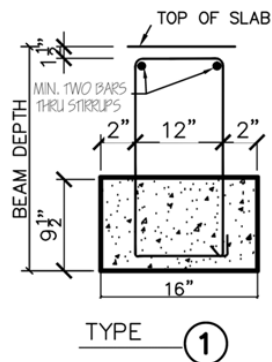
Figure 31. Cross-section of soffit beam (Sheet SC-3C-D of Submittal 328) showing 1.5 inches of cover to the transverse reinforcement

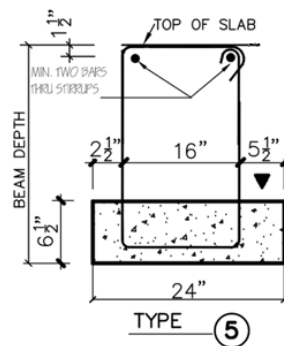
Figure 32. Cross-section of soffit beam (Sheet SC-3C-D of Submittal 328) showing approximately zero inches of cover to the transverse reinforcement

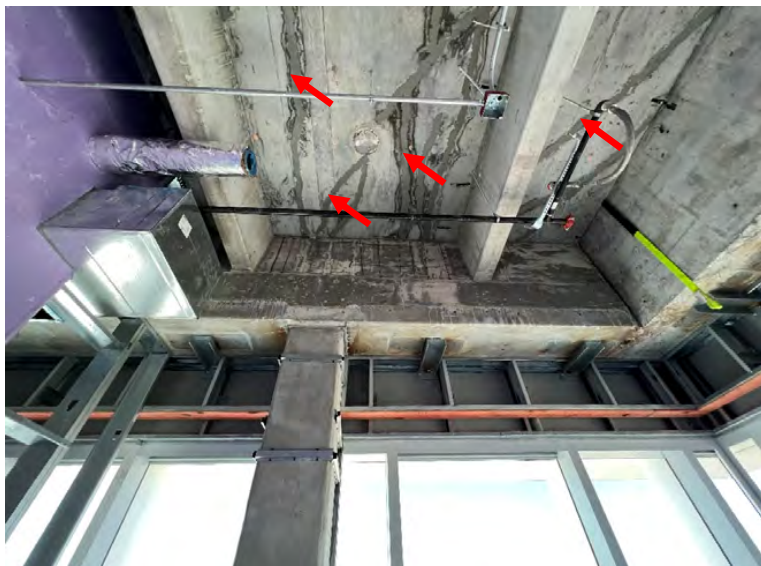
Figure 33. Example of cracks (see red arrows) in the reinforced concrete slab (at the roof) which have been repaired

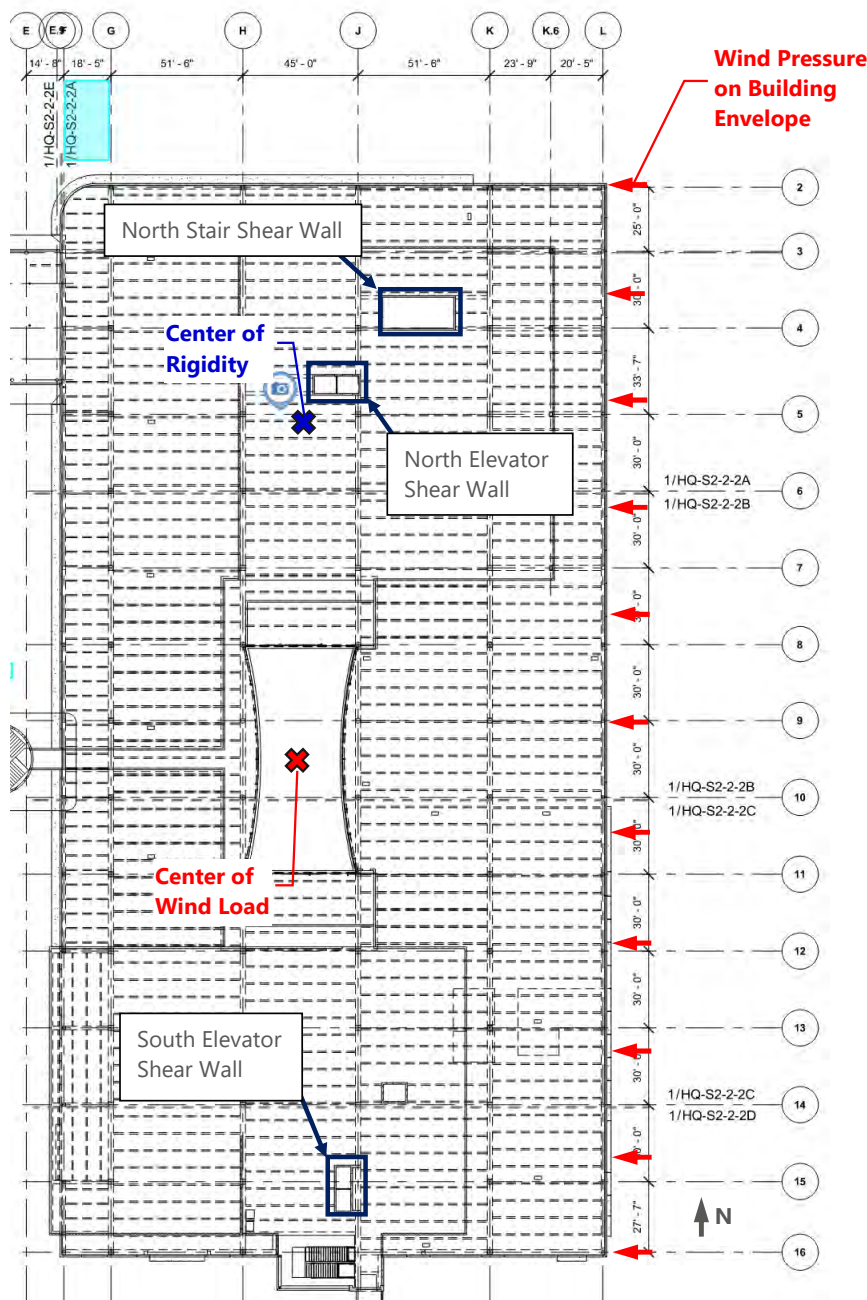
10. **Building Period.** Due to the relatively small length of shear wall in the southern half of the main building of the FLPHQ, the fundamental period of vibration of the building is over 0.9 seconds (which is significantly larger than typical concrete shear wall buildings having no more than three stories). The fundamental mode also corresponds with a twisting response of the structure. While this condition does not violate any code-prescribed performance limitations, it is not standard practice to design structures to perform this way. Adding an appropriately designed full-height shear wall (i.e., from foundation to roof) to the structure (as previously described) will rectify this condition.

Figure 34. Plan view of FLP HQ showing the approximate locations of the center of rigidity and east-west wind loads. Due to eccentricity between the two, the structure twists

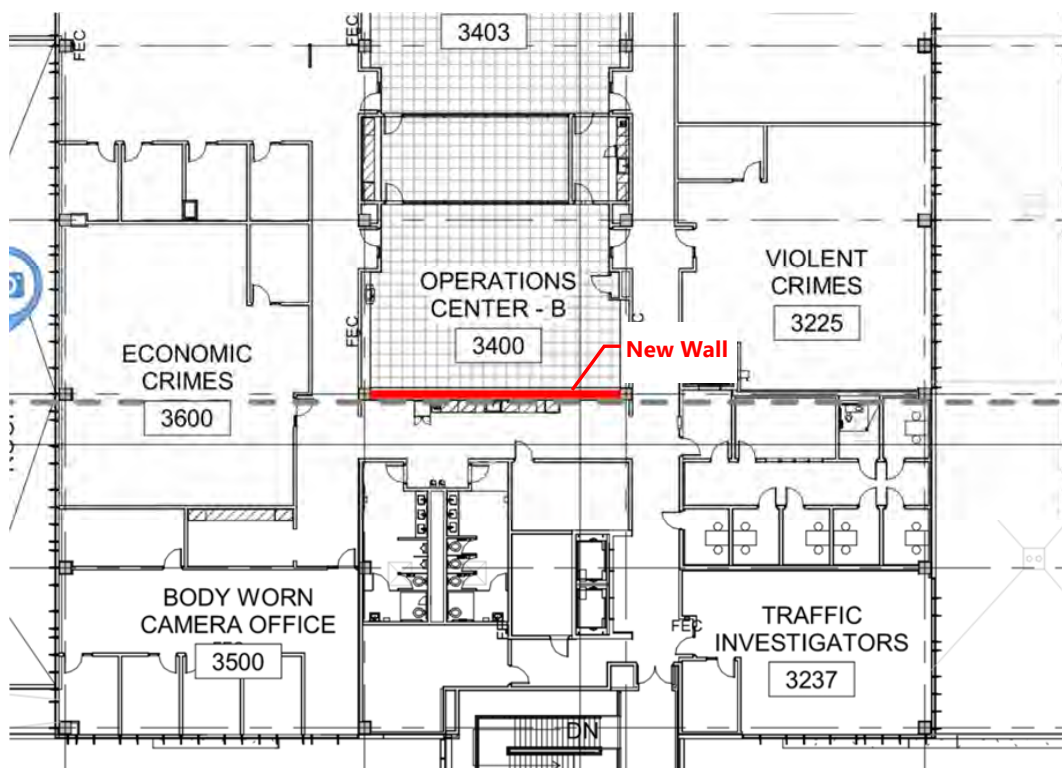
1. **Shear Wall Capacities.** The southern-most reinforced concrete core wall is not code-compliant for one-way shear strength or flexural strength between Levels 1 and 2. Adding a properly designed full-height shear wall (i.e., from foundation to roof) with an accompanying foundation to the structure on Gridline 14 between Gridlines H and J can rectify this condition. Rectification of this condition should be carried out *as soon as possible* (0 to 2 months) and should be completed before the building is occupied. Note that, contrary to the position of the SEOR, we do *not* believe that the concrete masonry unit (CMU) partition walls are a reliable part of the lateral load-resisting system. We have provided other findings related to the use of these CMU walls in the Documentation section below.

Figure 40. One potential location for the proposed new reinforced concrete shear wall

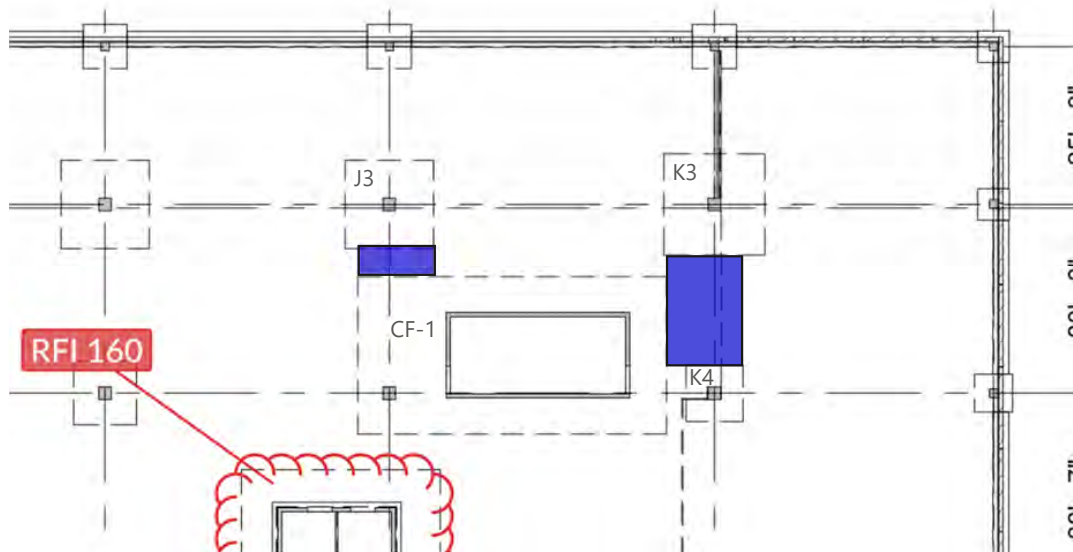
2. **Foundation Capacities at Shear Walls.** The mat foundations for the concrete shear walls around the north stair shaft (designated as CF-1 on the structural drawings) and the south elevator shaft (CF-3) all have lateral demands that exceed the allowable design capacity under design wind loads in the east-west direction and are therefore not code-compliant. Adding the aforementioned shear wall to the building can rectify conditions related to the south elevator shaft but not the sliding exceedance at the north stair shaft. Attaching mat footing CF-1 to its surrounding isolated

footings can rectify the sliding condition. Rectifications to the foundations should take place at the same time as those for the shear walls.

Figure 41. Conceptual rectification of sliding deficiency of mat footing CF-1. The mat footing is attached to nearby isolated footings (J3, K3, and K4) with new reinforced concrete (shown in blue font)
