CITY OF FORT LAUDERDALE

RIVERWALK CENTER PARKING GARAGE

Structural Condition Assessment – Final Report

May 12, 2021

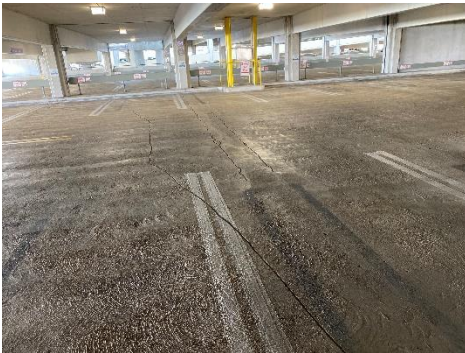
Several quantities of cracking, delamination and spalling with exposed reinforcement were observed on the elevated floor slabs. Previous floor cracks, overhead floor cracks, and concrete spalls were observed to be repaired. Several of the previous repairs were observed to be in poor conditions. Pourstrip areas were also observed to have many structural deficiencies. Additional cracks not observed may be present upon removal of dirt and debris from powerwashing the floor surface.

Floor Cracks

Number	Description	Notes
<u>CONCRETE REPAIRS</u>		
1.1, 1.2	Concrete Floor Cracks,	Kimley-Horn recommends routing and sealing all topside slab cracks to protect embedded reinforcement and potential leakage into subsequent levels. Quantification of cracking was difficult due to dirt/debris on the deck surfaces and additional quantities may arise after powerwashing the deck. These repairs would require removal of sealant from existing routed cracks, routing both new and existing cracks, and seal all floor cracks.

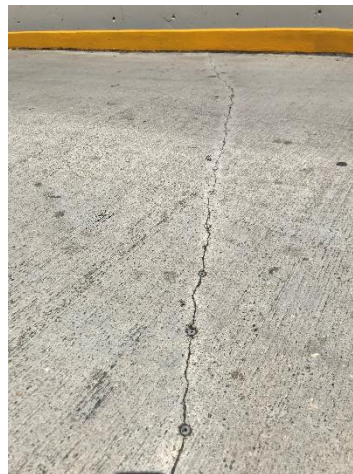
Floor Cracks

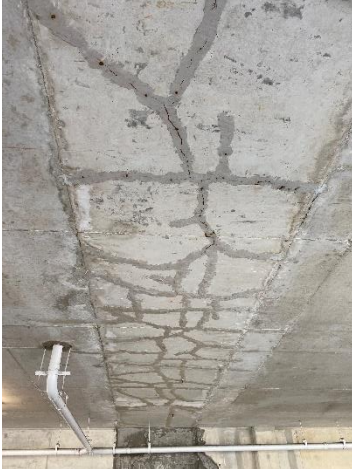
Overhead Floor Cracks

1.2, 1.5, 1.8, 1.12	Overhead Floor Cracks, Column Cracks, Wall Cracks, Overhead Beam Cracks	Kimley-Horn recommends epoxy injecting all concrete overhead slab, column, wall, and overhead beam cracks. The repairs would require epoxy injecting concrete cracks.

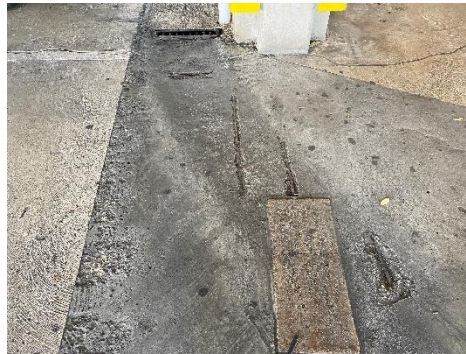
Exposed Rebar

1.3, 1.13	Concrete Floor Spalls, Exposed Rebar	Kimley-Horn recommends patching all concrete delaminations and spalls. These repairs would require removal of loose concrete at floor spalls, sandblasting repair cavity and exposed reinforcement, coat all exposed reinforcement and welded connections. Replace or supplement any reinforcement with significant section loss, and place concrete repair mortar.

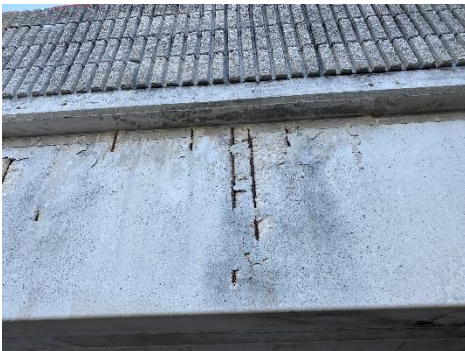
Limited quantities of cracking, delamination, and spalling with exposed reinforcement were observed on the P/T concrete beams. Previous concrete spall repairs were observed and found in poor conditions.

Exposed Rebar

1.4, 1.11, 1.14	Overhead Floor Spalls, Overhead Beam Spalls, Overhead Exposed Rebar	Kimley-Horn recommends patching all overhead concrete delaminations and spalls. The repairs would require removal of loose concrete at overhead floor spall, overhead beam spall, and overhead exposed rebar, sandblast repair cavity and exposed reinforcement, coat all exposed reinforcement and welded connections. Replace or supplement reinforcement with significant section loss, and place concrete repair mortar.

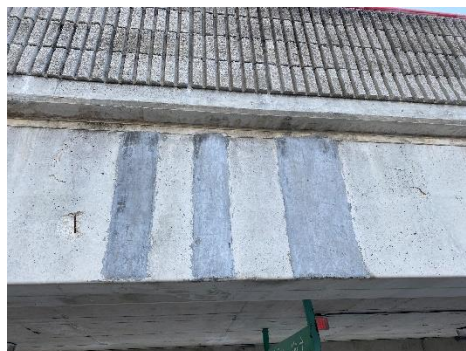
Overhead Beam Spalls

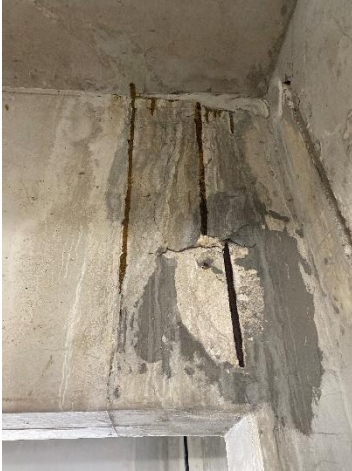
Exposed Rebar

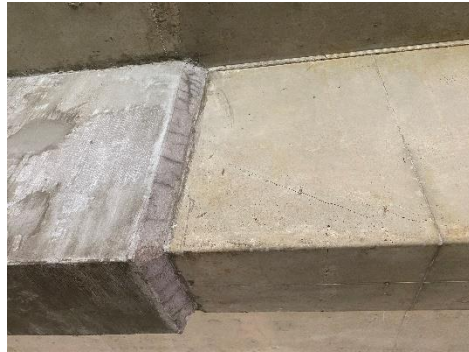
Overhead Beam Crack

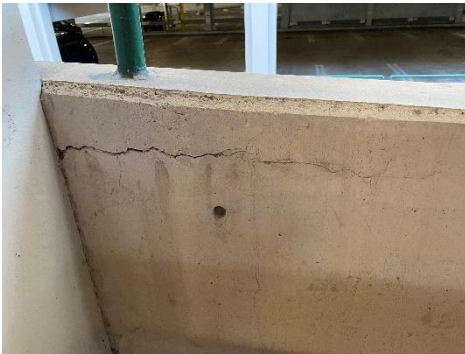
Limited quantities of wall cracks and wall spalls were observed on the concrete walls. Significant amount of previously repaired wall cracks were also observed and found in fair conditions.

Concrete Wall Spall

1.7, 1.9	Column Spall, Wall Spall	Kimley-Horn recommends patching all concrete column/ wall delaminations and spalls. The repairs would require removal of loose concrete at wall and column spalls, sandblast repair cavity and exposed reinforcement, coat all exposed reinforcement and welded connections. Replace or supplement reinforcement with significant section loss, and place concrete repair mortar.

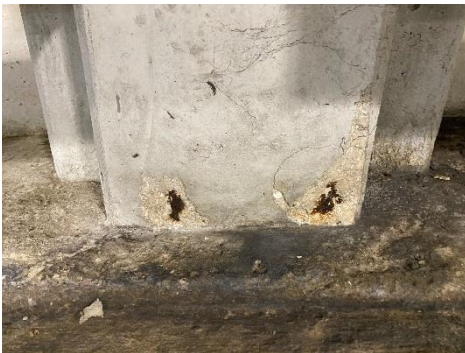
Numerous quantities of concrete spalling were observed on the lower portion of the columns and were typically found on the exterior bays.

Column Spalls

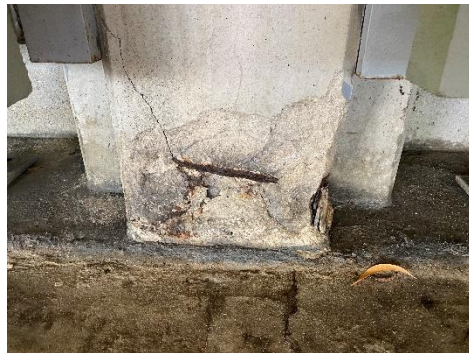
Column Spalls

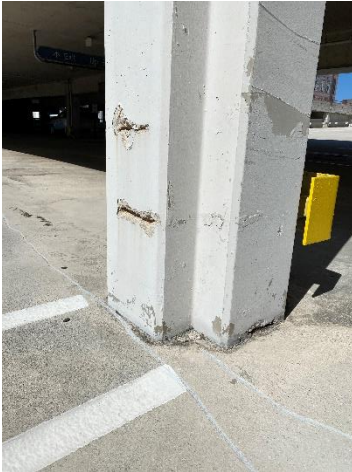
Column Spalls

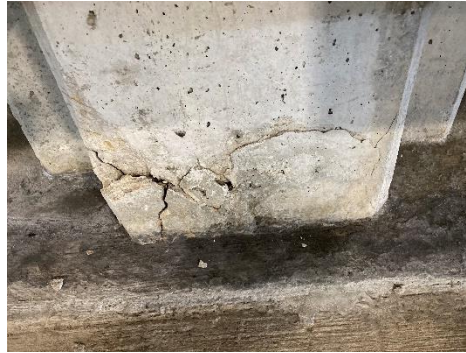
Column Spall

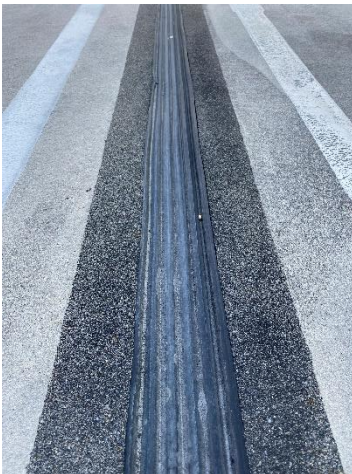
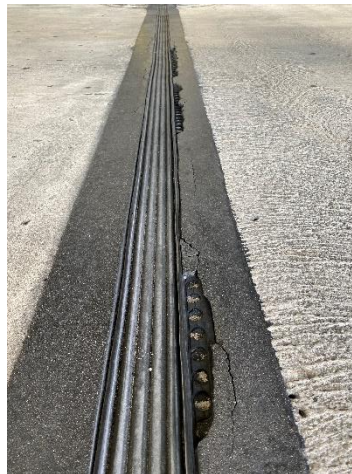
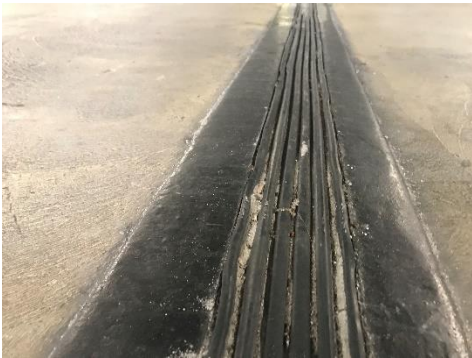
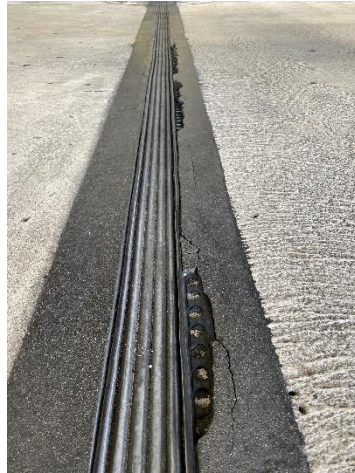
The expansion joints running east to west through the garage was observed to be in fair conditions. Some expansion joints were observed to be deteriorating. Additionally, areas of large water ponding were observed near the expansion joints, causing debris build up and deterioration of joints. Few plate covers installed over the expansion joint on the interior bays were observed to be detached. Vertical Joint on the exterior face of the building were observed to be in poor conditions, due to direction sun exposure.

Horizontal Expansion Joint

2.1, 2.2	Expansion Joint - Horizontal Vertical Joint - Horizontal	Kimley-Horn recommends replacing exterior vertical expansion joints and few horizontal expansion joints. The repairs would include removing and replacing joints, with minimal damage to the concrete.
<u>SEALANTS</u>

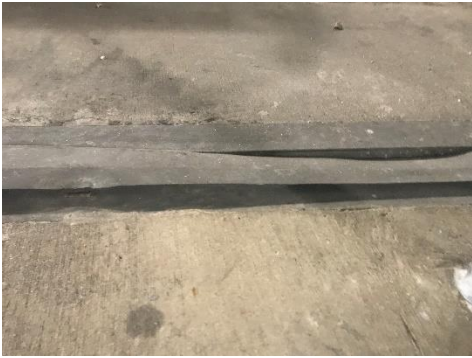
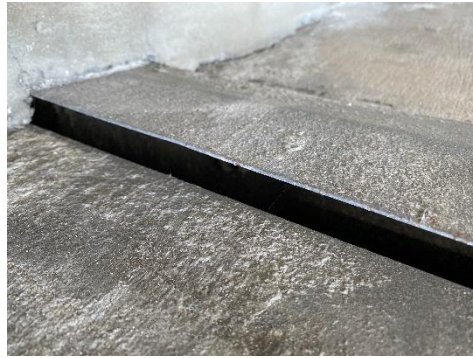
Horizontal Expansion Joint – Cover Plate

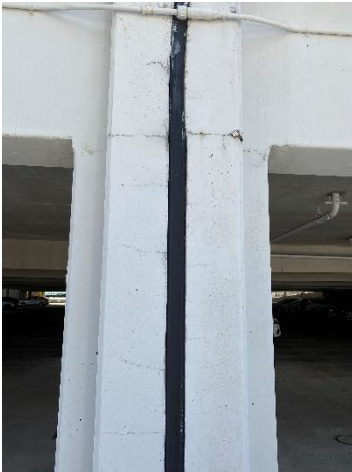
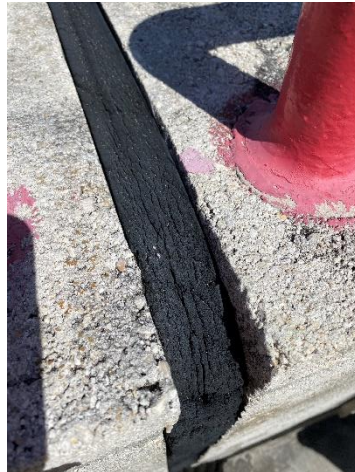
Vertical Expansion Joint

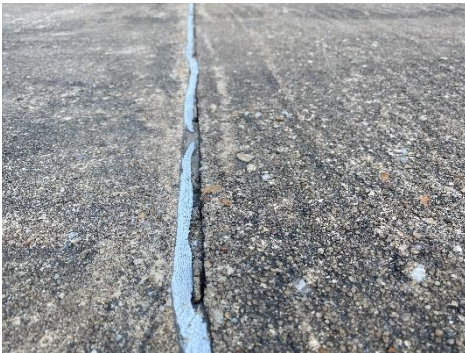
Various areas of deteriorated or missing sealant were observed, most significantly on the top level due to direct exposure to the elements. Horizontal sealants were observed on all floors at the pour strips, joints, topping areas, and planter covers and were found to be in fair conditions. Cove sealant was observed on the top floor around the barrier wall and concrete curb and was found to be in poor condition, due to direct exposure to the elements.

Horizontal Sealant

3.1, 3.2, 3.3, 3.4	Cove Sealant, Horizontal Sealant, Horizontal Sealant – Planter, Pour Strip/ Cold Joint Sealant	Kimley-Horn recommends full replacement of top-level cove sealant and horizontal sealants throughout the garage as priority 1. Horizontal sealants at pour strips, joints, topping, existing repairs, and planters are also recommended to be repaired. The repairs would include removal of existing cove and horizontal sealants along the top-level perimeter, pour strips, joints, existing repairs, and planer areas. Install backer rod where necessary and apply new sealants.
<u>WATERPROOFING</u>

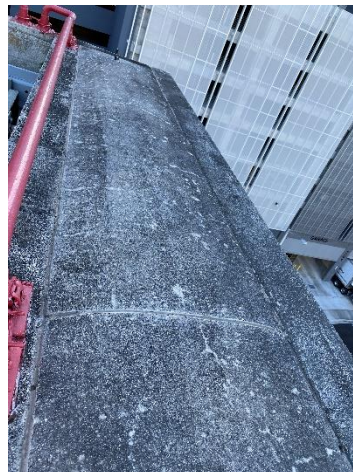
Horizontal Sealant at Planter

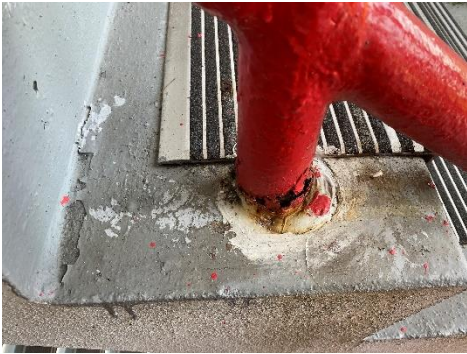
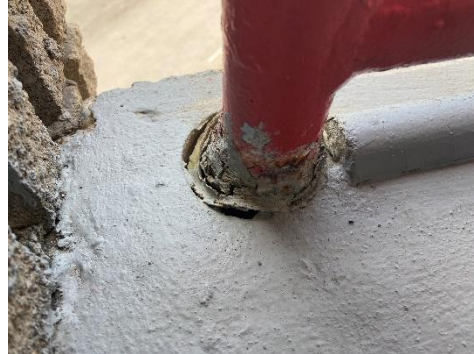
Several quantities of railing post corrosion were observed on all stairs.

Stair Railing Post Corrosion

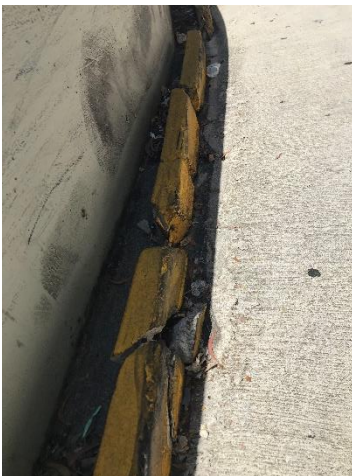
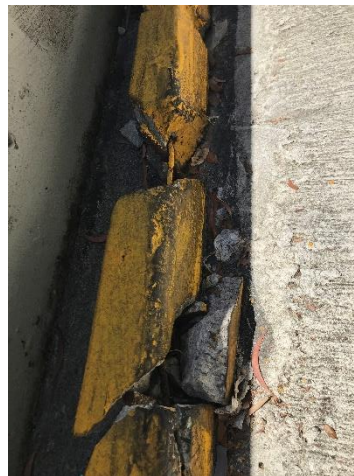
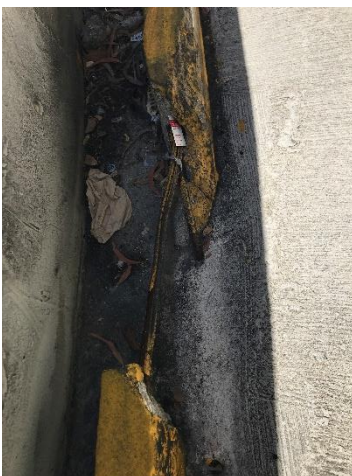
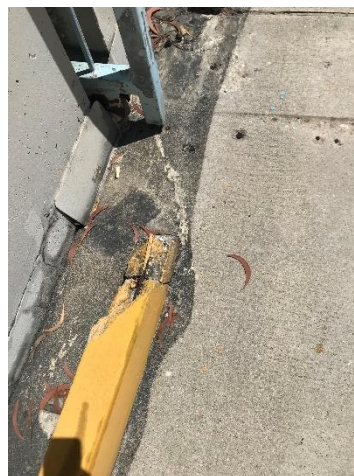
Concrete curb located on the exterior ramps were observed to be severely damaged.

Damaged Curb

1.17	Damaged Curb	Kimley-Horn recommends replacing severely damaged concrete curbs at exterior ramps.
1.18, 1.19, 1.20	Exposed Tendon, Damaged Tendon, Overhead Damaged Tendon	Kimley-Horn recommends repair and/or replacing post-tension tendons.

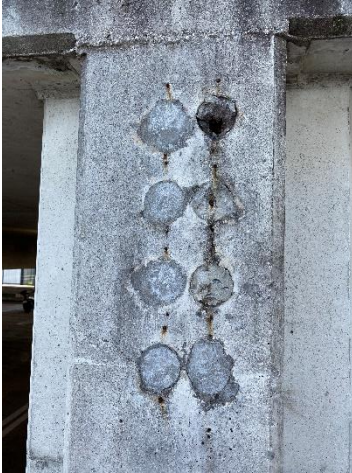
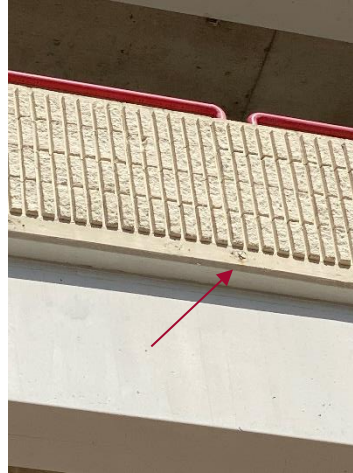
Post-tension pockets were observed to be missing grout. Additionally, signs of corrosion were observed on the post tension pockets located on the exterior slab edge.

Post-Tension Pockets

1.21	Post Tension Pockets	Kimley-Horn recommends repairing post tension pockets. The repair will consist of re-grouting post tension pockets and removing corrosion from end of tendons.
<u>EXPANSION JOINTS</u>

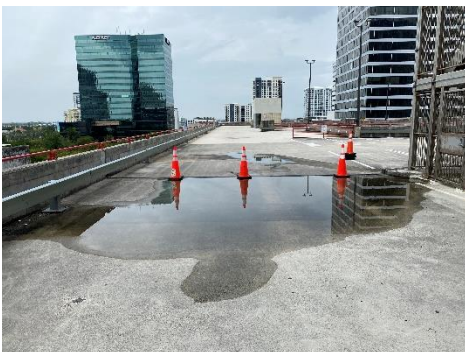
Numerous areas of large water ponding were observed throughout the garage, specifically near the expansion joints and bottom of ramps. Water intrusion onto the lower levels was observed to come from minor hole openings within the concrete slab and drain connections discharging onto the ramps. Additional water ponding areas were observed at the depressed slab “trench” like areas running throughout the parking bay edges. Multiple exposed rebars were also observed in this location due to a decrease of concrete cover of the slab and water ponds.

Water Ponding

1.15	Water Ponding	Kimley-Horn recommends addressing major water ponding areas. Water ponding shall be mitigated by adding floor drains, building up floor, or scoring the concrete to allow water to flow toward the drains. Additional concrete slab cores shall be grouted in order to avoid water intrusion from the top level. Clean up of debris near floor drain is also recommended in order to allow water to flow properly into the system.

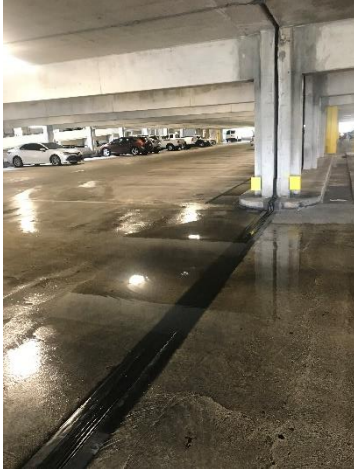
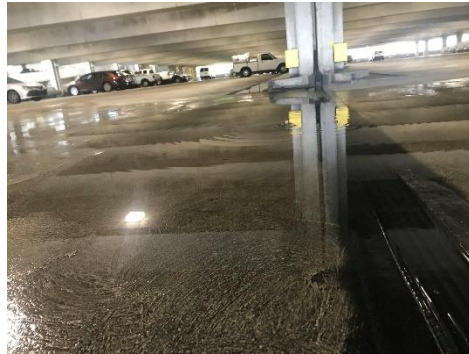
Water Ponding at Expansion Joint

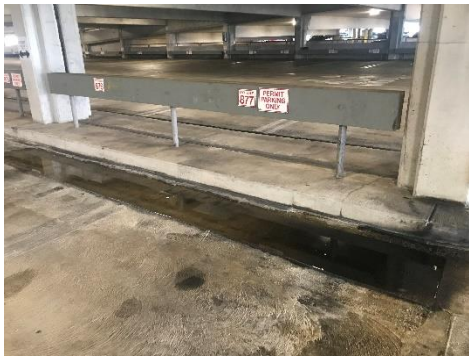
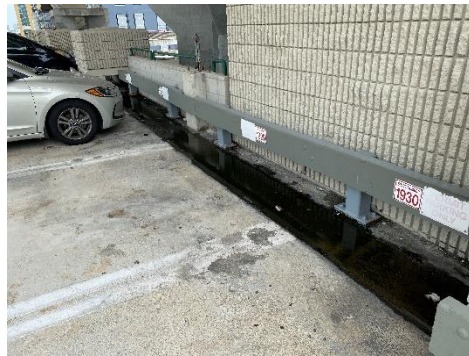
Water Ponding – Trench Area

4.1	Deck Coating	Kimley-Horn recommends installing deck coating at all depressed slab “trench” like areas running throughout the parking bay edges, in order to prevent additional exposed rebar deficiencies. Kimley-Horn also recommends installing deck coating at various pour strip or joint locations were spider like cracks were observed. These repairs would include application of deck coating in areas described above.

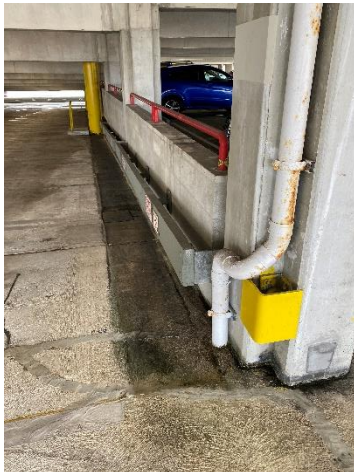
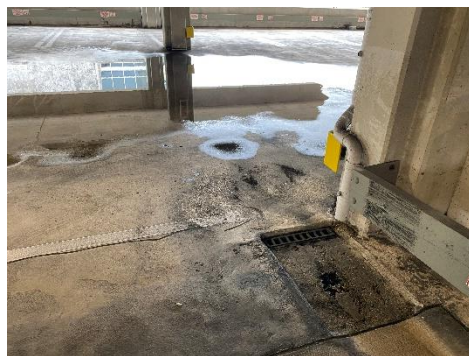
Pipe Discharging to Trench Area

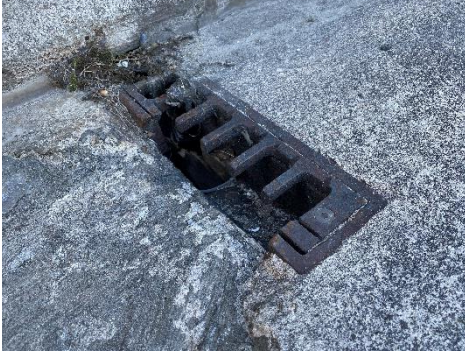
Several drains were observed to be blocked with debris preventing proper flow of the water into the system. The drain grates were also observed to be rusted or missing the drain grate.

Drain Grate

4.2	Powerwash	Kimley-Horn recommends powerwashing all garage levels as a Priority 3 item.
<u>GERNERAL</u>		
5.1	Drain Grate Replacement	Kimley-Horn recommends replacing or installing new drain grates where applicable.

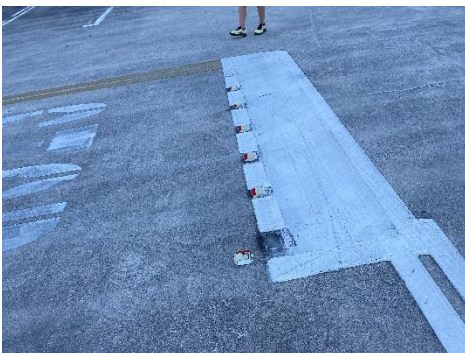
Striping was observed to be in poor conditions, specifically on the top level due to direct weather exposure. Stop bars and striping were observed to be illegible and pavement reflector marks were observed to be detached in some locations.

Striping

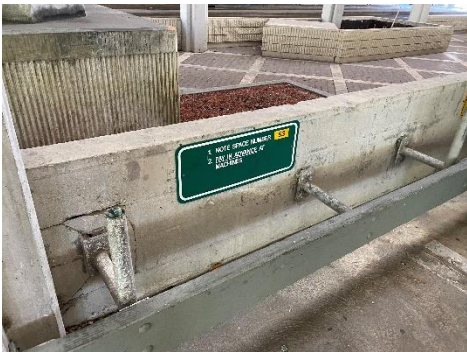
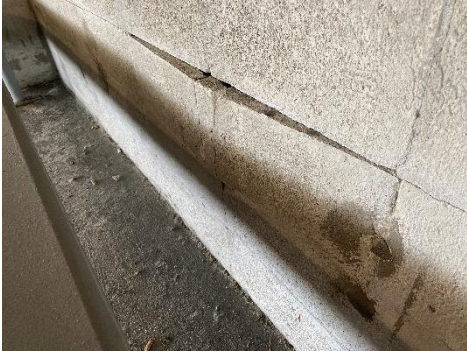
Limited quantities of wall cracks and wall spalls were observed on the masonry barrier walls. Barrier wall on the south side of level one was observed to be on a slight angle. Additionally, mortar was observed to be missing on some masonry blocks.

Masonry Wall Spall

1.10	Wall Spall (CMU)	Kimley-Horn recommends patching and/or replacing masonry wall spalls and mortar joints at masonry barrier walls. The repair will require removal of loose concrete at wall, sandblast repair cavity and exposed reinforcement, coat all exposed reinforcement and weld connections. Replace or supplement reinforcement with significant section loss, place concrete repair mortar. For masonry wall spalls with damaged CMU blocks, the repair will require removal and reinstallation of the CMU blocks. Additionally, the repair will consist of adding new epoxy mortar to any wall voids.

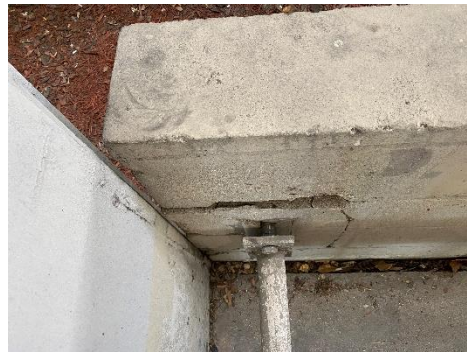
Masonry Wall at Angle

1.16	CMU Wall Replacement	Kimley-Horn recommends removing and replacing a span of masonry barrier wall at the south portion of level one. The repair would include the demolition of the existing wall and reconstruction of a new masonry barrier wall.

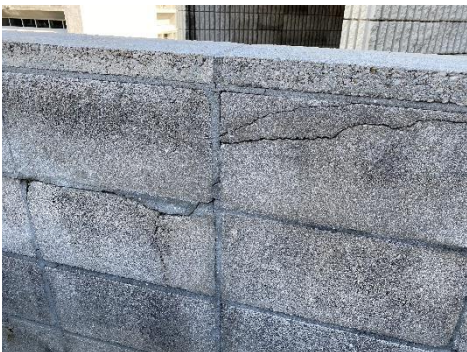
Masonry Wall Crack

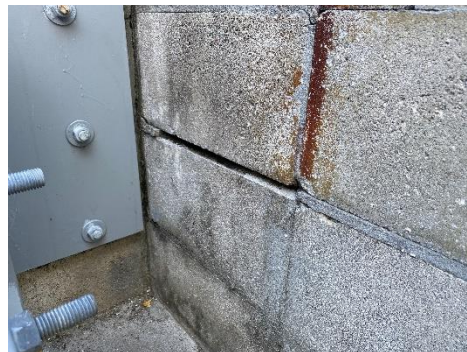
Masonry Mortar Missing

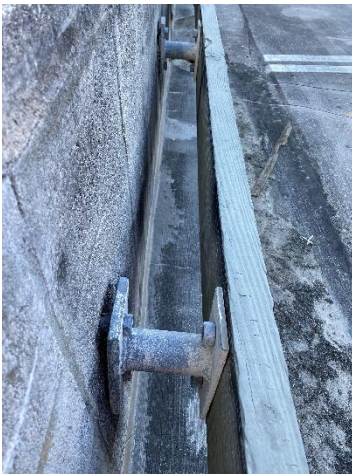
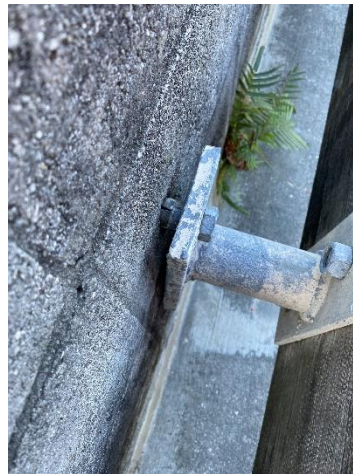
A guardrail system consisting of steel framing with wooden panels were observed to be connect to the masonry barrier walls. The steel members base plates and I-Beams were observed to be rusted, specifically on the top level due to direct weather exposure. Additionally, various of the guardrails were observed to be on a slight angle due to the anchor bolts not fully embedded into the masonry blocks.

Anchor Bolt

5.2	Guardrail System Anchors	Kimley-Horn recommends re-tightening guardrail system anchor bolt, which are embedded into the masonry barrier walls. This repair will consist of re-tightening the anchors into the masonry blocks to allow for proper connection of the guardrail system.

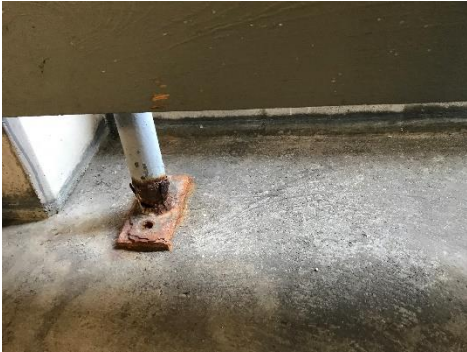
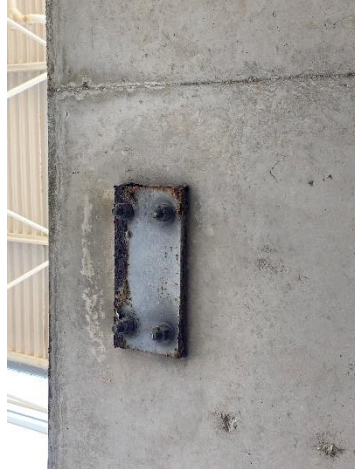
Steel Plate Rust

5.5, 5.6, 5.7	Steel Plate Rust, Steel Beam Rust, Pipe Support Rust	Kimley-Horn recommends cleaning corroded steel plates and beam of the guardrail system and steel pipe protections. The repair will consist of blast cleaning all steel surface and paint with a high-performance coating.
5.8	Guardrail System Wooden Planks	Kimley-Horn recommends replacing the deteriorated wood planks that are part of the guardrail system.
5.9	Railing Post Corrosion	Kimley-Horn recommends cleaning corroded stair railing posts. The repair will consist of blast cleaning all steel surface and paint with a high-performance coating.

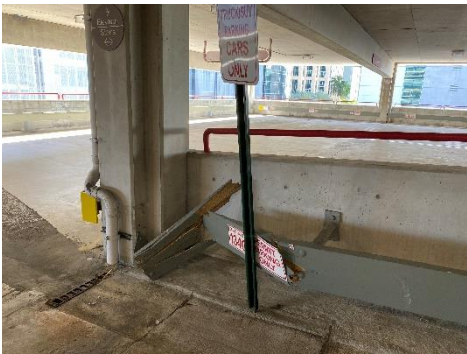
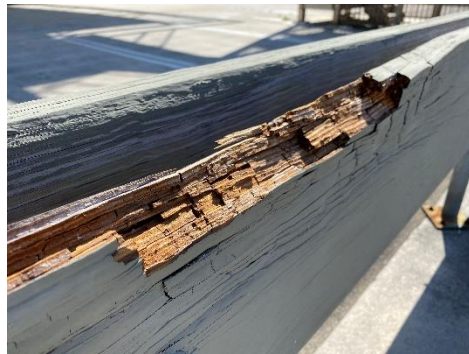
Wood Panel

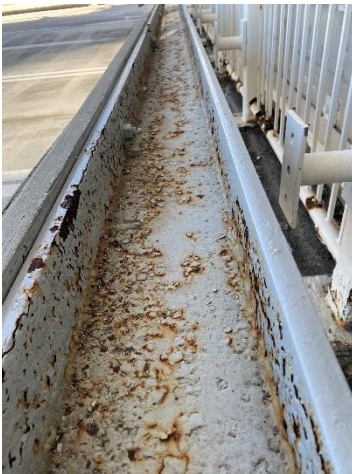
Steel Beam Rust

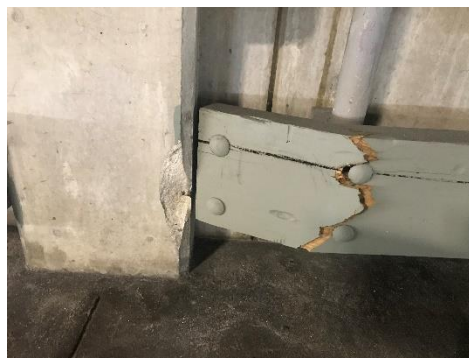
Guardrail Connection

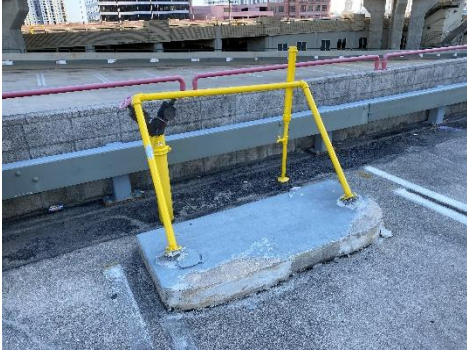
Several pipes and pipe supports were observed to be corroded or detached and in need of replacement.

Pipe Support

5.4	Pipe Guard Connections,	Kimley-Horn recommends reinstalling or replacing the steel pipe guard connections. The repair will consist of replacing/ reinstalling any corroded or damaged connection of the pipe guard supports.

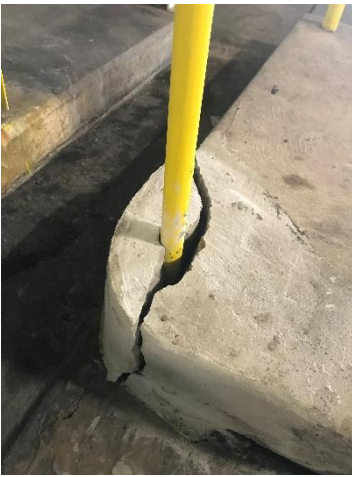
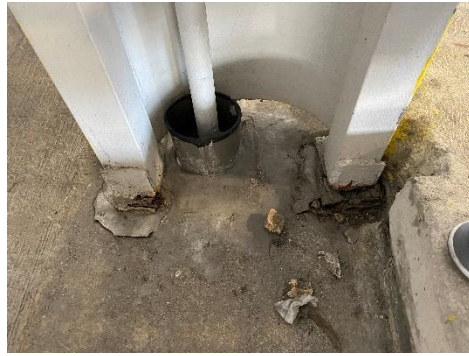
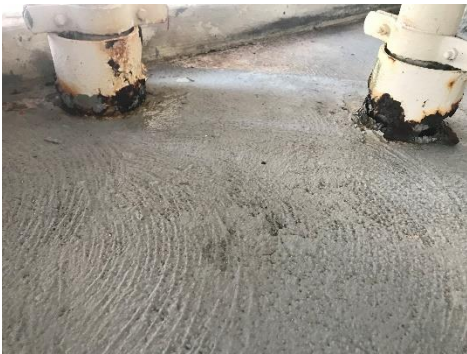
Pipe Support Rust

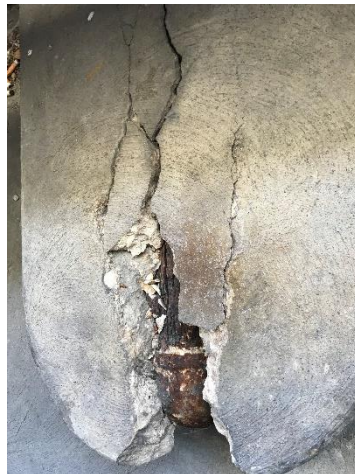
Steel Pipe Rust

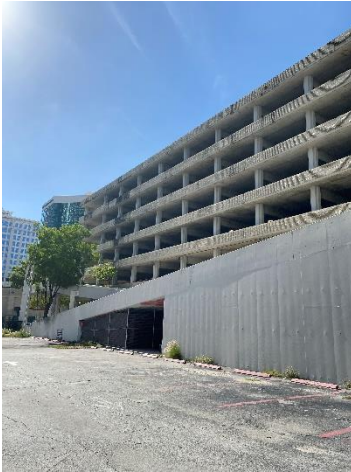
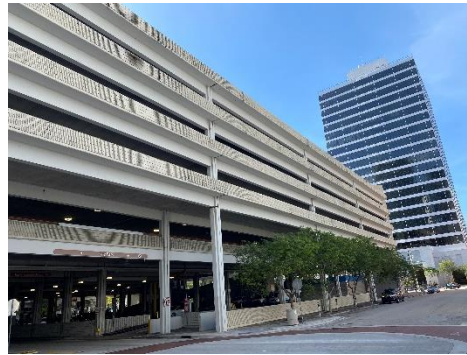
The façade was found in generally good condition, with a few post-tension pockets and planters in need of repair.

Façade
