## Fort Lauderdale Police Headquarters

WJE Peer Review, Phase 1 - North Elevation Evaluation

1300 West Broward Boulevard  
Fort Lauderdale, Florida 33312

December 31, 2024  
WJE No. 2024.4855.0

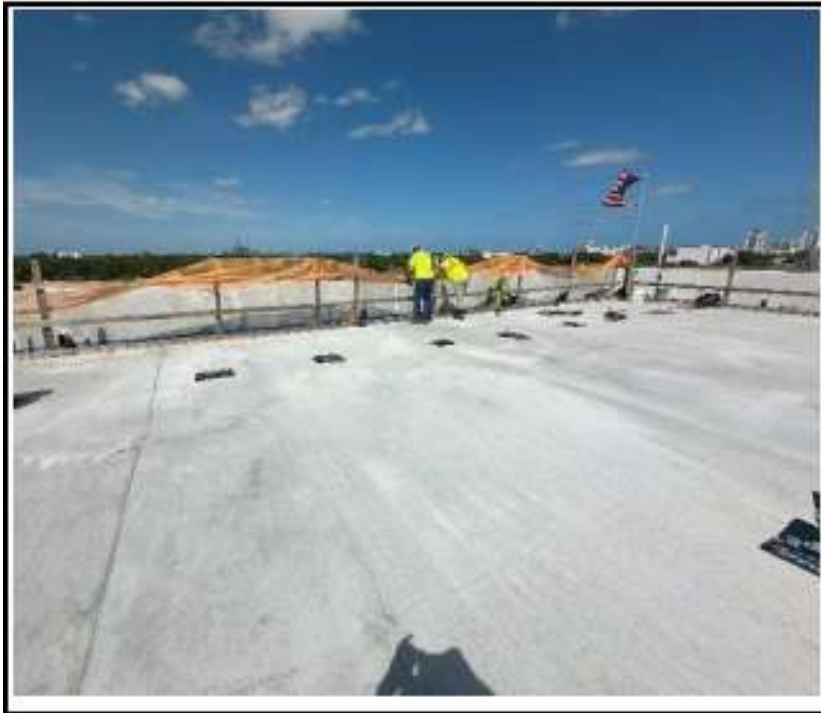
In the set of files we received, documentation of the cracking observed at the roof was primarily recorded in the threshold inspection reports and in a file named "*Pictures.pdf*." As noted in the timeline above, cracks in the roof slab were observed by the contractor immediately following the installation of the precast facade panels at the roof level. These observations are noted in Thornton Tomasetti's Threshold Inspection Report No. 125 along with photographs (Figure 25 through Figure 28).

Figure 25. Photograph from Threshold Inspection Report No. 125 showing conditions on top of roof slab at north end of building.

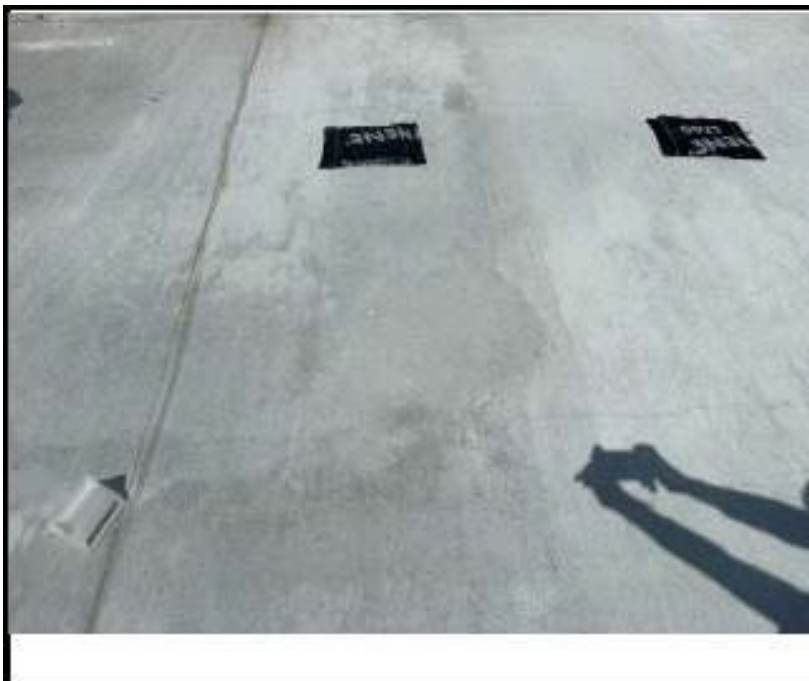
Figure 26. Photograph from Threshold Inspection Report No. 125 showing conditions on top of roof slab at north end of building.

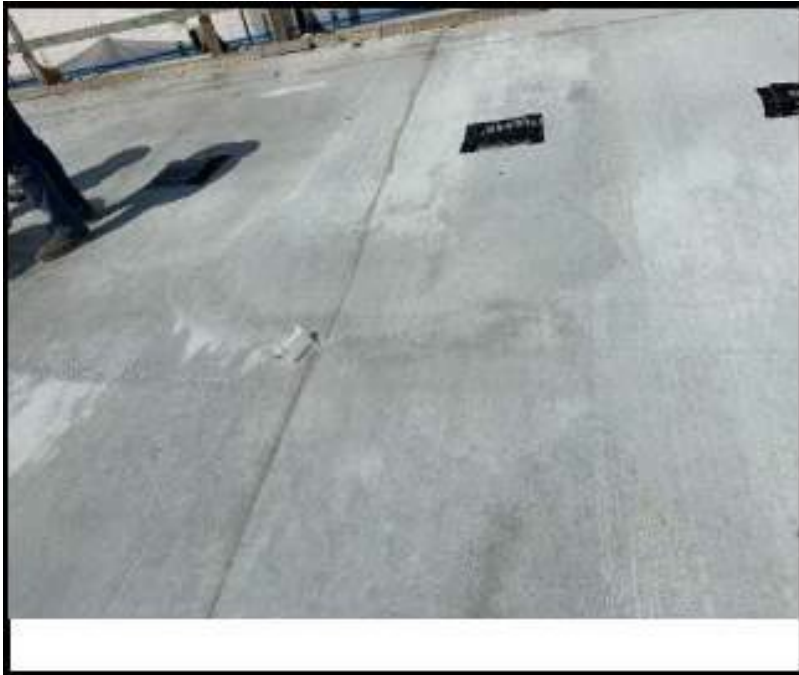
Figure 27. Photograph from Threshold Inspection Report No. 125 showing conditions on top of roof slab at north end of building.

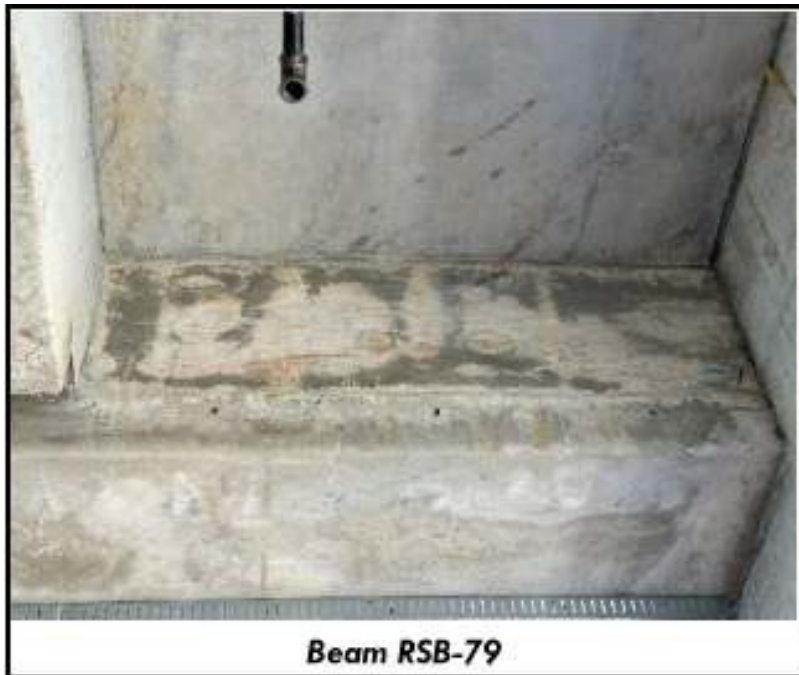
Figure 28. Photograph from Threshold Inspection Report No. 125 showing conditions at underside of roof slab and at beam RSB-79 (gridline J-2) at north end of building.

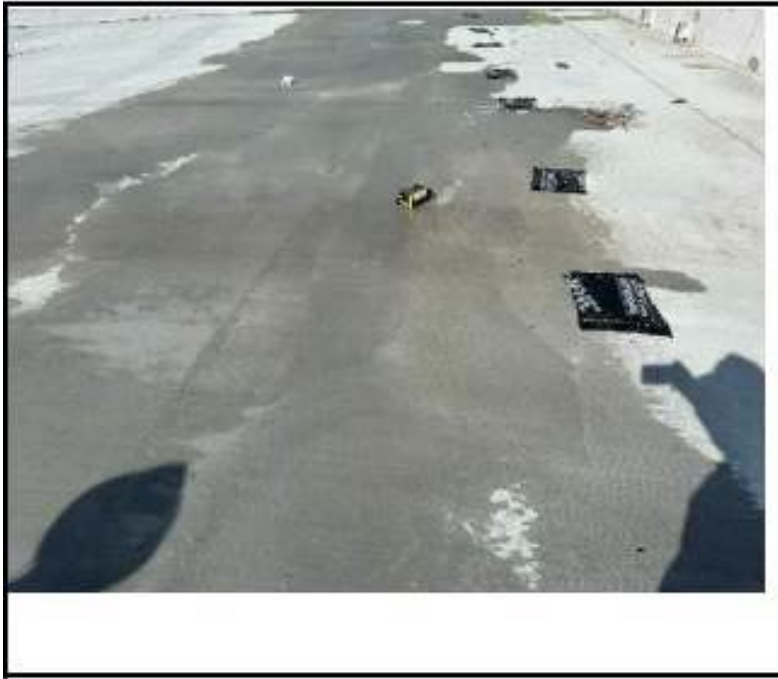
Additional documentation and observations were summarized in Threshold Inspection Report No. 127, dated March 13, 2024. Water was sprayed onto the top of the roof slab (Figure 29 and Figure 30) and it was observed that some water infiltrated through the cracks in the slab and was evident on the underside of the slab (Figure 31 through Figure 34), indicating that the cracks extended through the entire thickness of the slab.

Figure 29. Photograph from Threshold Inspection Report No. 127 showing water which was sprayed onto the top of the roof slab at the north end of building.

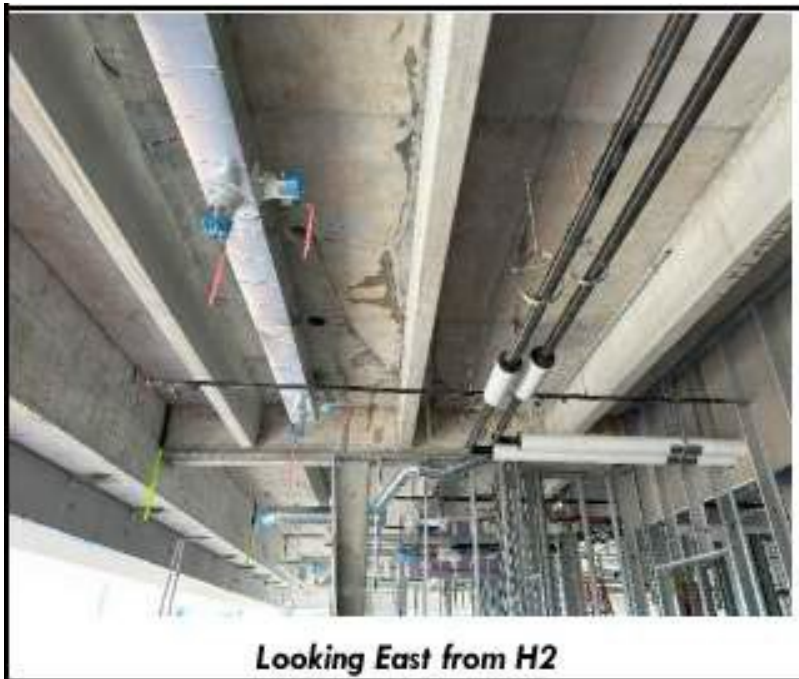
Figure 31. Photograph from Threshold Inspection Report No. 127 showing underside of roof slab at north end of the building showing water which has filtered through from the top of the roof slab at cracked slab locations.

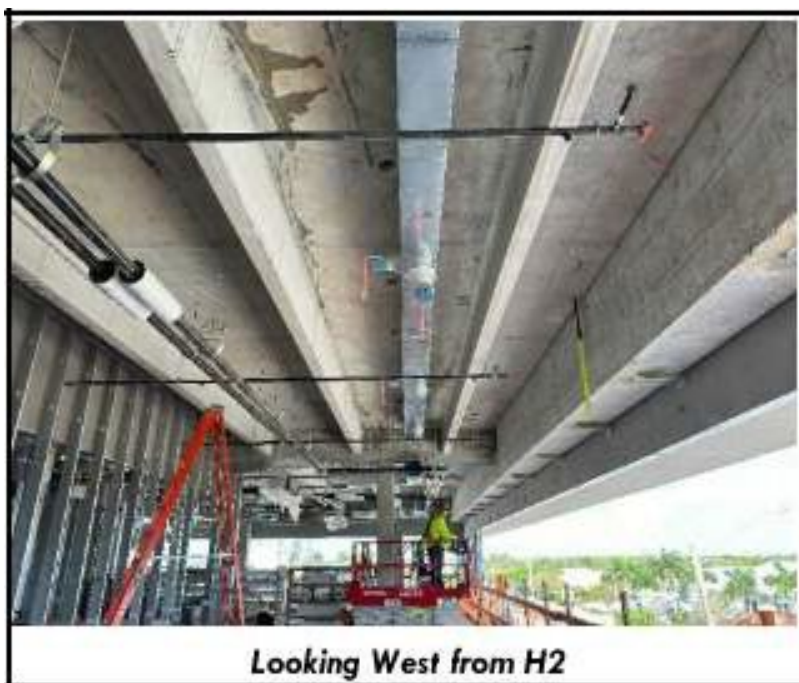
Figure 32. Photograph from Threshold Inspection Report No. 127 showing underside of roof slab at north end of the building showing water which has filtered through from the top of the roof slab at cracked slab locations.

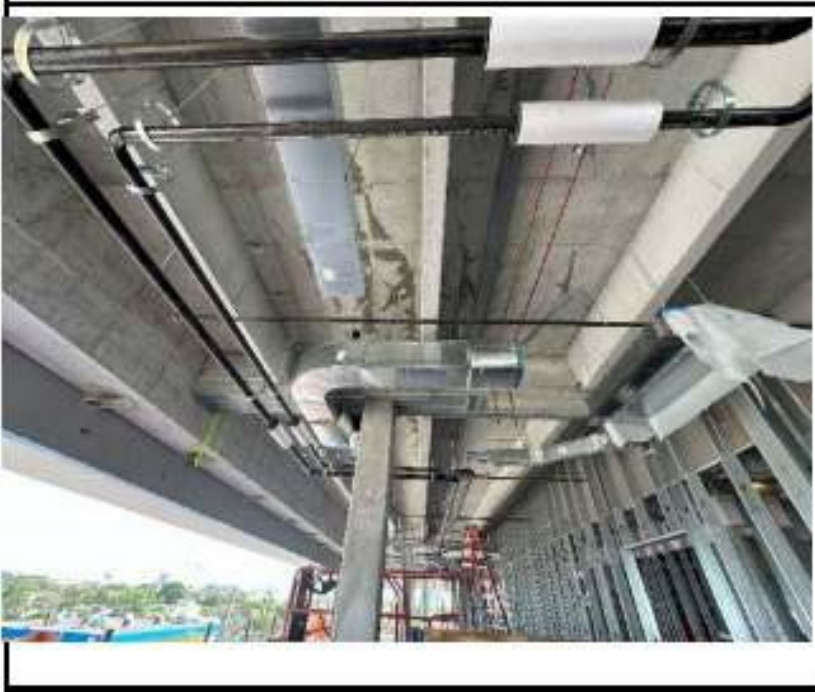
Figure 33. Photograph from Threshold Inspection Report No. 127 showing underside of roof slab at north end of the building showing water which has filtered through from the top of the roof slab at cracked slab locations.

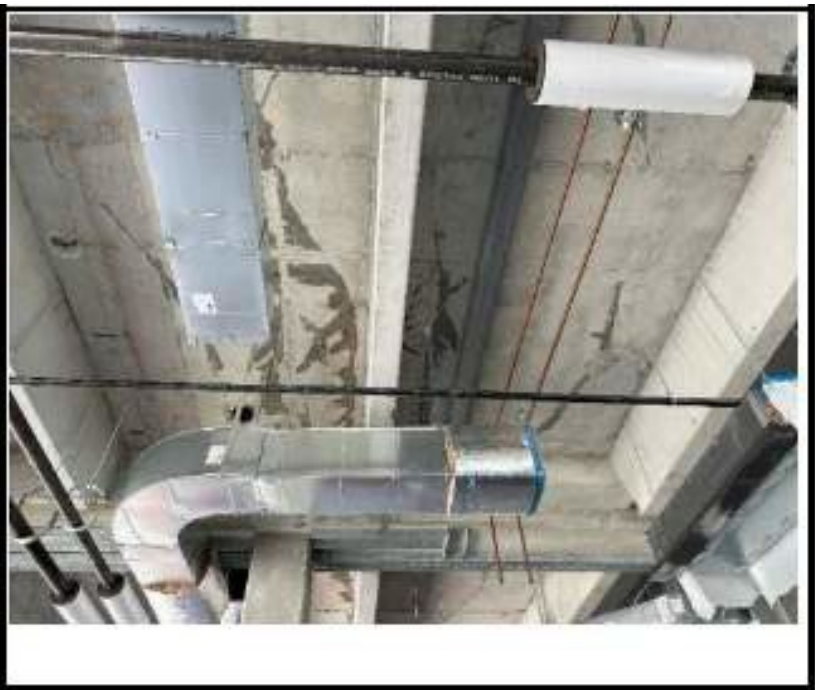
Figure 34. Photograph from Threshold Inspection Report No. 127 showing underside of roof slab at north end of the building showing water which has filtered through from the top of the roof slab at cracked slab locations.

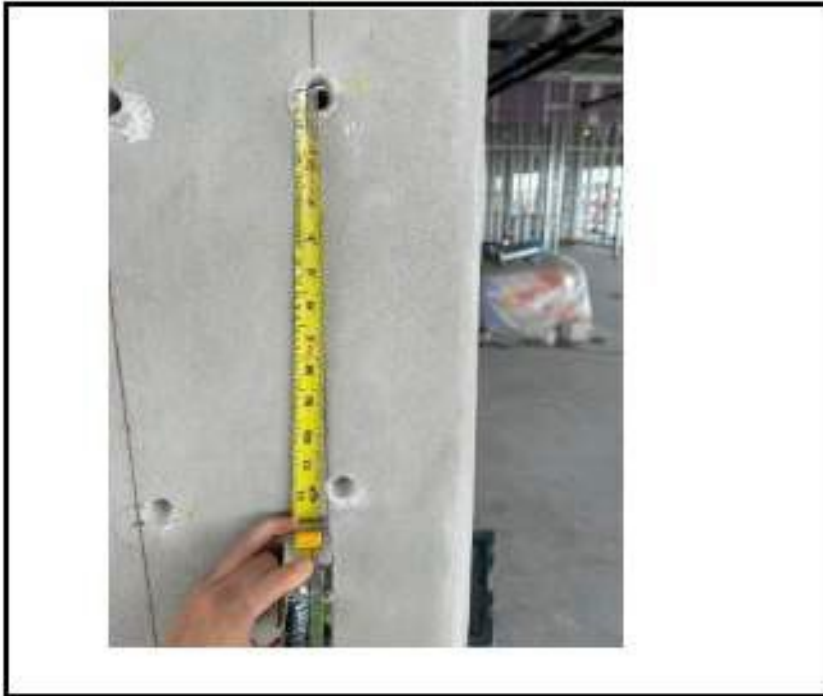
Figure 35. Photograph from Threshold Inspection Report No. 137 showing holes drilled in the north side of column H-2 to receive rebar dowels as part of the rectification of the column and roof structure.

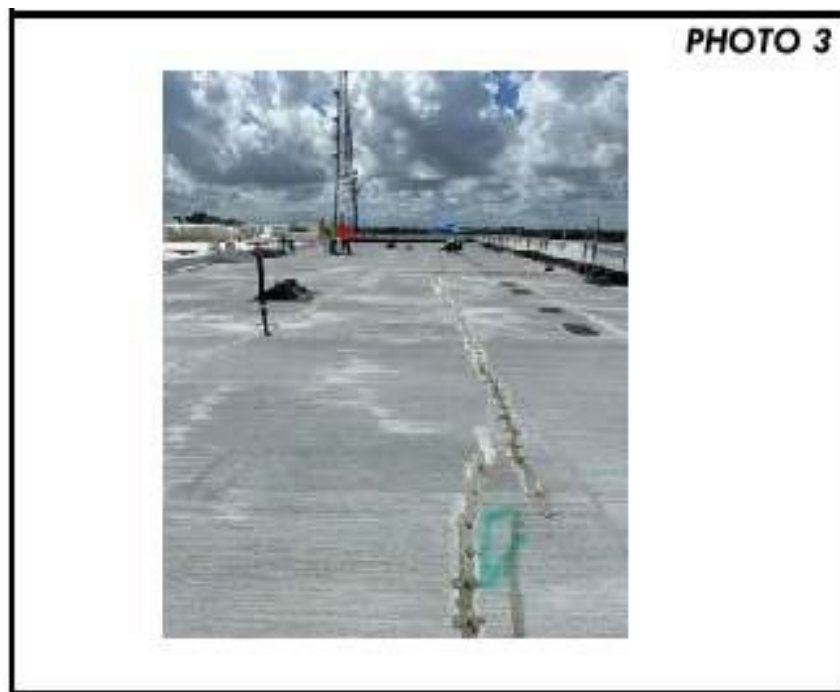
Figure 52. Photograph from Threshold Inspection Report No. 200 showing crack preparation and injection ports for epoxy injection of cracks in roof slab.

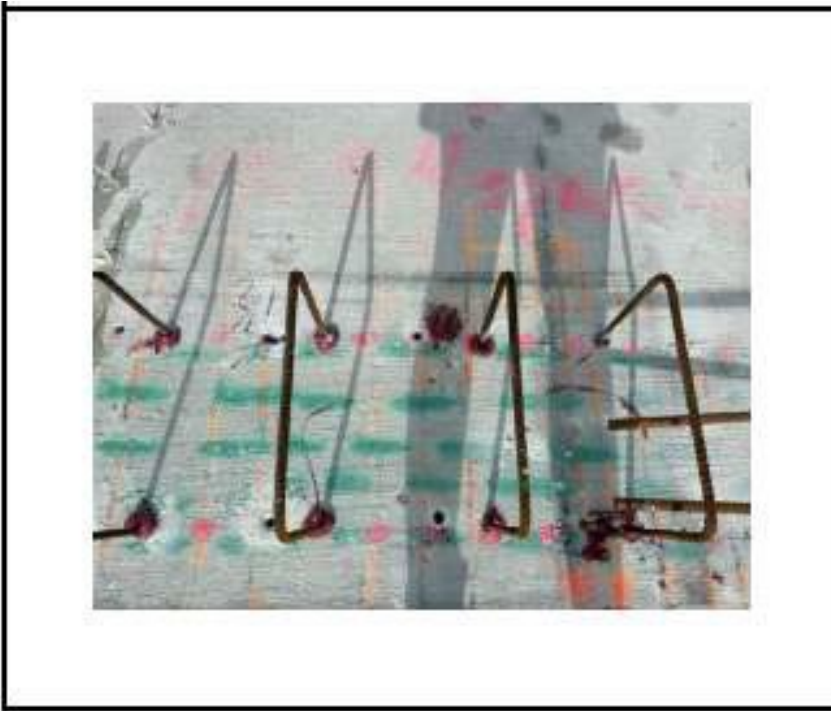
Figure 53. Photograph from Threshold Inspection Report No. 201 showing installed inverted "U" shaped stirrups in upturned beams.

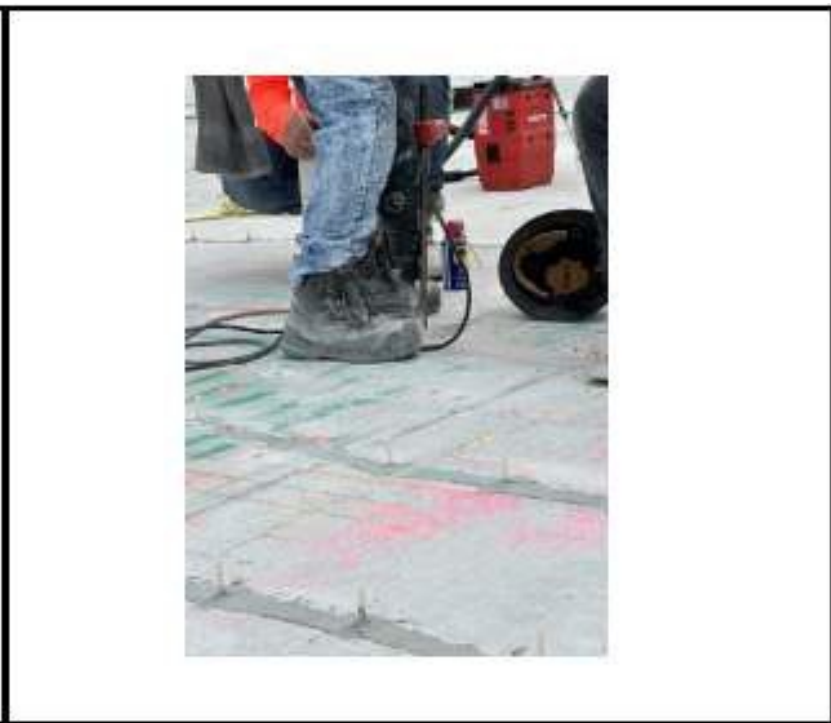
Figure 54. Photograph from Threshold Inspection Report No. 201 showing epoxy crack injection of cracks in roof slab.

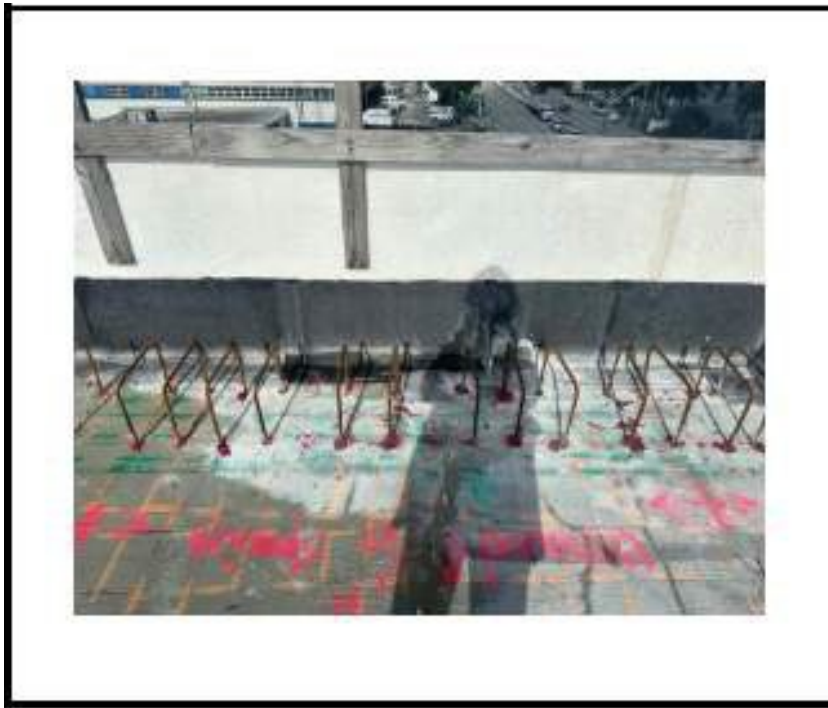
Figure 55. Photograph from Threshold Inspection Report No. 202 showing installed inverted "U" shaped stirrups in upturned beams.

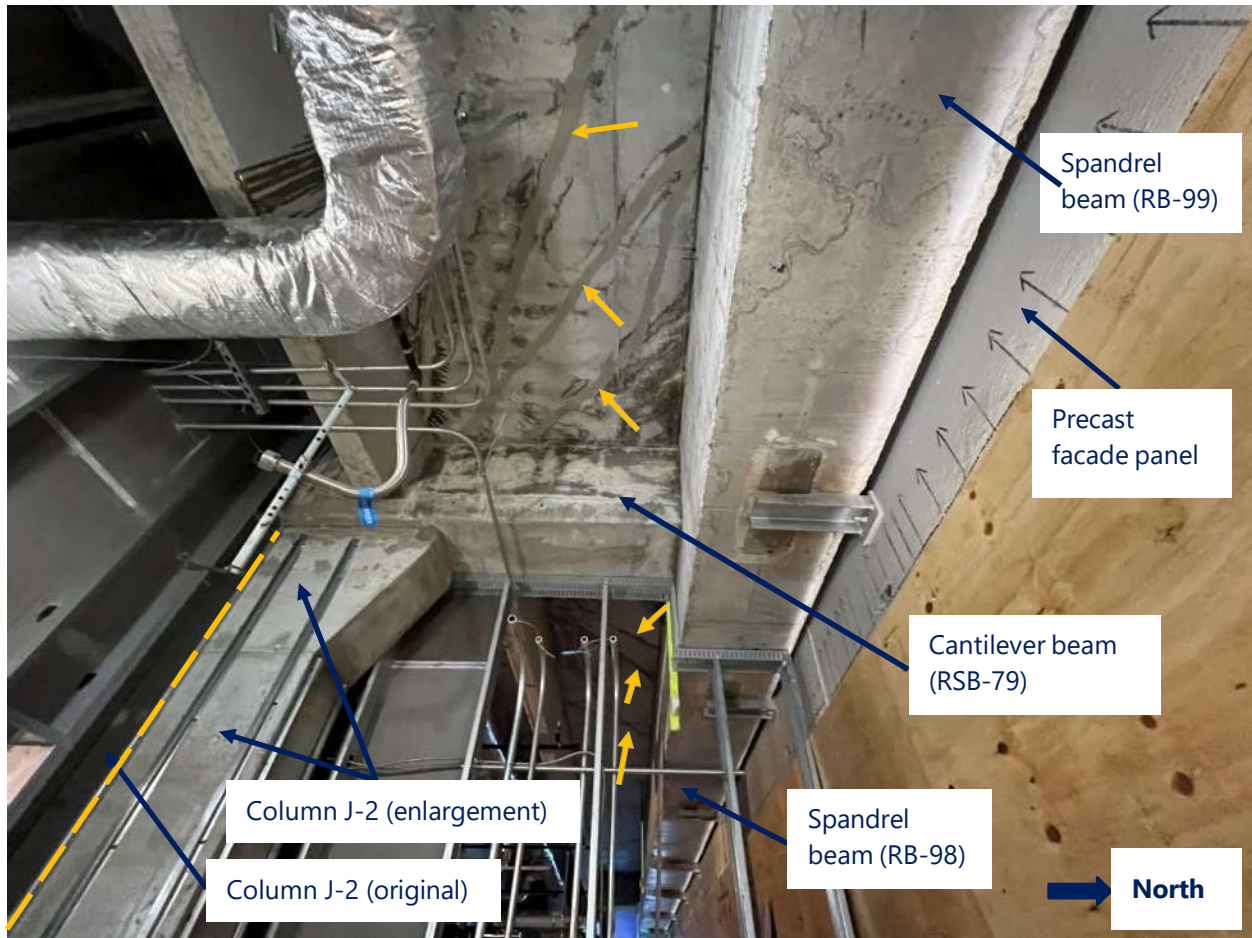
Figure 65. Cantilever roof beam and roof slab at gridline J-2. Orange arrows point to evidence of epoxy filled cracks in roof slab.

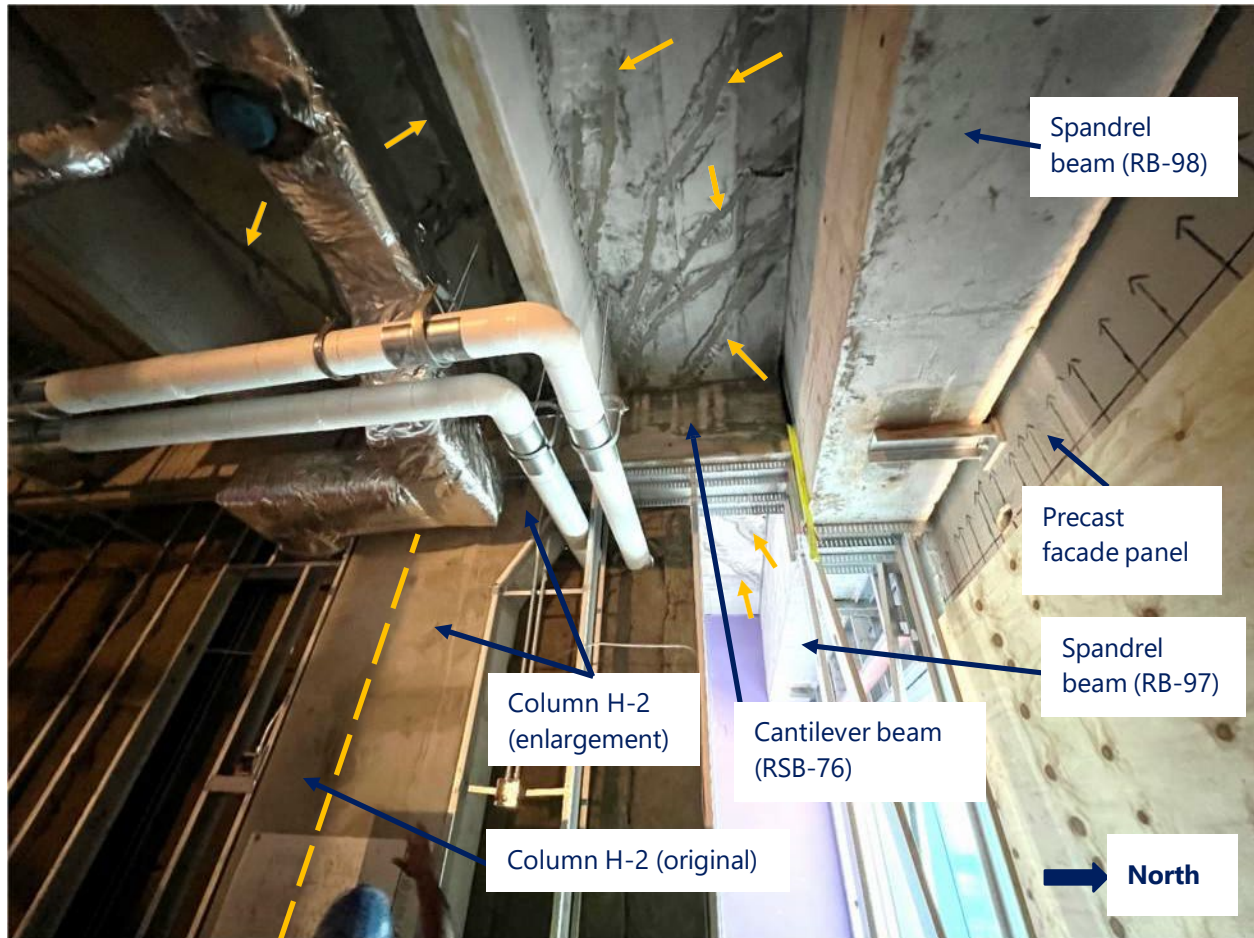
Figure 66. Cantilever roof beam and roof slab at gridline H-2. Orange arrows point to evidence of epoxy filled cracks in roof slab.

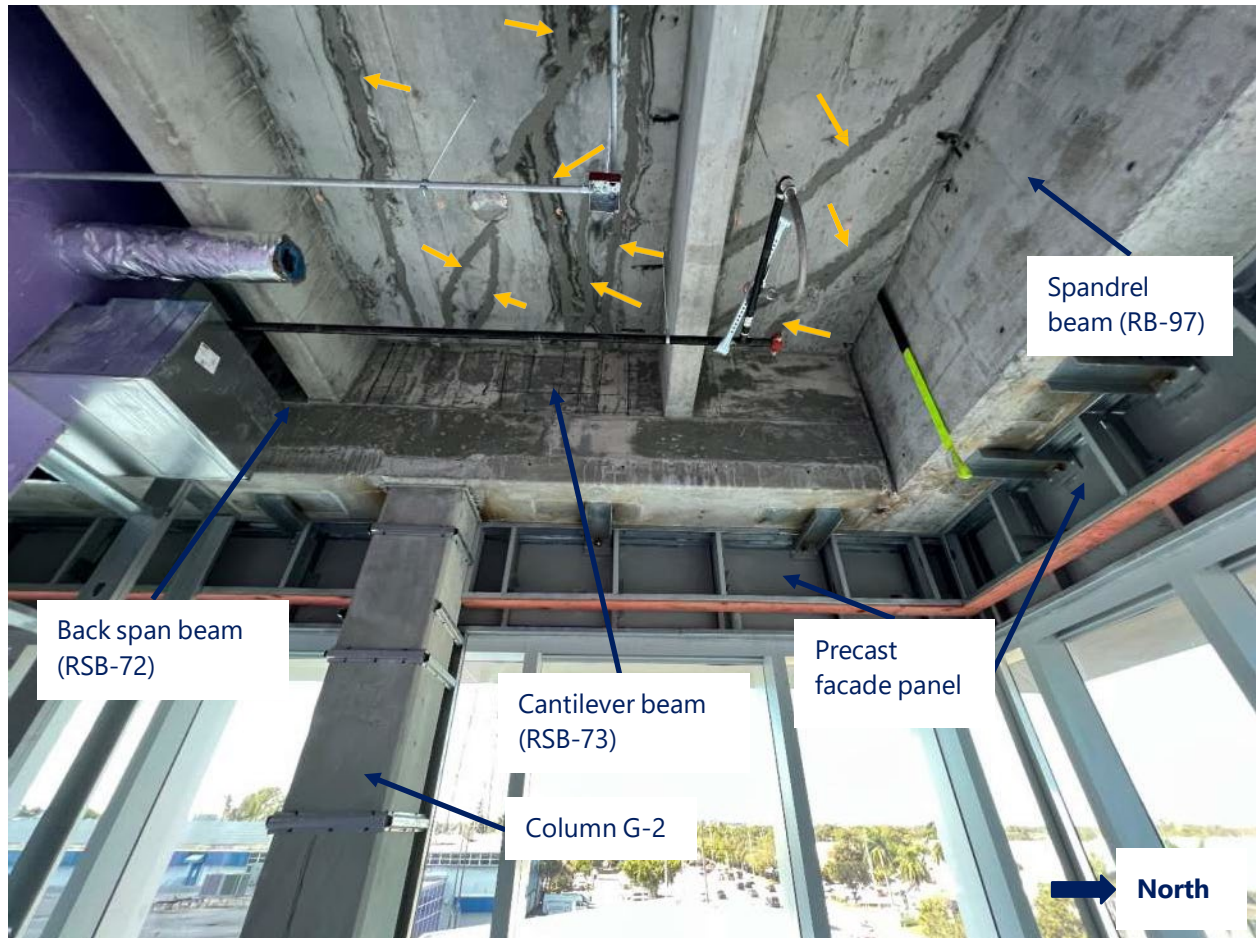
Figure 67. Cantilever roof beam and roof slab at gridline G-2. Orange arrows point to evidence of epoxy filled cracks in roof slab.

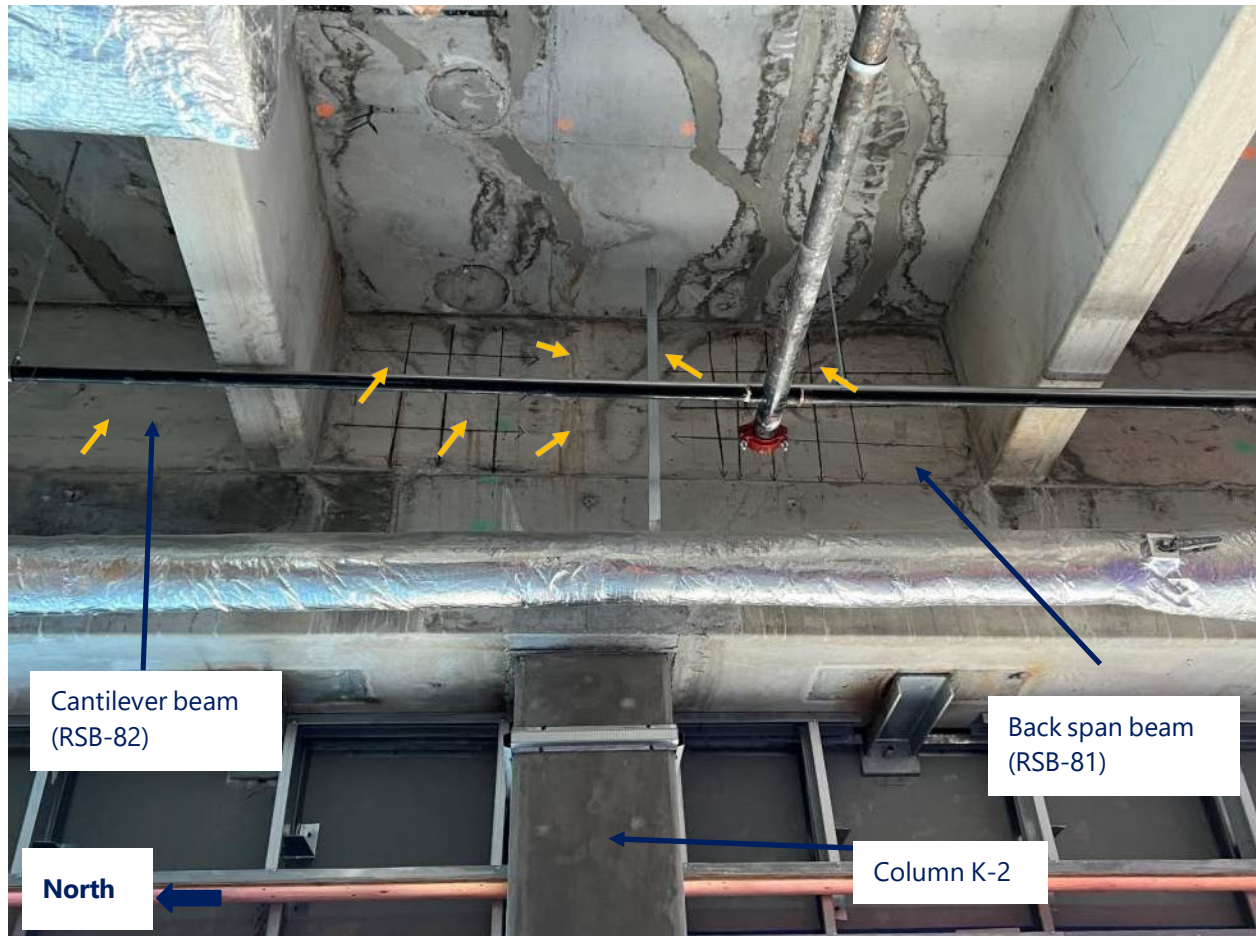
Figure 68. Cantilever roof beam back span roof beam at gridline K-2. Orange arrows point to cracks or evidence of possible cracks in beam.

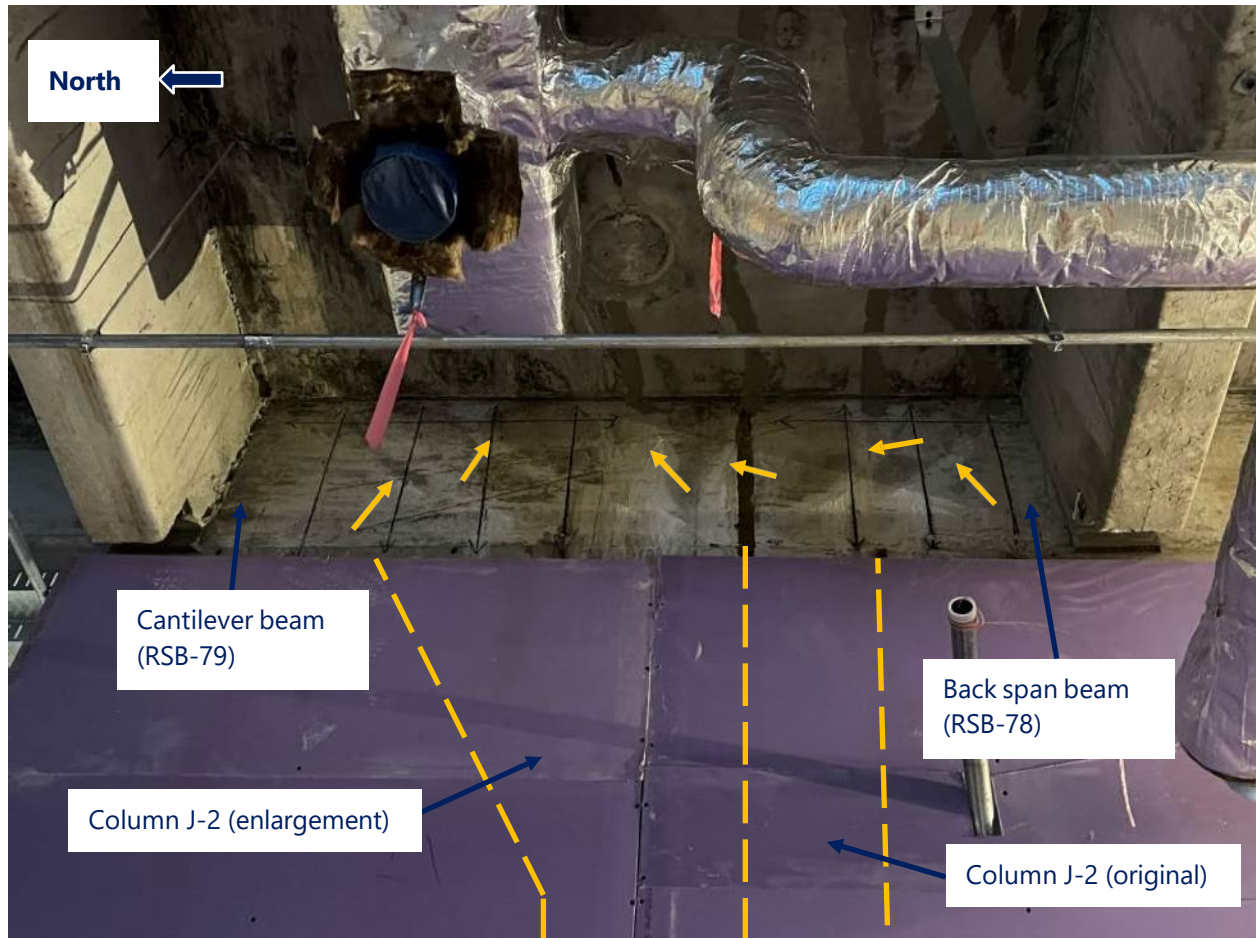
Figure 69. Cantilever roof beam back span roof beam at gridline K-2. Orange arrows point to cracks or evidence of possible cracks in beam. Column location shown is approximate.

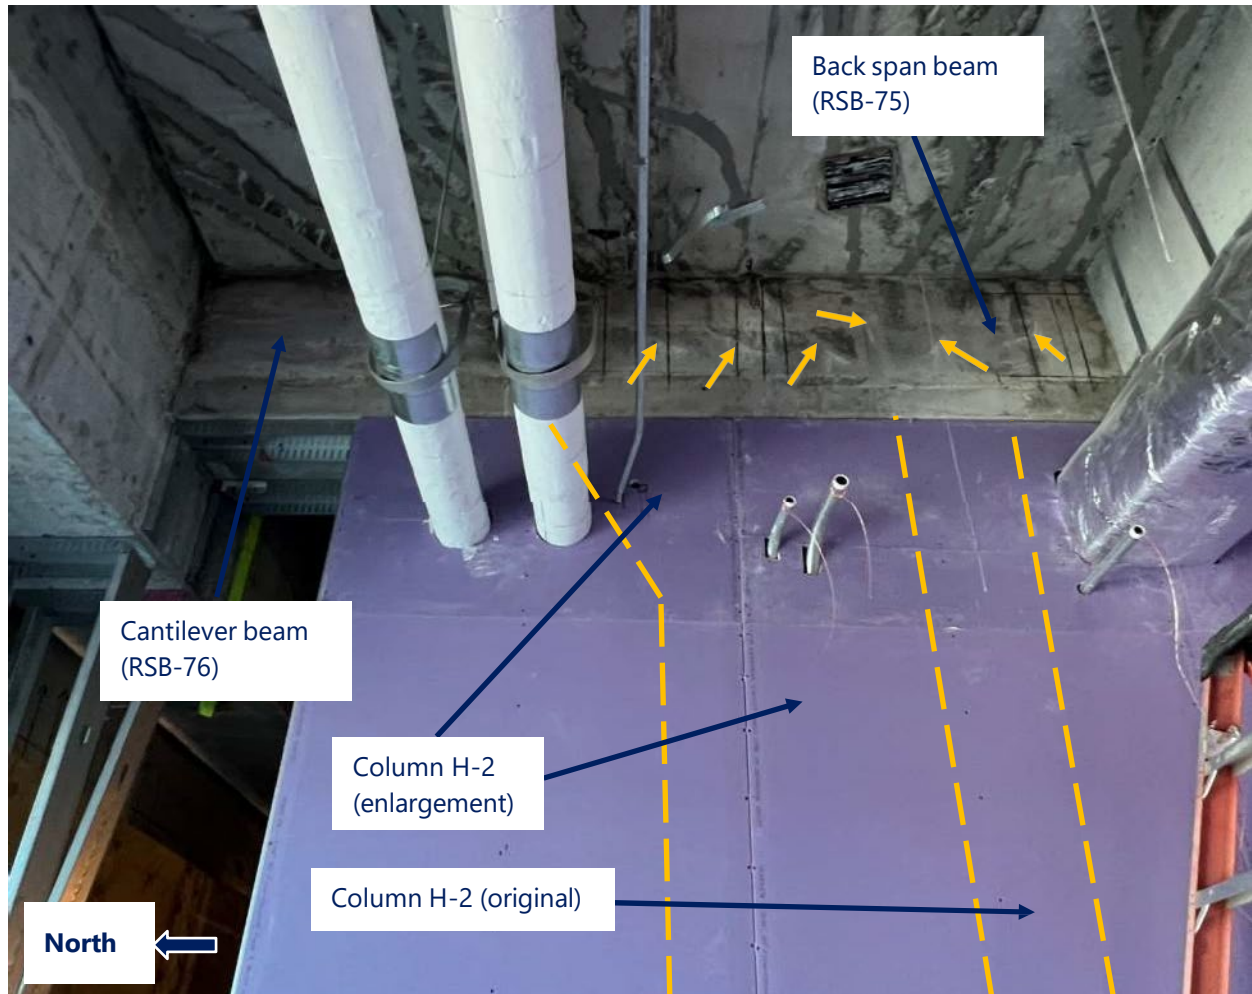
Figure 70. Cantilever roof beam back span roof beam at gridline H-2. Orange arrows point to cracks or evidence of possible cracks in beam. Column location shown is approximate.

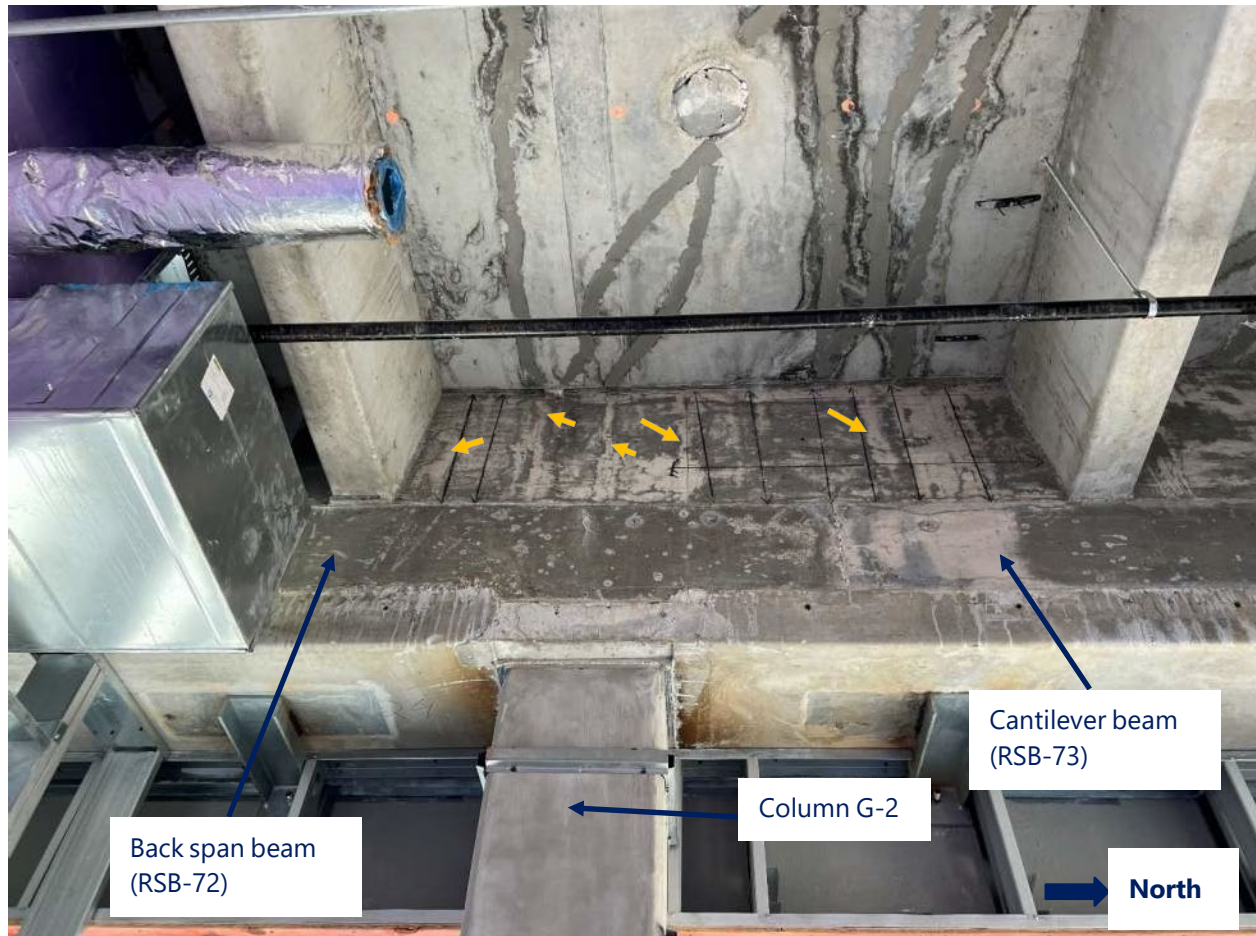
Figure 71. Cantilever roof beam back span roof beam at gridline G-2. Orange arrows point to cracks or evidence of possible cracks in beam.

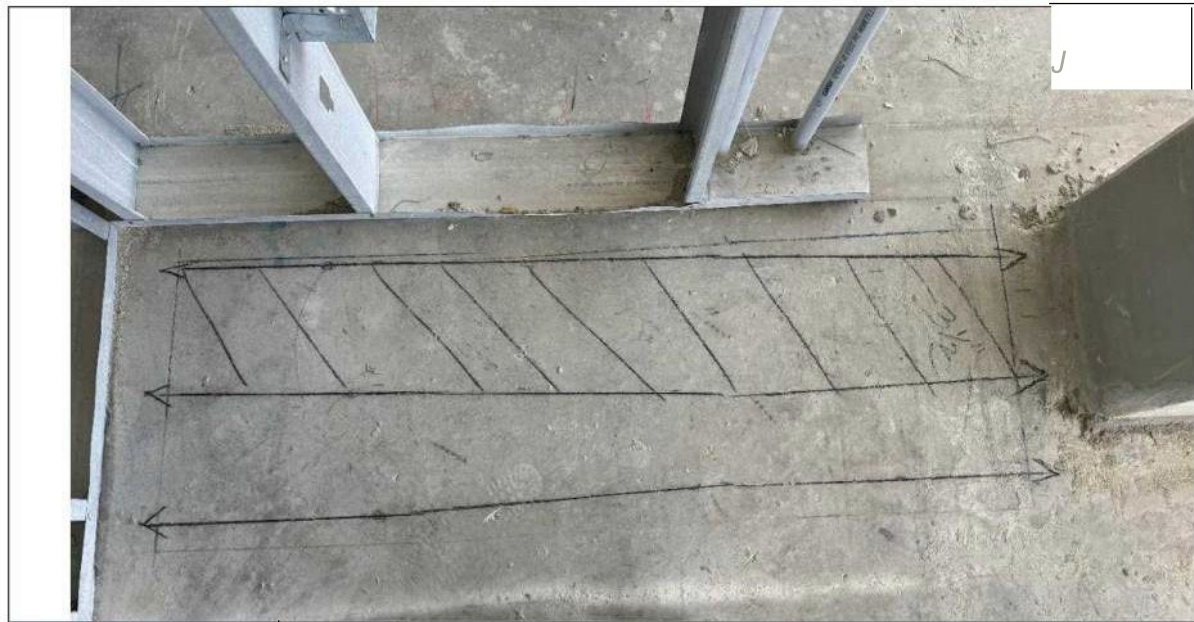
<b>Location:</b>	Behind column 12, 3rd Floor
<b>Comments:</b>	In this area a congestion area was found running along horizontally. No specific amount of rebar was able to be counted. Congested area was found to be 3.5" deep.

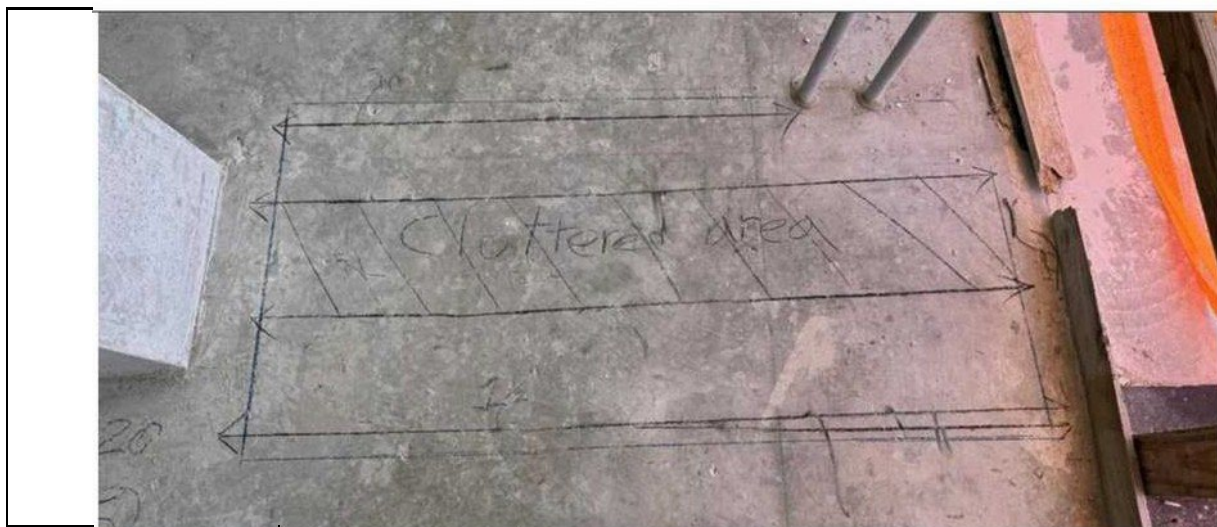
<b>Location:</b>	Column 2, 3rd Floor
<b>Comments:</b>	In this area a congestion area was found running along horizontally. No specific amount of rebar was able to be counted. Congested area was found to be 2" deep.

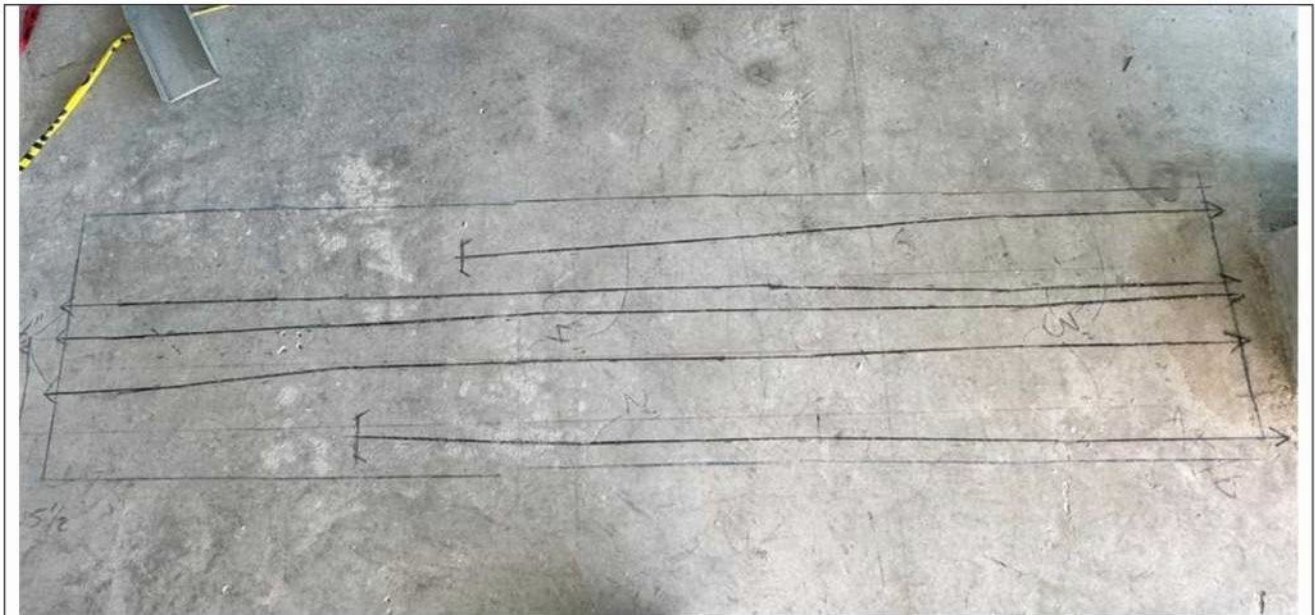
<b>Location:</b>	Behind Column 3 3 <sup>rd</sup> Floor
<b>Comments:</b>	5 horizontal rebars were found in this area with de ths ran in between 2"-4'

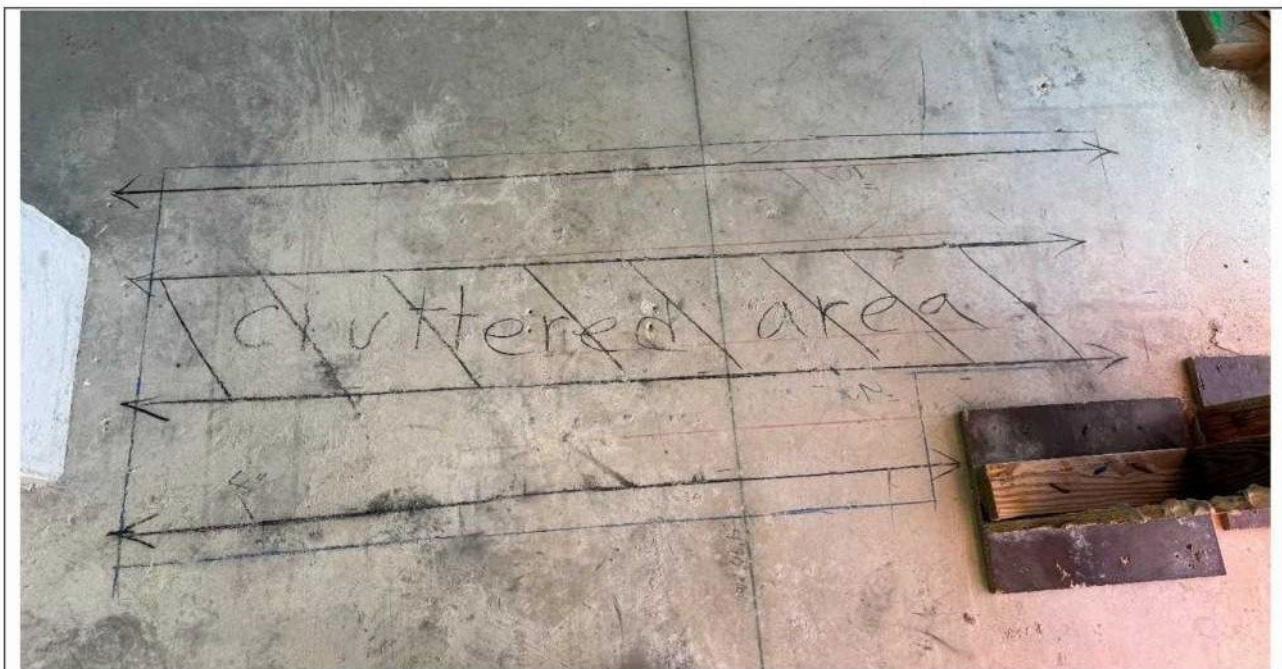
<b>Location:</b>	Column 3, 3 <sup>rd</sup> Floor
<b>Comments:</b>	In this area a congestion area was found running along horizontally. No specific amount of rebars was able to be counted. Con ested area was found to be 2" dee .

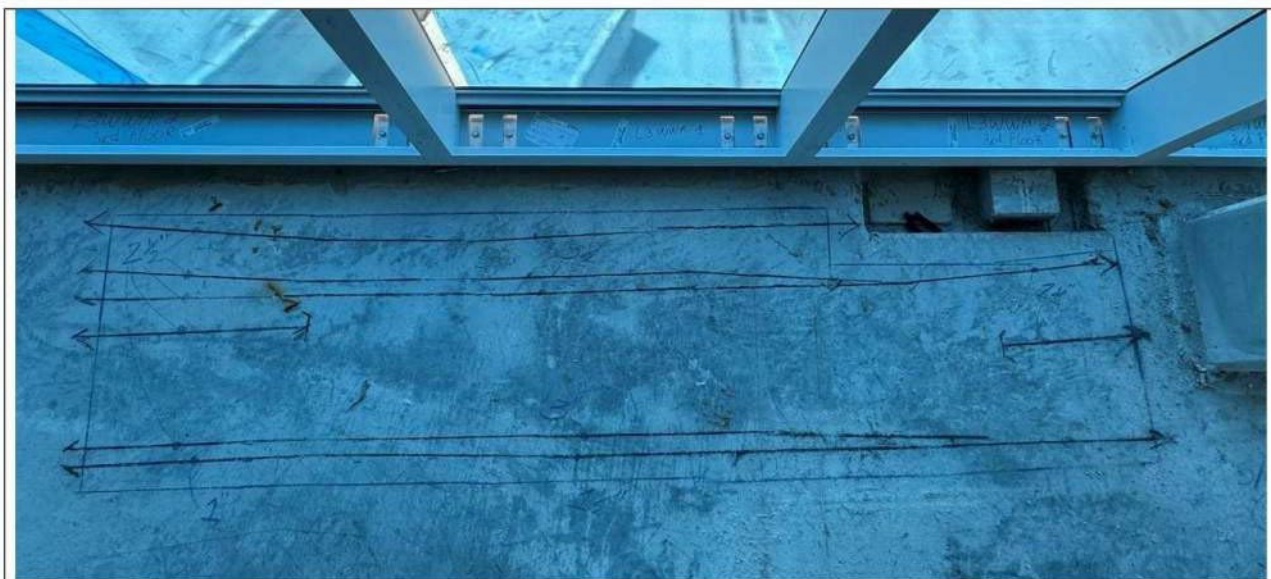
<b>Location:</b>	Behind column 4, 3 <sup>rd</sup> Floor
<b>Comments:</b>	About 5 horizontal rebars can be seen in at depths of 1.5" to 2.5" deep.
