Fort Lauderdale Police Headquarters Project Update

September 3, 2025

Fort Lauderdale Police Headquarters Project Status Exhibit 3

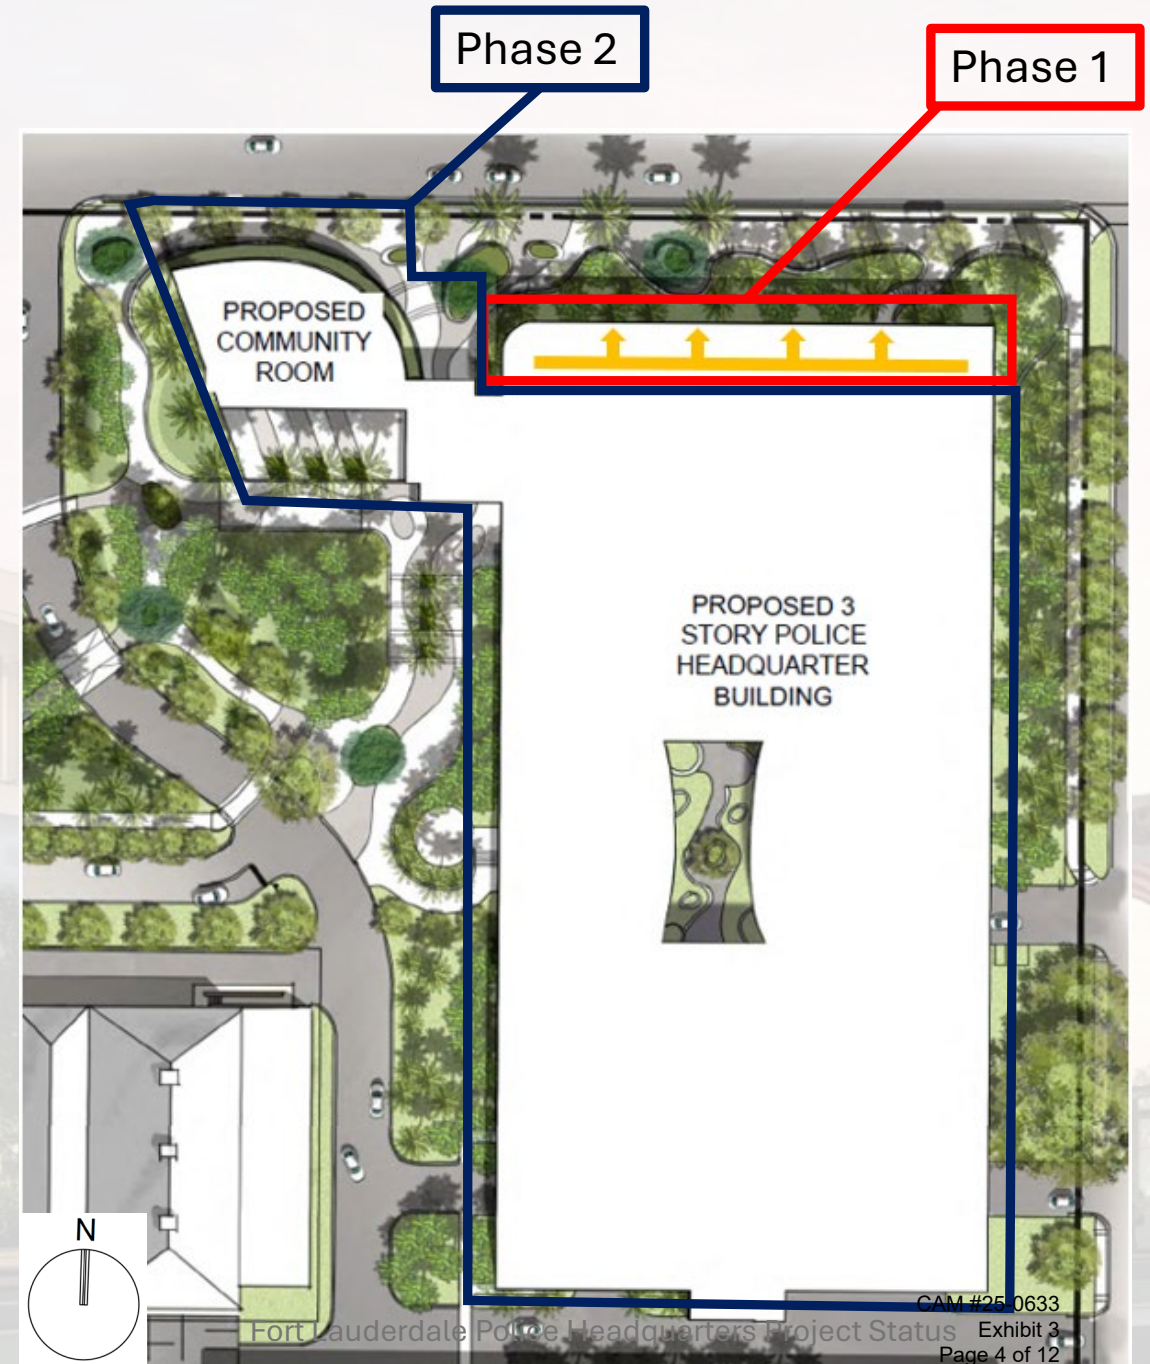
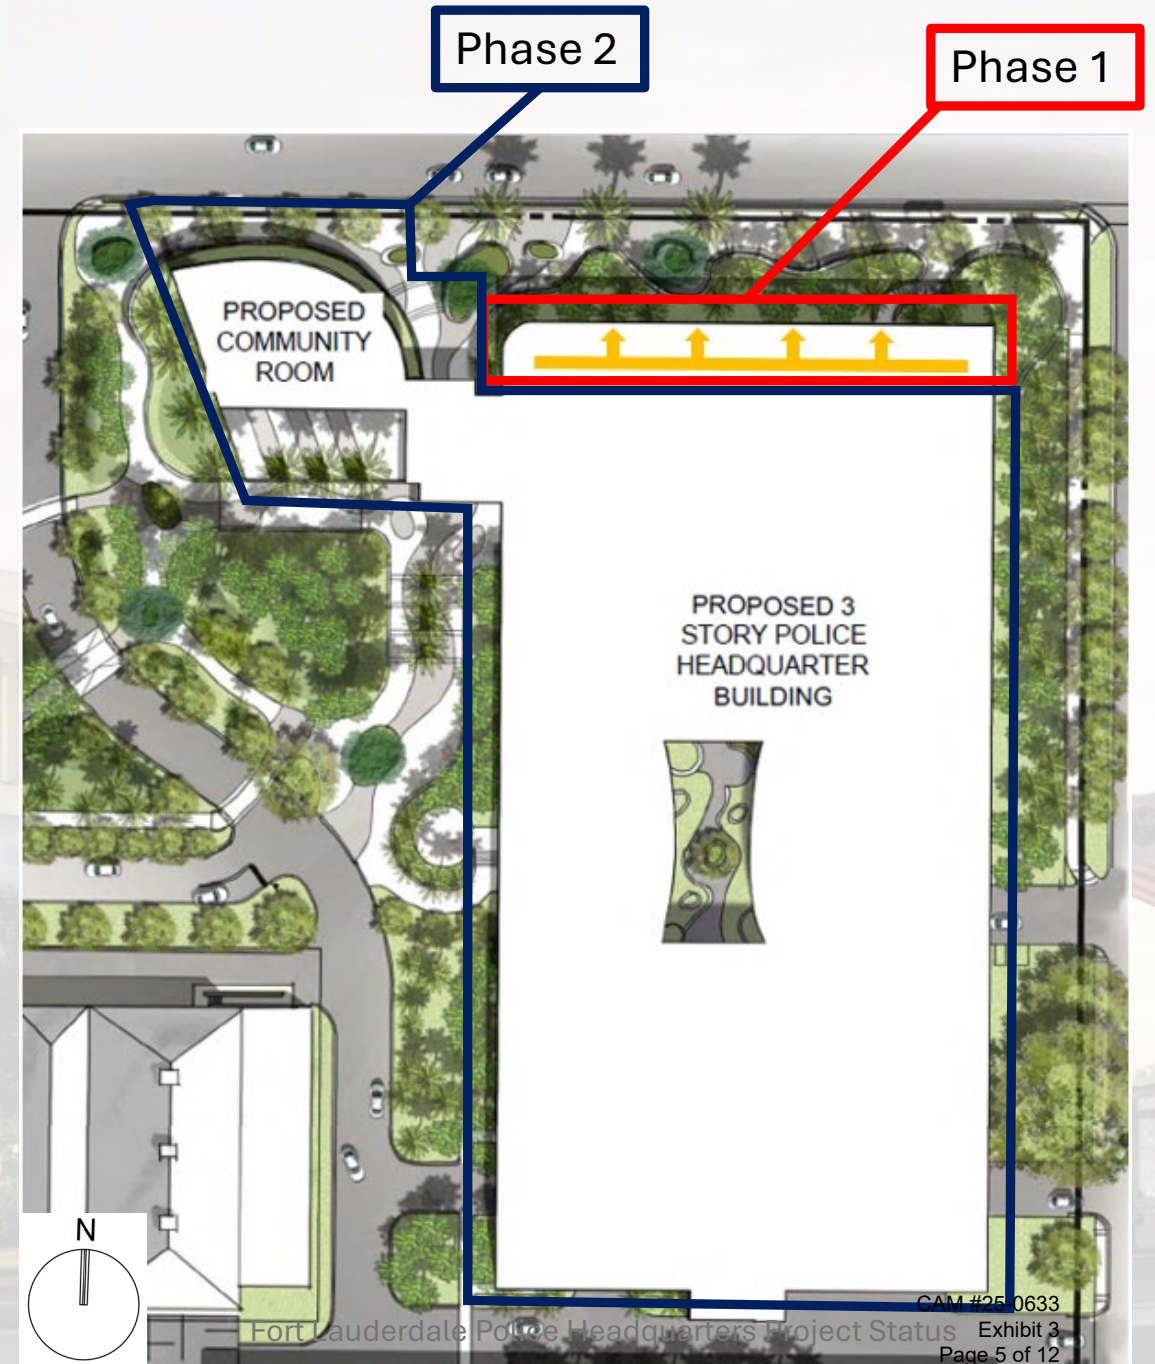
- Life Safety
 1. Shear Wall Capacity
 2. Foundation Capacity at Shear Walls
 3. Foundation Capacity at Columns
 4. Slide Bearing Capacity
 5. Structural Integrity
 6. Column Axial-Flexural Capacity
 7. Column Shear Capacity
 8. Roof Beam Capacity

- Life Safety
 1. Shear Wall Capacity
 - Pending Item 15 (masonry walls).
 2. Foundation Capacity at Shear Walls
 - Pending Items 1 & 15.
 3. Foundation Capacity at Columns
 - Resolved.
 4. Slide Bearing Capacity
 - Resolved (Permitting & Installation).
 5. Structural Integrity
 - Resolved.
 6. Column Axial-Flexural Capacity
 - Resolved – Pending Items 7 & 8.
 7. Column Shear Capacity
 - Resolved – Pending Submittal to DSD.
 8. Roof Beam Capacity
 - Resolved – Pending Submittal to DSD.

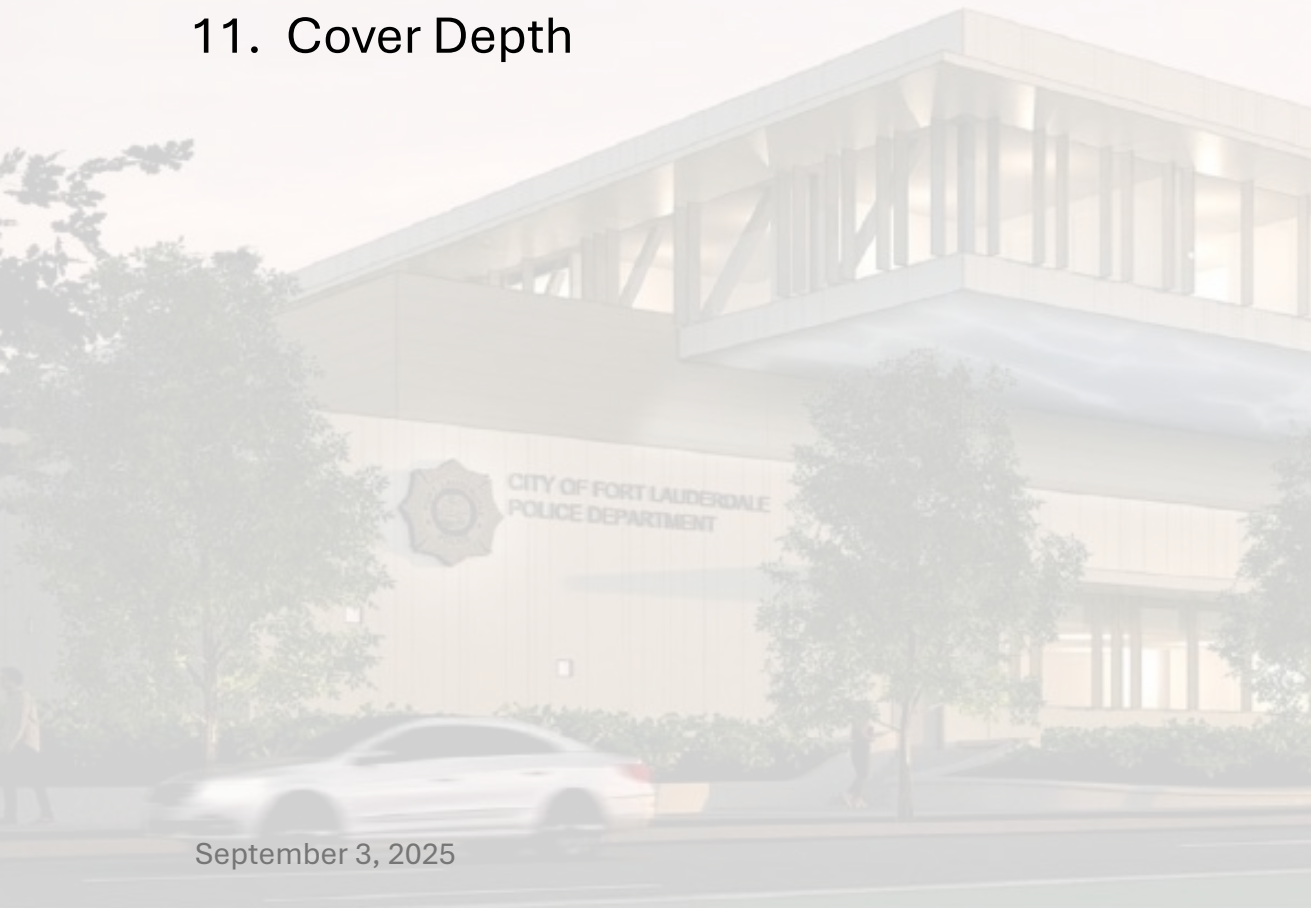
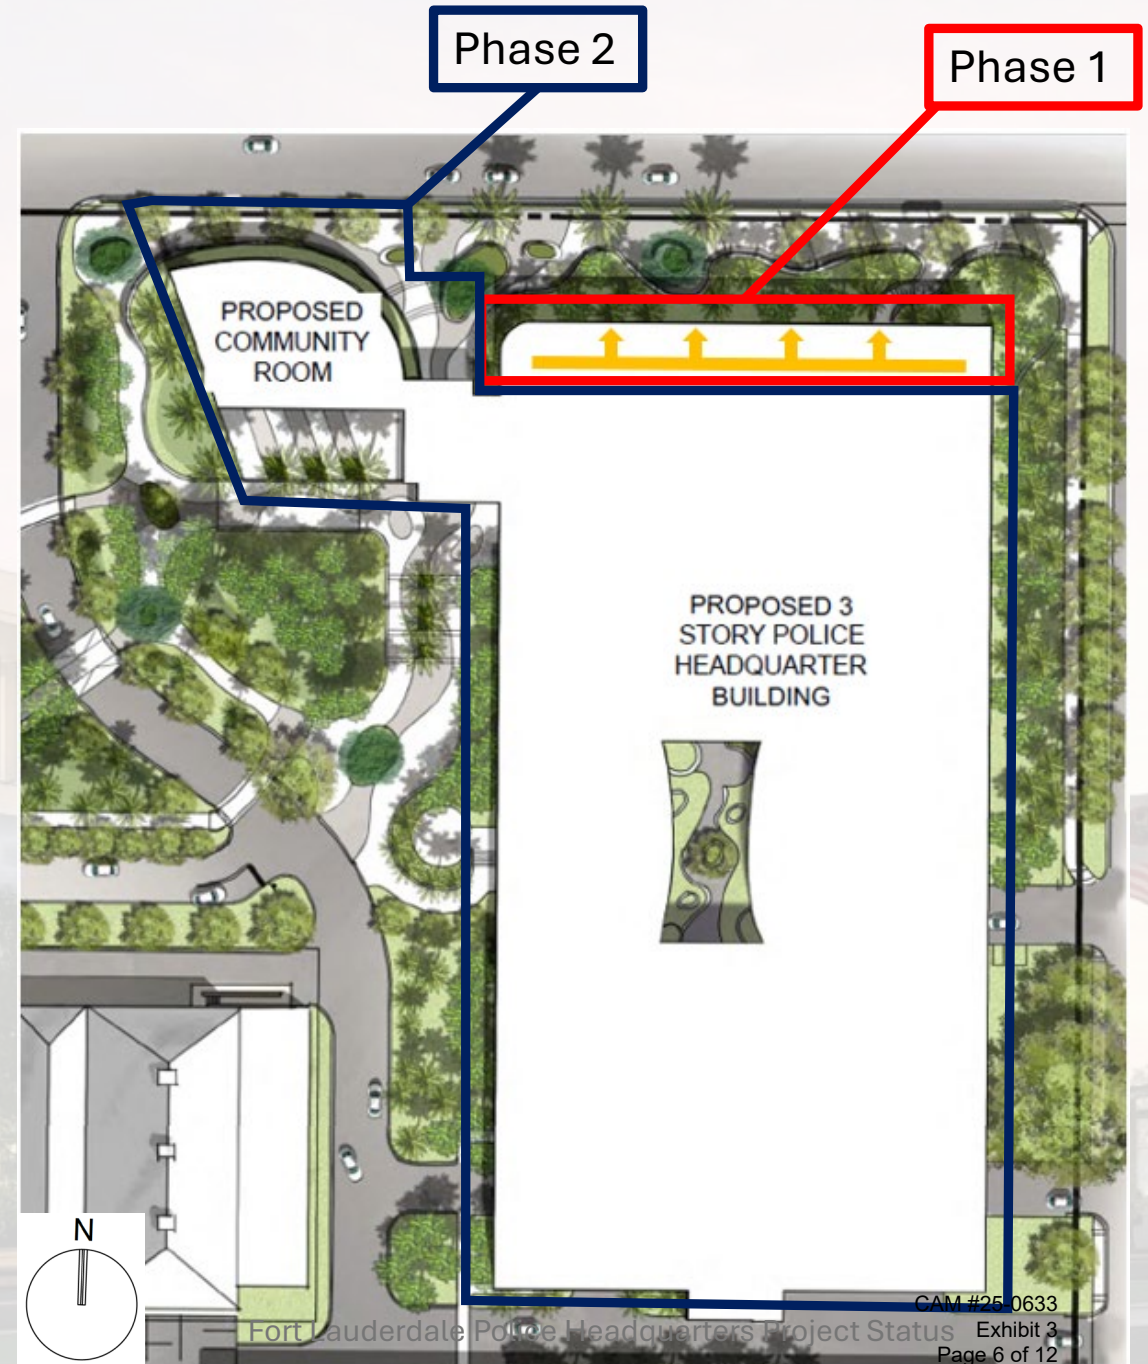
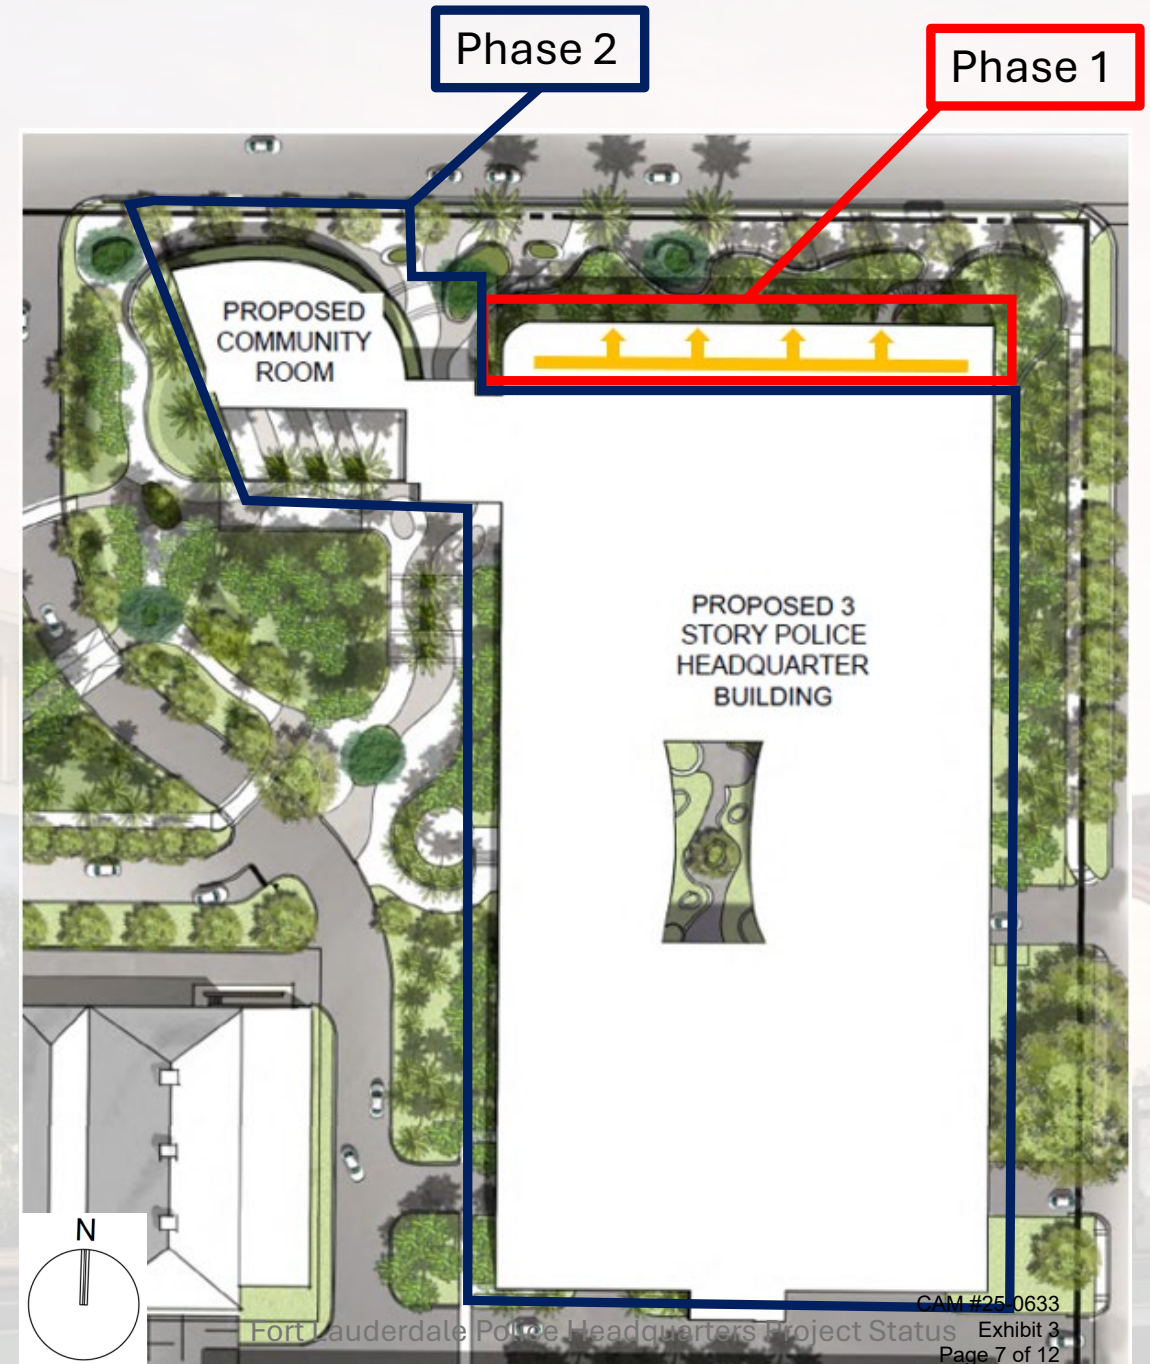
- Serviceability
 9. Community Room and Lobby Area
 10. Building Period
 11. Cover Depth

- Serviceability
 - 9. Community Room and Lobby Area
 - Resolved – Pending Updated Information.
 - 10. Building Period
 - Resolved - Pending items 1 & 15.
 - 11. Cover Depth
 - Resolved.

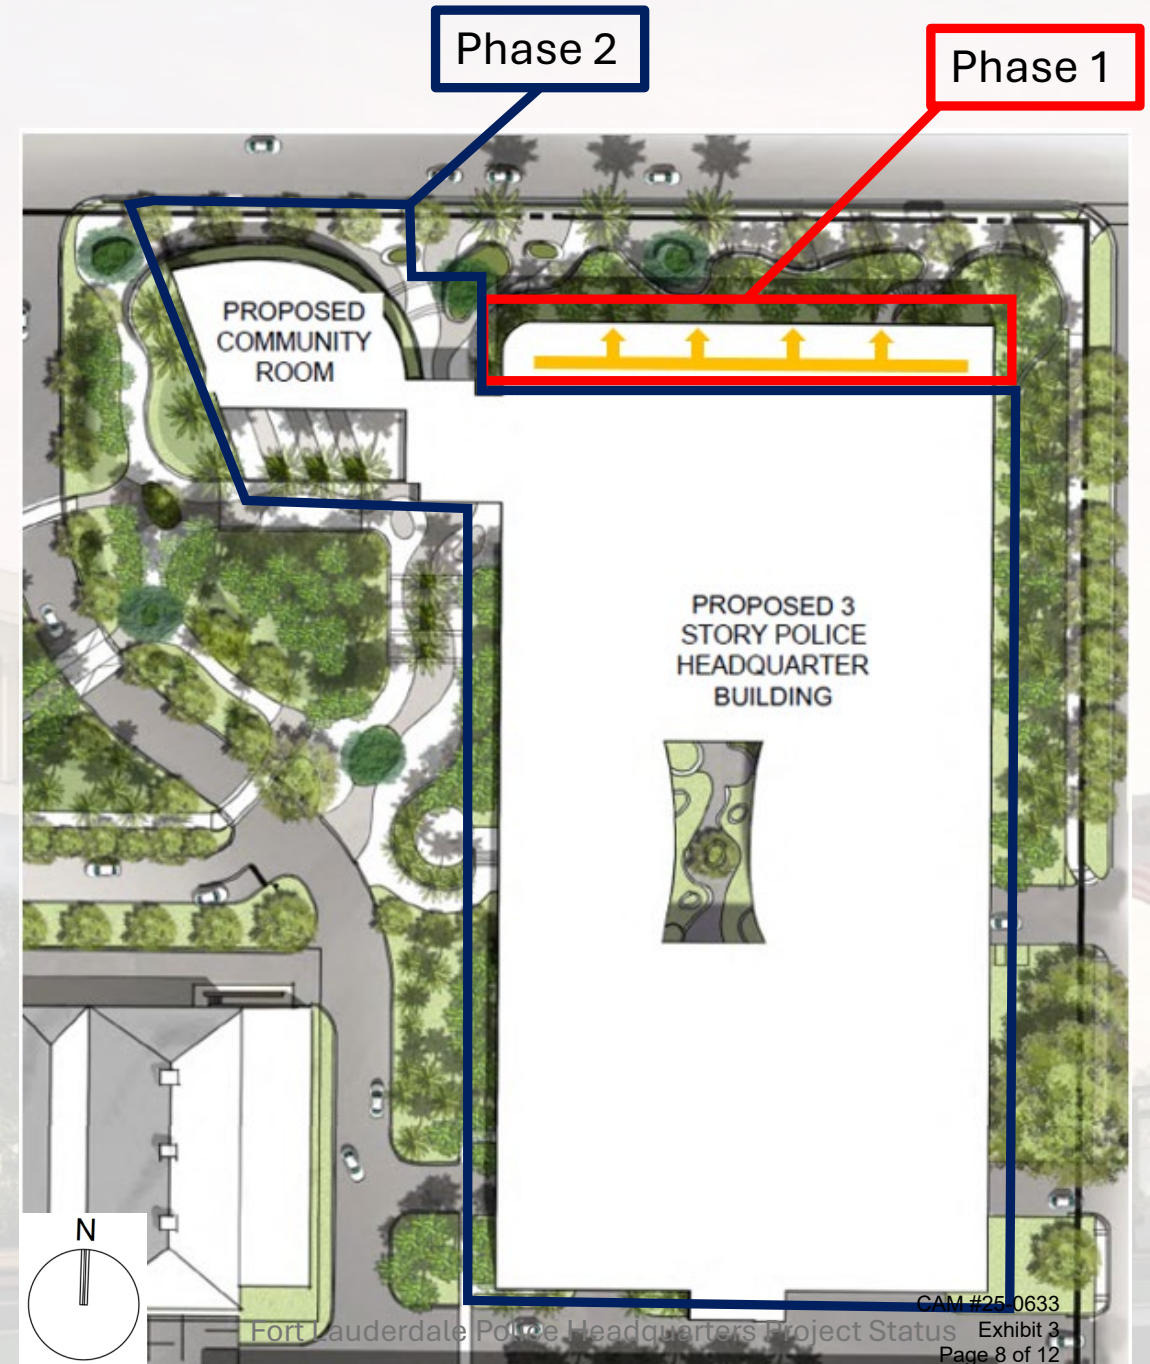
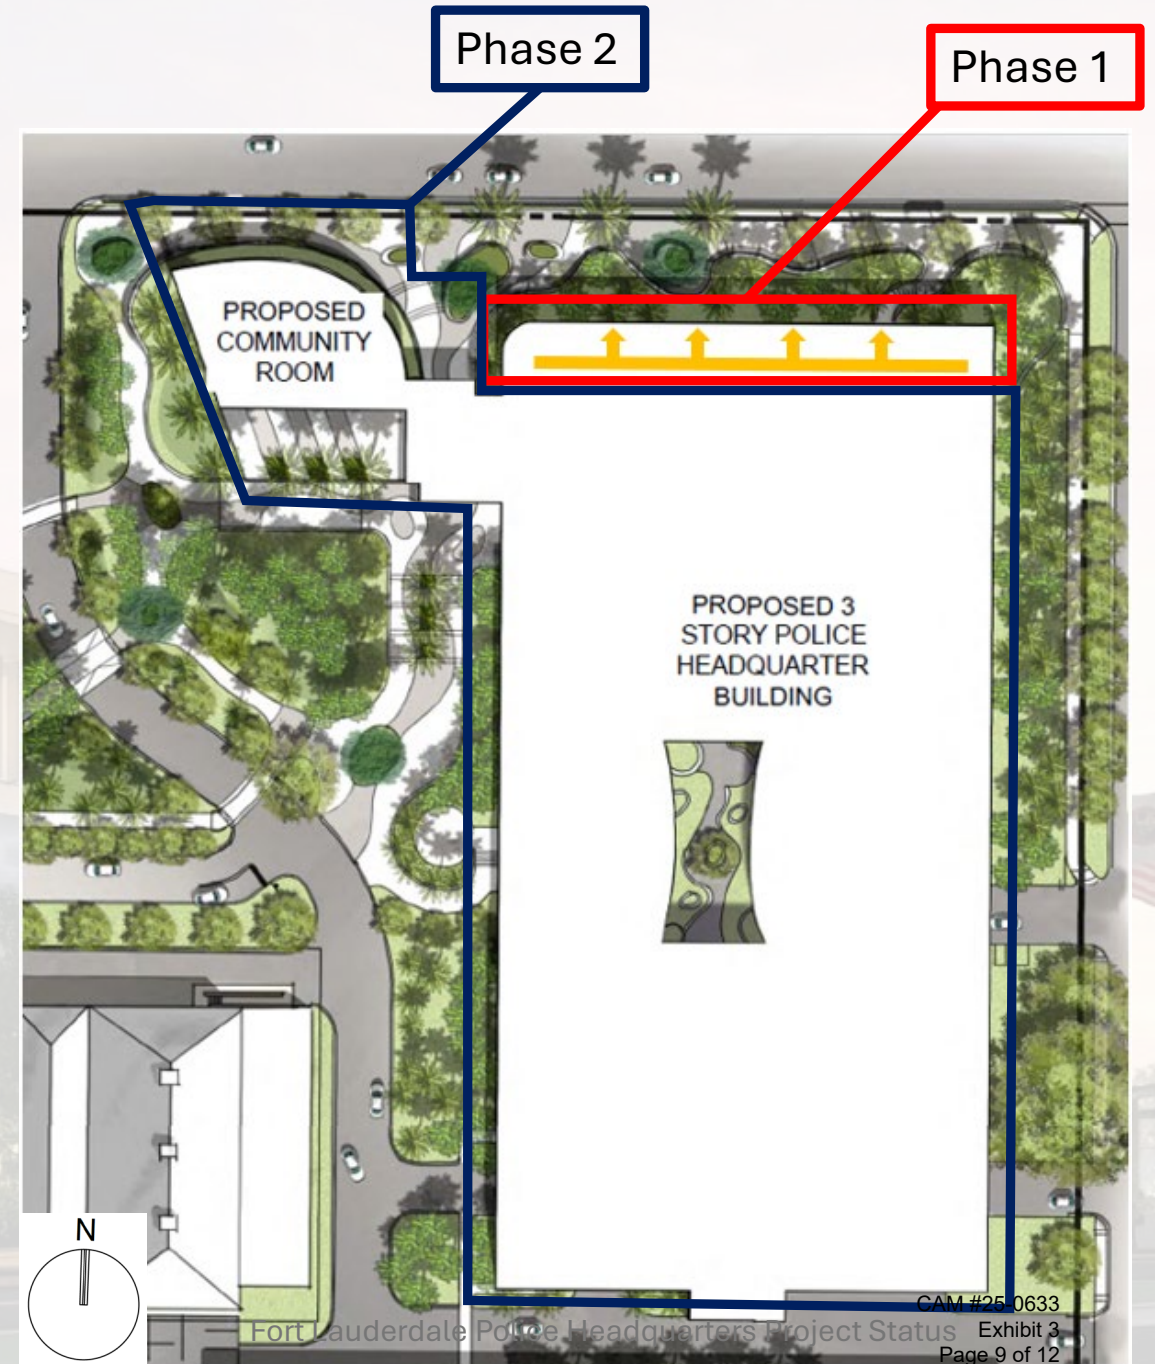
- Documentation
 - 12. Column Schedule
 - 13. Loads
 - 14. Mechanical Equipment
 - 15. Masonry Walls
 - 16. Column Flexural Stiffness Modifiers

- Documentation
 - 12. Column Schedule
 - Resolved.
 - 13. Loads
 - Resolved.
 - 14. Mechanical Equipment
 - Resolved.
 - 15. Masonry Walls
 - Pending Item 1.
 - 16. Column Flexural Stiffness Modifiers
 - Resolved – Items 1 & 15.
