Fort Lauderdale Police Headquarters

WJE Peer Review, Phase 2 – Building Structural Design Peer Review

Draft Report

April 22, 2025
WJE No. 2024.4855.0

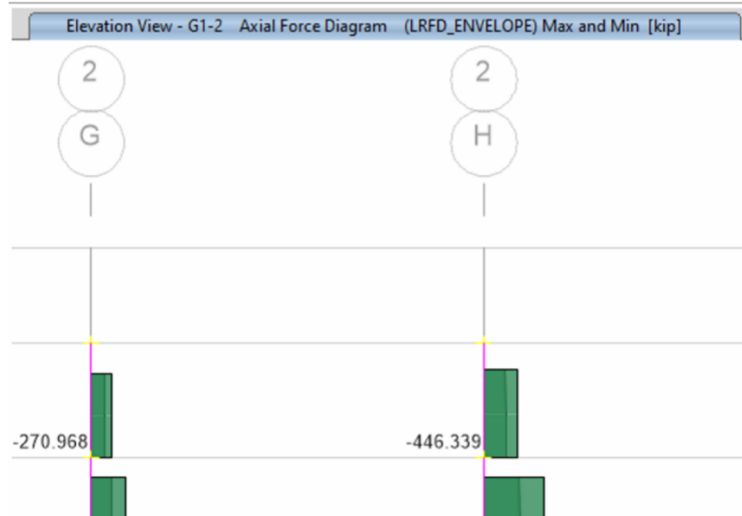
In their response, the SEOR concluded that “Micro-cracking at the spandrel-column interface will relieve nearly all of the bending moment at the column tops at Columns G/2 & K/2, and thus the shear calculated by WJE will not enter the columns at all.” To justify this conclusion, the SEOR approximated the flexural moment that would result in cracking of the columns, considering the tensile capacity of concrete and the compressive axial loading in the columns from gravity loading. The SEOR further noted that, based on WJE’s calculations of the negative moment capacity of the composite joist and slab, the cracking resistance of the columns was expected to be surpassed and therefore, the columns would crack. Continuing, the SEOR claimed that “This is normal behavior in a structural floor system of this nature. The introduction of a very small flexural crack at the top and bottom of the column will cause the traditional pin-ended column behavior that is commonly assumed for this type of floor system.” While we disagree with the SEOR that, once a reinforced concrete column cracks, it devolves into a pin-ended condition that no longer resists flexure at the cracked location, we understand this statement as indicating that the SEOR designed the FLPHQ by assuming that the columns have pinned ends. In other words, the columns had an effective flexural stiffness modifier of 0.00.

Figure 3. Image from the file "2025311_FLP Column H-2 and J-2 Validation.pdf" (dated March 11, 2025) prepared by the SEOR which indicates that they used a flexural stiffness modifier of 0.35 for reinforced concrete columns along Gridline 2

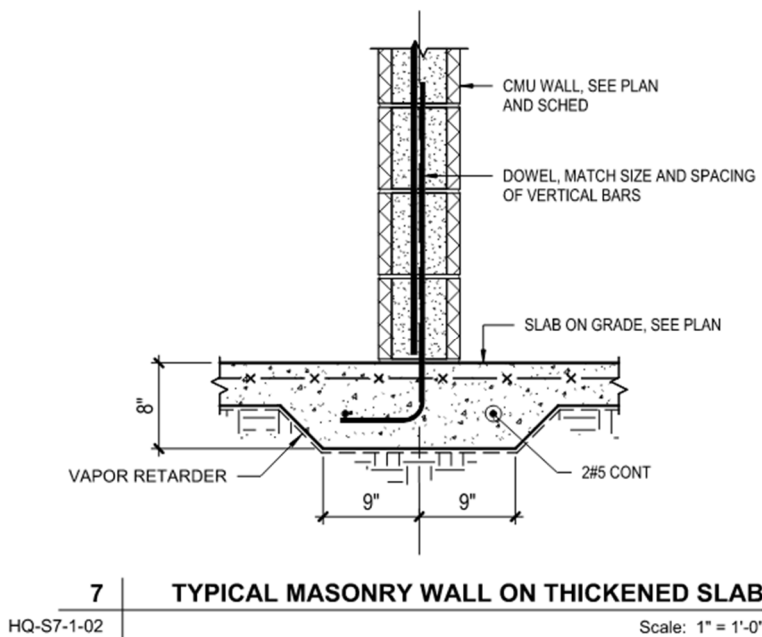
Figure 4. Detail 7 from Sheet HQ-S7-1-02 which shows CMU wall bearing on thickened slab-on-ground. Note that there is a vapor retarder under the slab-on-ground supporting the partition masonry walls

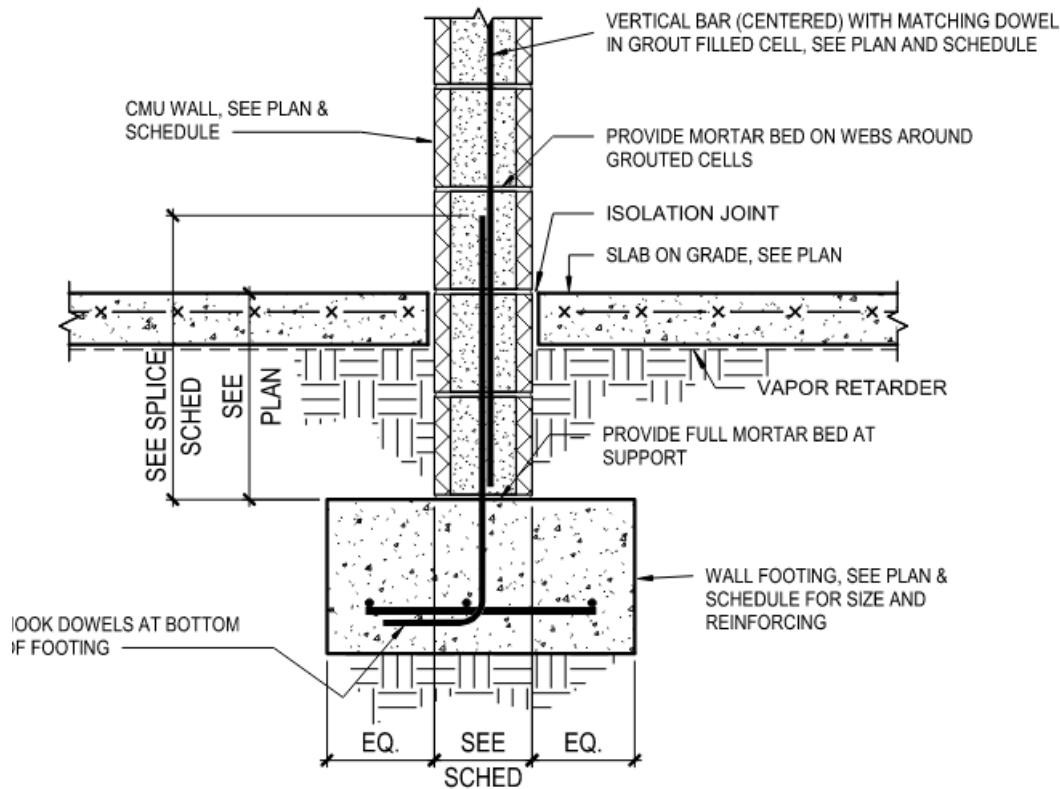
Figure 5. Detail 2 from Sheet HQ-S6-1-03 which shows CMU wall foundation for wall footings that have WF# designation on the foundation plans. Note that the vapor retarder under the slab-on-ground does not pass under the wall footing

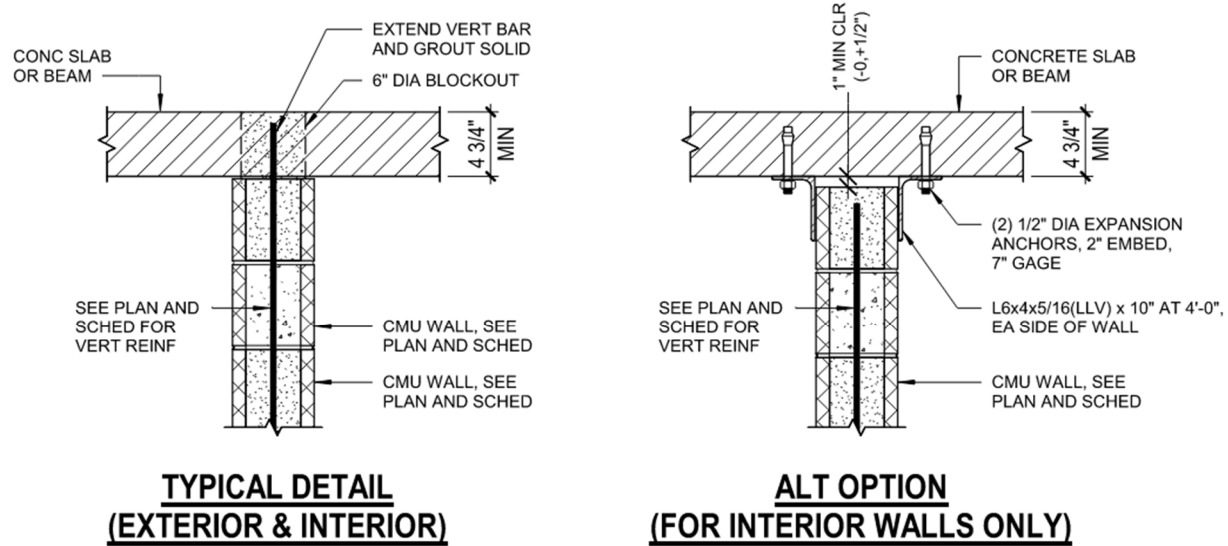
6 | TYPICAL TOP OF WALL BRACING - CONCRETE STRUCTURE
HQ-S7-1-02 | Scale: 1" = 1'-0"

- None of the connections of the partition masonry walls (i.e., not including the bearing wall in the community room and the masonry core wall in the main structure) to the diaphragm shown in the structural drawings (Detail 6 of Sheet HQ-S7-1-02) or noted in the special inspection reports (i.e., PTA anchors) satisfy ACI 318-14 Section 12.5.3.7. In other words, these connections do not satisfy the shear-friction provisions of ACI 318, which invalidates the masonry walls as code-compliant contributors to lateral resistance.

Figure 7. Detail 6 of Sheet HQ-S7-1-02 which shows two options for connecting the partition CMU walls to the elevated slabs or beams

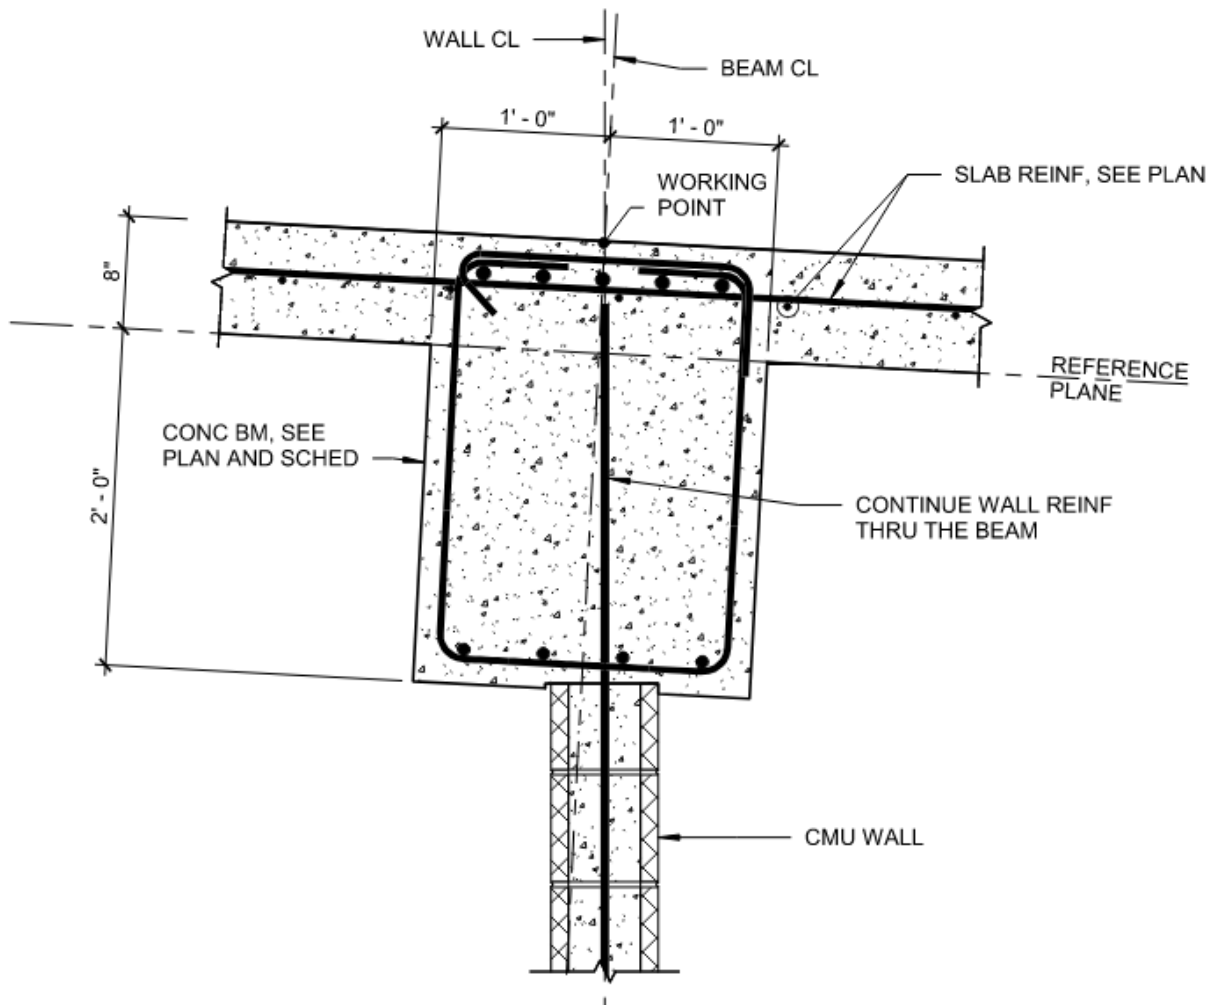
Figure 11. Detail 3 from Sheet HQ-S4-3-04, dated November 15, 2023 showing connection between top of CMU wall and reinforced concrete beam overhead in Area E. Note that the vertical wall reinforcement is well-anchored above the CMU wall to permit shear forces from the diaphragm to be transferred into the wall through shear friction

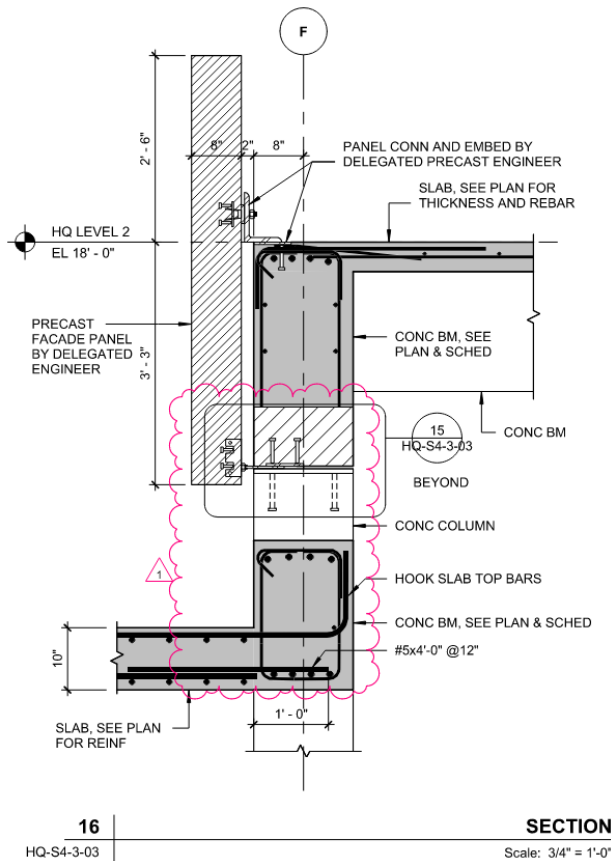
Figure 12. Section through joint between Area E and the main building of the FLPHQ showing the lower beam from Area A the stub column above, and the upper beam from the main building of the FLPHQ. The slide bearing is located at the top of the stub column

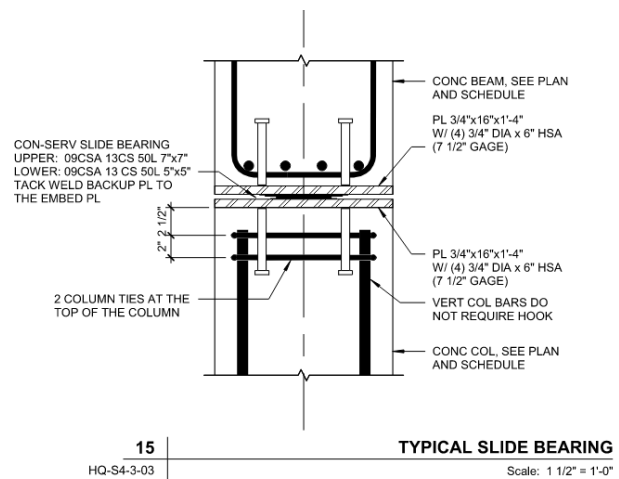
4. **Slide Bearing Capacity.** The bearing stress in the slide bearings on Gridline F (adjoining the community room and lobby area to the main structure of the FLPHQ) exceeds the manufacturer's published allowable capacity when subjected to design loads. Since the design demand exceeds the manufacturer's published design capacity, these bearings are not code-compliant. This condition can be rectified by replacing the existing bearings with a higher-capacity system. Replacement of the bearings may also require rectifications at the top of the stub column below the bearing to accommodate the size and thickness of the new bearing. This rectification should be completed before the building is occupied (0 to 6 months). We also recommend that the SEOR comments on the ranges of temperature and exposure conditions which the slide bearings will be subjected to and how those ranges will affect bearing performance. The SEOR should also provide the peak lateral displacement expected across the slide bearing under factored design level loads and/or thermal temperature differences for review.

Figure 13. Detail of slide bearing noting the manufacturer (Con-Serv) and the size of the lower portion of the bearing (5 inches by 5 inches)

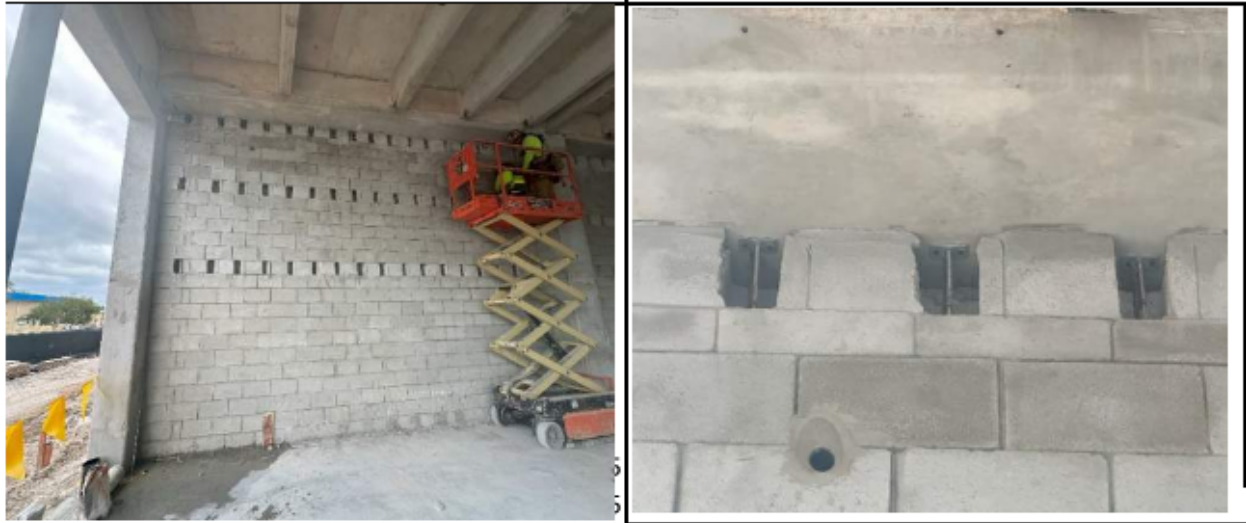
Figure 17. Photographs from Threshold Inspection Report No. 081. Left photograph shows overall wall construction on first story at one location. Right photograph shows the PTA anchors at the top of the wall. Note that two screws are used to connect each anchor to the above element

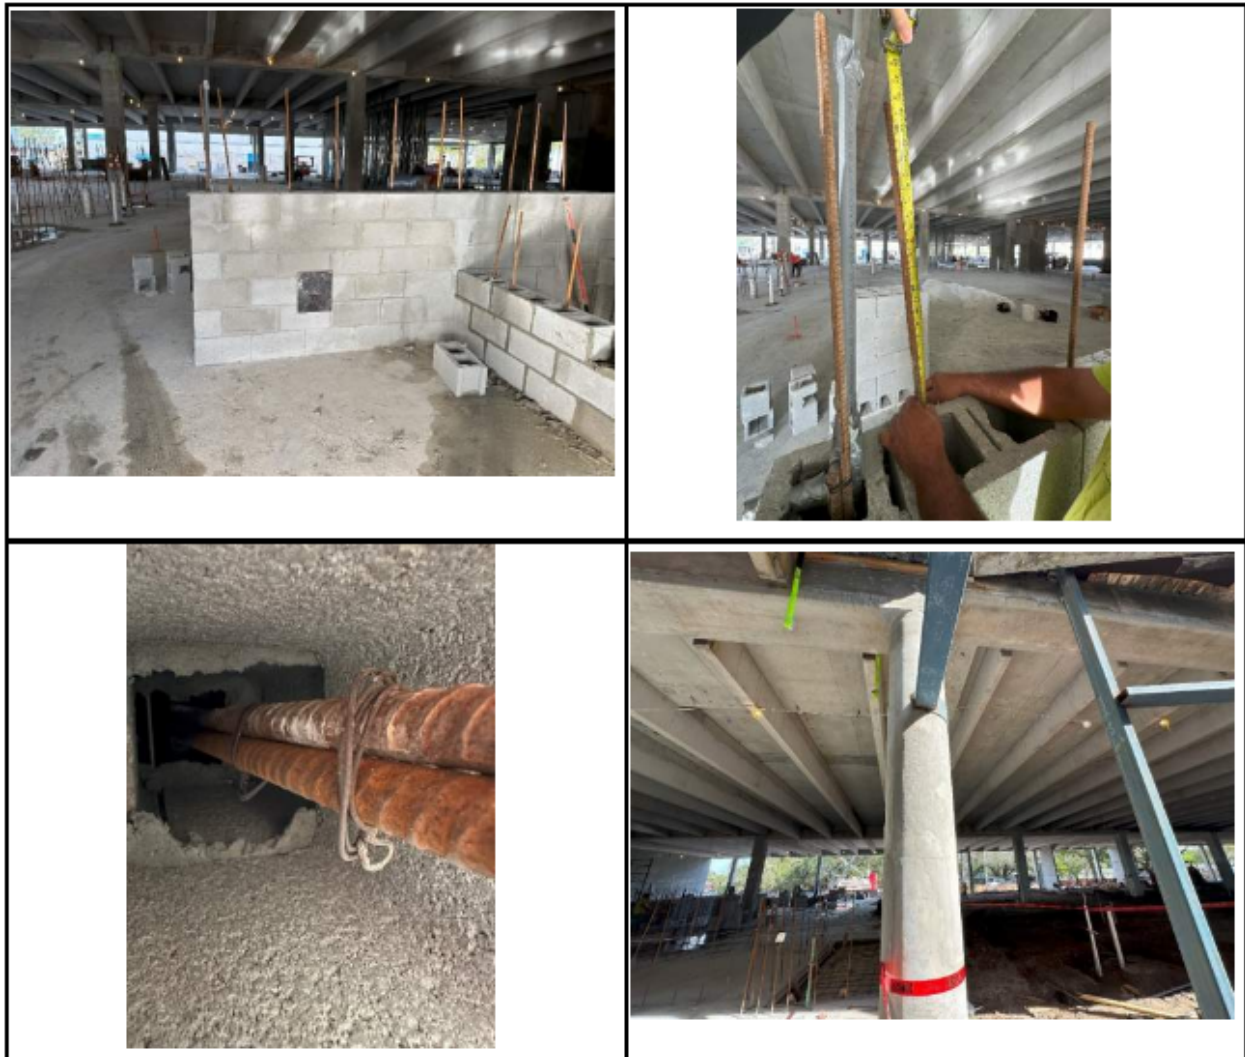
Figure 18. Photographs from Threshold Inspection Report No. 084. Upper photographs and lower right photograph appear to be of the first story prior to full installation of CMU walls. Note the lack of shoring indicating that the CMU walls were not constructed as bearing walls

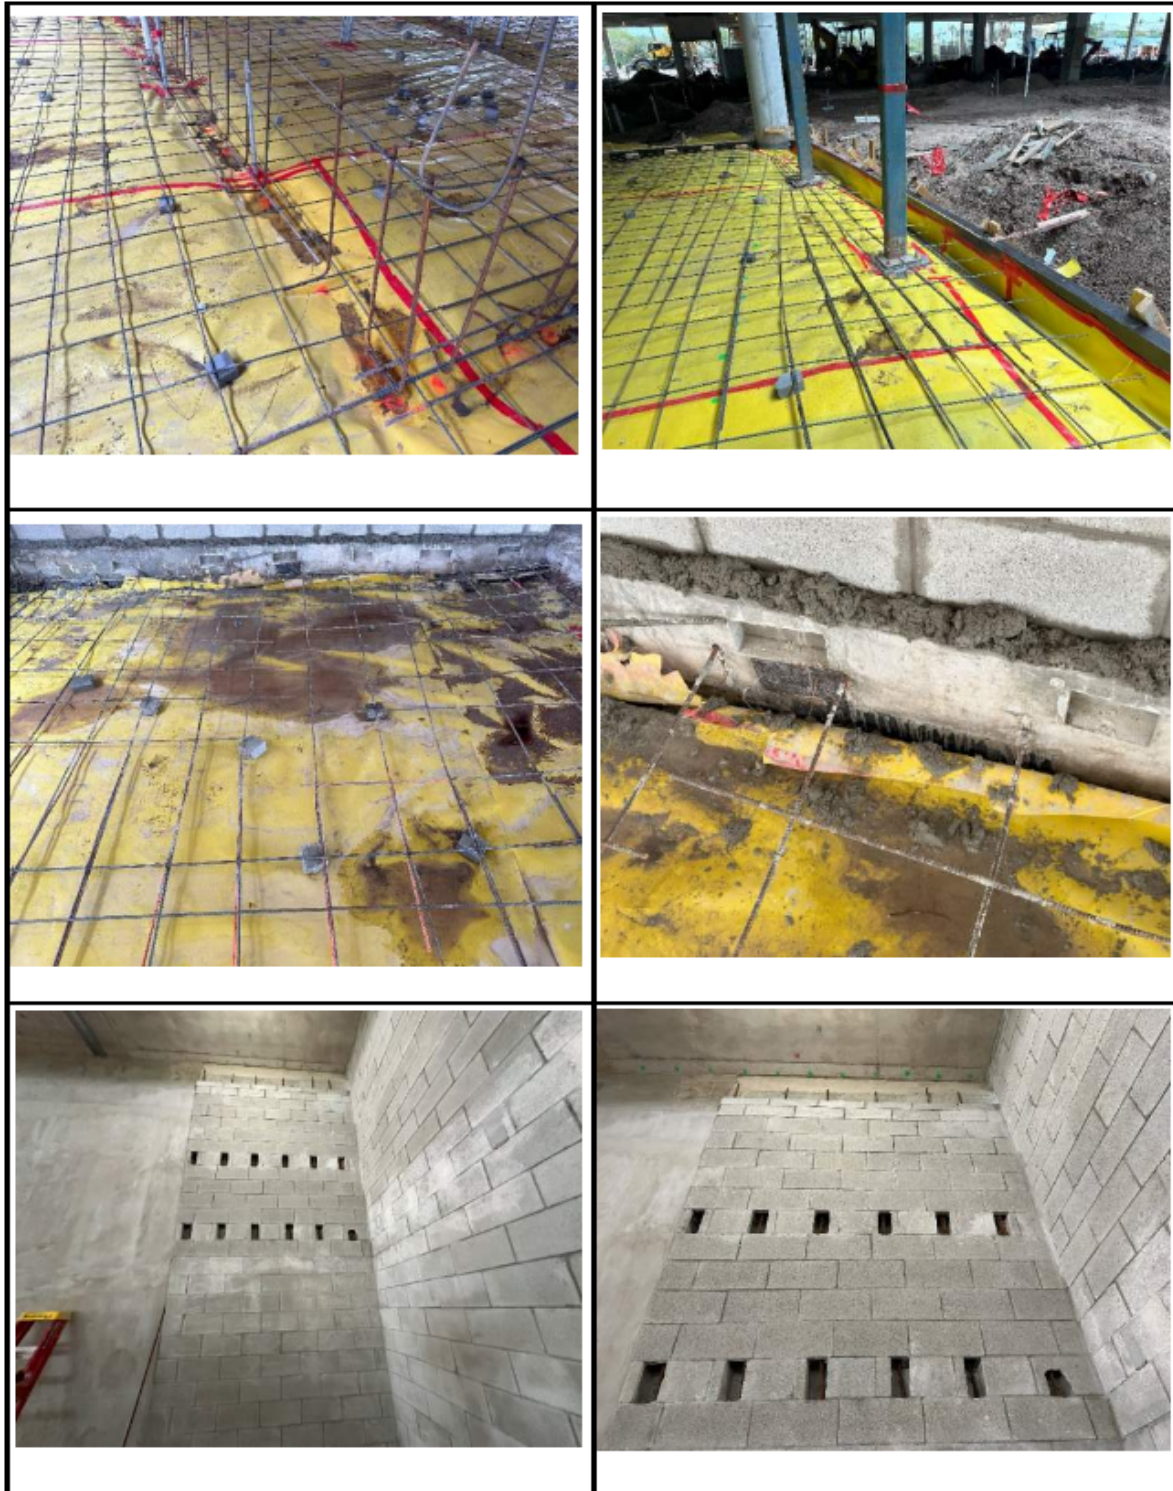
Figure 19. Photographs from Threshold Inspection Report No. 087 showing issue noted by inspector at thickened slab under CMU wall in upper left photograph and reinforcement not extending to the bottom of the slab above in the bottom two photographs

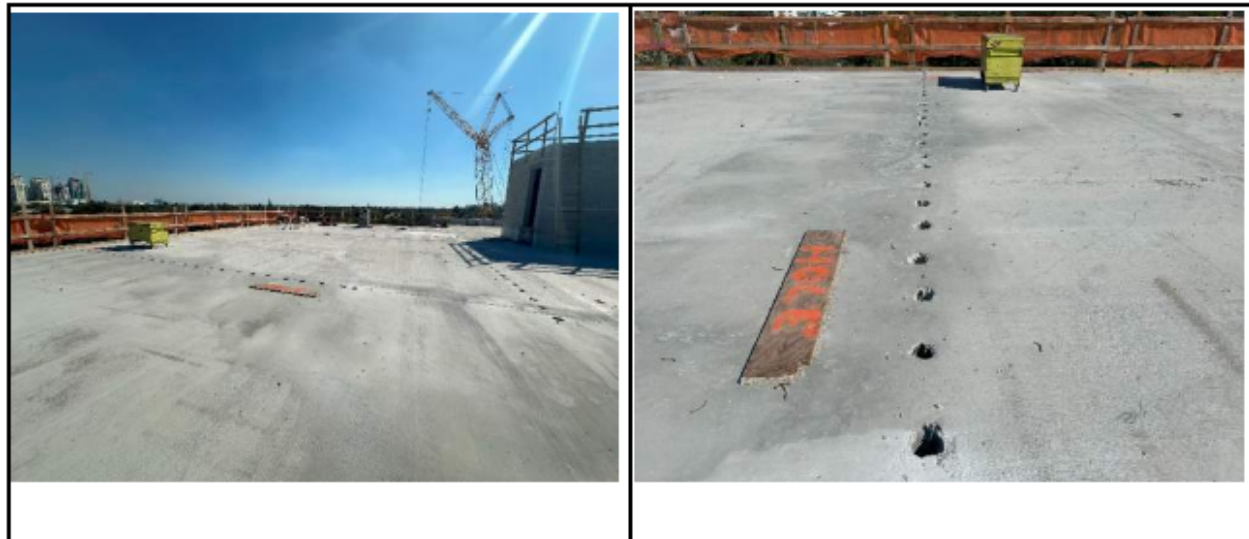
- **Report No. 101, Dated January 31, 2024:** The TI notes that “Checked vertical reinforcement of Level 3 area C CMU wall and there were two bars that were not tied to the coming dowels from previous block pour.” Photographs were included that appear to be of the third floor slab (Figure 21), but no photographs were included for the referenced condition.

Figure 21. Photographs from Threshold Inspection Report No. 101. While not clearly stated in the report, these images are believed to be of the third floor slab

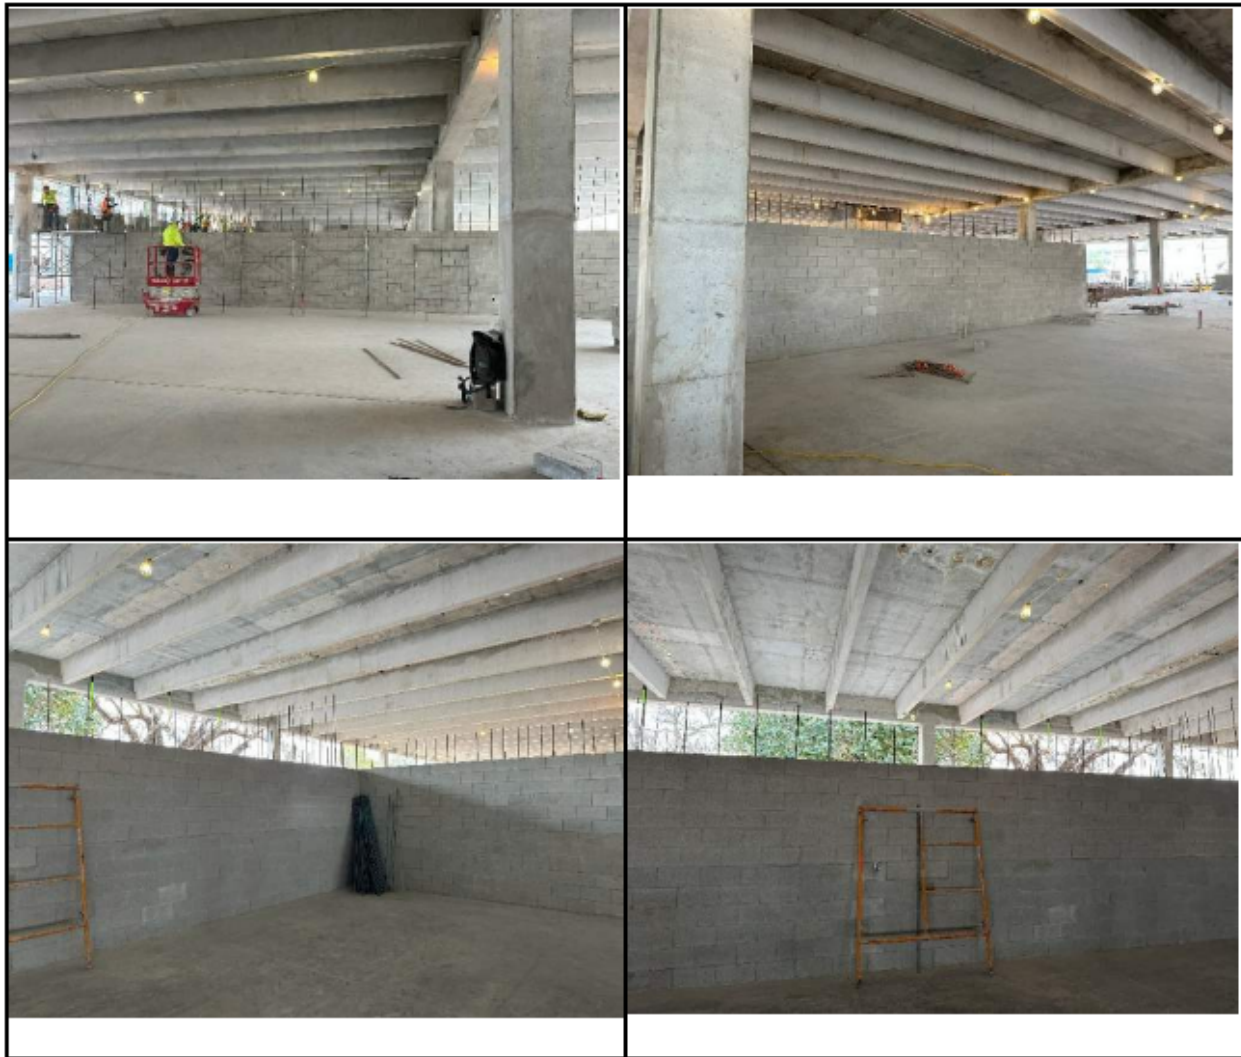
Figure 22. Photographs from Threshold Inspection Report No. 103 showing first story CMU walls under construction. Note the lack of shoring indicating that the CMU walls were not constructed as bearing walls

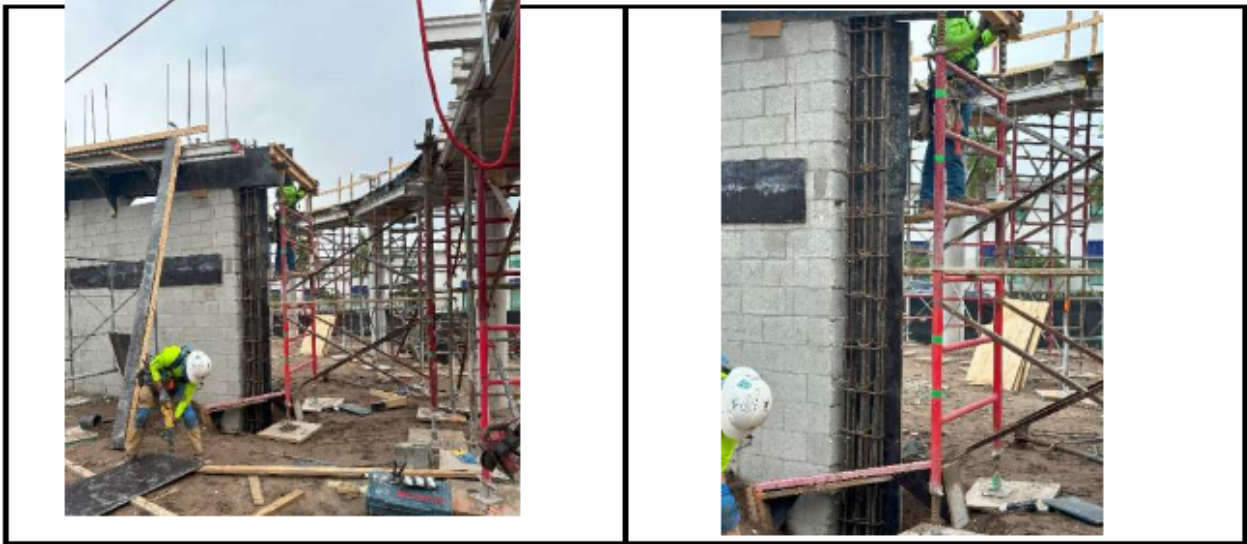
Figure 23. Photographs from Threshold Inspection Report No. 105 showing CMU wall in Area E under construction. Since the wall is being constructed prior to the roof structure, this CMU wall will take load from the roof structure as a bearing wall

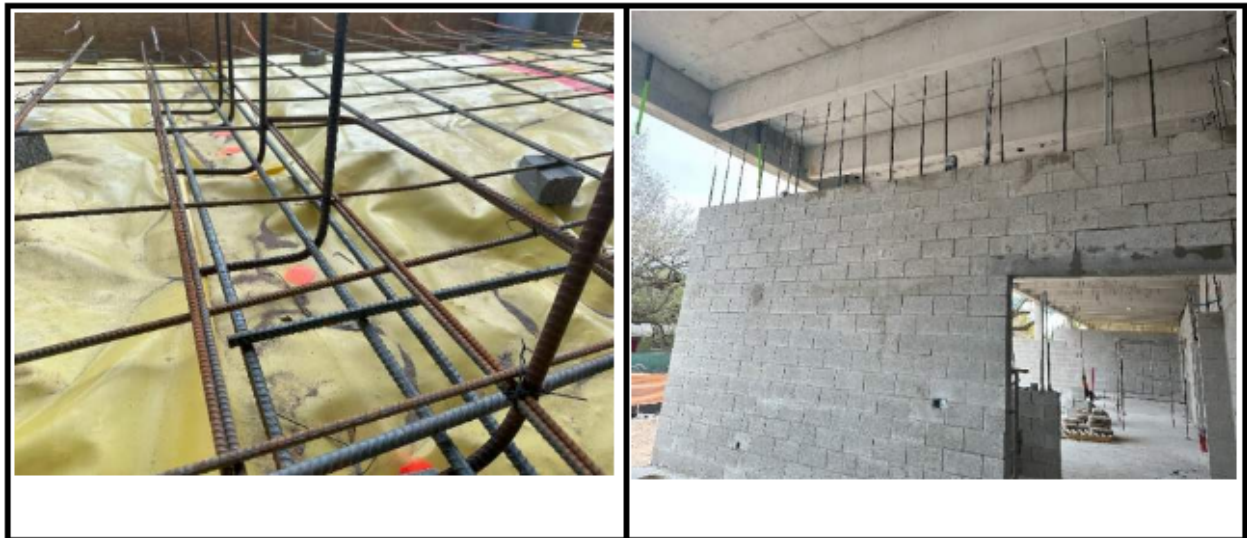
- **Report No. 107, Dated February 8, 2024:** The TI notes that “Partial inspection of slab rebar for SOG pour 5. Dowels for CMU need to be lowered to comply with what is specified on detail 7/HQ-S7-1-02.” Figure 24 shows a photograph of this condition and a photograph of a CMU wall under construction. Again, note that no shoring of the structure above is present, indicating that the CMU wall was not constructed as a bearing wall.

Figure 24. Photographs from Threshold Inspection Report No. 107. The photograph on the left shows hooked dowels at a thickened slab location under a wall. The inspector noted that the dowels needed to be shifted downwards. The photograph on the right shows a CMU wall in the first story under construction. Note that no shoring of the structure above is present, indicating that the CMU wall was not constructed as a bearing wall

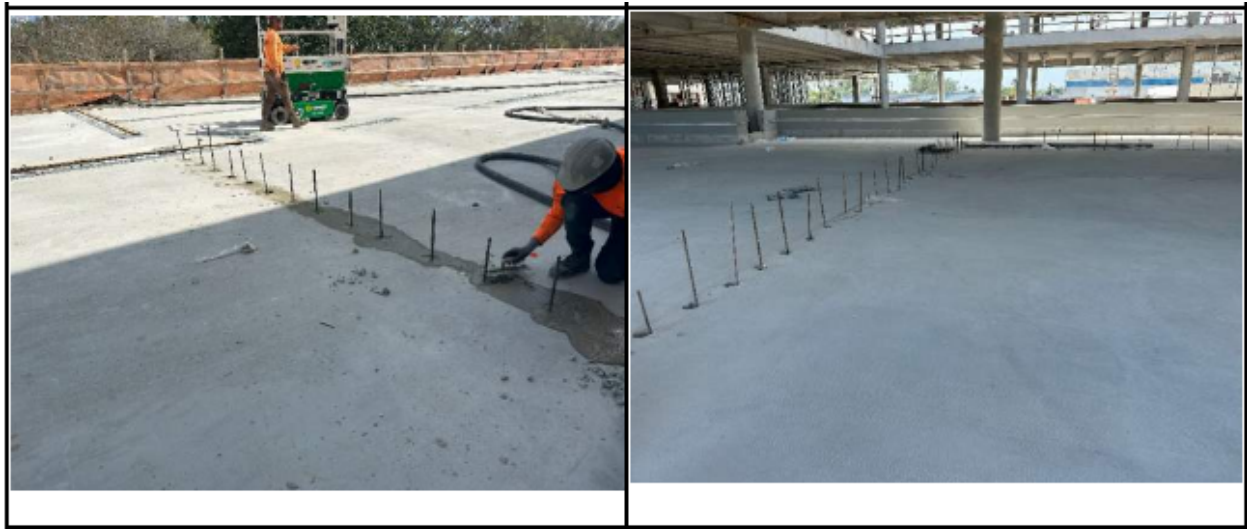
Figure 25. Photographs from Threshold Inspection Report No. 109 showing dowels extending through cored holes in slab. These dowels appear to be from the CMU wall below

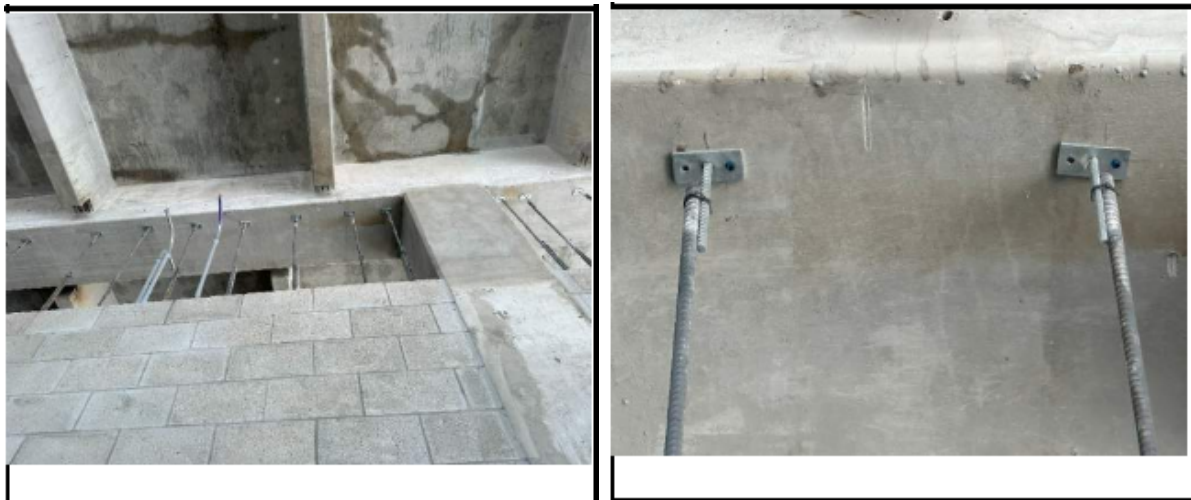
- **Report No. 123, Dated March 4, 2024:** The TI notes that “Anchors to attach the vertical reinforcement of CMU walls to soffit beams were placed with one tapcon screw instead of two how it's specified on the product specs.” Photographs of this condition are shown in Figure 26. The length of plate at the top of the PTA anchors is aligned parallel with the length of the CMU wall in contrast with the rendering shown on the manufacturer's website (Figure 10). No comments were made by the TI regarding the orientation of the anchor plate relative to the wall.

Figure 26. Photographs from Threshold Inspection Report No. 123 showing PTA connectors at bottom of soffit beam with only one screw attaching the plate of the anchor to the soffit beam

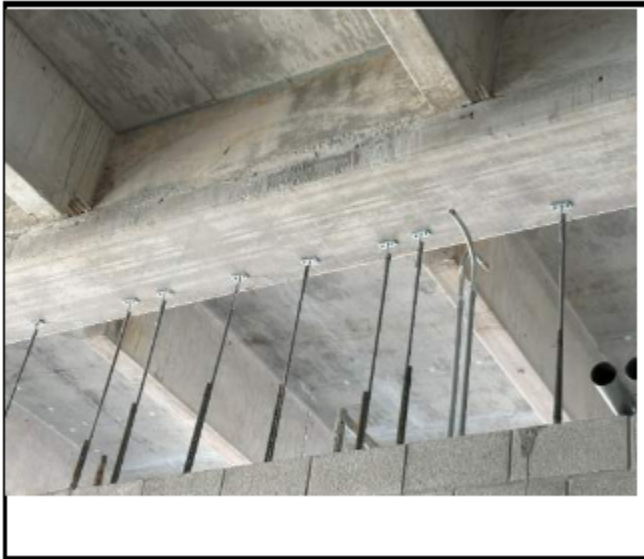
- **Report No. 125, Dated November 27, 2023 (Note that Report No. 124 is dated March 6, 2024 and Report No. 126 is dated March 12, 2024):** The TI notes that “Confirmed that vertical reinforcement anchors are being tied as per specification using two tapcon screws instead of one.” This statement appears to refer to the TI's comment in Report No. 123 above. A photograph of this condition was provided (Figure 27).

Figure 27. Photograph from Threshold Inspection Report No. 125 showing PTA connectors at bottom of soffit beam with the two screws attaching the plate of the anchor to the soffit beam

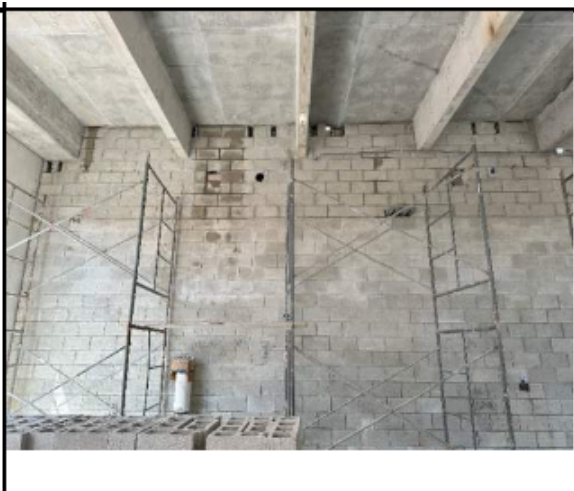
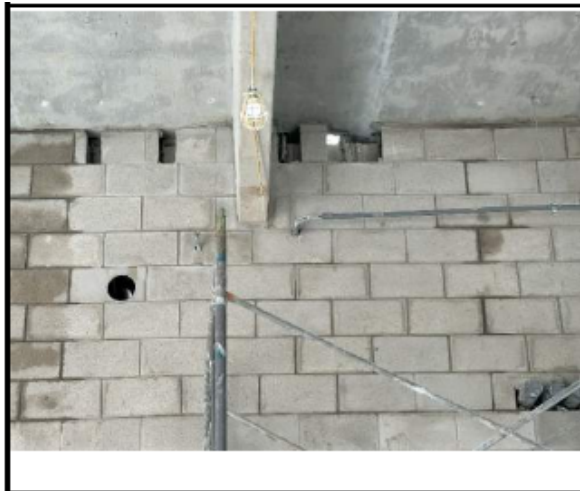
Figure 28. Photographs from Threshold Inspection Report No. 131 showing a wall that is nearly complete

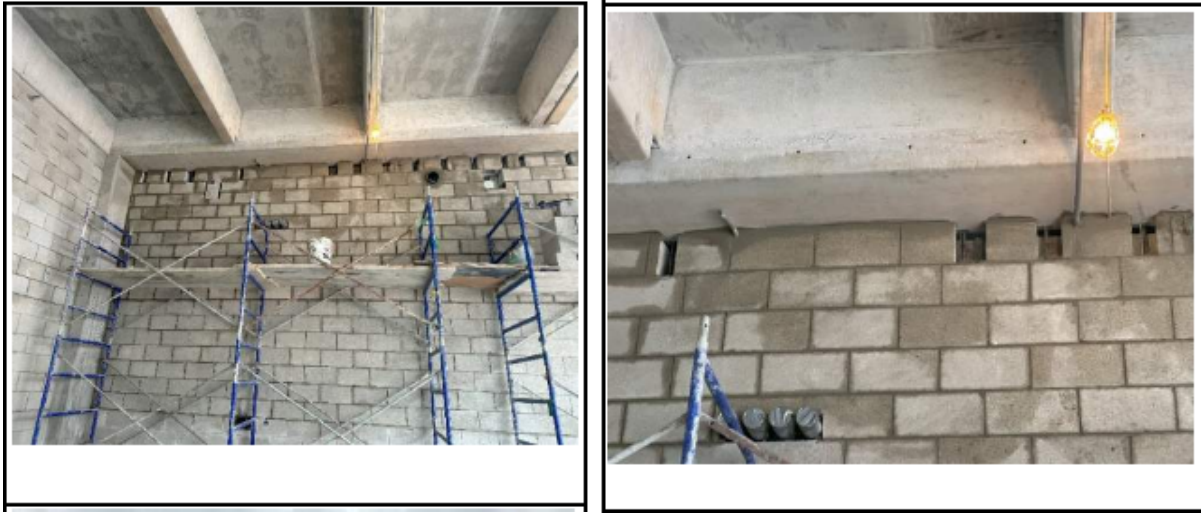
Figure 29. Photographs from Threshold Inspection Report No. 133 showing CMU wall at Level 1, Area D

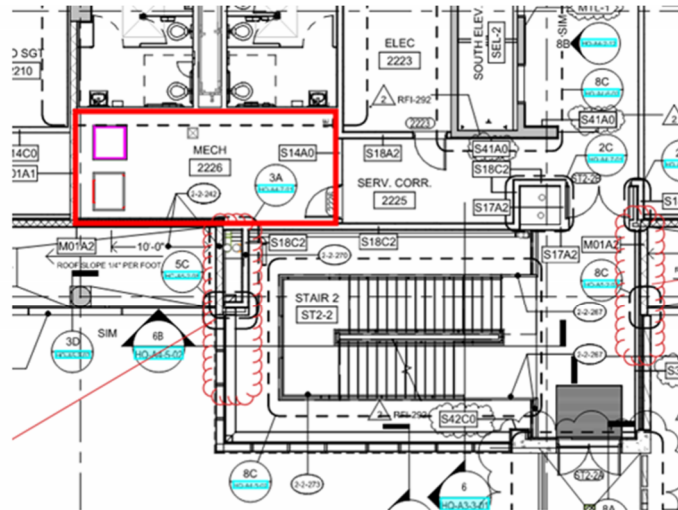
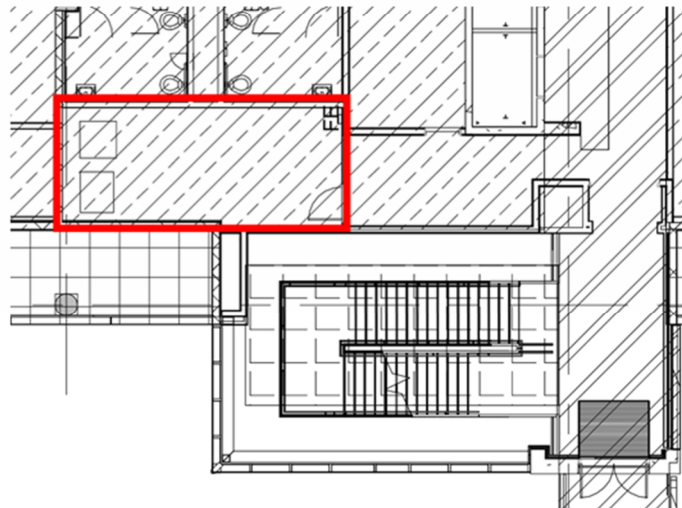
14. **Mechanical Equipment.** In addition to the loading discrepancy noted in Item 8 above regarding equipment weight versus uniform live loads, there is an area bounded by Gridlines H, J, 14, and 16 on Level 2 that is designated in the architectural drawings, but not in the structural drawings, as

Figure 30. Possible inconsistency between architectural drawings (top) and structural drawings (bottom) regarding the location of mechanical equipment. Note that the architectural drawings designate Room 2226 on Level 2 as a mechanical room; however, the structural drawings indicate that a General live load rather than a Mechanical live load was used to design that area

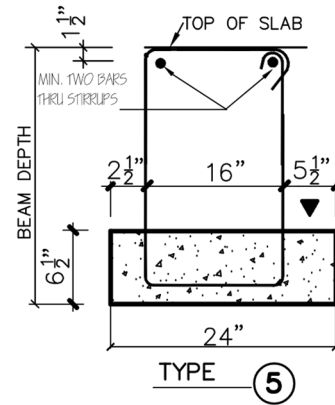
Figure 32. Cross-section of soffit beam (Sheet SC-3C-D of Submittal 328) showing approximately zero inches of cover to the transverse reinforcement

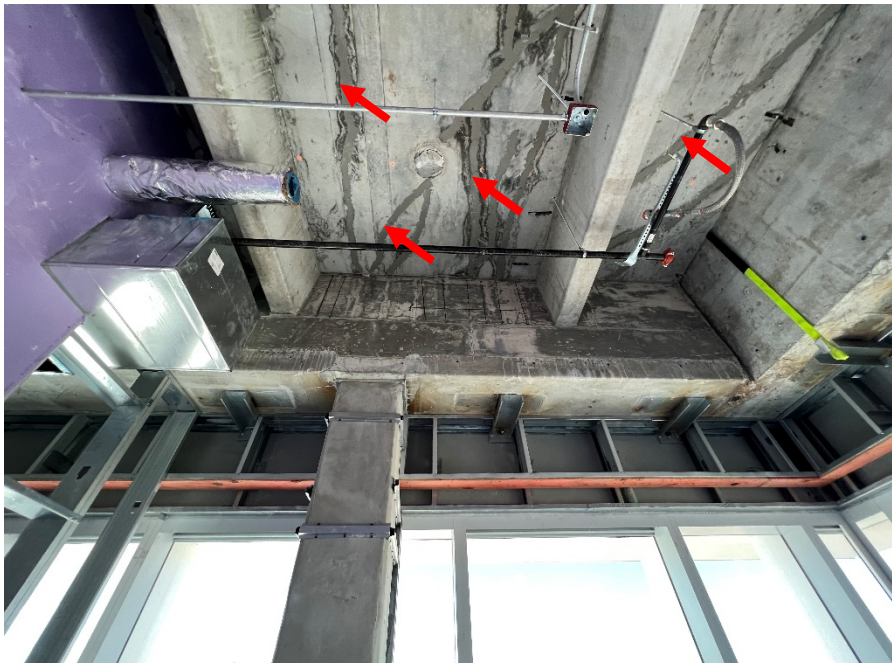
Figure 33. Example of cracks (see red arrows) in the reinforced concrete slab (at the roof) which have been repaired

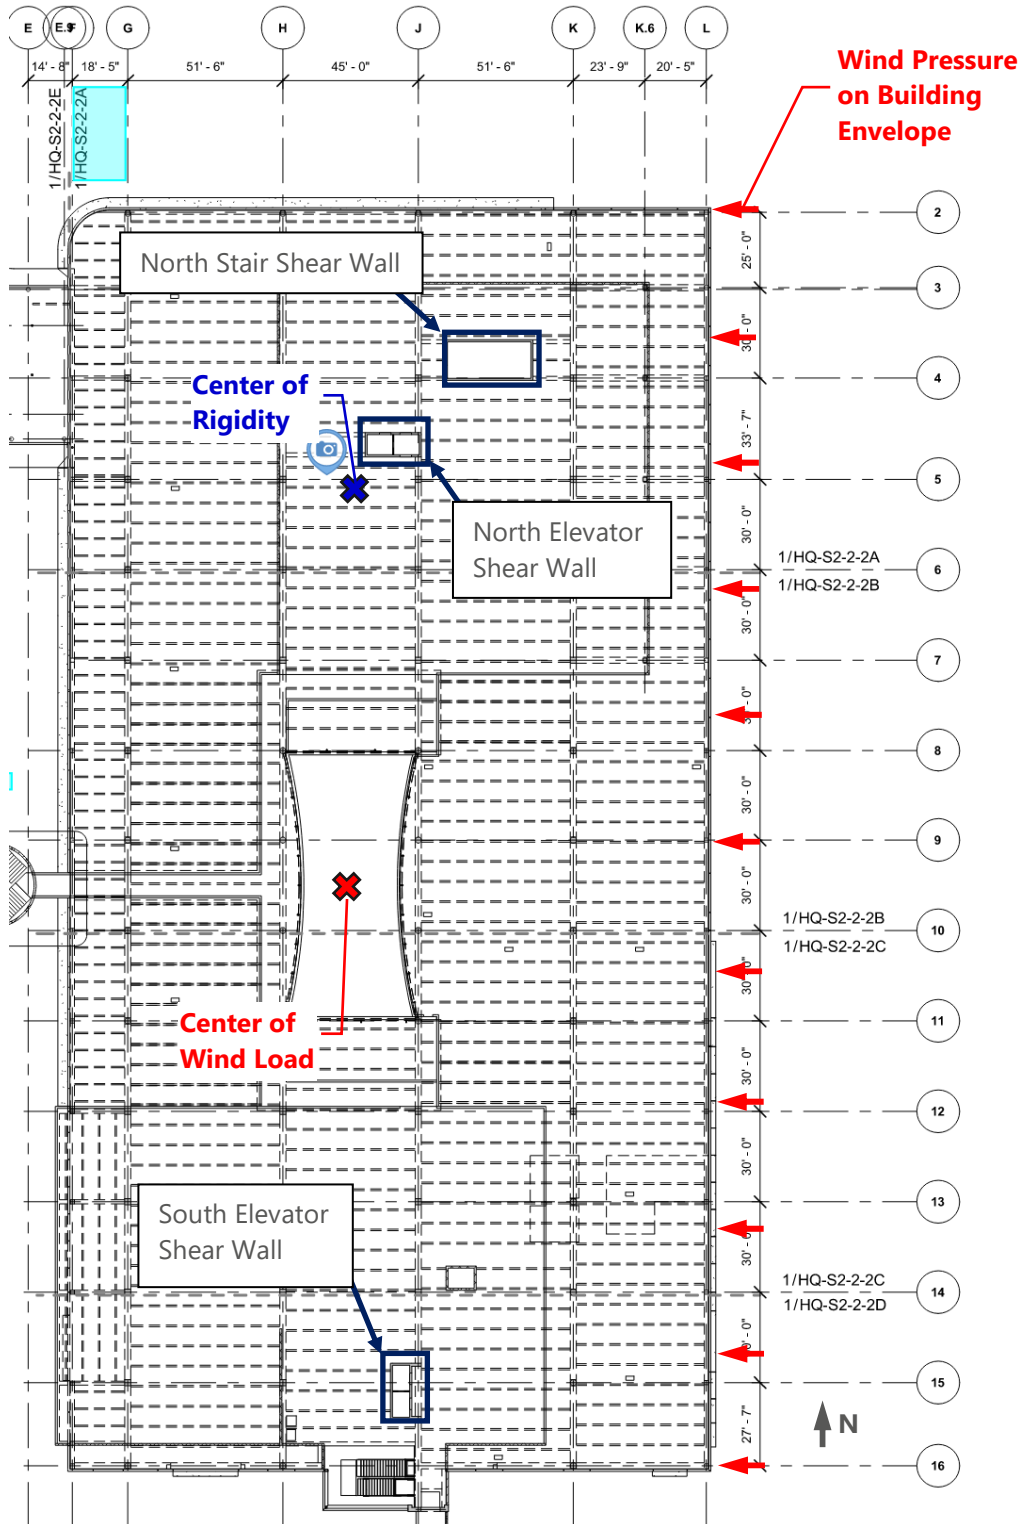
Figure 34. Plan view of FLPHQ showing the approximate locations of the center of rigidity and east-west wind loads. Due to eccentricity between the two, the structure twists

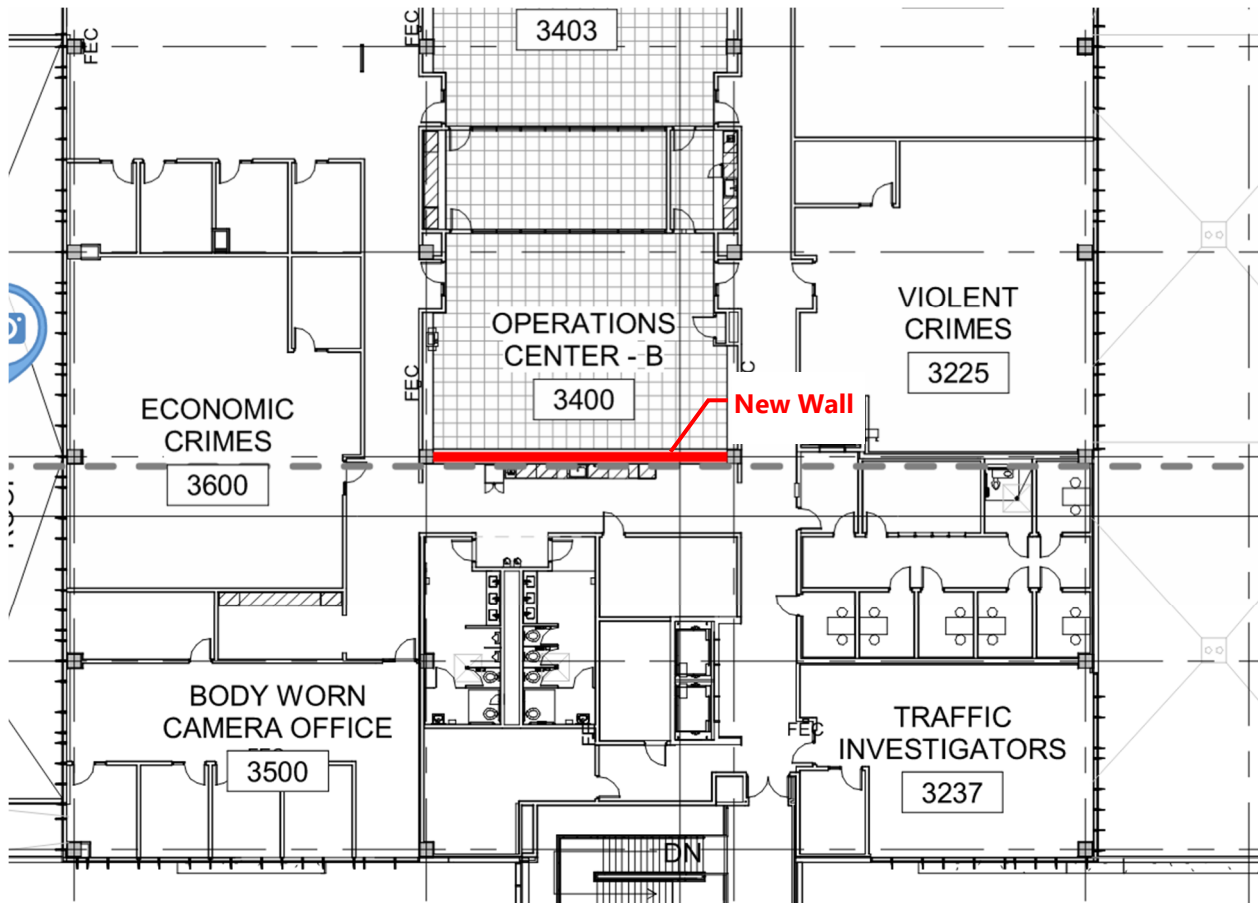
1. **Shear Wall Capacities.** The southern-most reinforced concrete core wall is not code-compliant for one-way shear strength or flexural strength between Levels 1 and 2. Adding a properly designed full-height shear wall (i.e., from foundation to roof) with an accompanying foundation to the structure on Gridline 14 between Gridlines H and J can rectify this condition. Rectification of this condition should be carried out *as soon as possible* (0 to 2 months) and should be completed before the building is occupied. Note that, contrary to the position of the SEOR, we do *not* believe that the concrete masonry unit (CMU) partition walls are a reliable part of the lateral load-resisting system. We have provided other findings related to the use of these CMU walls in the Documentation section below.

Figure 40. One potential location for the proposed new reinforced concrete shear wall

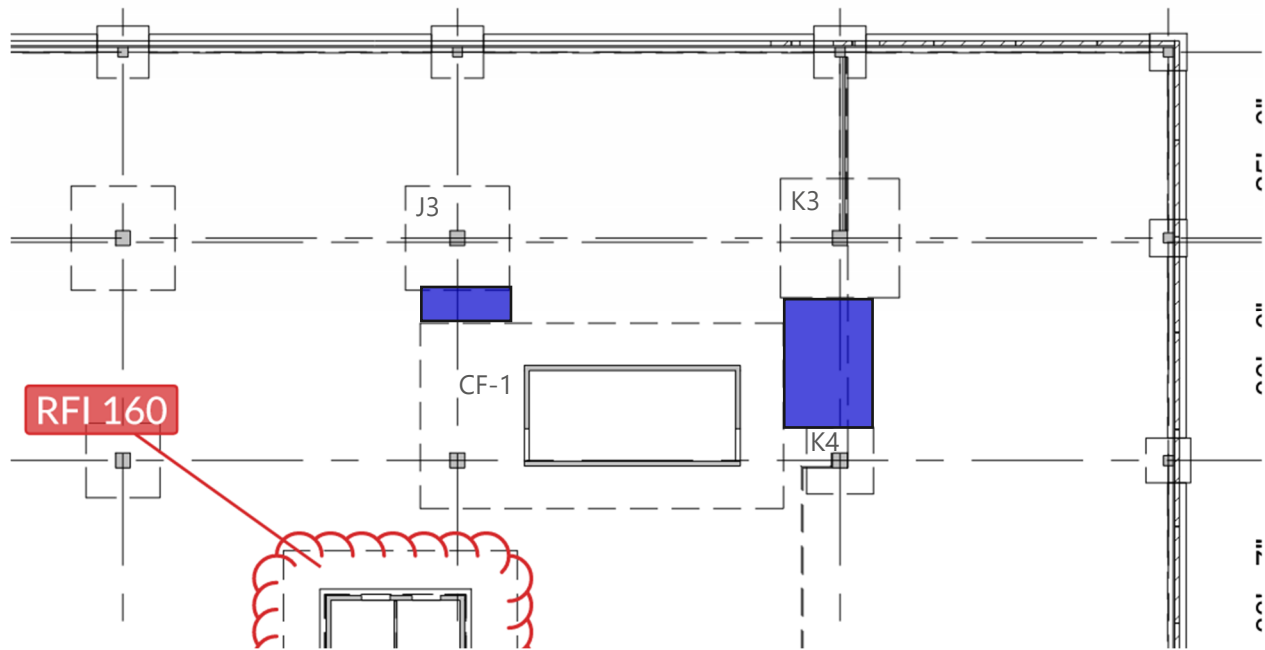
2. **Foundation Capacities at Shear Walls.** The mat foundations for the concrete shear walls around the north stair shaft (designated as CF-1 on the structural drawings) and the south elevator shaft (CF-3) all have lateral demands that exceed the allowable design capacity under design wind loads in the east-west direction and are therefore not code-compliant. Adding the aforementioned shear wall to the building can rectify conditions related to the south elevator shaft but not the sliding exceedance at the north stair shaft. Attaching mat footing CF-1 to its surrounding isolated

footings can rectify the sliding condition. Rectifications to the foundations should take place at the same time as those for the shear walls.

Figure 41. Conceptual rectification of sliding deficiency of mat footing CF-1. The mat footing is attached to nearby isolated footings (J3, K3, and K4) with new reinforced concrete (shown in blue font)
