TO: Honorable Mayor and Members of the Fort Lauderdale City Commission
FROM: Rickelle Williams, City Manager *RW*
DATE: May 5, 2025
SUBJECT: New Police Headquarters — Phase 2 Peer Review

Draft Report

April 22, 2025
WJE No. 2024.4855.0

Fort Lauderdale Police Headquarters
WJE Peer Review, Phase 2 – Building Structural Design Peer Review

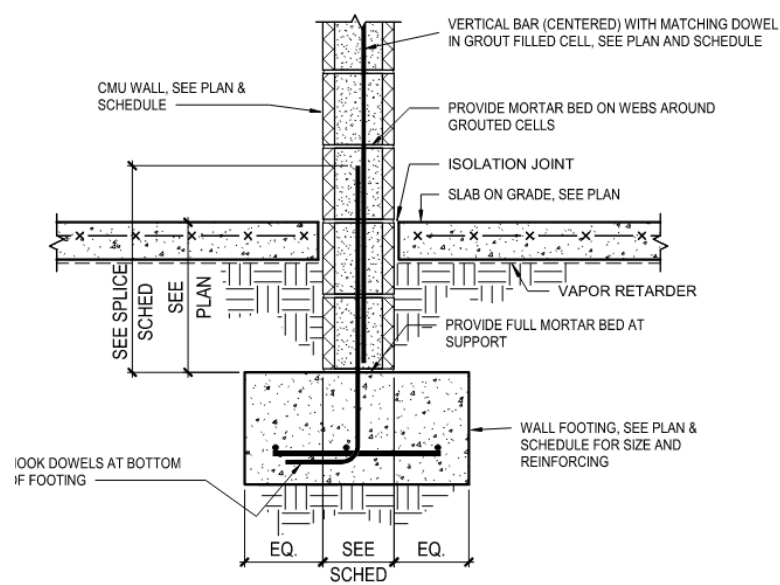
Figure 5. Detail 2 from Sheet HQ-S6-1-03 which shows CMU wall foundation for wall footings that have WF# designation on the foundation plans. Note that the vapor retarder under the slab-on-ground does not pass under the wall footing

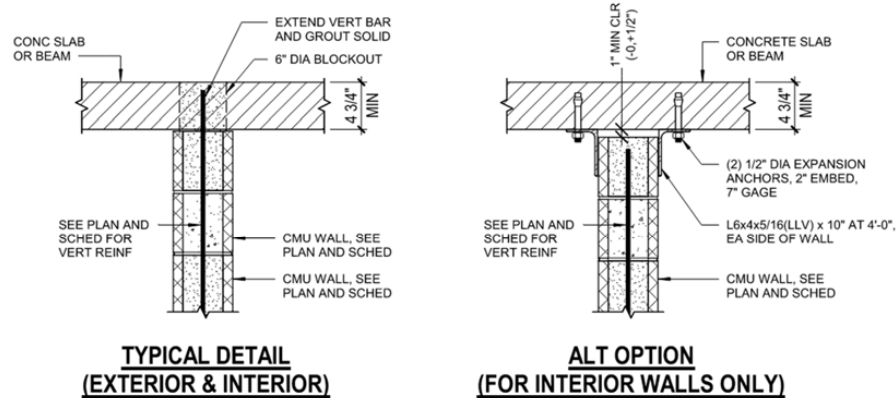
6 | TYPICAL TOP OF WALL BRACING - CONCRETE STRUCTURE
HQ-S7-1-02 | Scale: 1" = 1'-0"

- None of the connections of the partition masonry walls (i.e., not including the bearing wall in the community room and the masonry core wall in the main structure) to the diaphragm shown in the structural drawings (Detail 6 of Sheet HQ-S7-1-02) or noted in the special inspection reports (i.e., PTA anchors) satisfy ACI 318-14 Section 12.5.3.7. In other words, these connections do not satisfy the shear-friction provisions of ACI 318, which invalidates the masonry walls as code-compliant contributors to lateral resistance.

Figure 7. Detail 6 of Sheet HQ-S7-1-02 which shows two options for connecting the partition CMU walls to the elevated slabs or beams

For the reasons outlined above, we recommend that the SEOR reevaluate the adequacy of the FLPHQ without considering the partition masonry walls as part of the lateral force-resisting system. Note that WJE has *not* considered these partition masonry walls as contributing to the lateral force-resisting system when evaluating the FLPHQ and developing our findings. If the SEOR abandons the approach of attempting to use the partition masonry walls as part of the lateral force-resisting system, then adding the full-height shear wall and rectifying the foundations as noted above in Items 1 and 2, and properly designing them for predicted demands is expected to be sufficient to resolve Item 15.

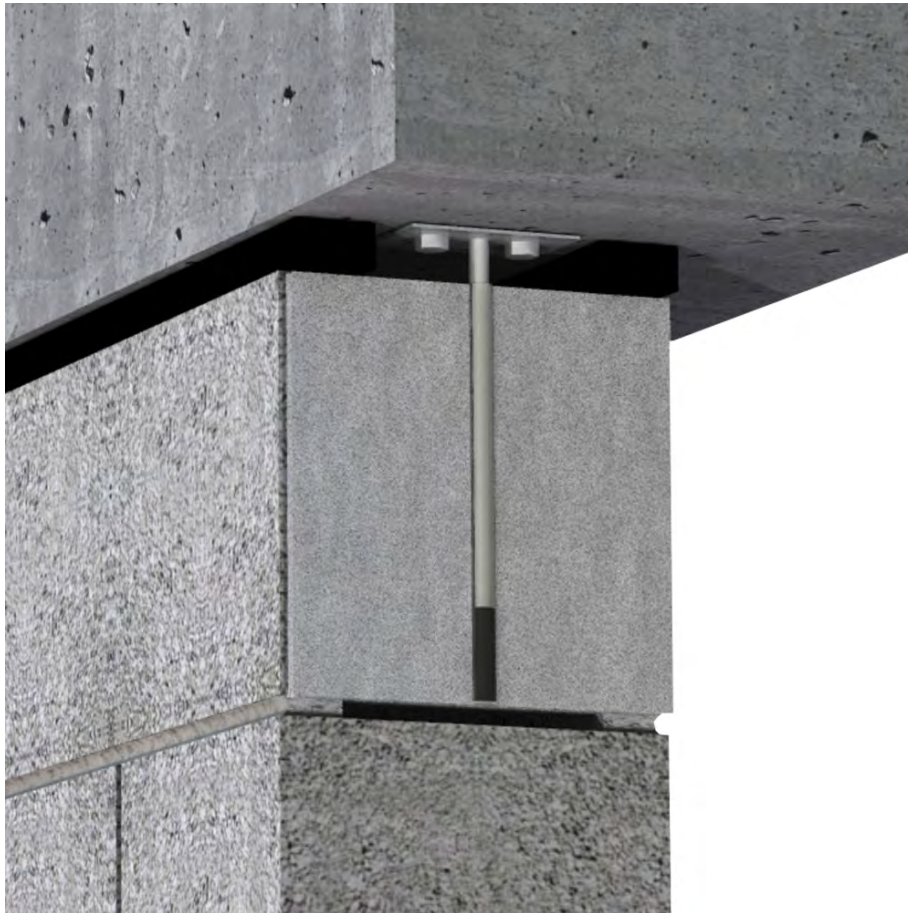
During our review of the special inspection reports, we also observed that the PTA anchors used to connect the partition masonry walls to the above floors were not oriented orthogonal to the walls, as shown on the anchor manufacturer's website. Accordingly, we recommend that the SEOR comment on which orientation of the anchors is appropriate and provide documentation from the anchor manufacturer supporting the use of that orientation.

Figure 10. Rendering of installed PTA 420 HS anchor from Hohmann and Barnard. Image taken from <https://www.h-b.com/products/pta-series-anchors-pta-420-hs> (accessed on April 13, 2025). Note that the length of the top plate of the anchor is oriented transverse to the length of the wall

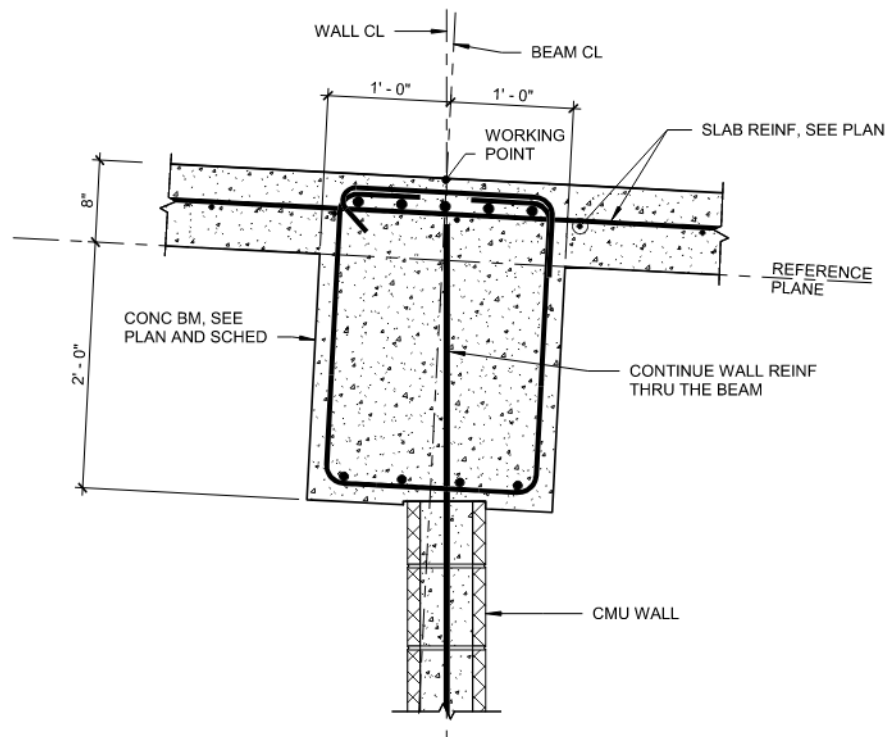
Figure 11. Detail 3 from Sheet HQ-S4-3-04, dated November 15, 2023 showing connection between top of CMU wall and reinforced concrete beam overhead in Area E. Note that the vertical wall reinforcement is well-anchored above the CMU wall to permit shear forces from the diaphragm to be transferred into the wall through shear friction

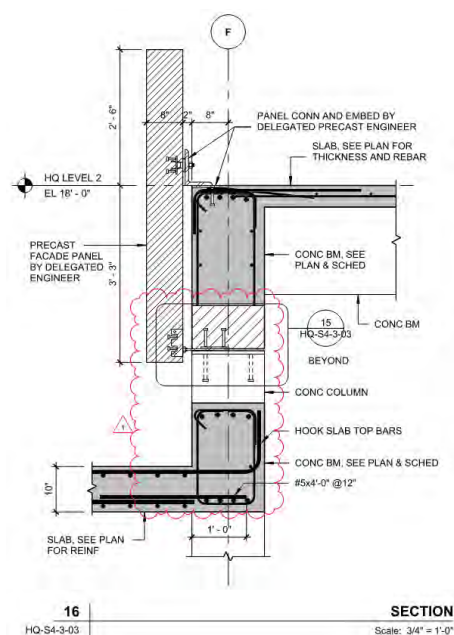
Figure 12. Section through joint between Area E and the main building of the FLPHQ showing the lower beam from Area A the stub column above, and the upper beam from the main building of the FLPHQ. The slide bearing is located at the top of the stub column

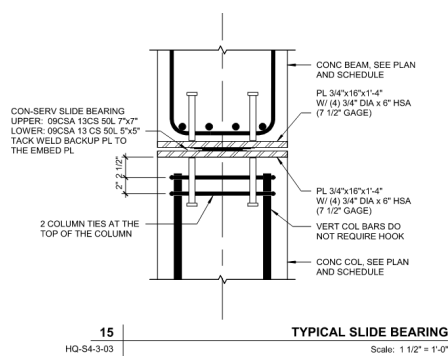
4. **Slide Bearing Capacity.** The bearing stress in the slide bearings on Gridline F (adjoining the community room and lobby area to the main structure of the FLPHQ) exceeds the manufacturer's published allowable capacity when subjected to design loads. Since the design demand exceeds the manufacturer's published design capacity, these bearings are not code-compliant. This condition can be rectified by replacing the existing bearings with a higher-capacity system. Replacement of the bearings may also require rectifications at the top of the stub column below the bearing to accommodate the size and thickness of the new bearing. This rectification should be completed before the building is occupied (0 to 6 months). We also recommend that the SEOR comments on the ranges of temperature and exposure conditions which the slide bearings will be subjected to and how those ranges will affect bearing performance. The SEOR should also provide the peak lateral displacement expected across the slide bearing under factored design level loads and/or thermal temperature differences for review.

Figure 13. Detail of slide bearing noting the manufacturer (Con-Serv) and the size of the lower portion of the bearing (5 inches by 5 inches)

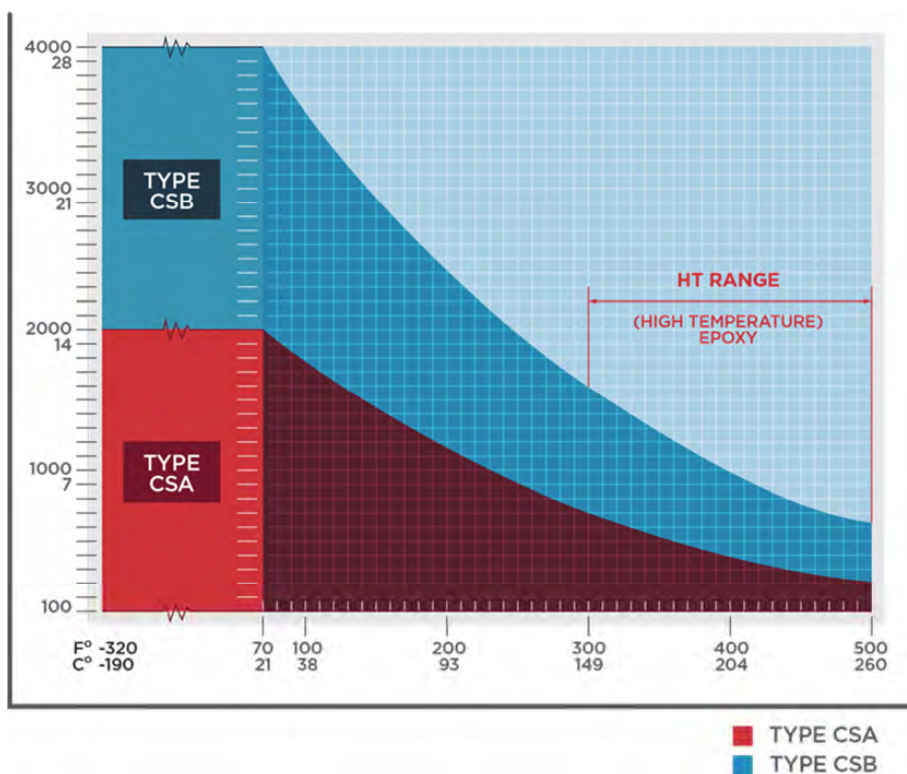
Figure 14. Plot from Con-Serv showing allowable bearing capacity versus temperature. Plot is taken from <https://con-servinc.com/con-slide-bearings-type-csa-csb/> (accessed on April 10, 2025)

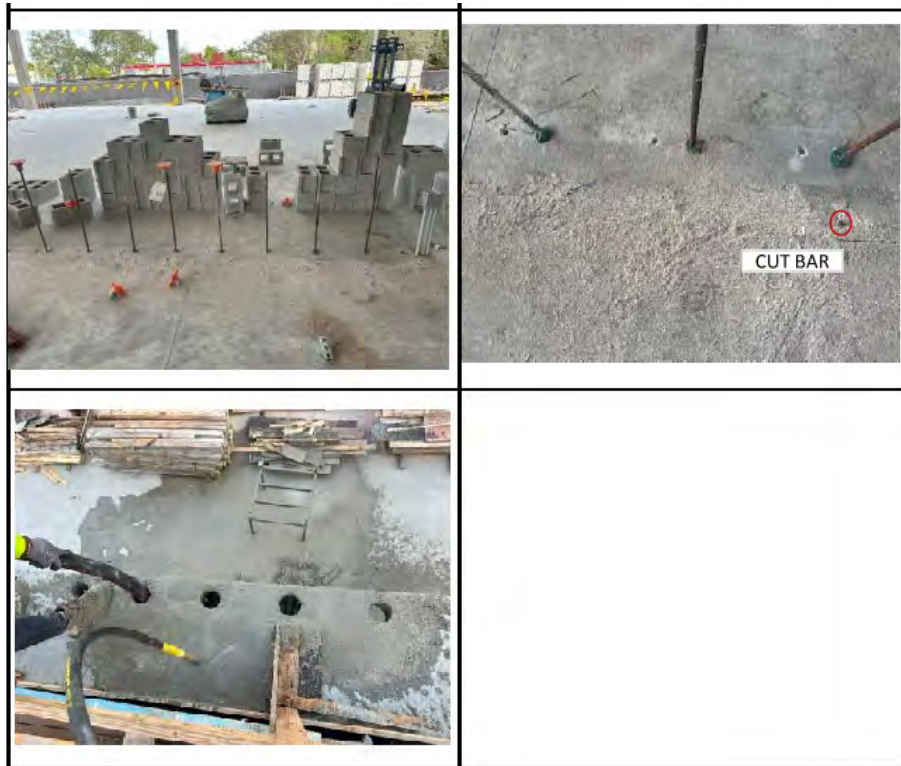
Figure 16. Photographs from Threshold Inspection Report No. 073 showing bars doweled 3 inches into slab-on-ground after original bars were mislocated (top photographs), and filling of grouted cells (bottom photograph)

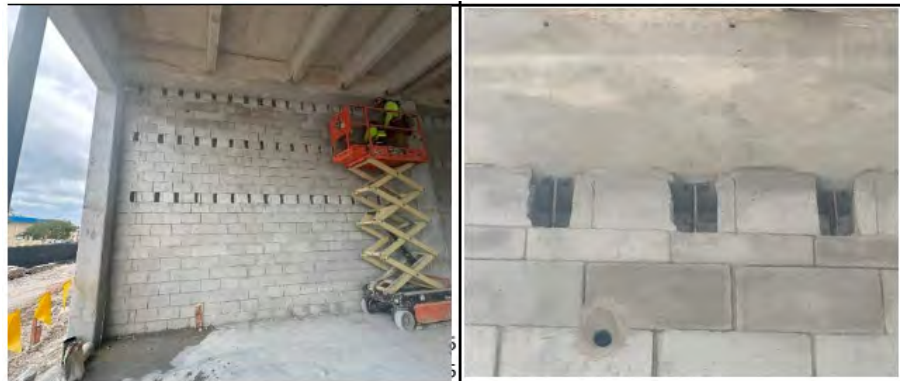
Figure 17. Photographs from Threshold Inspection Report No. 081. Left photograph shows overall wall construction on first story at one location. Right photograph shows the PTA anchors at the top of the wall. Note that two screws are used to connect each anchor to the above element

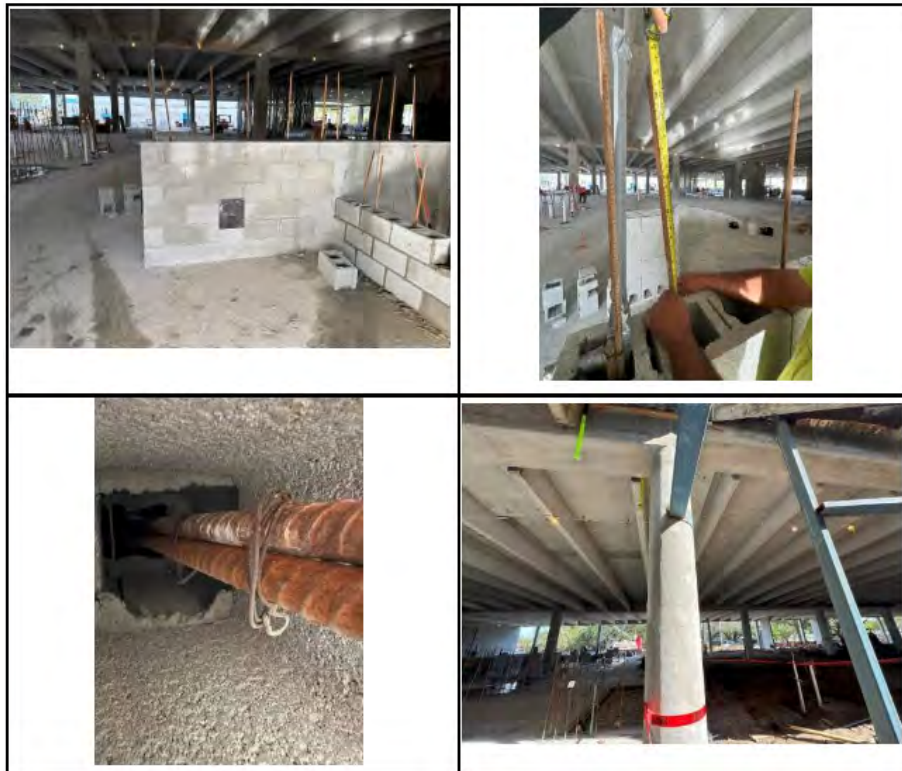
Figure 18. Photographs from Threshold Inspection Report No. 084. Upper photographs and lower right photograph appear to be of the first story prior to full installation of CMU walls. Note the lack of shoring indicating that the CMU walls were not constructed as bearing walls

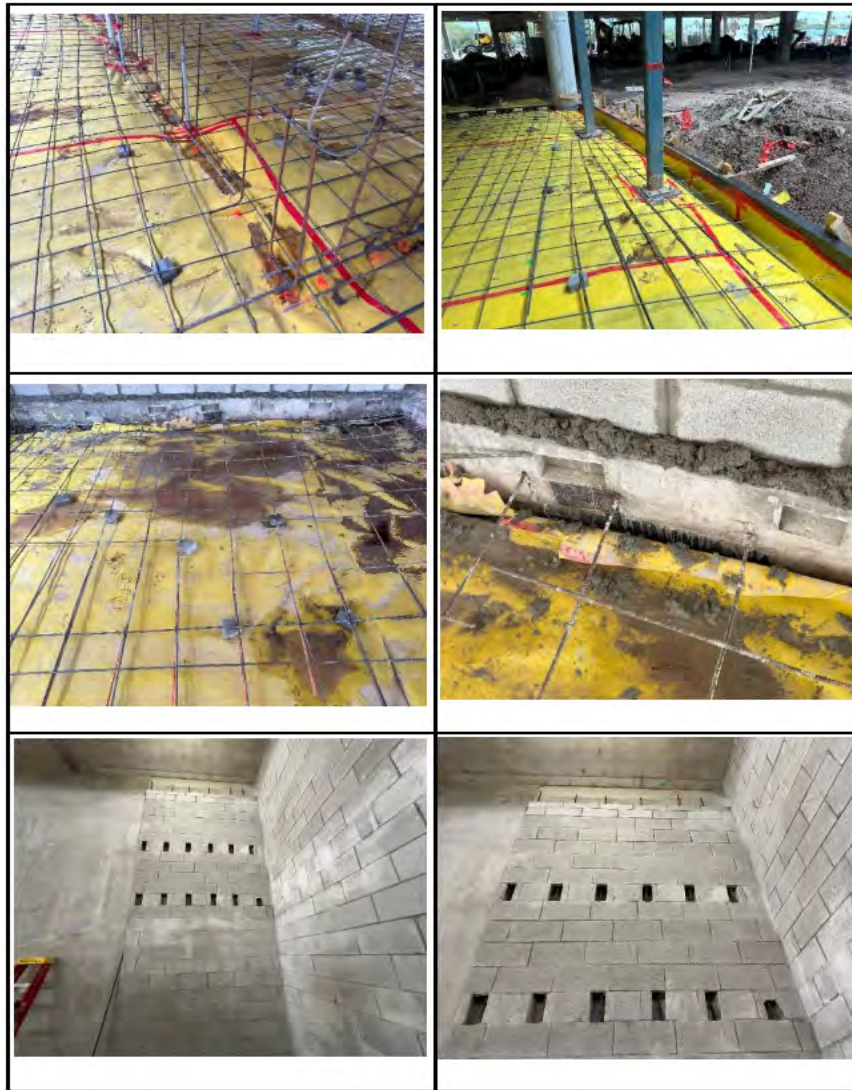
Figure 19. Photographs from Threshold Inspection Report No. 087 showing issue noted by inspector at thickened slab under CMU wall in upper left photograph and reinforcement not extending to the bottom of the slab above in the bottom two photographs

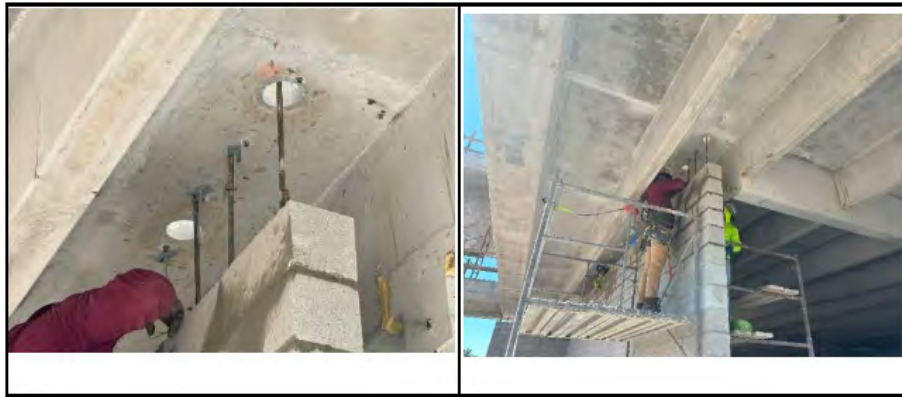
Figure 20. Photographs from Threshold Inspection Report No. 099 showing issue noted by inspector at top of "HQ Level 3 South CMU wall". Note PTA anchors and connection of vertical masonry bars to above slab in left image. Note that the bars are generally spliced to anchors attached to the slab with screws

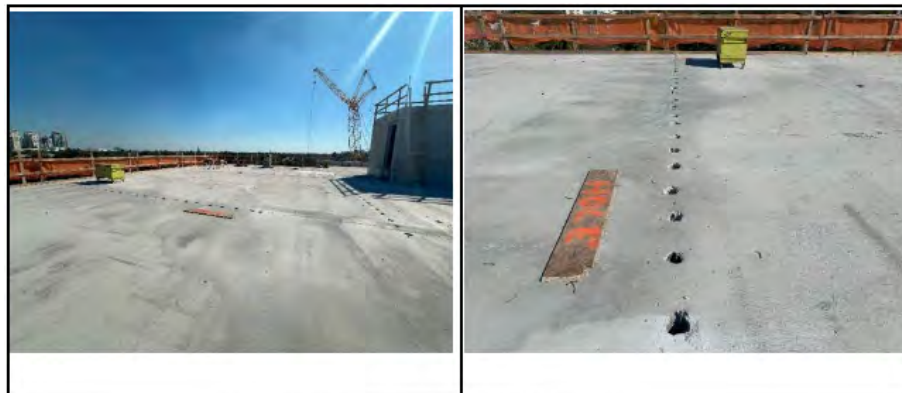
Figure 21. Photographs from Threshold Inspection Report No. 101. While not clearly stated in the report, these images are believed to be of the third floor slab

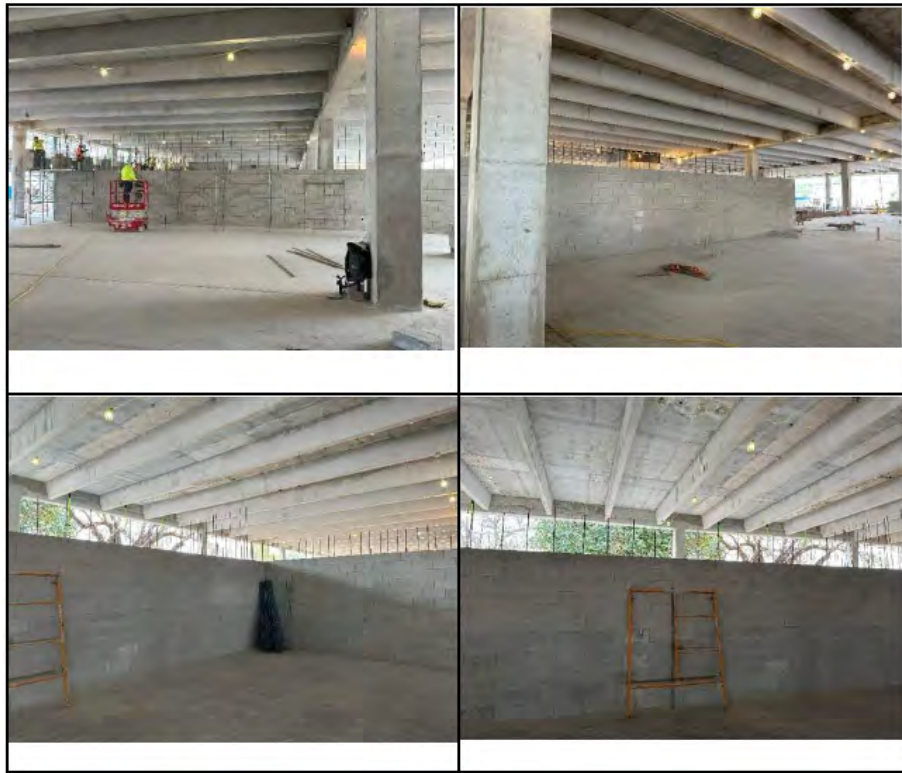
Figure 22. Photographs from Threshold Inspection Report No. 103 showing first story CMU walls under construction. Note the lack of shoring indicating that the CMU walls were not constructed as bearing walls

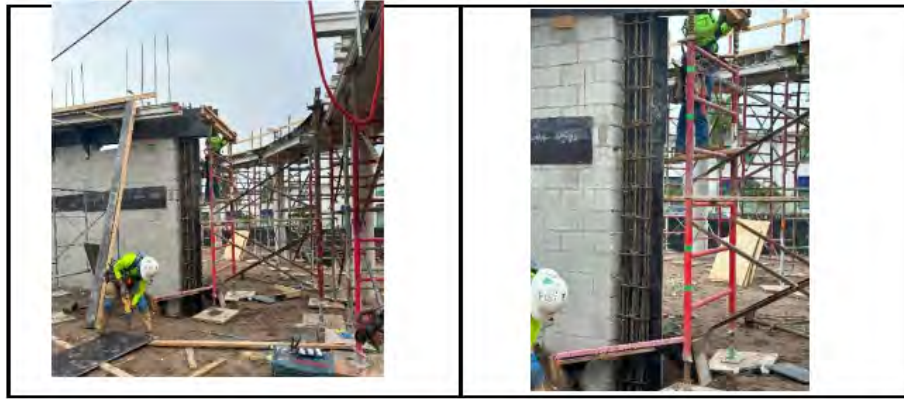
Figure 23. Photographs from Threshold Inspection Report No. 105 showing CMU wall in Area E under construction. Since the wall is being constructed prior to the roof structure, this CMU wall will take load from the roof structure as a bearing wall

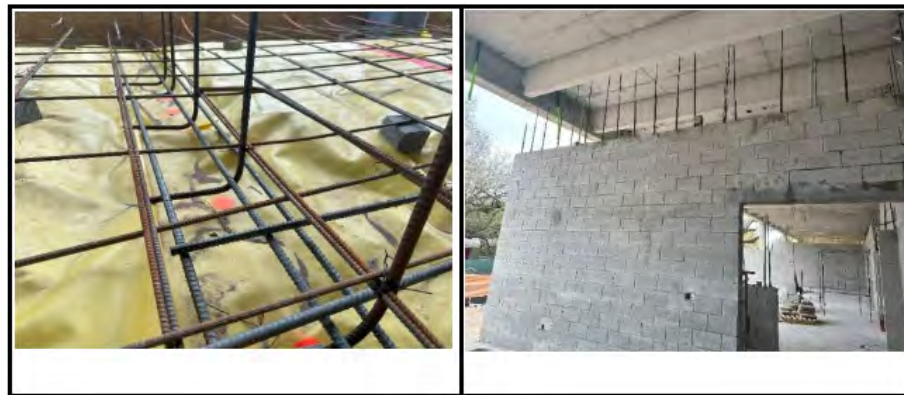
Figure 24. Photographs from Threshold Inspection Report No. 107. The photograph on the left shows hooked dowels at a thickened slab location under a wall. The inspector noted that the dowels needed to be shifted downwards. The photograph on the right shows a CMU wall in the first story under construction. Note that no shoring of the structure above is present, indicating that the CMU wall was not constructed as a bearing wall

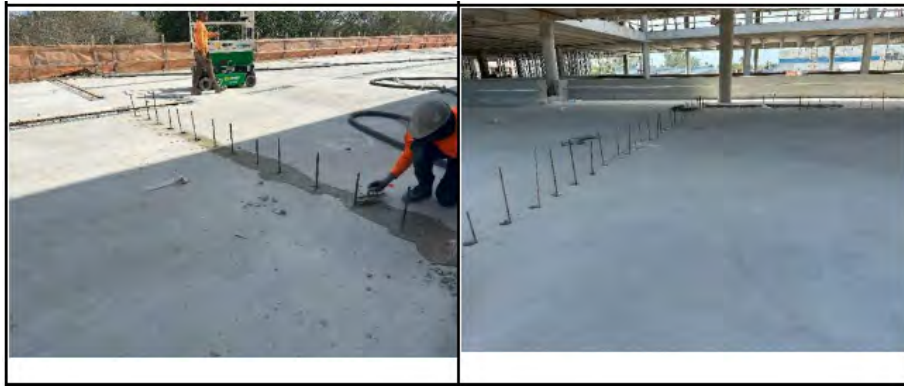
Figure 25. Photographs from Threshold Inspection Report No. 109 showing dowels extending through cored holes in slab. These dowels appear to be from the CMU wall below

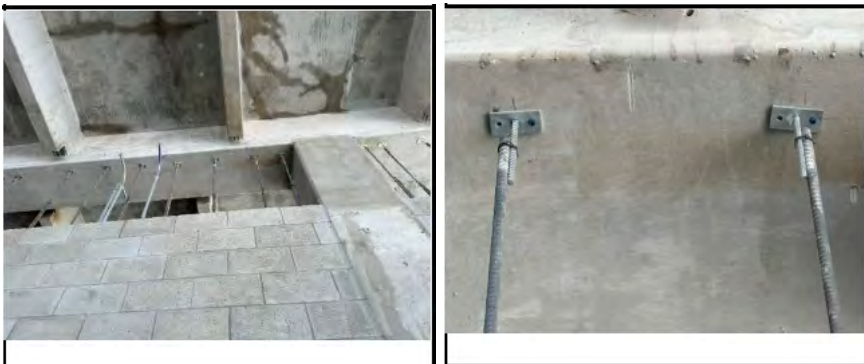
Figure 26. Photographs from Threshold Inspection Report No. 123 showing PTA connectors at bottom of soffit beam with only one screw attaching the plate of the anchor to the soffit beam

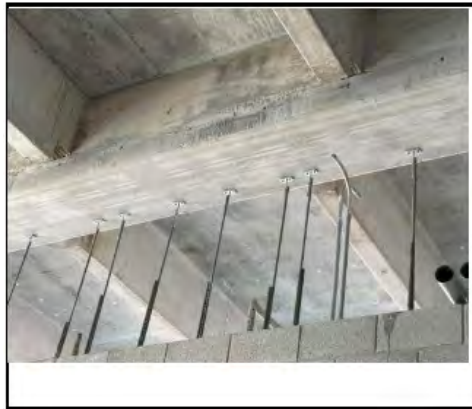
Figure 27. Photograph from Threshold Inspection Report No. 125 showing PTA connectors at bottom of soffit beam with the two screws attaching the plate of the anchor to the soffit beam

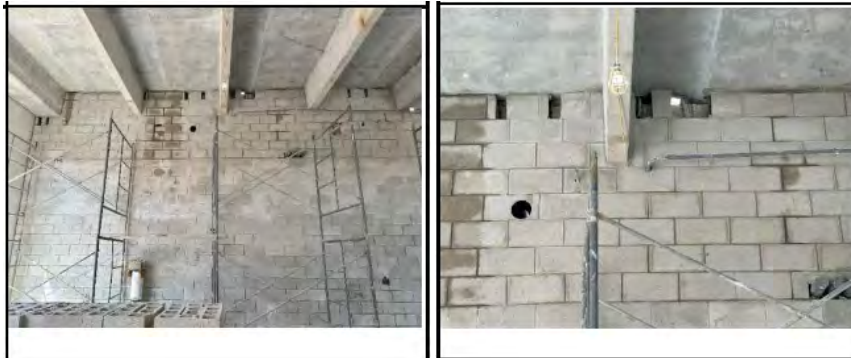
Figure 28. Photographs from Threshold Inspection Report No. 131 showing a wall that is nearly complete

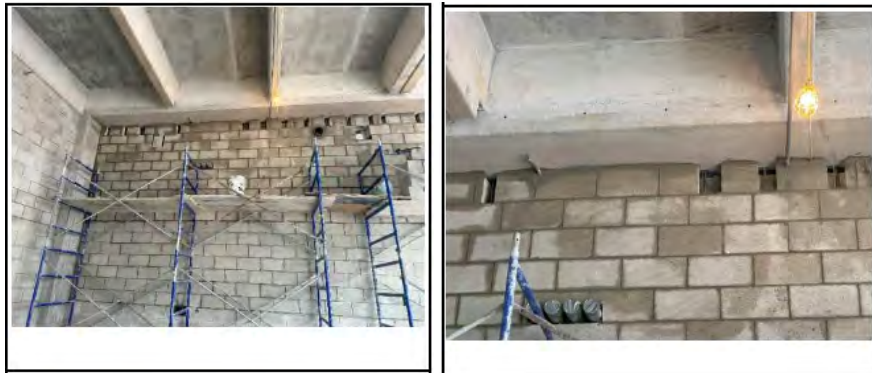
Figure 29. Photographs from Threshold Inspection Report No. 133 showing CMU wall at Level 1, Area D

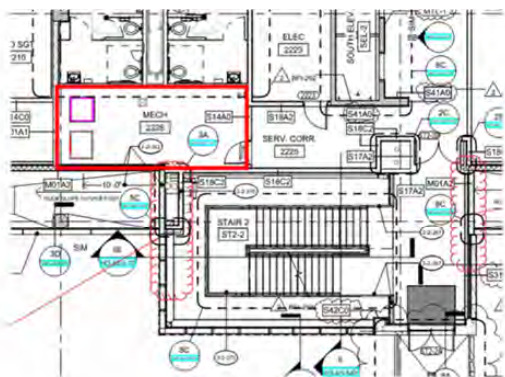
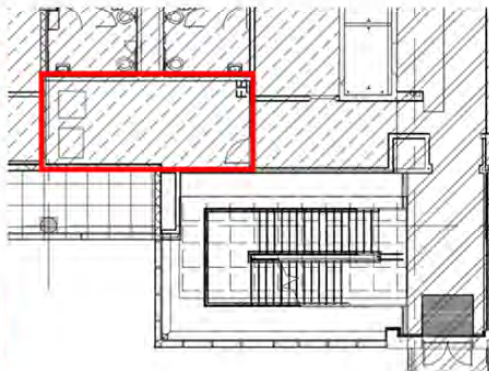
14. **Mechanical Equipment.** In addition to the loading discrepancy noted in Item 8 above regarding equipment weight versus uniform live loads, there is an area bounded by Gridlines H, J, 14, and 16 on Level 2 that is designated in the architectural drawings, but not in the structural drawings, as

Figure 30. Possible inconsistency between architectural drawings (top) and structural drawings (bottom) regarding the location of mechanical equipment. Note that the architectural drawings designate Room 2226 on Level 2 as a mechanical room; however, the structural drawings indicate that a General live load rather than a Mechanical live load was used to design that area

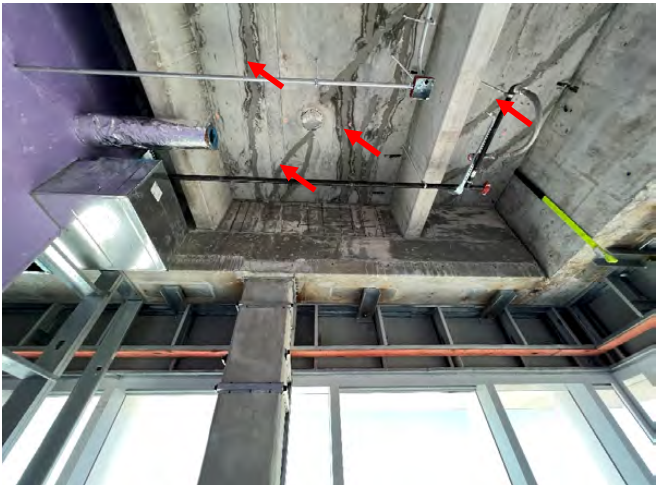
Figure 33. Example of cracks (see red arrows) in the reinforced concrete slab (at the roof) which have been repaired

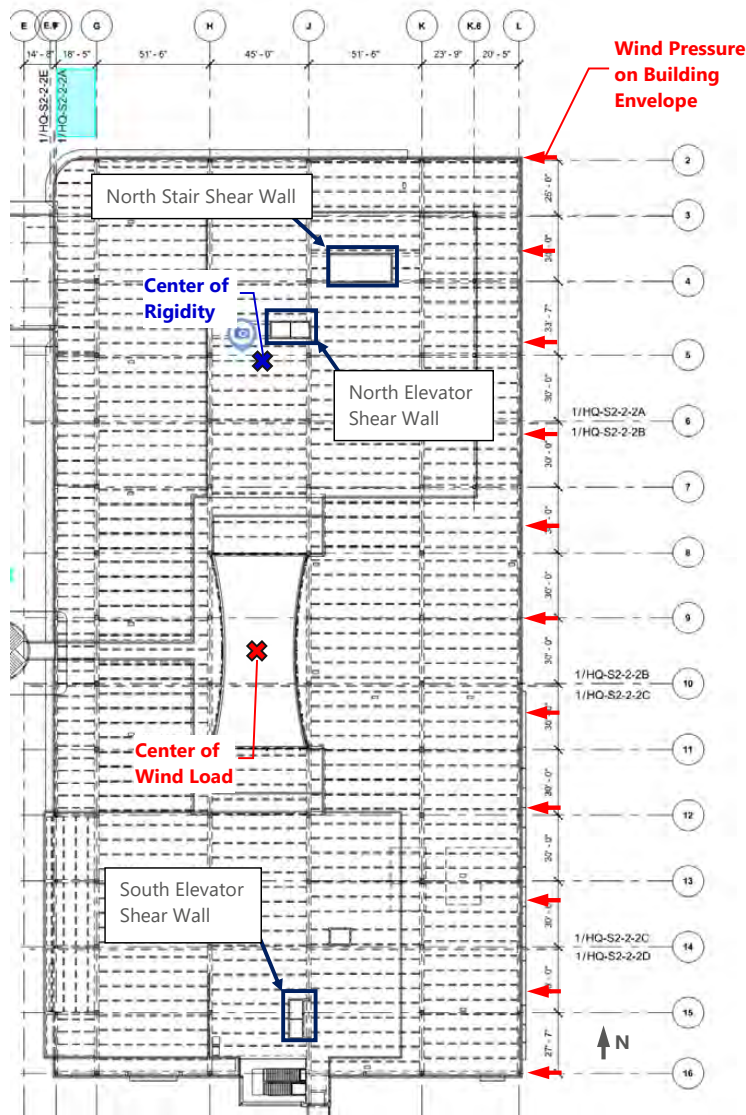
10. **Building Period.** Due to the relatively small length of shear wall in the southern half of the main building of the FLPHQ, the fundamental period of vibration of the building is over 0.9 seconds (which is significantly larger than typical concrete shear wall buildings having no more than three stories). The fundamental mode also corresponds with a twisting response of the structure. While this condition does not violate any code-prescribed performance limitations, it is not standard practice to design structures to perform this way. Adding an appropriately designed full-height shear wall (i.e., from foundation to roof) to the structure (as previously described) will rectify this condition.

Figure 34. Plan view of FLPHQ showing the approximate locations of the center of rigidity and east-west wind loads. Due to eccentricity between the two, the structure twists

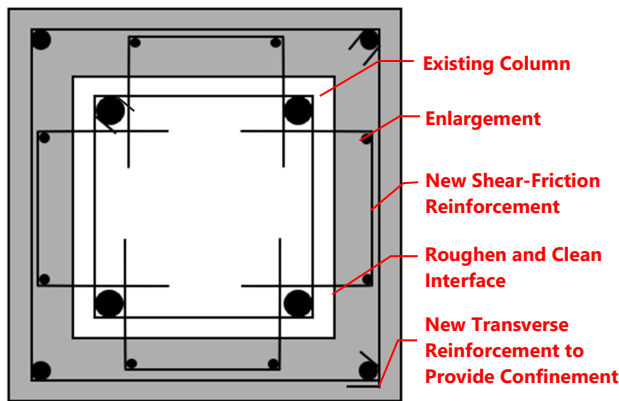
Figure 35. Sectional view of a reinforced concrete column which is enlarged to increase resistance. Note that the new transverse reinforcement should be spaced closely to provide confinement

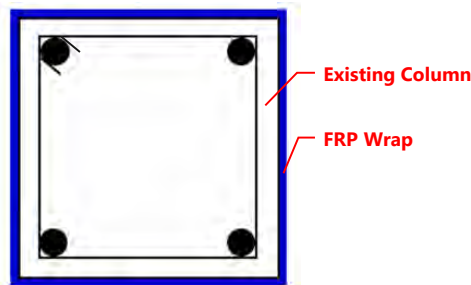
Figure 36. Sectional view of a reinforced concrete column which is wrapped with FRP to enhance shear strength and member deformability

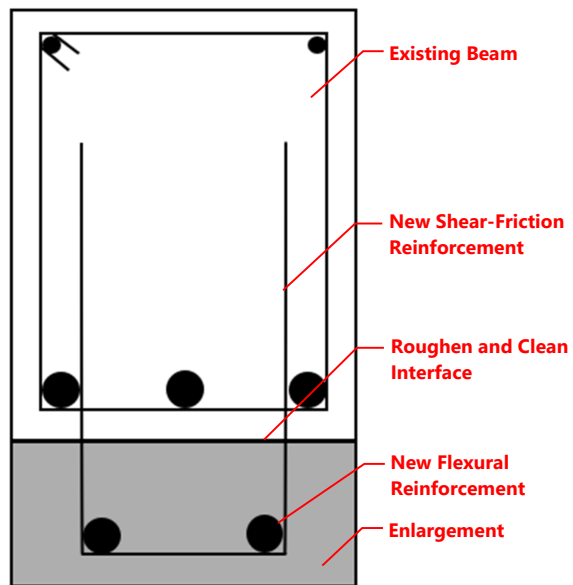
Figure 37. Section view of a reinforced concrete beam which is enlarged to increase flexural resistance

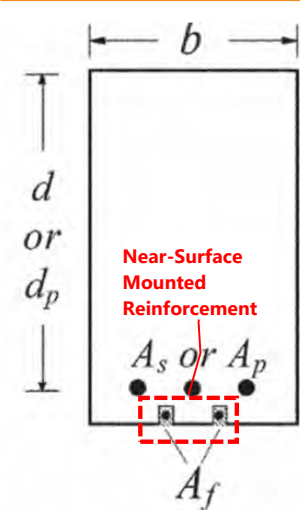
Figure 38. Section view of a reinforced concrete beam showing strengthening with near-surface mounted reinforcement (adapted from ACI 440.2-23)

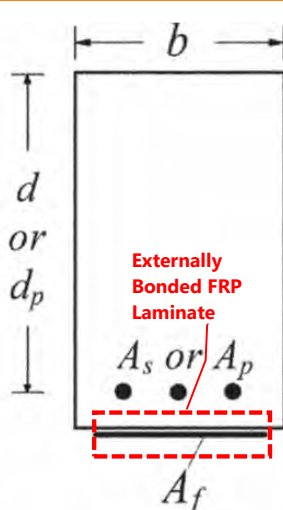
Figure 39. Section view of a reinforced concrete beam strengthened with an externally bonded FRP laminate (adapted from ACI 440.2-23)

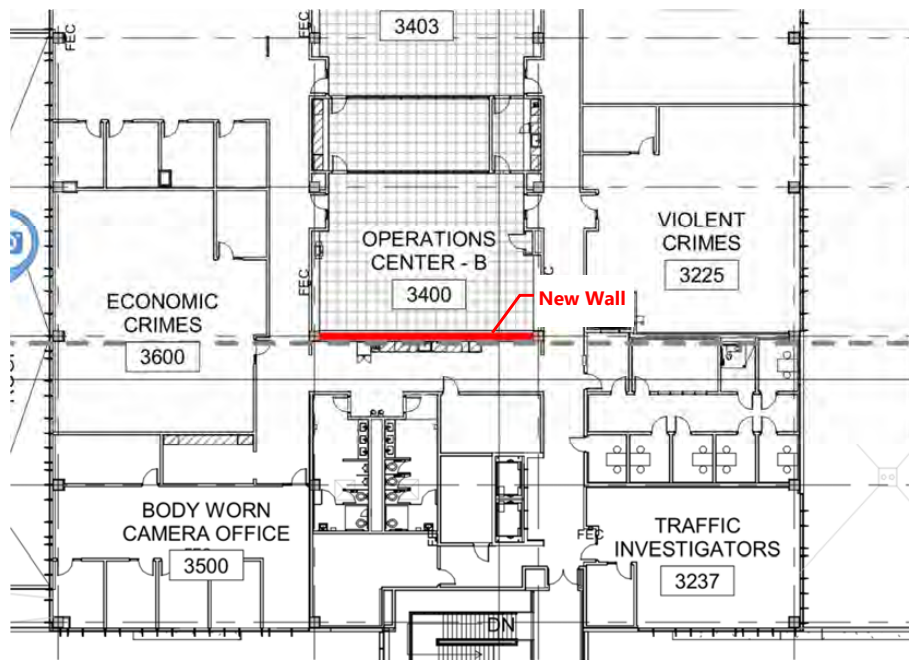
- 1. Shear Wall Capacities.** The southern-most reinforced concrete core wall is not code-compliant for one-way shear strength or flexural strength between Levels 1 and 2. Adding a properly designed full-height shear wall (i.e., from foundation to roof) with an accompanying foundation to the structure on Gridline 14 between Gridlines H and J can rectify this condition. Rectification of this condition should be carried out *as soon as possible* (0 to 2 months) and should be completed before the building is occupied. Note that, contrary to the position of the SEOR, we do *not* believe that the concrete masonry unit (CMU) partition walls are a reliable part of the lateral load-resisting system. We have provided other findings related to the use of these CMU walls in the Documentation section below.

Figure 40. One potential location for the proposed new reinforced concrete shear wall

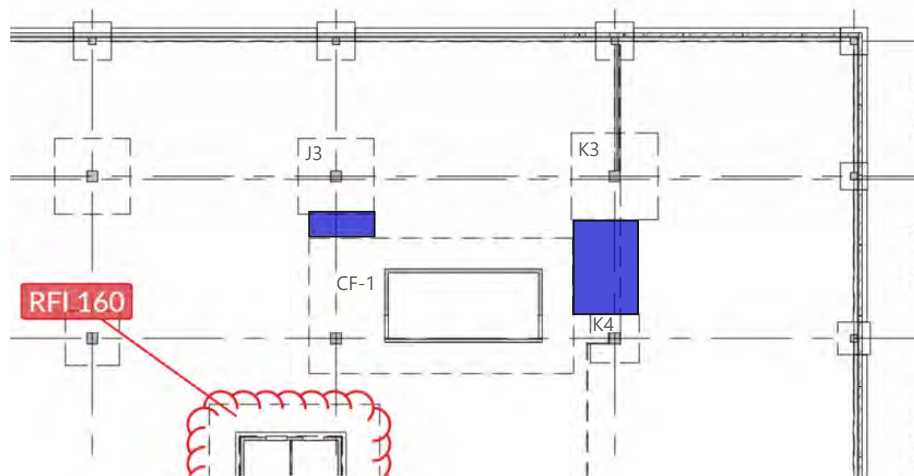
- 2. Foundation Capacities at Shear Walls.** The mat foundations for the concrete shear walls around the north stair shaft (designated as CF-1 on the structural drawings) and the south elevator shaft (CF-3) all have lateral demands that exceed the allowable design capacity under design wind loads in the east-west direction and are therefore not code-compliant. Adding the aforementioned shear wall to the building can rectify conditions related to the south elevator shaft but not the sliding exceedance at the north stair shaft. Attaching mat footing CF-1 to its surrounding isolated

Figure 41. Conceptual rectification of sliding deficiency of mat footing CF-1. The mat footing is attached to nearby isolated footings (J3, K3, and K4) with new reinforced concrete (shown in blue font)

footings can rectify the sliding condition. Rectifications to the foundations should take place at the same time as those for the shear walls.
