Fort Lauderdale Police Headquarters

WJE Peer Review, Phase 1 - North Elevation Evaluation

1300 West Broward Boulevard
Fort Lauderdale, Florida 33312

December 31, 2024
WJE No. 2024.4855.0

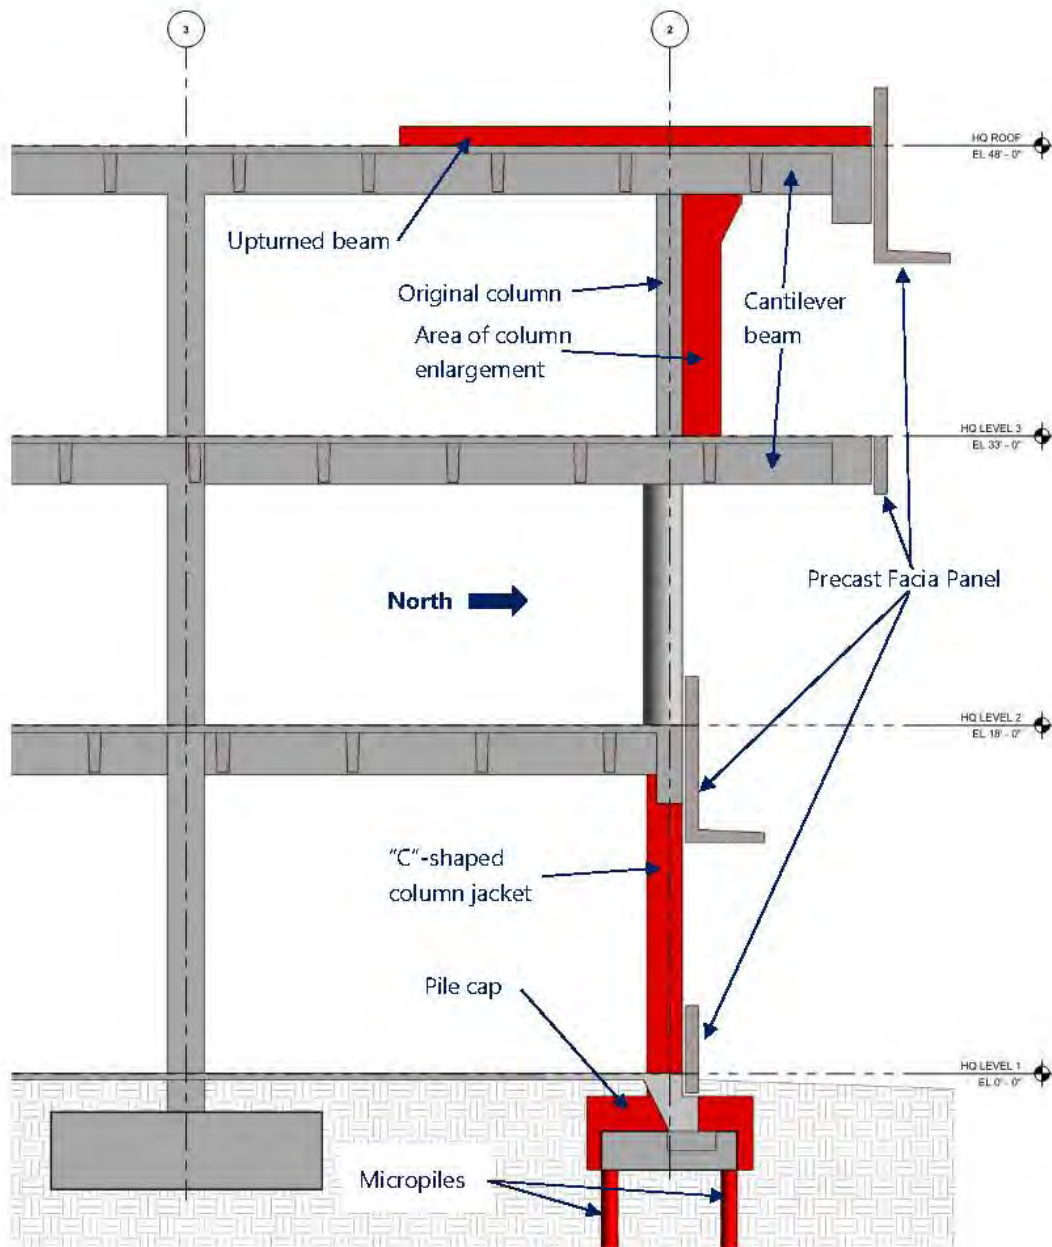
Figure 6. Building section at gridline H showing area north of gridline 3 (from file *Police HQ Views*). Annotations in blue by WJE. Section shows implemented rectifications at third story and proposed rectifications at first story and foundations in red.

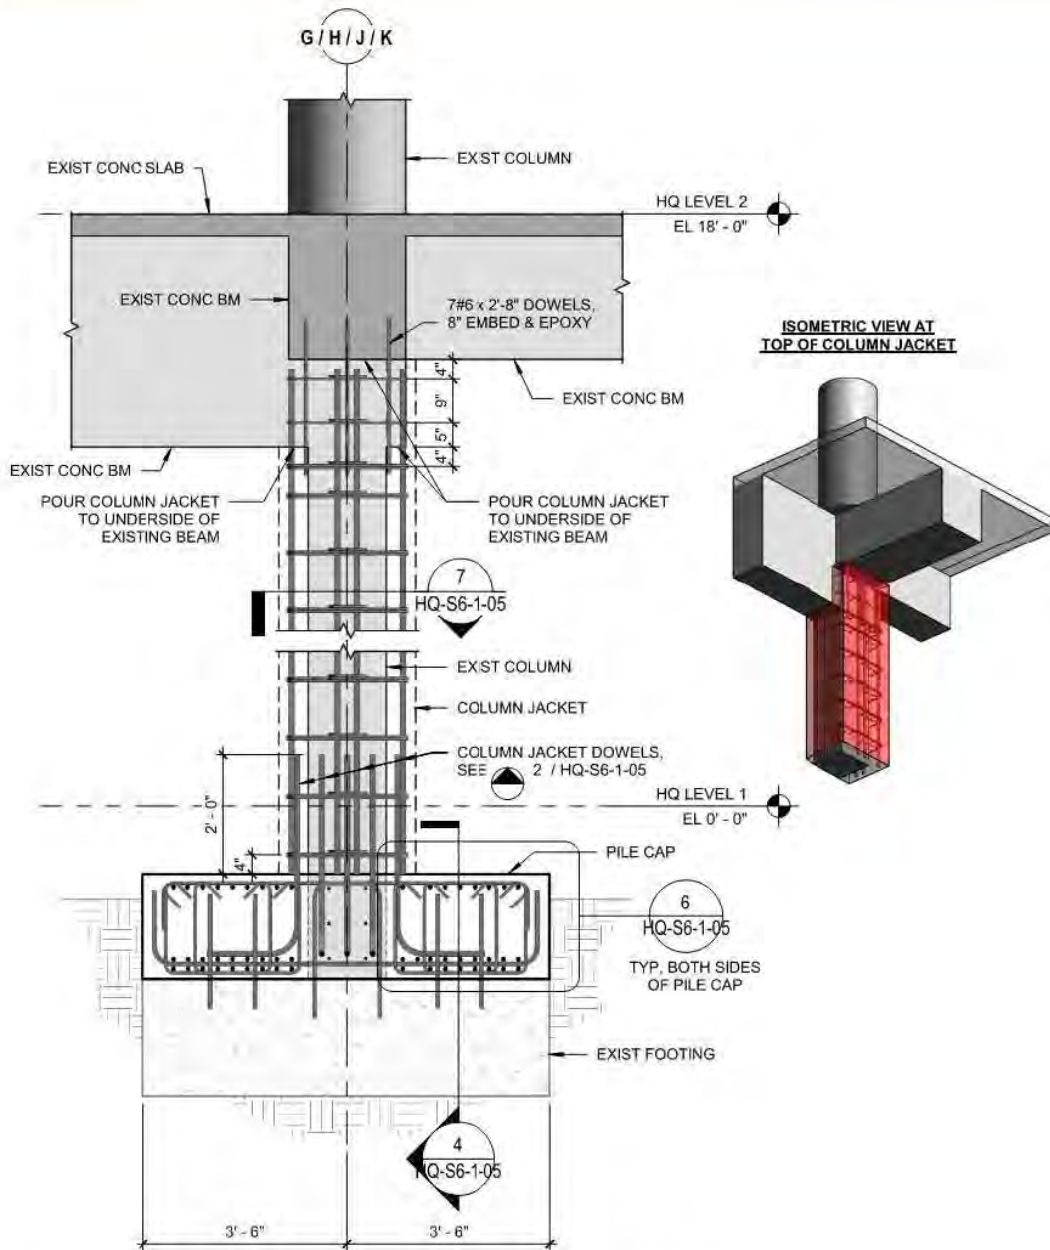
Figure 17. Section and isometric view from detail 3 of Sheet HQ-S6-1-05 (dated September 12, 2024) showing new column jacket and pile cap at first story columns at gridline 2. Section view is facing north.

The design of the column jackets in the first story at gridline 2, the added micropile, and the associated pile cap is found on Sheets HQ-S6-1-04 and HQ-S6-1-05, both dated September 12, 2024. The installation sequence for these elements was set forth diagrammatically in six steps on Sheet HQ-S6-1-04, as shown in Figure 15 (steps 1 through 3) and Figure 16 (steps 4 through 6). The details of the supplemental elements, including structural member sizes and reinforcement, are found on Sheet HQ-S6-1-05 and are shown in Figure 17 and Figure 18.

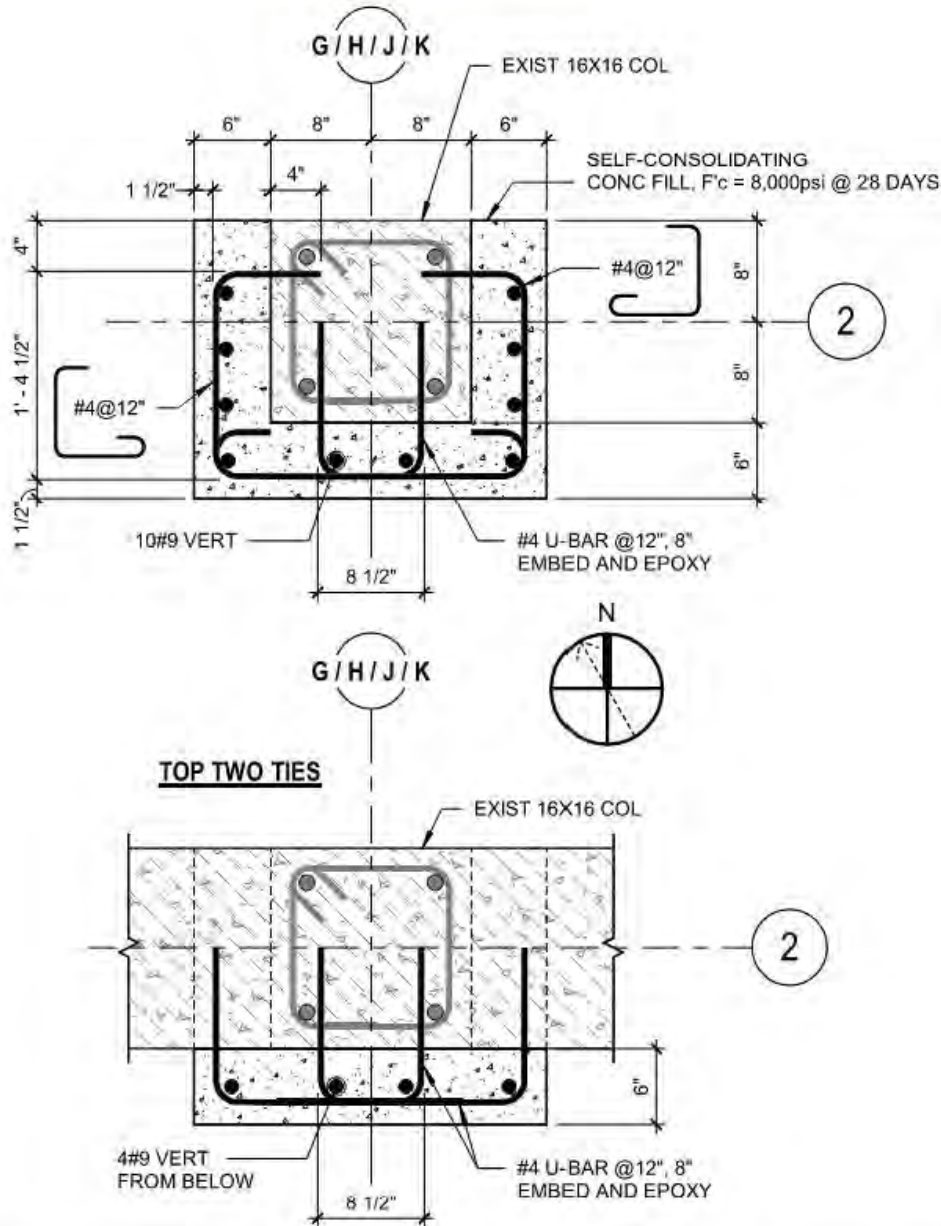
Figure 18. Detail 7 of Sheet HQ-S6-1-05 (dated September 12, 2024) showing column reinforcement for new column jacket at first story columns at gridline 2. Upper detail is for all but the top of the column while the lower detail is for the portion of the column that extends up past the east-west beams to the soffit of the north-south second floor beam.

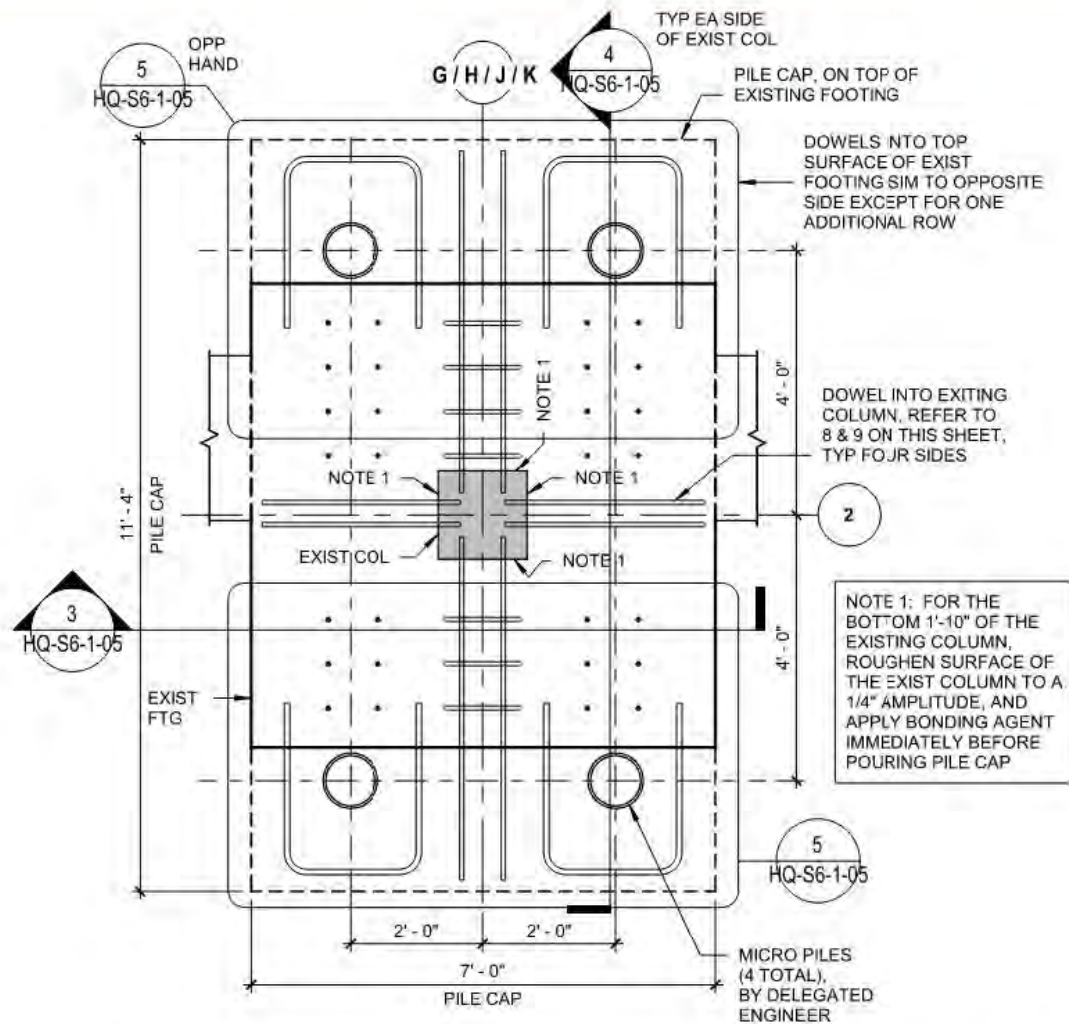
Figure 19. Detail 1 of Sheet HQ-S6-1-05 (dated September 12, 2024) showing partial plan view of new pile cap at columns at gridline 2.

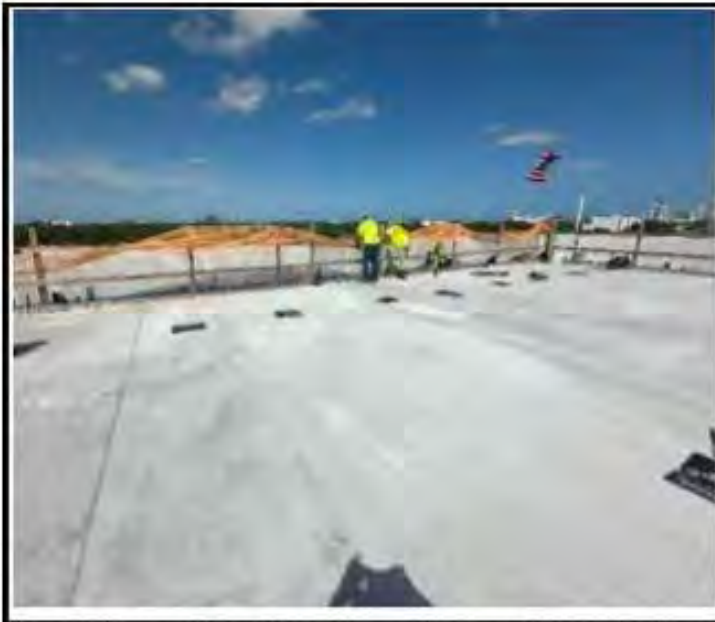
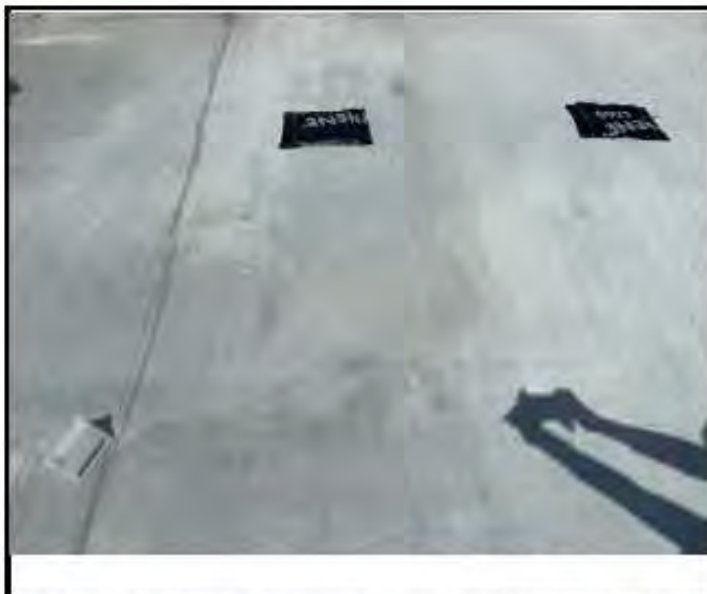
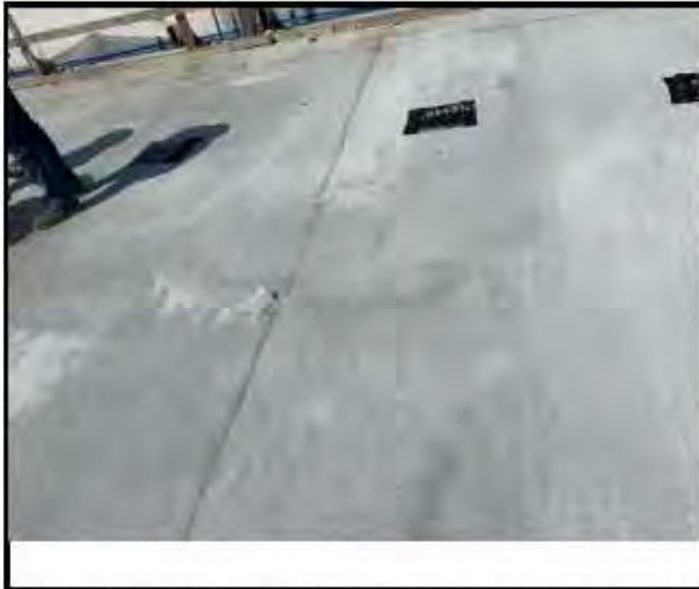
In the set of files we received, documentation of the cracking observed at the roof was primarily recorded in the threshold inspection reports and in a file named "*Pictures.pdf*." As noted in the timeline above, cracks in the roof slab were observed by the contractor immediately following the installation of the precast facade panels at the roof level. These observations are noted in Thornton Tomasetti's Threshold Inspection Report No. 125 along with photographs (Figure 25 through Figure 28).

Figure 25. Photograph from Threshold Inspection Report No. 125 showing conditions on top of roof slab at north end of building.

Figure 26. Photograph from Threshold Inspection Report No. 125 showing conditions on top of roof slab at north end of building.

Figure 27. Photograph from Threshold Inspection Report No. 125 showing conditions on top of roof slab at north end of building.

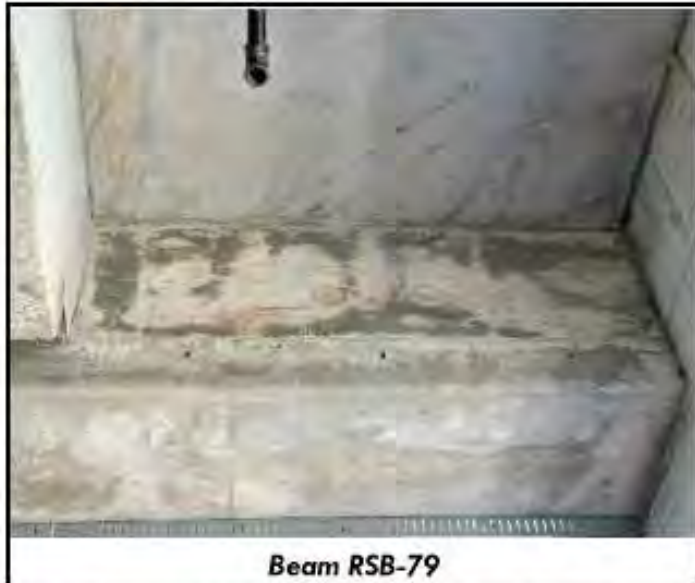
- Cracks observed in roof slab and in Beam RSB-79
- Threshold Inspection Report No. 126
 - Dated March 12, 2024
 - Cracks observed "on the north of gridline 2 on the Roof Level Area A. Contractor stated that the slab has deflected 1/2" to 3/4" on the area above and to the east of gridline J."

Figure 28. Photograph from Threshold Inspection Report No. 125 showing conditions at underside of roof slab and at beam RSB-79 (gridline J-2) at north end of building.

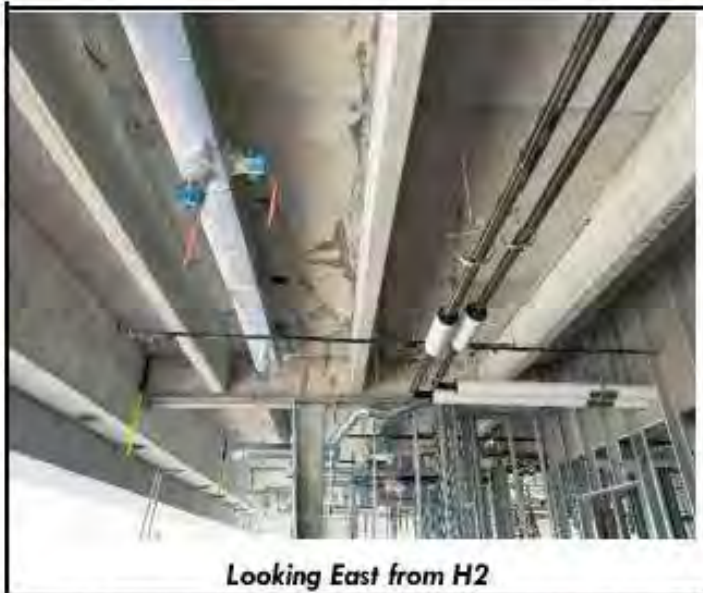
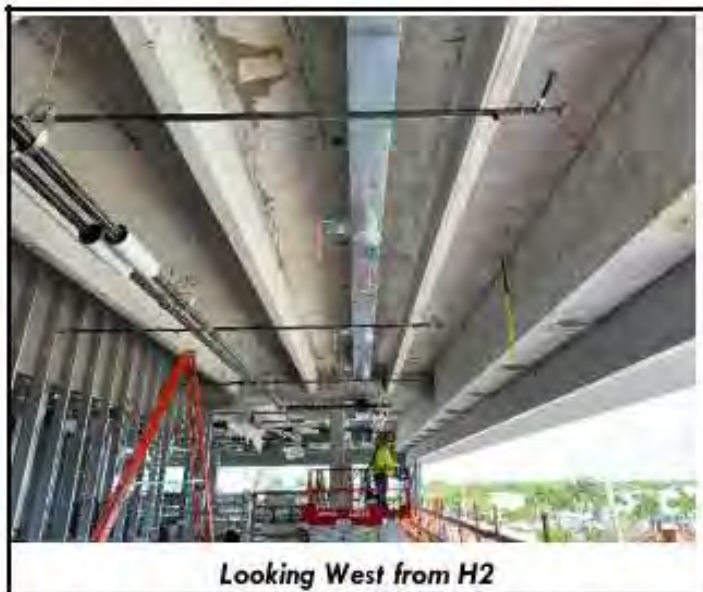
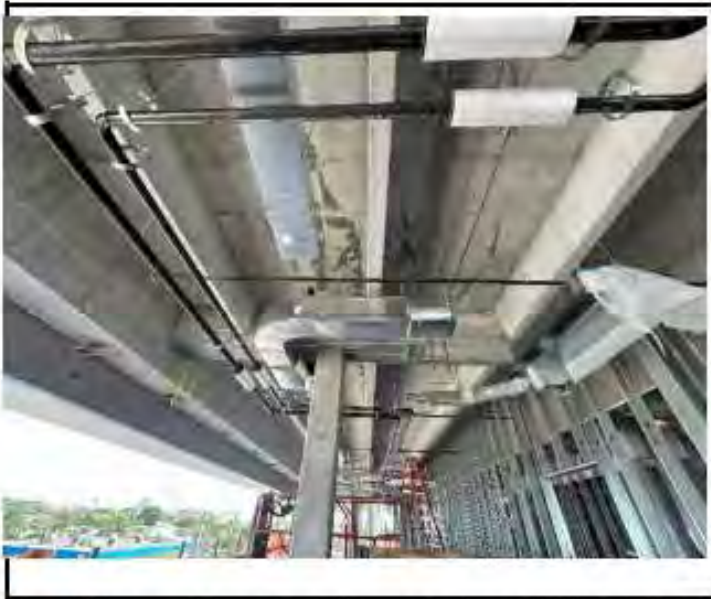
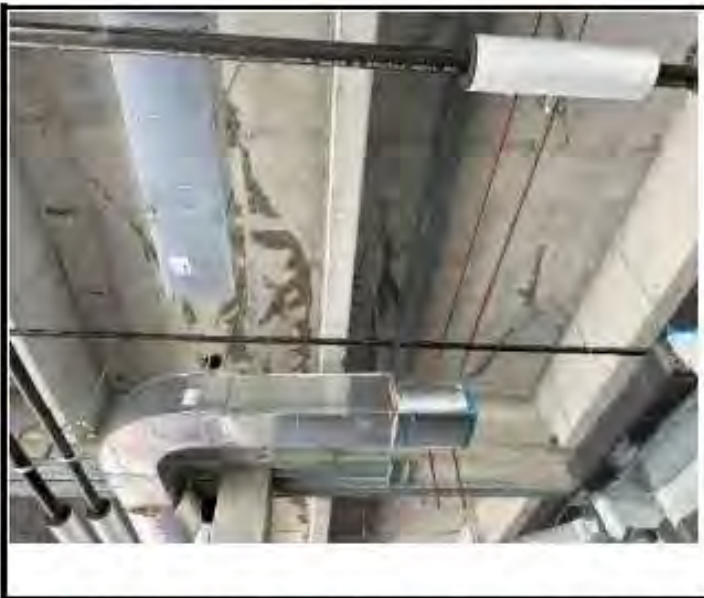
Additional documentation and observations were summarized in Threshold Inspection Report No. 127, dated March 13, 2024. Water was sprayed onto the top of the roof slab (Figure 29 and Figure 30) and it was observed that some water infiltrated through the cracks in the slab and was evident on the underside of the slab (Figure 31 through Figure 34), indicating that the cracks extended through the entire thickness of the slab.

Figure 31. Photograph from Threshold Inspection Report No. 127 showing underside of roof slab at north end of the building showing water which has filtered through from the top of the roof slab at cracked slab locations.

Figure 32. Photograph from Threshold Inspection Report No. 127 showing underside of roof slab at north end of the building showing water which has filtered through from the top of the roof slab at cracked slab locations.

Figure 33. Photograph from Threshold Inspection Report No. 127 showing underside of roof slab at north end of the building showing water which has filtered through from the top of the roof slab at cracked slab locations.

Figure 34. Photograph from Threshold Inspection Report No. 127 showing underside of roof slab at north end of the building showing water which has filtered through from the top of the roof slab at cracked slab locations.

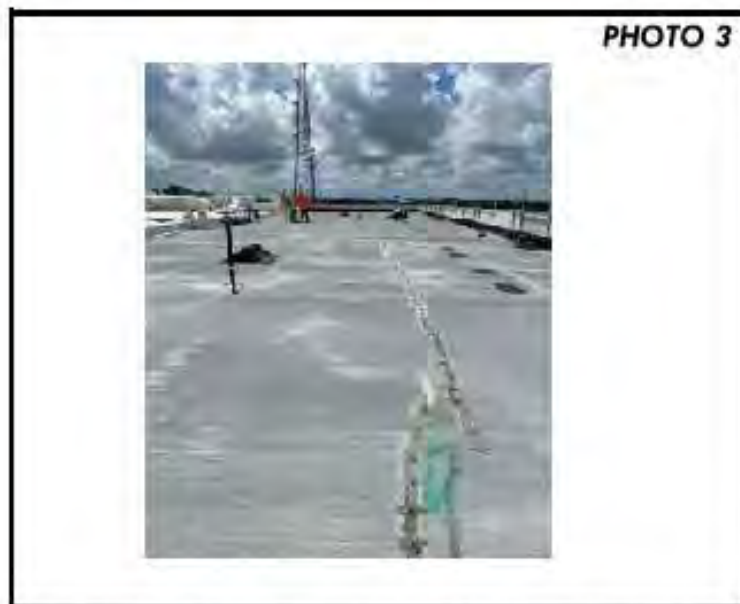
Figure 52. Photograph from Threshold Inspection Report No. 200 showing crack preparation and injection ports for epoxy injection of cracks in roof slab.

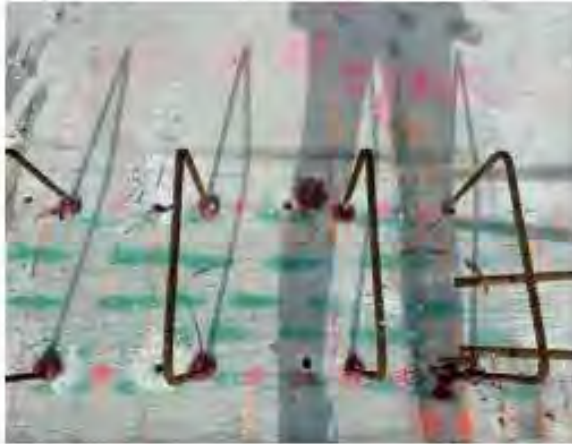
Figure 53. Photograph from Threshold Inspection Report No. 201 showing installed inverted "U" shaped stirrups in upturned beams.

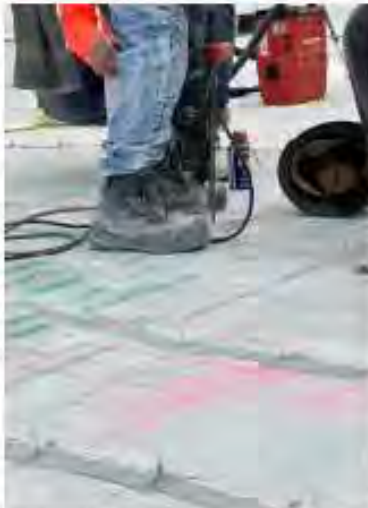
Figure 54. Photograph from Threshold Inspection Report No. 201 showing epoxy crack injection of cracks in roof slab.

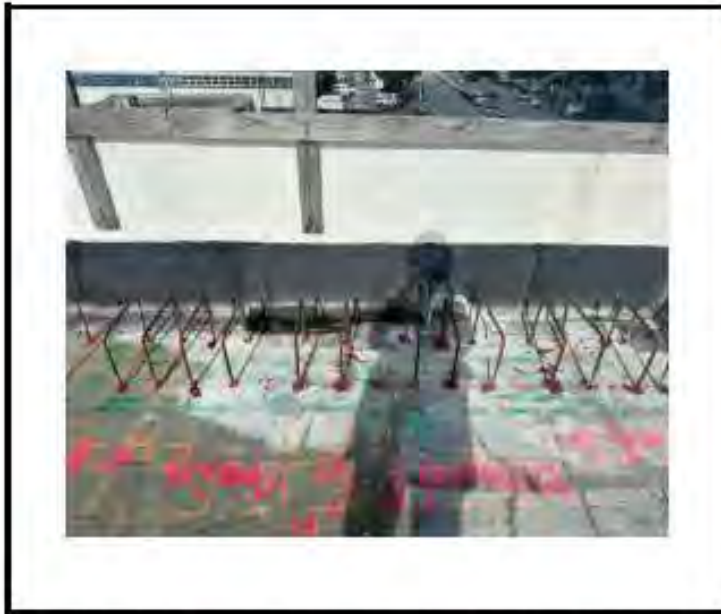
Figure 55. Photograph from Threshold Inspection Report No. 202 showing installed inverted "U" shaped stirrups in upturned beams.

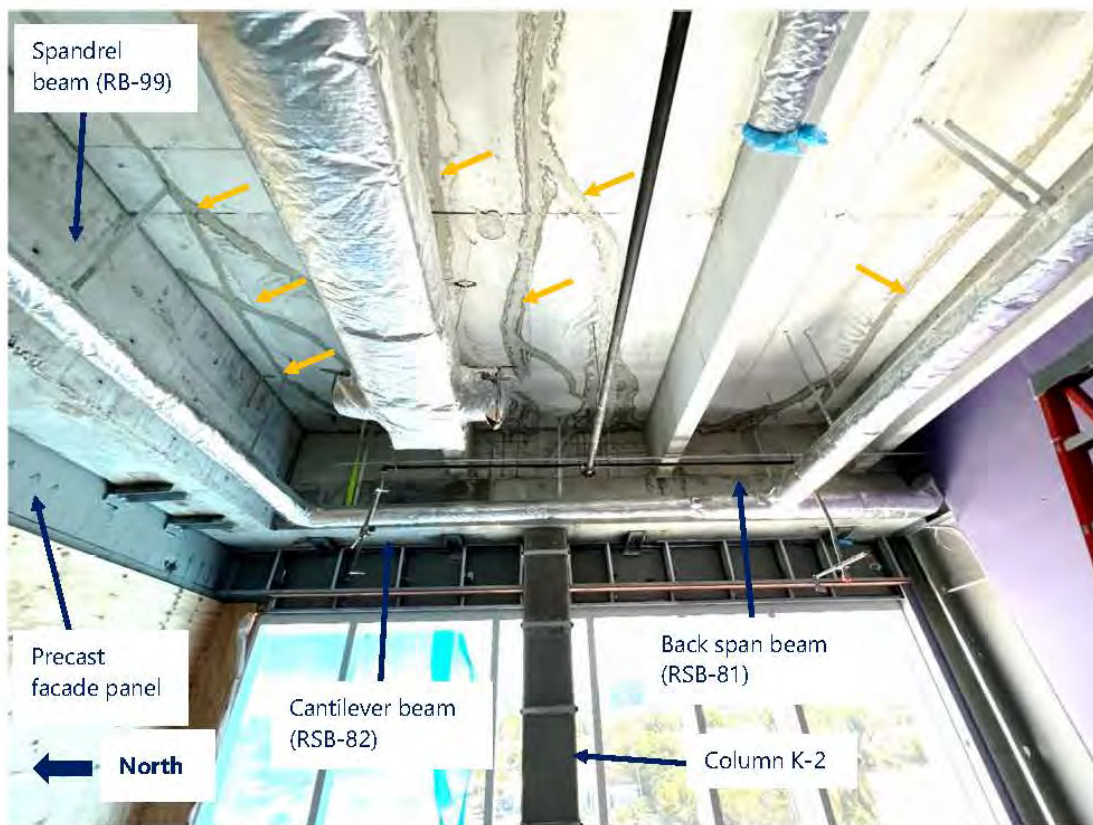
Figure 64. Cantilever roof beam and roof slab at gridline K-2. Orange arrows point to evidence of epoxy filled cracks in roof slab.

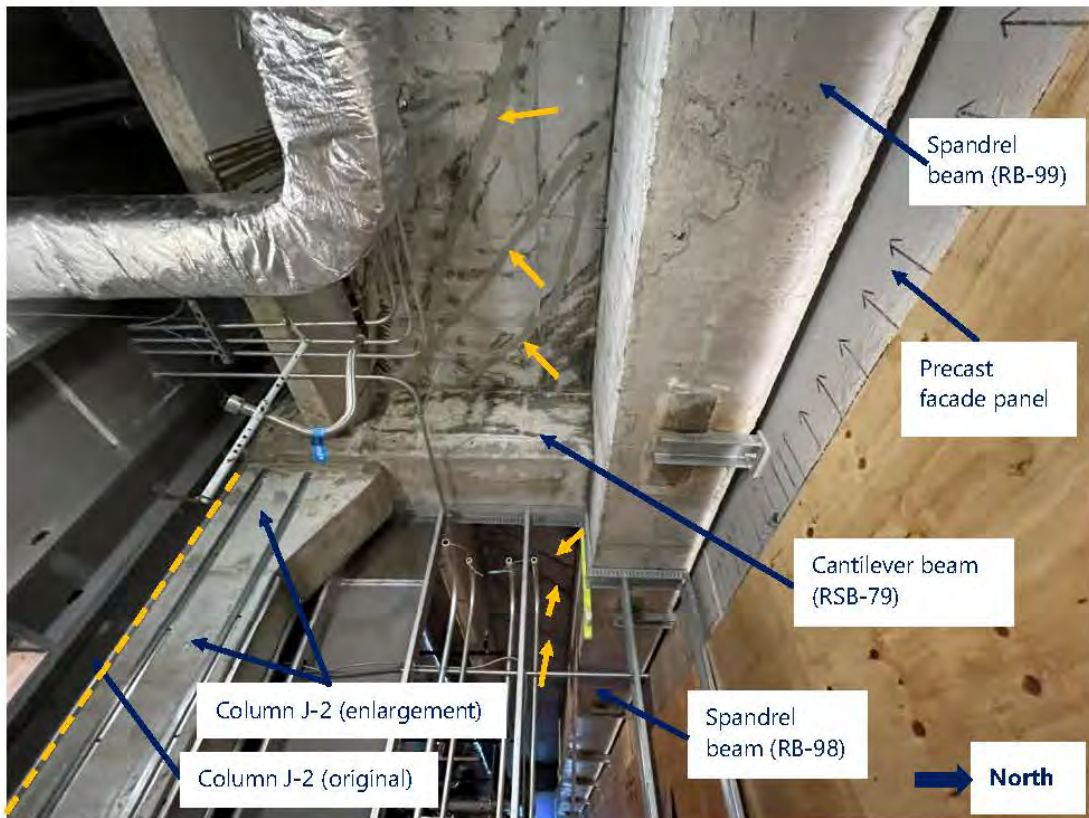
Figure 65. Cantilever roof beam and roof slab at gridline J-2. Orange arrows point to evidence of epoxy filled cracks in roof slab.

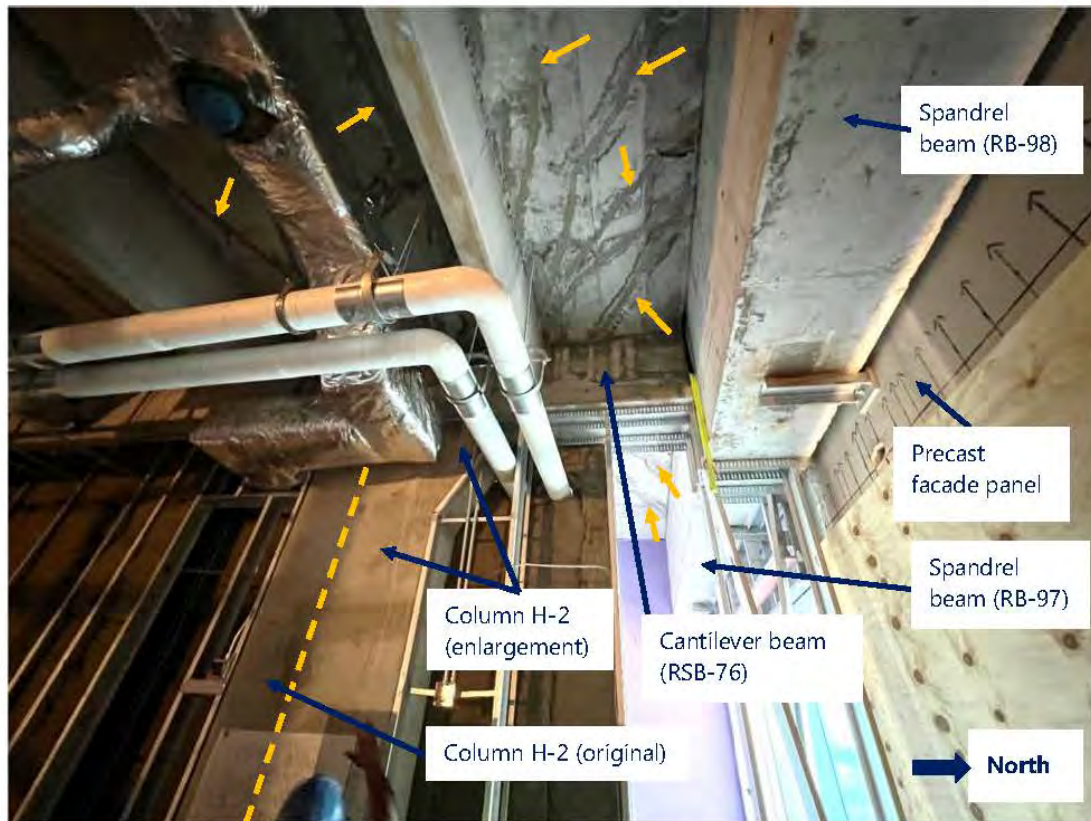
Figure 66. Cantilever roof beam and roof slab at gridline H-2. Orange arrows point to evidence of epoxy filled cracks in roof slab.

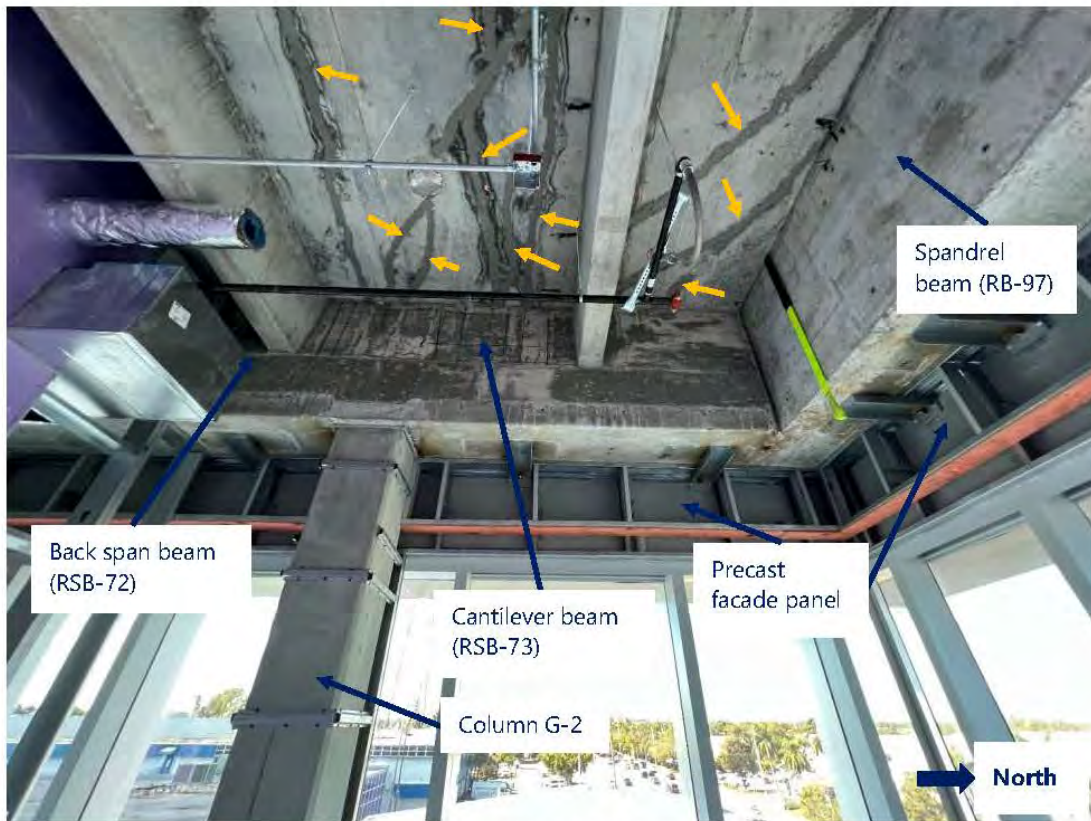
Figure 67. Cantilever roof beam and roof slab at gridline G-2. Orange arrows point to evidence of epoxy filled cracks in roof slab.

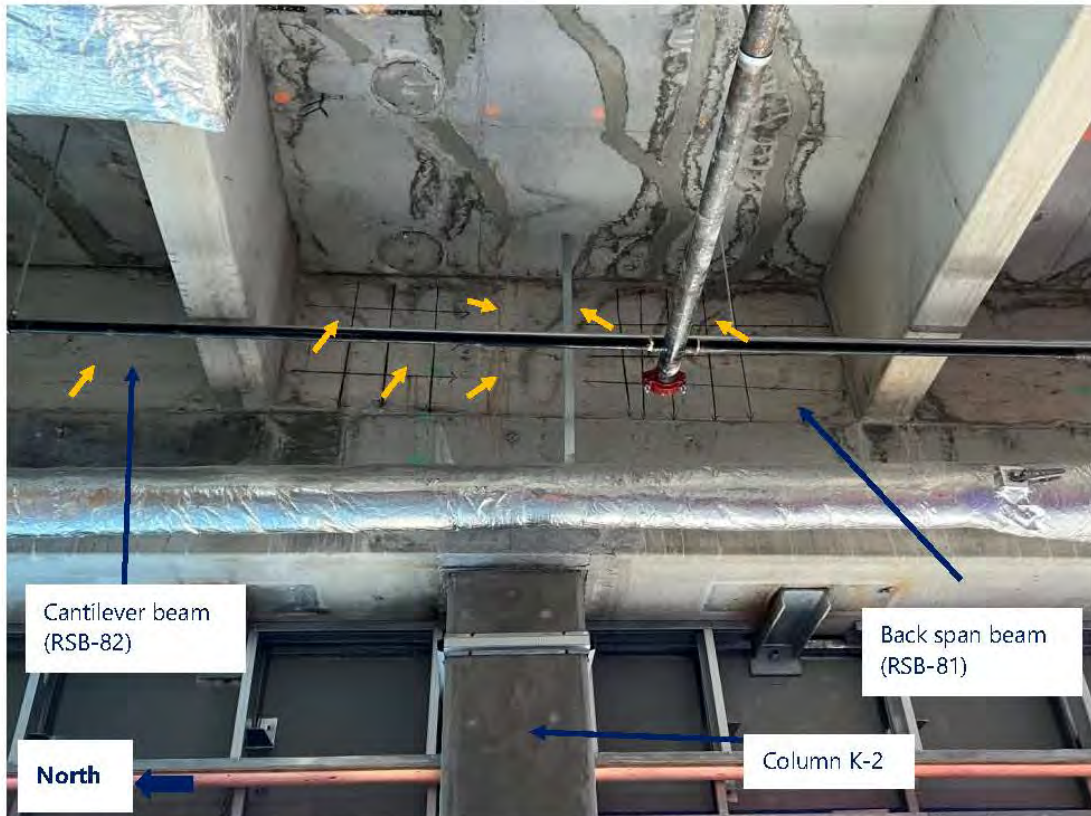
Figure 68. Cantilever roof beam back span roof beam at gridline K-2. Orange arrows point to cracks or evidence of possible cracks in beam.

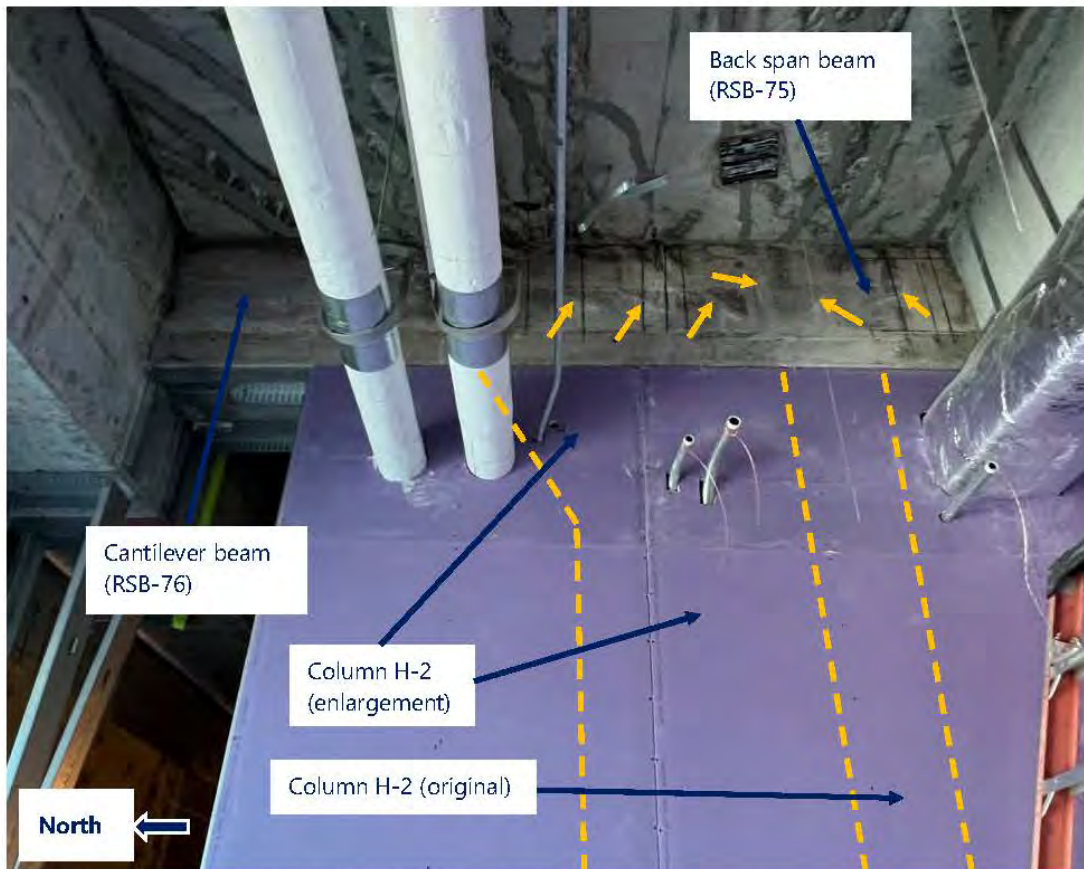
Figure 70. Cantilever roof beam back span roof beam at gridline H-2. Orange arrows point to cracks or evidence of possible cracks in beam. Column location shown is approximate.

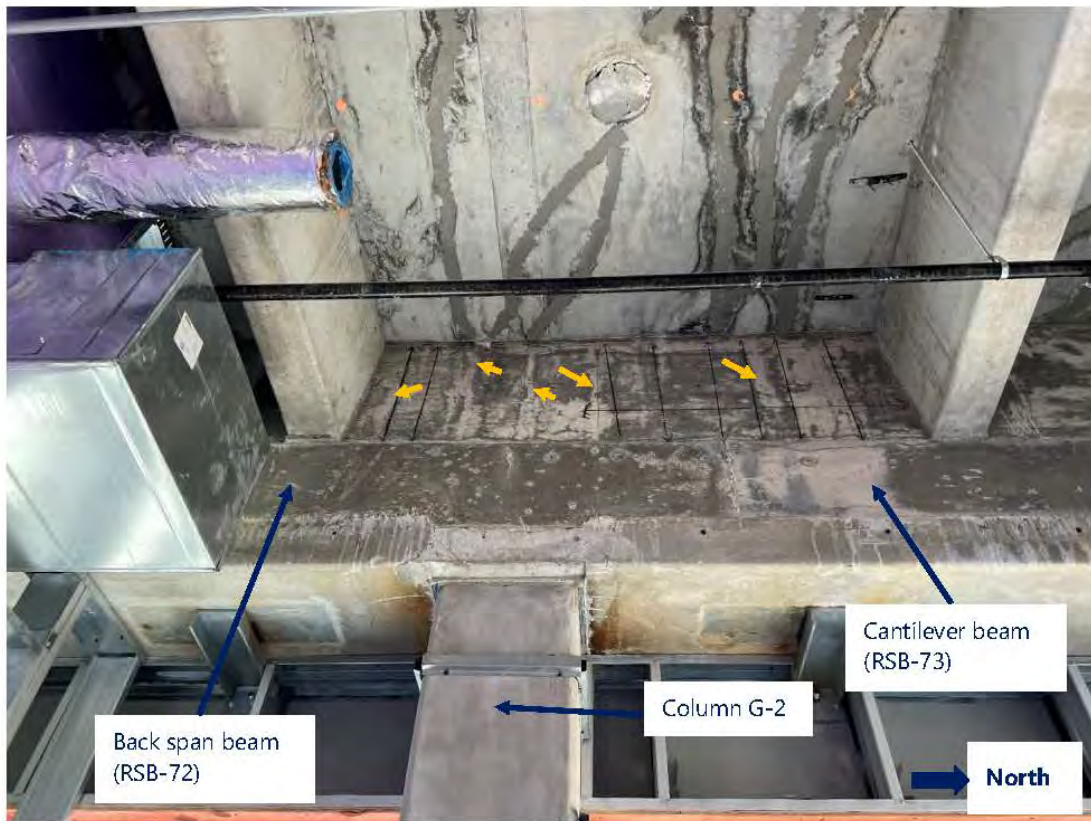
Figure 71. Cantilever roof beam back span roof beam at gridline G-2. Orange arrows point to cracks or evidence of possible cracks in beam.

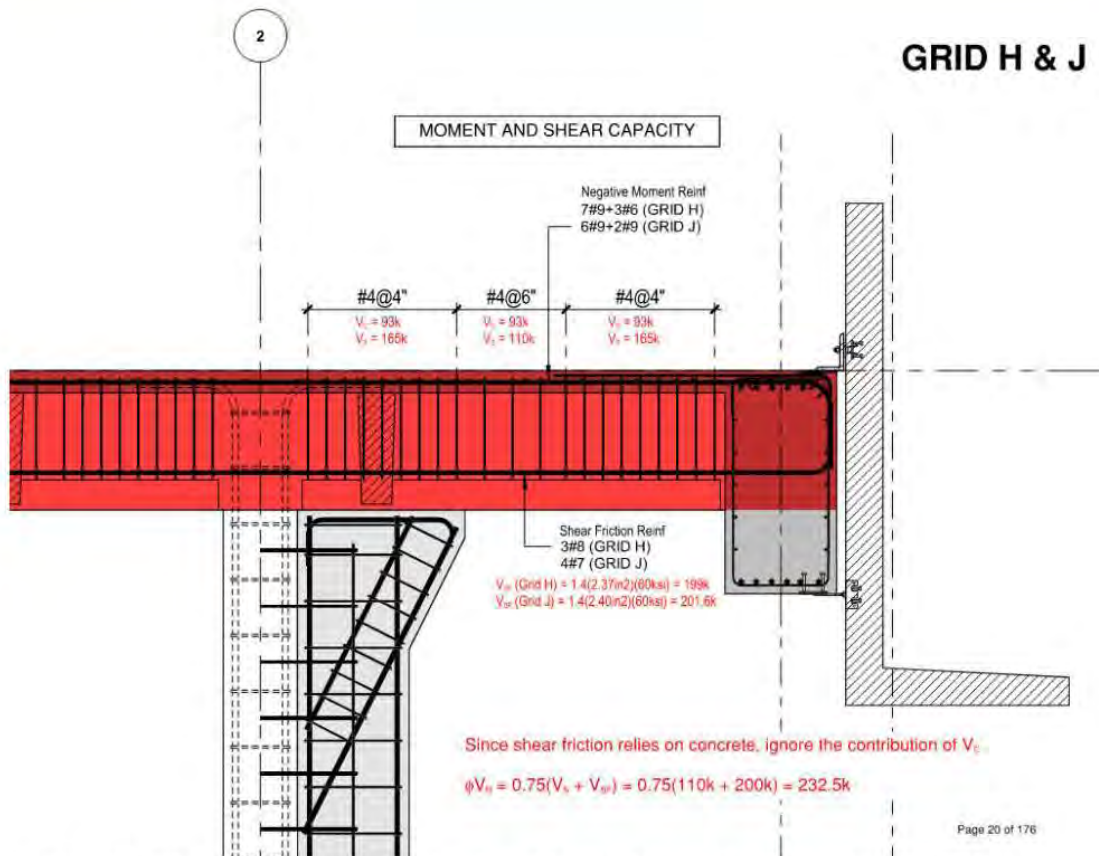
Figure 82. Calculations of cantilever beam shear capacity at gridlines H-2 and J-2 by SEOR (from File 2024-04-25_CALC_HQ Roof Cantilever Field Fix at North Elevation.pdf) showing assumption of including shear friction of bars in bottom side (compression side) of the beam.

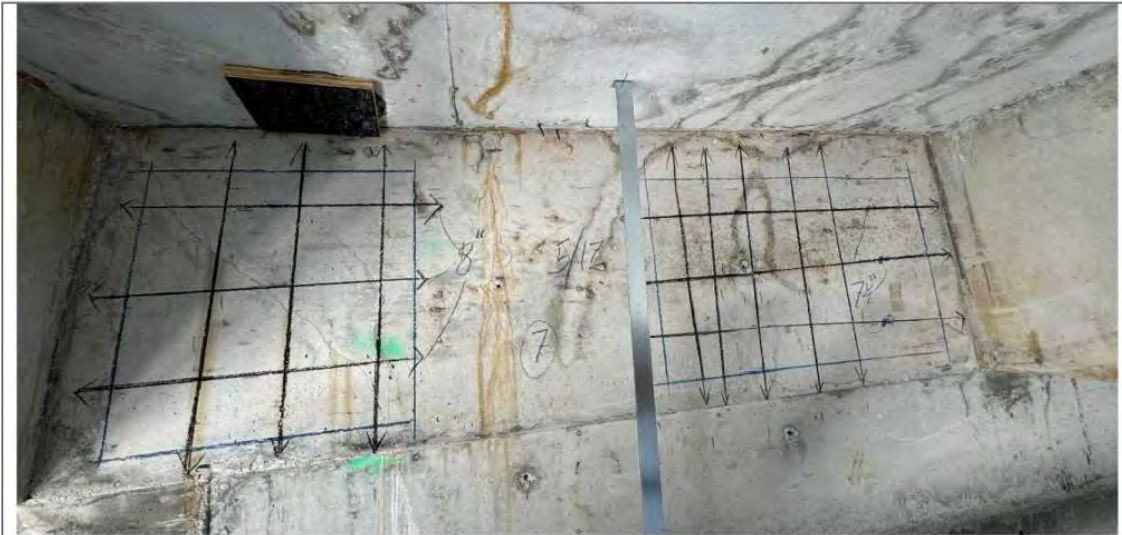
Location:	Column 1, beam, 3 rd Floor
Comments:	All horizontal rebar depths were labeled. From left to right it looks like the rebar starts to move closer to the surface. Starting from 8" deep to 7.5" deep.

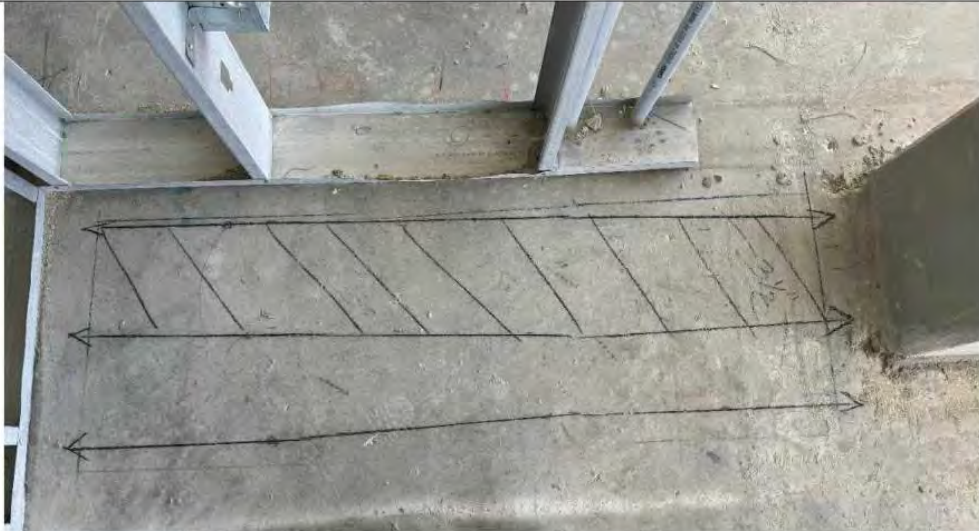
Location:	Behind column 2, 3 rd Floor
Comments:	In this area a congestion area was found running along horizontally. No specific amount of rebars was able to be counted. Congested area was found to be 3.5" deep.

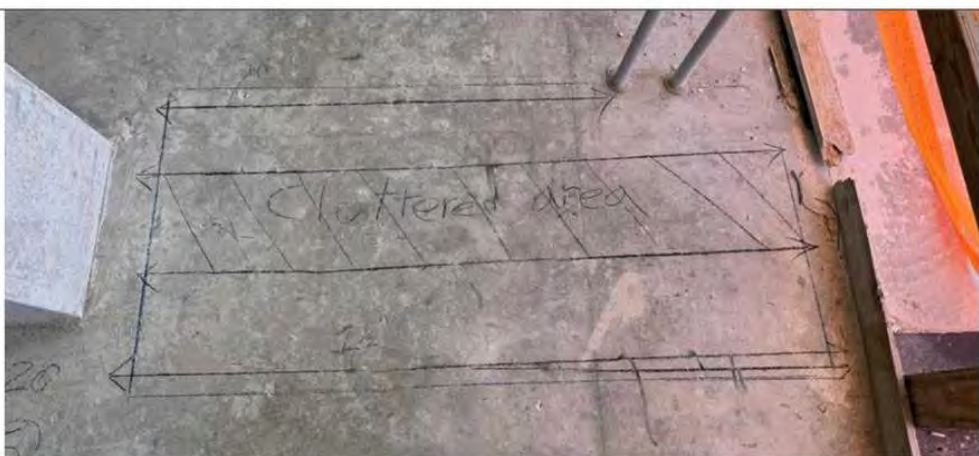
Location:	Column 2, 3 rd Floor
Comments:	In this area a congestion area was found running along horizontally. No specific amount of rebars was able to be counted. Congested area was found to be 2" deep.

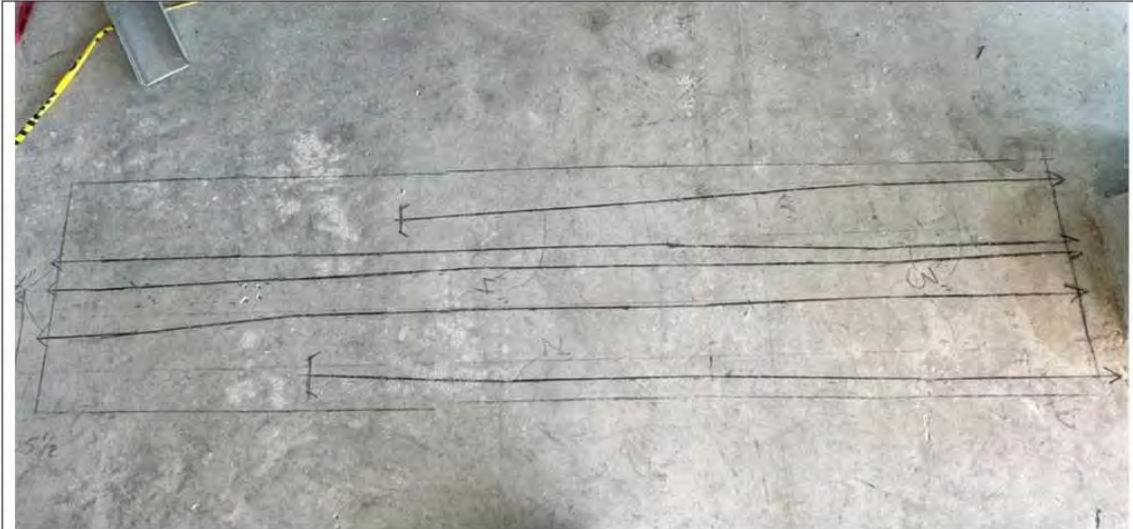
Location:	Behind Column 3, 3 rd Floor
Comments:	5 horizontal rebars were found in this area with depths ranging between 2"-4"

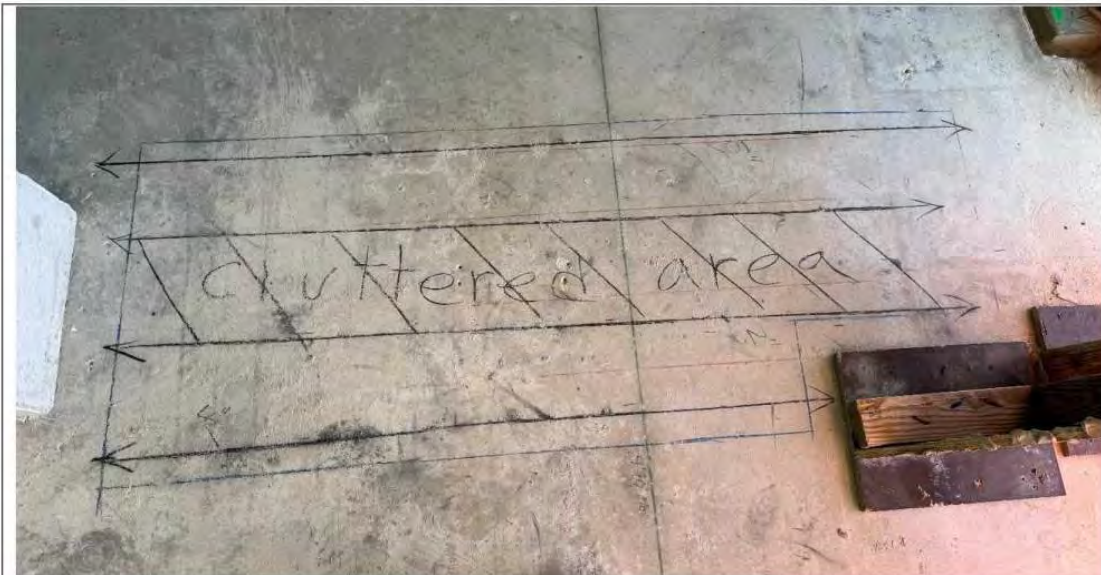
Location:	Column 3, 3 rd Floor
Comments:	In this area a congestion area was found running along horizontally. No specific amount of rebars was able to be counted. Congested area was found to be 2" deep.

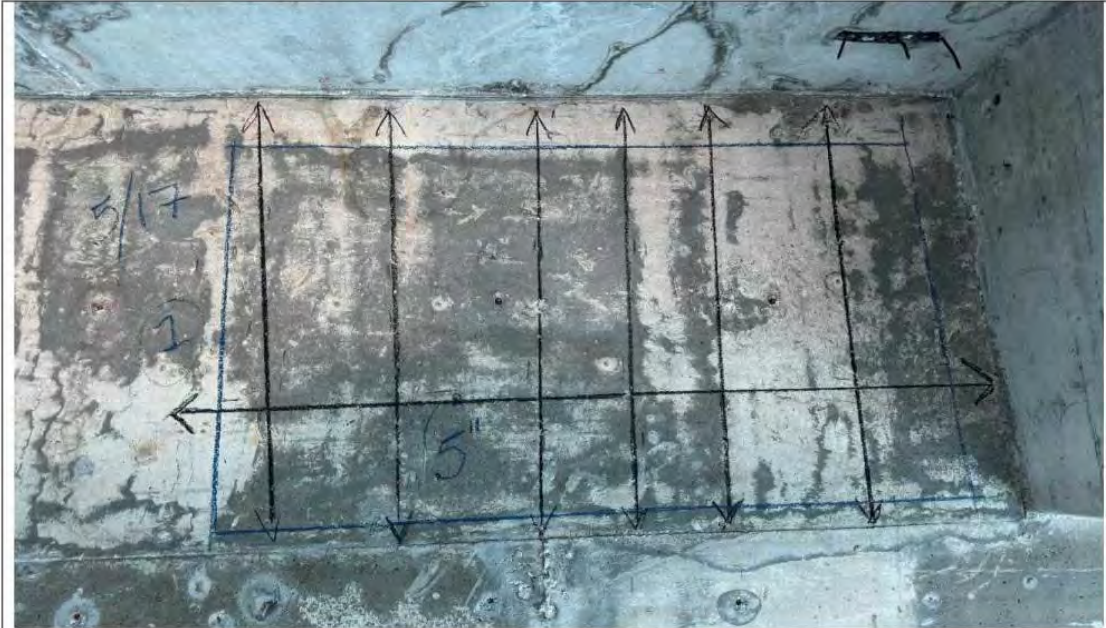
Location:	Column 4, 3 rd Floor
Comments:	The beam above column 2 was about 24" thick. The Mini XT was about to see about 10" deep. Vertical rebar was recorded to 6"-7" deep. A horizontal rebar was found about 5" deep. More rebars may be present past the depth of 10"

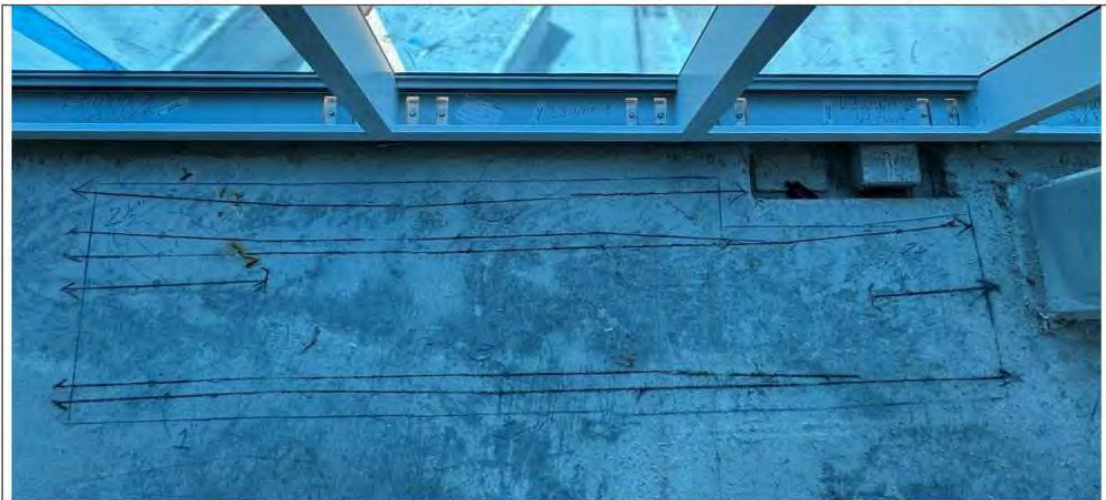
Location:	Behind column 4, 3 rd Floor
Comments:	About 5 horizontal rebars can be seen ranging at depths of 1.5" to 2.5" deep.
