***Tree Resource Evaluation for a Samanea
saman located on the property to the east
of 408 SW 4th Avenue, Ft. Lauderdale***

May 20, 2021

Summary

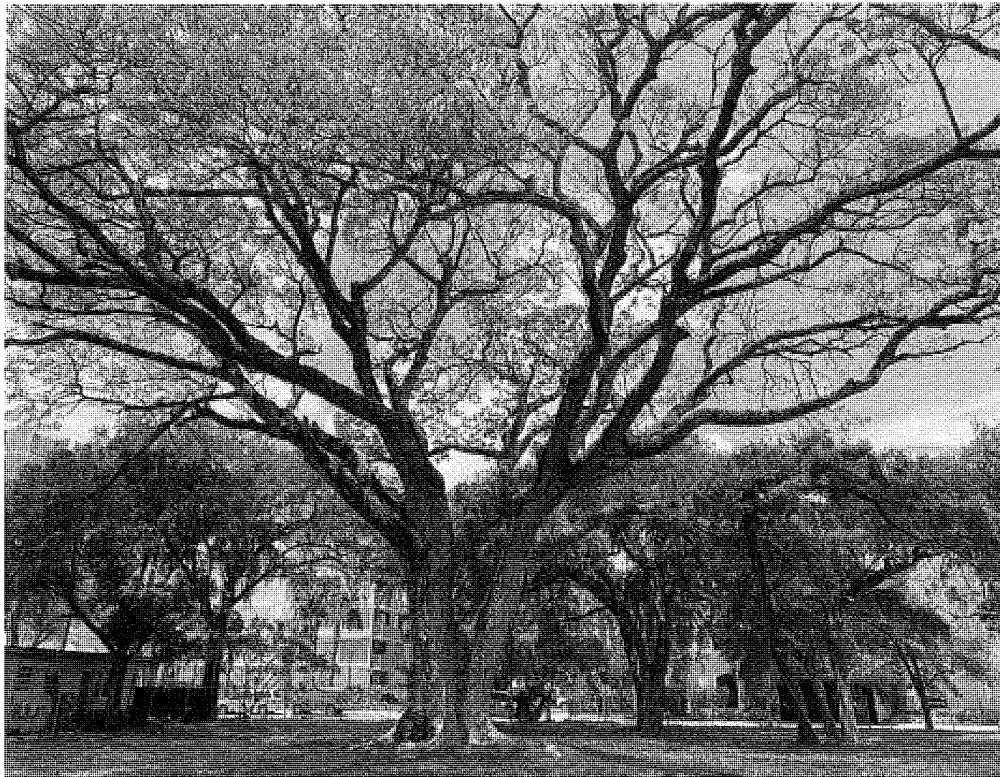
There is some dead wood in the canopy that should be removed if any work is to be performed underneath or near the canopy of this tree. The dead wood/branches that I noted in the lower canopy are normal as the tree will shed branches that are being shaded-out by the upper canopy.

Photo 1 above is the rain tree viewed from the east. There are some dead branches in the lower canopy. This is a normal shedding of lower branches that are being shaded-out by the upper canopy. If any work is to be performed beneath or near this tree, any dead wood in the canopy should be removed.

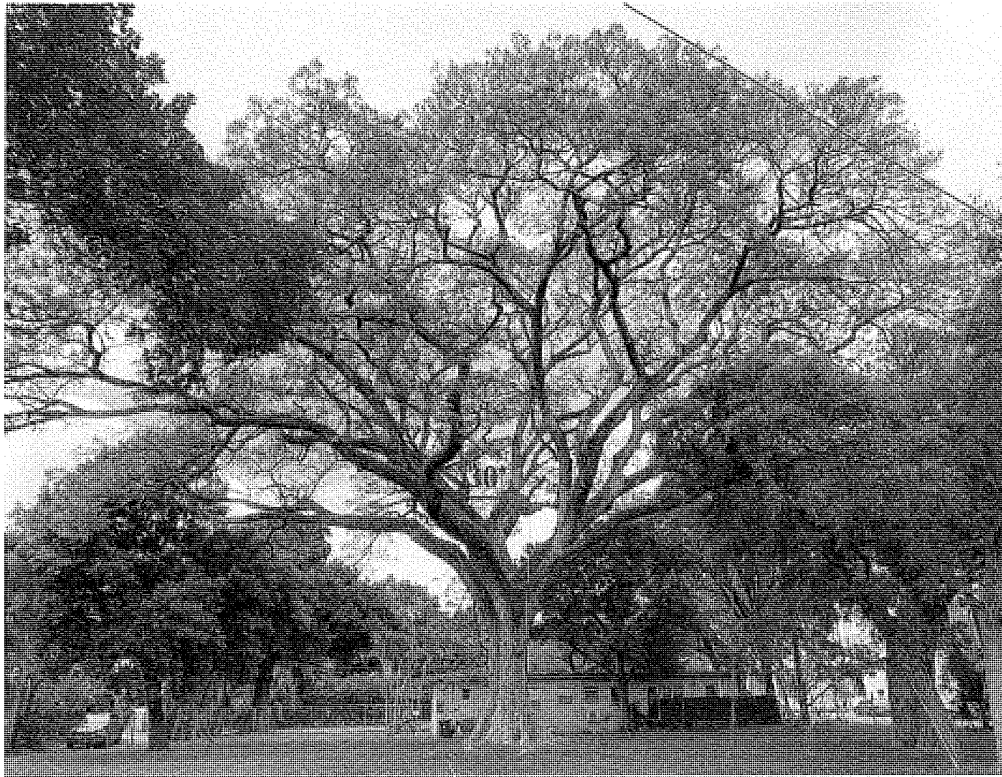
Photo 2 above is the rain tree viewed from the north. Note the yellow measuring pole indicating an approximate height of 30 feet.

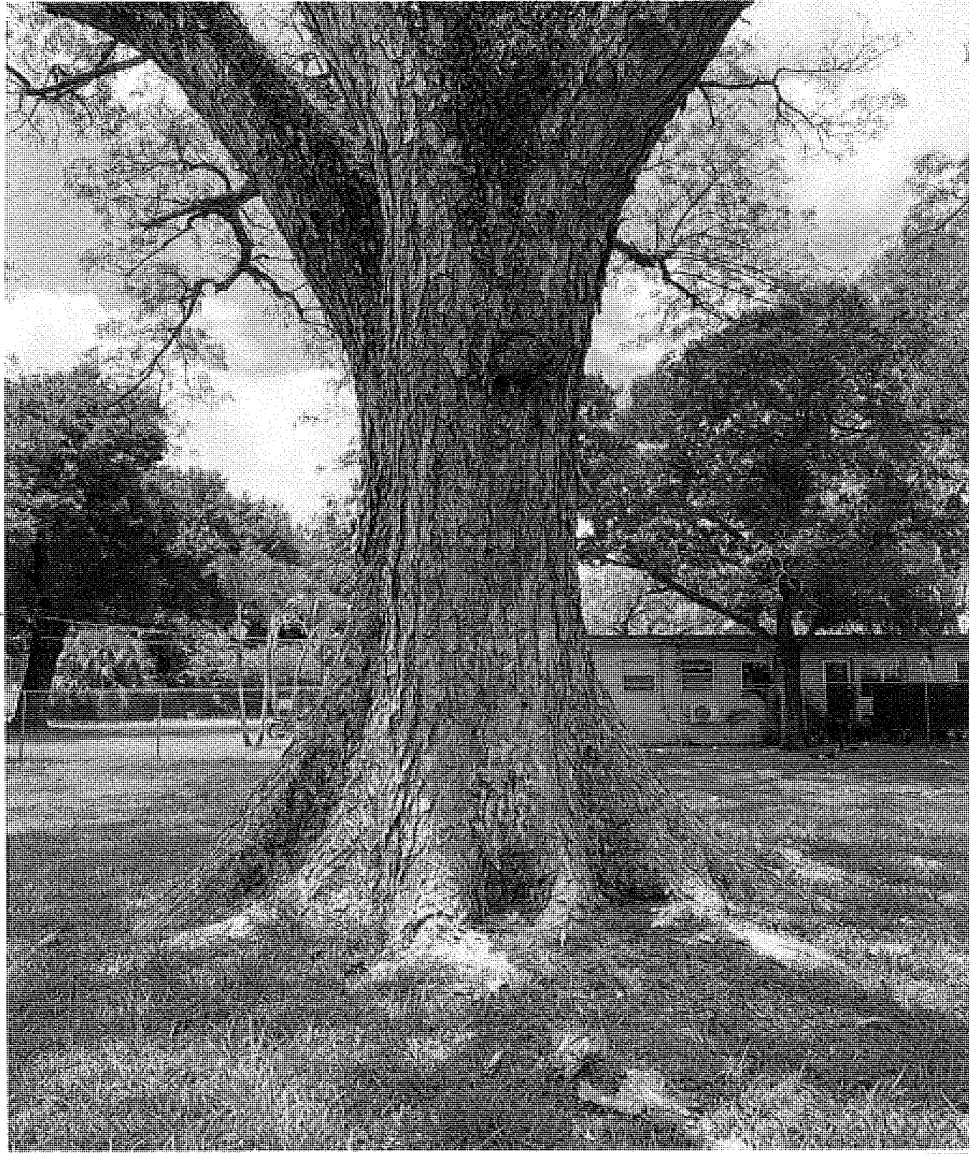
There is the appearance of sections of the bark sloughing-off the trunk. This is a normal characteristic this species and not a sign of poor health or vigor.

Photo 3 above is the north side of the trunk with no signs of cavities, fungal fruiting bodies, or decay noted. Sections of bark that appear to be sloughing-off the trunk is a normal characteristic for this species and not a sign of disease or poor vigor.

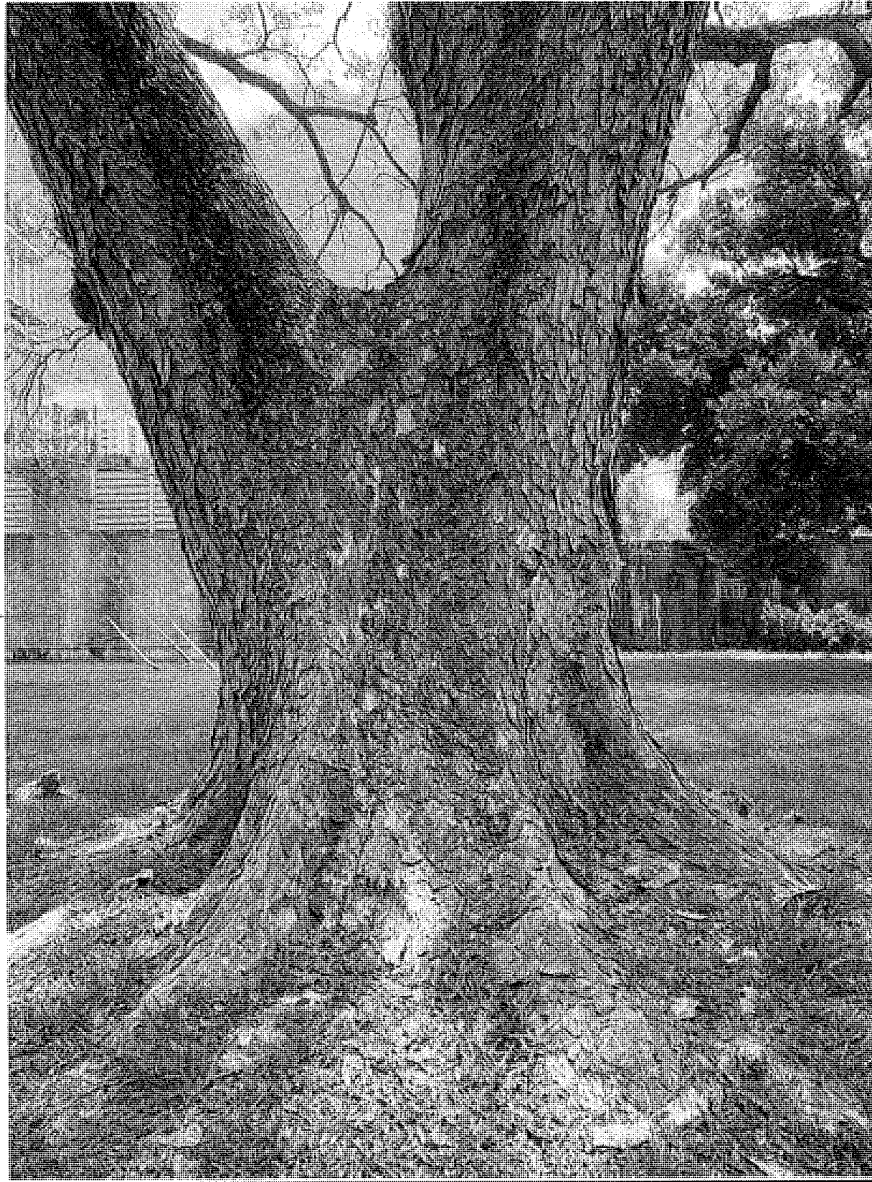
Photo 4 above is the west side of the trunk with no signs of cavities, fungal fruiting bodies, or decay noted.

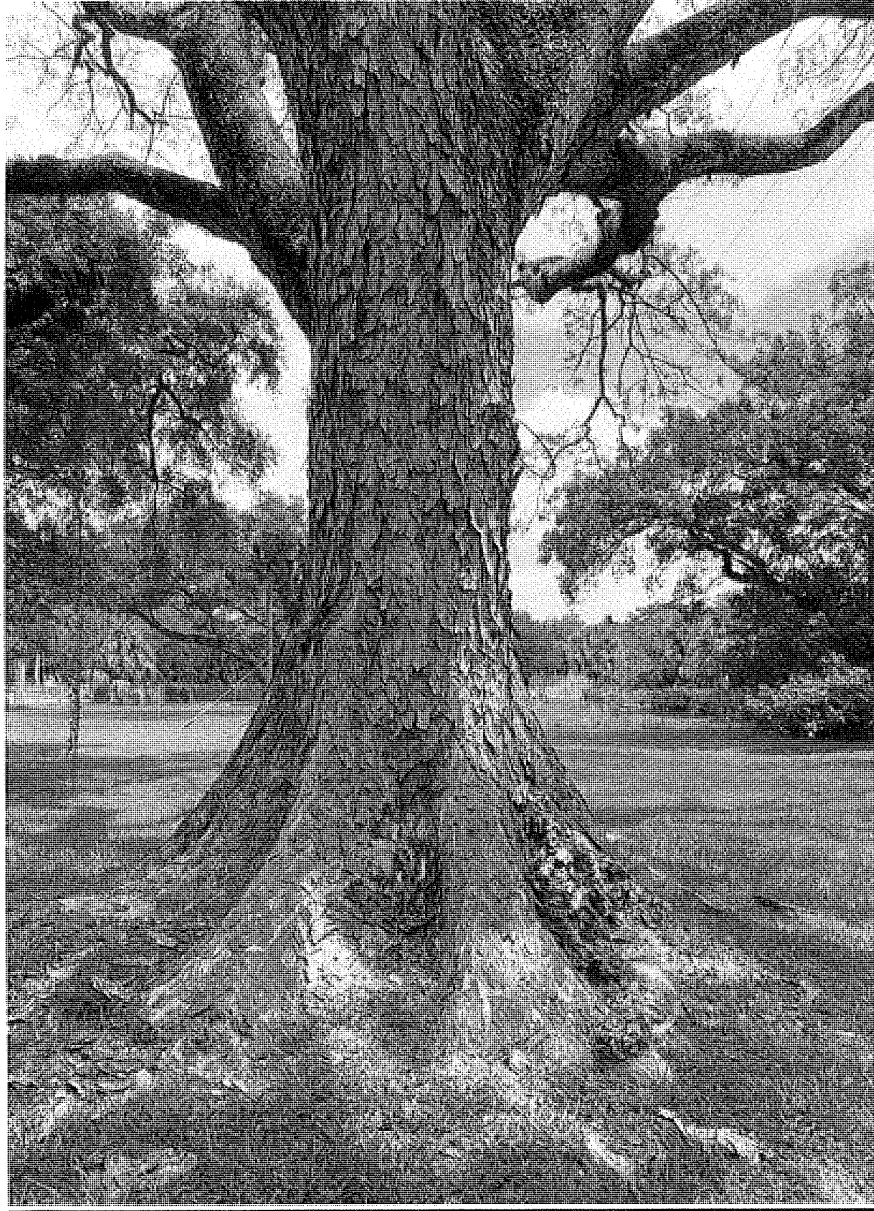
Photo 5 above is the south side of the trunk with no signs of cavities, fungal fruiting bodies, or decay noted.

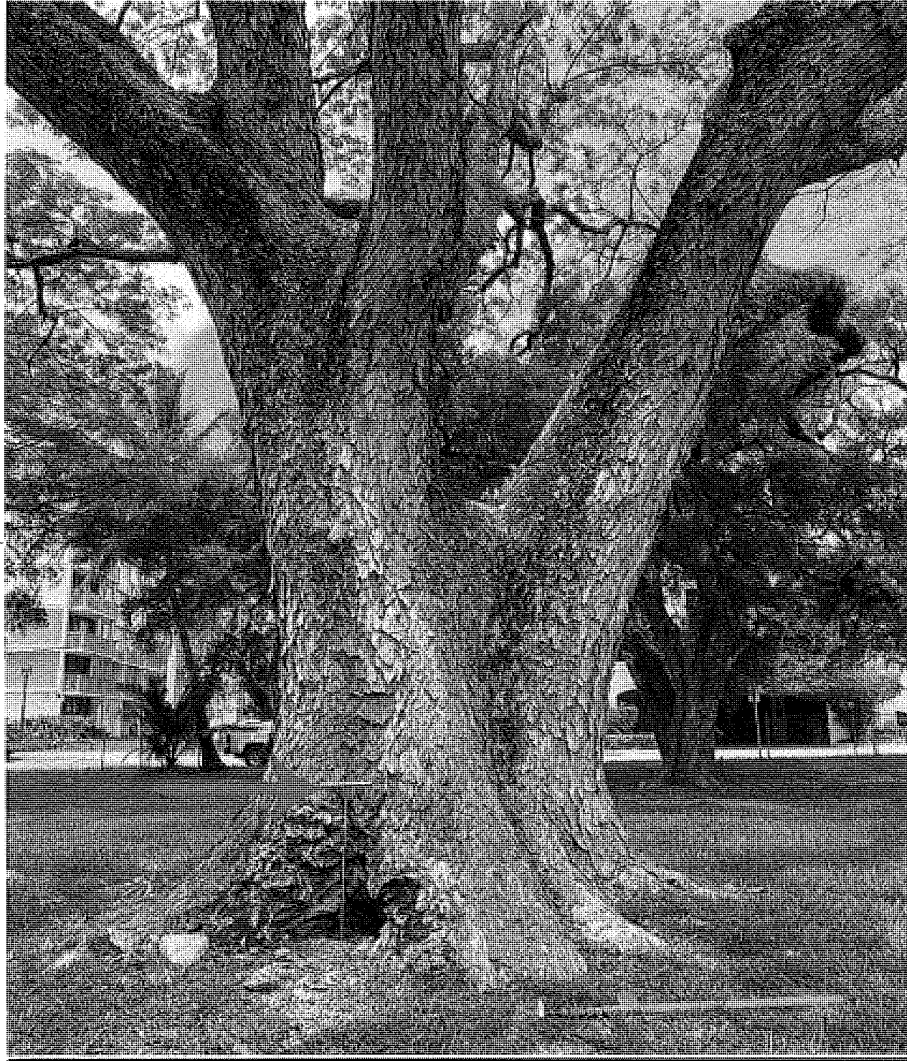
I have rated this tree to be in moderate condition due to a cavity at the root collar on the east side of the trunk. This cavity has not appeared to have any changes or grown larger since the last time I inspected the interior of the cavity in February 2018.

Photo 6 above is the east side of the trunk with a small cavity at the trunk base/root collar. The arrow indicates a steel spike that I utilized to probe the cavity to determine if there was active decay inside. This spike is 40 inches tall, and the handle is 12 inches wide.

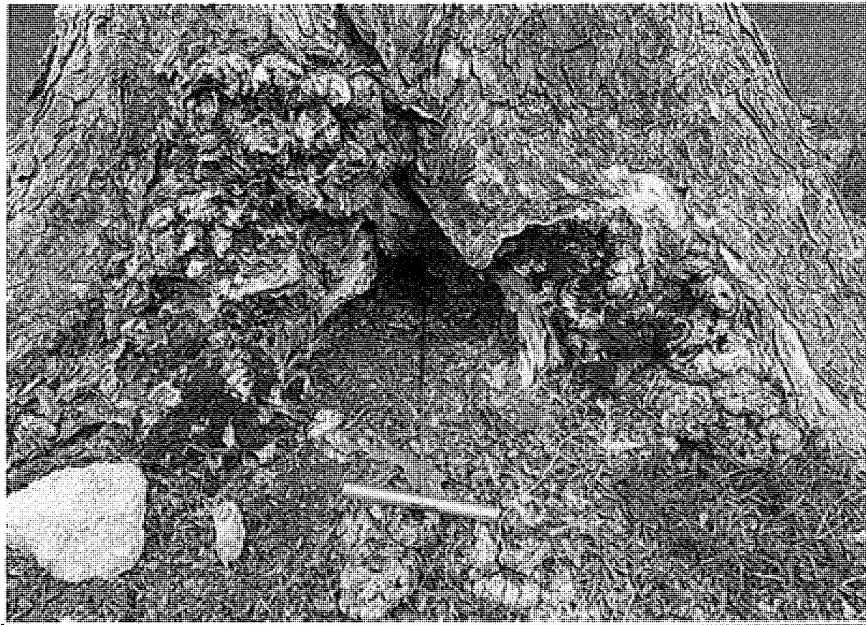
Photo 7 above is the steel spike inserted into the cavity. As I probed the sides and top of the cavity, I was unable to insert the spike into any soft wood that may be decaying. The top and sides of the cavity was very hard showing no signs of active decay.

I had previously inspected this tree, and the cavity, in February 2018 and could note no changes in the size of the cavity or the exterior wood characteristics.

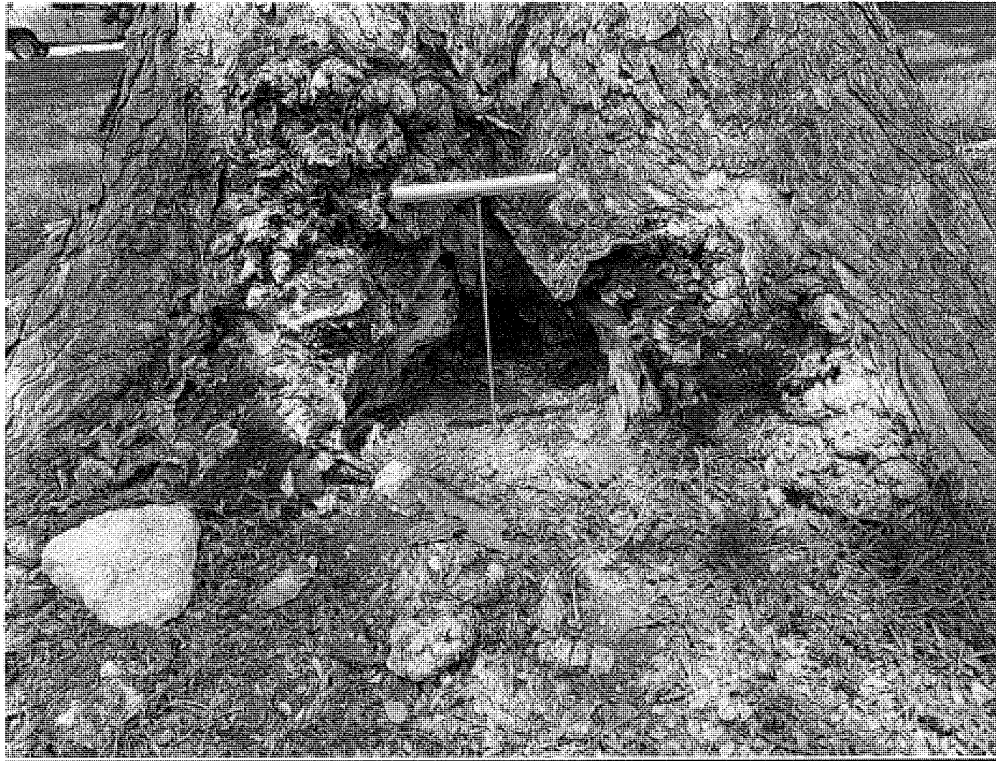
Photo 8 above is the steel spike inserted into the ground approximately 18 to 20 inches. The spike stopped moving downward due to what felt like hard wood.
