CITY OF FORT LAUDERDALE AQUATIC CENTER

FACILITY ASSESSMENT REPORT

March 28, 2016

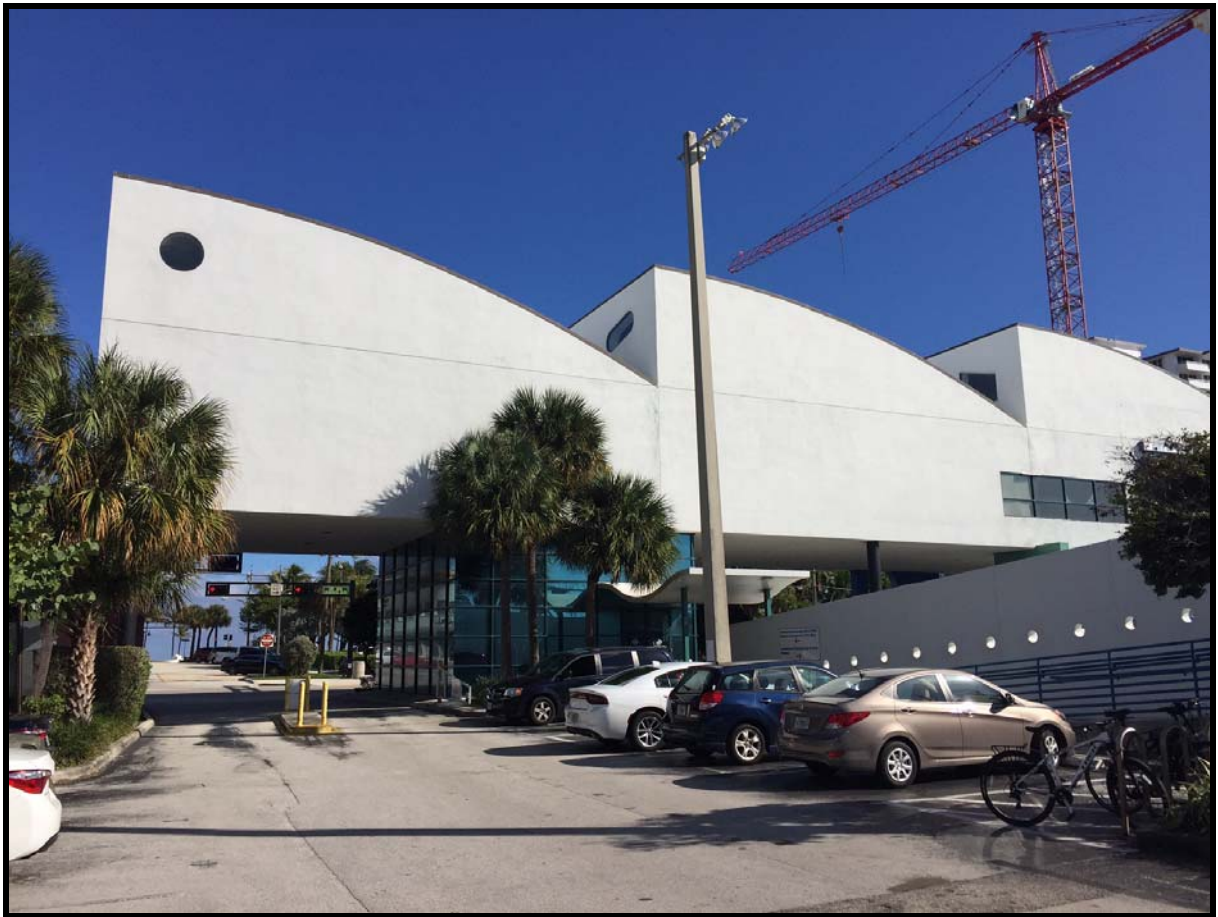
Figure 6 Building 1, west elevation showing drive through entry and gift shop below

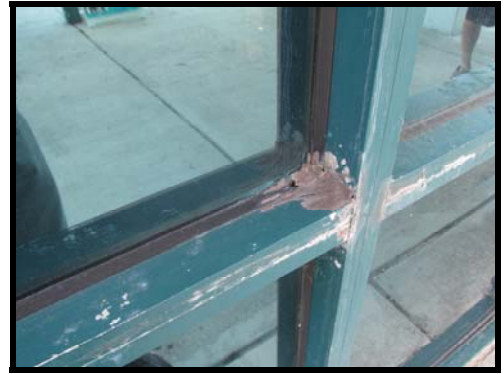
The entry to the gift shop has storefront aluminum doors which are in poor condition, due to age and proximity to the ocean environment. The aluminum appears rusted at corners. Existing door hardware is also in poor condition. The hinges have been replaced but have since rusted. There are holes in the frame where the previous hinges were installed.

Figure 12 Exterior gift shop, patched corner of rusted storefront window frame

The aluminum needs to be refinished, holes patched and painted. Hardware needs to be replaced.

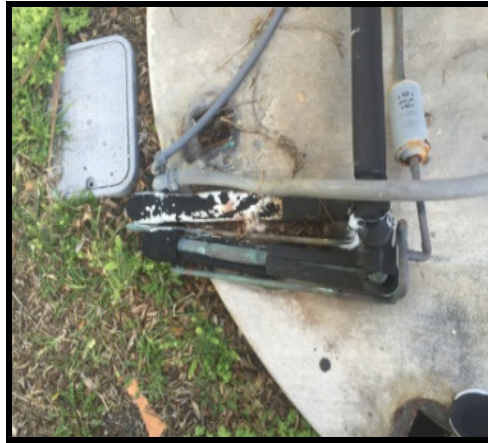
Figure 28 Refrigerant piping missing

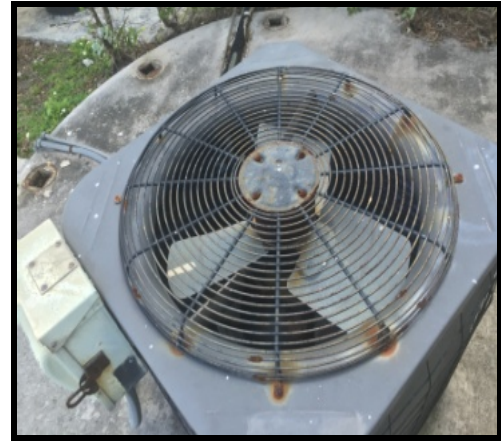
- 1) Location: Ground Level, Exterior South Side
 - 2) Criteria: Industry Standard.
- d. There are three existing condensing units located on the north side of the building. One of the units is a residential type condensing unit in the 2-5 ton range and the other two condensing units vary from 10 to 15 tons (nameplate data is either missing or weathered and not legible). Visually, the equipment appears to be in poor condition due to age and weathering. Refrigerant piping insulation is missing as well. Remaining useful life for these condensing units is approximately one to two years.

Figure 29 2-5 ton condensing unit, worn and rusting

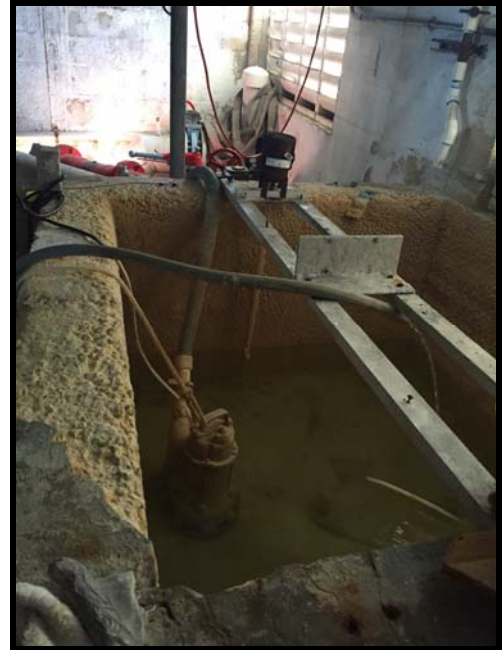
The interior walls are covered with gypsum and plaster. In these areas there are no cracks. However, in the areas with exposed concrete block, specifically in the pool filtration/equipment room where the water is treated, the concrete walls and floor are badly deteriorated from the chemical used throughout the years.

Figure 37 Interior pump room, chemicals deteriorating concrete

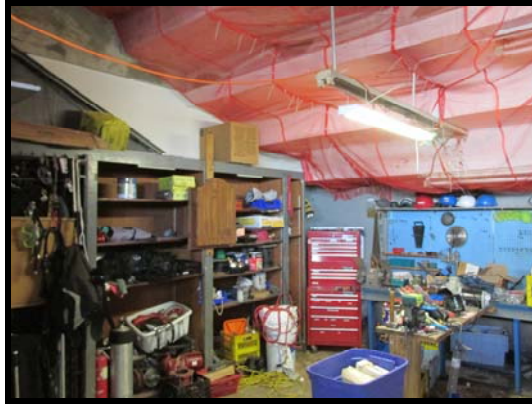
- g. Ceilings: Interior ceilings are plaster in some areas which appear to be in good condition. There are no cracks or water stains. In the areas where the ceiling is exposed to the concrete slab above, the concrete is spalling, cracked, chipped and falling off revealing rusted rebar underneath. It is the poor condition of this structural roof that has caused the building to be condemned by the city.

Figure 38 Interior maintenance/storage area, safety netting installed to prevent concrete falling on occupants. Hard hat area.

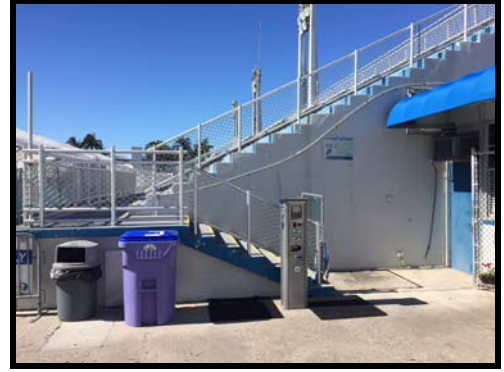
- 1) Main grandstands (bleachers): The concrete stairs and ramps appear to be in poor structural condition. The ramps are too steep for ADA accessibility. Currently the bleacher area does not provide any ADA accessibility or seating area. An exterior lift or ADA ramp, for example, would need to be installed to provide access. The bleacher area was not evaluated as the area was fenced off for safety and could not be accessed. Based on the poor structural condition of the bleachers, they must be fully removed and replaced.

Figure 41 Exterior access to bleachers, showing inadequate railings and no ADA access.

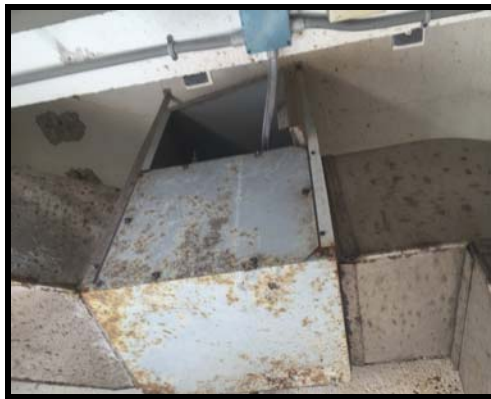
- a. All exhaust ductwork is rusted and in poor condition

Figure 42 rusted ductwork

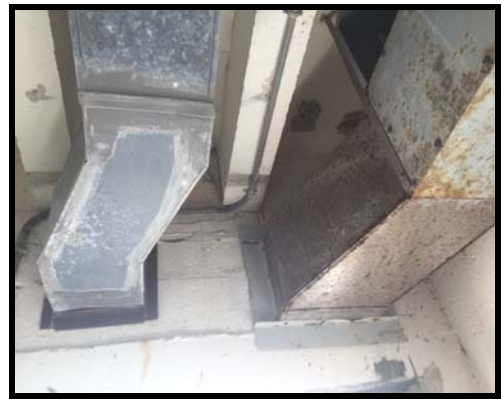
Figure 43 rusted ductwork

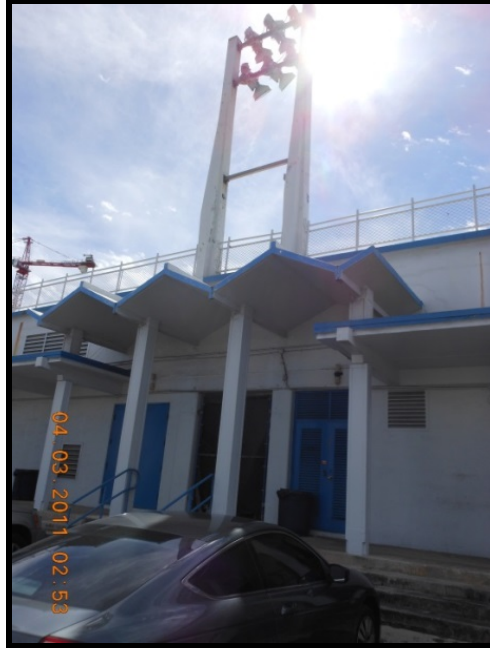
- a. The building, in general, is in poor condition. Two major FPL vaults are inside this building and extra planning on how to repair their structure needs to be well coordinated with FPL Company and the owner, as there are other buildings in the complex that shall remain powered from these vaults. Also, special coordination needs to be made with building personnel in order to maintain operation of a main pool equipment area during the building reconstruction.
 - 1) Location: 1st and only floor.
 - 2) Criteria: Safety hazard.
- b. The building has 3 main sport lighting structures that contain old technology lighting fixtures that are not energy efficient, provide light pollution and may not be turtle friendly. See picture, from observation 1, for existing structure example.

Figure 46 sport lighting structure and doors to FPL vault below

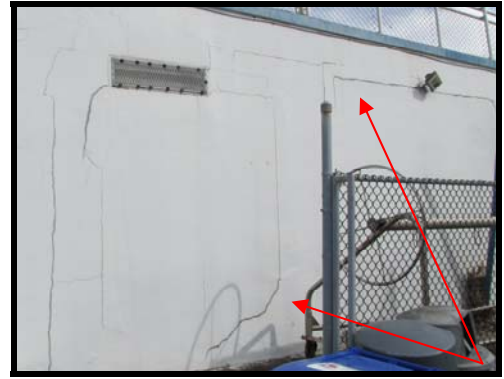
Figure 56 Building 3, south wall cracks along entire wall

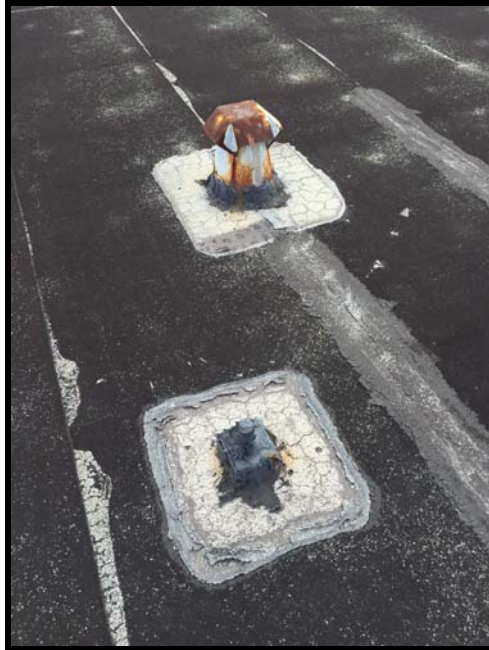
The observation deck which serves as the roof to the first floor is a built-up roofing system over 1 ½” rigid insulation board on precast concrete slabs. The roof membrane is in poor condition and the sealants and membrane is cracking. The roof is original to the building which was built in 1965.

Figure 57 Roof of Building 3, showing cracked sealant around penetrations as well as between roof membrane pieces

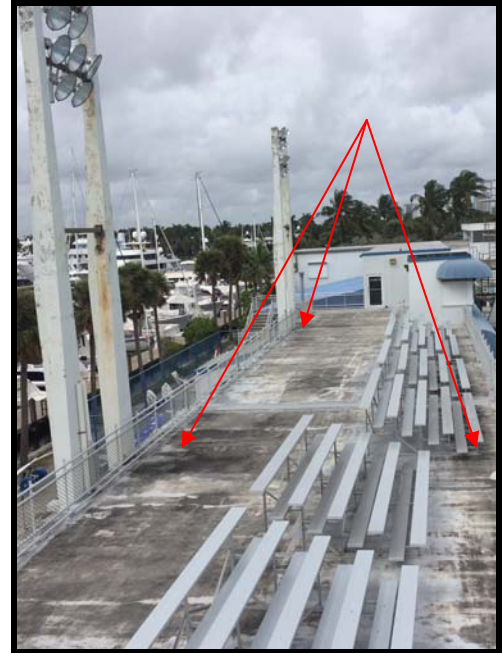
Figure 58 Observation deck between Buildings 3 & 4, showing dark spots indicating pooling of water and water damage

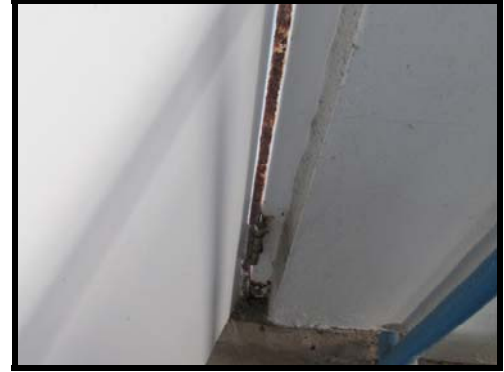
Figure 60 Exterior door on west side of Building 3 going into women's locker room, showing rusted door frame

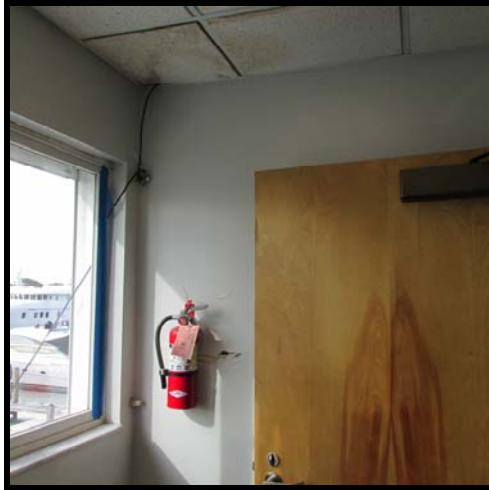
Figure 63 Building 3 window, top of stairs, water intrusion at window, ceiling and wall behind fire extinguisher

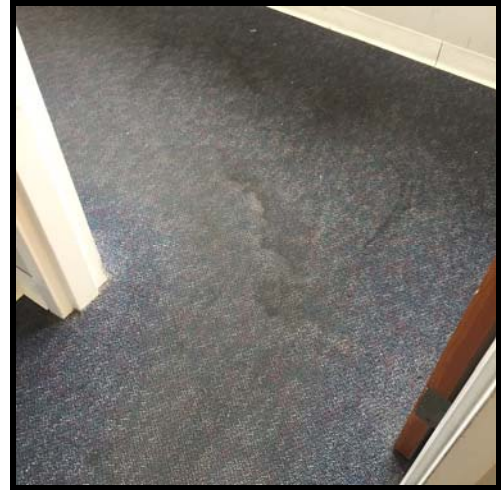
Figure 64 Building 3, top of stairs, water damage from window and roof

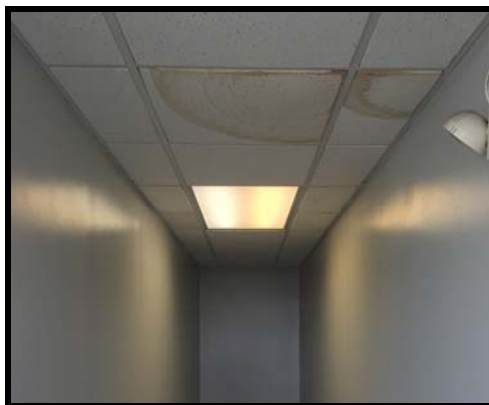
Most of the ceilings are drop down ceiling grid with acoustical tiles or metal tiles. There is evidence of water damage on the ceilings throughout both buildings. Some of the water stains on the ceiling tiles appear to have mold growth which needs to be remediated properly.

Figure 65 Ceiling above stairs in Building 3 showing water damage

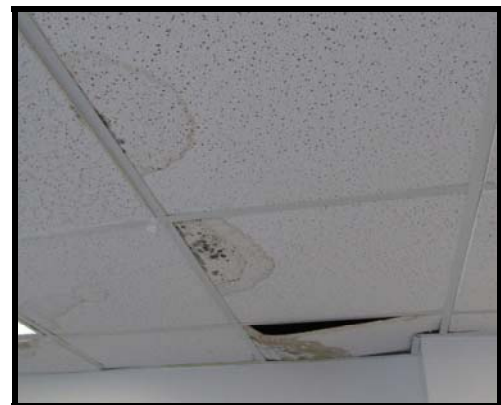
Figure 66 Building 4, meeting room ceiling on first floor, water damage and mold

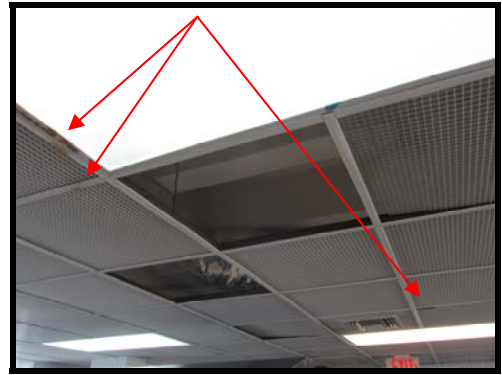
Figure 68 Building 3 men's locker room showing rusted grid and broken ceiling tiles

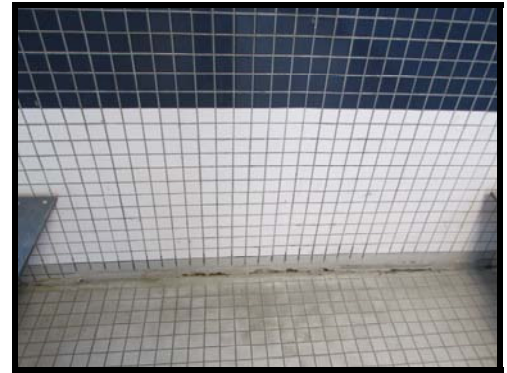
Figure 70 Building 3, men's locker room, cracked and deteriorating sealant

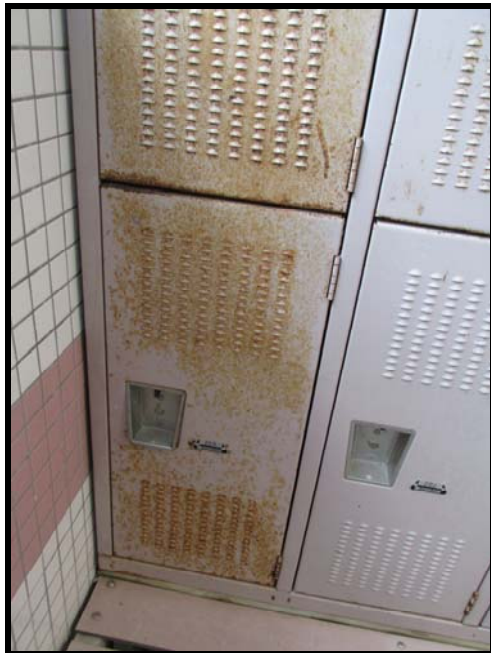
Figure 71 Building 3, women's locker room, rusted lockers

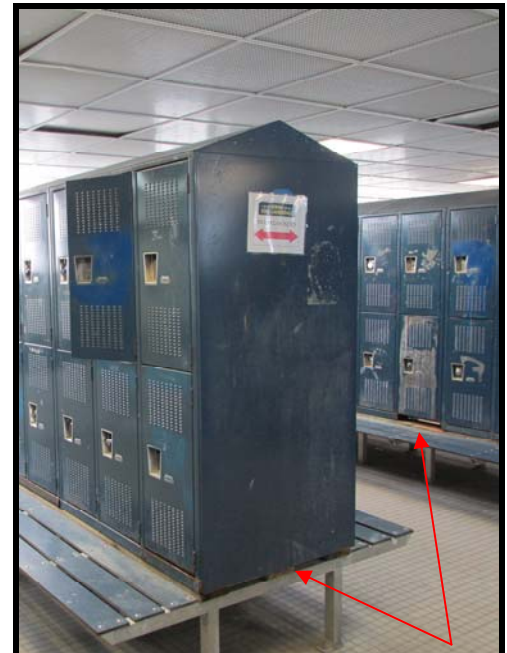
Figure 72 Building 3, men's locker room, rust along the bottom and work locker doors, sides and benches

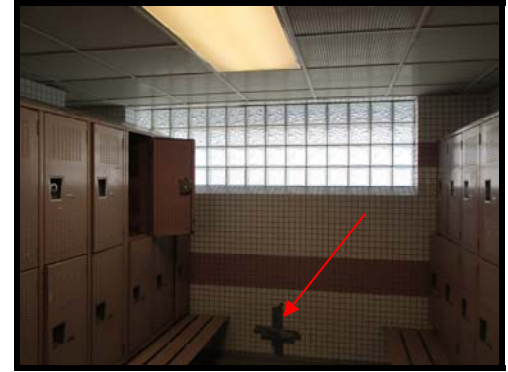
Figure 74 Building 3, women's locker room, broken wall tiles that were taped

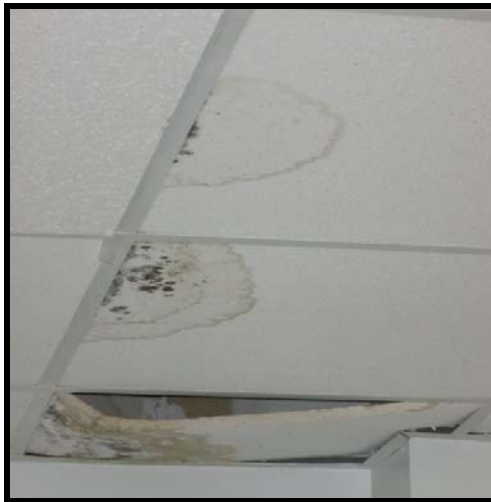
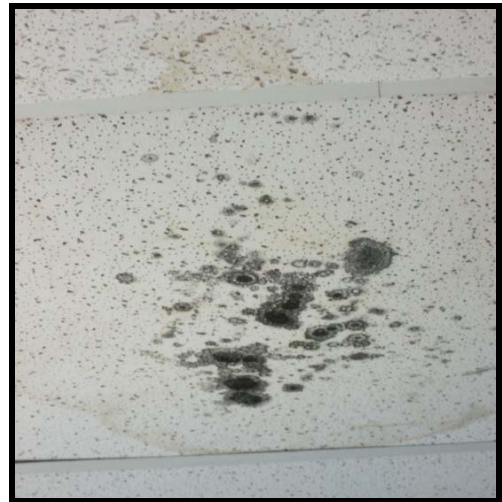
c. Visible leaking of condensate piping above ceiling. Ceiling is showing signs of water damage and mold. Photographs below are of the damaged ceiling tiles.

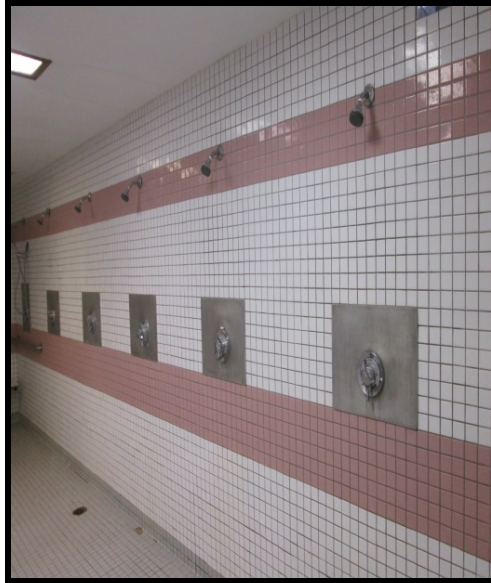
Figure 113

d. Men and Women's Bathrooms and Shower: Gas Water Heater (Bradford White Magnum model # D65T3703N, 1965), water closets, showers and floor drains are showing signs of age and are deteriorated. See photographs below.

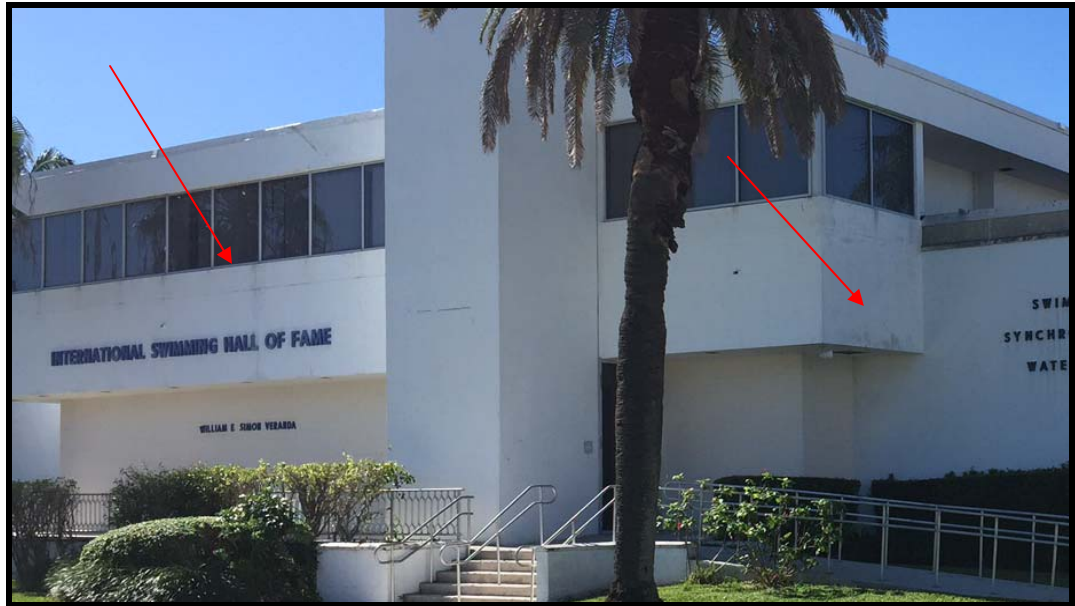
The majority of the masonry walls and concrete tie beams seem to be good condition with exception of the areas under the windows. The stucco is cracked or bubbling and the paint is peeling indicating water damage. Further investigation is needed to determine if the damage is structural. Destructive testing and analysis would be required to gather more definite information for each component.

Figure 116 View of west elevation of Building 5, showing cracks, chipped paint and water damage under windows

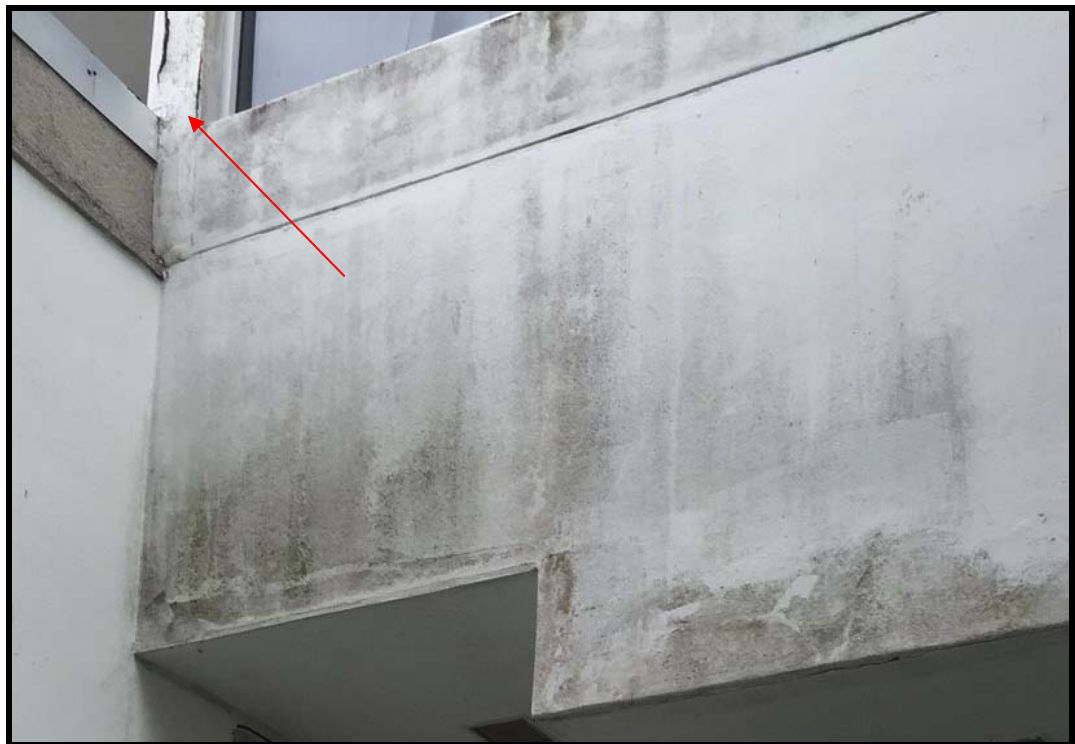
Figure 117 Exterior of Building 5 at northwest exit stair, showing cracked and deteriorating stucco allowing water intrusion

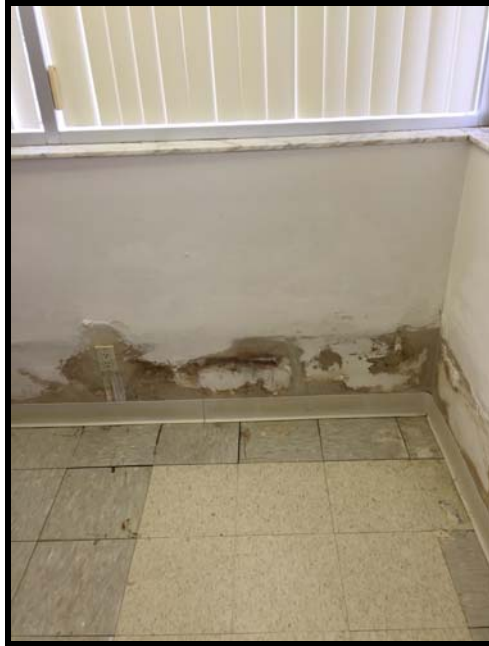
The interior walls are covered with gypsum, plaster and tile. In these areas there is severe water damage.

Figure 118 Second floor lunch room, southwest corner, showing severe water damage to wall and floor, rot and mold

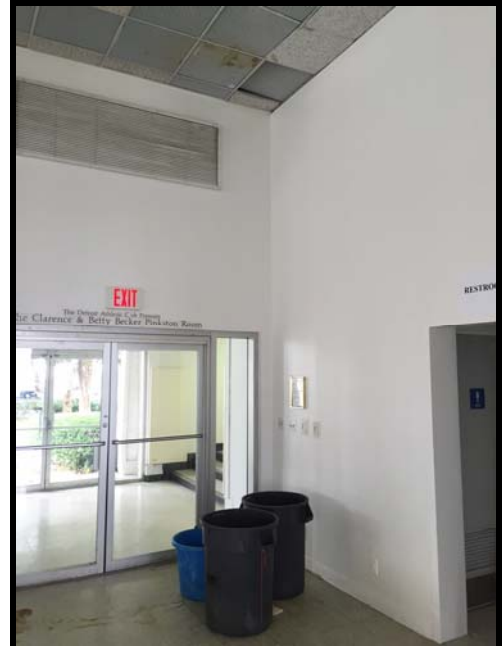
Figure 119 Northeast corner of banquet hall showing major roof leaks leading to the closing of the space to the public

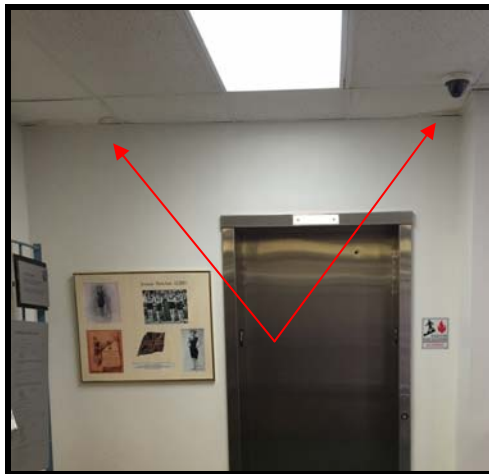
There is also water damage on the ceiling adjacent to the elevator tower on the first and second floors. This is most likely from the roof material deteriorating allowing water penetration. The roof should be replaced.

Figure 126 Second floor elevator lobby indicating water damage to ceiling tiles from roof above

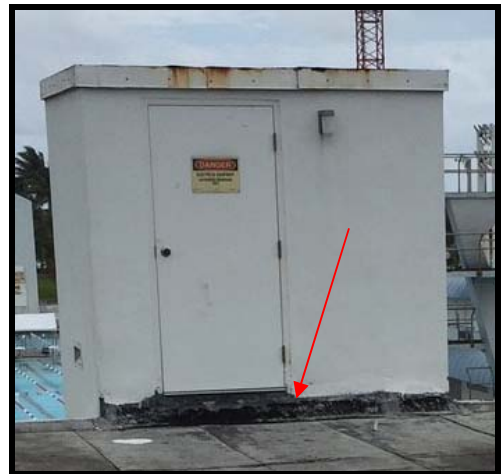
Figure 127 Deteriorating roofing material at elevator tower causing leaks and water damage below

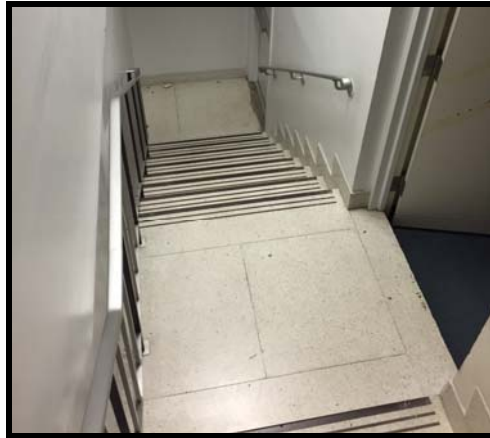
- 1) Stair railings: Several stairs throughout the building do not comply with the Florida Building Code, such as the height, width between rails and extension beyond the landing. The railings should be replaced with new that meet required codes.

Figure 128 Stairs from office and mechanical room to outside. Railings do not comply with Florida Building Code

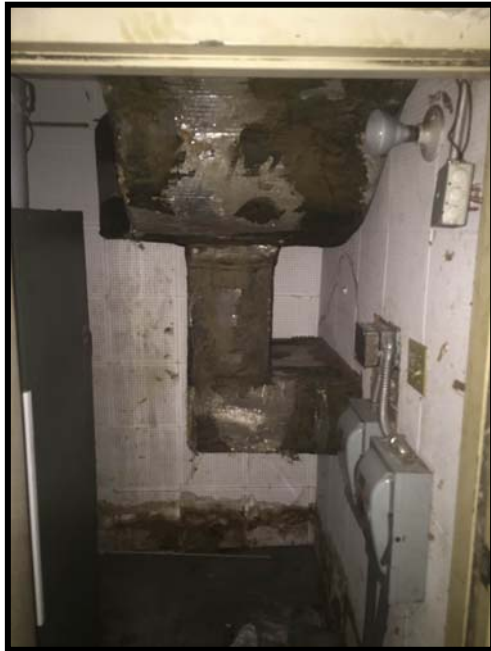
- a. Existing exposed ductwork in mechanical above banquet hall restrooms is leaking, damaged and uninsulated. Some of the ductwork is below the code required height.

Figure 130 low ductwork in mechanical space above restrooms in banquet area

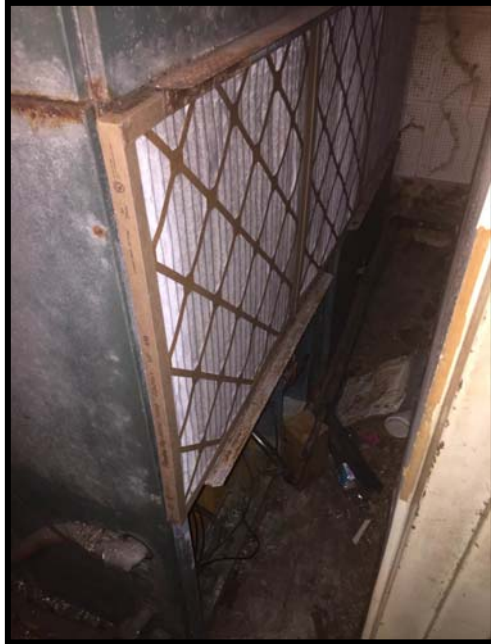
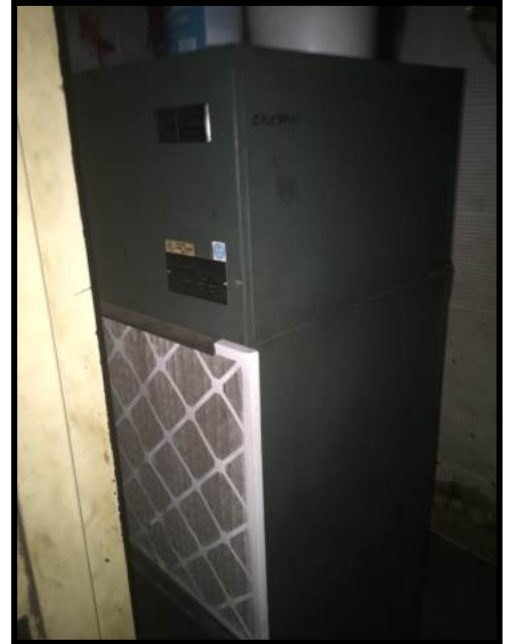
- b. Maintenance clearance for existing heat pump units is minimal. Heat pump units shall be provided with maintenance. The existing units vary in capacity from 5-10 tons. The remaining useful life expectancy is 2-3 years.

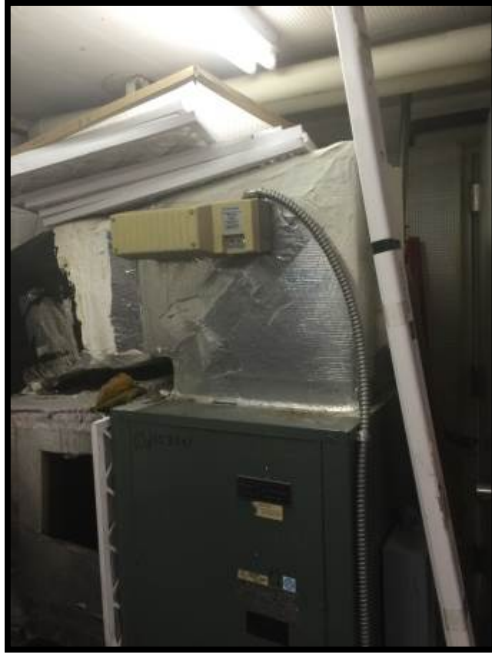
Figure 136

- 1) Location: 2nd Floor
 - 2) Criteria: Code Violation and industry standard.
- c. Remaining heat pumps on the 2nd floor: Maintenance clearance for existing heat pump units is minimal. Heat pump units shall be provided with maintenance. The existing units vary in capacity from 5-10 tons. The remaining useful life expectancy is 2-3 years.

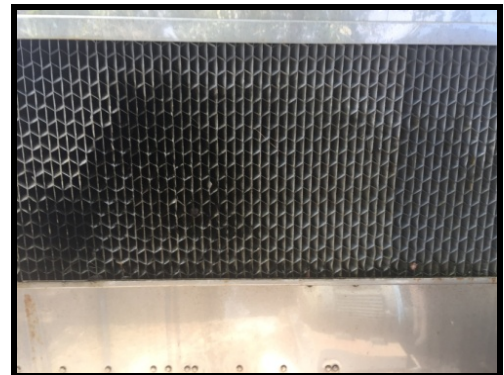
Figure 143 cooling tower beginning to rust

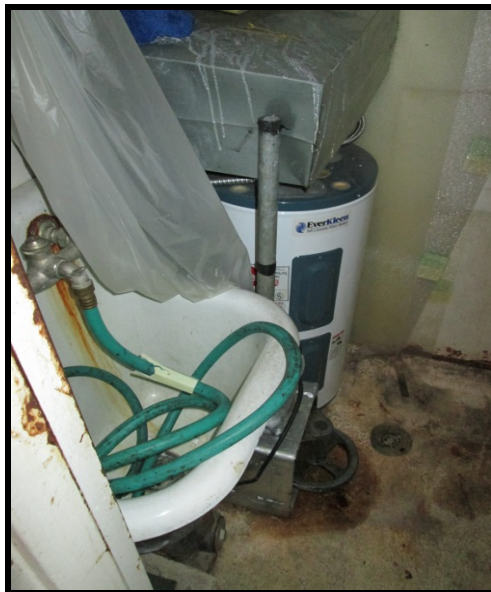
Figure 148

- a. Public Bathrooms (Men’s and Women’s): Toilets, lavatories, urinals, the water heater and the electric water cooler are showing signs of age and are not water efficient by current standards. Photographs below show current condition of plumbing fixtures (piping is not accessible).

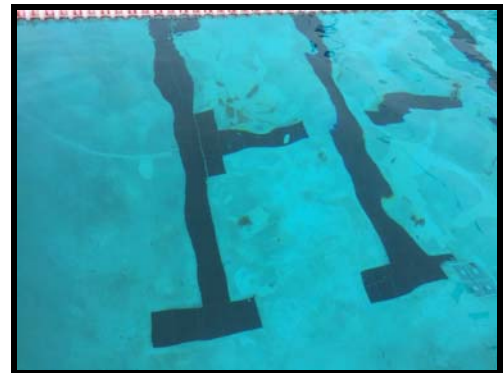
Figure 154 Worn grout lines and interior pool plaster

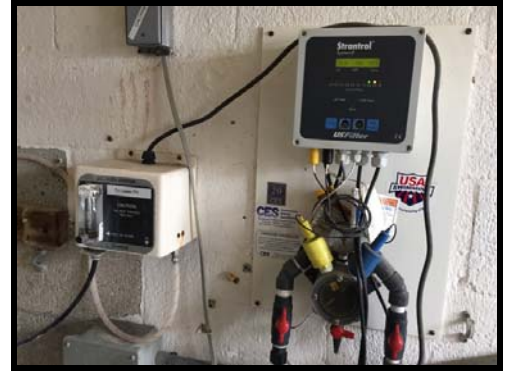
Figure 160 Circa 1994 controller is in need of repair or replacement, and does not provide the control features required in a 50-meter pool facility

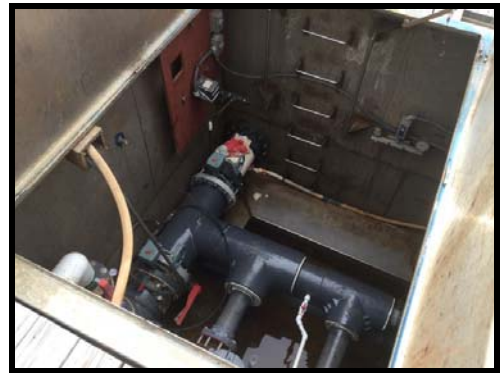
Figure 165 Training pool filtration system vault, Circa 1990 is functional but has some code compliance, safety and operational issues that need to be addressed

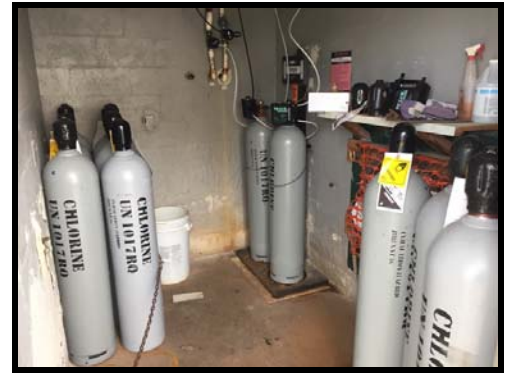
Figure 176 Gas Chlorination system is very dangerous to operators and patrons alike and should be either replaced or outfitted with scrubbers, etc. Staff certification for gas is minimal and should be revisited ASAP.

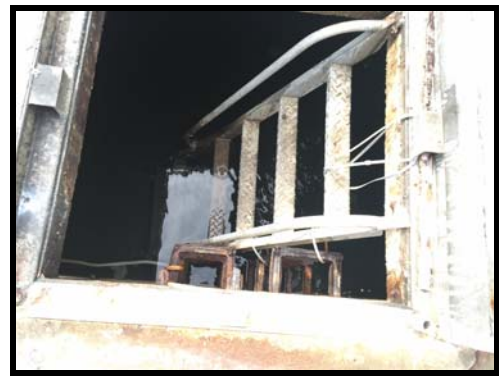
Figure 181 Ladder into dive observation room, corroded and filled with water

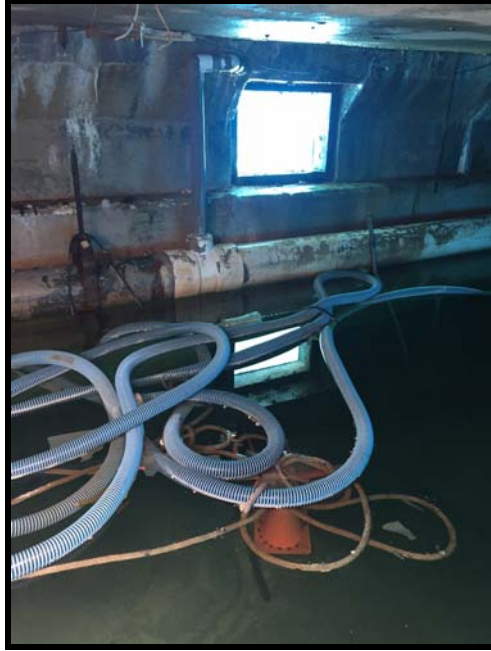
Figure 182 Underground view of competition pool window, room filled with water

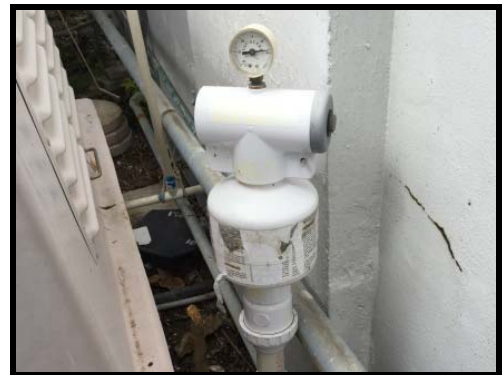
Figure 189 Some of the units have been retrofitted to comply with recent Federal Guidelines such as the direct suction line which now includes the use of a “Vac-Alert” anti-entrapment device

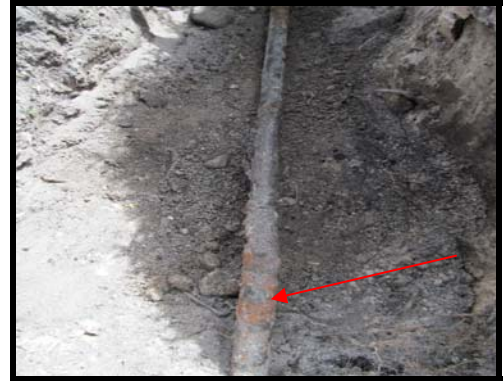
Figure 200 Tie back: exposed section of seawall tieback, condition of steel is very good, slight section of rust which was directed to be re-coated
