NOTICE OF FINAL PUNCH LIST AND DEFECTIVE ITEMS

Project Name: SW 2nd Avenue Median Parking

Project #: 12381

FINAL SITE INSPECTION REPORT

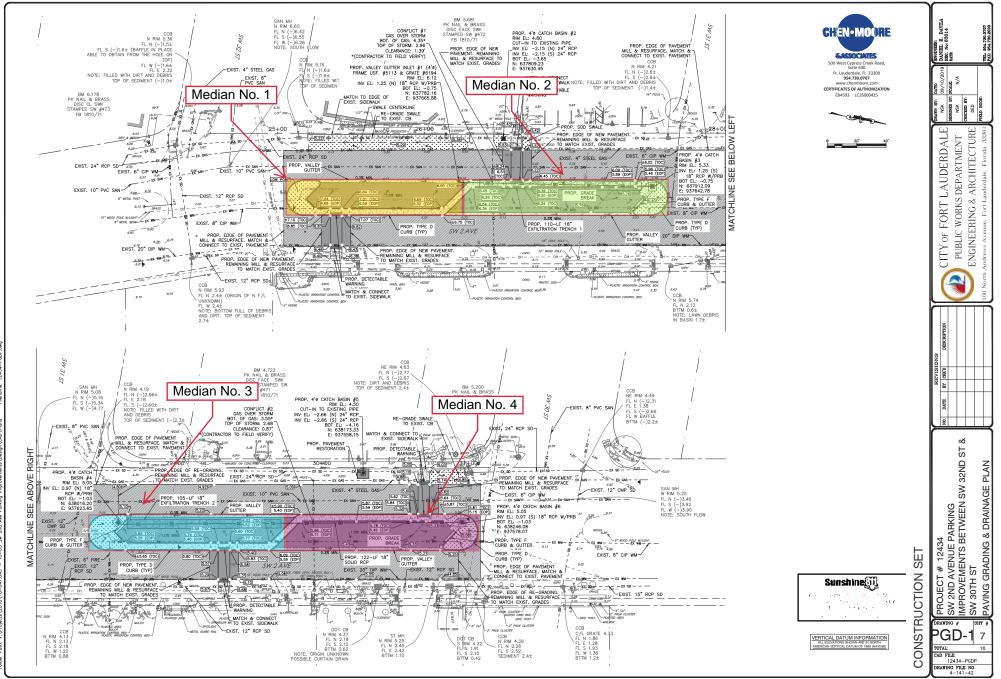
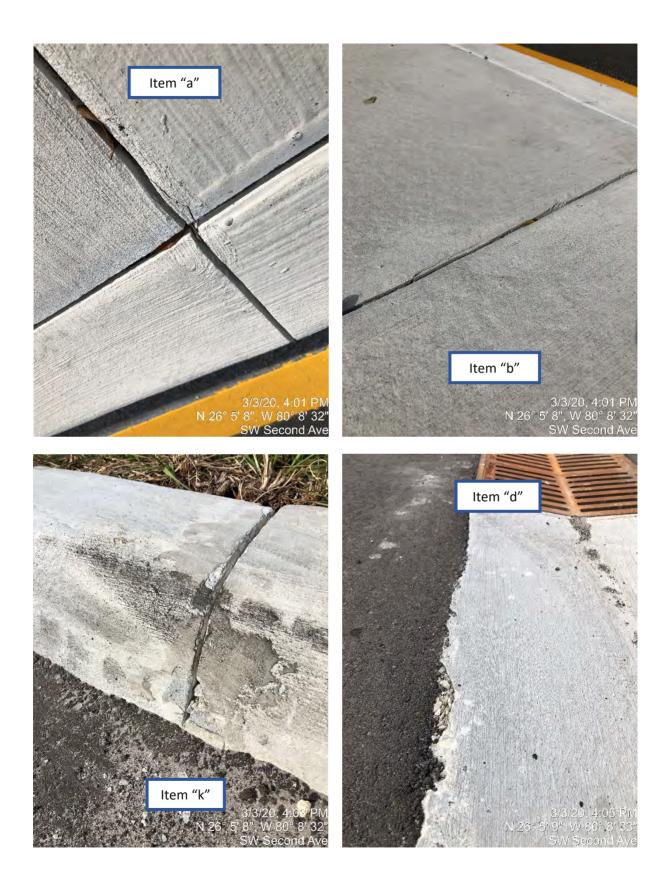
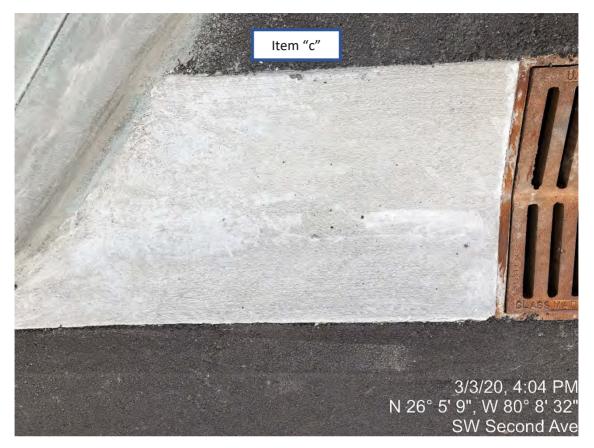
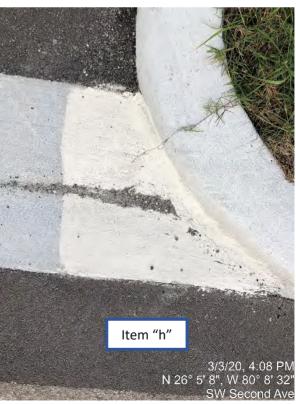
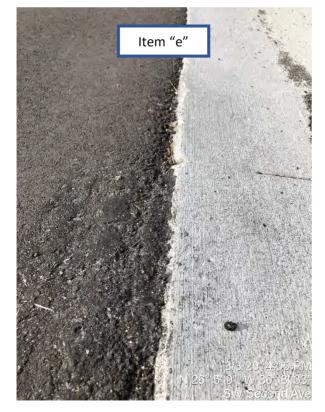
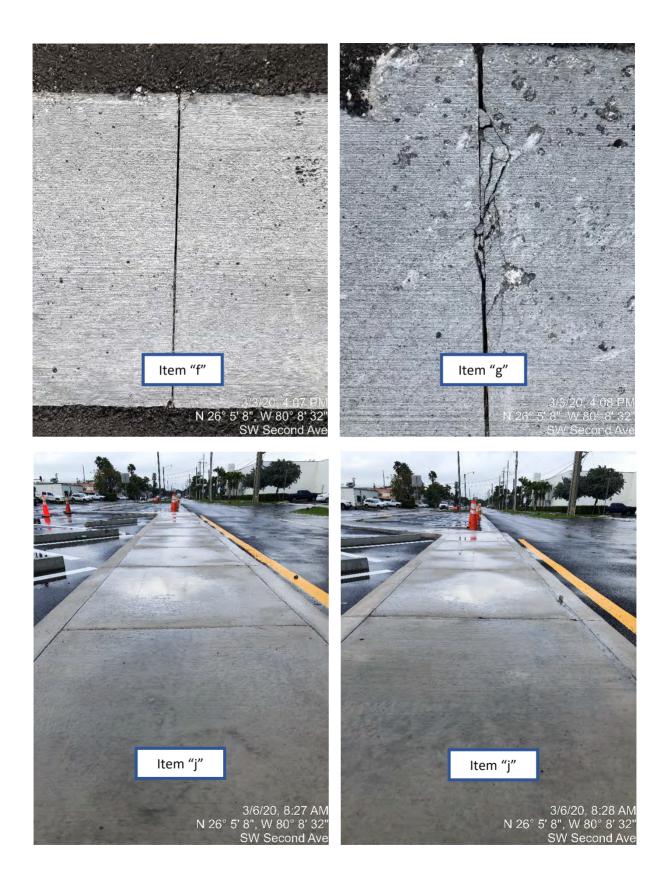
Median No. 1 (STA 25+05 - STA 26+30)

- a. Crack(s) recorded at Concrete Sidewalk STA 25+64 (4th joint North of ADA detectable warning surface).
- b. Crack(s) recorded at Concrete Sidewalk STA 25+69 (5th joint North of ADA detectable warning surface).

- c. Grinding of concrete at Valley Gutter STA 26+26 (North of catch basin No. 1 inlet).
- d. Crack(s) recorded at Valley Gutter STA 26+19 (South of catch basin No. 1 inlet).

- e. Deficient Valley Gutter Concrete/Asphalt interface STA 25+92 (3rd joint South of inlet of catch basin No. 1).
- f. Crack(s) recorded at Valley Gutter STA 25+39 (1st joint from South to North).

- g. Crack(s) recorded at Valley Gutter STA 25+49 (2nd joint from South to North).
- h. Joint missing and crack(s) recorded at Valley Gutter STA 25+30 (convergence of Valley Gutter and Type F Curb).

- i. Incorrect jointing pattern recorded on Concrete Sidewalk STA 25+25 to 26+33 (entire median).
- j. Ponding recorded on Concrete Sidewalk flags No. 1, No. 4, and No. 9 from North to South (STA 26+10, STA 25+95, and STA 25+35 respectively).

- k. Crack(s) recorded on curved portion of Type D Curb STA 25+05.

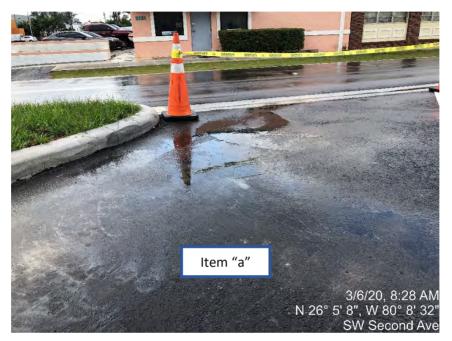
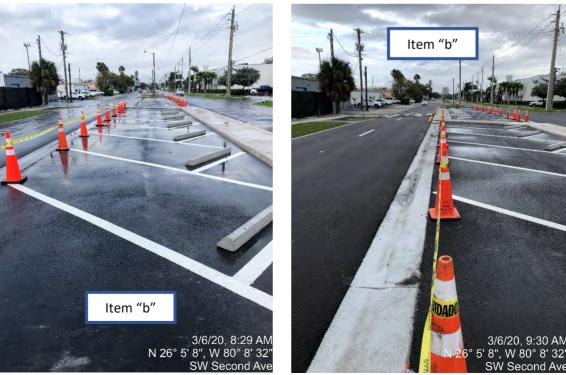
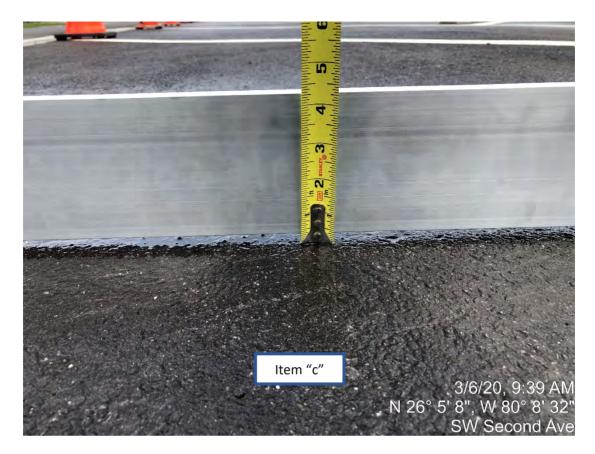
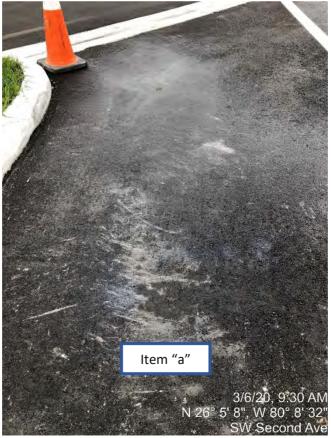
- a. Oil stains recorded on parking spaces No. 1, No. 2, and No. 8 from North to South STA 26+00 to STA 26+30, and STA 25+40.
- b. Ponding recorded on parking spaces No. 1, No. 2, No. 3, No. 4, and No. 8 from North to South (STA 26+25 to STA 25+85, and STA 25+30 respectively).
- c. CONTRACTOR failed to test for conformity with the specified grade after initial compression. Variance in surface more than 1/8-inch from the lower edge of a 12-foot straightedge recorded on parking space No. 8 from North to South STA 25+30.

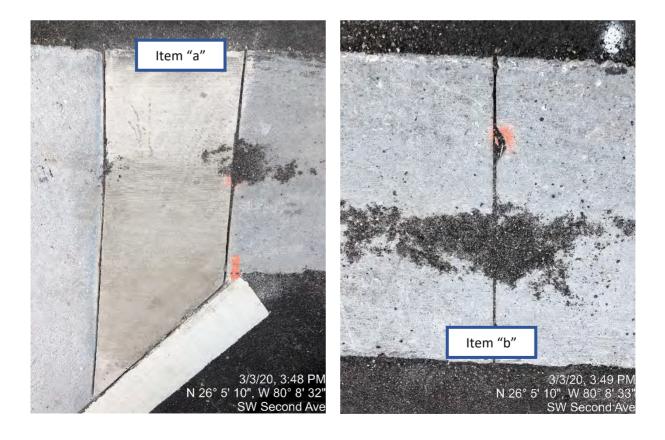
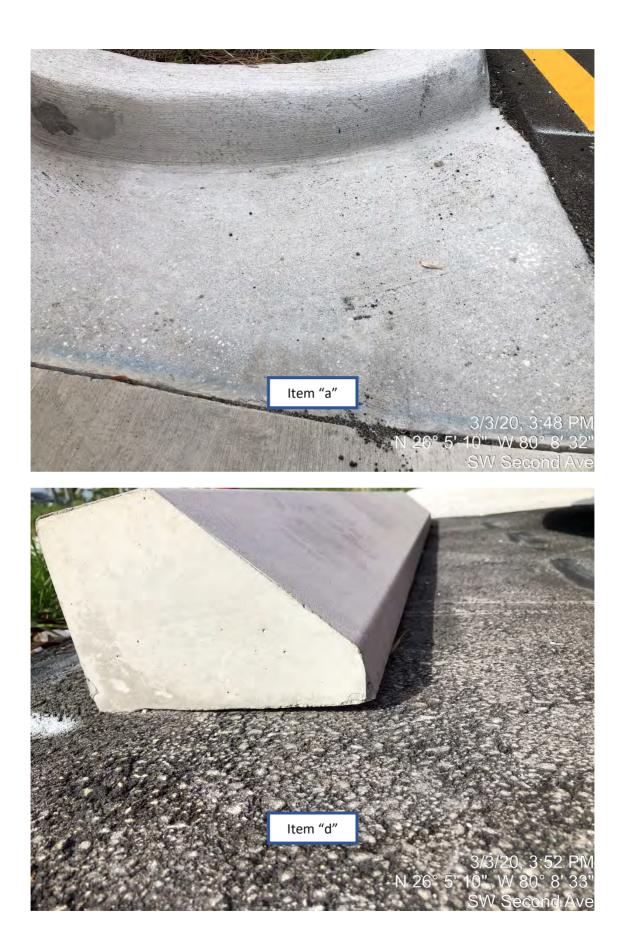
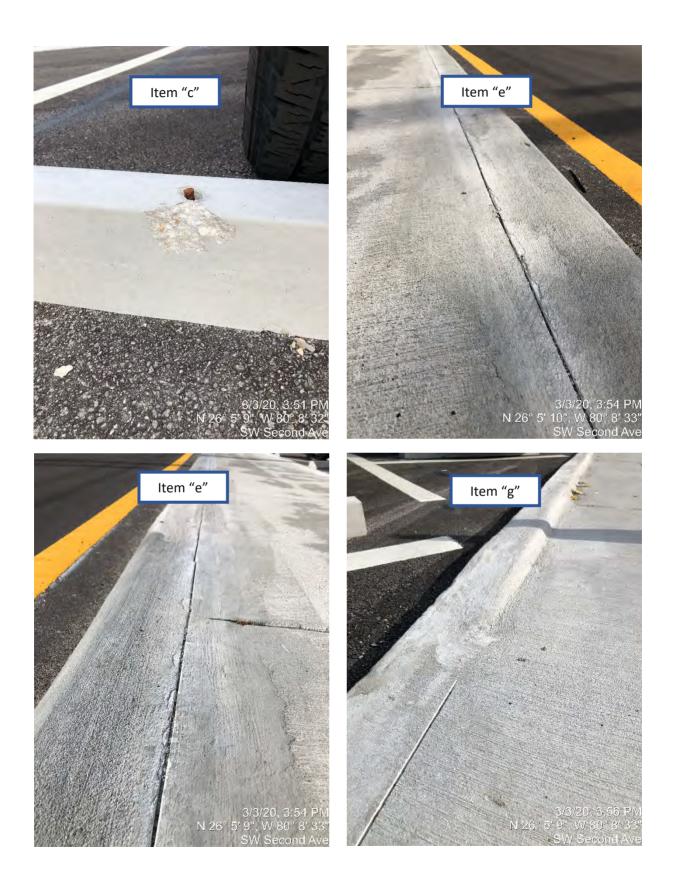
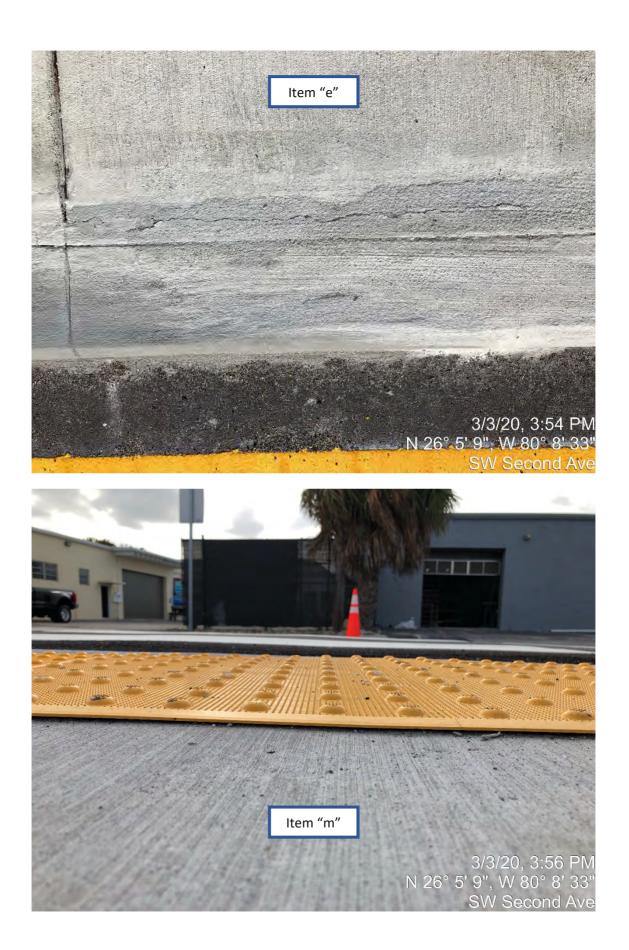
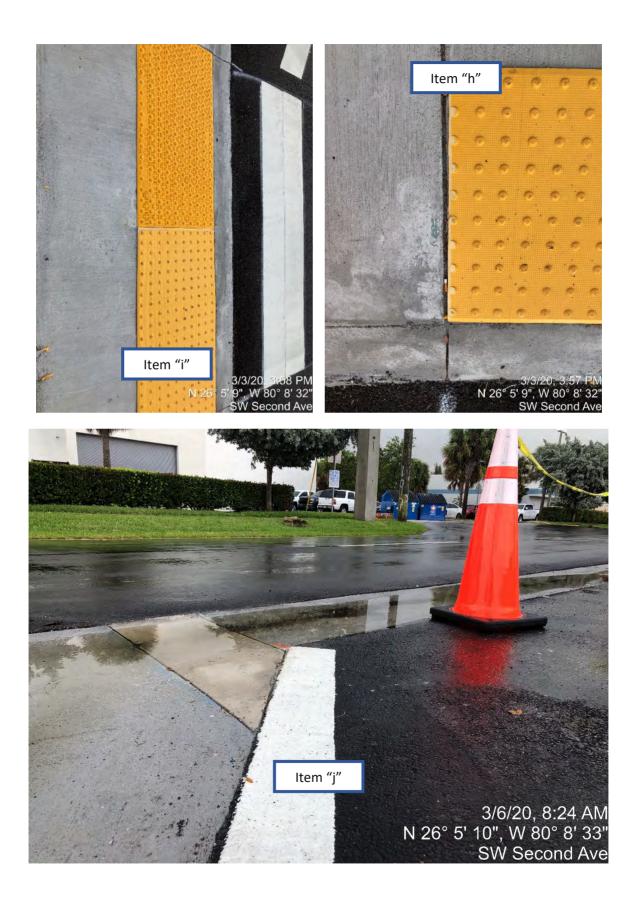
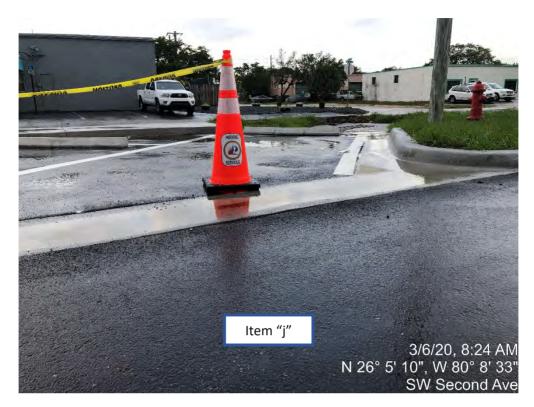
Median No. 2 (STA 26+15 - STA 27+65)

- a. Grinding of concrete at Valley Gutter STA 27+40 (convergence of Valley Gutter and Type F Curb).
- b. Crack(s) recorded at Valley Gutter STA 27+30 (1st joint from North to South).

- c. Concrete Wheel Stop damaged STA 26+49 (2nd from South to North).
- d. Concrete Wheel Stop inadequately installed 27+45 (1st from North to South).
- e. Repair method was not reviewed/approved by the City and it shows poor finish on Type D Curb STA 26+33 to STA 27+43. (deficiencies recorded at both sides of Concrete Sidewalk).

- f. Incorrect jointing pattern recorded on Concrete Sidewalk STA 26+33 to STA 27+43 (entire median).
- g. Expansion joint between Concrete Sidewalk and Type D Curb is interrupted at ADA accessible route ramp STA 26+62.

- h. Concrete grinding and/or poor finish on Concrete Sidewalk STA 26+67. (North and against detectable warning surface).
- i. Mismatch of detectable warning surfaces recorded STA 26+62.

- j. Ponding recorded on Valley Gutter STA 27+40 to STA 27+10. Low elevation grade at North end of Valley Gutter.
- k. Ponding recorded on Concrete Sidewalk flags No. 2, No. 3, and No. 5 from North to South (STA 27+35 to STA 27+25, and STA 27+15 respectively).

- I. Ponding recorded on Concrete Sidewalk behind detectable warning surface STA 26+63.
- m. Trip hazard between Type D Curb and Concrete Sidewalk STA 26+62.

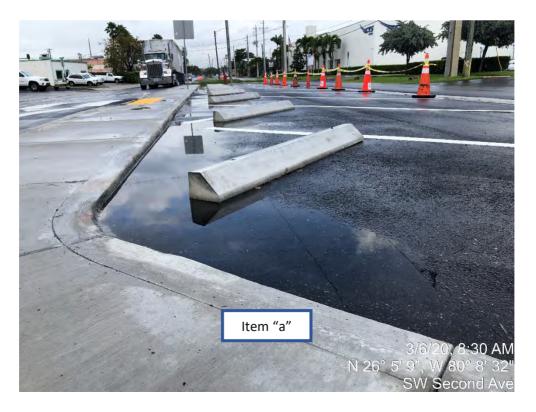
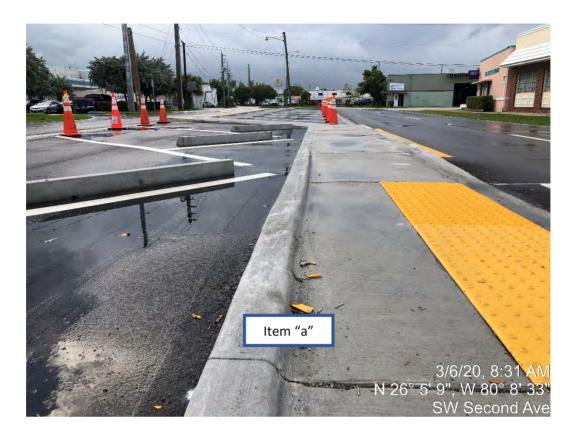
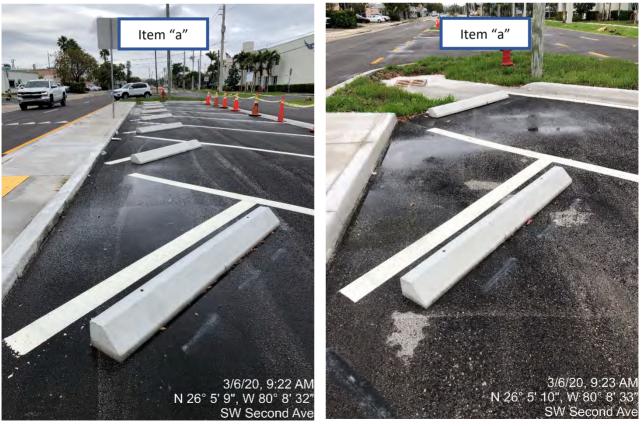
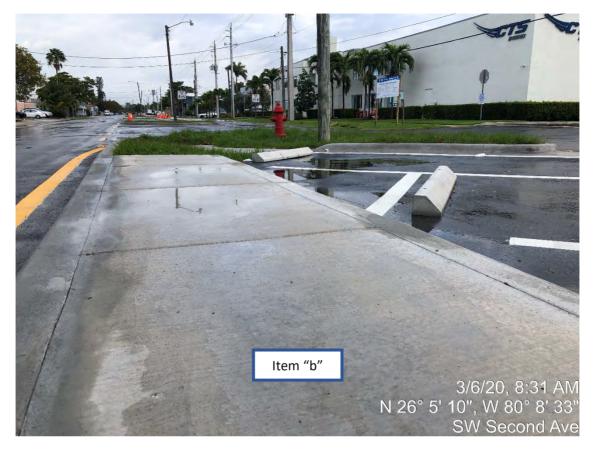
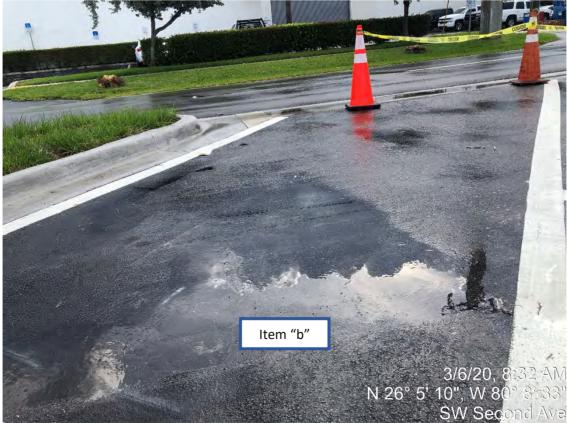
- a. Ponding recorded behind Wheel Stops of parking spaces No. 2 and No. 8 from North to South STA 27+31 and STA 26+54 respectively.
- b. Ponding recorded on parking spaces No. 1 and No. 10 from North to South STA 27+39 and 26+33 respectively.

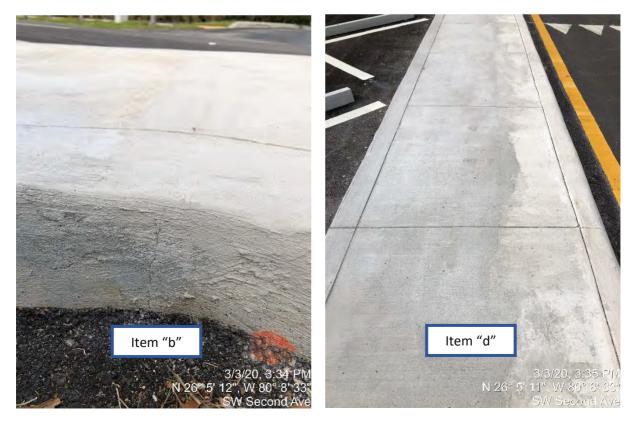
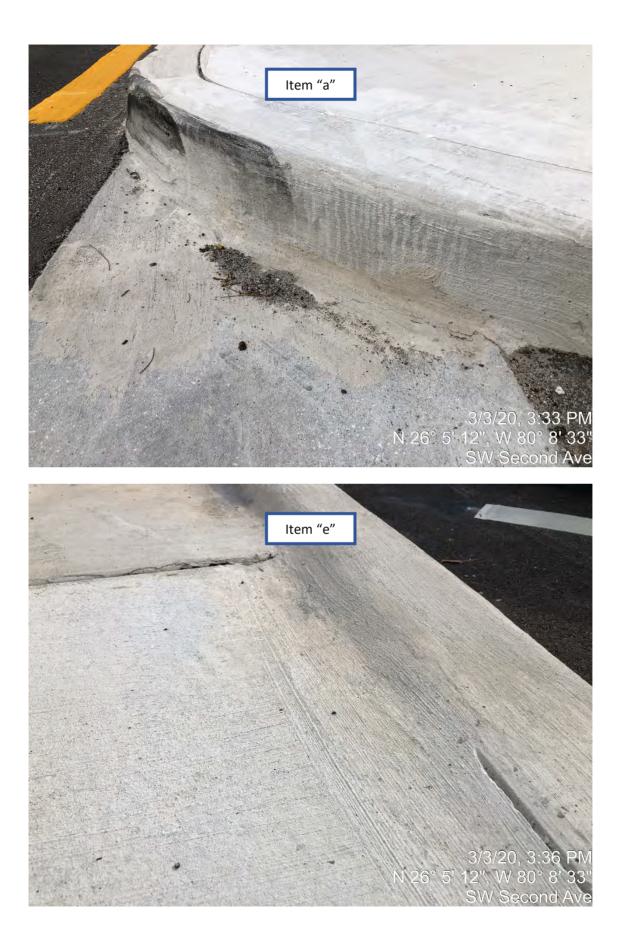
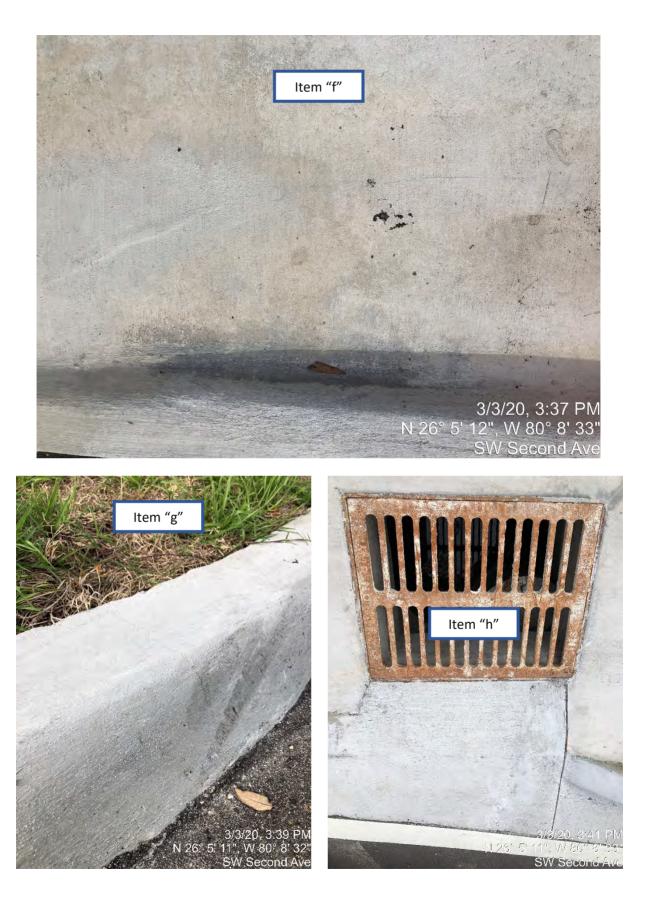
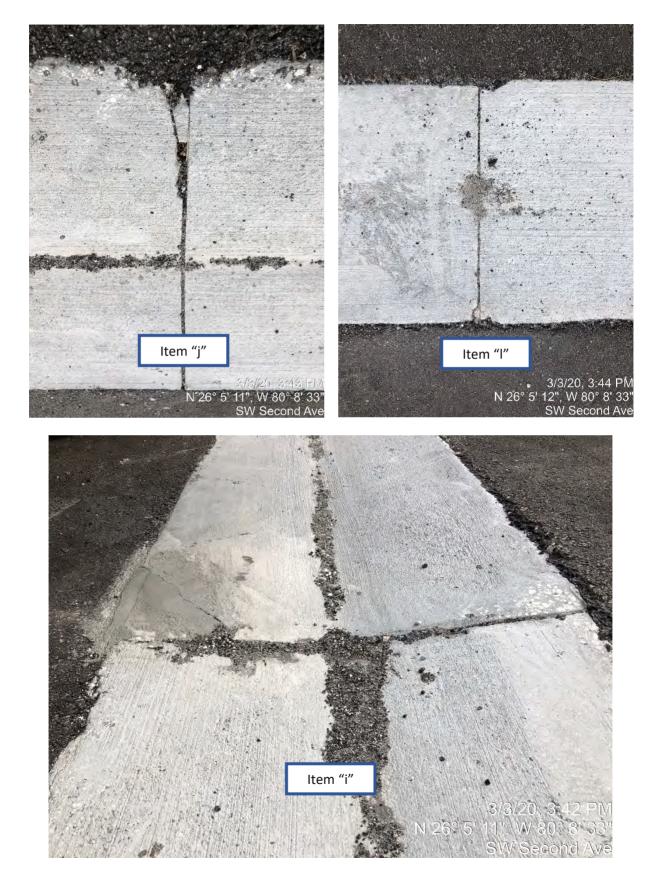
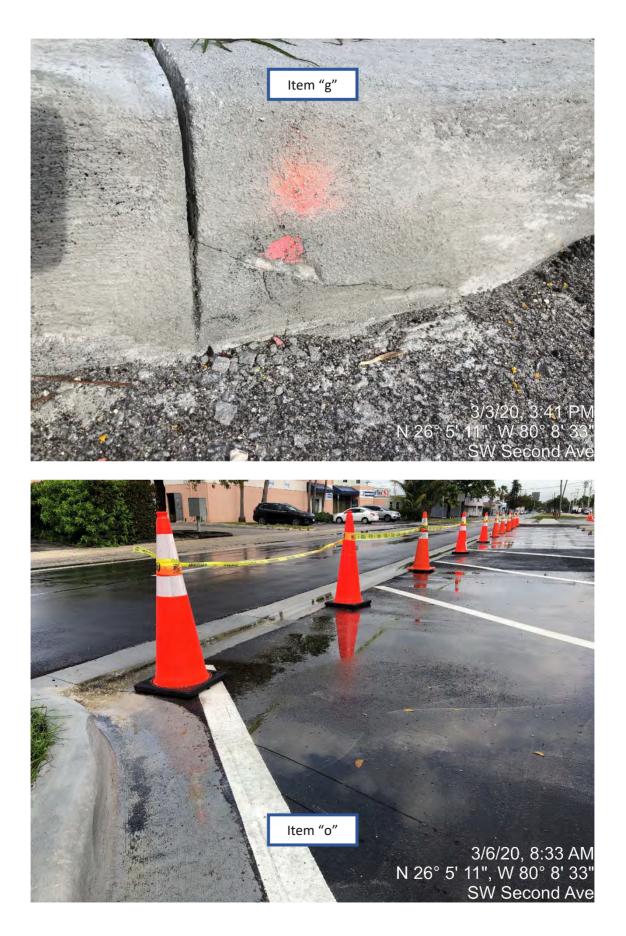
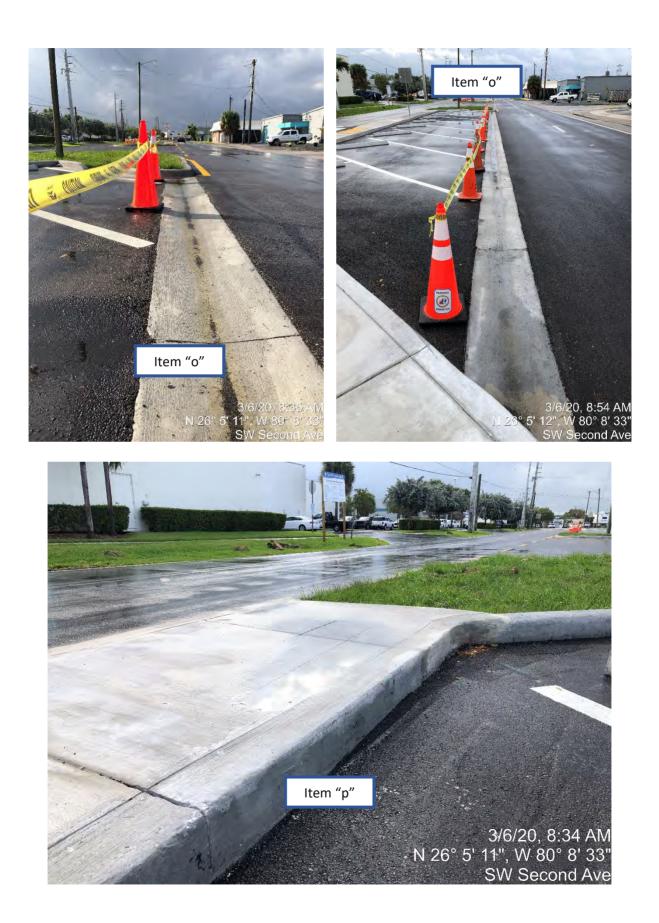
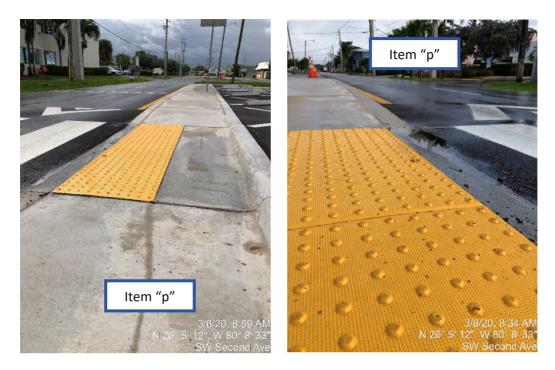
Median No. 3 (STA 28+40 - STA 29+85)

- a. Crack(s) recorded at Valley Gutter STA 29+82 (convergence of Valley Gutter and Type F Curb).
- b. Repair method was not reviewed/approved by the City and it shows poor finish on Type D Curb STA 29+66 to STA 29+85.

- c. Crack(s) repair method was not reviewed/approved by the City and it shows poor finish on Concrete Sidewalk STA 29+66.
- d. Repair method was not reviewed/approved by the City and it shows poor finish on Concrete Sidewalk STA 26+05 to STA 28+65.

- e. Expansion joint between Concrete Sidewalk and Type D Curb is interrupted at ADA accessible route ramp STA 29+31.
- f. Crack(s) repair method was not reviewed/approved by the City and it shows poor finish on Concrete Sidewalk STA 29+24 to STA 29+42 (ADA accessible route ramps and landing).

- g. Crack(s) recorded at Type F Curb STA 28+45 (two locations on the curved portion of the curb).
- h. Grinding of concrete recorded at catch basin No. 4 pad STA 28+62.

- i. Crack(s) and grinding recorded at Valley Gutter STA 28+76 (1st joint from South to North).
- j. Crack(s) recorded at Valley Gutter STA 28+85 (2nd joint from South to North).

- k. Incorrect jointing pattern recorded on Concrete Sidewalk STA 28+65 to STA 29+85 (entire median).
- I. Crack(s) recorded at Valley Gutter STA 29+82 (1st joint from North to South).

- m. Trip hazard between Type D Curb and Concrete Sidewalk STA 29+50.
- n. Expansion joints on curved portion of Type D Curb are irregular and not beveled.

- o. Ponding recorded throughout the Valley Gutter STA 28+67 to STA 29+54 and at STA 29+84 (North end). Low elevation grade recorded at both ends of Valley Gutter.

- p. Ponding recorded on Concrete Sidewalk behind detectable warning surface STA 29+34, and at flags No. 12 and No. 13 South of ADA accessible route ramp (STA 28+67 to STA 28+77).

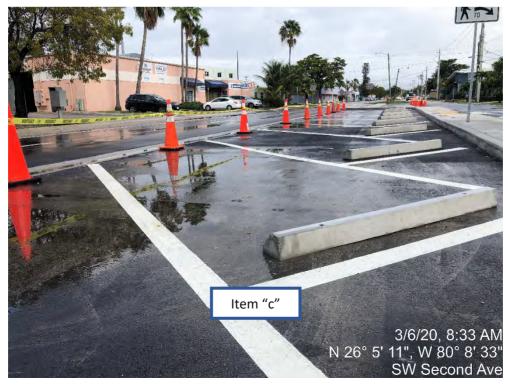
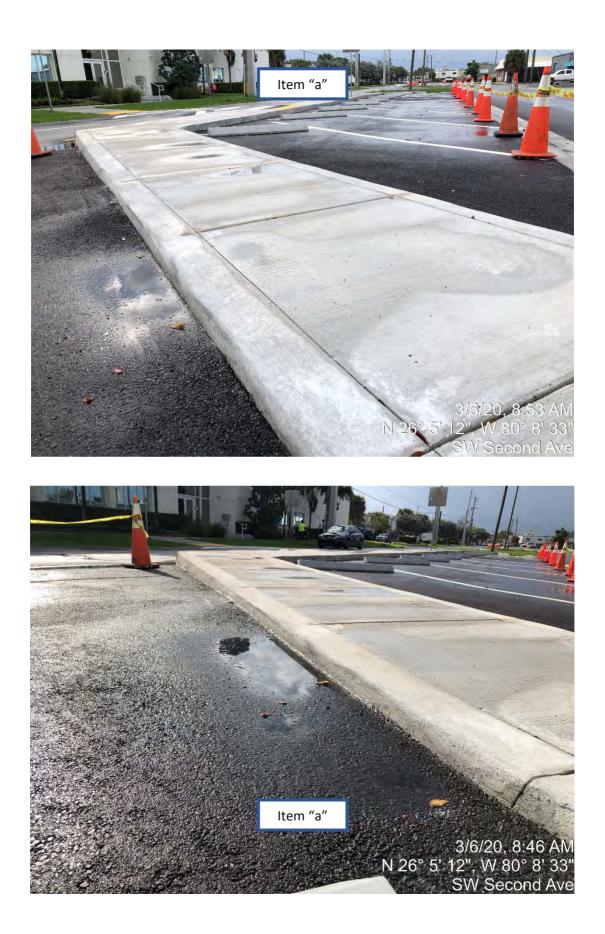
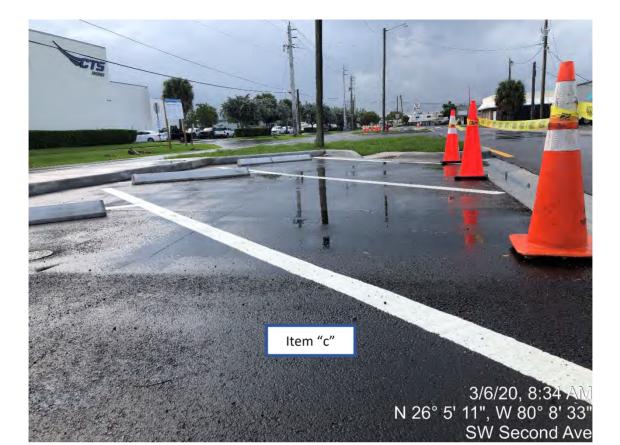
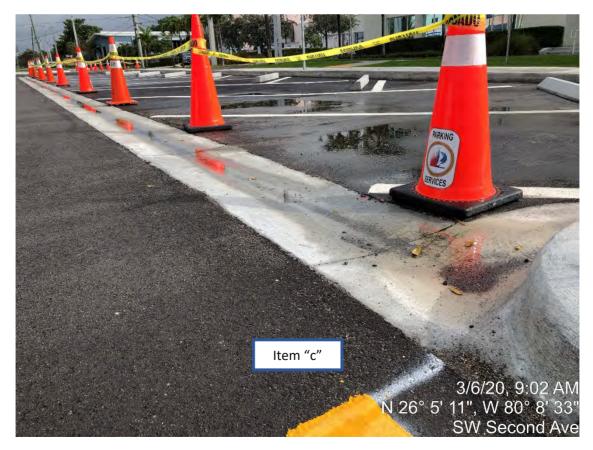
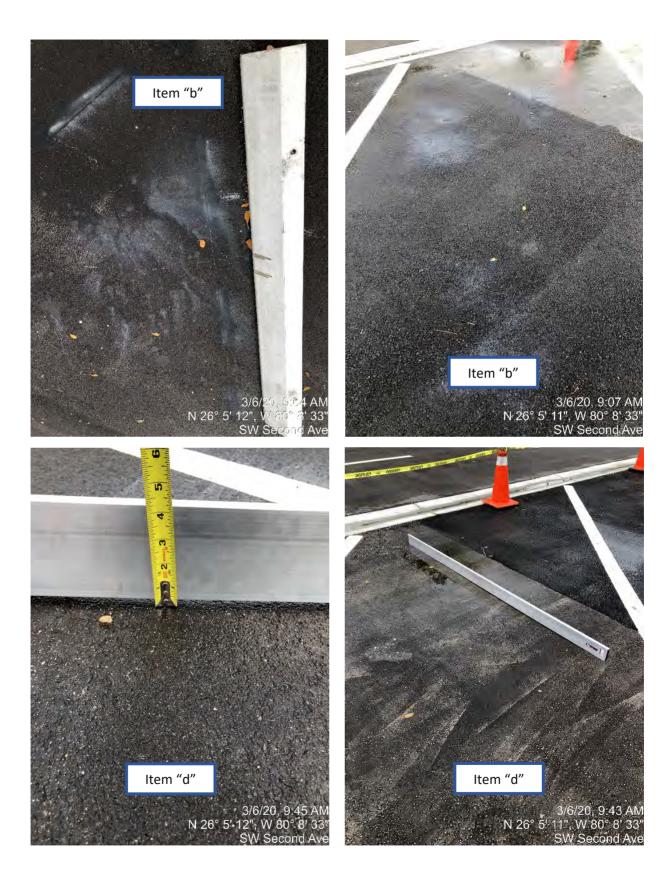
- a. Ponding recorded on Concrete Sidewalk between medians III and IV (STA 29+65 to STA 29+84)
- b. Oil stains recorded on parking spaces No. 3, No. 6, and No. 7 from North to South (STA 29+43, STA 29+95, and STA 29+12 respectively).
- c. Ponding recorded on parking spaces No. 5, No. 6, No. 8, and No. 9 (STA 29+05 to STA 29+30, and STA 28+60 to STA 28+90).
- contractor failed to test for conformity with the specified grade after initial compression. Variance in surface more than 1/8-inch from the lower edge of a 12-foot straightedge recorded on parking spaces No. 2, No. 6, and No. 8 from North to South STA 29+67, STA 29+06, and STA 28+88.

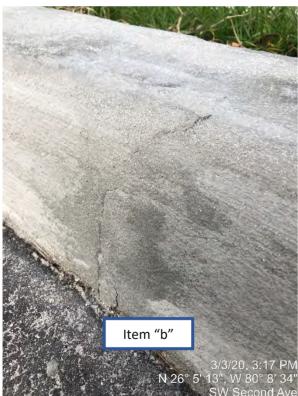
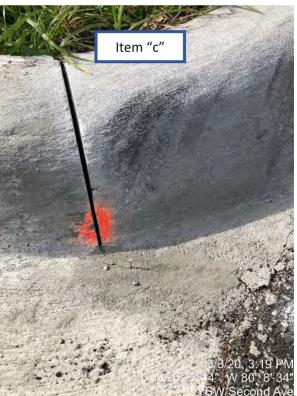
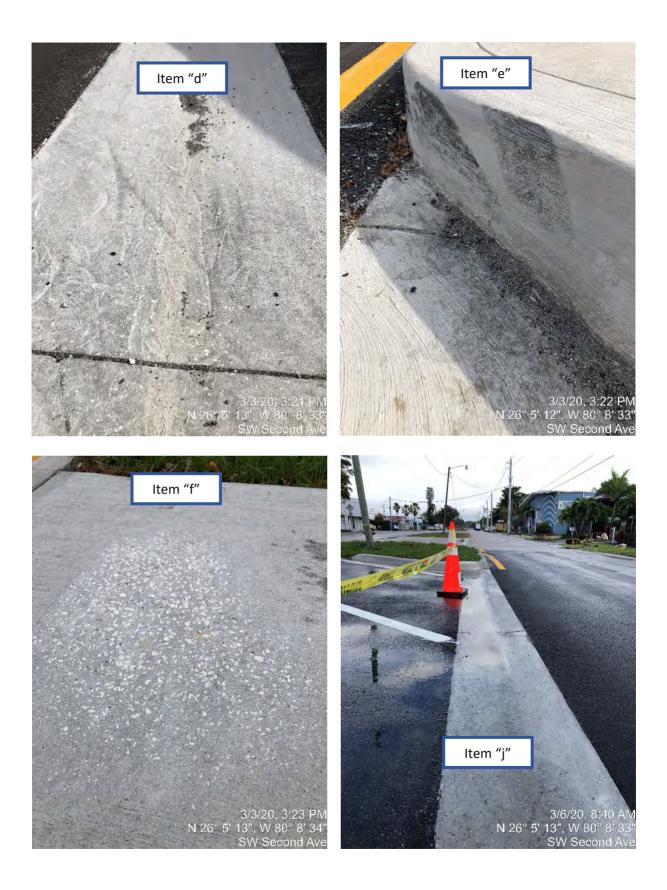
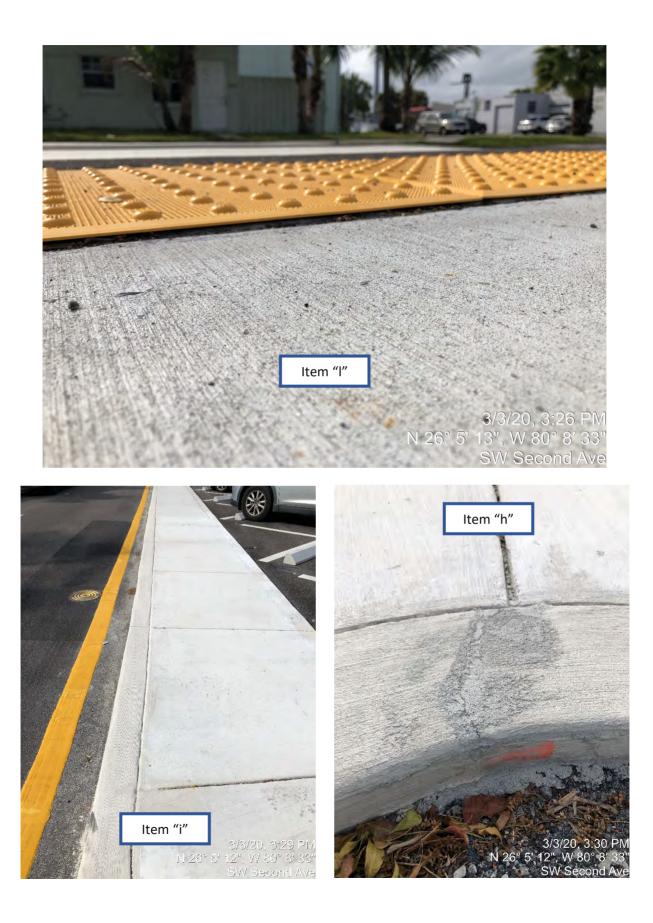
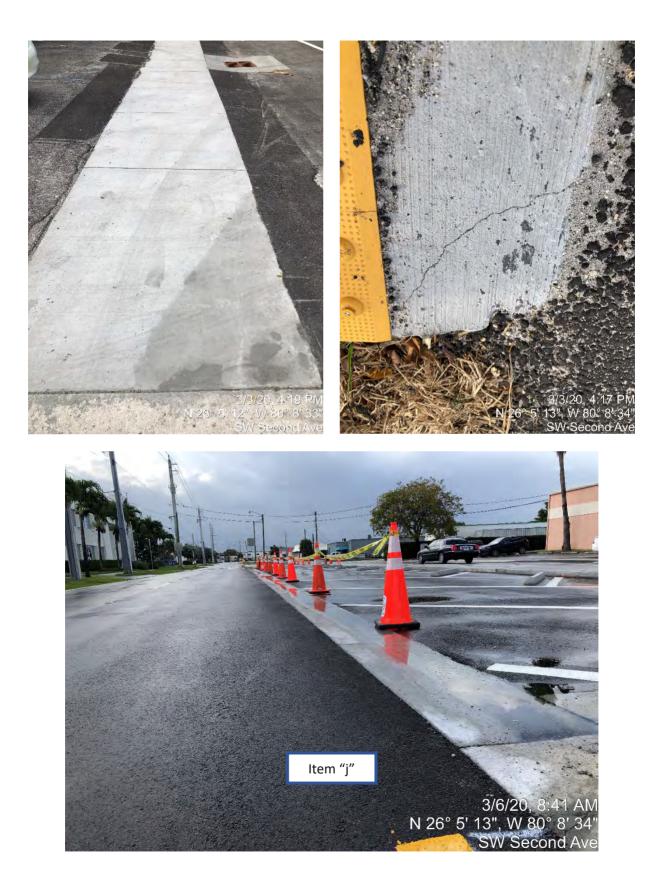
Median No. 4 (STA 29+64 - STA 31+08)

- a. Expansion joints on curved portion of Type D Curb are not beveled.
- b. Crack(s) recorded at Type D Curb STA 30+94 (West side of curb).
- c. Crack(s) and low elevation grade recorded on Type F Curb STA 30+83 (convergence of Valley Gutter and Type F Curb).

- d. Grinding of concrete at Valley Gutter STA 30+29 and STA 30+66
- e. Crack(s) and low elevation grade recorded at Valley Gutter STA 29+67 (beginning of Valley Gutter).

- f. Grinding of concrete at Sidewalk STA 30+82 (1st flag from North to South)
- g. Incorrect jointing pattern recorded on Concrete Sidewalk STA 29+85 to STA 30+85 (entire median).

- h. Crack(s) repair method was not reviewed/approved by the City and it shows poor finish on Type D Curb STA 29+85 to STA 30+65.
- i. Crack(s) repair method was not reviewed/approved by the City and it shows poor finish on Concrete Sidewalk and Type D Curb STA 29+88 (1st joint from South to North).

- j. Ponding recorded throughout the Valley Gutter STA 29+66 to STA 30+83. Low elevation grade recorded at both ends of Valley Gutter.
- Ponding recorded on Concrete Sidewalk behind detectable warning surface STA 30+71, and at flags No. 2, No. 7, No. 9, and No. 12 South of ADA accessible route ramp (STA 30+56, STA 30+24, 30+15, and STA 30+00 respectively).

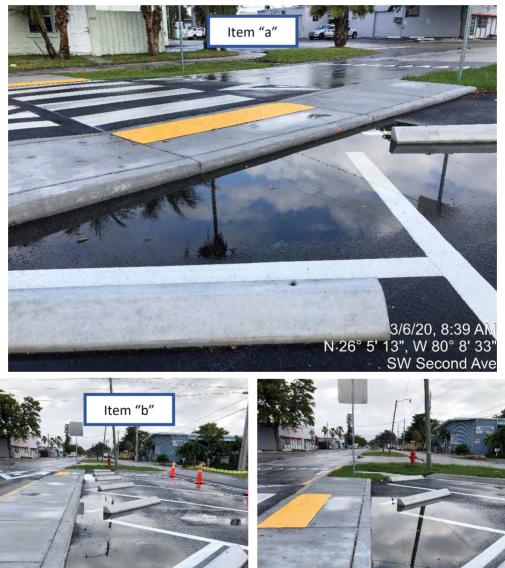
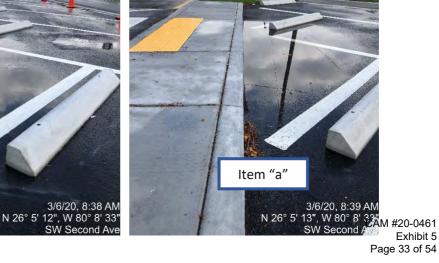
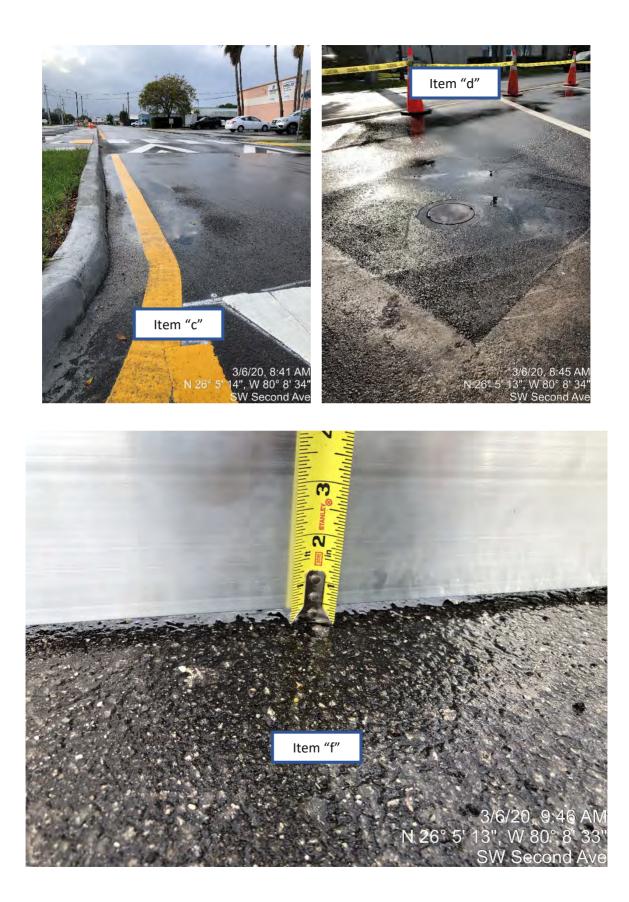
- a. Ponding recorded behind Wheel Stops of parking spaces No. 2 and No. 3 from North to South STA 30+58 to STA 30+76.
- b. Ponding recorded behind Wheel Stops of parking spaces No. 5 and No. 6 from North to South STA 30+22 to STA 30+45.
- c. Ponding recorded on SW 2nd Avenue Southbound lane STA 30+85.
- d. Ponding recorded on parking space No. 5 from North to South due to irregular asphalt patch surrounding gas valve STA 30+31.
- e. Ponding recorded on parking space No. 9 from North to South against Type D Curb STA 29+76.
- f. CONTRACTOR failed to test for conformity with the specified grade after initial compression. Variance in surface more than 1/8-inch from the lower edge of a 12-foot straightedge recorded on parking space No. 2 from North to South STA 30+68.

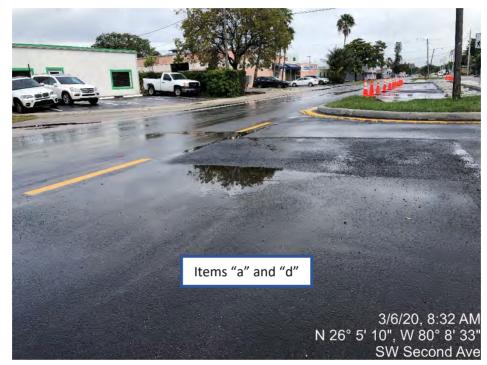
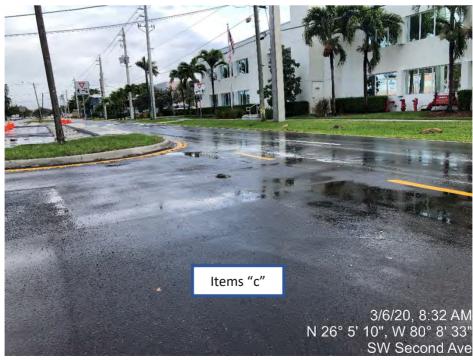
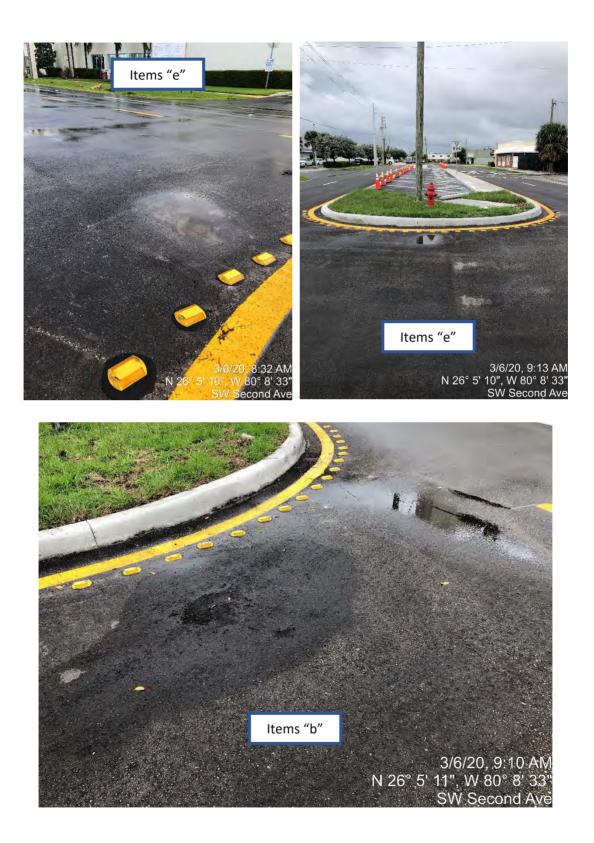
Median Crossover (STA 27+65 to STA 28+40)

- a. Ponding recorded along the longitudinal joint between SW 2nd Avenue Southbound lane and median crossover (STA 27+65 to STA 28+40).
- b. Oil stain left to saturate into the surface softened the asphalt STA 28+38. Heavy damage recorded.
- c. Ponding recorded STA 28+38 to STA 28+18 next to SW 2nd Avenue Northbound lanes.
- d. Poor finish recorded on asphalt patch STA 28+26.
- e. Ponding recorded STA 27+68 at water valve (in front of existing fire hydrant).

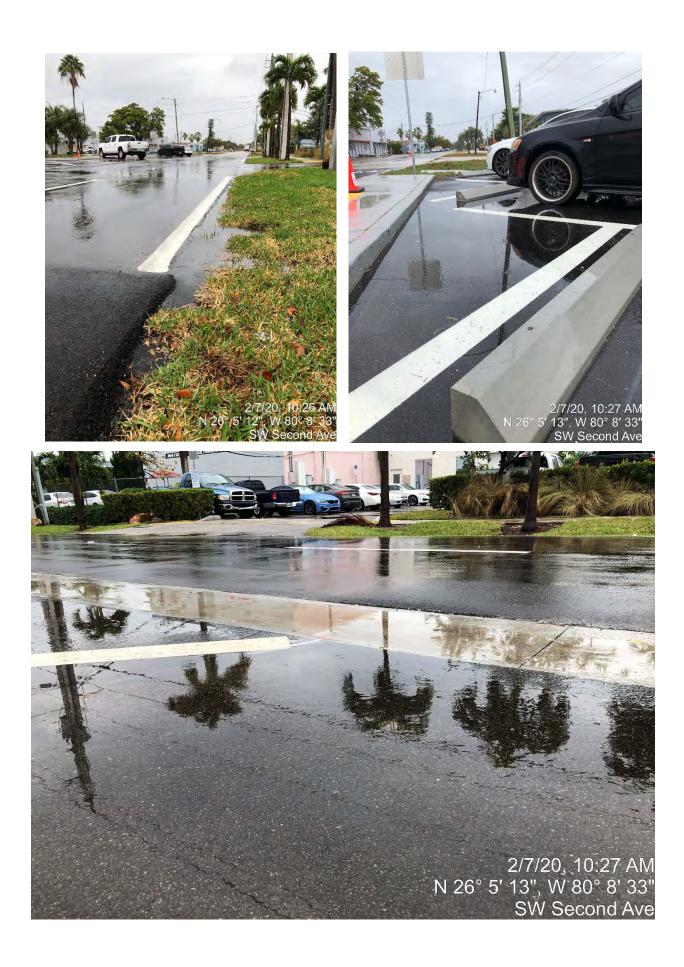
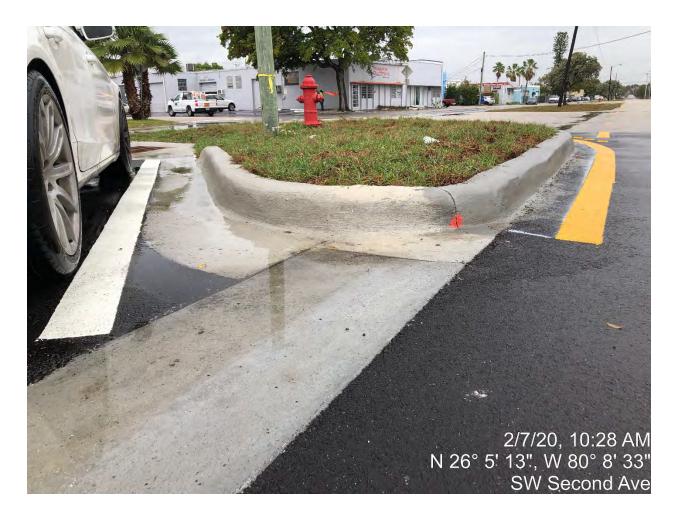
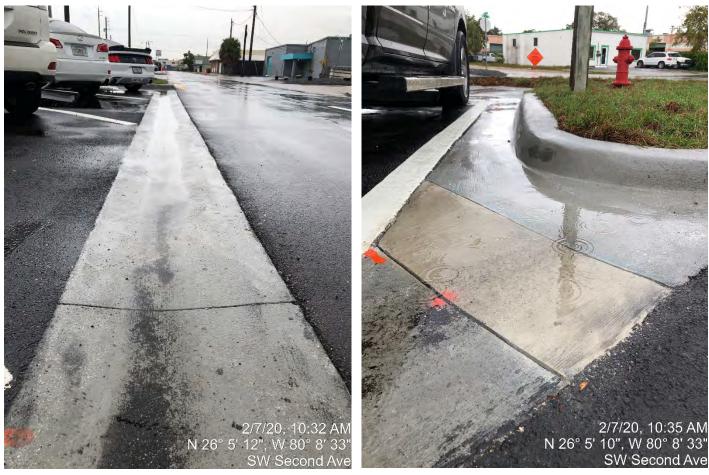
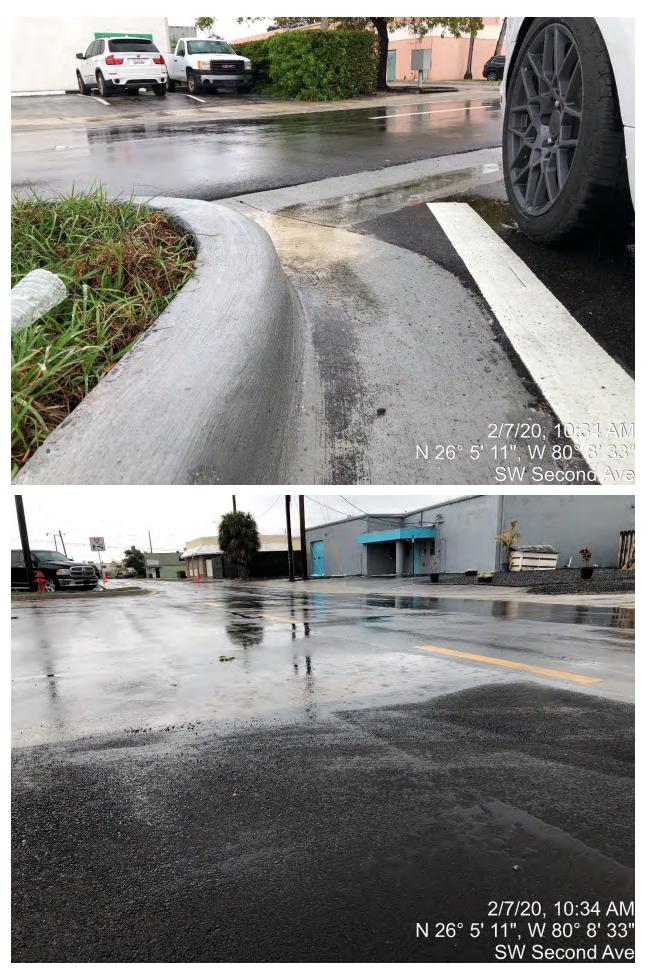
- Sod on swale in front of CTS requires restoration.
- Water ponding was recorded behind the wheel stops at every parking lot
- Valley gutter running slope is insufficient to convey runoff. Ponding was recorded at both parking lots of North median and North parking lot of South Median
- The point where the valley gutter meets the curb and gutter is prone to ponding. Slope between this point and the corresponding inlet is inadequate.
- Irregularities in pavement at the parking lots lead to water puddles.
- Considerable water ponding recorded at the median crossover.
- Water puddles at the ADA detectable warning.

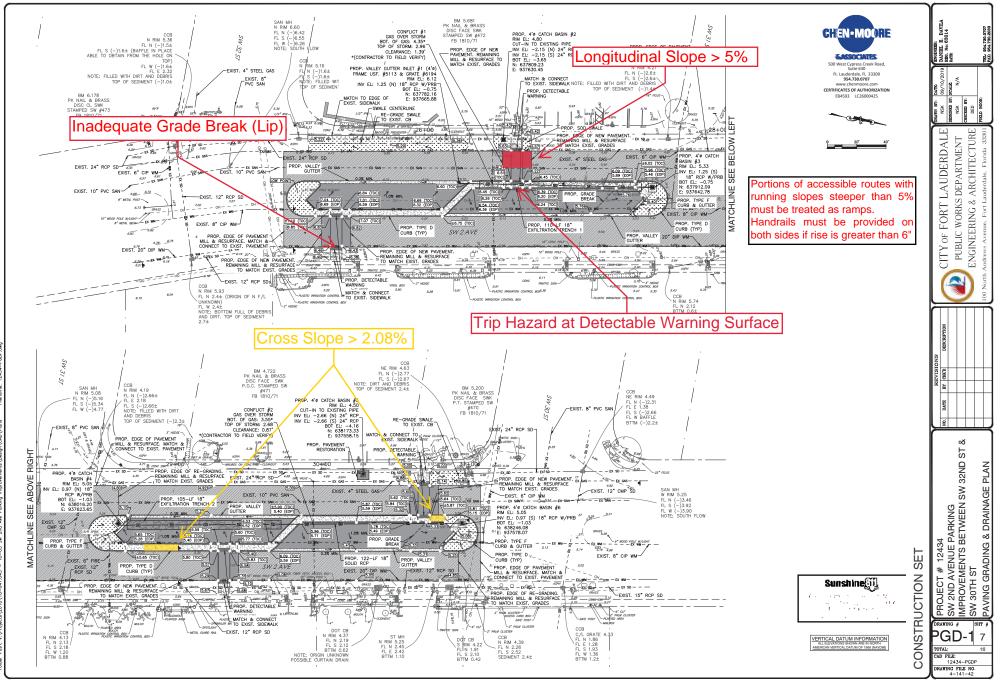
CONTRACTOR failed to comply with ADA running slope of accessible routes walking surfaces requirements. The running slope cannot exceed 1:20 (5%). The South raised crosswalk of SW 2nd Avenue Southbound right lane longitudinal slope is greater than 5%. The slope was measured at 7.5% - 8%, which represents a rise of approximately 9-inches in a 10-feet run.

Portions of accessible routes with running slopes steeper than 5% must be treated as ramps as prescribed in the *United States Access Board Guideline – Chapter 4: Ramps and Curb Ramps.* Ramps running slope cannot exceed 1:12 (8.33%). Ramps must be equipped with handrails at both sides if rise is greater than 6 inches.

CONTRACTOR failed to provide adequate grade break or smooth transitioning between raised crosswalk and concrete sidewalk. Uneven surfaces were identified on the South raised crosswalk of SW 2nd Avenue Northbound right lane grade break with existing sidewalk. No lips or other variations in slope within runs are allowed, as they can disrupt wheelchair travel.
