# City of Fort Lauderdale Comparative Facility Analysis Report

*An Assessment of Three Existing Buildings for Potential  
Conversion to a New City Hall*

City of Fort Lauderdale, Florida

June 18, 2026

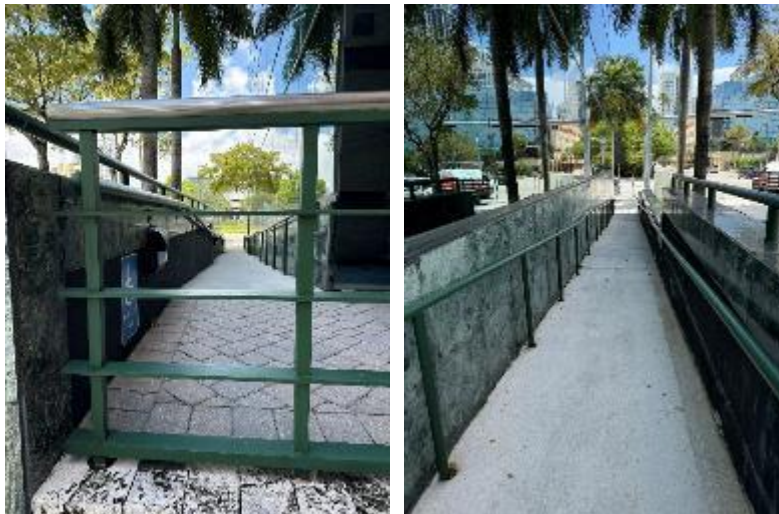
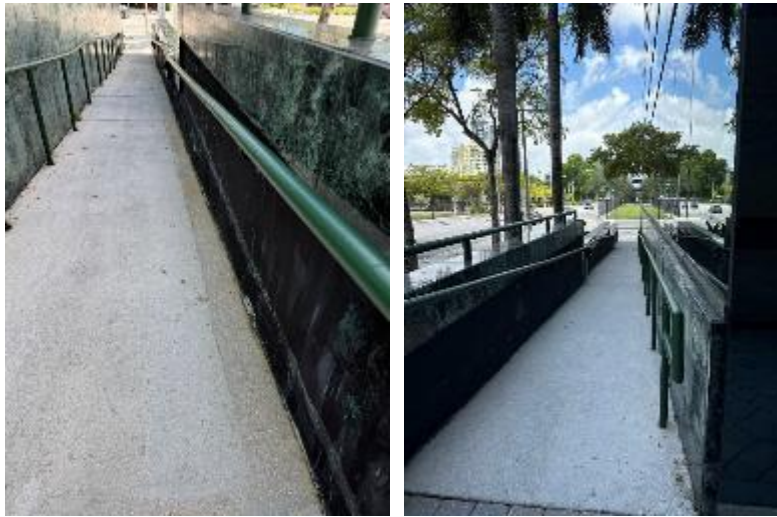
Figure 2A.3.7 Exterior Ramp

2A.3.7. Exterior ramps to access the building from the street are 50 inches wide between handrails and have 60 inches intermediate landings. The slope is no steeper than 1:12 but the surface needs some repairs. It is noted that handrails and guardrails will need to be replaced to comply with current codes.

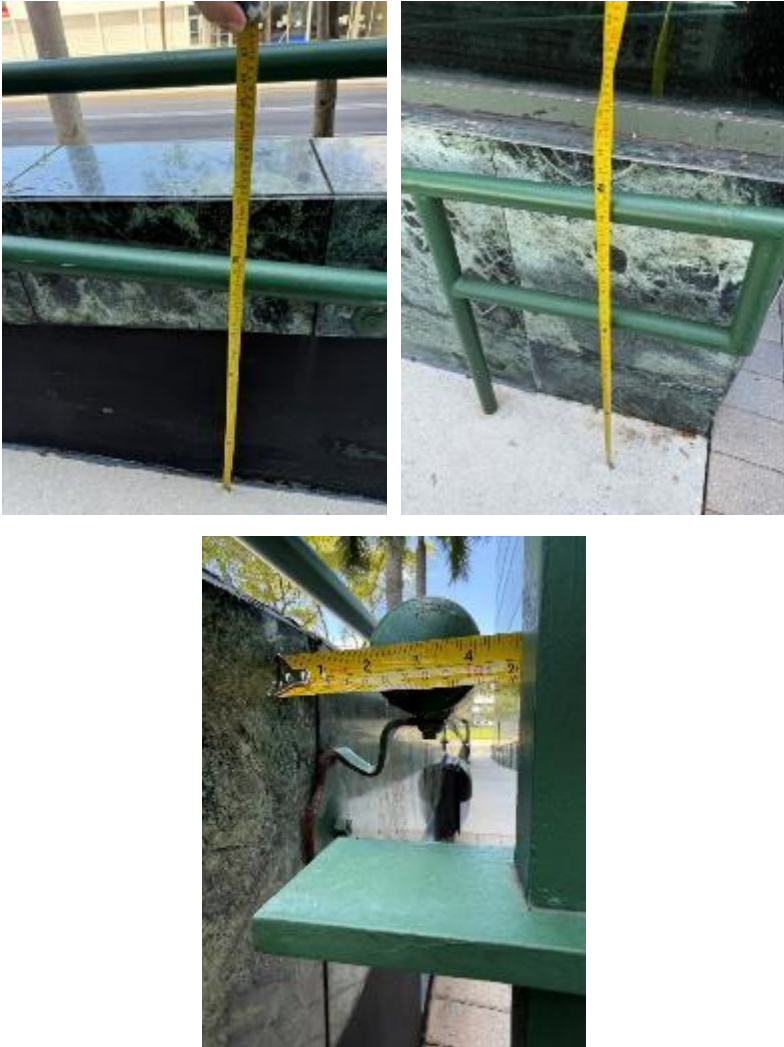
Figure 2A.3.9 Exterior Ramp Railing

2A.3.9. Guardrails from ramp landings do not comply with fall protection code that requires spacing to reject a 4-inch sphere.

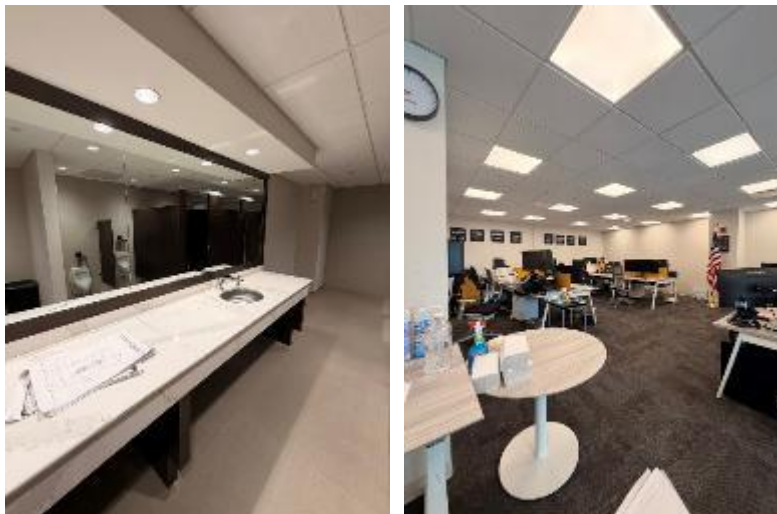
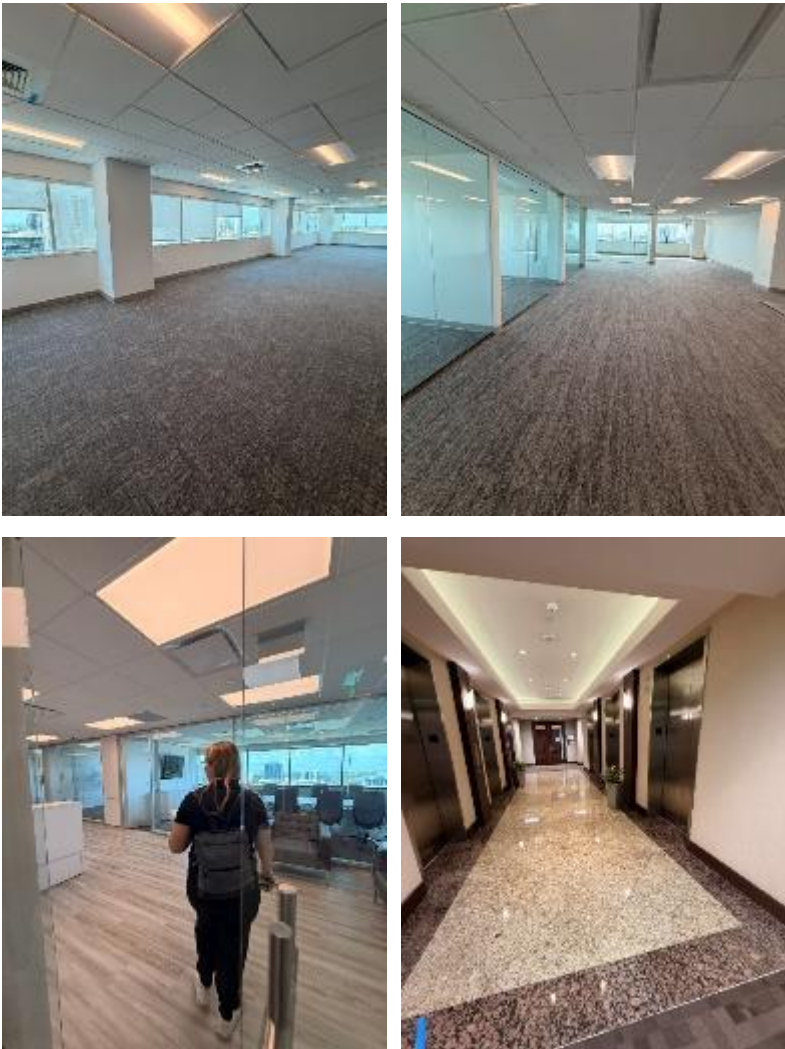
Figure 2A.3.13 Ceilings

- 2A.3.13. Ceilings and lighting are overall in good condition; however they are not uniform throughout; tiles and lights would need to be replaced if a uniform appearance throughout the building is required.

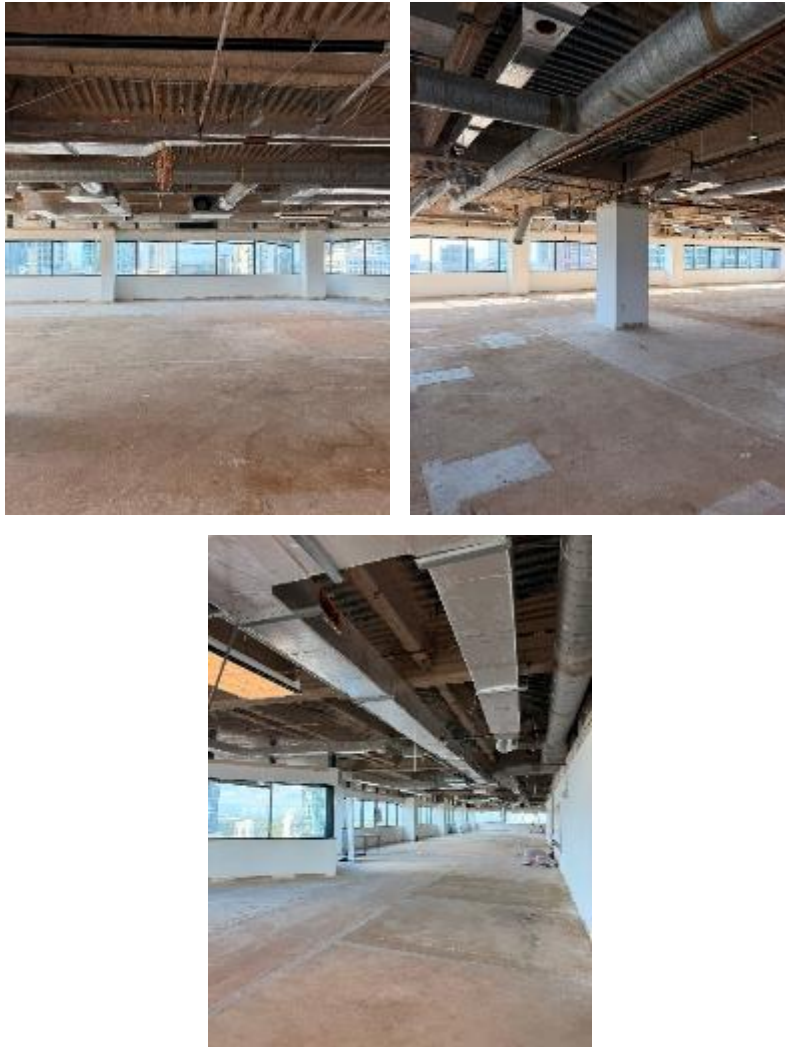
Figure 2A.3.14 16th Floor

2A.3.14. Most of the floors have tenant build outs except for the 16<sup>th</sup> floor that is empty and completely gutted. Interior doors, lockset, ceilings and fixtures are relatively consistent throughout the facility. There is a uniform building standard for finish elements provided by the landlord, however some tenants have selected their own finishes, lighting and furnishings. In this building case an estimated 25% of tenant layout would need minor modifications but many of the floors are ready to be occupied. Depending on the City programmatic requirements this estimated percentage could change.

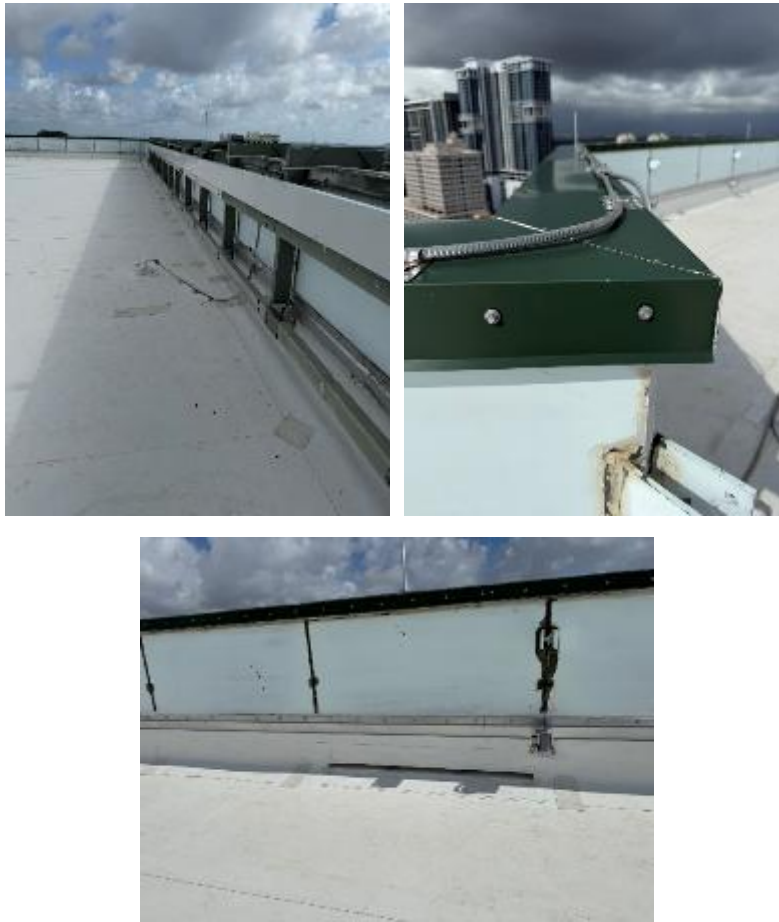
**Figure 2A.3.15 Roof**

- 2A.3.15. Roof, flashing and drains have been replaced in 2021 and 2024 and are in good condition.

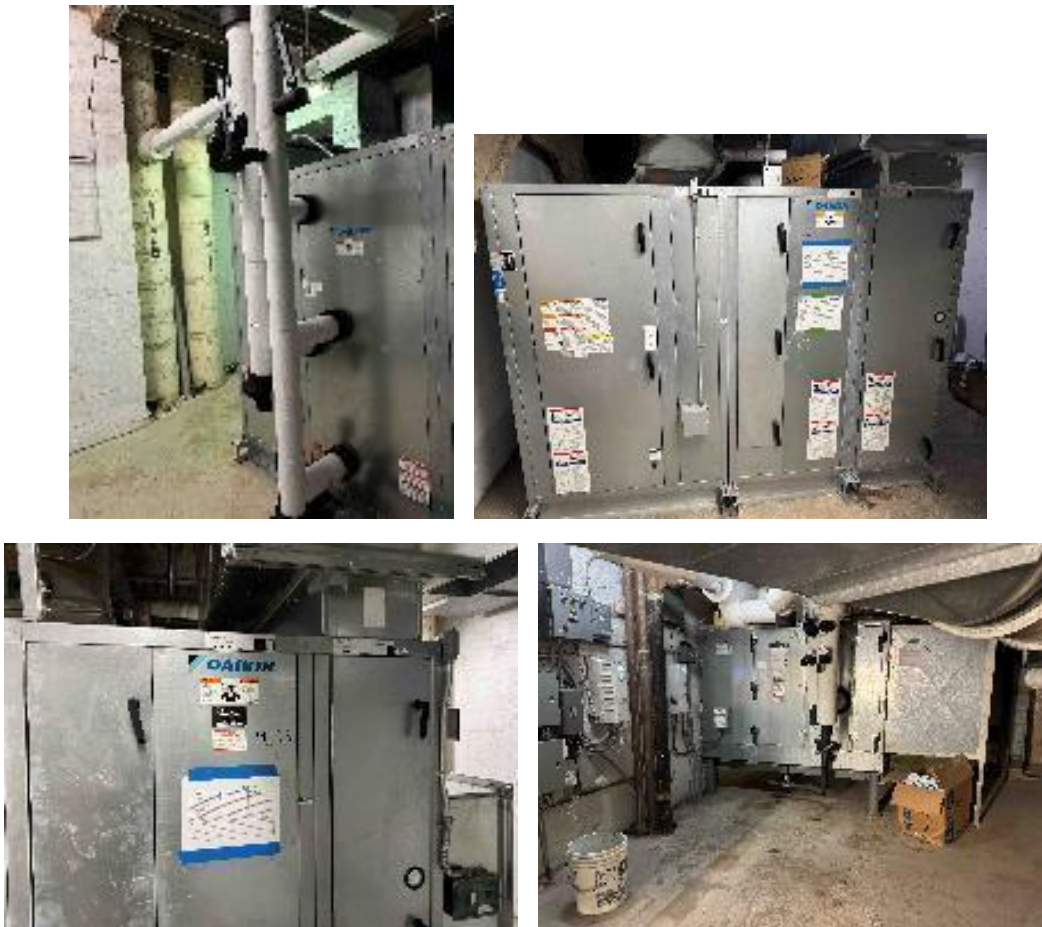
**Figure 2A.4.3 AHUs in good condition**

2A.4.1. Of the 21 air handling units (AHUs) observed during the site visit, 9 units have been replaced since the original construction and are currently in good condition; these units are not expected to require replacement within the next five years. Eight of these units are Daikin units (AHU-5, AHU-7, AHU-11, AHU-13D, AHU-14D, AHU-16, AHU-18, and AHU-23), and one unit (AHU-3) is a Trane unit. Continued preventive maintenance is recommended to sustain performance.

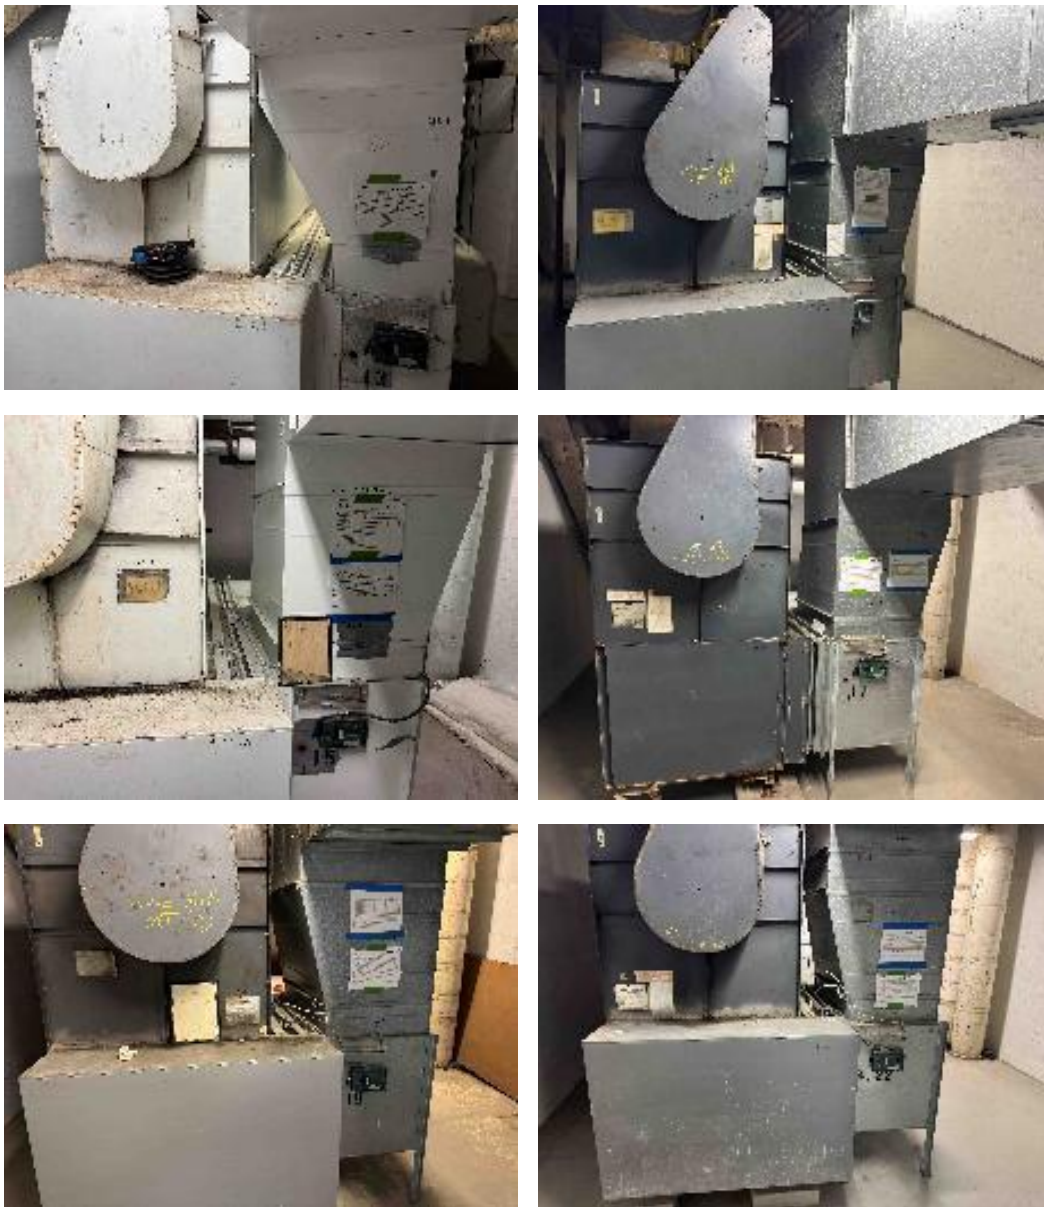
Figure 2A.4.2 AHUs requiring replacement

2A.4.2. The remaining 12 AHUs are original to the facility, appear to date back to the 1980s, and are in poor condition. These units include AHU-4, AHU-6, AHU-8, AHU-9, AHU-10, AHU-12, AHU-13T, AHU-14T, AHU-15, AHU-17, AHU-19, and AHU-22. Based on their age and observed condition, immediate replacement is recommended. ASHRAE equipment life expectancy guidelines indicate a typical service life of approximately 15 years for commercial air handling units, which has been significantly exceeded for these systems.

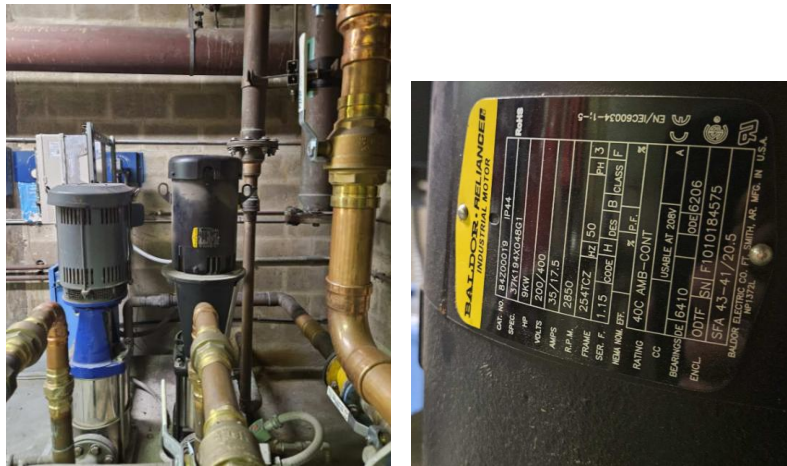
Figure 2A.4.6 Domestic water pumps

- 2A.4.5. In general, the bathroom facilities plumbing fixtures were in good condition.
- 2A.4.6. The domestic water booster pumps were observed to be in working condition and are not advised for replacement.

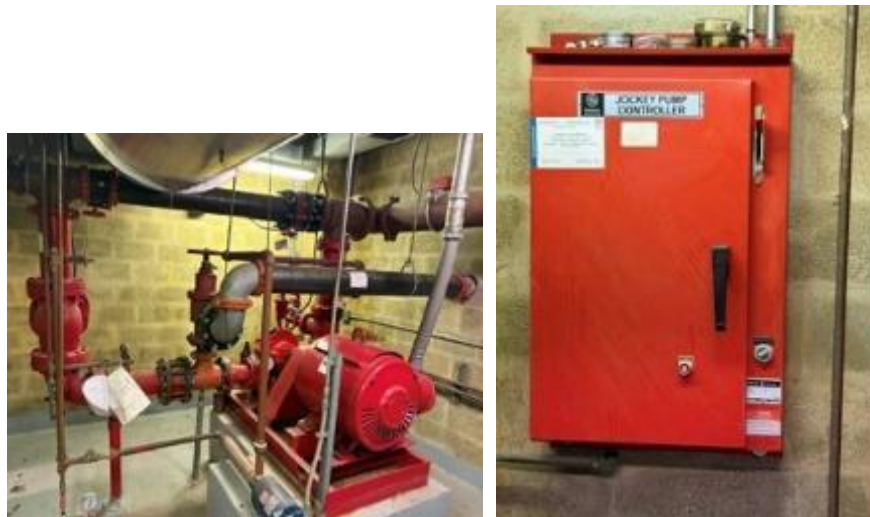
Figure 2A.5.1 Fire Pump/Controller

- 2A.5.1 Due to the age of the centrifugal fire pump. Recommend replacing the fire pump, controller, jockey pump, and jockey pump controller.

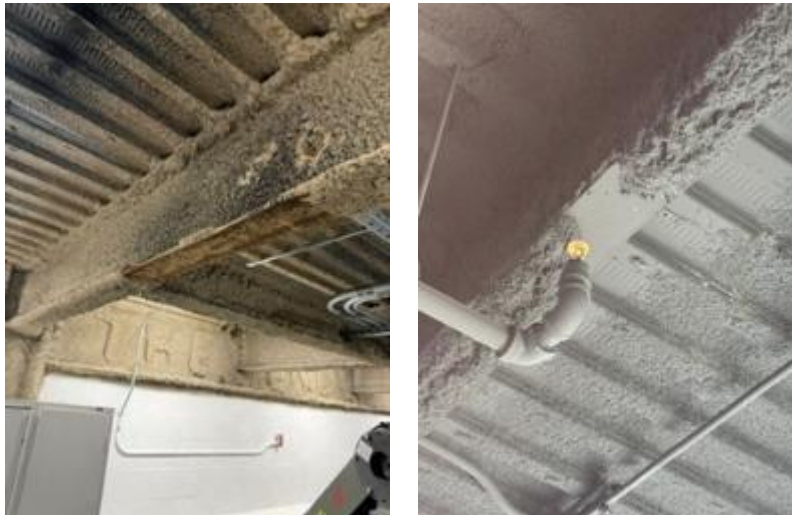
**Figure 2A.5.5 Fire Proofing**

- 2A.5.4 Standpipe Pressure Gauges were showing different readings. Minimum pressure for the existing standpipes should be 65 psi. Some show 60 psi or less. Pressure gauges should be replaced and the pump standby pressure may need to be reset.
- 2A.5.5 Structural Steel Fire Proofing – Found on each floor fire proofing missing from structural steel. Estimate 10 to 15 patches per floor will be needed.

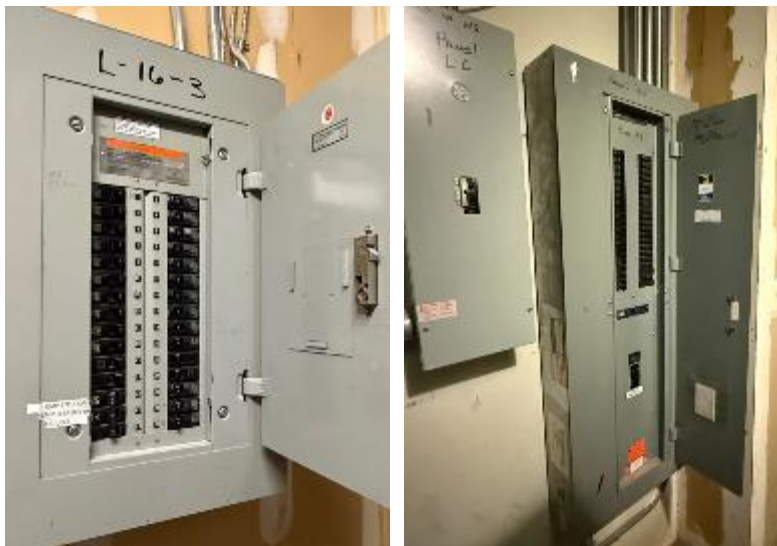
Figure 2A.6.1 Electrical working clearance deficiencies

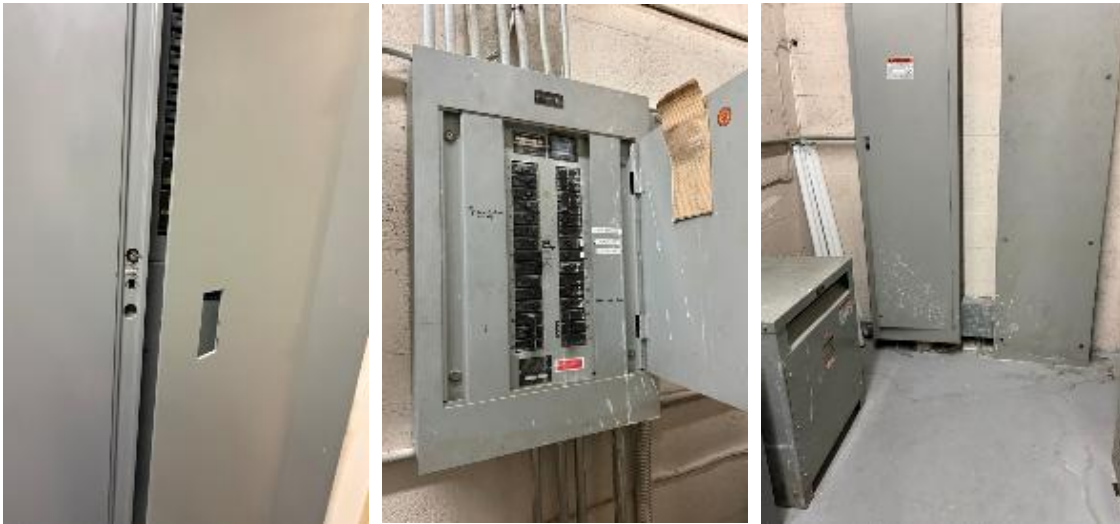
Figure 2A.6.3 Electrical panelboards condition and deficiencies

2A.6.3. Several panelboards and transformers appear to be aging and approaching the end of their useful life. Approximately 75% of the existing panelboards and transformers should be considered for replacement as part of future modernization efforts.

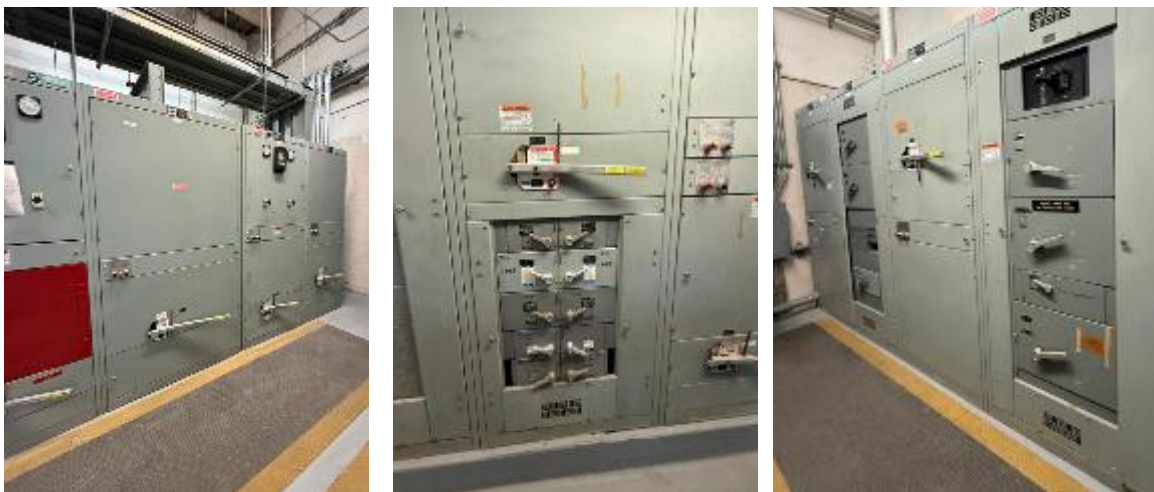
Figure 2A.6.4 Electrical main switchboards and primary electrical distribution

2A.6.4. The existing main switchboards and primary electrical distribution equipment appear to be aging and should be evaluated for replacement. Future municipal occupancy and EV charging requirements may necessitate replacement of major distribution equipment and utility service upgrades.

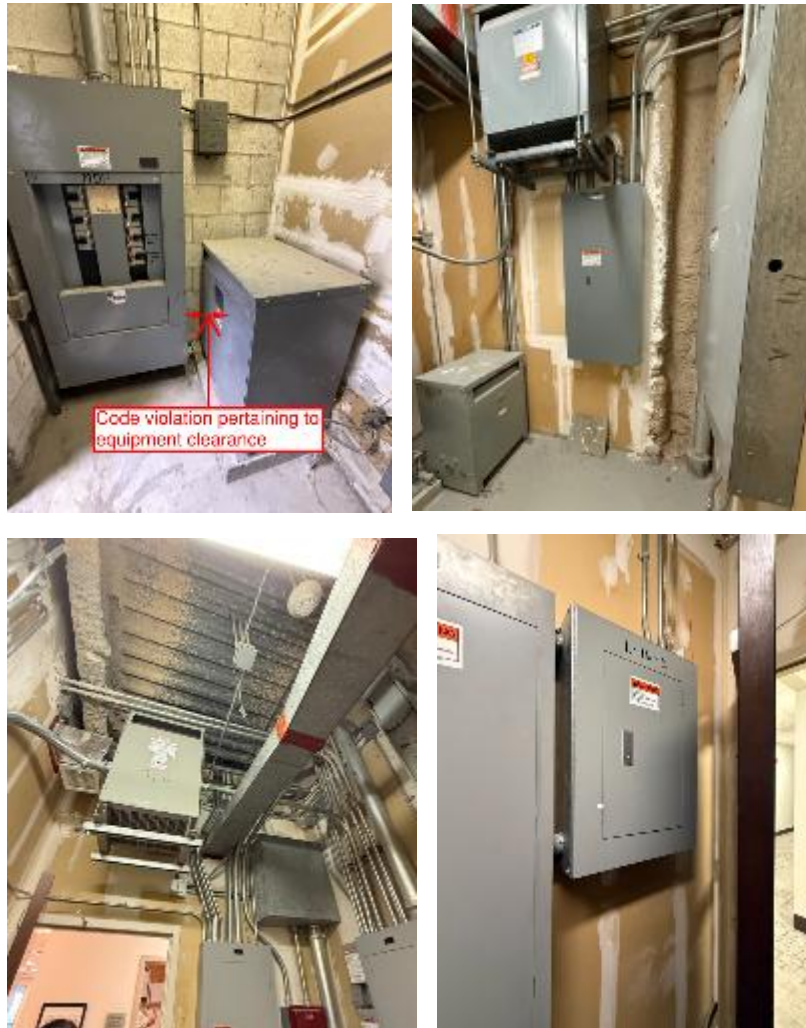
Figure 2A.6.6 Electrical equipment working clearance deficiencies

2A.6.6. Multiple electrical rooms contain working clearance deficiencies and equipment accessibility concerns.

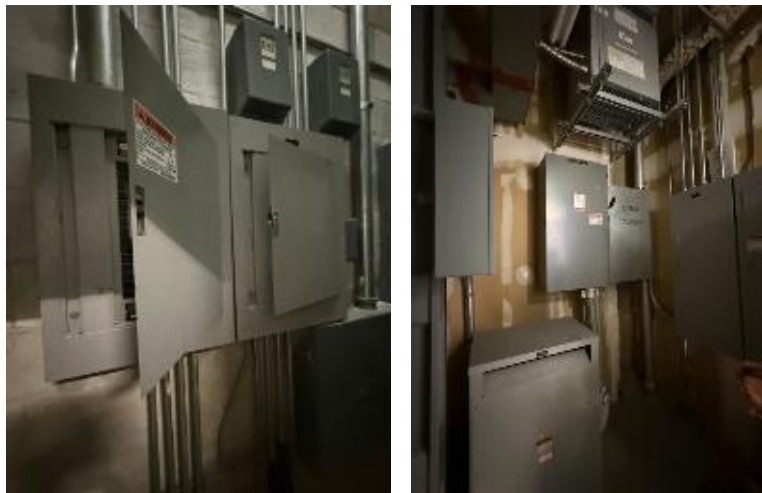
Figure 2A.6.7 Electrical rooms inadequate lighting levels

- 2A.6.7. Several electrical and mechanical rooms contain inadequate lighting levels for maintenance and operation activities.

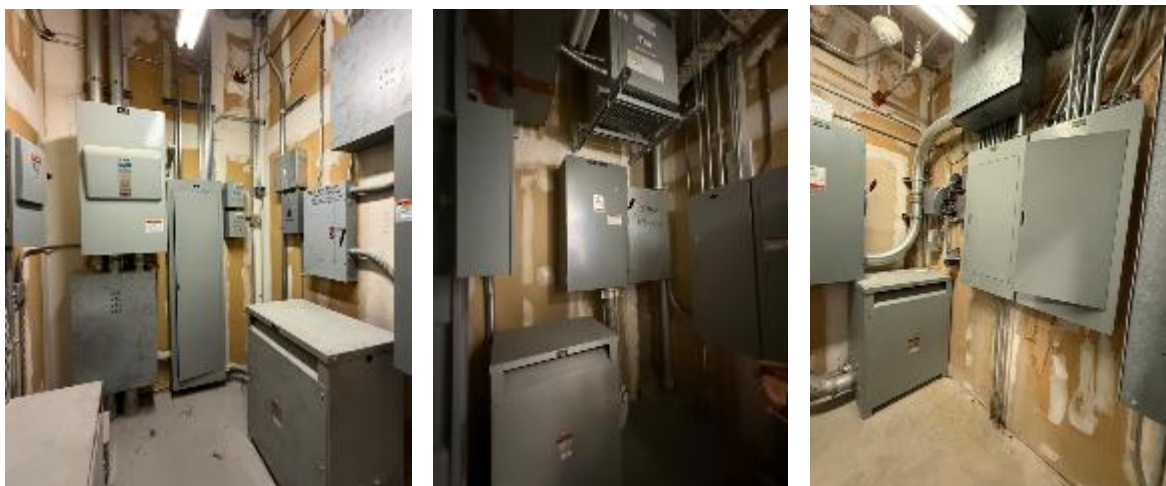
Figure 2A.6.8 Electrical rooms limited space

- 2A.6.8. Existing electrical rooms provide limited space for future expansion and installation of additional distribution equipment.

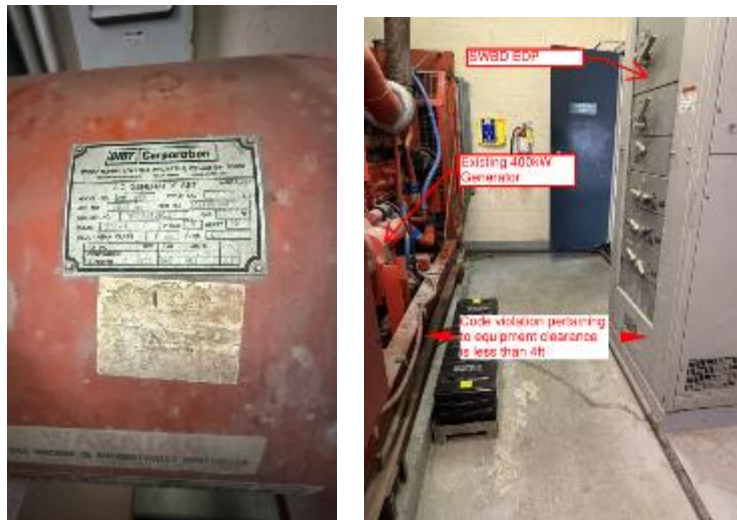
Figure 2A.6.14 Existing emergency generator

- 2A.6.14. The existing emergency generator is assumed to be operational based on discussions with facility personnel; however, the equipment appears aged, and exhibits limited remaining useful life.

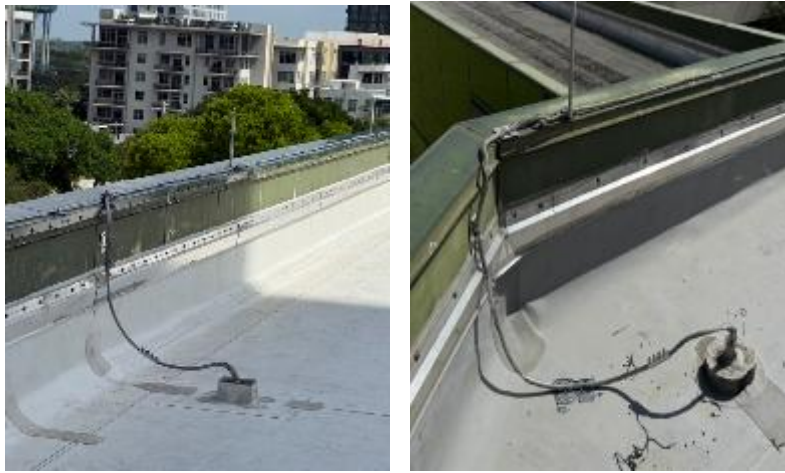
**Figure 2A.6.17 Existing lightning protection system on roof**

- 2A.6.17. The lightning protection system was reportedly upgraded in 2022 and appears to be in generally good condition.

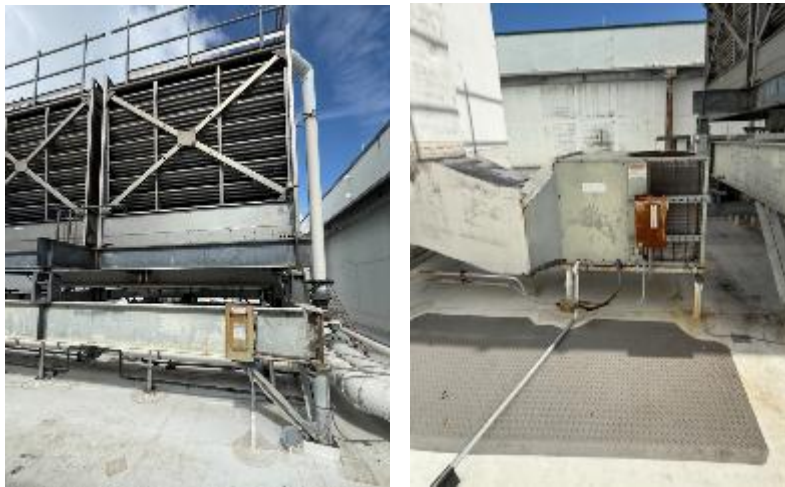
**Figure 2A.6.20 Existing disconnect switches on roof**

2A.6.20. Two rooftop disconnect switches exhibit visible corrosion and deterioration.

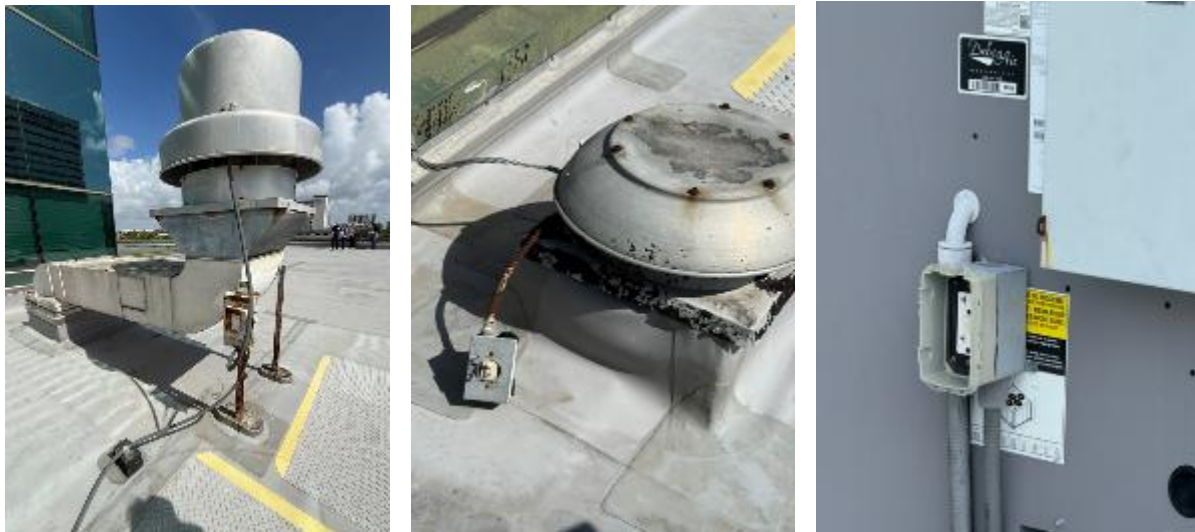
Figure 2A.6.22 Existing rooftop electrical equipment

2A.6.22. Additional rooftop electrical equipment exhibits age-related deterioration associated with long-term outdoor exposure.

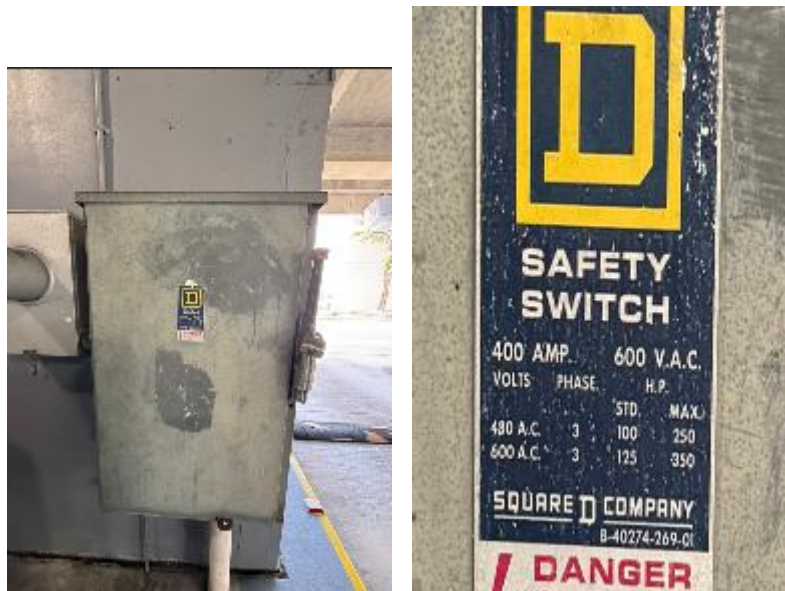
Figure 2A.6.24 Existing garage electrical service

2A.6.24. The existing garage electrical service appears insufficient to support the City's anticipated EV charging requirements.

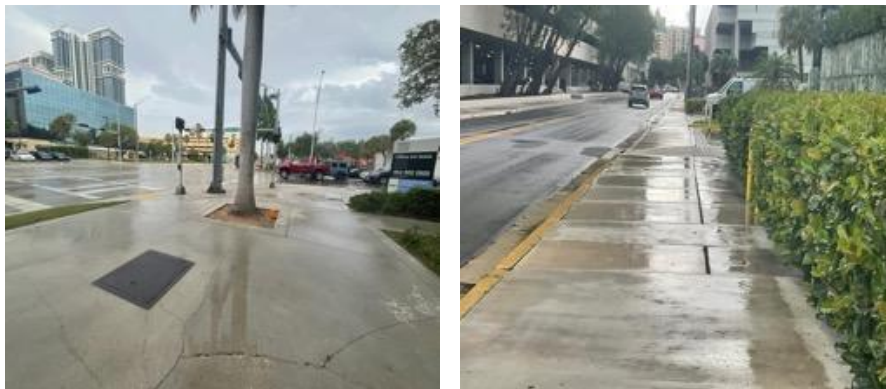
Figure 2A.8.2 Existing sidewalk cracks & horizontal gaps

2A.8.2 The existing sidewalks are ADA compliant and in relatively good condition. A few heavily cracked areas will need to be leveled and a few horizontal gaps in sidewalk slabs will need to be narrowed for wheelchair compliance, which would likely fall under the responsibility of the City.

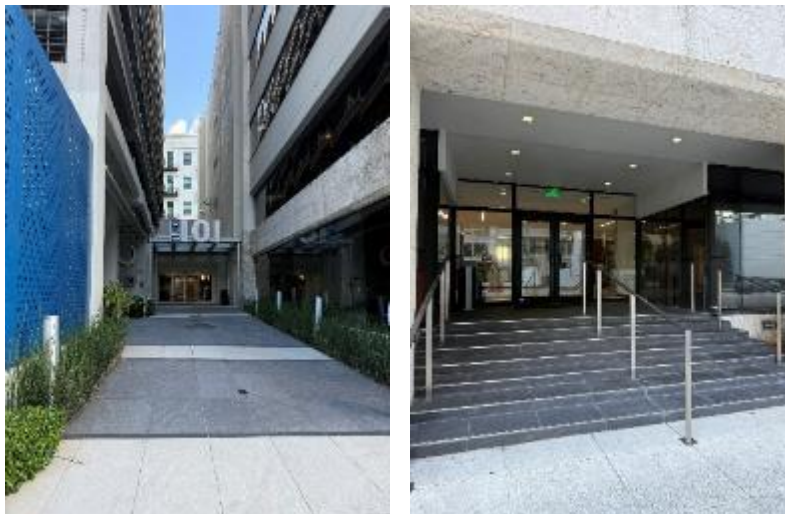
Figure 2B.3.7 Exterior access

2B.3.7. The main entrance is accessible from the street and the parking garage with a sidewalk slope that is not steeper than 1:12; however, the East side entrance is accessible only by stairs. This condition may require an accessibility modification if the renovations design is considered Alteration Level 3.

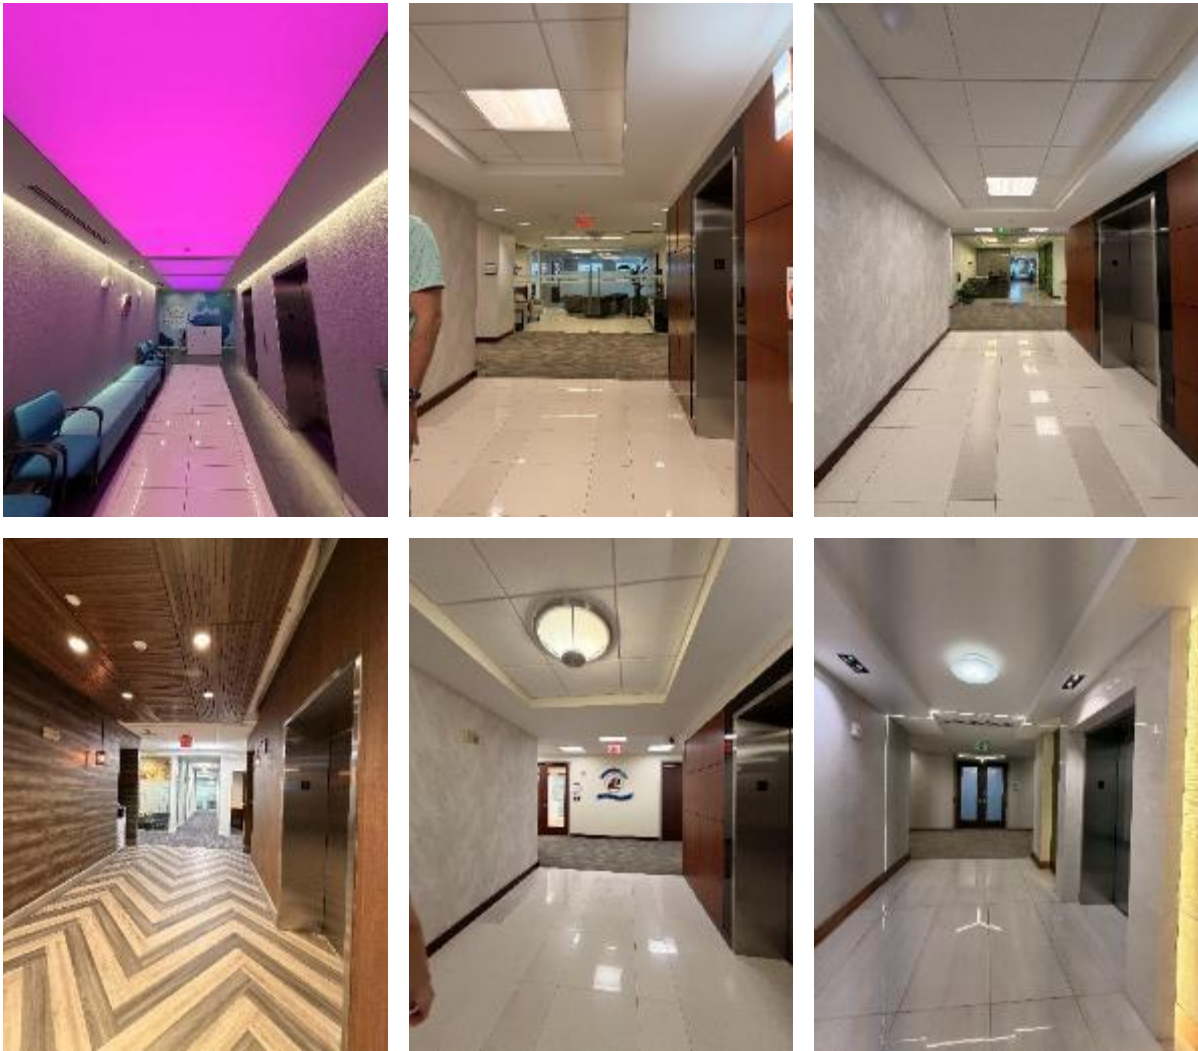
Figure 2B.3.8 Elevator lobbies

2B.3.8. Most of the elevator lobby areas have been renovated with new carpets and finishes; however, renovations do not appear to be uniform or consistent between floors. There is no evidence of loose carpeting or missing floor tiles.

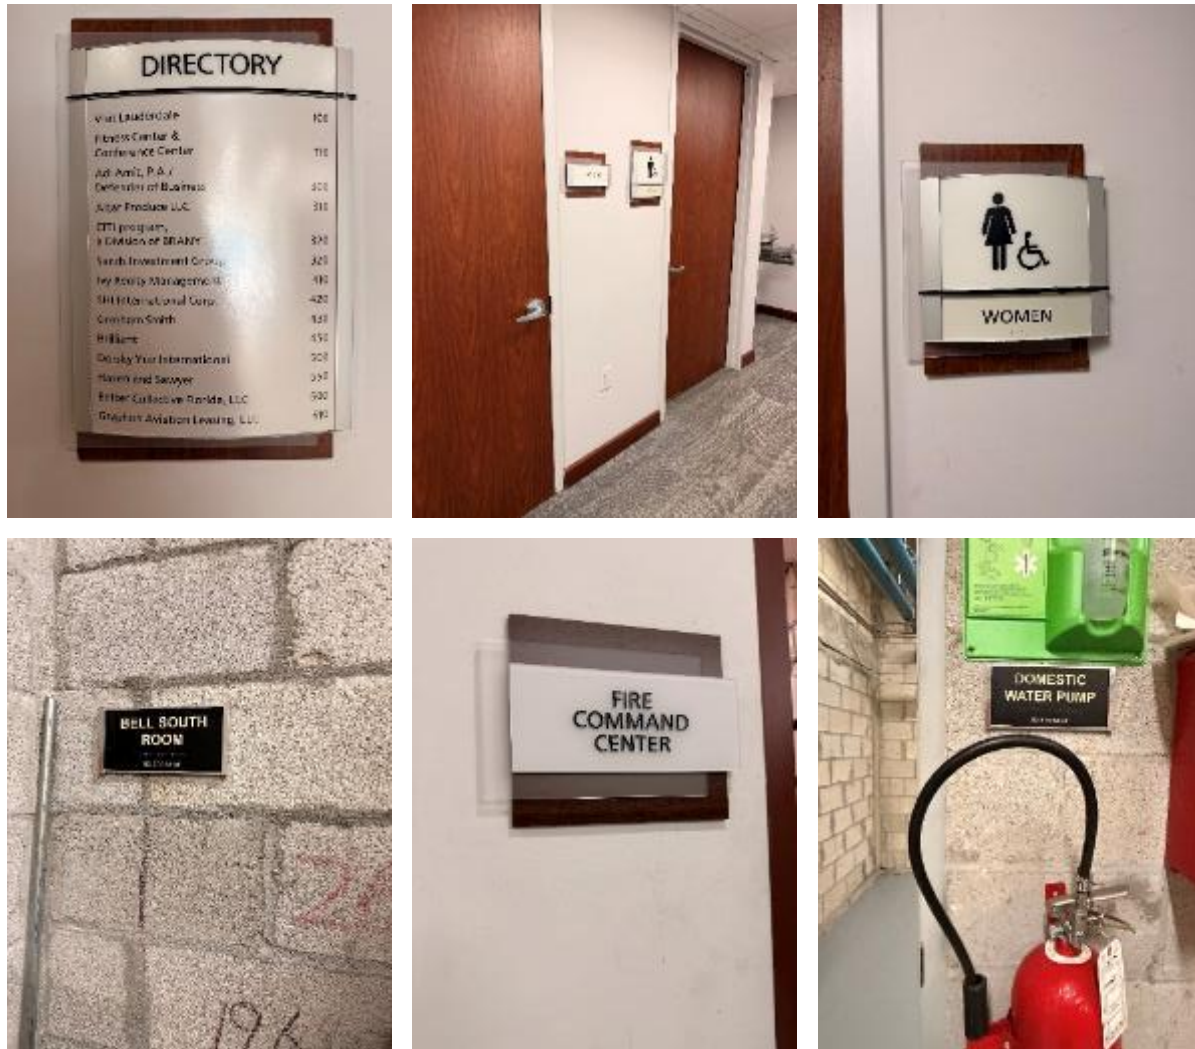
Figure 2B.3.10 Interior signage

2B.3.10. Signage was renovated throughout the building and includes accessible features. Most office signage will need to be revisited as part of the tenant improvements.

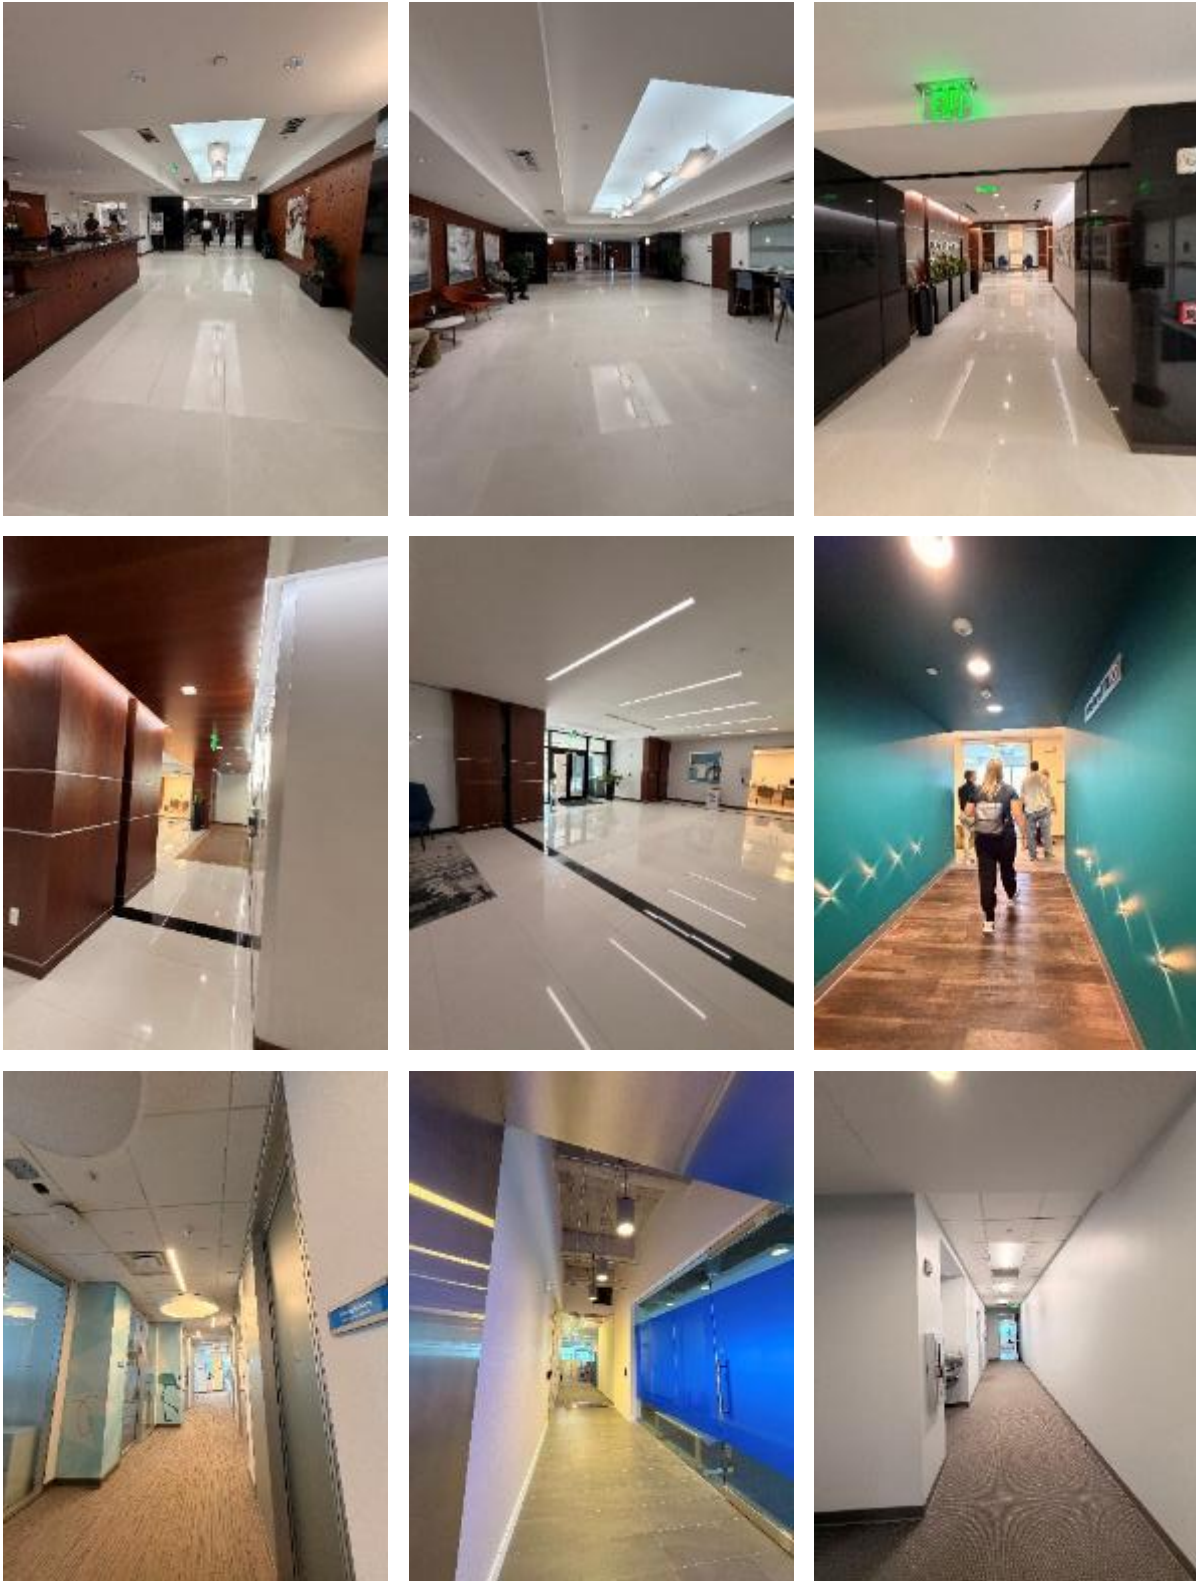
**Figure 2B.3.11 Interiors**

2B.3.11. Ceilings and lighting are overall in good condition. All floors have tenant build outs, either occupied by single or multiple tenants, and if a consistent appearance is desired, ceilings and lighting would need to be replaced in approximately 75% of the spaces.

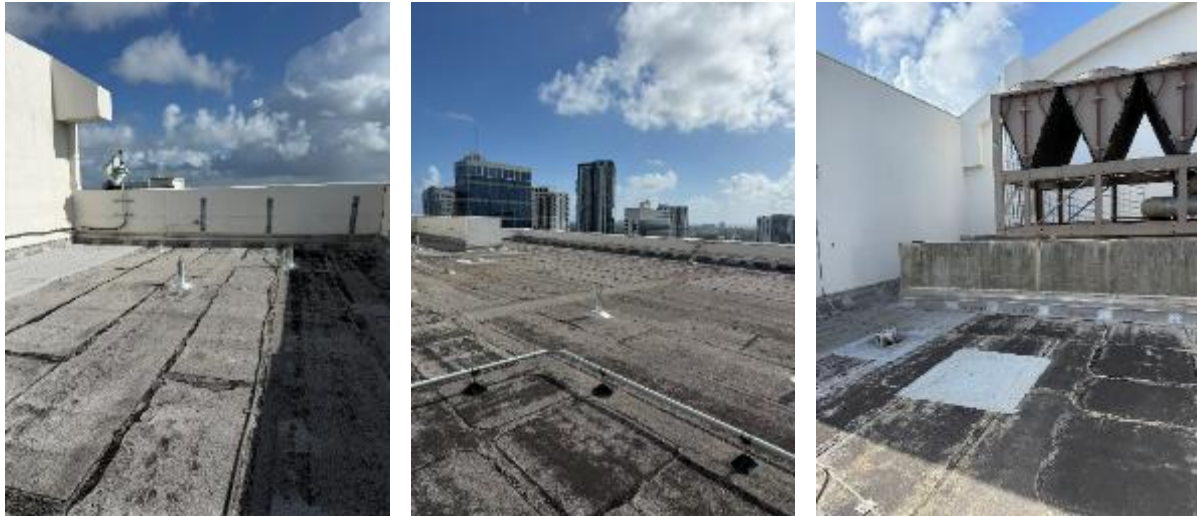
**Figure 2B.3.12 Roof**

2B.3.12. Roof, flashing and drains, are generally maintained in good operational condition but are over 25 years old, nearing the end of remaining useful life.

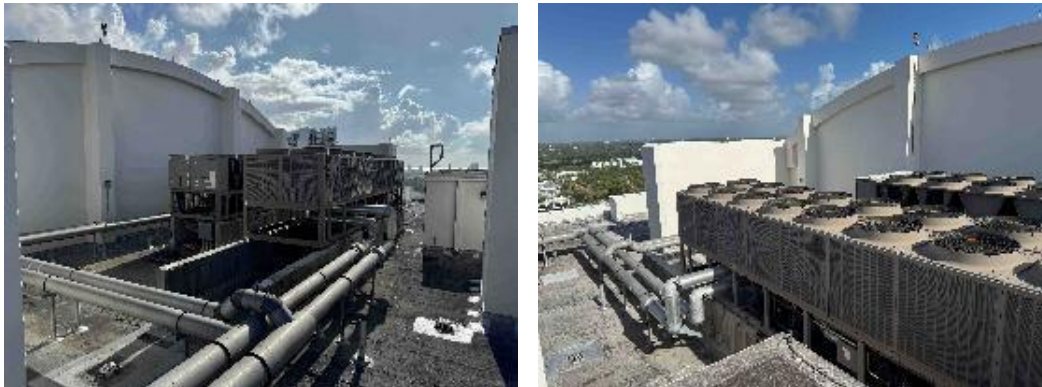
Figure 2B.4.1 Chillers

2B.4.1 The facility is served by two chillers, one replaced in 2021, currently in good operating condition with no immediate deficiencies observed. Second chiller significantly older, exhibits signs of age-related wear and reduced reliability. Replacement of the older chiller is recommended in the near term to improve overall system reliability, operational efficiency, and maintainability, as continued reliance on a mixed-age chiller plant presents increased risk during peak load conditions or unplanned outages.

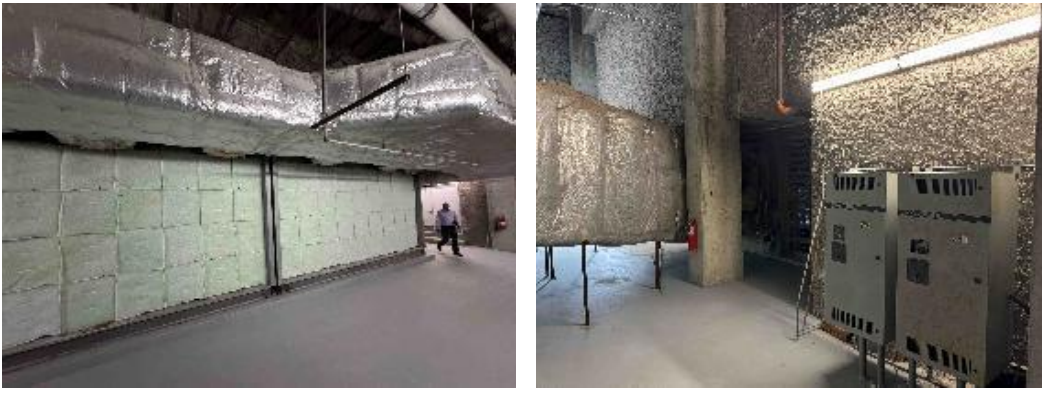
**Figure 2B.4.2 Penthouse AHUs**

2B.4.2 AHU-1a and AHU-1b (Rooftop Penthouse) are large, combined air handling units located within the rooftop penthouse and serve Floors 7 through 21. Both are currently in good operating condition, and appear to have been well maintained; however, based on available information, they were manufactured over 25 years ago. While operationally sound at the time of this report, these units have exceeded typical service life expectations. Replacement is recommended due to age and long-term reliability concerns. This work may pose significant engineering and logistical challenges, as the systems serve multiple occupied floors. Replacement will require either temporary cooling systems, or full or partial vacancy of the floors served during demolition and installation.

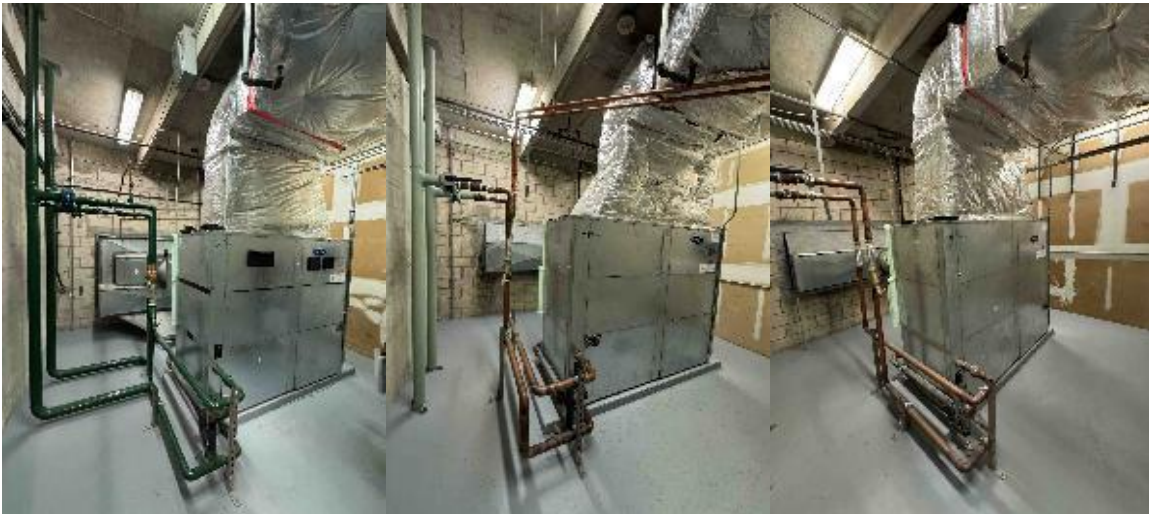
**Figure 2B.4.3 AHUs in good condition**

2B.4.3 AHU-2, AHU-3, and AHU-4 were manufactured in 2013 and are currently in good condition; not expected to require replacement within the next five years. Continued preventive maintenance is recommended to sustain performance.
