# City of Fort Lauderdale Comparative Facility Analysis Report

*An Assessment of Three Existing Buildings for Potential  
Conversion to a New City Hall*

City of Fort Lauderdale, Florida

June 18, 2026

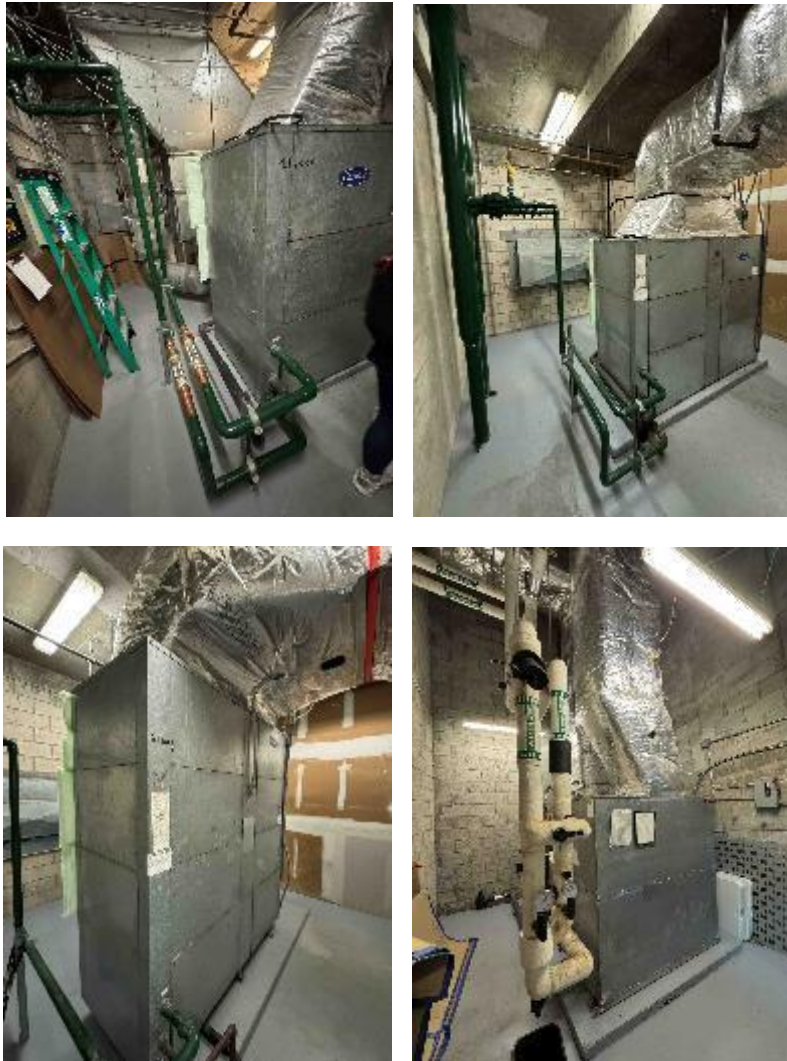
Figure 2B.4.4 AHUs needing replacement

2B.4.4 AHU-1 (manufactured in 2006), AHU-5 (manufactured in 2007), AHU-6 (manufactured in 2006), and the AHU serving the lobby are in comparatively worse condition than the newer AHUs; should be scheduled for replacement within the next five years as they approach the end of their useful service life.

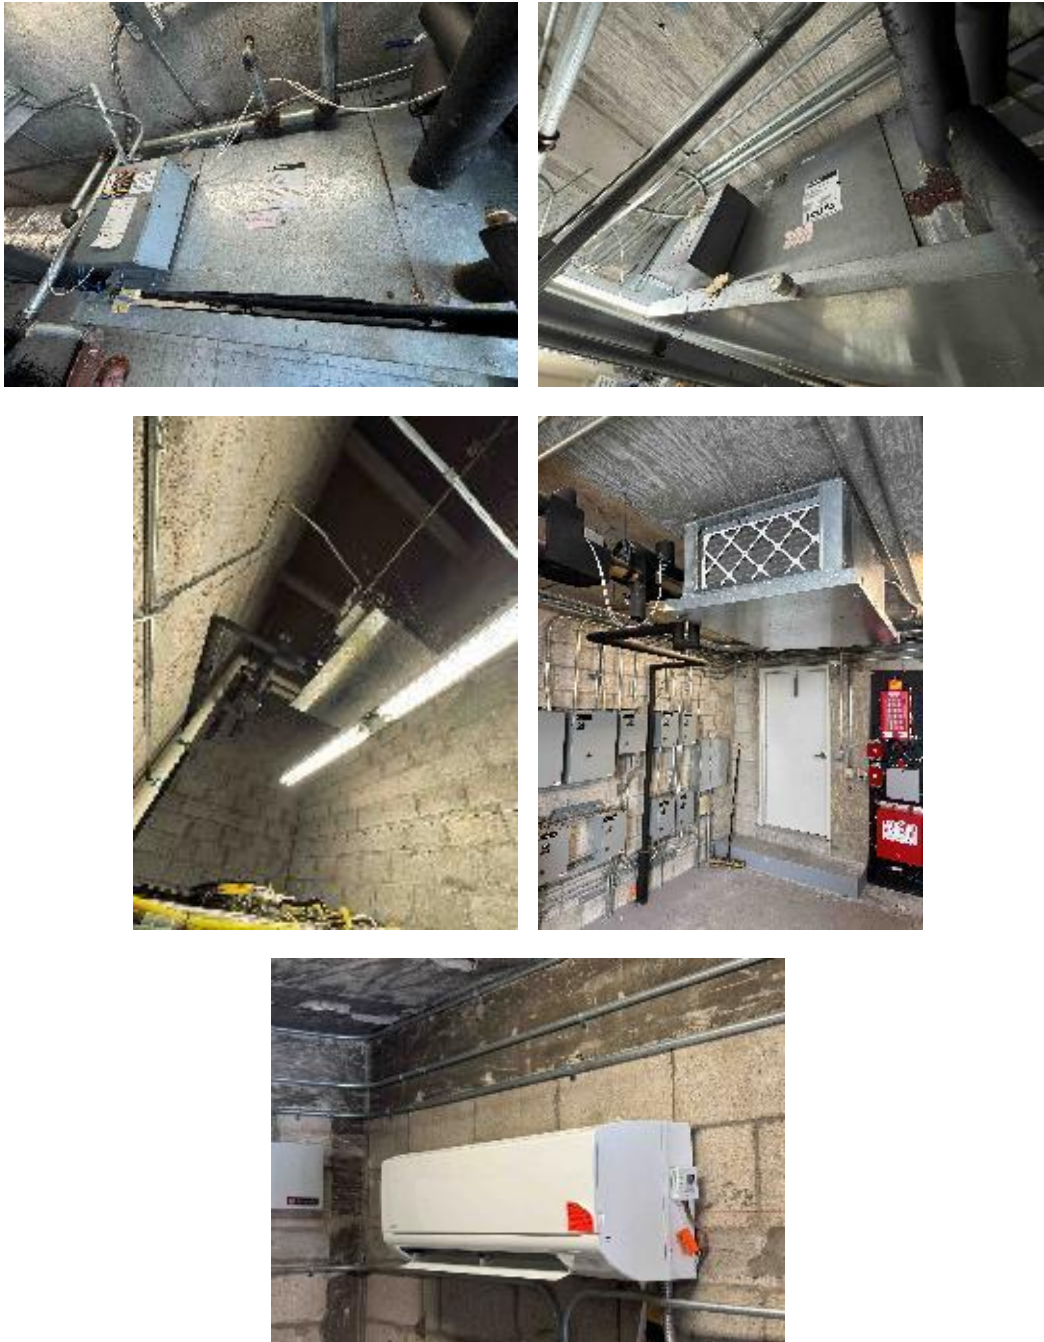
Figure 2B.4.5 Fan Coil Units

2B.4.5 Fan Coil Units (FCU): FCU-1, FCU-2, FCU-3, FCU-4, and FCU-5 were all manufactured over 25 years ago; although they are currently in generally good condition, they have exceeded their typical lifecycle. These units should be replaced to improve system reliability, reduce maintenance requirements, and enhance occupant comfort.

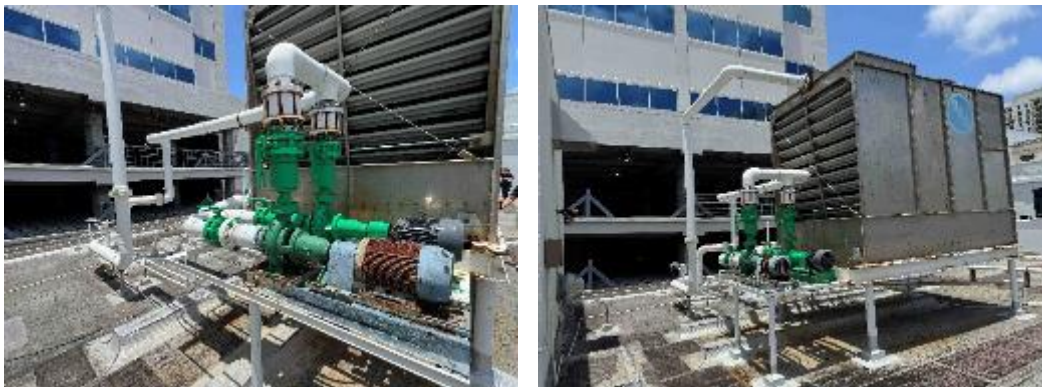
**Figure 2B.4.8 Cooling tower**

2B.4.8 Existing cooling tower on the lower roof in poor condition, should be prioritized for replacement.

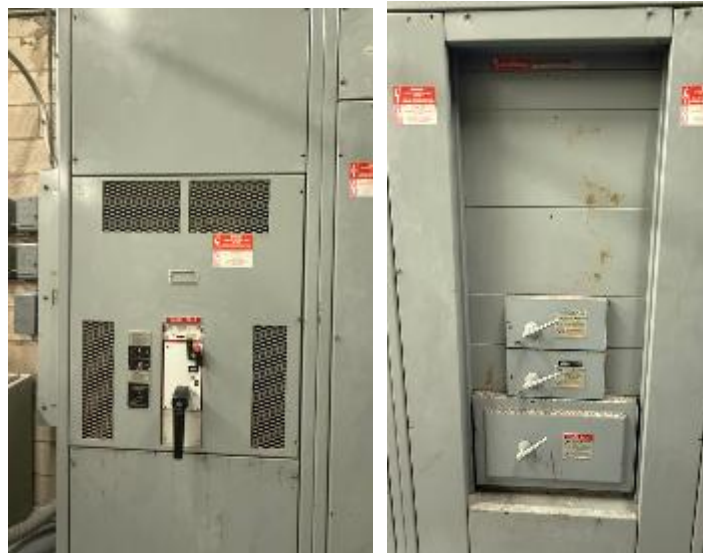
**Figure 2B.6.3 Electrical Distribution equipment serving the 6-story tower**

2B.6.3. Due to the age of the Center electrical infrastructure and anticipated future municipal occupancy requirements, replacement of major portions of electrical distribution infrastructure should be considered as part of future modernization efforts.

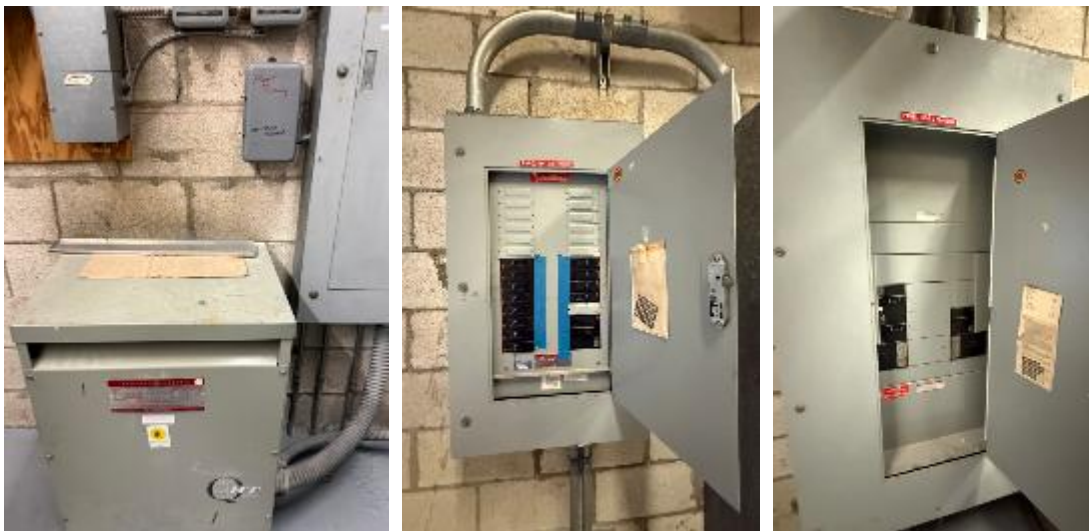
**Figure 2B.6.4 Existing electrical panels (Center)**

2B.6.4. Several panel schedules are outdated and do not accurately reflect existing tenant loads and circuit assignments.

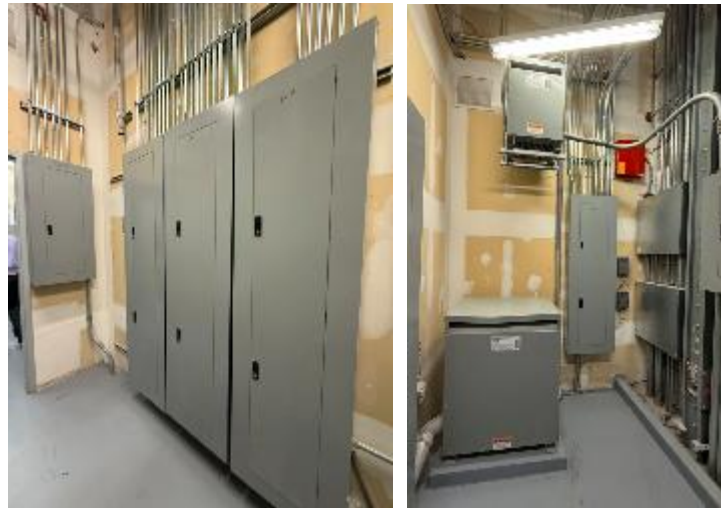
Figure 2B.6.6 Example of electrical room layout

2B.6.6. Electrical rooms throughout the facility are generally well maintained and provide adequate working clearances.

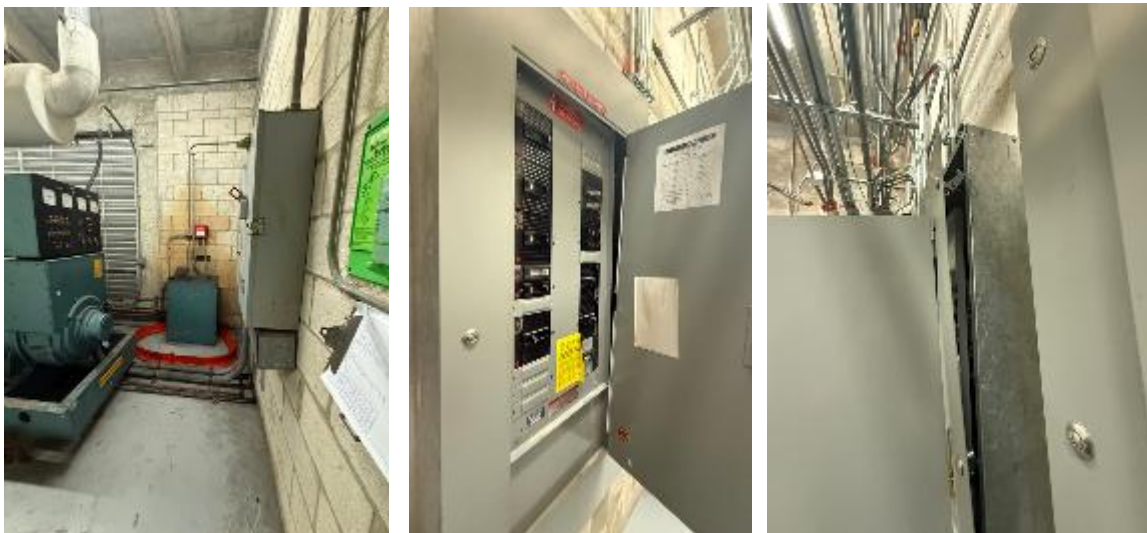
Figure 2B.6.7 Existing electrical equipment

2B.6.7. Minor code-related deficiencies were observed including outdated labeling, incomplete panel schedules, and isolated maintenance concerns.

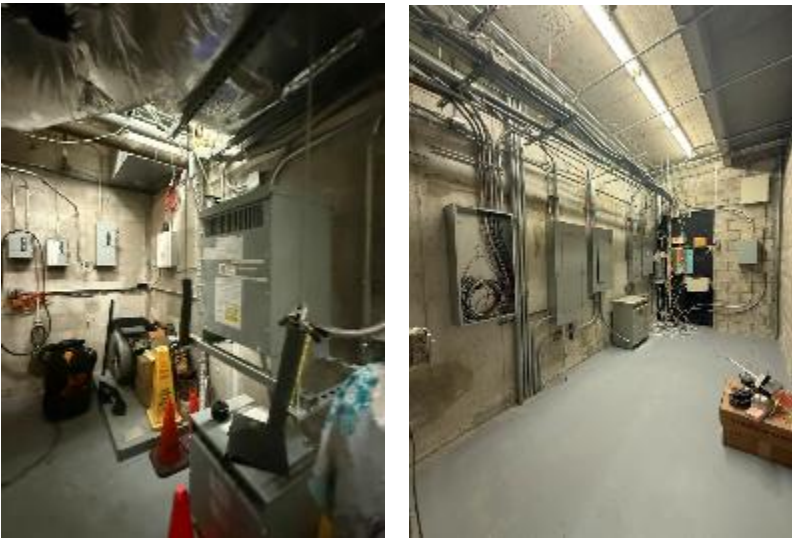
Figure 2B.6.8 Electrical Rooms lighting examples

2B.6.8. Selected electrical and telecommunications rooms contain inadequate lighting levels and should be upgraded as part of future renovations.

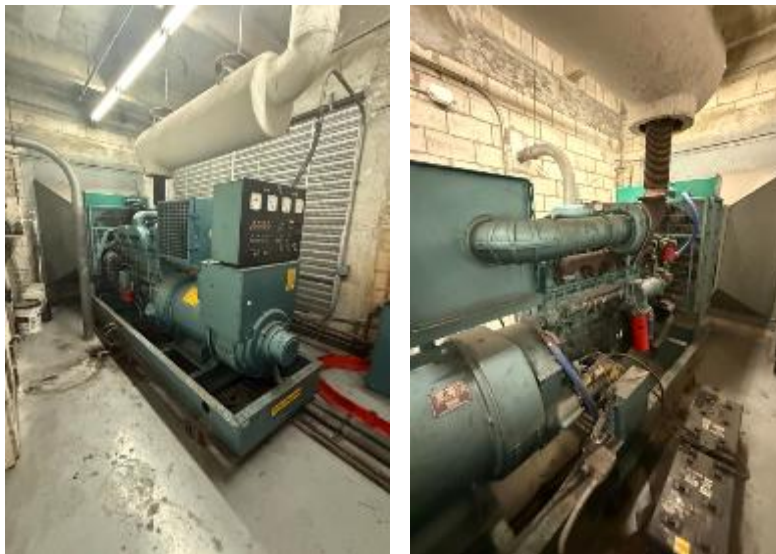
**Figure 2B.6.14 Emergency generator (Center)**

- 2B.6.14. The 230 kW emergency generator serving the Center appears operational but exhibits signs of age and long-term service.

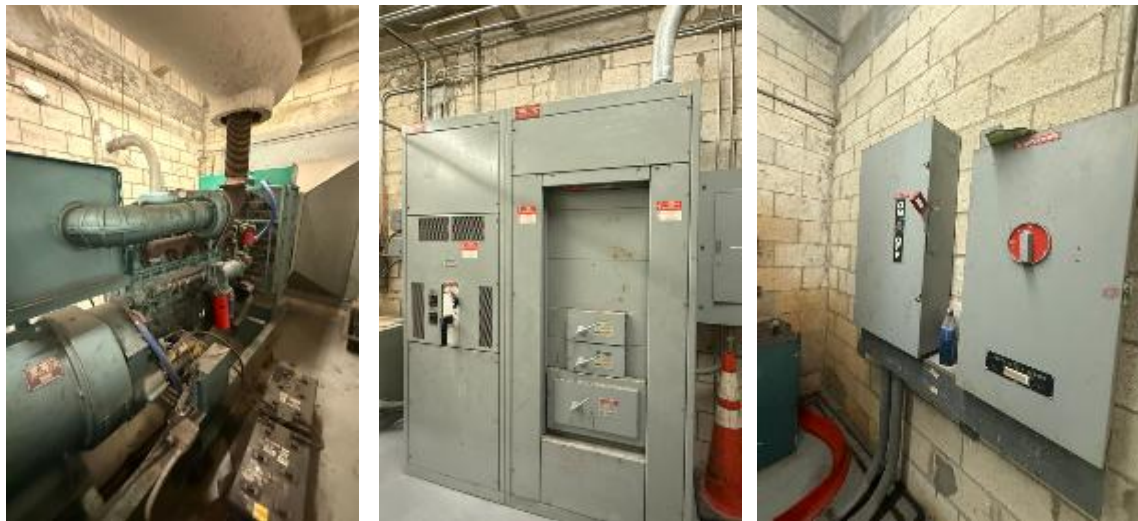
**Figure 2B.6.16 Center generator and associated emergency power distribution**

2B.6.16. Due to the age of the equipment, limited remaining useful life, and future municipal occupancy requirements, replacement of the Center's generator and associated emergency power distribution infrastructure should be considered as part of future modernization efforts.

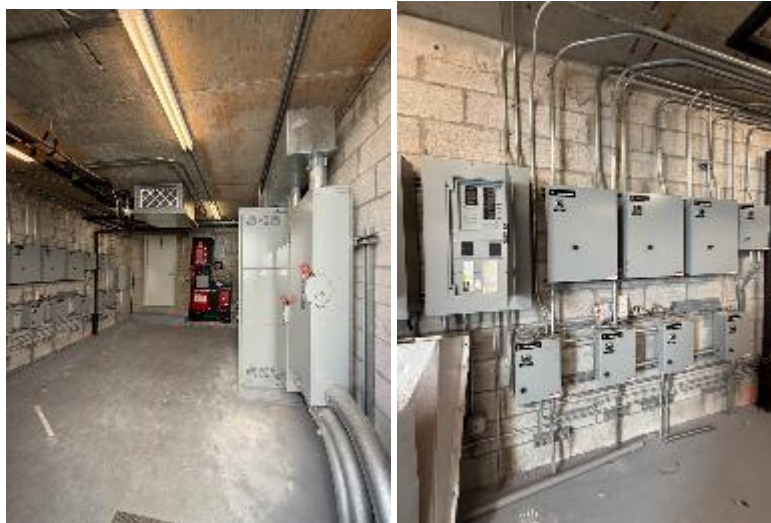
**Figure 2B.6.21 Rooftop electrical equipment**

2B.6.21. Rooftop electrical equipment is generally in fair to good condition.

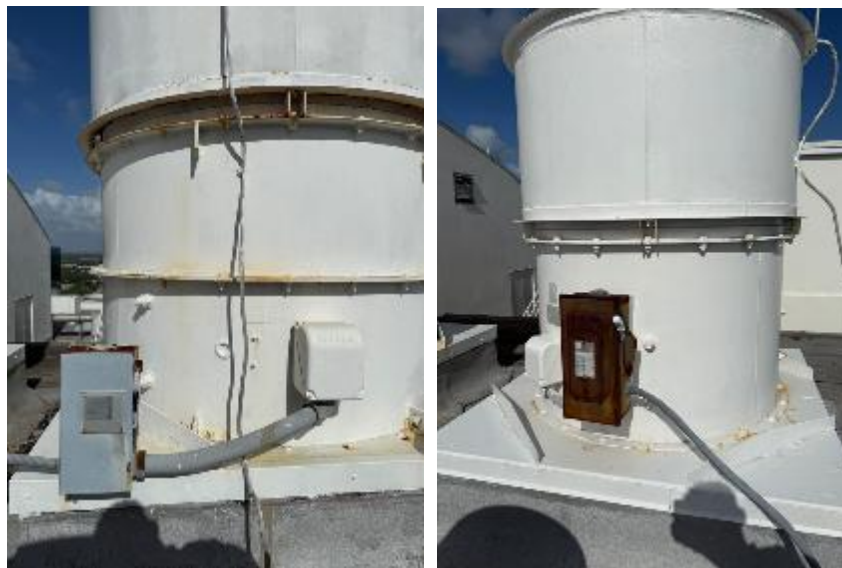
2B.6.22. Isolated corrosion, aging disconnect switches, and weather-related deterioration were observed on selected rooftop equipment.

**Figure 2B.6.22 Isolated corrosion, aging disconnect switches on the roof**

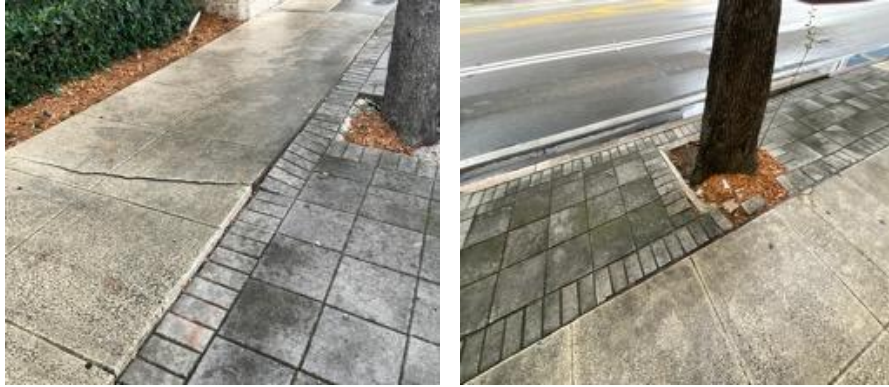
2B.8.1 Concrete sidewalks exist along NE 1<sup>st</sup> Street and NE 3<sup>rd</sup> Avenue. These streets are designated public roadways and are maintained by the City of Fort Lauderdale. The existing sidewalks are ADA compliant and in relatively good condition. A few heavily cracked areas will need to be leveled and several of the existing planted trees within the sidewalks will require tree grates to keep pedestrian pathways clear.

Figure 2B.8.1 Existing sidewalk cracks & Recommend tree grates (typical)

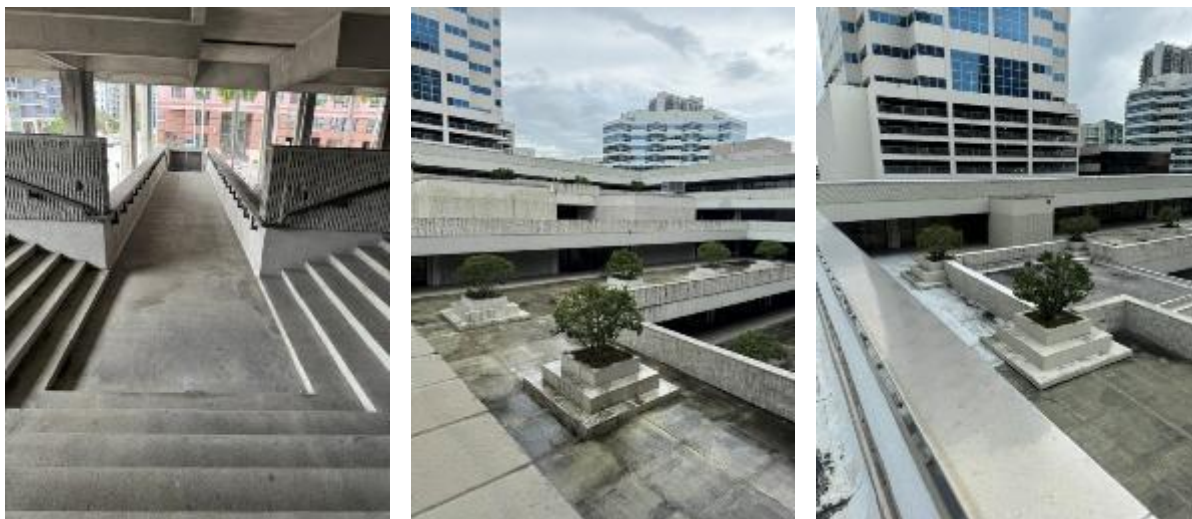
Figure 2C.3.3 Terraces

- 2C.3.1. Parking garage (for employees only) below building has no accessible (ADA-compliant) parking spaces, nor accessible route into building.
- 2C.3.2. Elevated exterior terraces do not have code-compliant 42" high guards; terrace walls are too short (33"); in some areas walls have supplementary metal rail, which is also too short (37.5").
- 2C.3.3. Some small areas of ponding observed on terraces; however they appear to have adequate drainage, with no reported issues of water damage to the interior resulting from water accumulation on the terrace. Most areas of the terrace appear dirty; maintenance advised power washing occurs approximately twice a year.

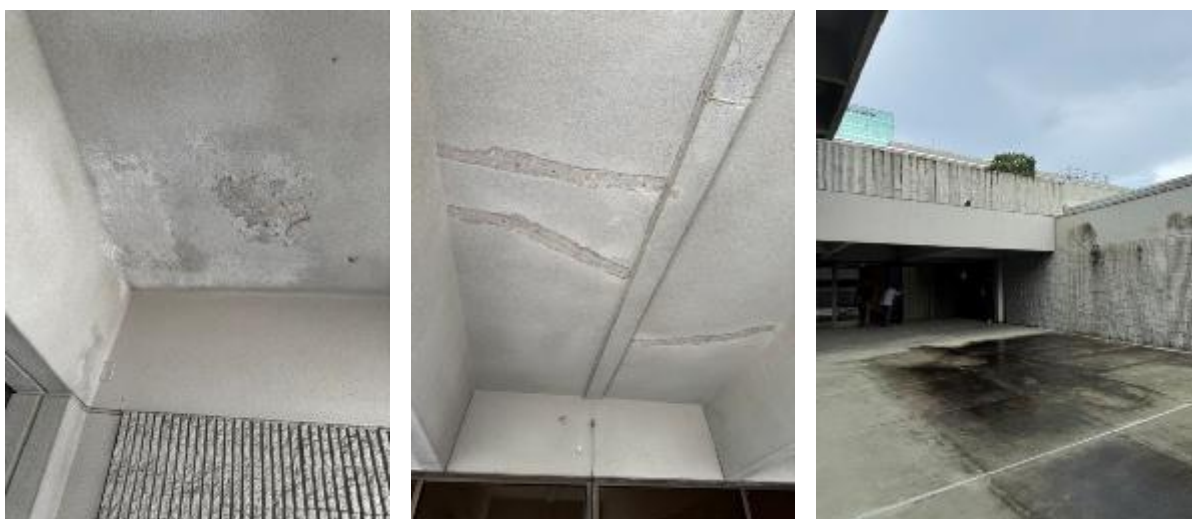
**Figure 2C.3.4 Exterior Surfaces**

- 2C.3.4. Several areas of surface patching were observed on the exterior in various locations, on columns, beams, terrace ceilings, and vertical surfaces. Many vertical surfaces have visible staining due to water accumulation or runoff.

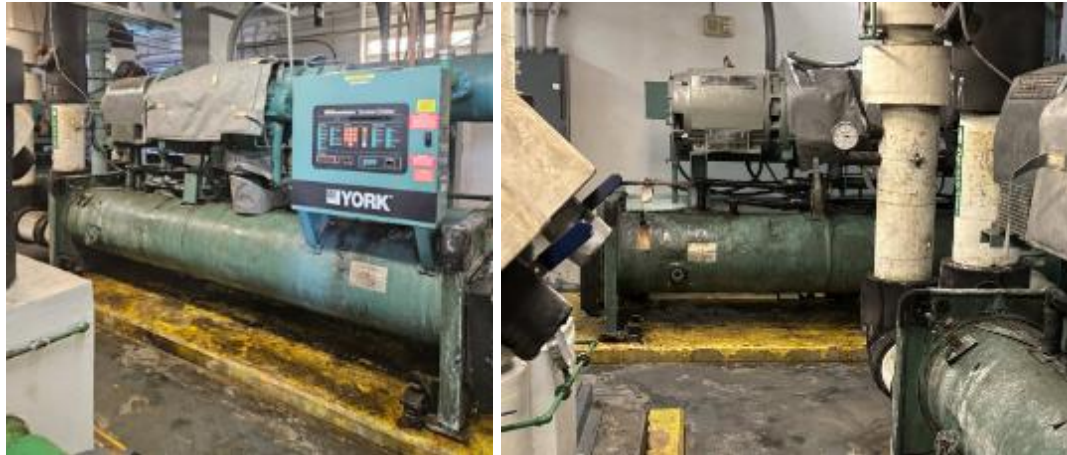
2C.4 1 Chillers with visible wear

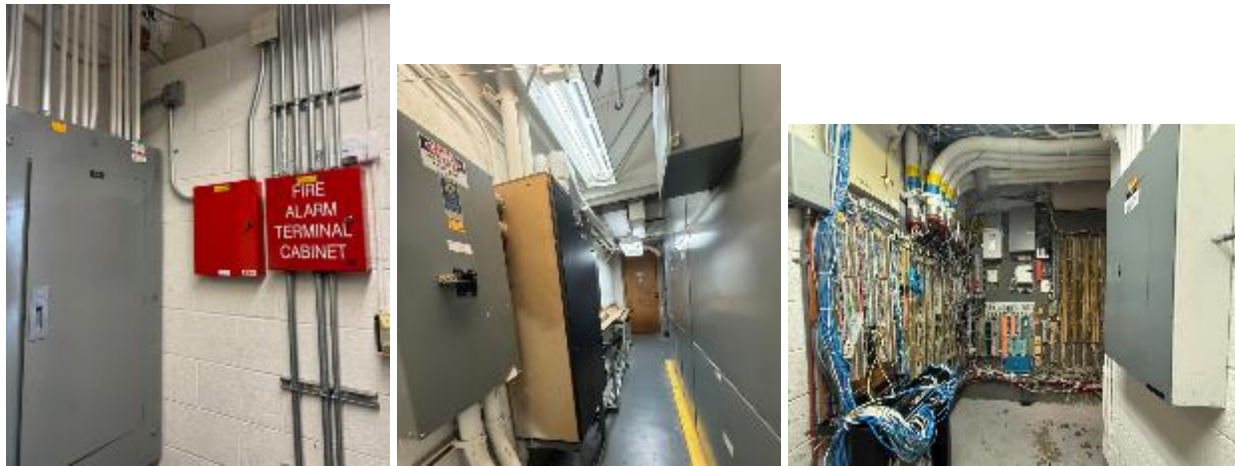
2C.6.6. Multiple electrical room working clearance deficiencies were observed throughout the facility.

Figure 2C.6.6 Examples of electrical room working clearance deficiencies

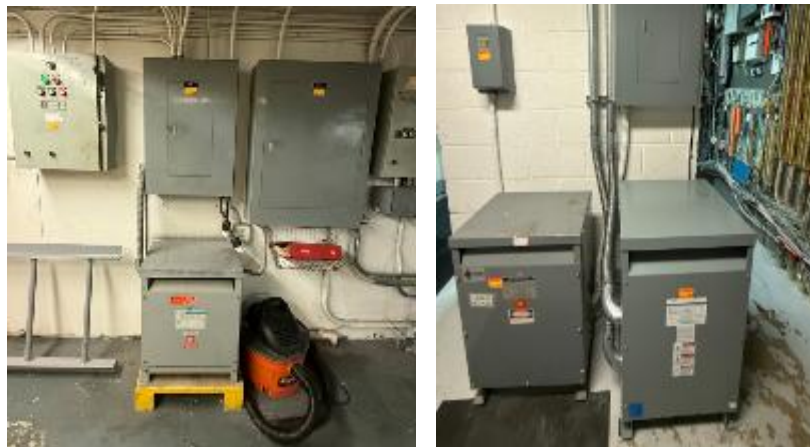
Figure 2C.6.7 Electrical panels with accessibility and clearance deficiencies

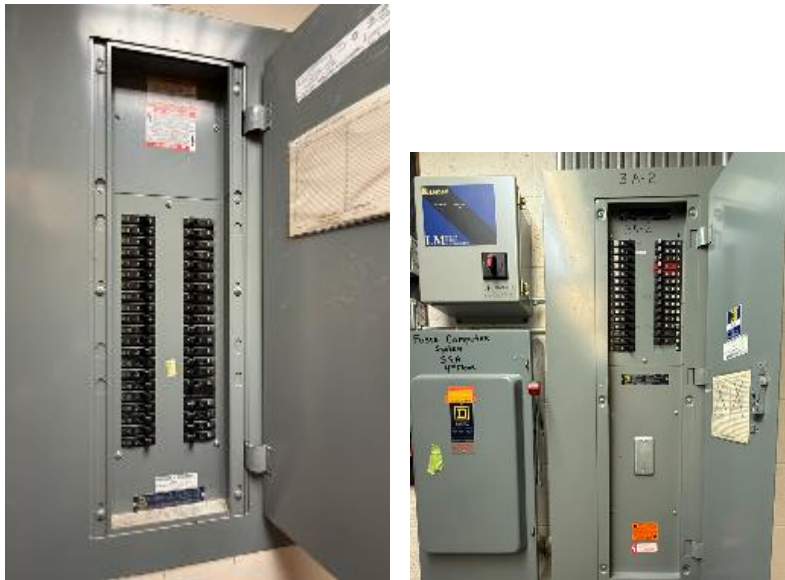
Figure 2C.6.10 Electrical Panels with Missing Breaker Identification

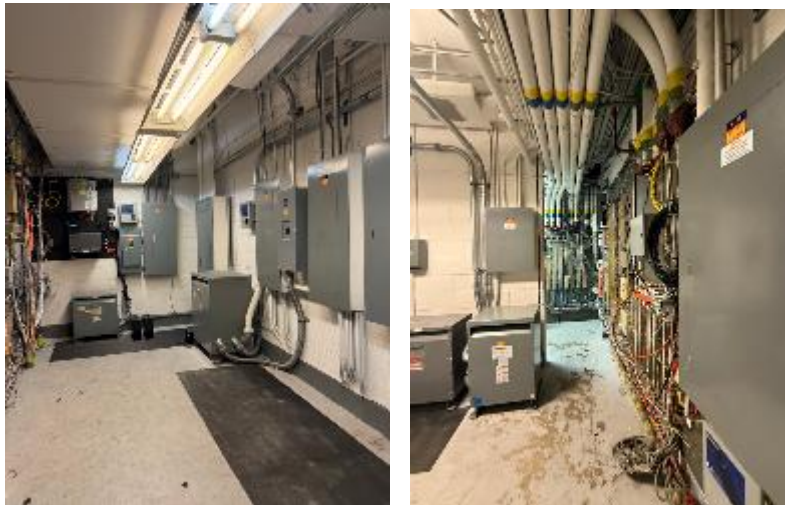
Figure 2C.6.10 Electrical rooms limited space
