March 1, 2017

Data Center and UPS Room Audit

Report #1702019

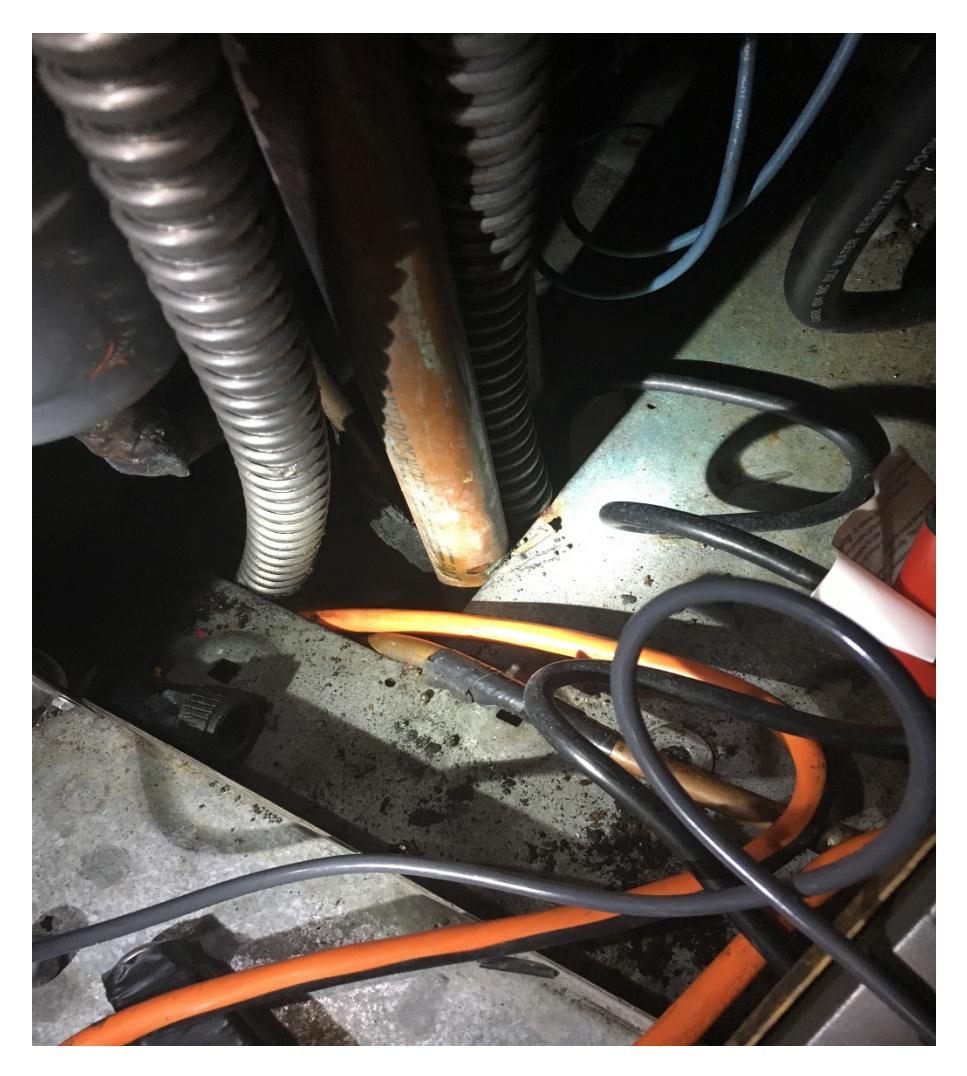
Unsupported hot-gas & water make up line for APC unit. The lines are in contact with sharp edge of sheet metal and are subject to rub-through. Mechanical stress is also on the joints from sagging. Also note the lack of insulation on the hot-gas lines.

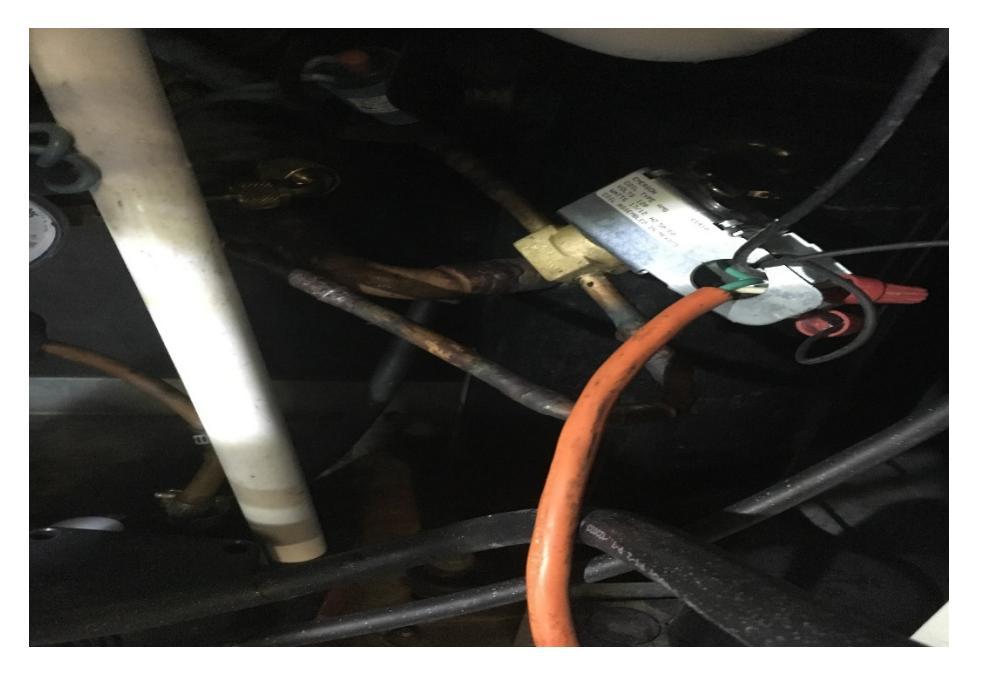
This valve was added to the unit. It directly bypasses hot gas to the suction line drier at all times due to design.

The unit appears to have had several major repairs made to it over its short operational life. The workmanship is clearly substandard and will cause further damage to system. Due to the cool, turbulent air and high conductivity of the copper, the temperature of the hot gas lines are dropping about 30° F. The amount of heat added back to the room should not be underestimated.

- <u>EOC</u> center: the most pressing issues found are with the APC cooling equipment. The unit is not operating as designed due to leaks and field modifications made. Refrigerant piping is lacking necessary oil traps per design and condenser doesn't have low voltage control wireing interconnecting with air handler. Also, airflow design may be deficient to minimum requirements. The modification to space volume and lack of room being sealed will result in clean agent fire suppression being ineffective.

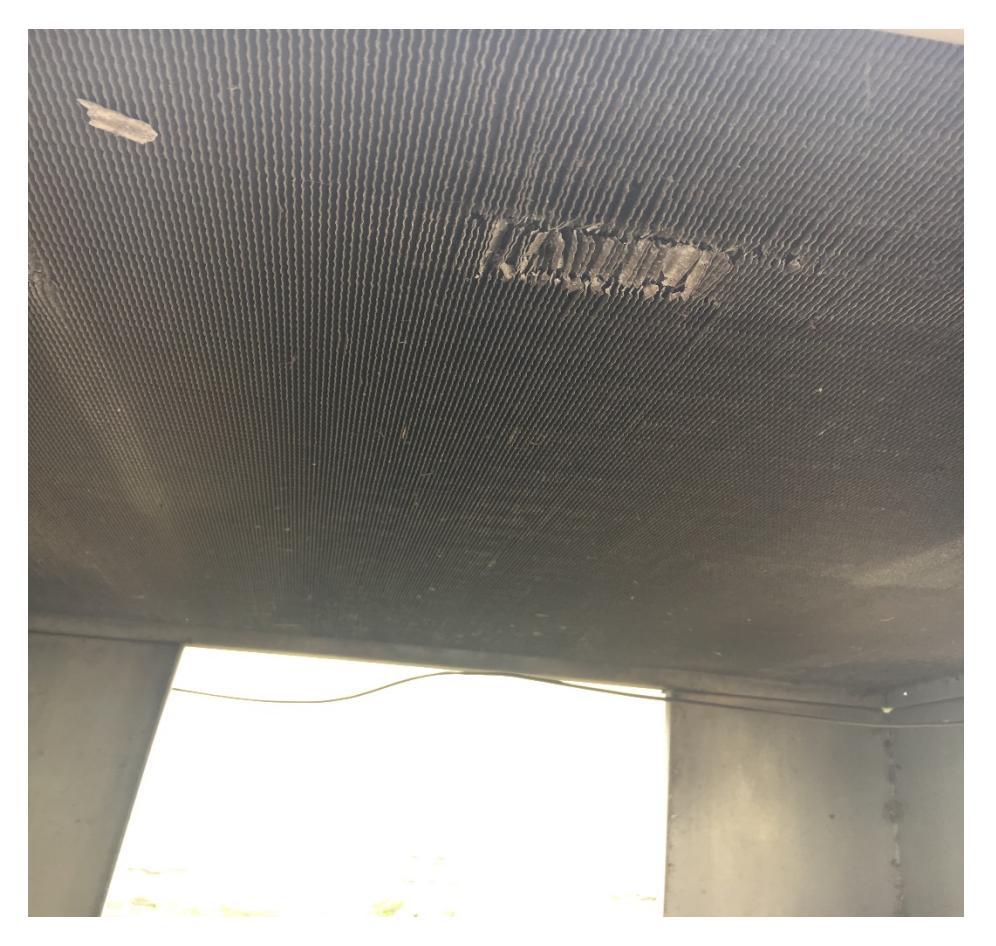
Stulz CRAC condensing unit coil badly corroded. View from bottom shows flaking fins that are typical in 10+ year old condensing units in humid environments.

- 2. <u>Public Works</u> building: the most impactful issues is the Stulz CRAC. Unit is leaking refrigerant, condenser is badly degraded and piping is not designed correctly. This site is also without fire protection.

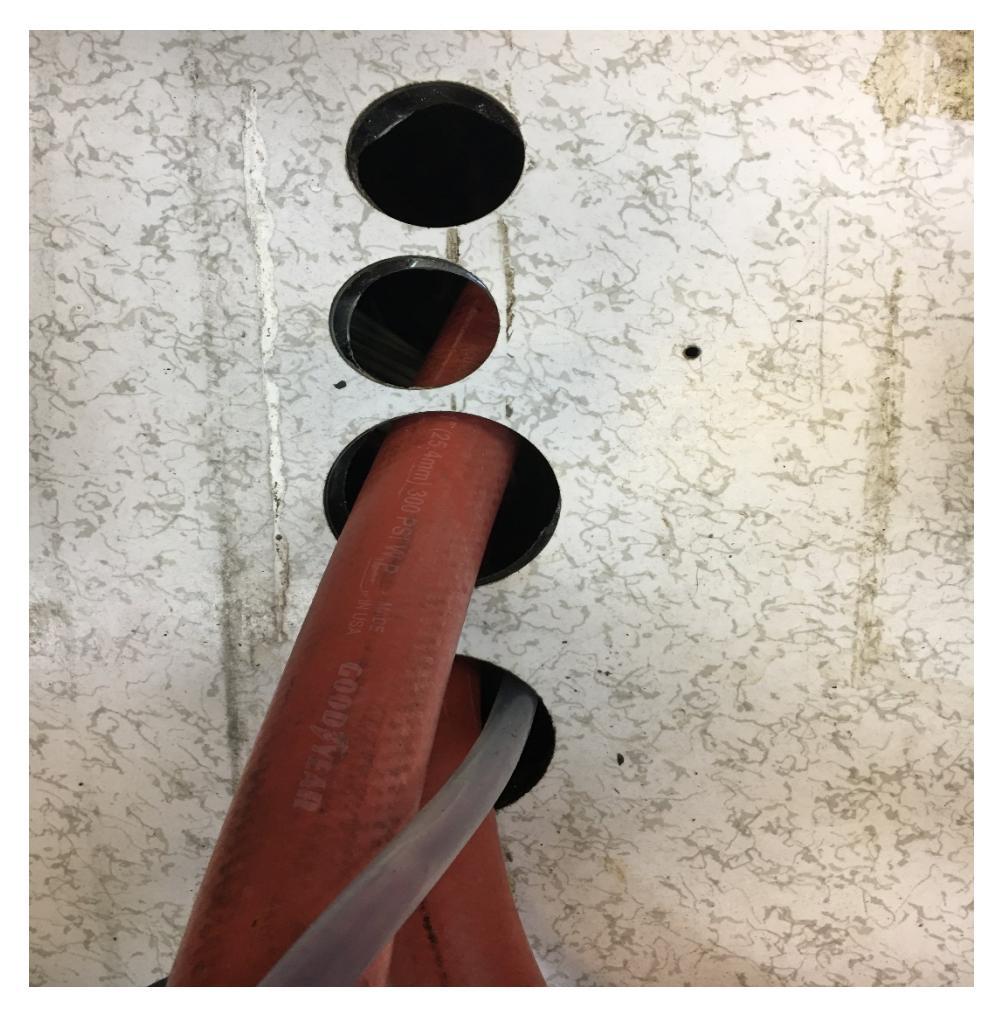
Flexible water lines being cut by sharp edges of floor tiles.

connected to the Bosh units is a serious risk to water damage and flooding inside building. This site has fire system disabled leaving room at risk of fire. The control wiring to generator is run inside high voltage piping. This will induce voltage in control wiring and cause issues.

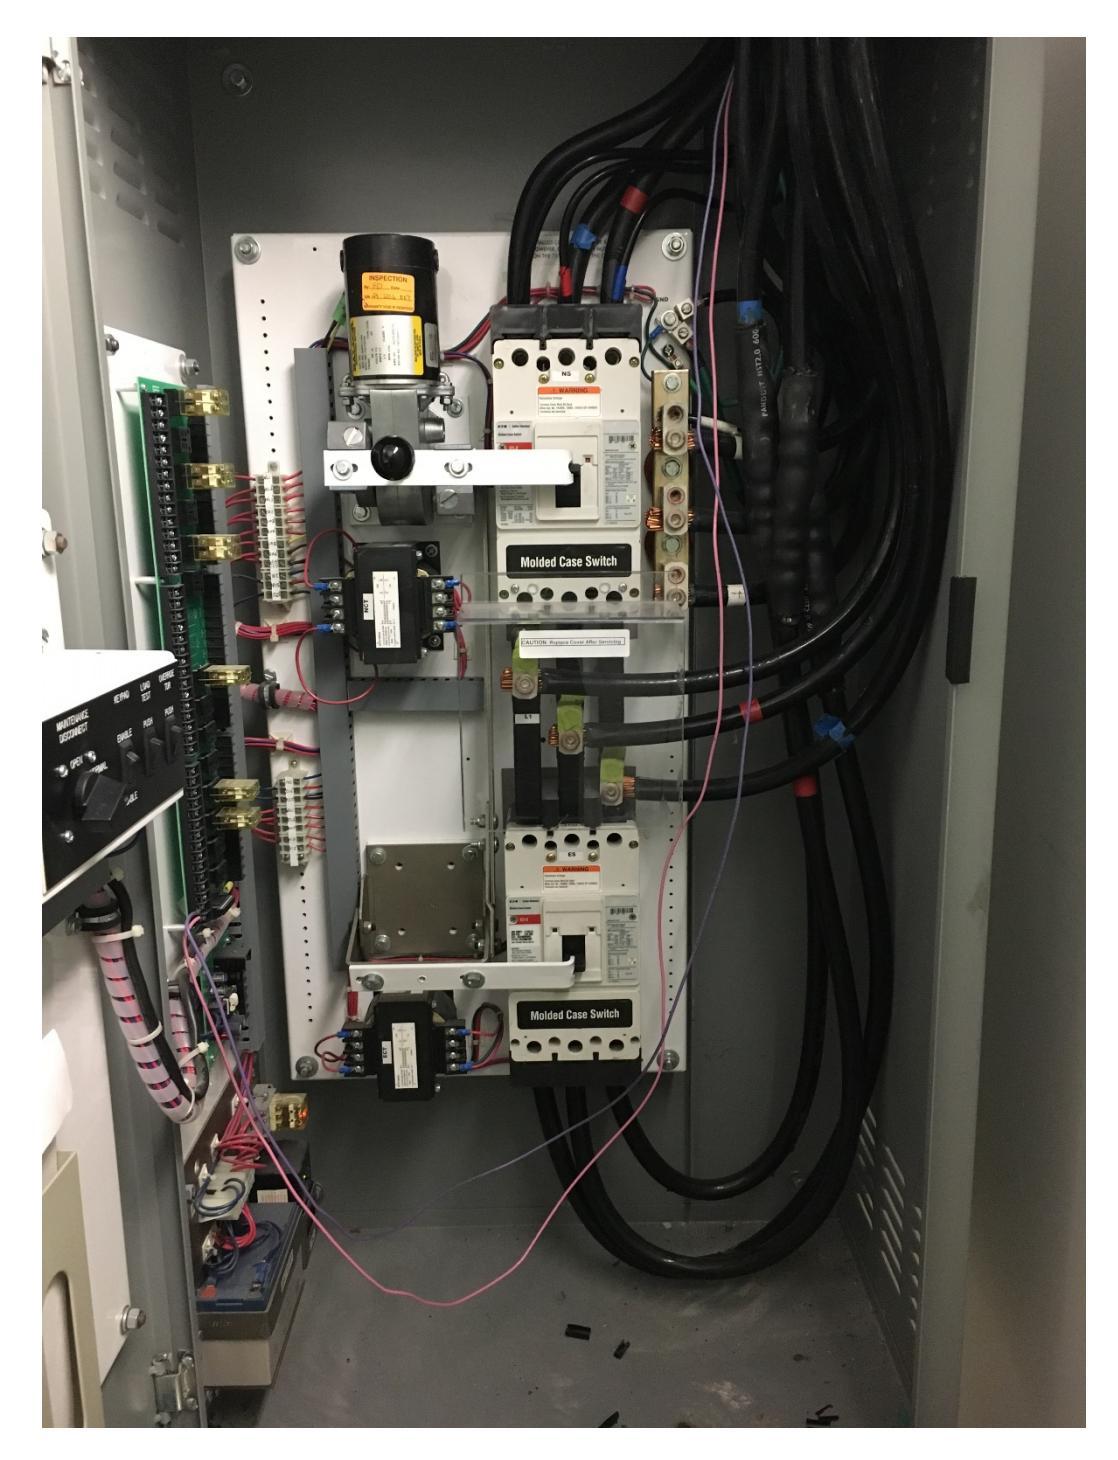
Pink and purple control wires routed inside high voltage conduit.

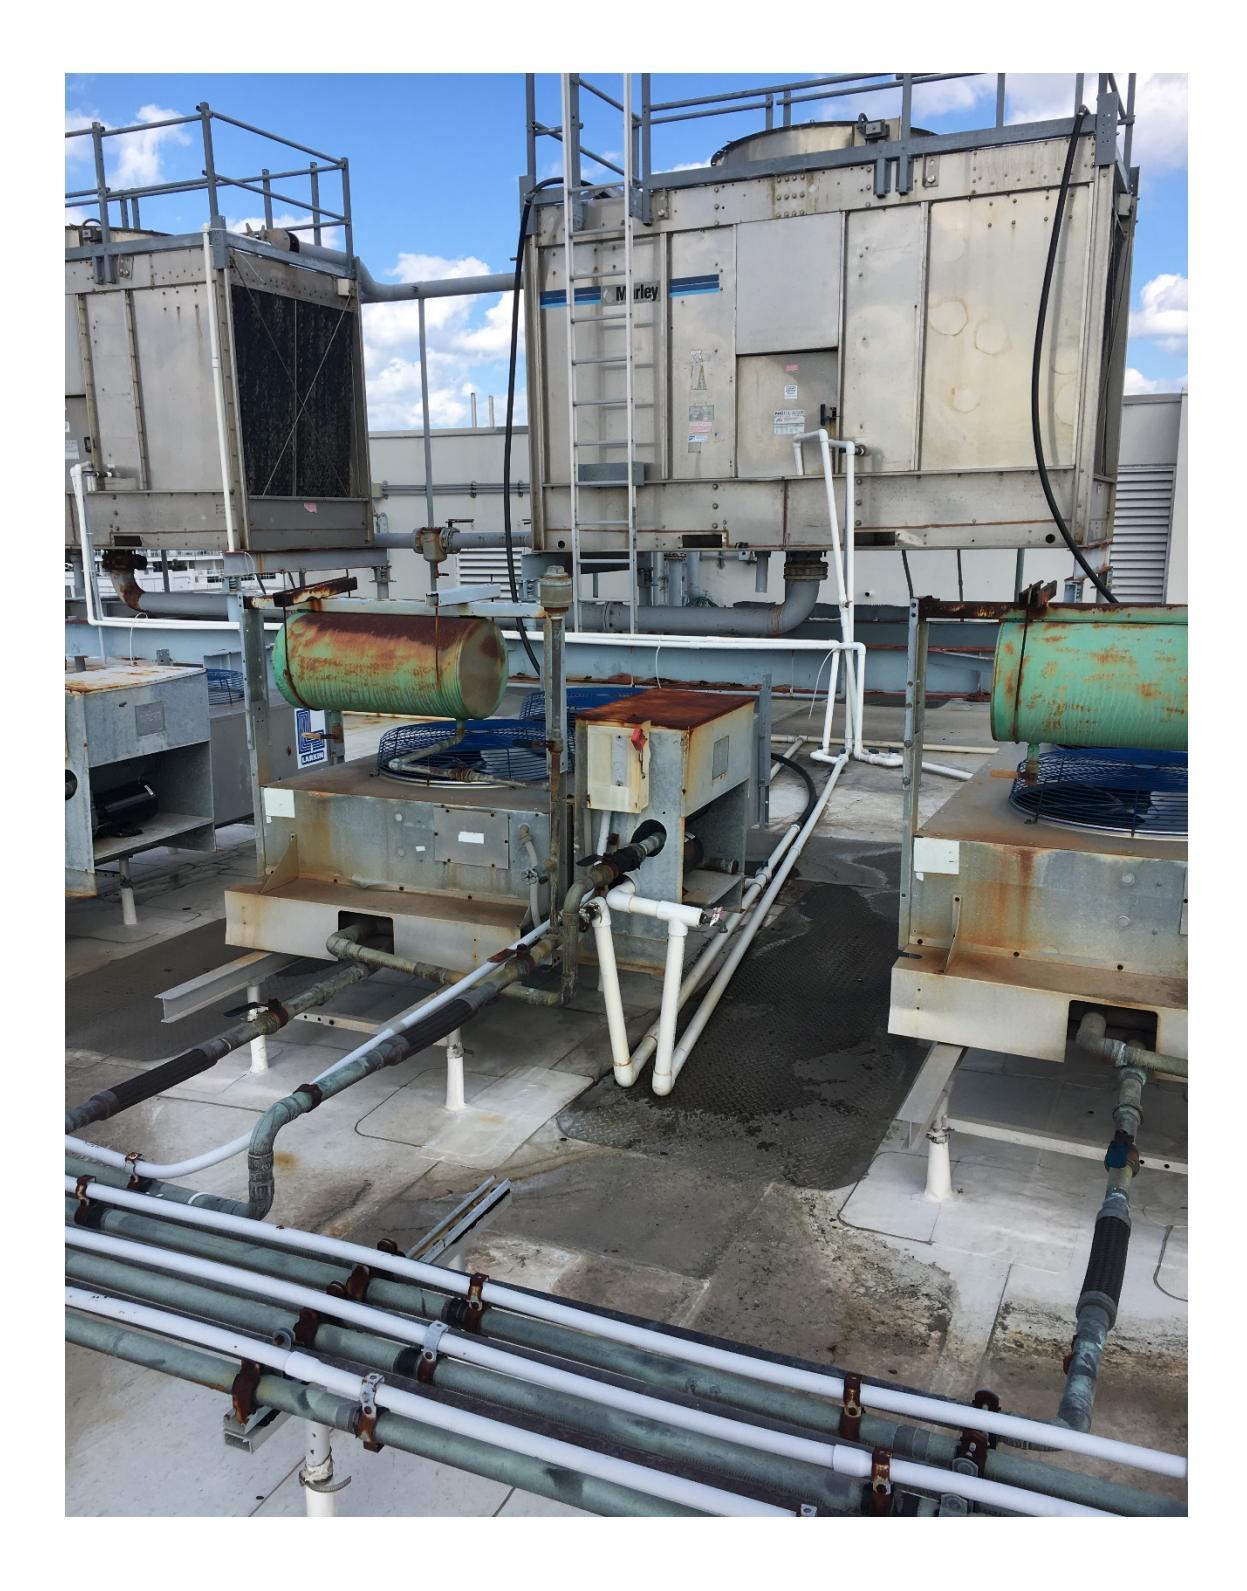
Dry-coolers bypassed and connected to cooling tower open loop.

- 3. <u>City Hall</u> data center: The legacy cooling equipment at this site is degraded to the point of being inoperable. 2 of the 5-rooftop dry-coolers are bypassed and connected to cooling tower's open loop. This will likely clog the condensers of newer Bosh units very soon. The flexible piping

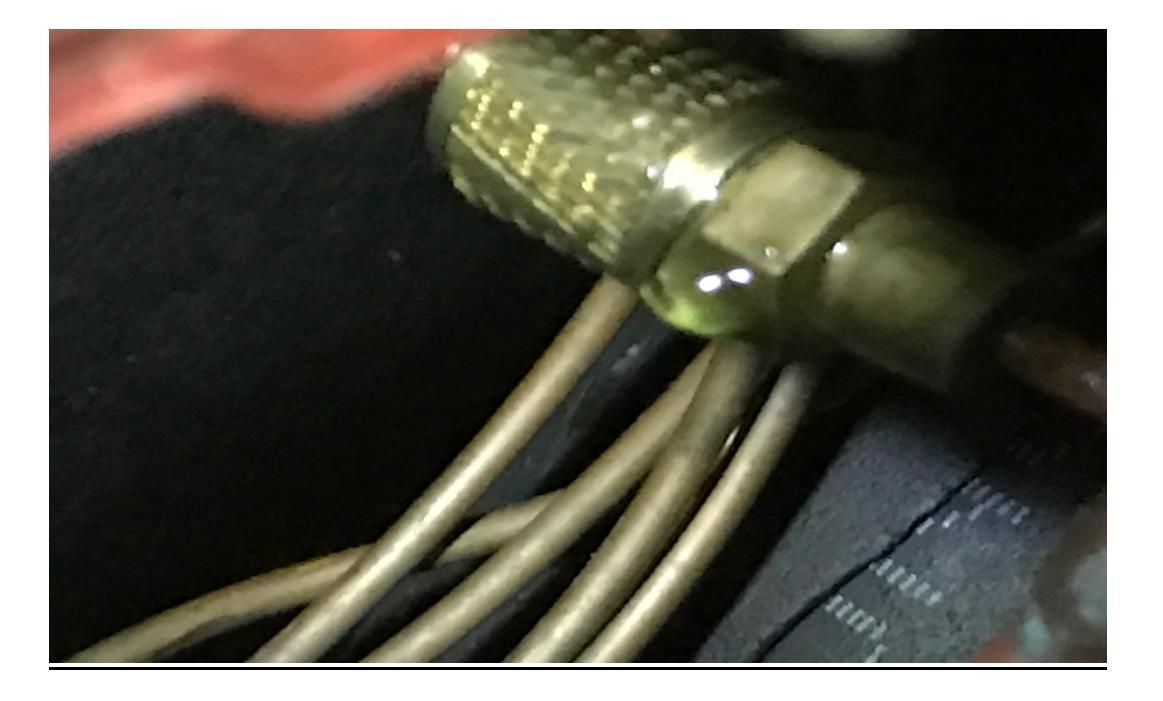
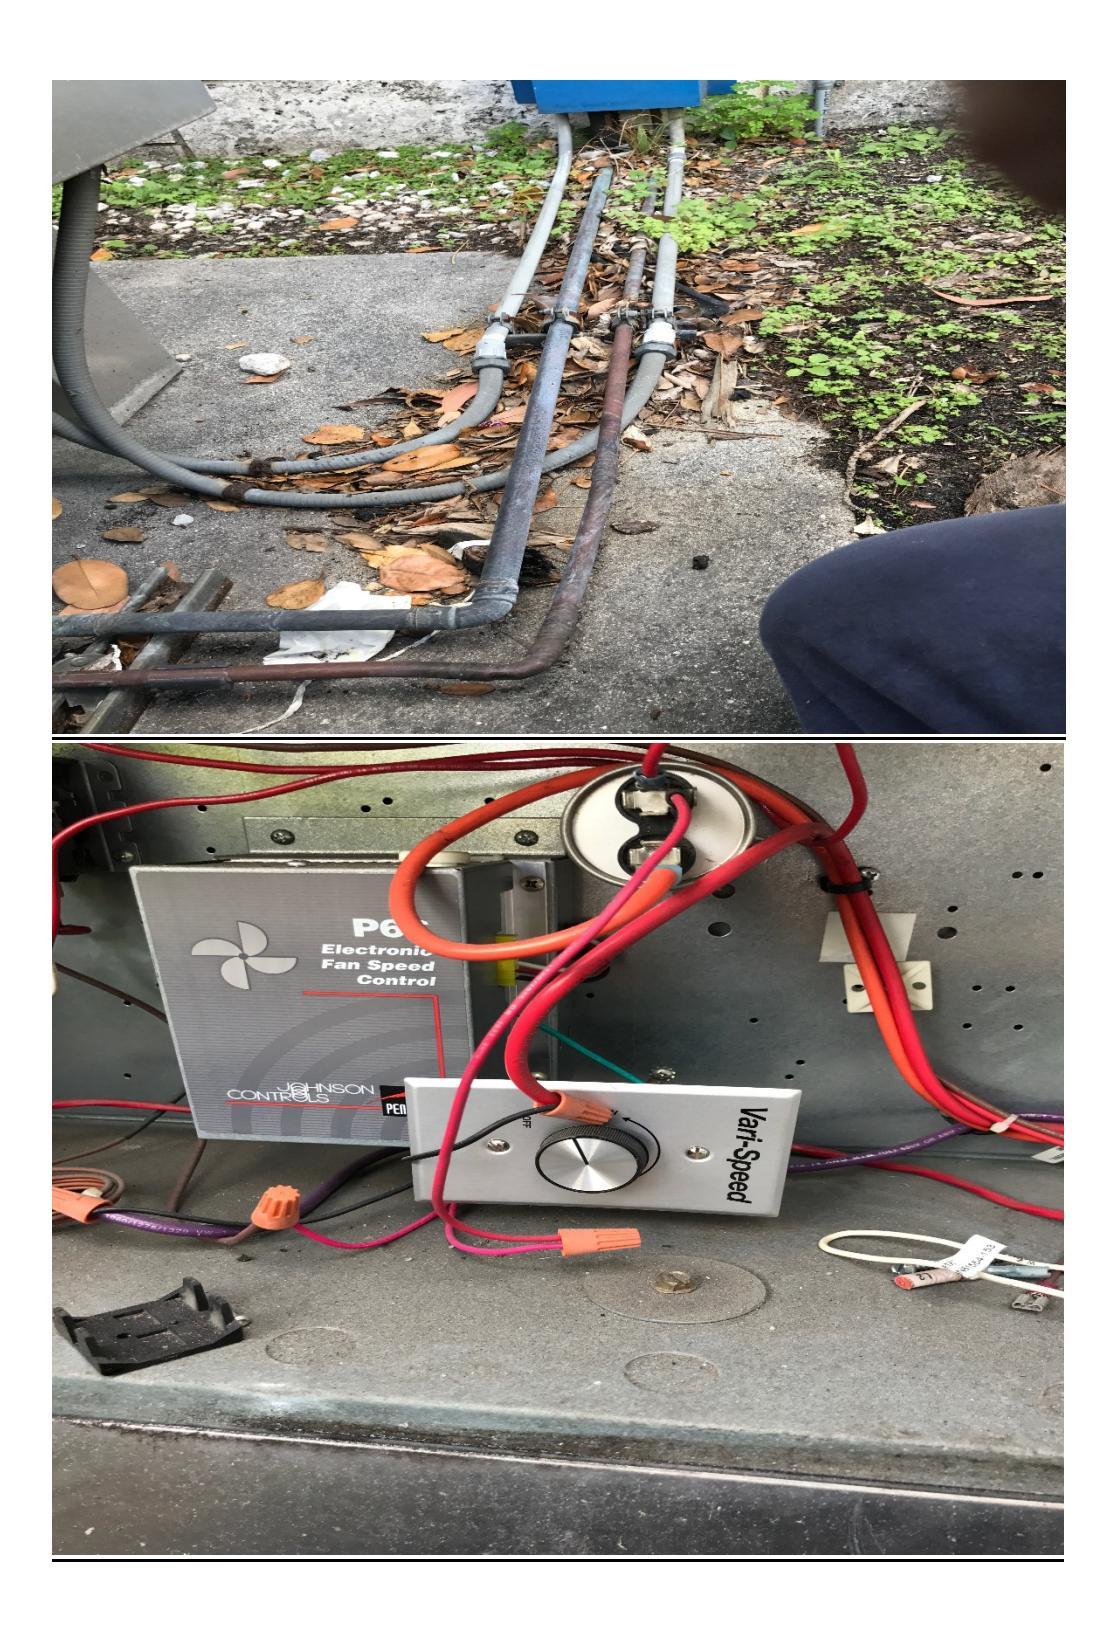
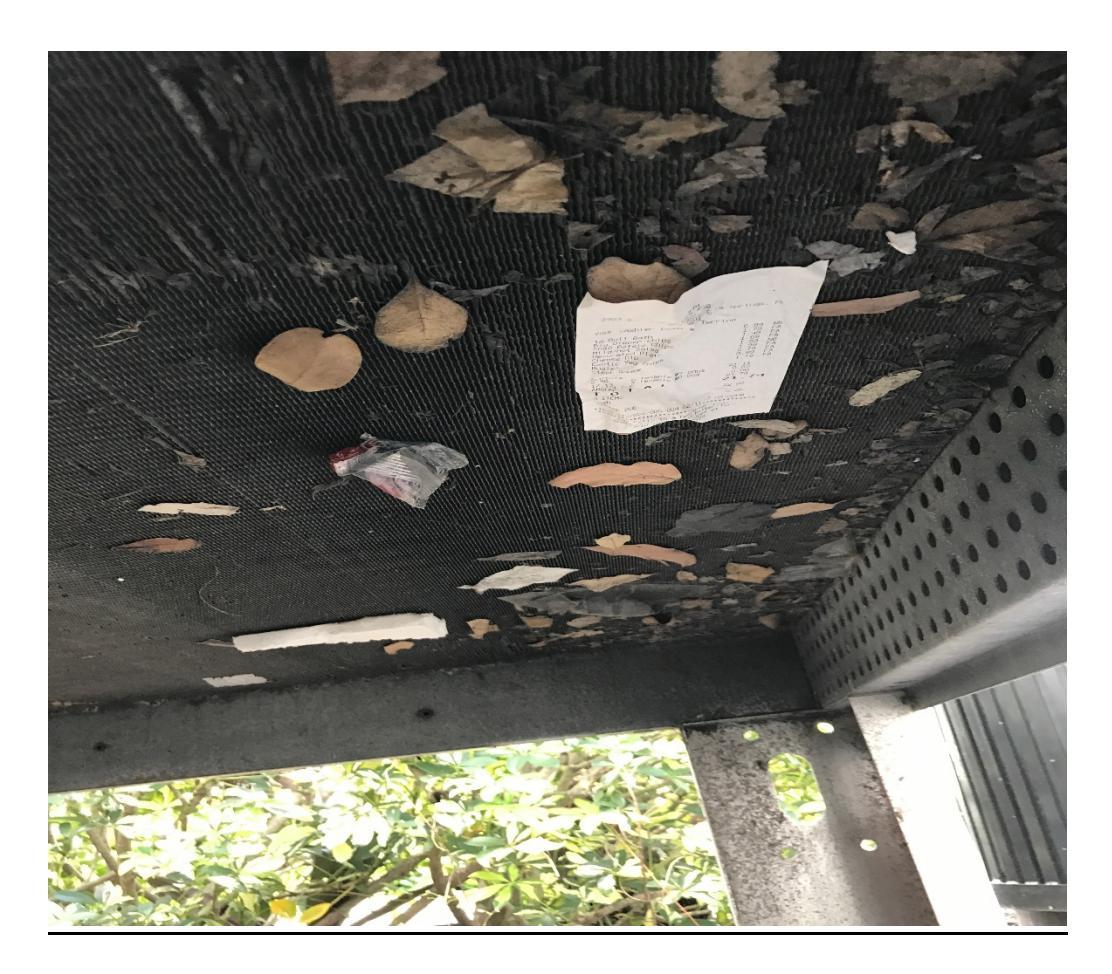
- Data Center unprotected against fire currently
- Airflow of room is extremely inefficient. Some racks exhausting air into same space as intake of others
- CRAC unit not operating to capacity due to refrigerant leaks
- Refrigerant lines not supported correctly
- Condenser extremely dirty and degraded cutting heat rejection capacity
- Condenser fan speed control bypassed with electrical rheostat
- Estimated cost of repairs for items found during review. \$197,000.00
- Estimated cost of yearly maintenance for Fire system, UPS, Batteries, Cooling \$10,500.00

4. <u>Police department</u>: This site has several airflow issues that limit the capacity of both CRAC units in space to effectively cool. Most supply air is directed into the hot aisle. Some racks are discharging air into cold aisle. The condenser for the Liebert equipment is extremely dirty and degraded. The refrigerant lines are not properly supported outside. The controls are bypassed to control low ambient operation. This site is without fire protection.
