**EXHIBIT LIST**  
**HISTORIC PRESERVATION BOARD HEARING**  
**MICHELLE GROSMAN: 1016 WAVERLY ROAD**  
**12/1/14**

Re: Michelle Grosman Application: 1016 Waverly Road, Fort Lauderdale, Florida  
Case No. H14014

## **Archaeological Assessment at 1016 Waverly Road Demolition Management Plan**

EVALUATION OF AN  
EXISTING ONE-STORY RESIDENCE  
AT 1016 WAVERLY ROAD  
FORT LAUDERDALE, FL.

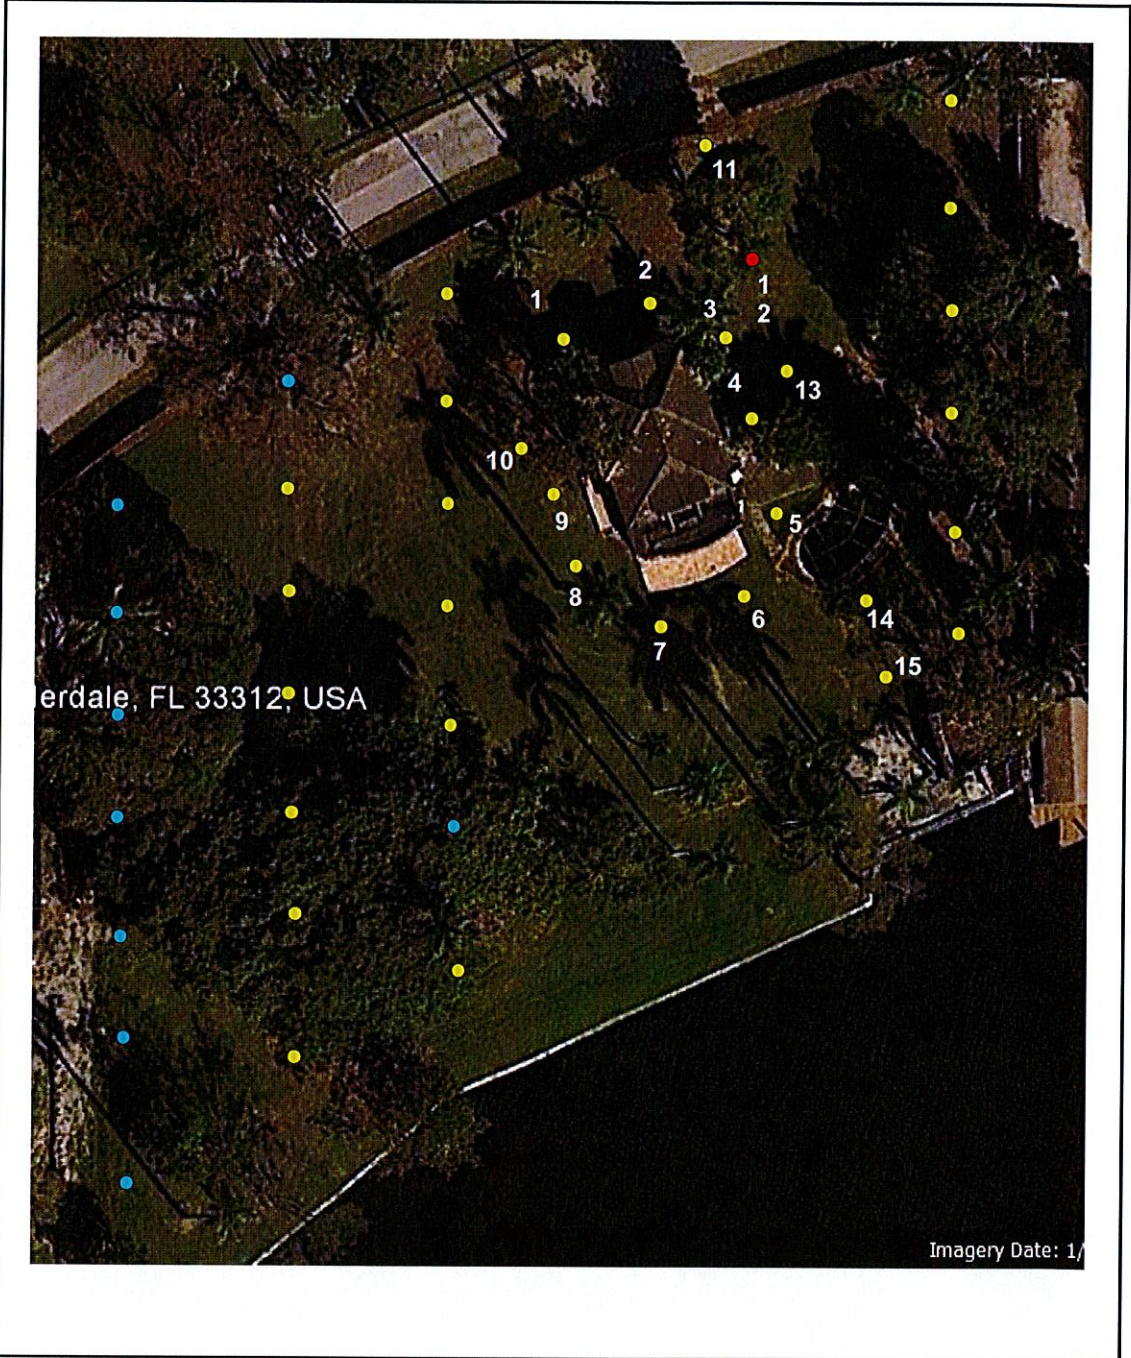
Figure 1. 2014 color aerial orthophotograph of the project parcel depicting completed and pending shovel test locations.

- = Completed shovel test
- = Pending shovel test
- = Completed shovel test with human tooth

A Phase 1 assessment of the 1016 Waverly Road house lots was conducted in October and November of 2014. The survey was conducted in two stages. The first stage involved excavation of judgmental and systematic shovel tests around the structure and along one transect from the eastern entrance gate to the pool and south of the pool to the garage. A total of 15 shovel tests were excavated during this stage; 10 around the house and 5 along the transect (Figure 1).

A human molar was found in shovel test 12. Notice of the discovery was provided to the State on November 6, 2014, in accordance with State Statute 872.05. No other human remains were identified from that shovel test. Materials from the other shovel tests have not been fully analyzed or catalogued, and a final report will be provided upon completion of the analysis.

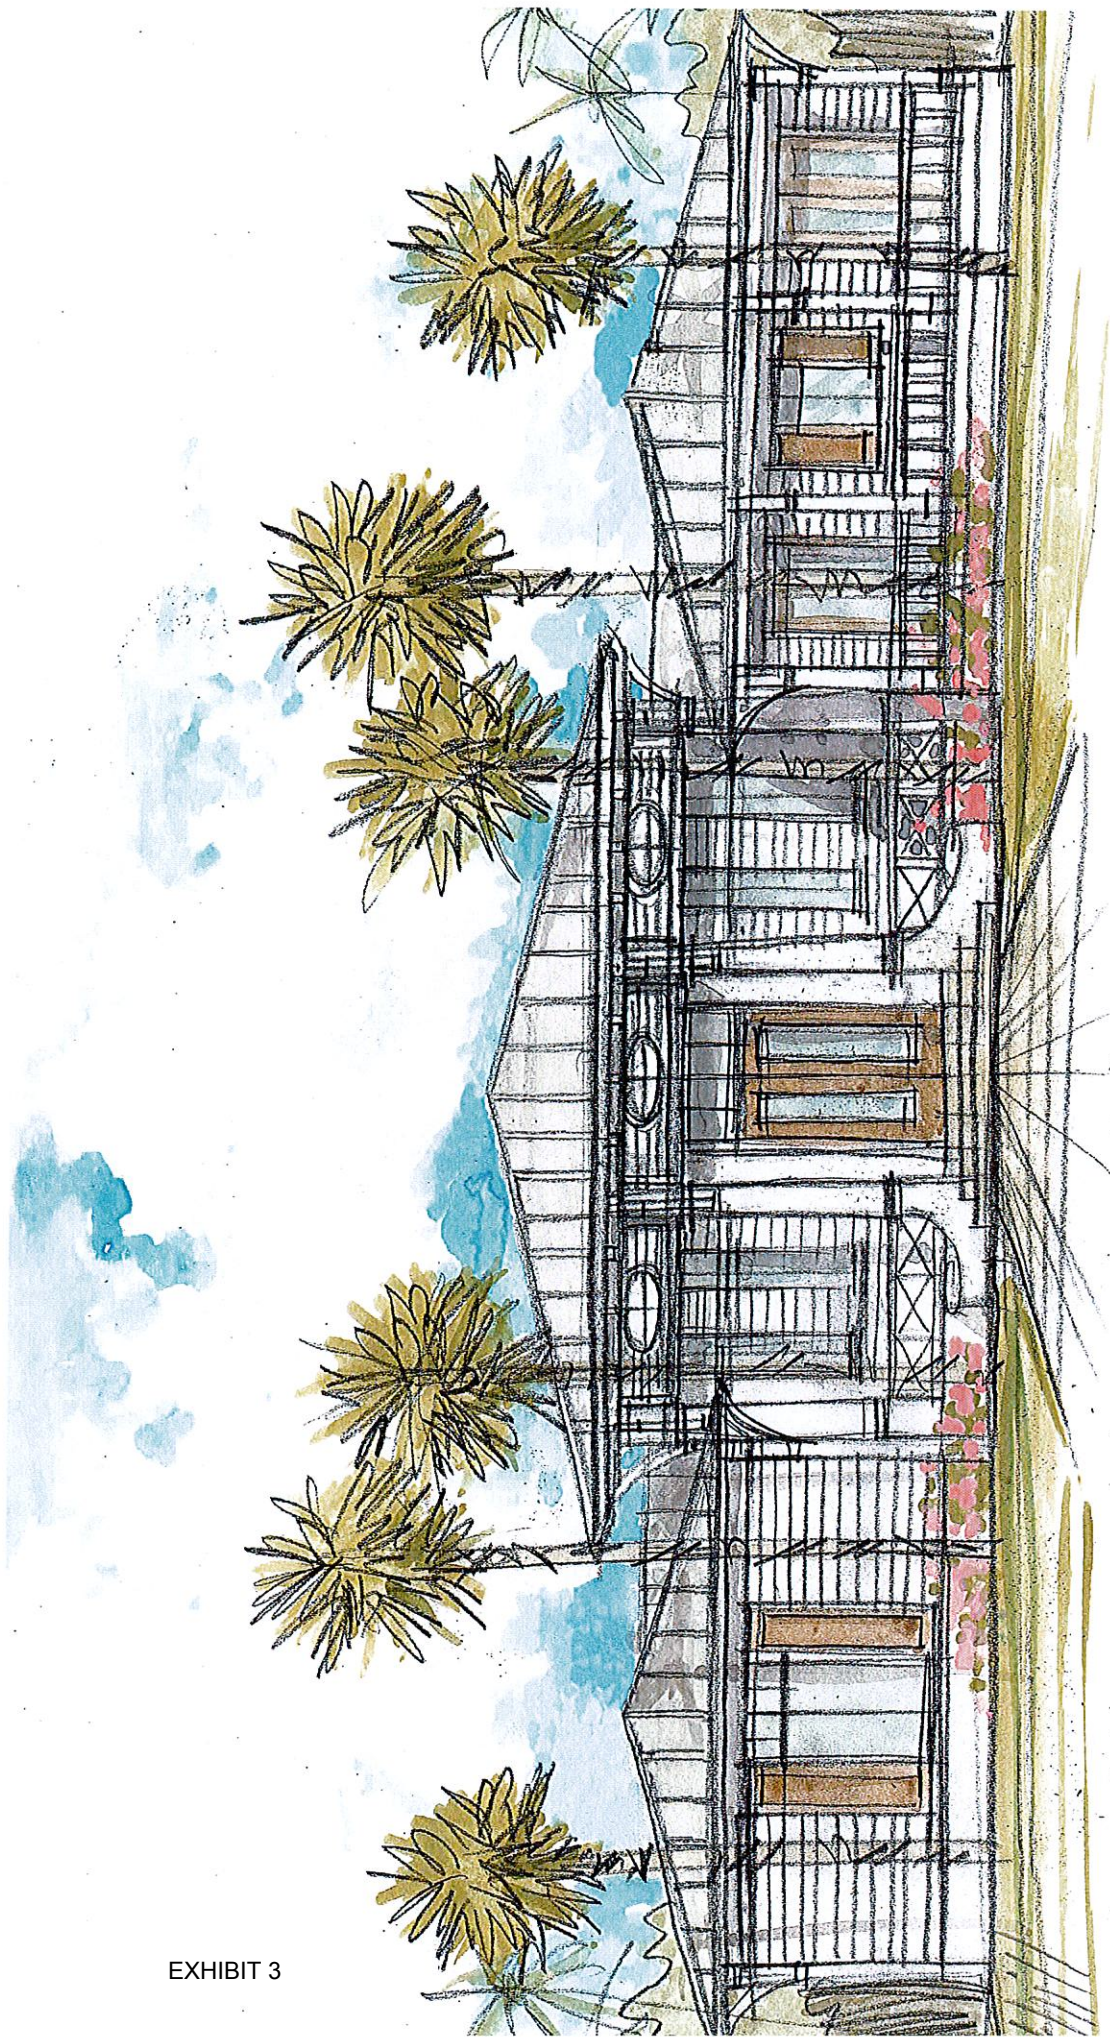
# Exhibit E

610 SF  
REMODELED ON SEVERAL OCCASIONS  
MOST ORIGINAL PARTITION WALLS REMOVED AND REPLACED  
NO ORIGINAL WINDOWS OR DOORS REMAIN  
ROOF IS LATE 20TH C. CONCRETE & TILE  
FLOOR NOT ORIGINAL  
EXTERIOR DOORS AND WINDOWS RELOCATED  
REMODELED STYLE INCONSISTENT WITH ORIGINAL

540 SF  
ORIGINALLY AN OPEN, PARTIALLY COVERED PORCH  
REMODELED ON SEVERAL OCCASIONS  
ORIGINAL REAR ELEVATION OF HOUSE COMPLETELY REMOVED  
CEILING AND MINOR STRUCTURAL DAMAGE AT KITCHEN  
REMODELED STYLE INCONSISTENT WITH ORIGINAL

410 SF  
NOT PART OF ORIGINAL STRUCTURE  
CONSIDERABLE DAMAGE TO FLOOR AND WALLS  
OVERHANG DAMAGED AND FALLEN TO GROUND  
LATE 20TH C. ADDITION

There is a substantive difference in the amount of deterioration between what is the original construction of the house and the later additions. In general, the additions are in worse condition than the original areas. The additions and alterations represent a significant proportion of the house total area.

The additions and alterations have compromised the integrity of the original structure. The extent of the repairs would be a considerable challenge for a public works, and a great burden for private owners. In other words, the effort extended would exceed the importance of the structure.

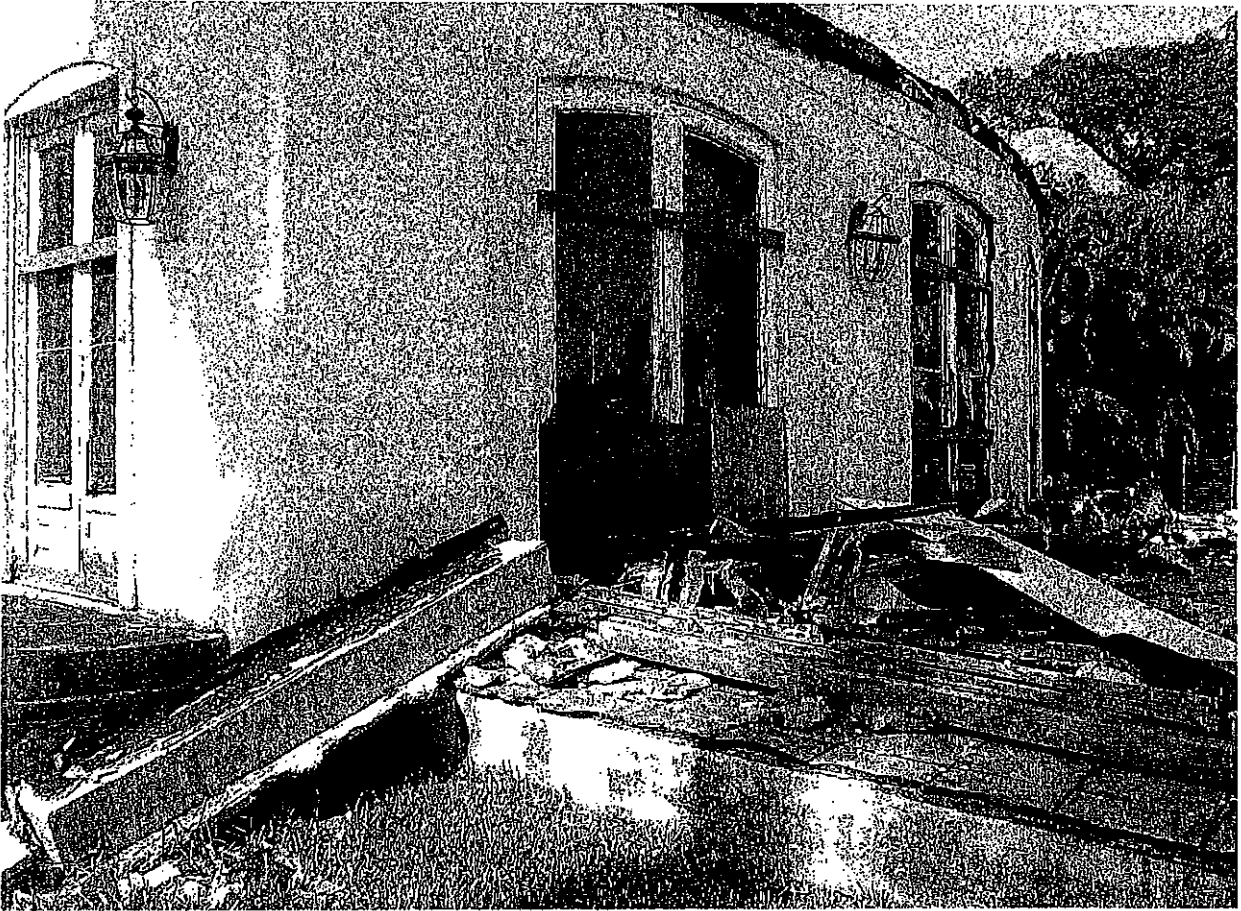
**A view of the residence from the south.**

Another example of the poor quality of the construction which basically reformed the entire residence is evident in this view which shows a masonry eave (an unusual detail, to be generous) that has fallen to the ground. This happened recently, sandwiched between visits by the architects to the site.

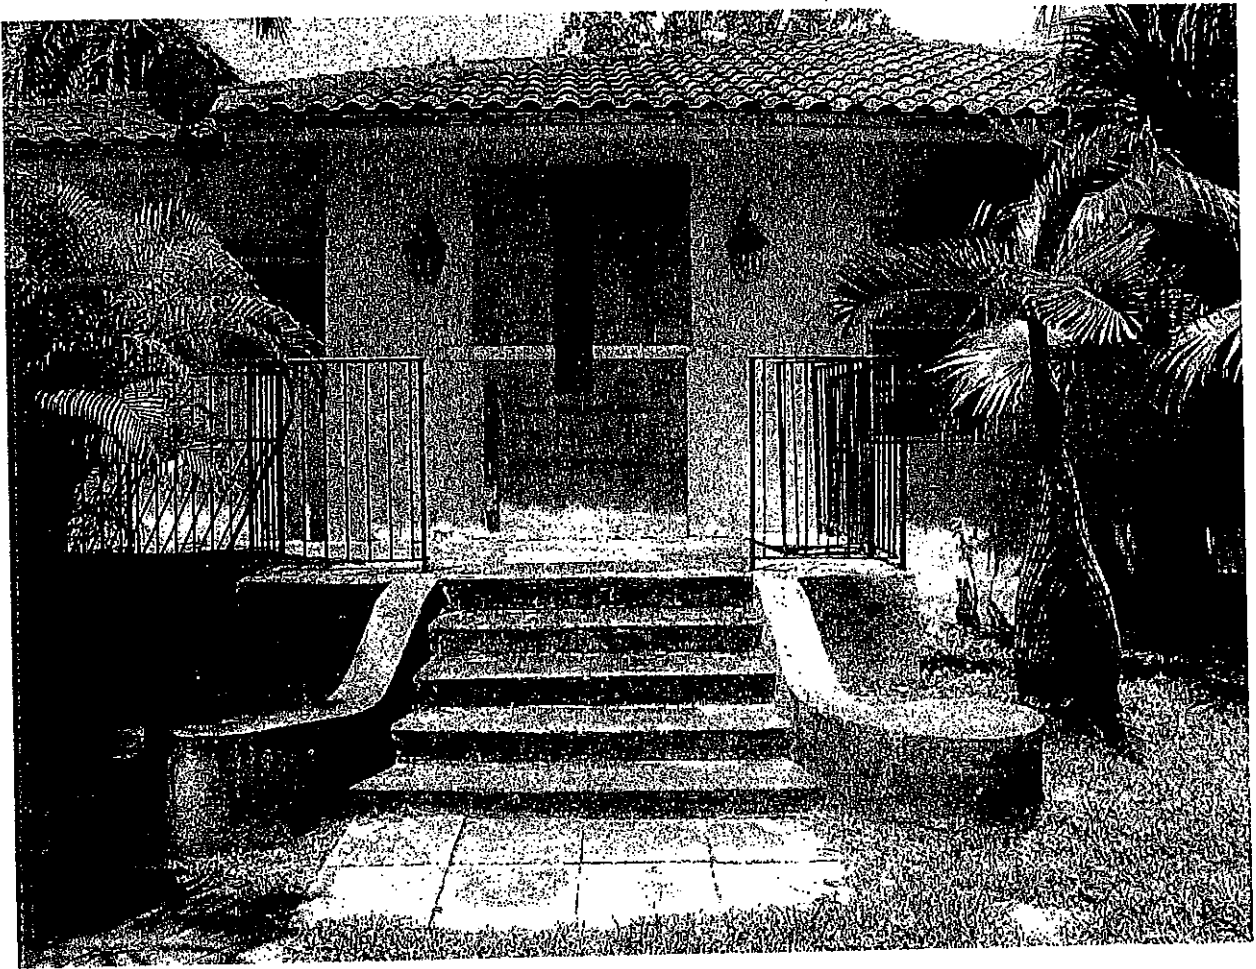
**A view of the residence from the east.**

This photograph shows several elements that are typical for the condition of the house. The windows are not original – awning from the 1950's or 1960's. The railing is not historical. The roof is not historical. The concrete steps and stoop, which is probably original, is bare concrete.

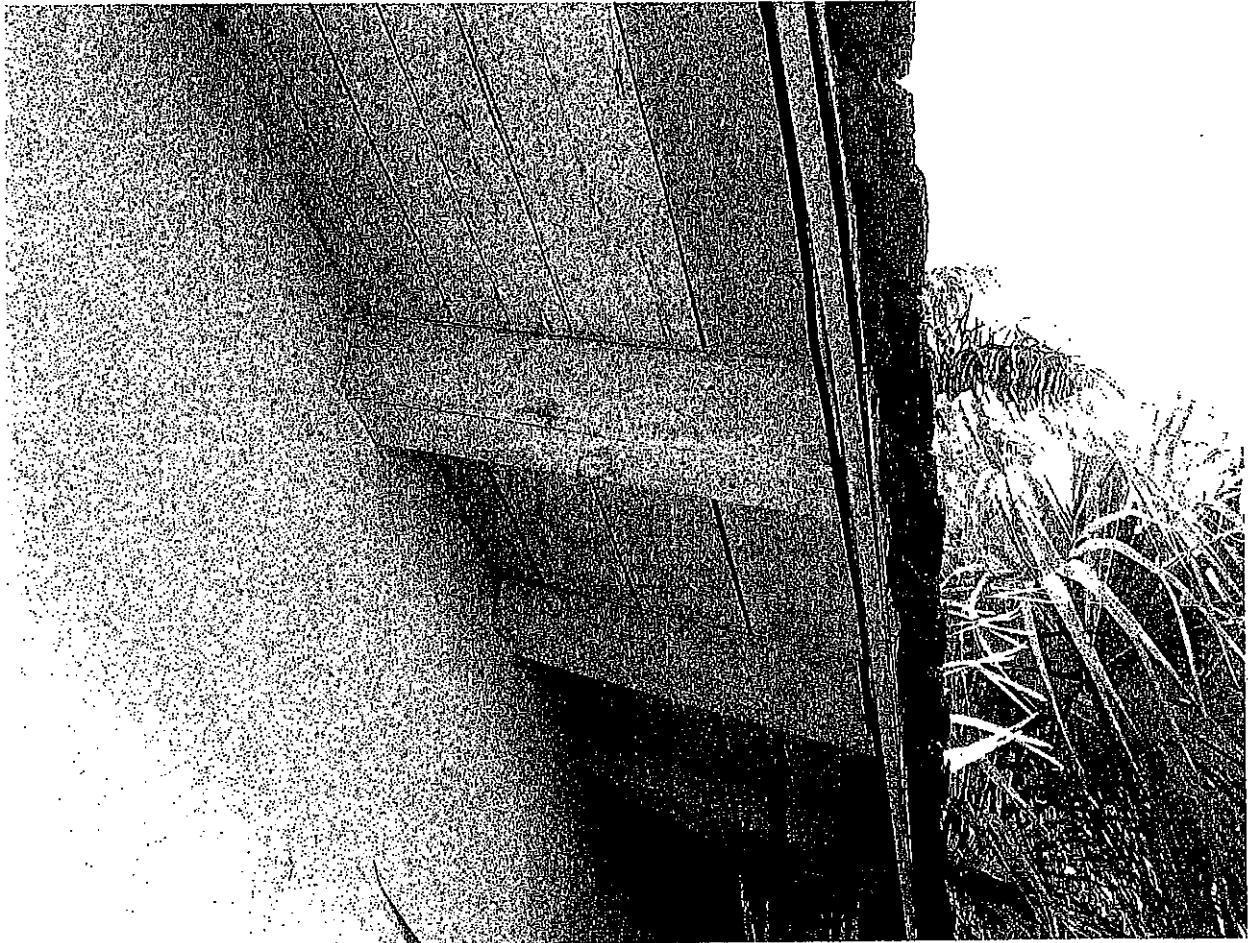
**A view of soffit on the east side of the house.**

The original beaded siding which was used in the original construction represents a fraction of the current eave length, but can be used to determine the extents of the original construction. Later additions used tongue and groove soffit.
