JAN 6, 2015 PH-3  
SUSAN McCLELLAN

## HISTORIC PRESERVATION WORK (updated)

Full Report (+15 minutes) with Figures [handed in at least]  
20 pages total

## 1.0 INTRODUCTION

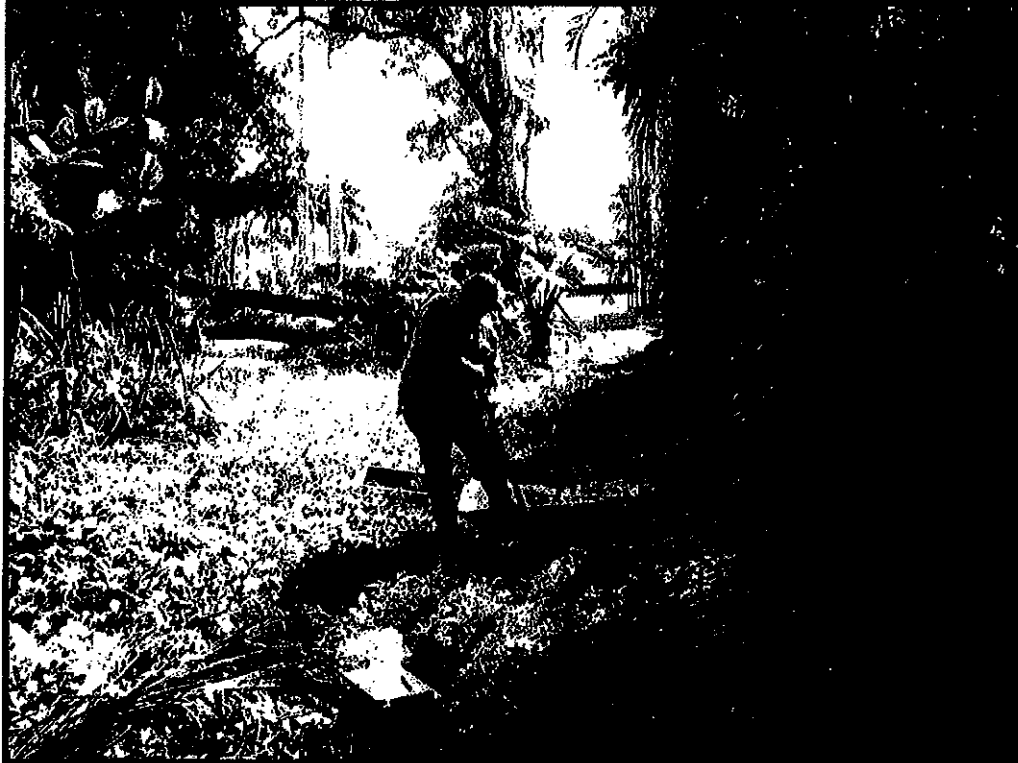
**Figure 8: Photograph depicting shovel test activities in progress along the proposed fence alignment**

The tests measured approximately 50 by 50 centimeters in size and were excavated to one meter below the ground surface or to depths no longer considered to have the potential of containing non-random artifact bearing matrices. The excavated soil was screened through ¼ inch hardware cloth to aid in artifact recovery. Artifacts and ecofacts (shell and bone) recovered were bagged and the bags were labeled with the appropriate provenance information. Other information such as soil color, depositional characteristics, disturbances and estimated artifact/ecofact densities were recorded on a shovel test inventory sheet and in the field book; Figures 6 and 7 depict the shovel testing activities and an example shovel test.

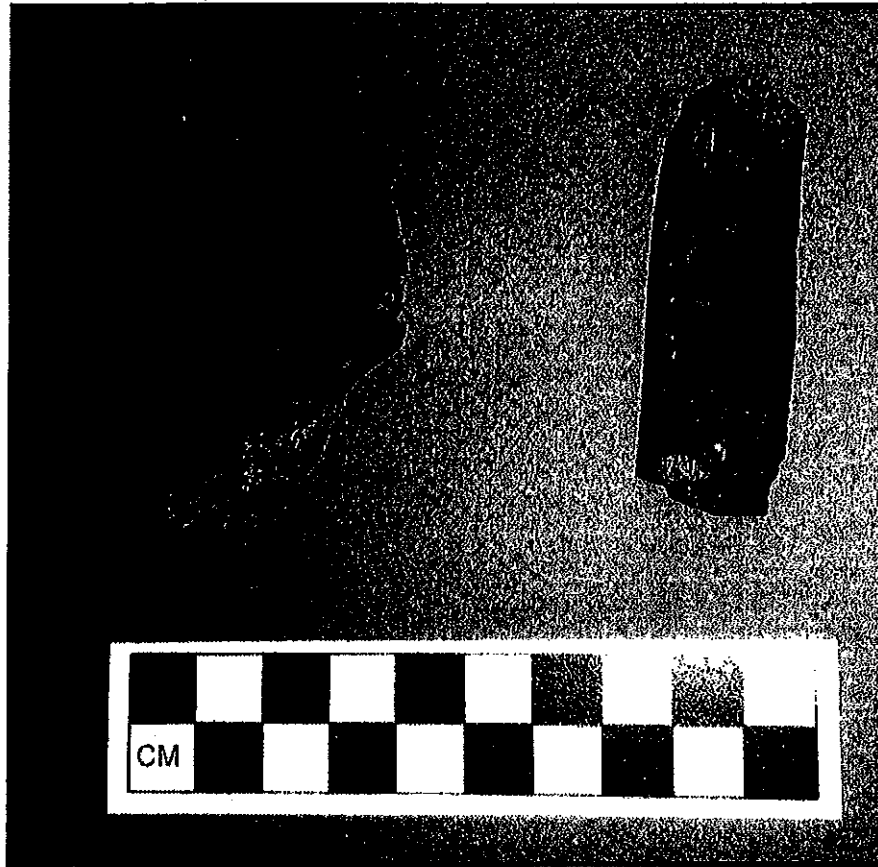
**Figure 17: Photograph showing the large mammal remains, specimen on the right is possibly a manatee rib**
