CITY OF FORT LAUDERDALE

2017 Algal Bloom

Algal Bloom Water Quality Sampling

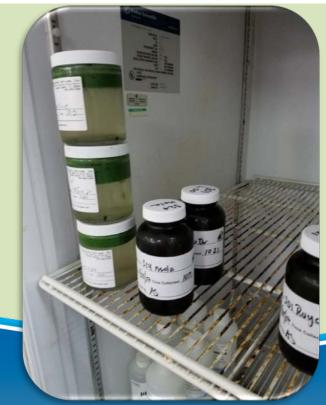
Micrographs

Microcystis spp. at 40X

- Private lab identifies various algae including a potentially toxic algae: Microcystic spp
- Private lab recommends toxin analysis of original sample
- Private lab reports toxins present in the single sample submitted
- FDEP contacted but no specific action is recommended

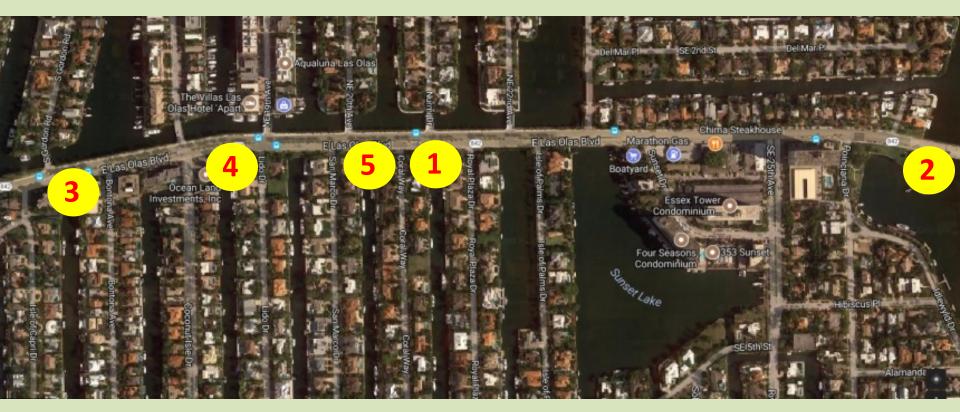
- 1) East of Royal Plaza
- 2) East Las Olas (Background)
- 3) East of Bontona
- 4) East of Lido
- 5) East of Coral Way

Four Dates

* DNA Bacteria Source Sampling

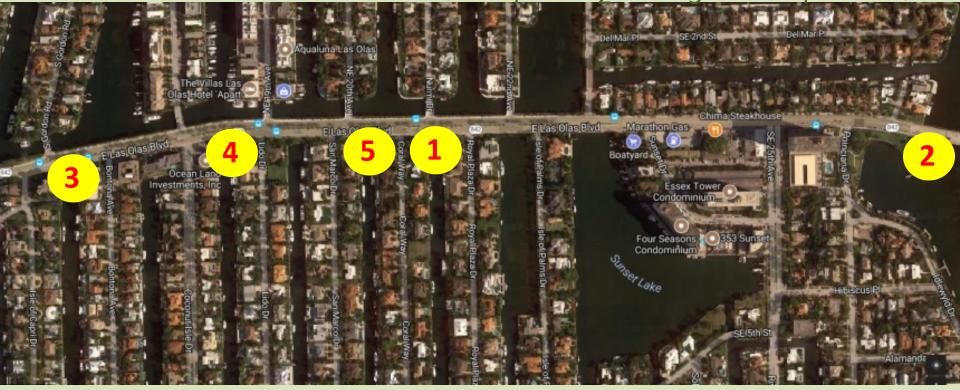
Algal Bloom Water Quality Sampling

Nutrients (NH₄, NO₂, NO₃, oPO₄, TKN)

- Nutrient concentrations relatively low
 - May be due to active uptake by algae

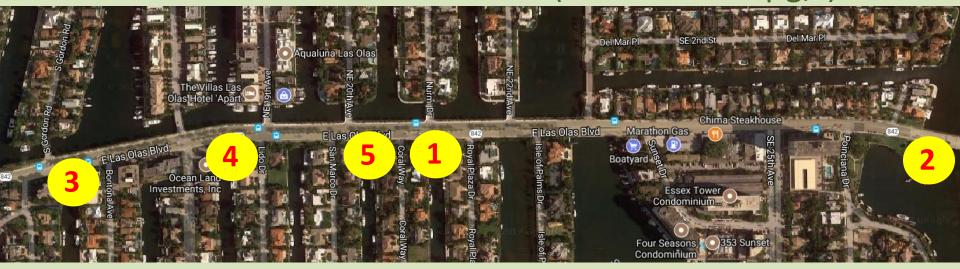
Algal Bloom Water Quality Sampling CHLOROPHYLL a (FDEP Std -12 µg/l)

| SAMPLING SITES | Times Standard Exceeded | |
| 1 - East of Royal Plaza | 2 of 4 (10.6-186 μg/l) | |
| 2 - East Las Olas (Background) | 0 of 4 (1.98-4.45 μg/l) | |
| 3 - East of Bontona | 2 of 3 (8.43-18 μg/l) | |
| 4 - East of Lido | 2 of 3 (6.41-48.3 μg/l) | |
| 5 - East of Coral Way | 2 of 2 (19.9-35.6 μg/l) | |

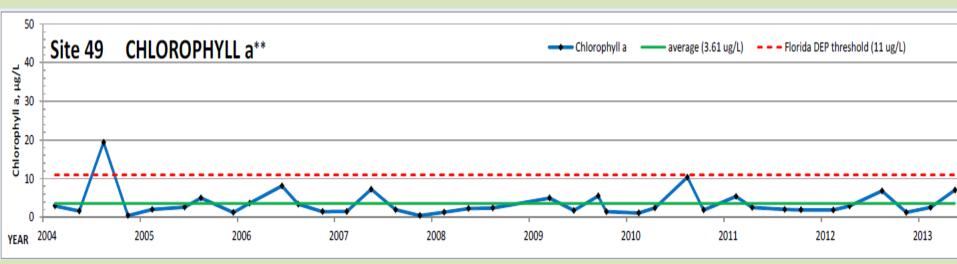
SITE 49 - estuarine

Sospiro Canal, Hendricks Isle, at Las Olas Isle Bridge Water Body ID (WBID) # 3226G4

Chlorophyll is an indicator of algae and other plant materials in the water column.

Spikes common in summer and fall sampling.

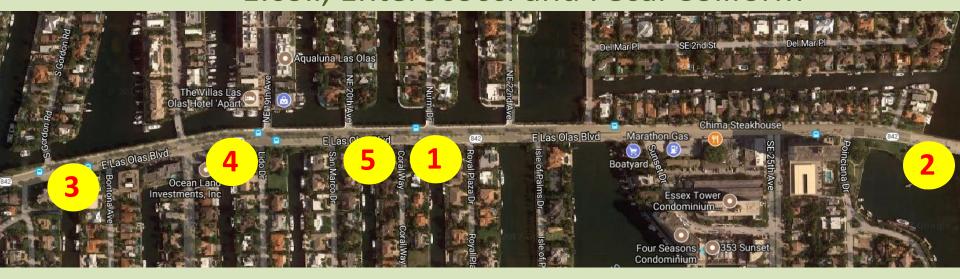
Algal Bloom Water Quality Sampling E.coli, Enterococci and Fecal Coliform

| Bacterial Test | Date of Exceedance | Sites Where Std Exceeded |
| E. coli | | 0 (16 samples) |
| Enterococci | Sep 27 | 1, 3, and 5 |
| | Oct 2 | 3, 4, and 5 |
| Fecal Coliform | Sep 20 | 1, 3, 4, and 5 |
| | Oct 2 | 3 |

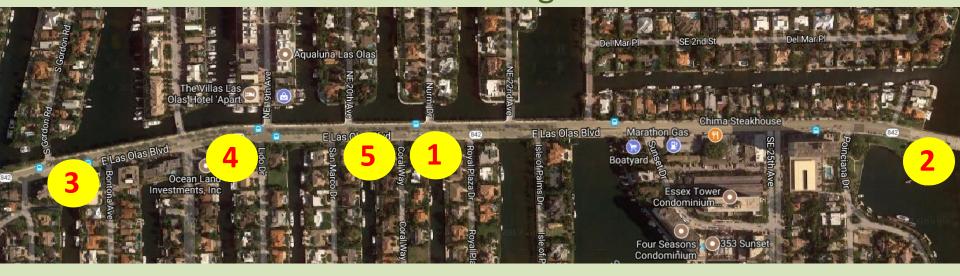
Algal Bloom Water Quality Sampling DNA Source Tracking HF183

HF183 test indicates human-source fecal contamination

- Detected at all sites for both sampling dates
- 7 of 8 samples averaged 344 HF 183 target copies for 100 ml
- One sample, Site 4 = 10,596 on Sep 20

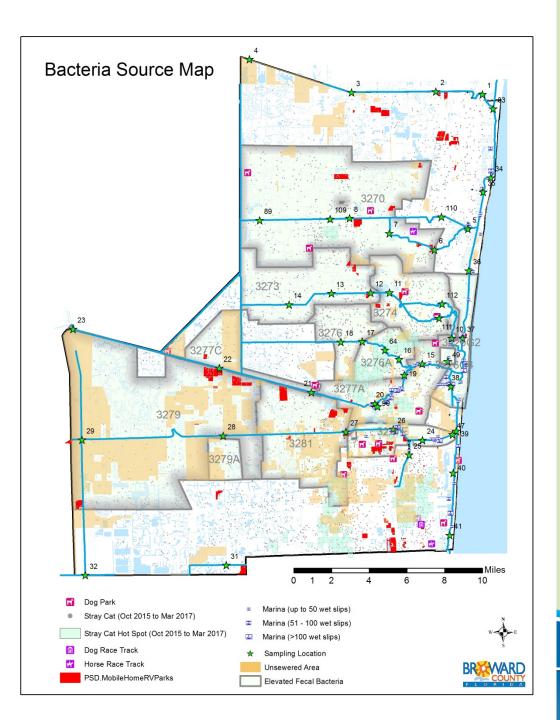
Bacteria Source Sampling Sites in Broward County and Fort Lauderdale

- Map identifies sources of concern
- 2 rounds of sampling –
 Pre-Irma
- 7 dates collected
- 10 Broward sites sampled
- HF 183 detected in 17 of 18 samples

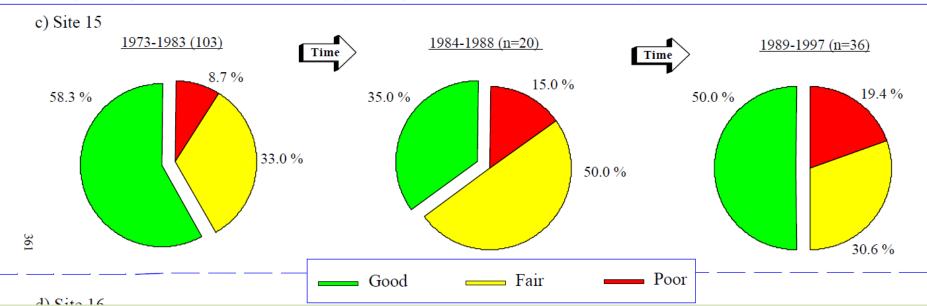
Water Quality Site 15 = Andrews Avenue and New River. The majority of water bodies in Broward County are impaired for fecal coliform bacteria.

Figure IV.52 (Cont.). Fecal Coliform (FC) Concentrations Observed in the New River Basin over Three Time Periods. Concentrations are categorized in terms of compliance with the Broward County marine FC standards which state the monthly average shall be equal to or less than 200 colonies/100 ml (good rating) and no single reading shall be above 800 colonies/100 ml (poor rating). Values between 201 and 800 colonies per 100 ml are defined as fair.

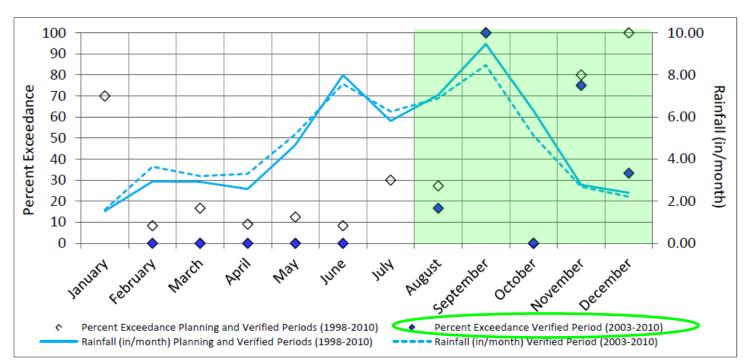
Historic Concentrations of Fecal Coliform Las Olas Finger Isles – FDEP TMDL Report 1998-2010

FINAL TMDL Report: Southeast Coast-Biscayne Bay Basins, Las Olas Isles Finger Canal System (WBID 3226G4), Fecal Coliform, April 9, 2012

Exceedances of Fecal Coliform
Standard are common in the fall (Range: 7-2700 MPN/100mL)

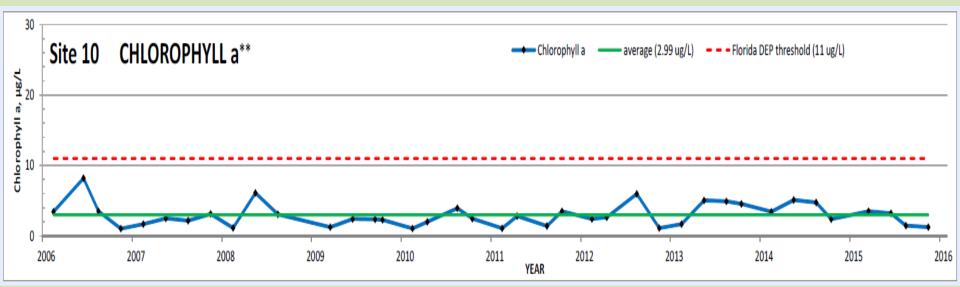
SITE 10 - estuarine

Middle River at East Sunrise Blvd Water Body ID (WBID) # 3274

Chlorophyll is an indicator of algae and other plant materials in the water column.

Spikes common in summer and fall sampling.

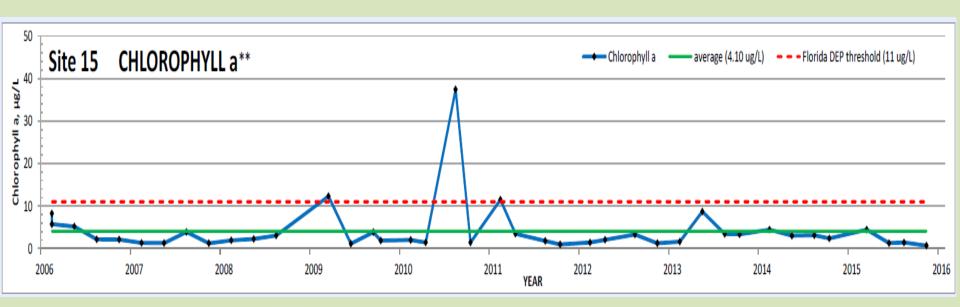
SITE 15 - estuarine

New River Canal at Andrews Ave Bridge Water Body ID (WBID) # 3277A

Chlorophyll is an indicator of algae and other plant materials in the water column.

Spikes common in summer and fall sampling.
