Fort Lauderdale Police Headquarters Project Update

June 3, 2025

CAM #25-0630 EXHIBIT 3 Page 1 of 28

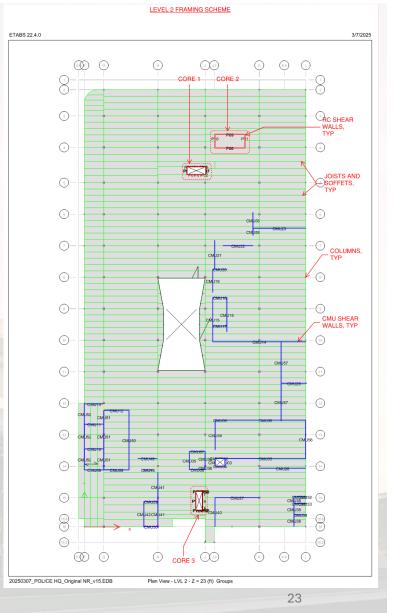
- Update Drawings
- 14.Mechanical Equipment Loads
 - Update Drawings
- 15. Masonry Walls (CMU Partitions)
- Recommended Concrete Shear Wall and Foundation Rectifications (items 1 and 2) will Address This Item.
 16.Column Flexural Stiffness Modifiers
 - It is Not Necessary for the Structural Engineer of Record to Respond <u>if</u> Recommendations made by WJE in Items 1 – 7 are

The current information WJE has suggests that the CMU partition walls will not provide a reliable (calculable) load path.

Accepted AECOM/TT is planning to update drawings, as necessary, to address Items 12-14.
