**TO:** Honorable Mayor and Members of the Fort Lauderdale City Commission  
**FROM:** Rickelle Williams, City Manager *RW*  
**DATE:** May 5, 2025  
**SUBJECT:** New Police Headquarters — Phase 2 Peer Review

Draft Report

April 22, 2025  
WJE No. 2024.4855.0

**Fort Lauderdale Police Headquarters**  
WJE Peer Review, Phase 2 – Building Structural Design Peer Review

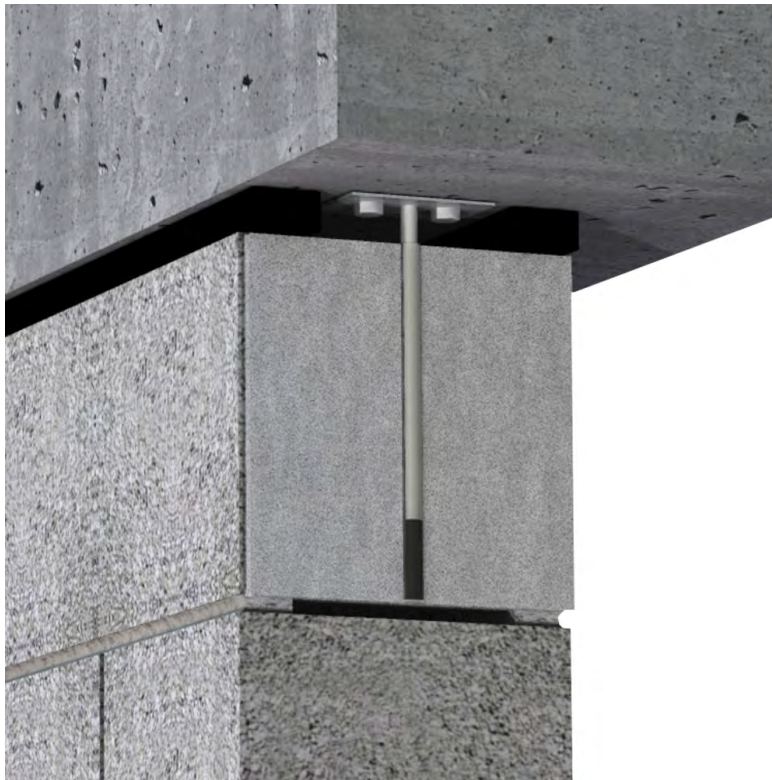
- **Report No. 081, Dated December 19, 2023:** Comments by the TI are in regard to the concrete used in slab-on-ground Pour 3. However, photographs of CMU walls in the first story are also shown in the report (Figure 17). These photographs show the overall CMU wall construction at one location in the first story and the approved PTA anchors at the top of the wall. The length of plate at the top of the PTA anchors is aligned parallel with the length of the CMU wall in contrast with the rendering shown on the manufacturer's website (Figure 10).

Figure 10. Rendering of installed PTA 420 HS anchor from Hohmann and Barnard. Image taken from <https://www.h-b.com/products/pta-series-anchors-pta-420-hs> (accessed on April 13, 2025). Note that the length of the top plate of the anchor is oriented transverse to the length of the wall

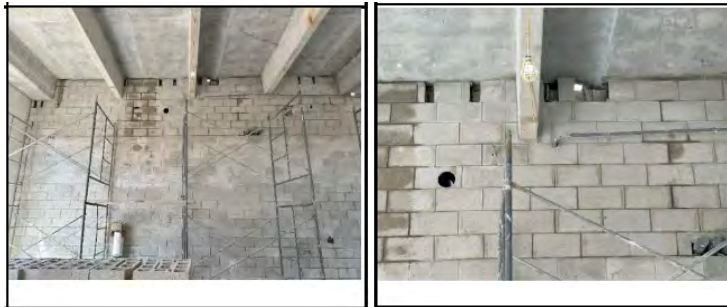
Figure 28. Photographs from Threshold Inspection Report No. 131 showing a wall that is nearly complete

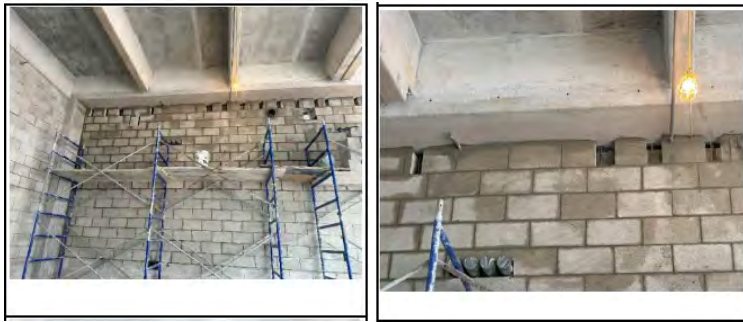
Figure 29. Photographs from Threshold Inspection Report No. 133 showing CMU wall at Level 1, Area D

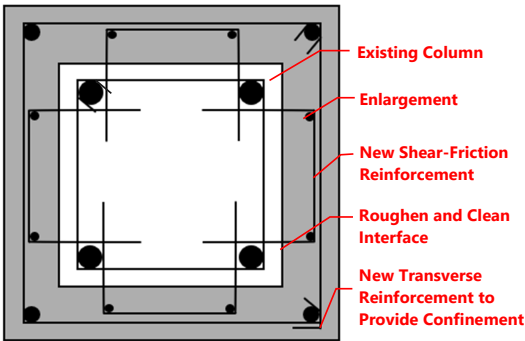
Figure 35. Sectional view of a reinforced concrete column which is enlarged to increase resistance. Note that the new transverse reinforcement should be spaced closely to provide confinement

The cross section of the column can be enlarged to strengthen the column for both combined axial and flexural loading and for shear. Figure 35 conceptually illustrates the enlargement of a reinforced concrete column. Since it will be difficult to anchor new flexural reinforcement at the top and bottom of the columns due to the presence of potentially conflicting reinforcement in the soffit beams, the flexural strength of the column can be enhanced primarily by increasing the effective depth of the section rather than by adding flexural reinforcing steel.

Enlarging the cross section as shown in Figure 35 provides an added benefit of confining the concrete in the original column. When concrete is confined it has a greater strain capacity, thereby increasing the strength and ductility of the column, even without additional anchored vertical reinforcement.

In the column enlargement rectification shown in Figure 35, the perimeter of the existing column is roughened and cleaned to allow for composite action with the enlargement. New shear-friction reinforcement is post-installed into the existing column to enhance interface shear strength between the original column and the enlargement. For columns that are overstressed in axial-flexural loading, the new transverse reinforcement should be spaced closely to provide confinement. For other columns, the new transverse reinforcement need only be spaced more closely than one-half the effective depth of the column. We expect that using No. 4 reinforcing bar ties at this spacing will meet the minimum shear reinforcement provisions in ACI 318-14.

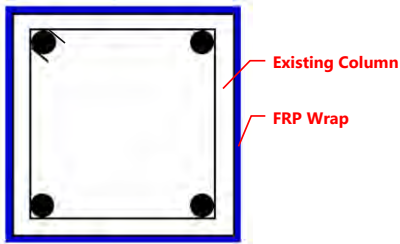
Figure 36. Sectional view of a reinforced concrete column which is wrapped with FRP to enhance shear strength and member deformability

Fiber-reinforced polymer (FRP) jacketing of the columns may also be a viable option to rectify the axial-flexural and shear conditions previously identified. As illustrated in Figure 36, this rectification entails wrapping a column with FRP and adhering it using epoxy. FRP jacketing can be used to provide

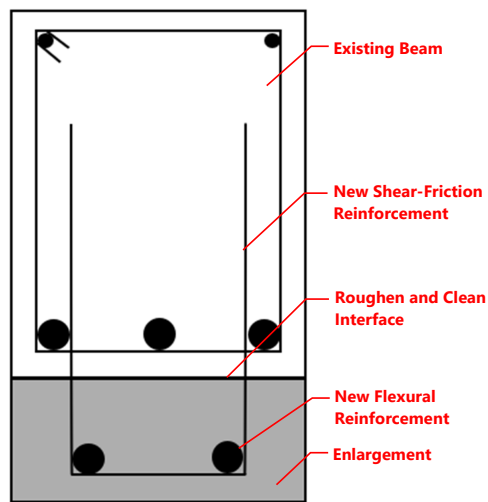
Figure 37. Section view of a reinforced concrete beam which is enlarged to increase flexural resistance

Enlarging the overstressed beams can enhance their flexural strength, similar to the upturned beams on roof soffit beams RSB 76 and 79. A conceptual illustration of this type of rectification is shown in Figure 37. The tension-face of the existing beam is roughened to allow for sufficient interface-shear strength with the new enlargement. Post-installed U-shaped ties embedded (at least one development length on either side of the interface) are provided to enhance interface-shear strength. Adequately anchored tension reinforcement is provided in the enlargement to increase flexural resistance of the beam.

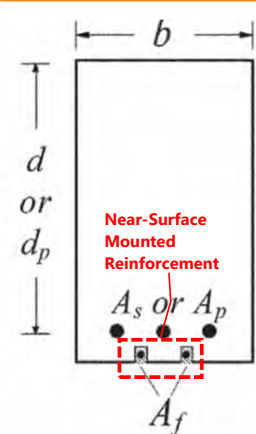
Figure 38. Section view of a reinforced concrete beam showing strengthening with near-surface mounted reinforcement (adapted from ACI 440.2-23)

Similar to beam enlargements, a near-surface mounted (NSM) rectification entails providing new longitudinal tension reinforcement to increase the flexural strength of the overstressed beams. As shown in Figure 38, grooves are cut into the existing beam to receive the new reinforcement. The substrate within the groove should be properly prepared to enhance bond strength with new epoxy or cementitious paste which is placed in the groove with the reinforcement. Steel reinforcement may be used, although non-metallic reinforcement or corrosion-resistant metals may be preferable to mitigate the risk of corrosion.

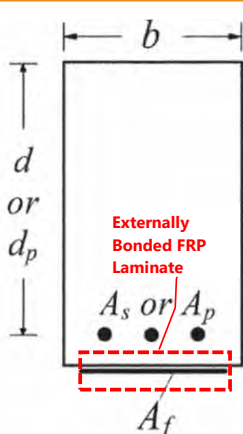
Figure 39. Section view of a reinforced concrete beam strengthened with an externally bonded FRP laminate (adapted from ACI 440.2-23)

Other externally bonded systems may be utilized to increase the flexural resistance of a beam. ACI 440.2-23 also provides guidance for designing other external FRP systems, such as bonded laminates (Figure 39). Otherwise, a steel plate may be bonded to the beam but would likely require fireproofing. No matter the system used, sufficient anchorage of the external system should be provided such that it may develop its intended strength at the critical regions requiring strengthening.
