**SUBJECT:** Police Headquarters WJE Clarification Letter – Phase 2 Peer Review Report – Life Safety Category

**Draft Report**

WJE No. 2024.4855.0

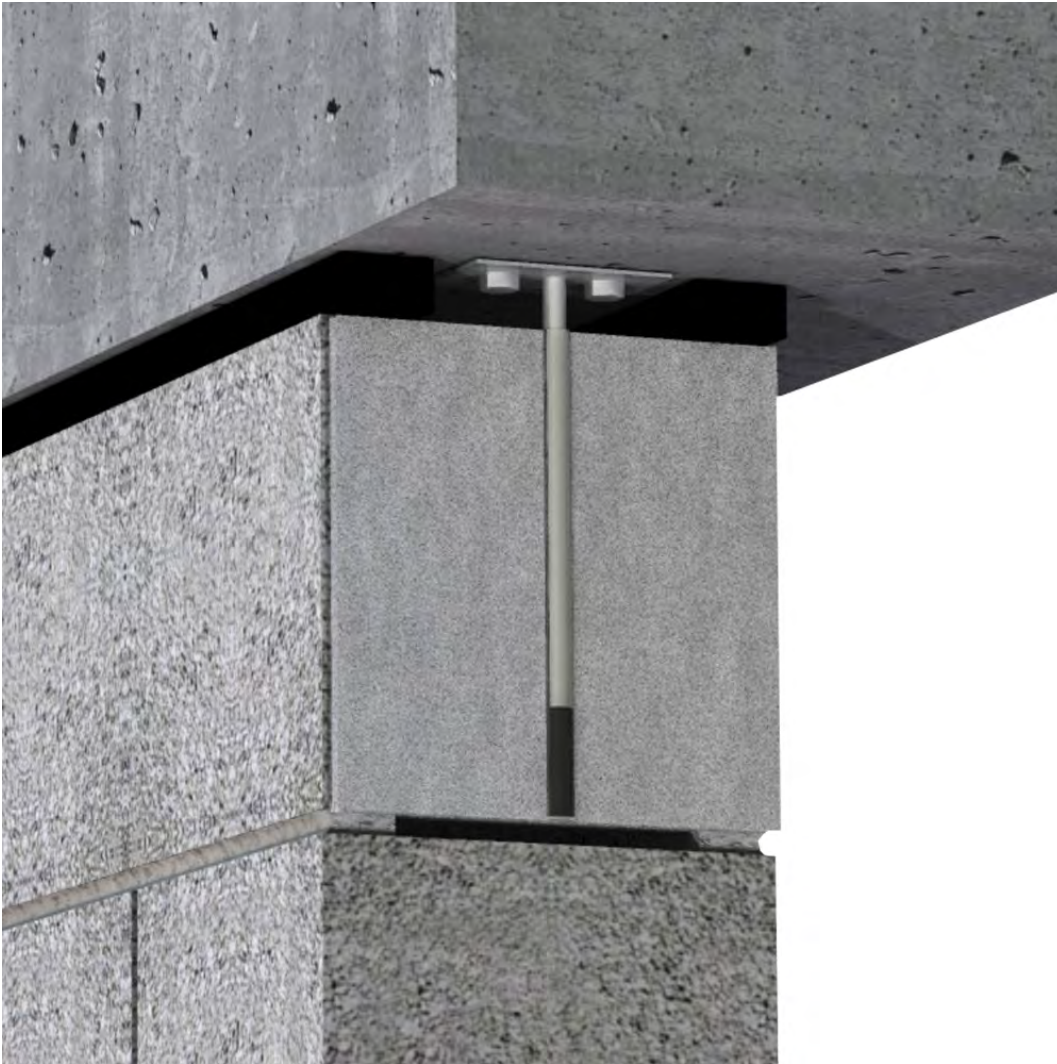
**Report No. 081, Dated December 19, 2023:** Comments by the TI are in regard to the concrete used in slab-on-ground Pour 3. However, photographs of CMU walls in the first story are also shown in the report (Figure 17). These photographs show the overall CMU wall construction at one location in the first story and the approved PTA anchors at the top of the wall. The length of plate at the top of the PTA anchors is aligned parallel with the length of the CMU wall in contrast with the rendering shown on the manufacturer’s website (Figure 10).

Figure 10. Rendering of installed PTA 420 HS anchor from Hohmann and Barnard. Image taken from <https://www.h-b.com/products/pta-series-anchors-pta-420-hs> (accessed on April 13, 2025). Note that the length of the top plate of the anchor is oriented transverse to the length of the wall

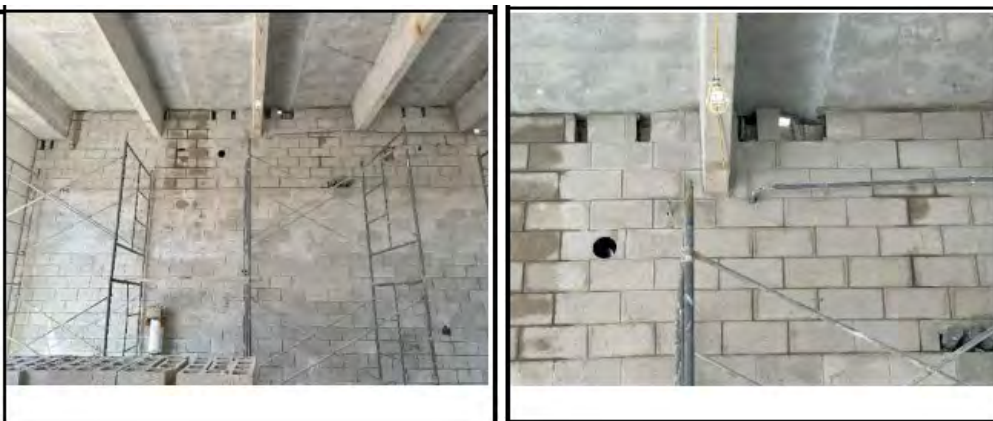
**Report No. 131, Dated March 19, 2024:** The TI notes that “Vertical reinforcement of Level 1 area D CMU checked for adequate lap splice.” Two photographs are shown of a wall that appears nearly complete (Figure 28).

Figure 28. Photographs from Threshold Inspection Report No. 131 showing a wall that is nearly complete

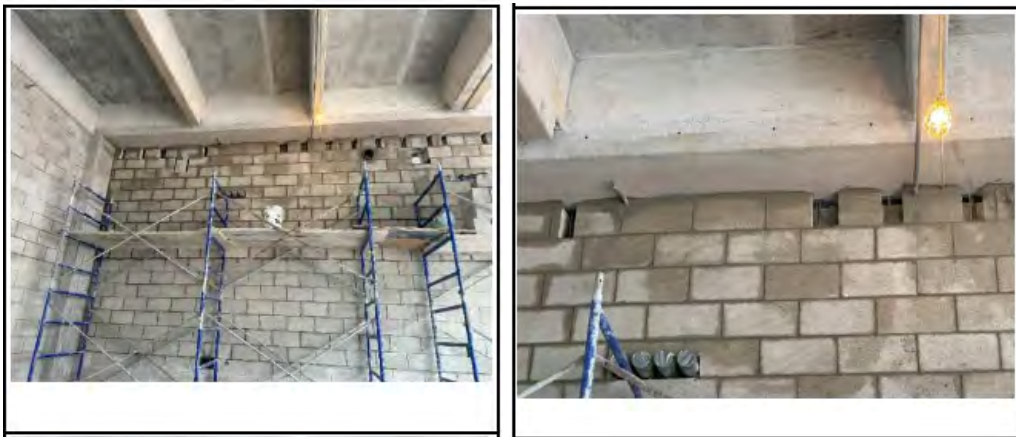
**Report No. 133, Dated March 21, 2024:** The TI notes that “Inspection of CMU on Level 1 area D between grid lines 15 and 16. Checked anchors are properly installed and rebar tied to them.” See Figure 29.

Figure 29. Photographs from Threshold Inspection Report No. 133 showing CMU wall at Level 1, Area D
