CITY OF FORT LAUDERDALE

RIVERWALK CENTER PARKING GARAGE

Structural Condition Assessment – Final Report

May 12, 2021

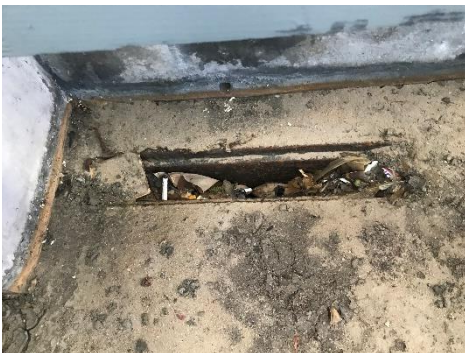
Debris in Drain

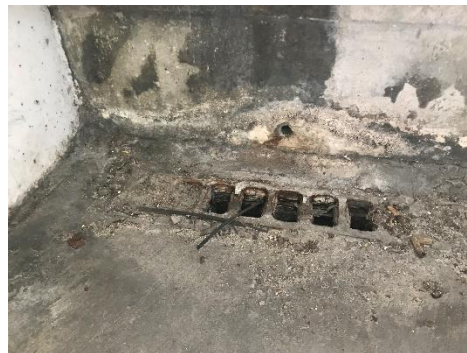
Debris in Drain
