## Fort Lauderdale Police Headquarters

WJE Peer Review, Phase 1 - North Elevation Evaluation

1300 West Broward Boulevard  
Fort Lauderdale, Florida 33312

December 31, 2024  
WJE No. 2024.4855.0

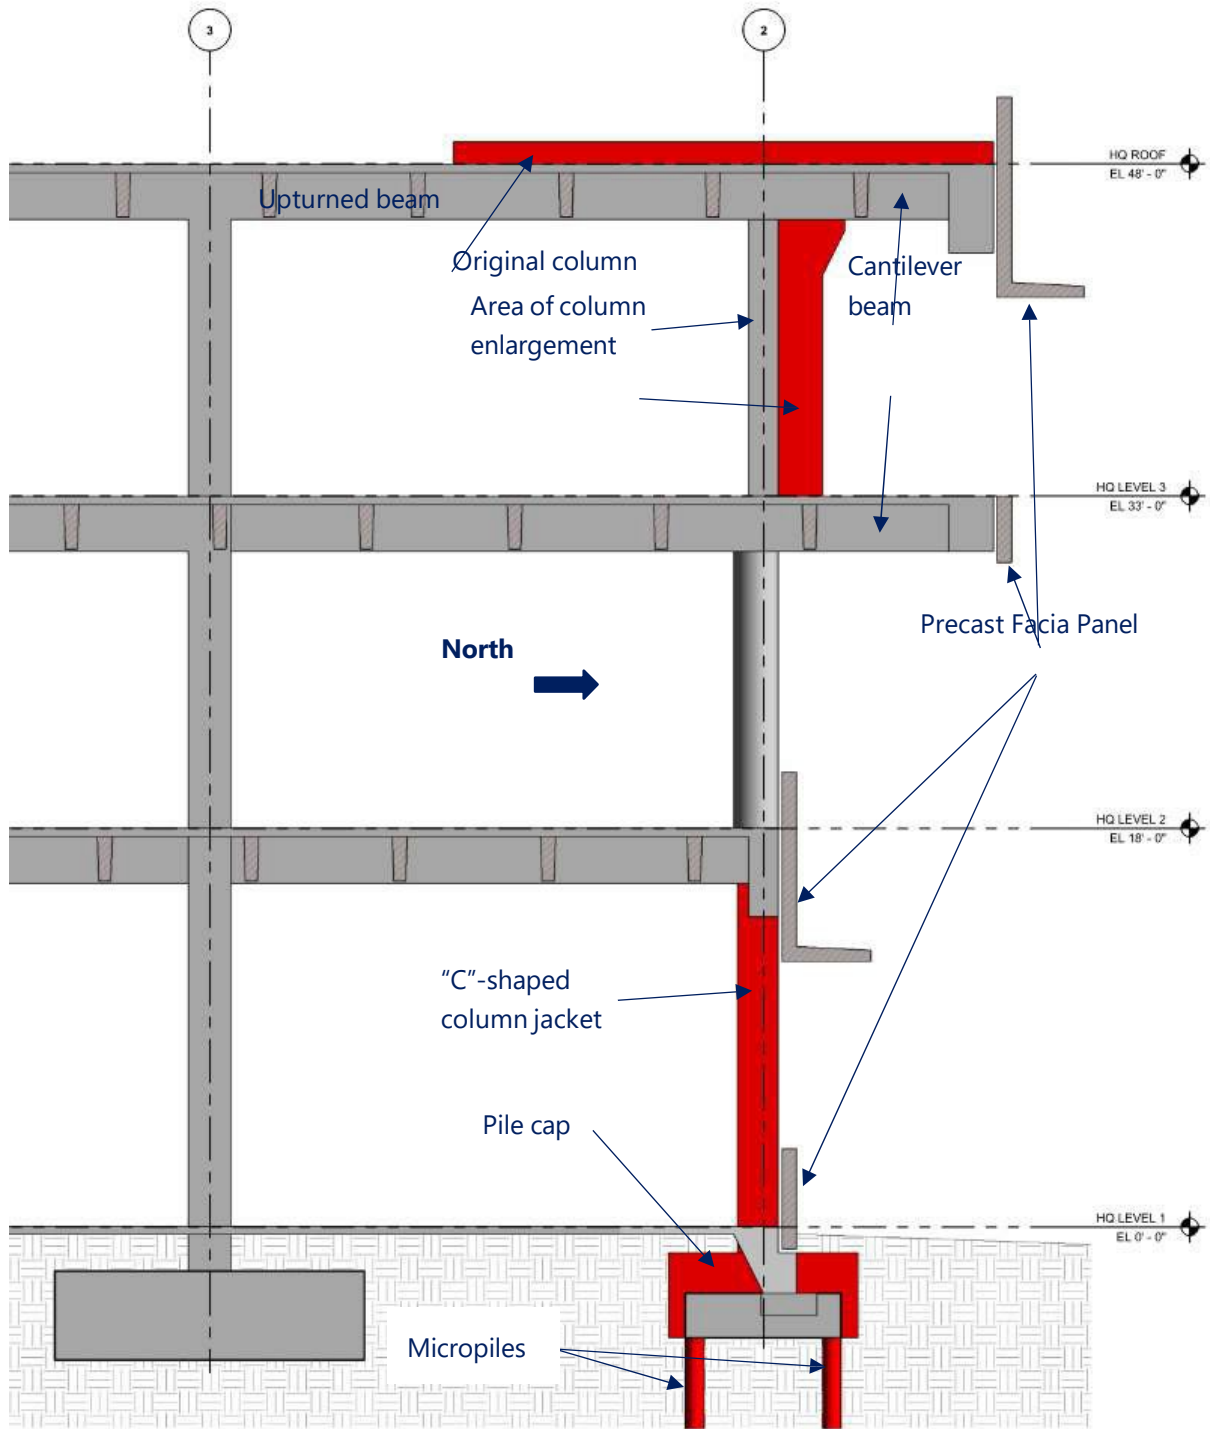
Figure 6. Building section at gridline H showing area north of gridline 3 (from file *Police HQ Views*). Annotations in blue by WJE. Section shows implemented rectifications at third story and proposed rectifications at first story and foundations in red.

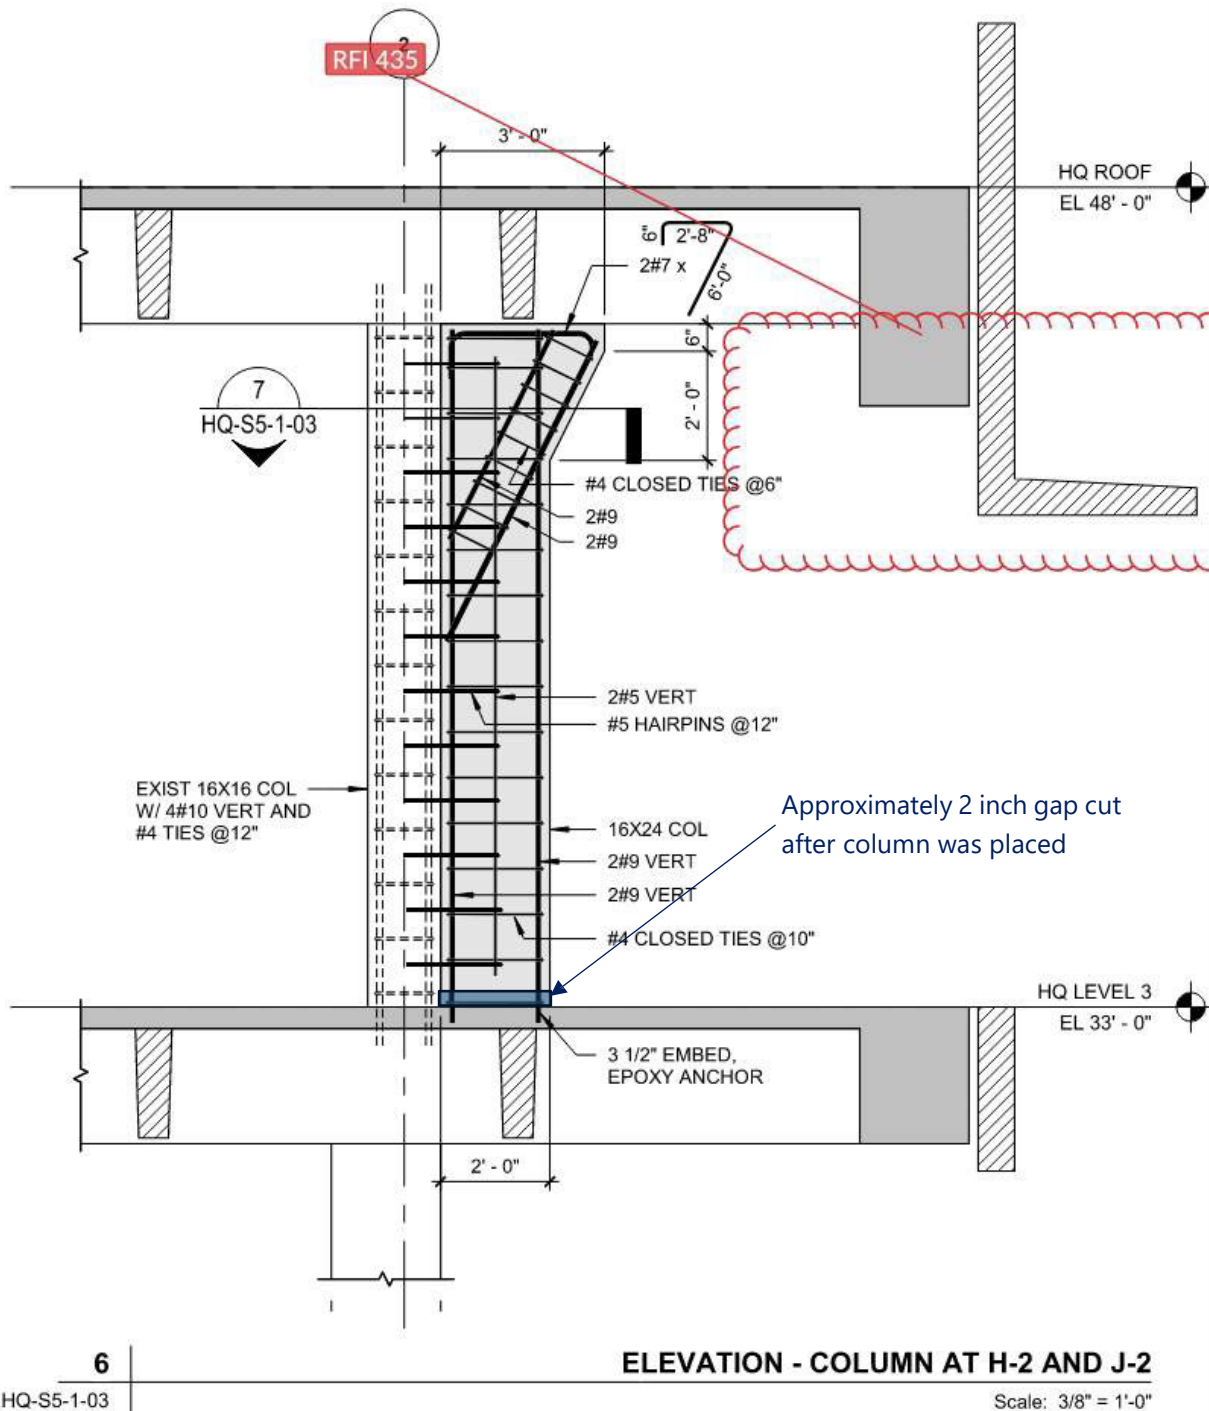
The column enlargement and corbel at the top of the enlarged column are connected to the original column with "U"-shaped No. 5 bar stirrups at 12 inches on center (see Figure 12 and Figure 13). While this distributed connection "stitches" the two columns together, it is our opinion that these "U"-shaped stirrups do not sufficiently resolve the horizontal force that is developed as a result of the inclined "strut" in the corbel. To sufficiently resolve the horizontal force, a tie that spans from the north side of the corbel to the south side of the original column is appropriate. Lakdas also suggested such a tie in their report (Figure 87). This tie should be designed for the horizontal component of the maximum diagonal strut force that is determined through staged-construction analysis. Long-term load-transfer effects due to creep should be considered in the design.

Figure 12. Detail 6 from Sheet HQ-S5-1-03 dated May 24, 2024, showing rectifications details for third story columns at gridlines H-2 and J-2. Annotations in blue by WJE. Note that later the rectifications were modified so an approximately 2 inch gap was cut between the bottom of the column enlargement and the third floor slab.

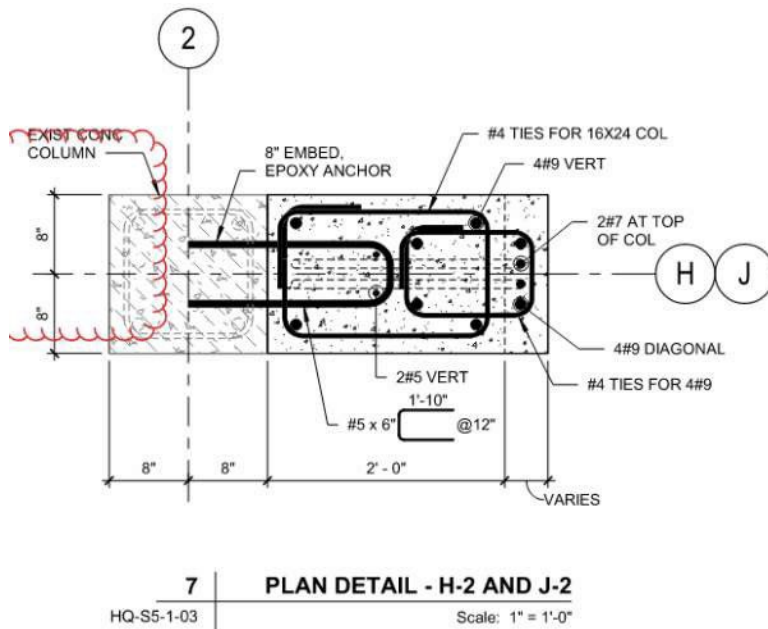
Figure 13. Detail 6 from Sheet HQ-S5-1-03 dated May 24, 2024, showing section through column enlargement rectification for third story columns at gridlines H-2 and J-2.

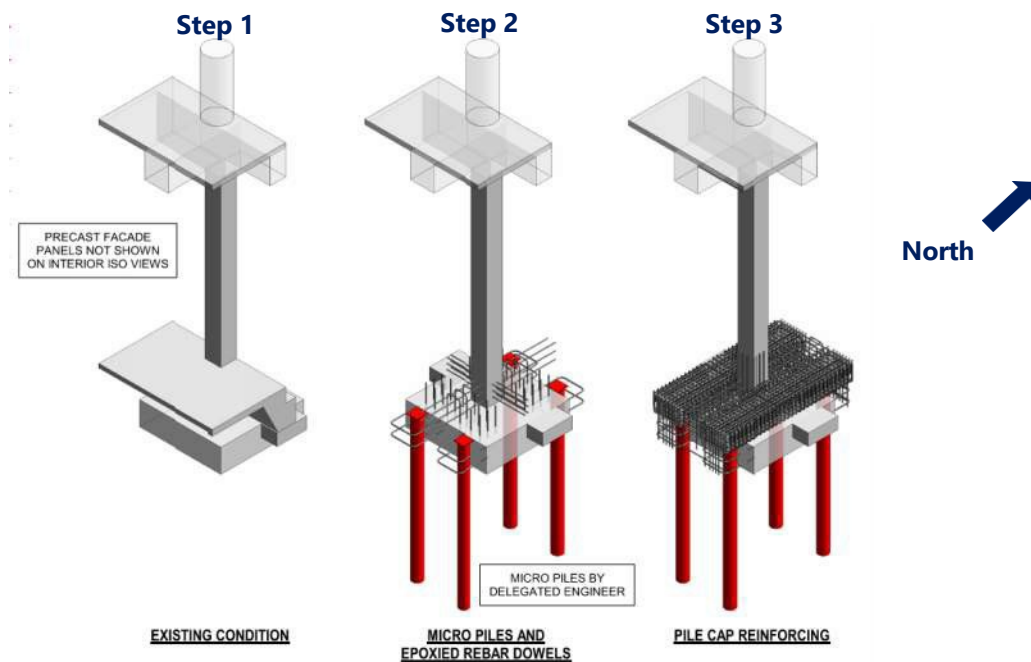
Figure 15. Installation sequence of new micropile and first story column jacket at gridline 2 from detail 2 of Sheet HQ-S6-1-04 dated September 12, 2024. Annotations in blue by WJE. See Figure 16 for subsequent steps.

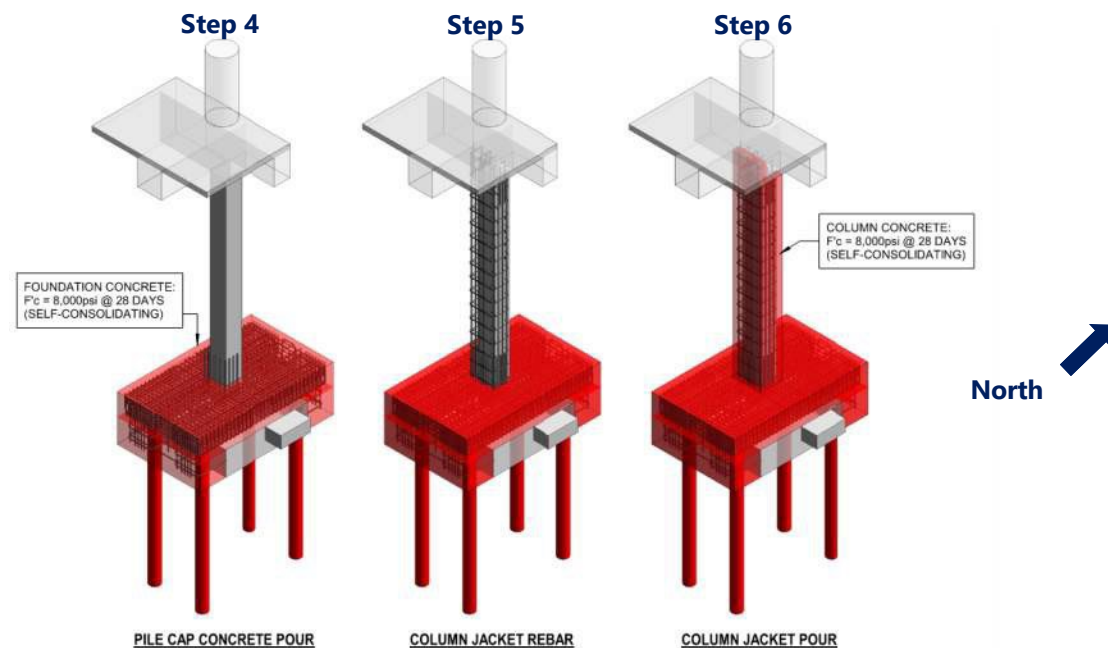
Figure 16. Installation sequence of new micropile and first story column jacket at gridline 2 from detail 2 of Sheet HQ-S6-1-04 dated September 12, 2024. Annotations in blue by WJE. See Figure 15 for preceding steps.

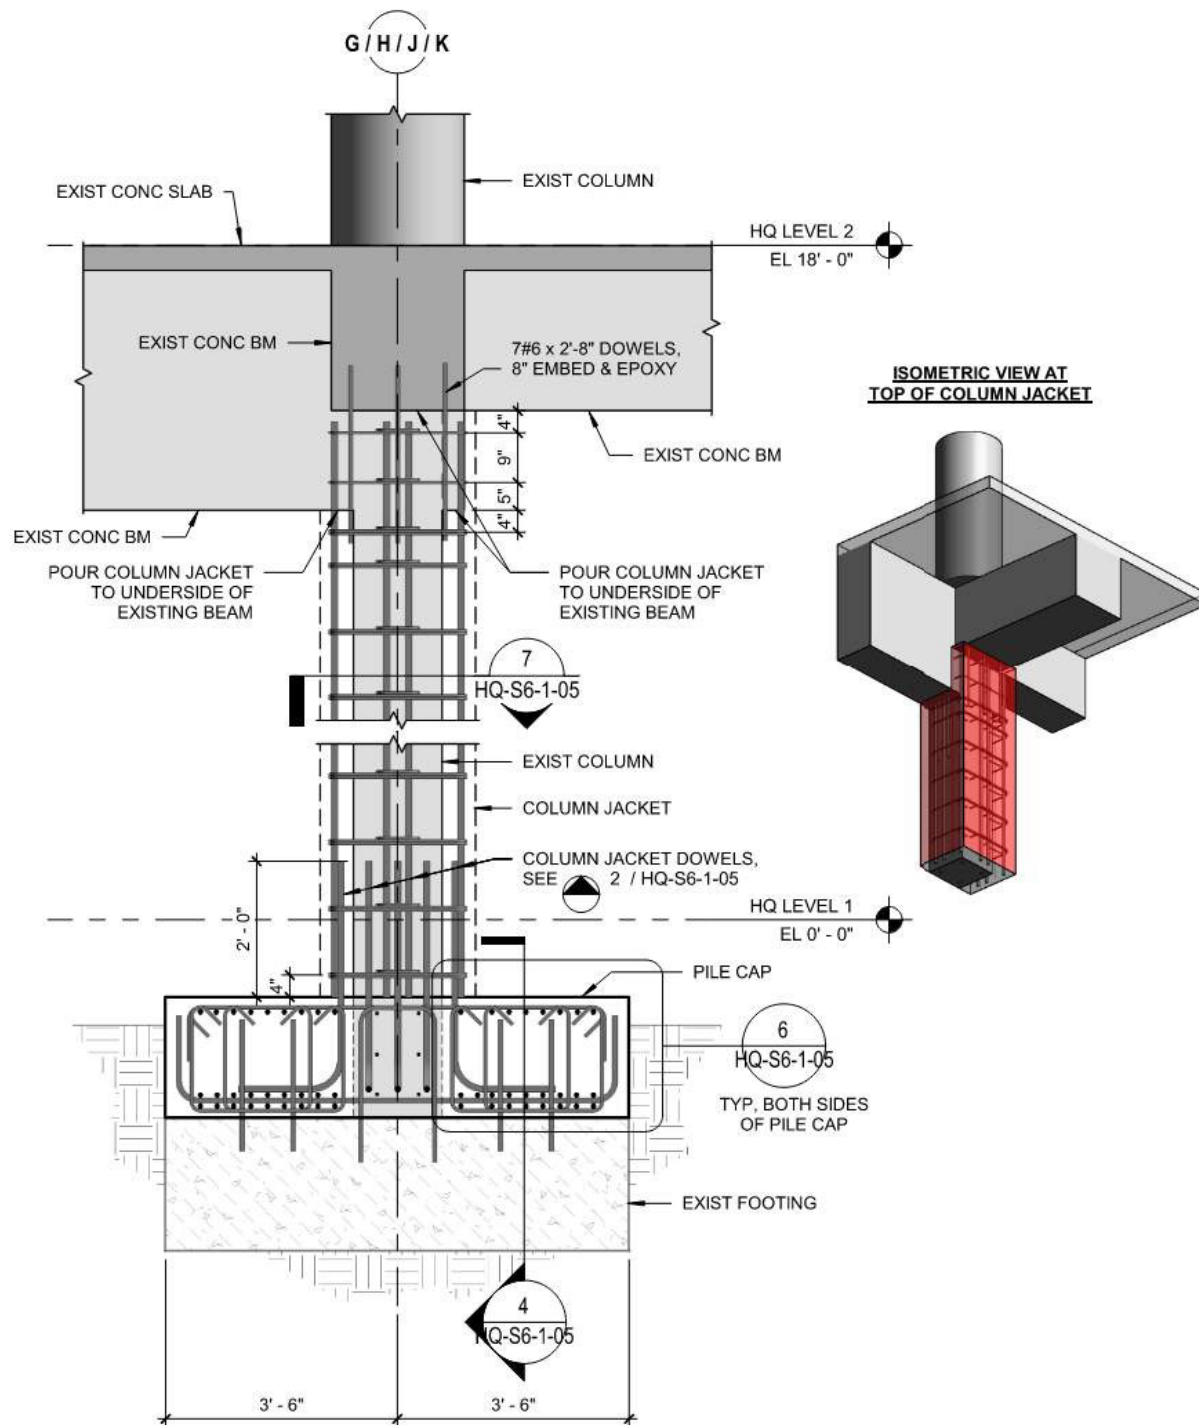
Figure 17. Section and isometric view from detail 3 of Sheet HQ-S6-1-05 (dated September 12, 2024) showing new column jacket and pile cap at first story columns at gridline 2. Section view is facing north.

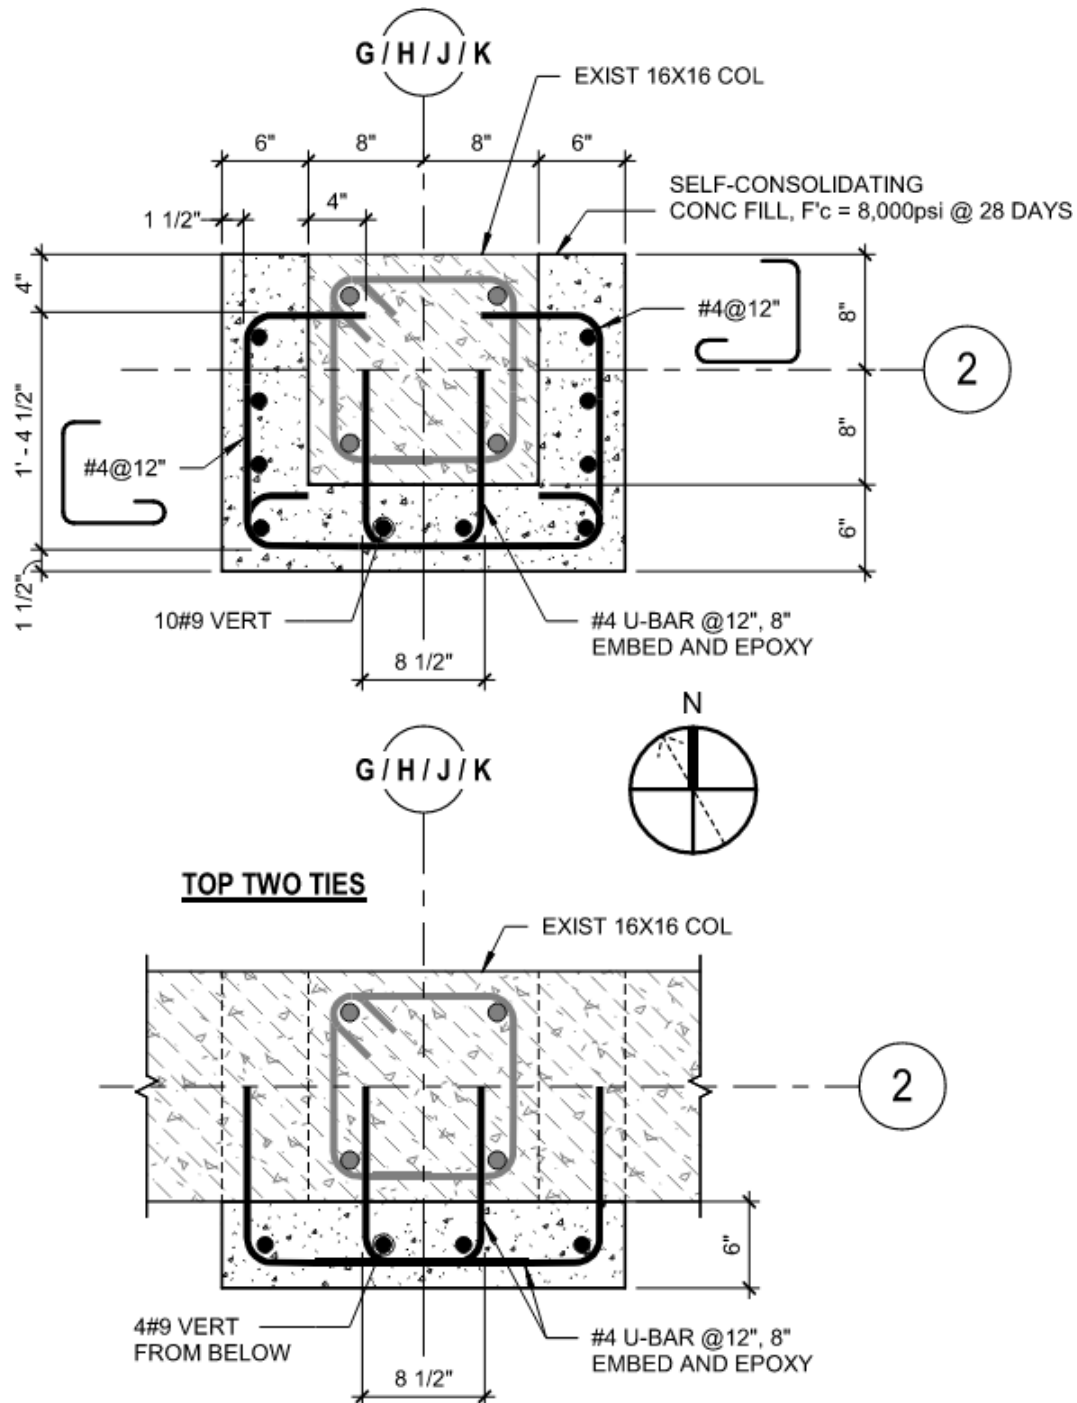
That said, we have some reservations about how the column jackets will be implemented. Currently, the ties for the column jacket (Figure 18), have their termination on the northern side of the column, embedded 4 inches into the column using epoxy adhesive. Terminating the tie in this manner will not

Figure 18. Detail 7 of Sheet HQ-S6-1-05 (dated September 12, 2024) showing column reinforcement for new column jacket at first story columns at gridline 2. Upper detail is for all but the top of the column while the lower detail is for the portion of the column that extends up past the east-west beams to the soffit of the north-south second floor beam.

- We concur with the findings by others that rectification measures are necessary to provide code-compliant strength and we find the proposed column jackets are a reasonable rectification measure.
- We recommend that the ties of the column jacket proposed by the SEOR be closed ties as discussed herein and we recommend that the surface of the existing column be roughened prior to the installation of the column jacket.

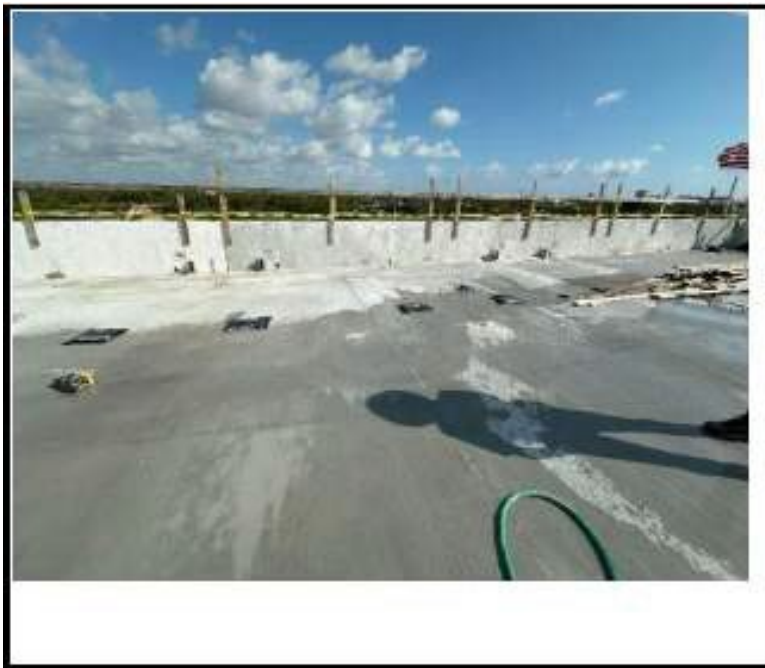
Additional documentation and observations were summarized in Threshold Inspection Report No. 127, dated March 13, 2024. Water was sprayed onto the top of the roof slab (Figure 29 and Figure 30) and it was observed that some water infiltrated through the cracks in the slab and was evident on the underside of the slab (Figure 31 through Figure 34), indicating that the cracks extended through the entire thickness of the slab.

Figure 30. Photograph from Threshold Inspection Report No. 127 showing water which was sprayed onto the top of the roof slab at the north end of building.

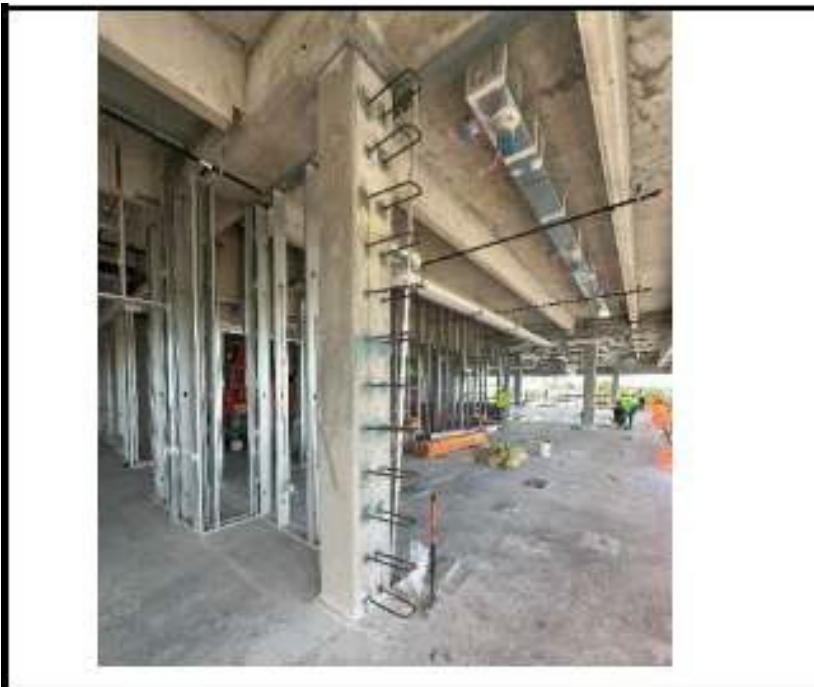
Figure 36. Photograph from Threshold Inspection Report No. 138 showing installed dowels on the north side of column J-2 part of the rectification of the column and roof structure.

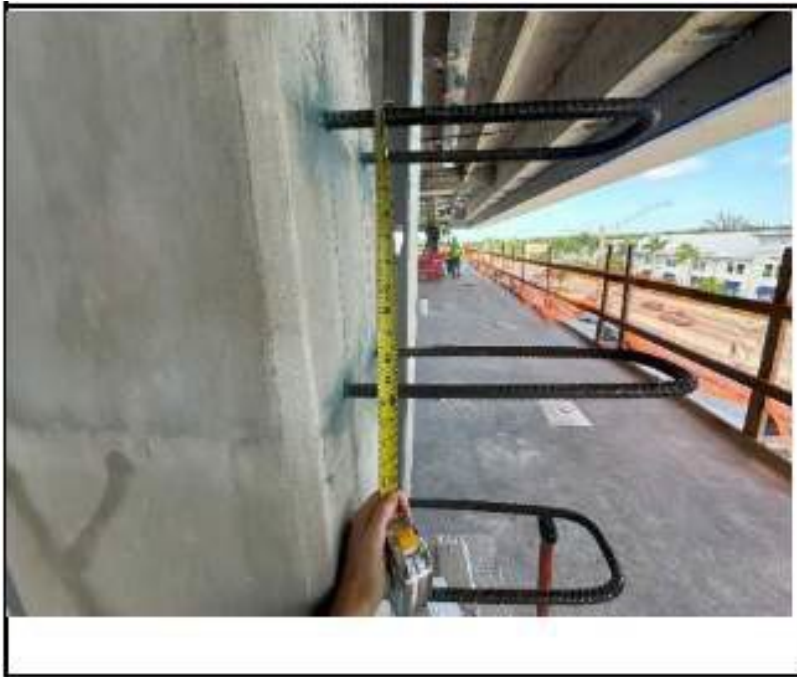
Figure 37. Photograph from Threshold Inspection Report No. 138 showing installed dowels on the north side of column J-2 part of the rectification of the column and roof structure.

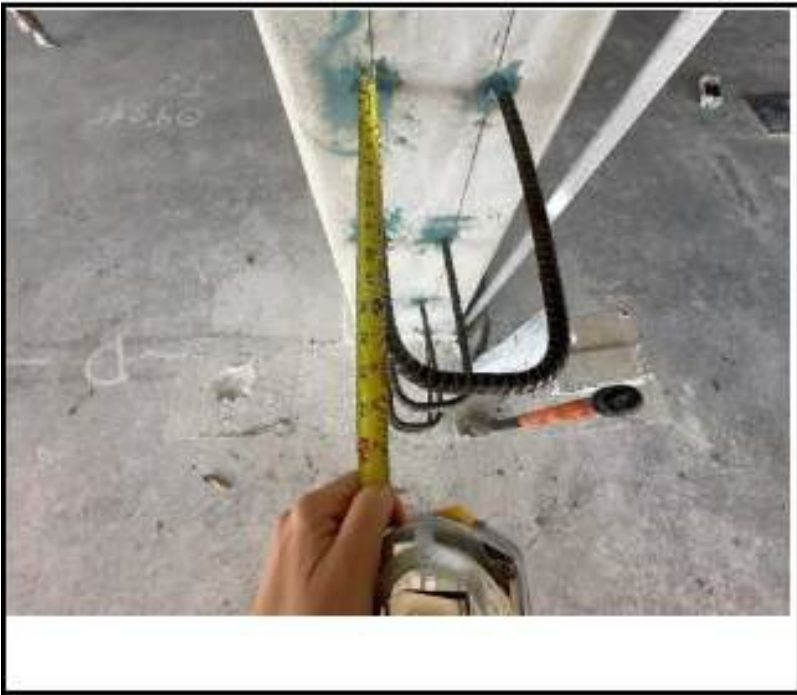
Figure 38. Photograph from Threshold Inspection Report No. 138 showing installed dowels on the north side of column J-2 part of the rectification of the column and roof structure.

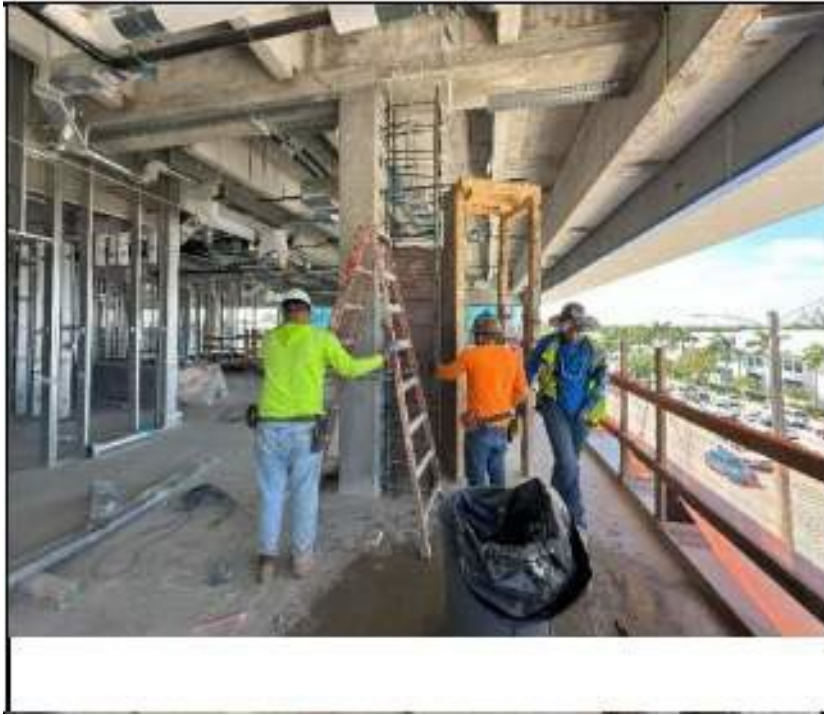
Figure 39. Photograph from Threshold Inspection Report No. 139 showing installed vertical reinforcement and horizontal ties at third story column enlargement.

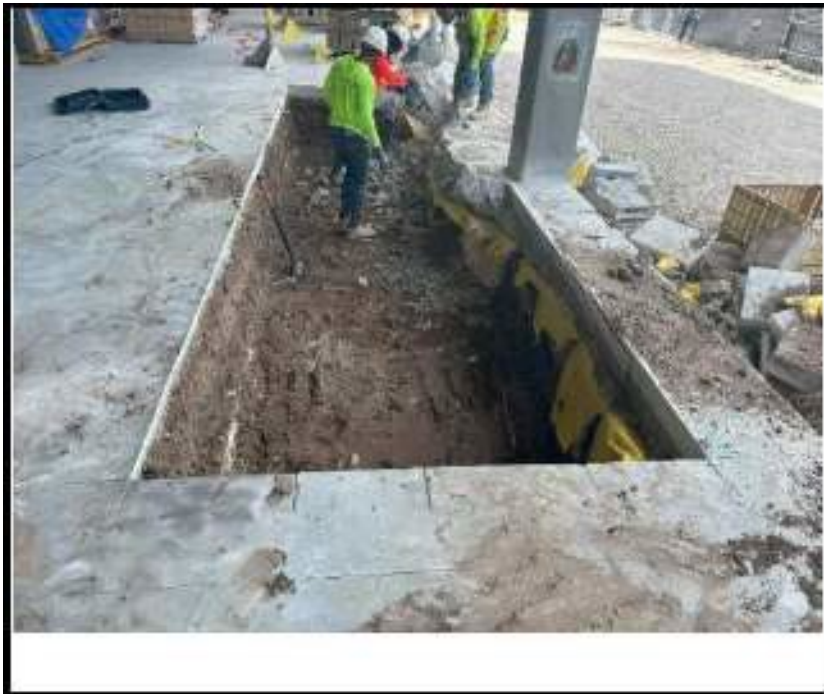
Figure 40. Photograph from Threshold Inspection Report No. 139 showing work to enlarge the footing at the base of either column H-2 or J-2.

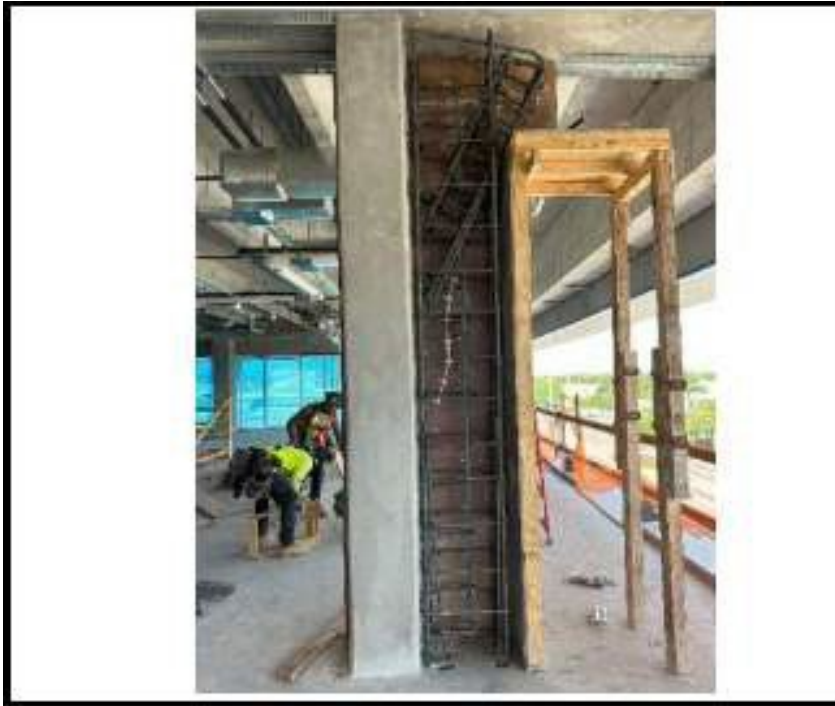
Figure 41. Photograph from Threshold Inspection Report No. 140 showing completed reinforcement installation at third story column enlargement.

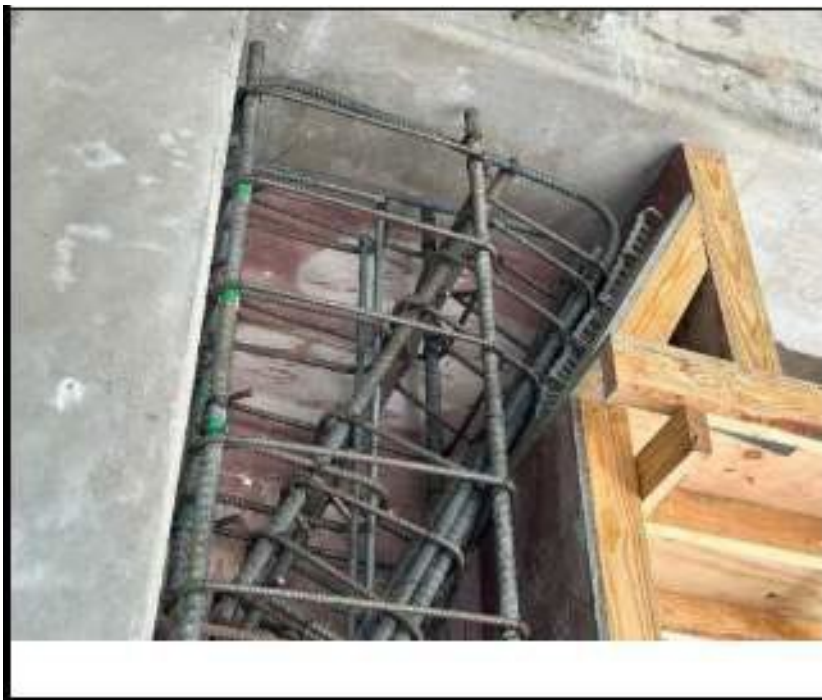
Figure 42. Photograph from Threshold Inspection Report No. 140 showing completed reinforcement installation at third story column enlargement.

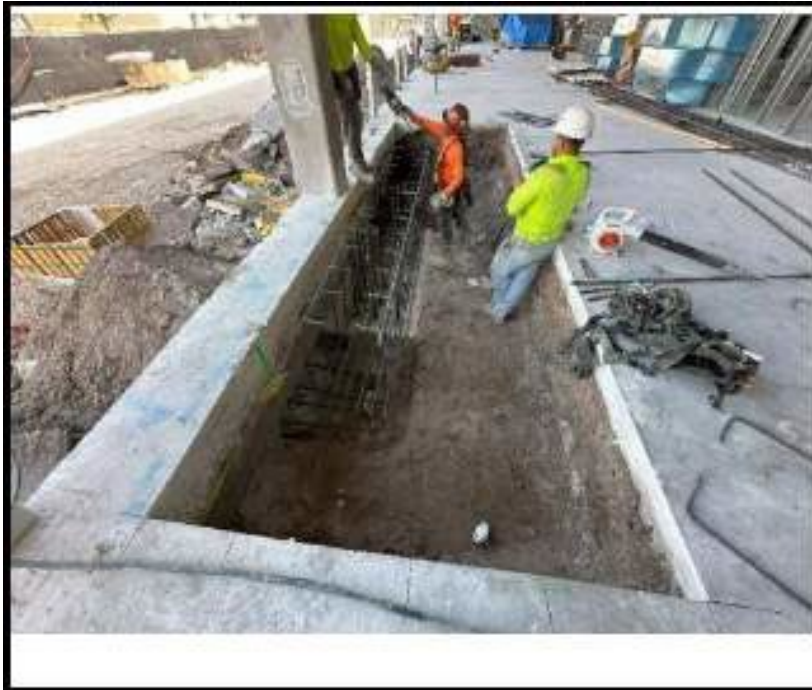
Figure 43. Photograph from Threshold Inspection Report No. 140 showing continuing work on column footing enlargement.

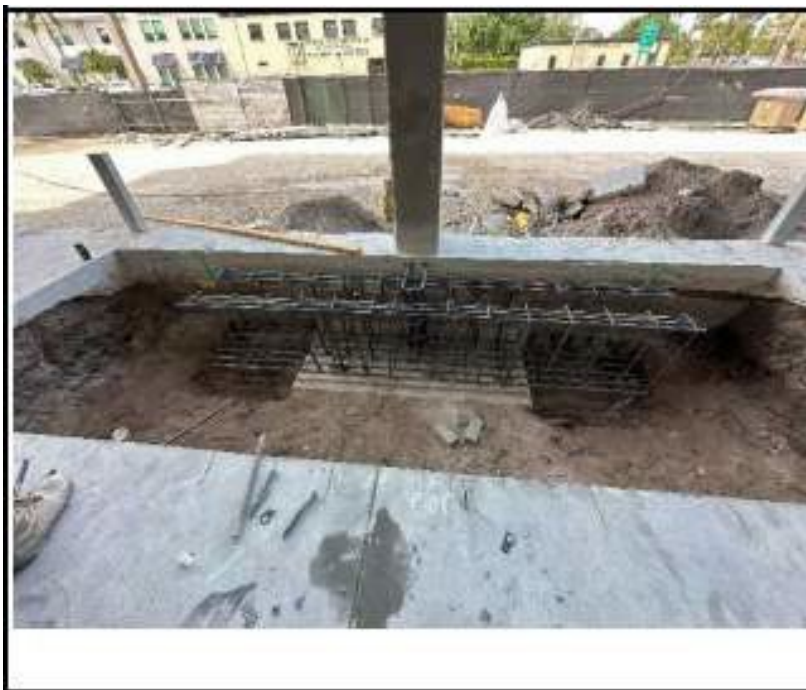
Figure 44. Photograph from Threshold Inspection Report No. 140 showing continuing work on column footing enlargement.

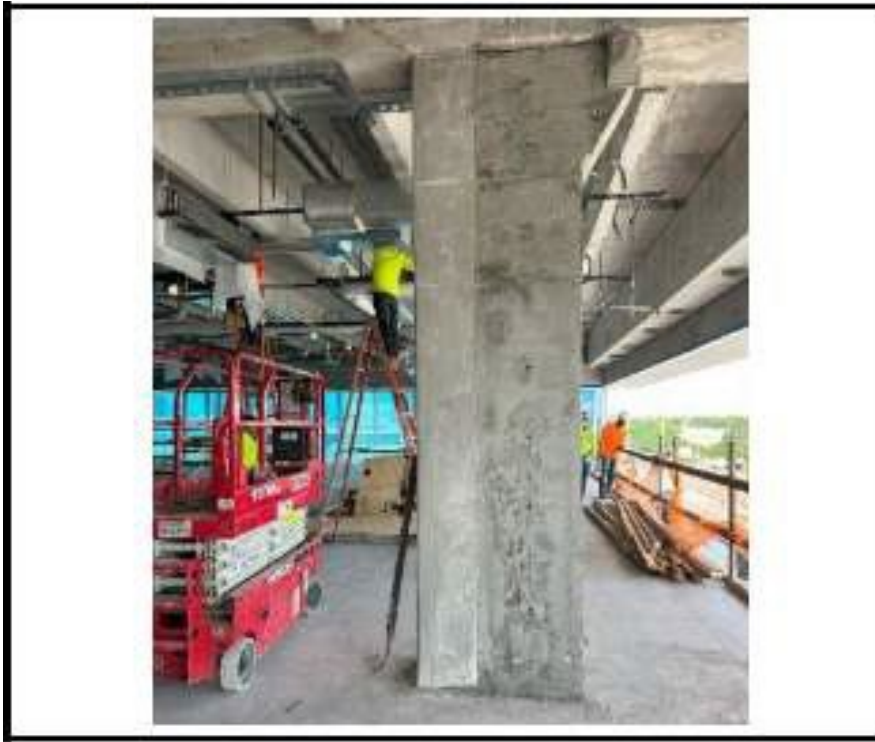
Figure 45. Photograph from Threshold Inspection Report No. 141 showing completed column enlargement.

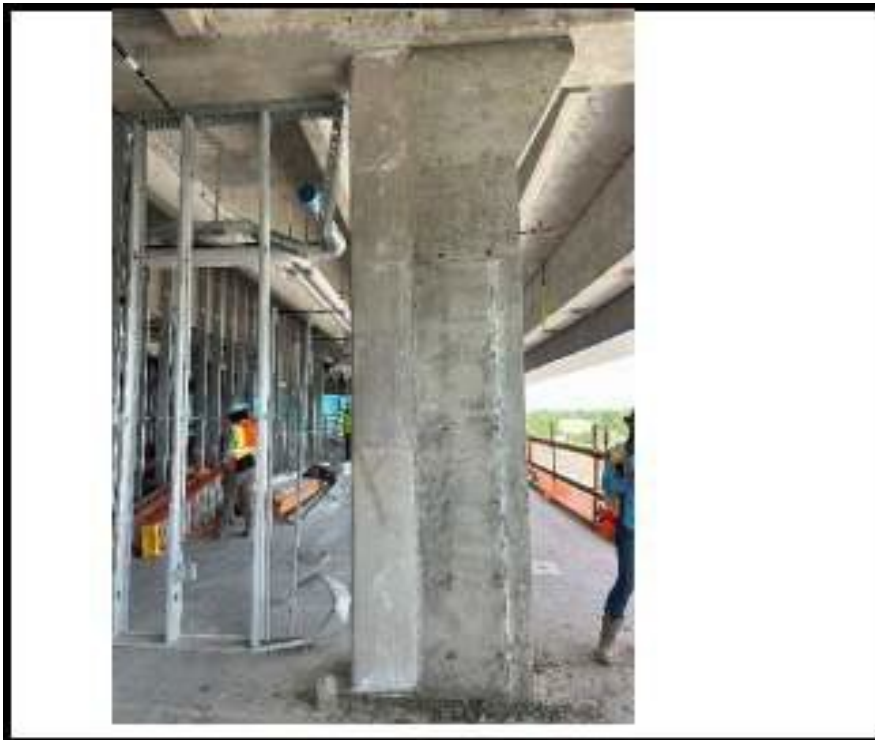
Figure 46. Photograph from Threshold Inspection Report No. 141 showing completed column enlargement.

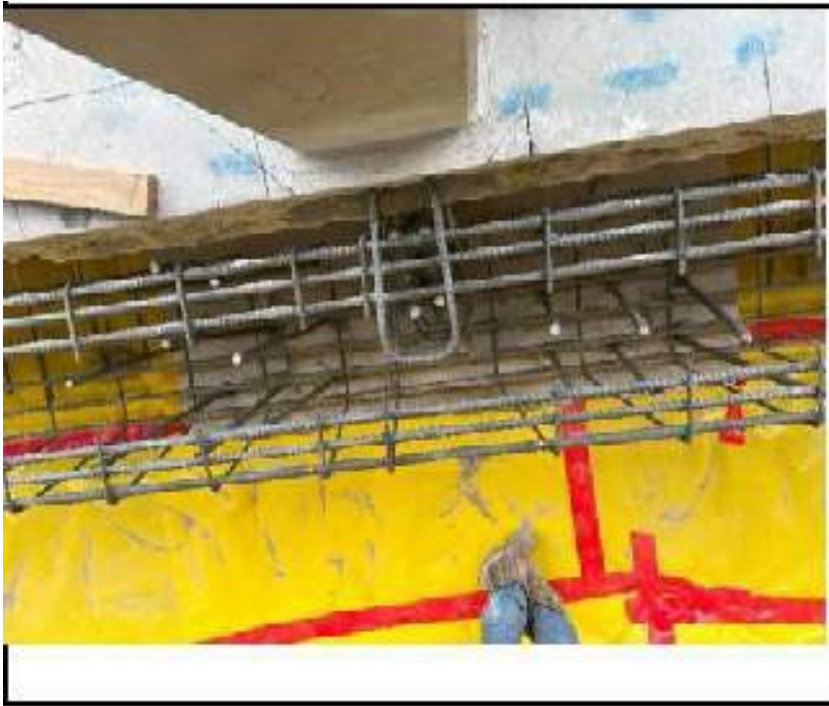
Figure 47. Photograph from Threshold Inspection Report No. 141 showing continuing work on column footing enlargement.

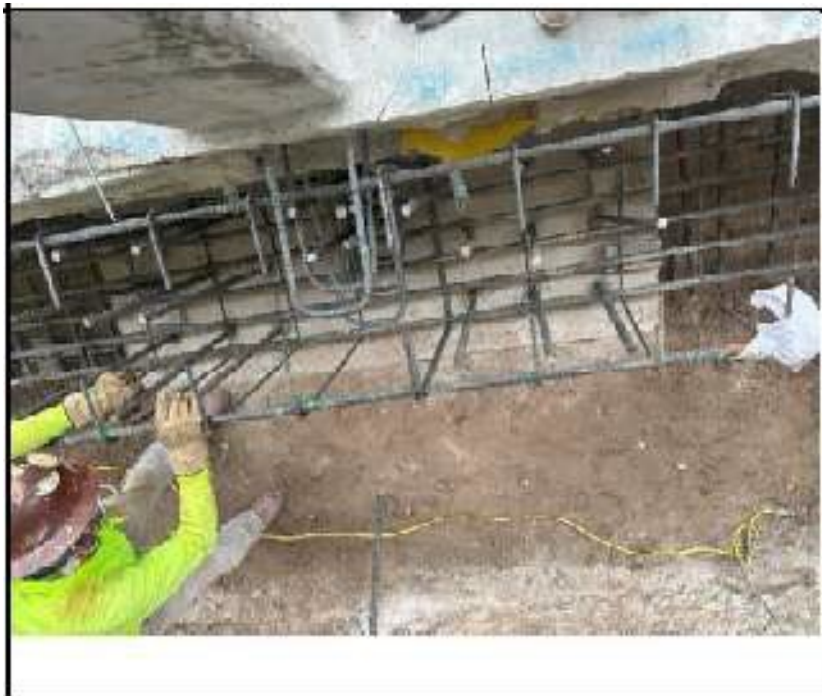
Figure 48. Photograph from Threshold Inspection Report No. 141 showing continuing work on column footing enlargement.

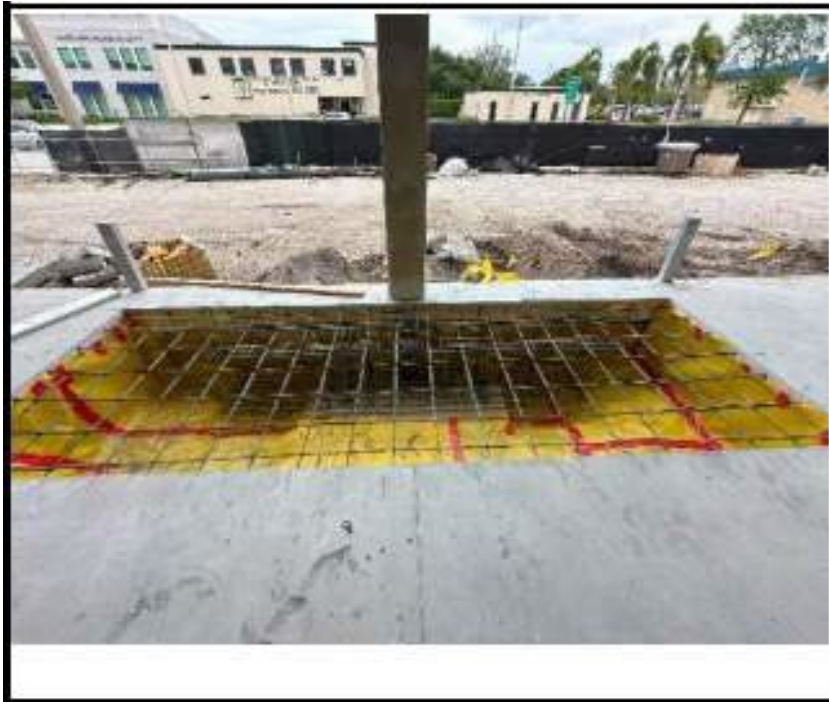
Figure 49. Photograph from Threshold Inspection Report No. 142 showing completed reinforcement placement at column footing enlargement.

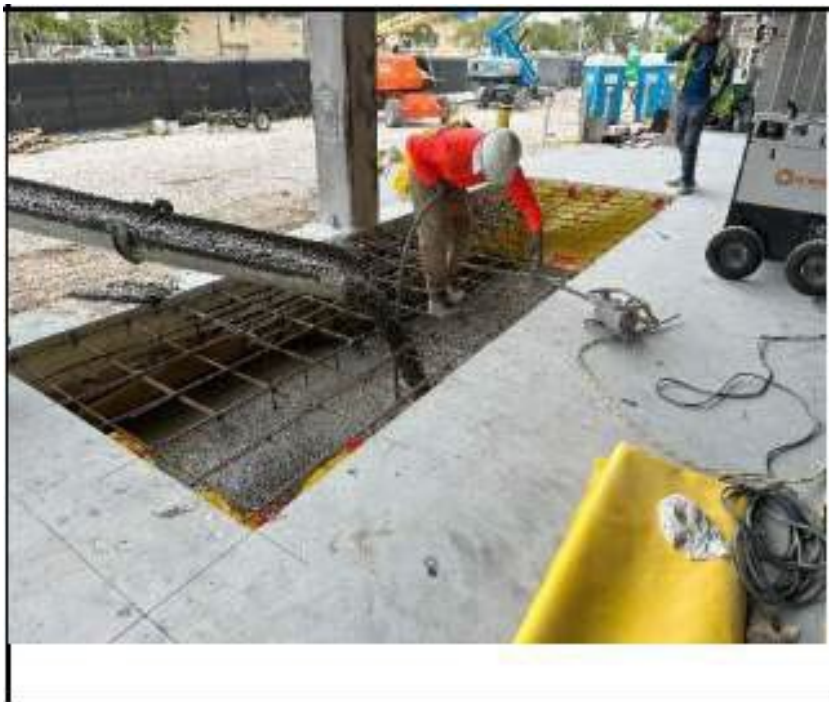
Figure 50. Photograph from Threshold Inspection Report No. 142 showing concrete placement at column footing enlargement.

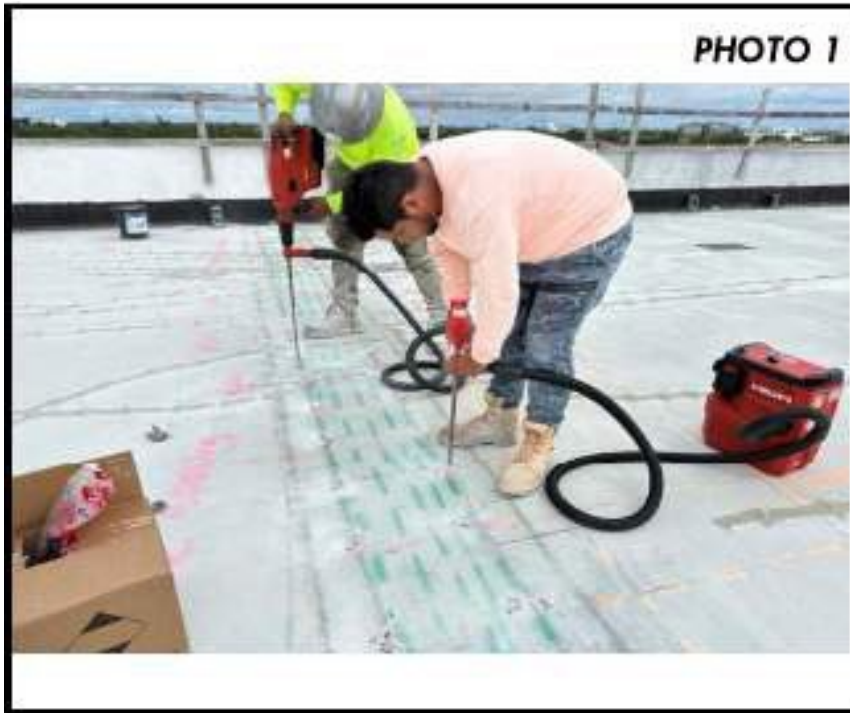
Figure 51. Photograph from Threshold Inspection Report No. 200 showing drilling of holes for inverted “U” shaped stirrups in upturned beams.

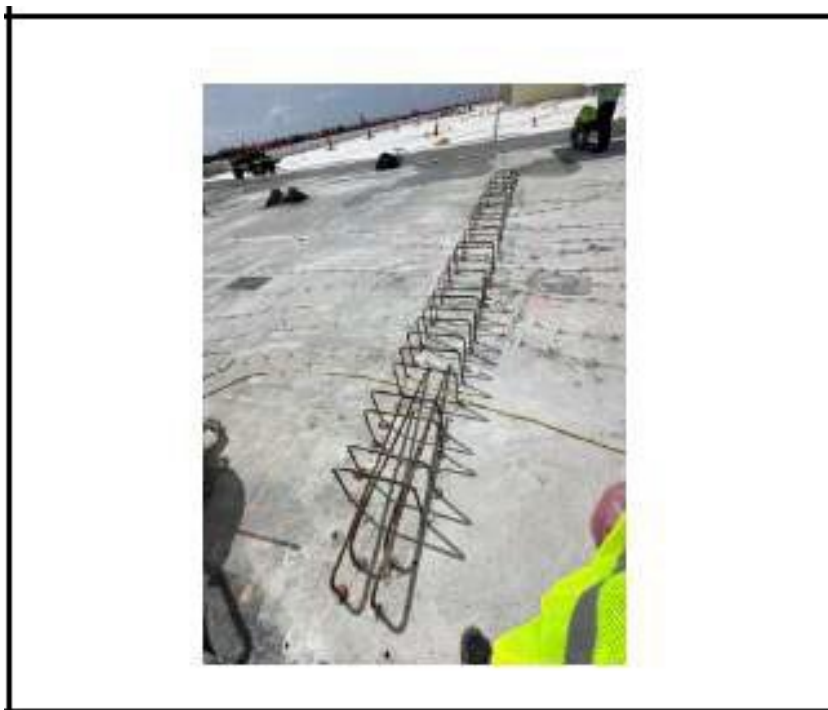
Figure 56. Photograph from Threshold Inspection Report No. 202 showing installed inverted "U" shaped stirrups and end "L" bars in upturned beams.

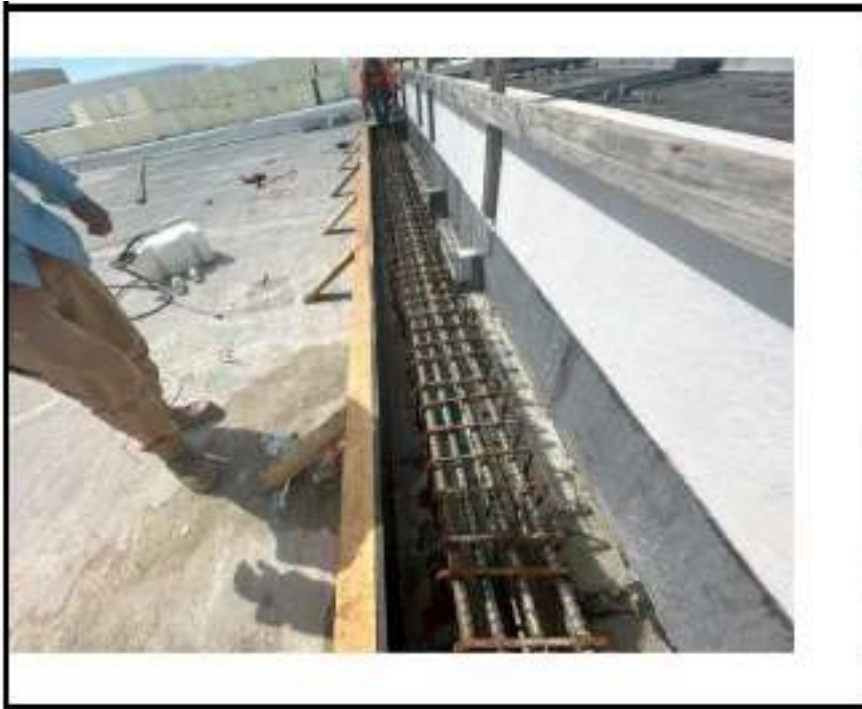
Figure 57. Photograph from Threshold Inspection Report No. 207 showing completed installation of reinforcement in in upturned beam.

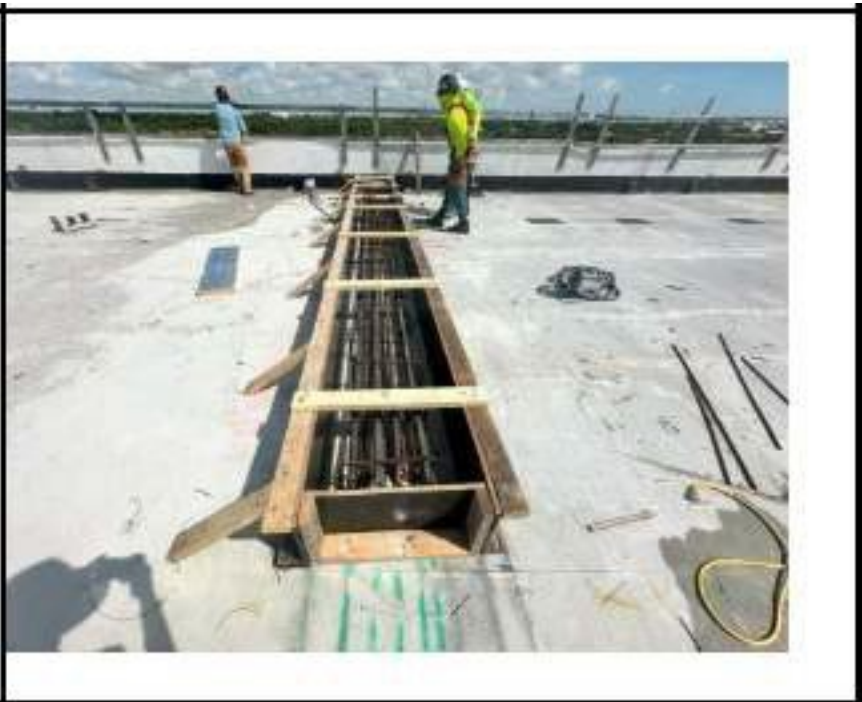
Figure 58. Photograph from Threshold Inspection Report No. 207 showing completed installation of reinforcement in in upturned beam.

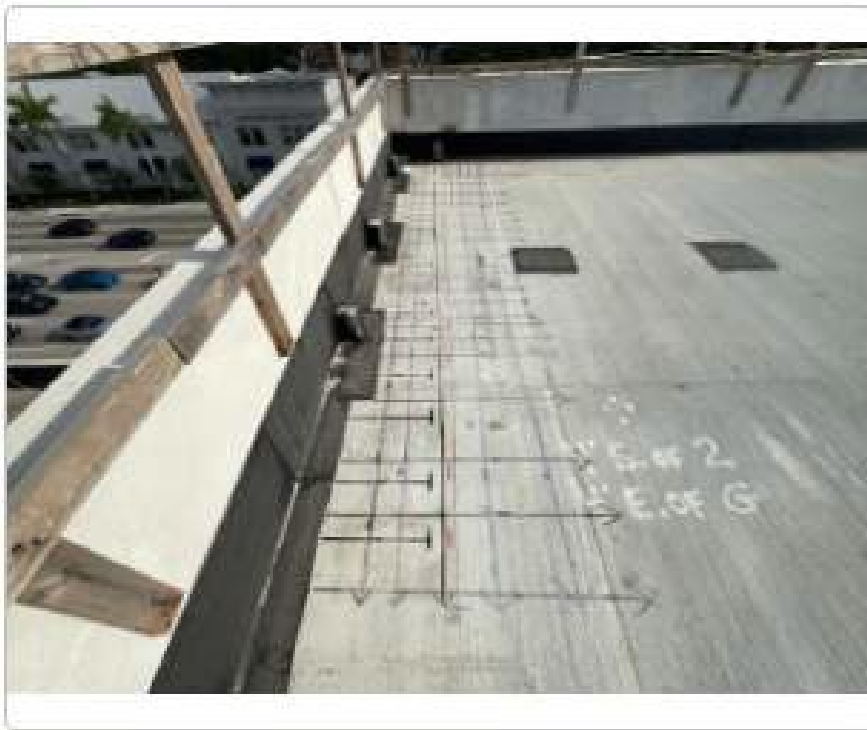
Figure 59. Photograph from ScanTek GPR report at Spot 1 (beams RSB-72 and RSB-73).
