## Fort Lauderdale Police Headquarters

WJE Peer Review, Phase 1 - North Elevation Evaluation

1300 West Broward Boulevard  
Fort Lauderdale, Florida 33312

December 31, 2024  
WJE No. 2024.4855.0

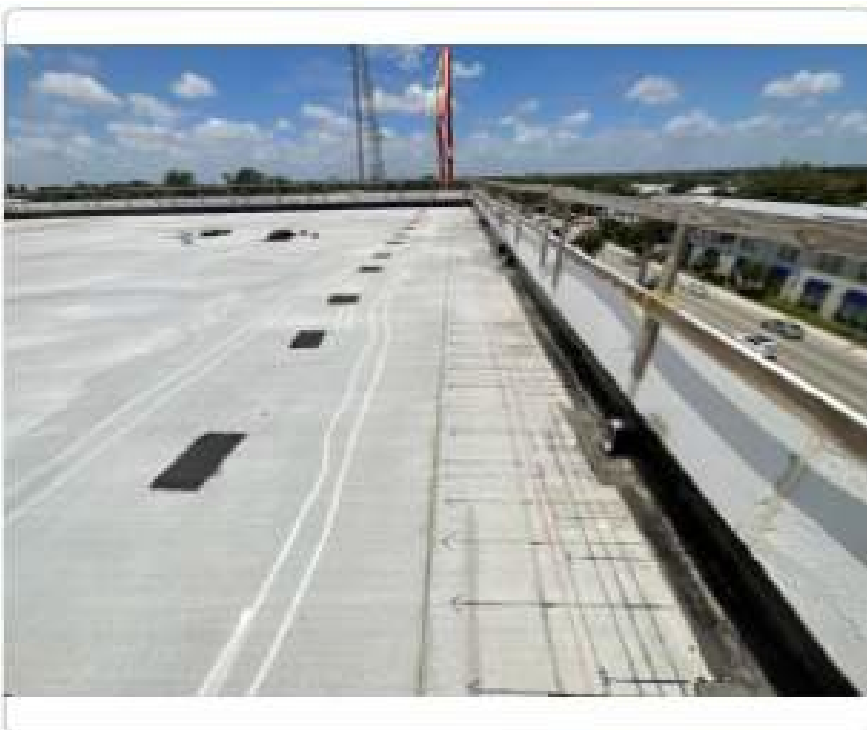
Figure 60. Photograph from ScanTek GPR report at Spot 2 (beam RB-97).

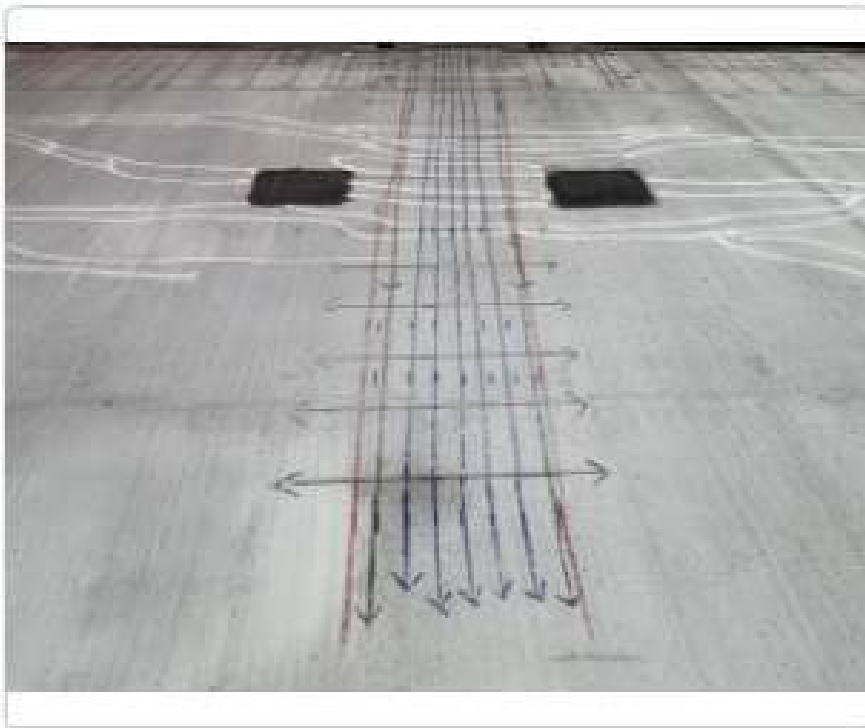
Figure 61. Photograph from ScanTek GPR report at Spot 3 (beams RSB-75 and RSB-76).

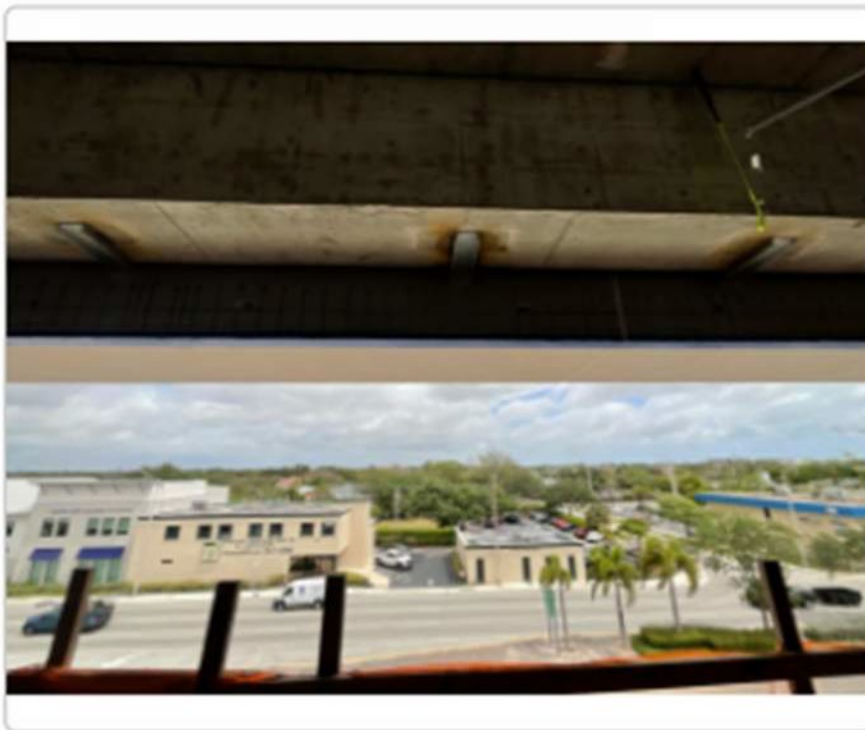
Figure 62. Photograph from ScanTek GPR report at Spot 4 (precast facade panel at roof).

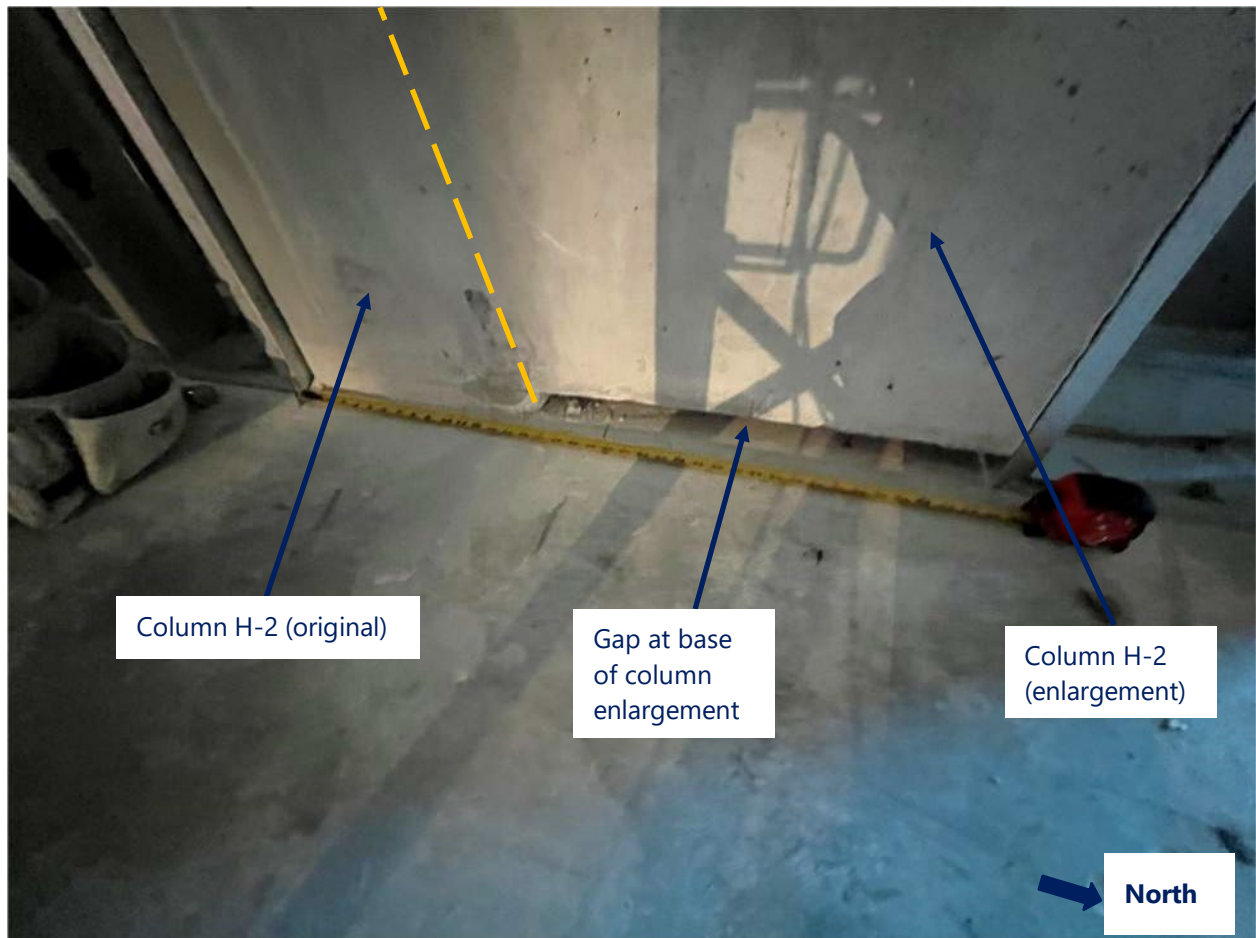
- This result is due to the condition at the base of the column where the column enlargement was demolished in combination with the biaxial bending in the column. If 12 inches of the column enlargement are grouted (see Figure 79) with non-shrink grout having a minimum 28-day compressive strength of 5,000 psi, then the column would be code-compliant for strength for axial plus biaxial bending.

Figure 72. Base of third story column at H-2 showing gap after bottom of column enlargement was cut.

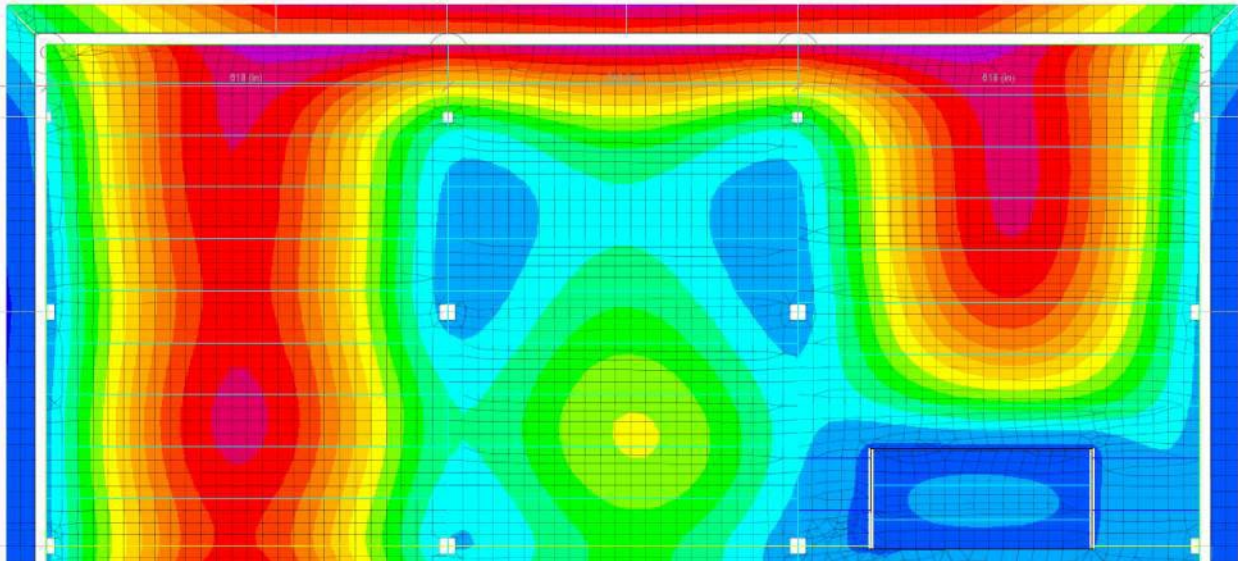
Figure 76. Roof-level deflected shape prediction by ETABS after 10 years of service; as-designed building configuration; purple corresponds with 4 inches of deflection.

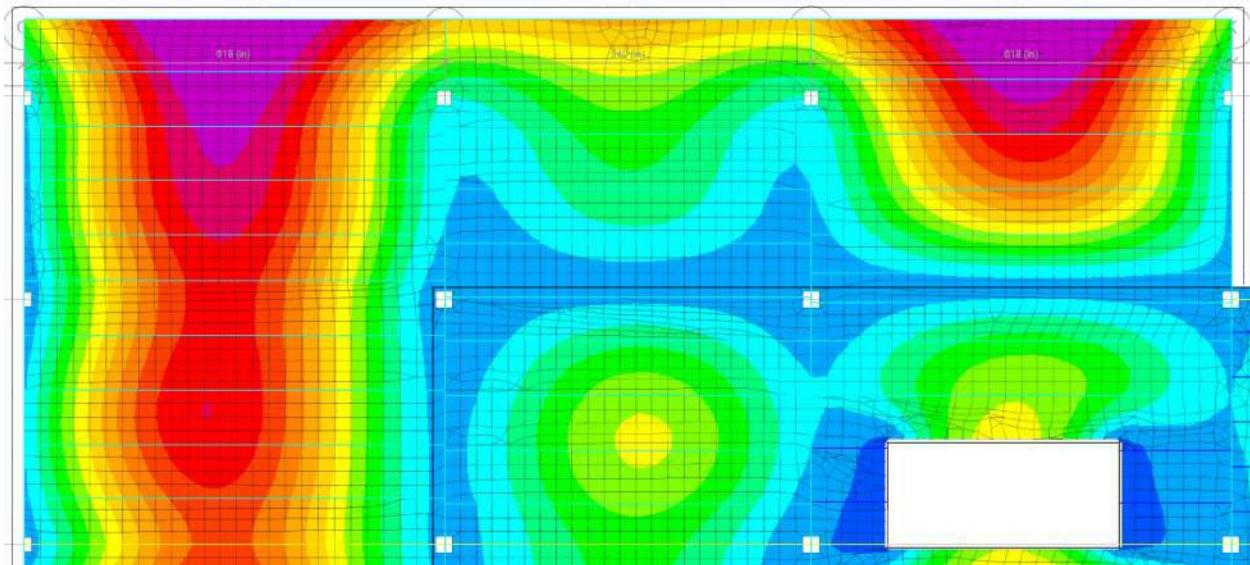
Figure 77. Level 3 deflected shape prediction by ETABS after 10 years of service; as-designed building configuration; purple corresponds with 4 inches of deflection.

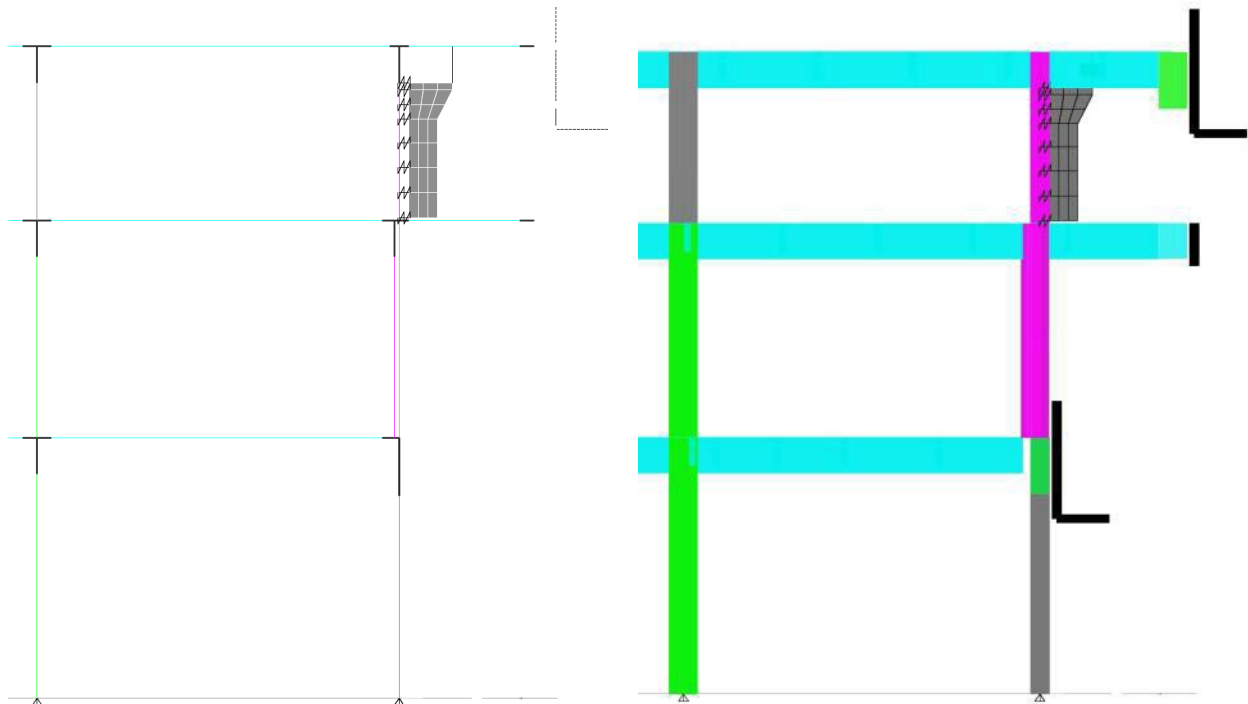
To evaluate the installed and recommended rectification measures, WJE modified the ETABS model described in the preceding section to incorporate the rectification measures into our staged construction analysis. Specifically, the following modifications were made to the model (Figure 78):

- The geometry of the Level 3 columns (supporting the Roof level) was updated using shell elements to reflect the new geometry in the retrofitted configuration. Note that the retrofit portion was not modeled as extending or attaching to the Level 3 floor slab, consistent with it having been saw-cut and removed approximately 2 inches above the third floor in the current as-built configuration.
- The Level 1 columns (supporting Level 2) were enlarged on three sides, resulting in overall cross-sectional dimensions of 22 inches by 28 inches (modeled, but not depicted in Figure 78 due to stage of construction at which snapshot of the model was extracted).

The depth of the beams at the roof level oriented in the north-south direction (parallel to the cantilever) was increased by 12 inches on the top surface of the roof level (modeled, but not depicted in Figure 78).

Figure 78. Cross section of analysis model in as-rectified configuration (unextruded left, extruded right).

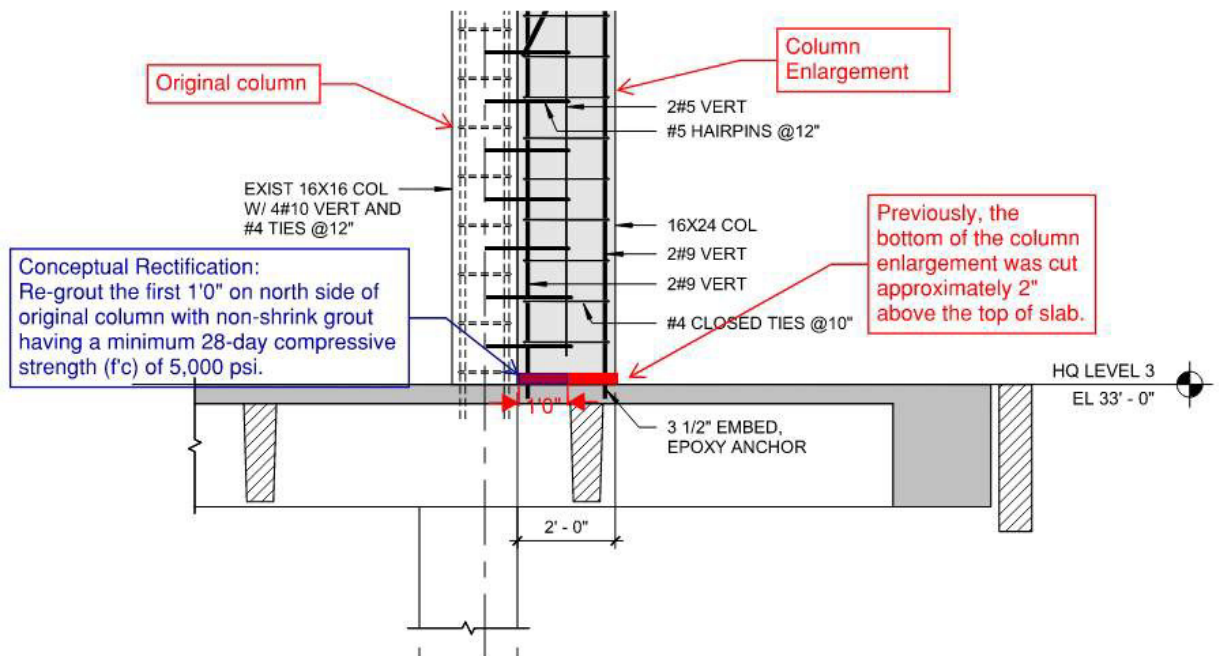
Figure 79. Conceptual rectification for partial re-grouting of base of column enlargement

must be resisted by the original column. We determined that once the enlargement was added and then the lower portion removed, the remaining original column cross-section is no longer code-compliant for axial plus biaxial bending due to the cut but could be brought back into compliance if 12 inches of the base of the column are regouted (see Figure 79).

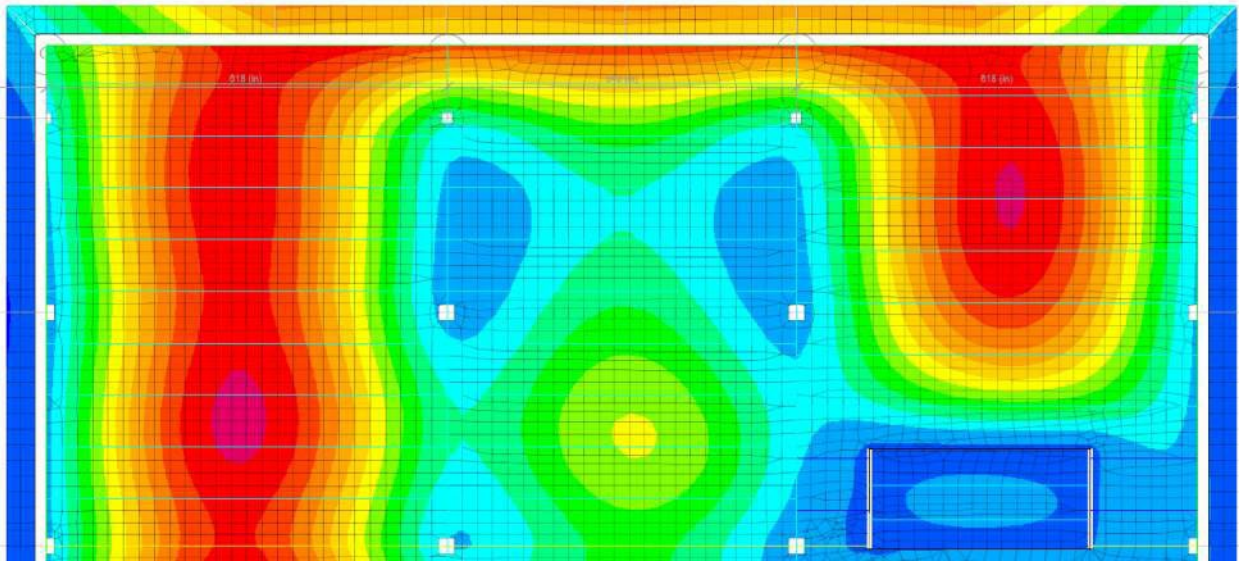
Figure 80. Roof-level deflected shape prediction by ETABS after 10 years of service; rectified building configuration; purple corresponds with 4 inches of deflection.

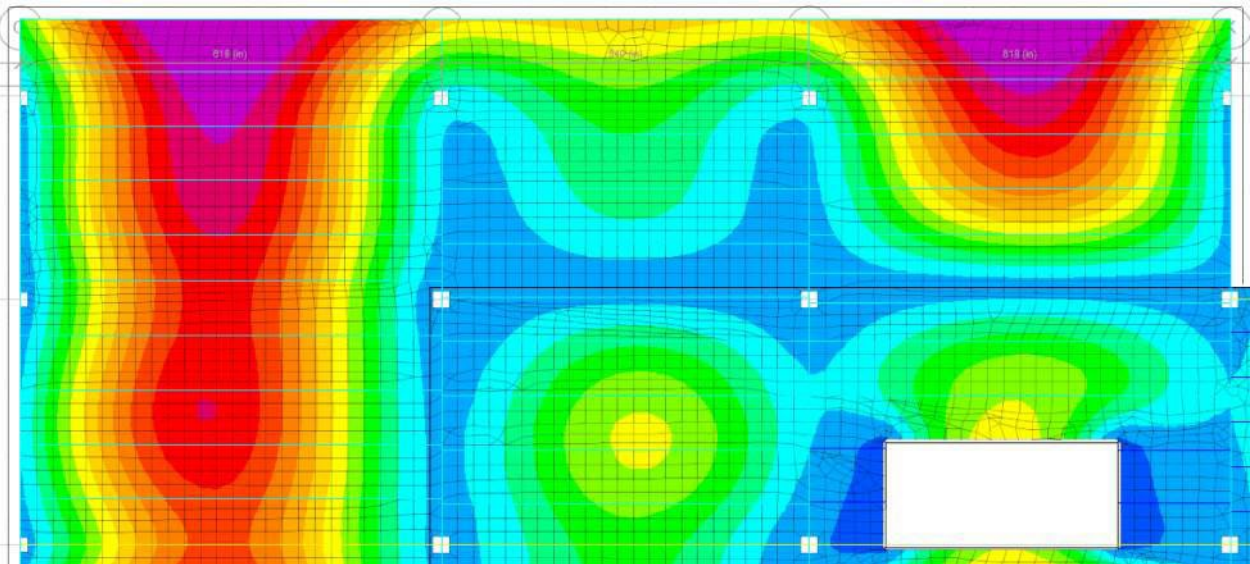
Figure 81. Level 3 deflected shape prediction by ETABS after 10 years of service; rectified building configuration; purple corresponds with 4 inches of deflection.

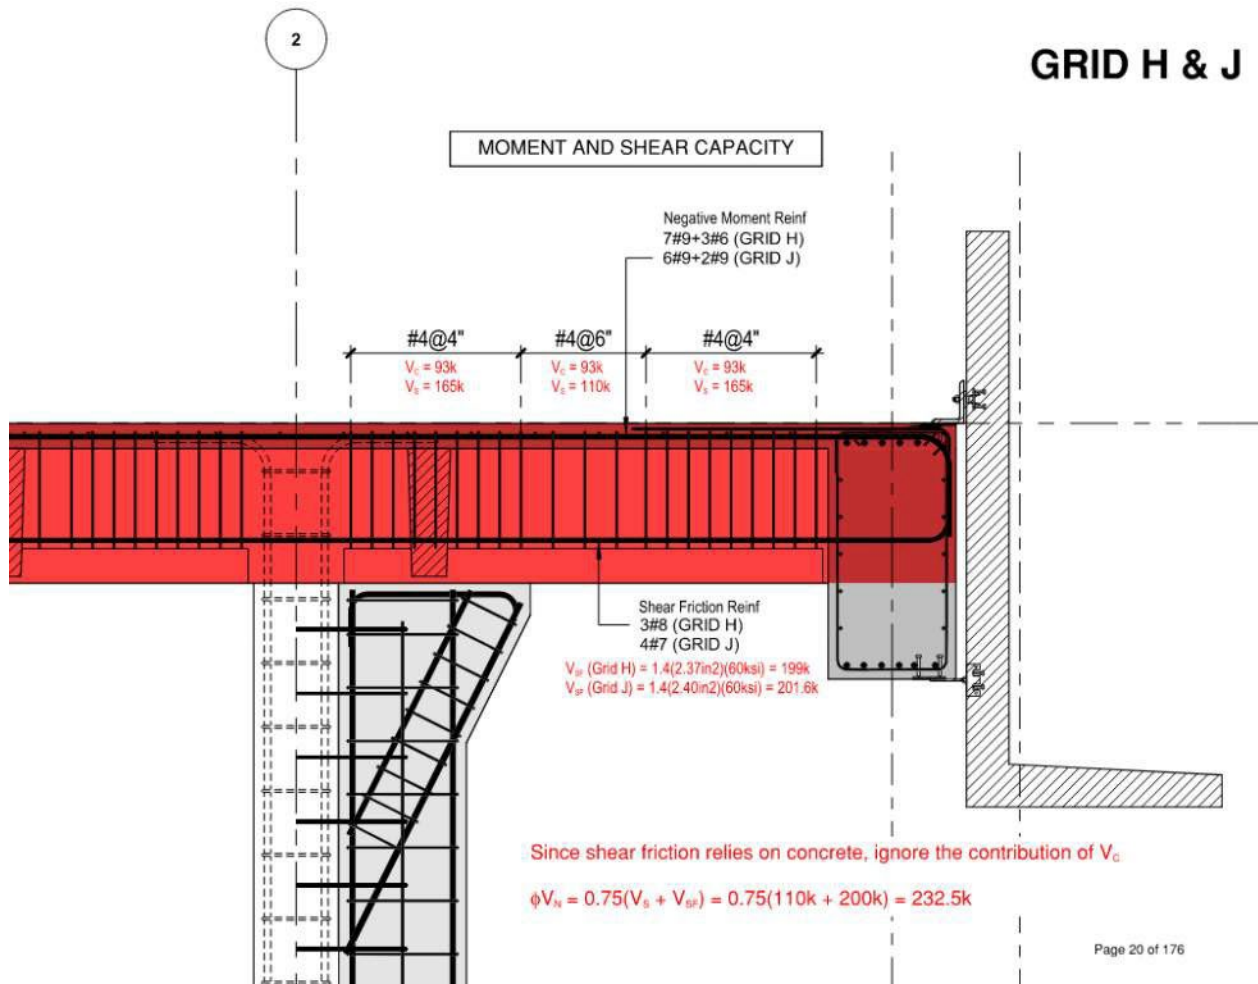
beam stirrups acting in a classical strut and tie shear resisting mechanism plus shear friction resistance that relies on longitudinal steel on the bottom side of the beam just above the precast soffit (Figure 82). However, in our understanding of the ACI provisions for beam shear and our experience<sup>4</sup>, combining shear friction resistance with classical strut and tie resistance to calculate the total sectional shear capacity of any beam is neither appropriate from a mechanics perspective nor permitted by ACI.

Figure 82. Calculations of cantilever beam shear capacity at gridlines H-2 and J-2 by SEOR (from File 2024-04-25\_CALC\_HQ Roof Cantilever Field Fix at North Elevation.pdf) showing assumption of including shear friction of bars in bottom side (compression side) of the beam.

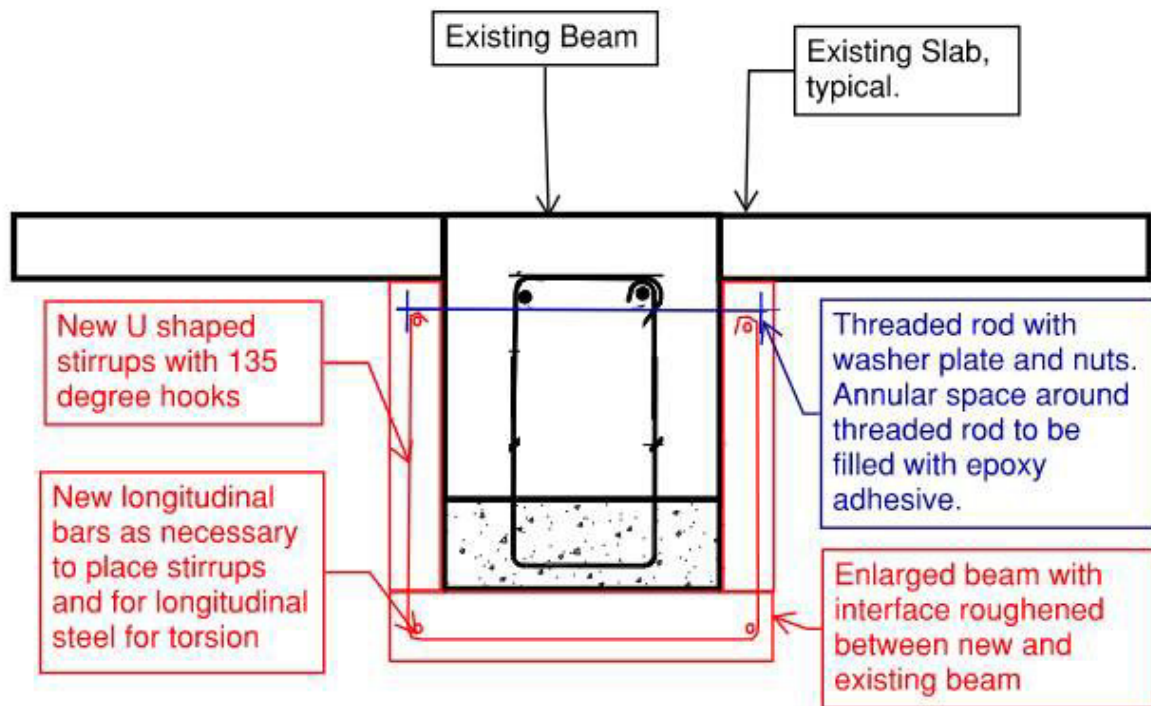
Figure 83. Conceptual solution for strengthening of cantilever roof beams

In our opinion the beam sections north of the column enlargement (i.e., along gridlines H-2 and J-2), need to be strengthened. Strengthening could be accomplished through the addition of a beam jacket with closed stirrups (e.g. Figure 83).

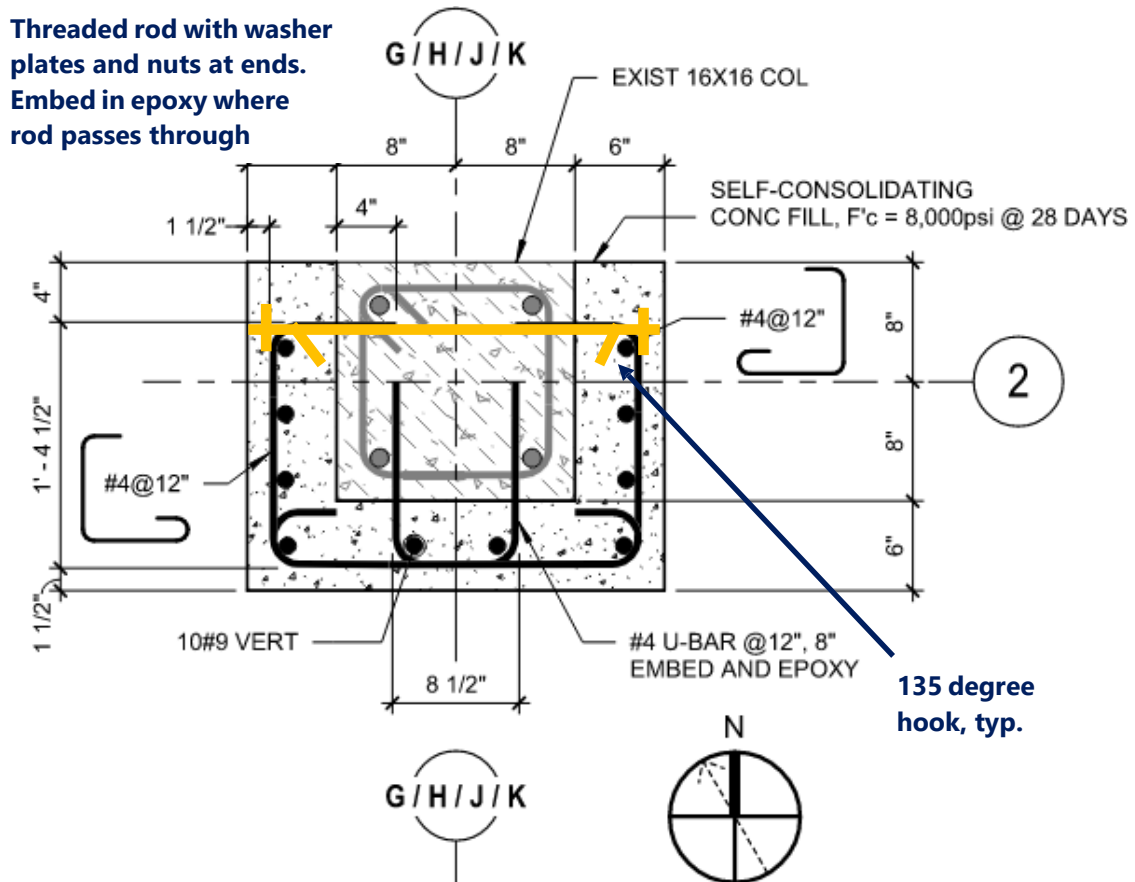
Figure 85. Schematic of alternate tie configuration. WJE annotations in orange and blue.

provide a closed tie. Closed ties will provide a more reliable means of restraining and bracing the flanges of the column bracket and will also serve to provide additional confinement to the original column. We recommend that the tie detail be modified such that a closed tie can be provided. One possible option to achieve a closed tie is shown conceptually in Figure 85.

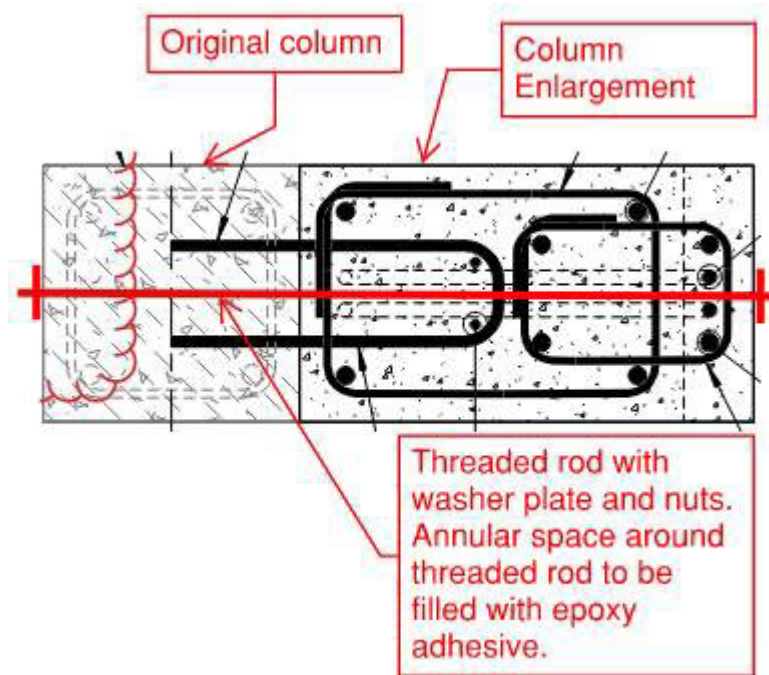
Figure 86. Conceptual rectification to tie original column and column enlargement together for shear strengthening

Moreover, these columns were not code-compliant for shear as originally designed. In the as-rectified configuration (with the enlargement), there is additional shear demand on the column as the result of the column enlargement and corbel acting as a strut to transfer some of the bending moment demand from the beam above. The column enlargement does provide some additional shear capacity, but the actual distribution and load sharing of shear demand between the original column and the column enlargement is difficult to ascertain. Further, the total shear demand on the total cross section (original plus column enlargement) is large enough in magnitude that ACI 318-14 Section 10.6.2 requires that minimum shear reinforcement be installed, and currently no shear reinforcement extending the full depth of the combined cross section is provided. As such, it is our opinion that these columns require additional measures to increase the shear capacity to a level sufficient for the demand. We believe a reasonable rectification is to wrap the columns with fiber reinforced polymers (if allowed by code provisions, see preceding section) or to jacket the columns and add closely spaced ties as discussed for columns G-2 and K-2 above. Alternatively, threaded rods with washer plates and nuts could be used to tie the two columns together as shown conceptually in Figure 86.

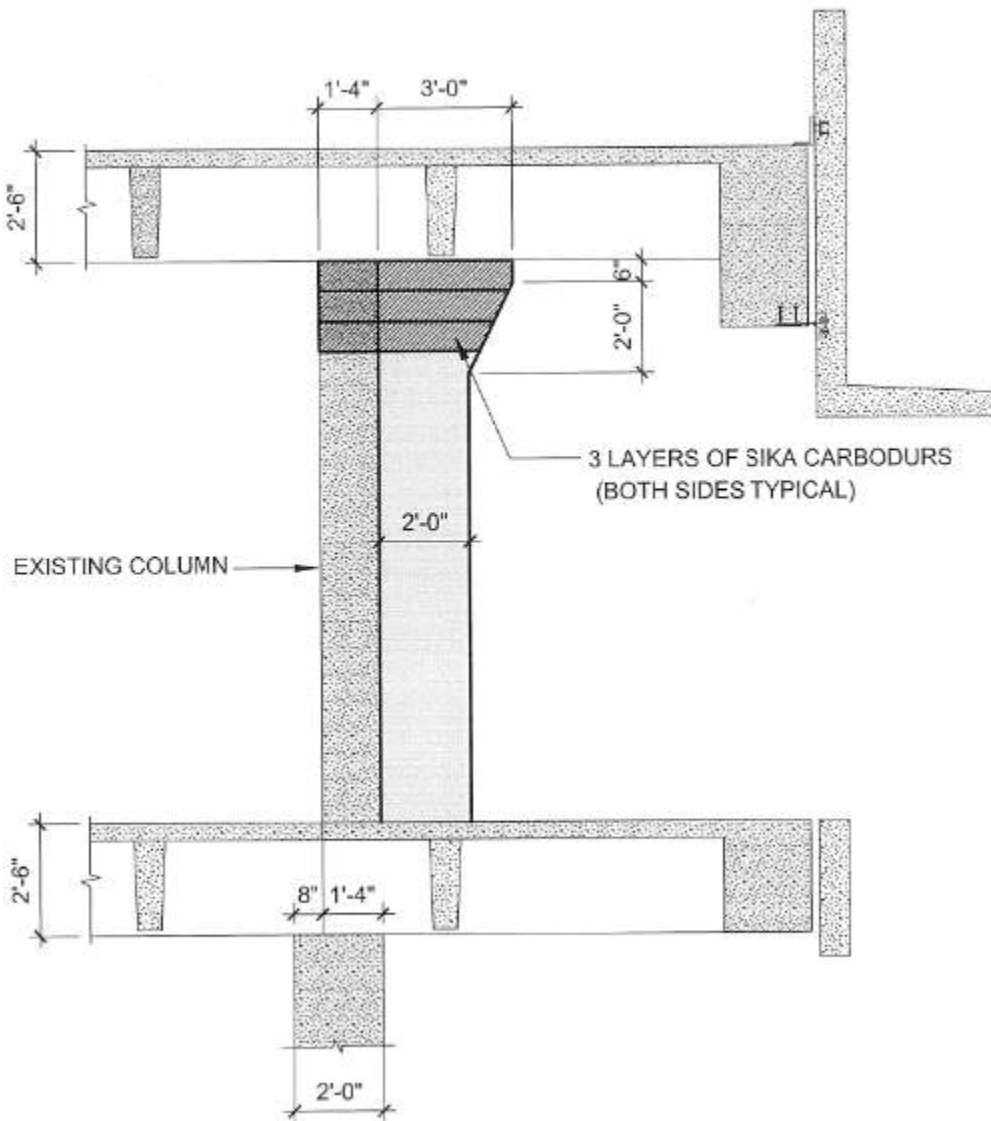
Figure 87. Conceptual rectification proposed by Lakdas to provide tie at corbel

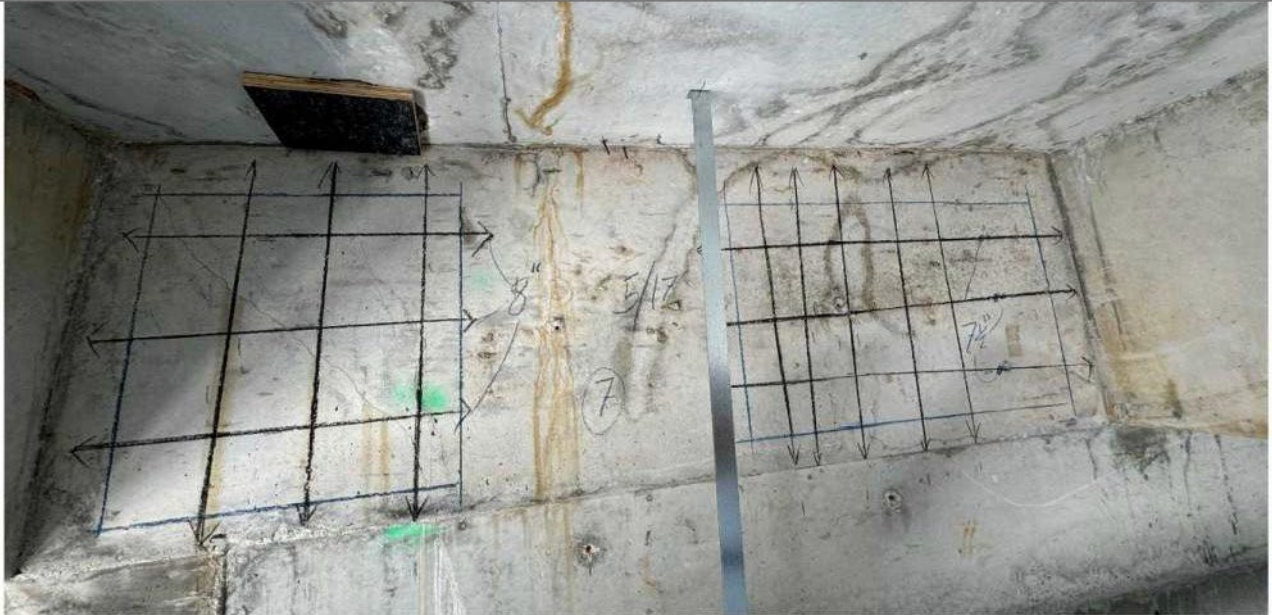
<b>Location:</b>	Column I, beam, 3 <sup>rd</sup> Floor
<b>Comments:</b>	All horizontal rebar depths were labeled. From left to right it looks like the rebar starts to move closer to the surface. Starting from 8" deep to 7.5" deep.

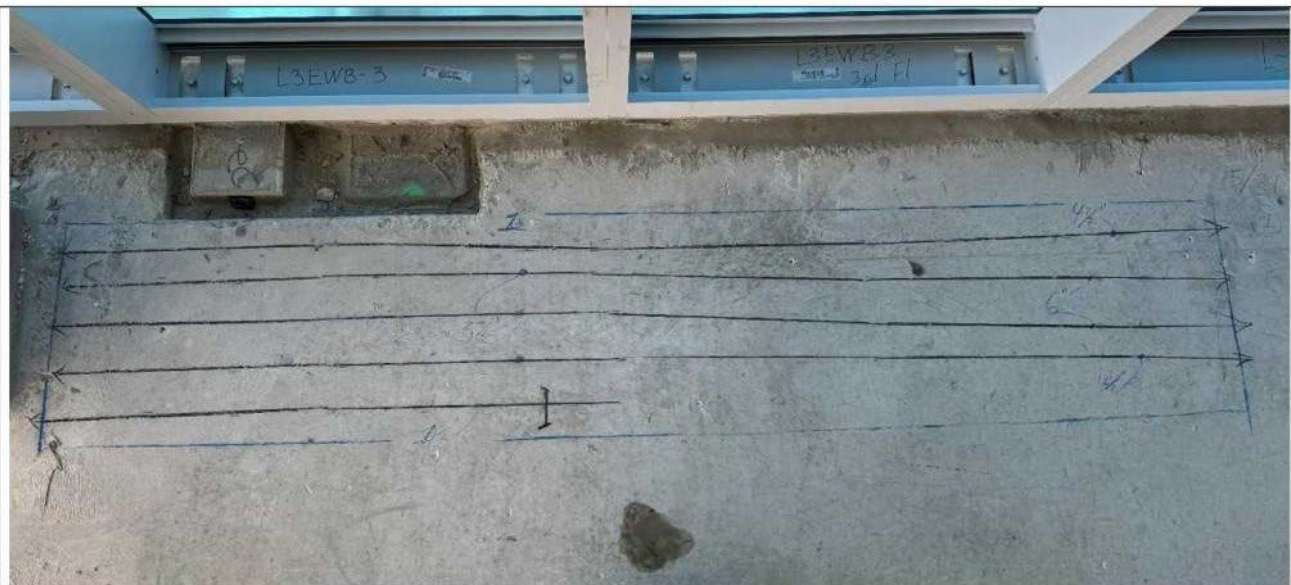
<b>Location:</b>	Behind column I, 3 <sup>rd</sup> Floor
<b>Comments:</b>	5 rebars were spotted. Depths ranging from 1" to 6".

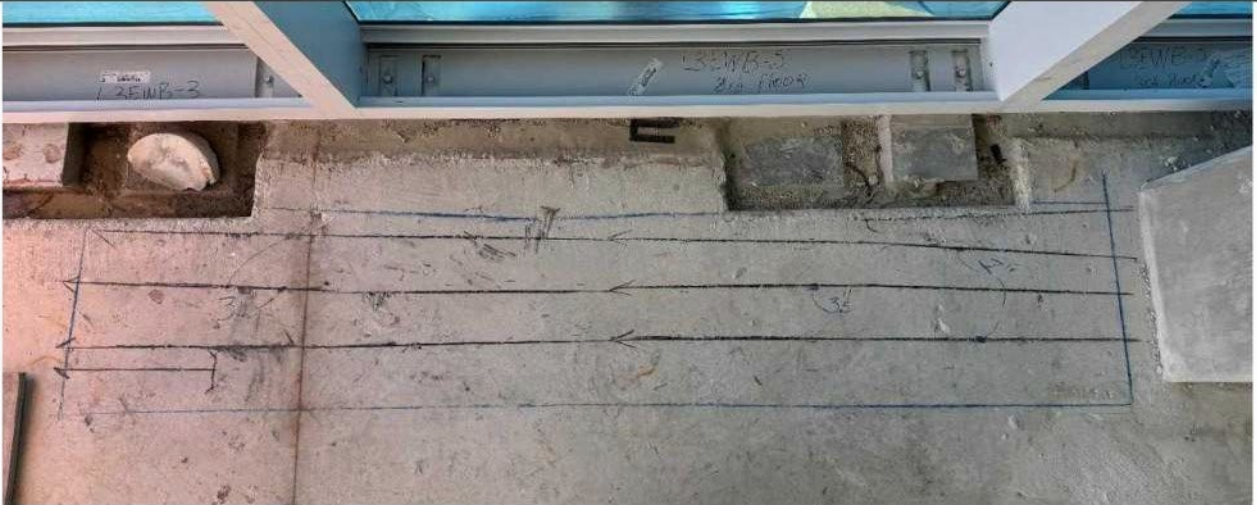
<b>Location:</b>	Front of column I 3 <sup>rd</sup> Floor
<b>Comments:</b>	Brietl 5 rebars were sotted horizontally. Depths rangin .1"-3.5"

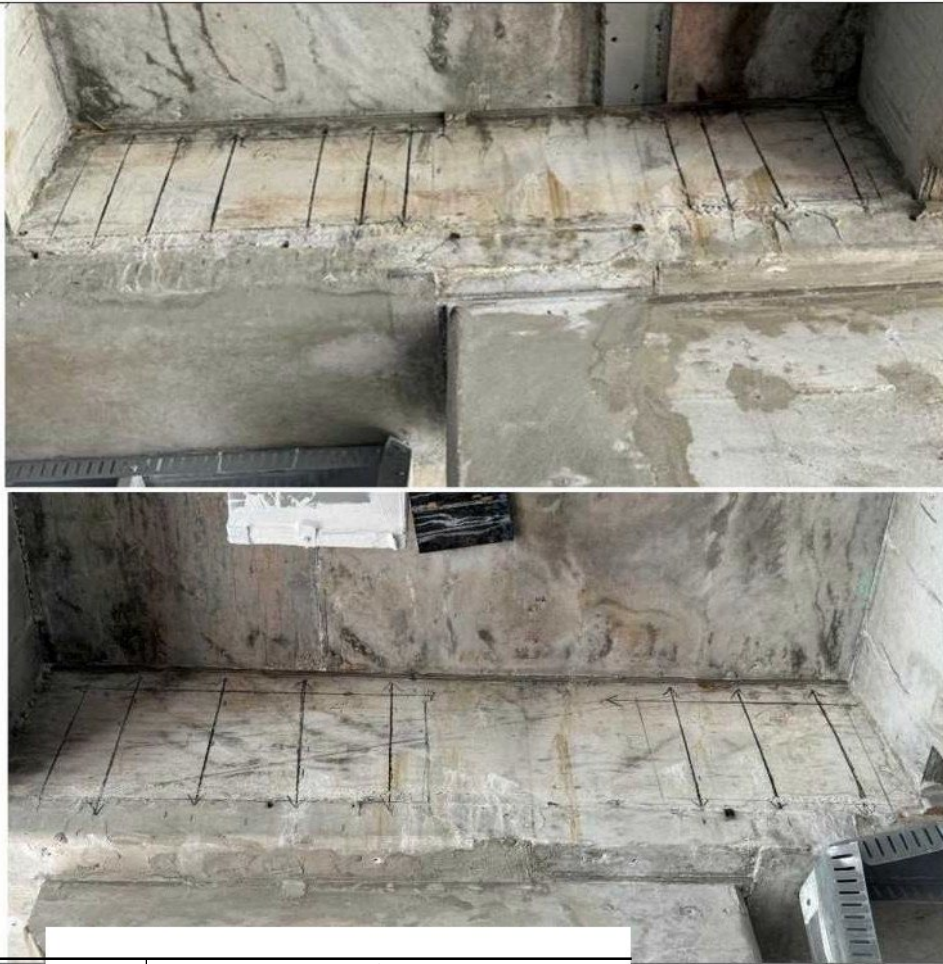
<b>Location:</b>	Column 2, beam, 3 <sup>rd</sup> Floor
<b>Comments:</b>	The beam above column 2 was about 24" thick. The Mini XT was about to see about 10" dee . Vertical rebar was recorded to 7"-8" dee

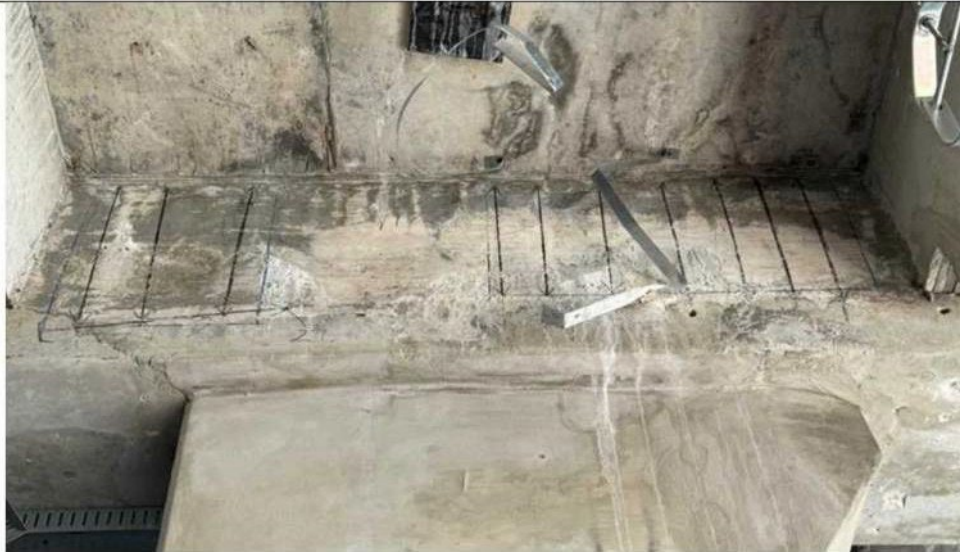
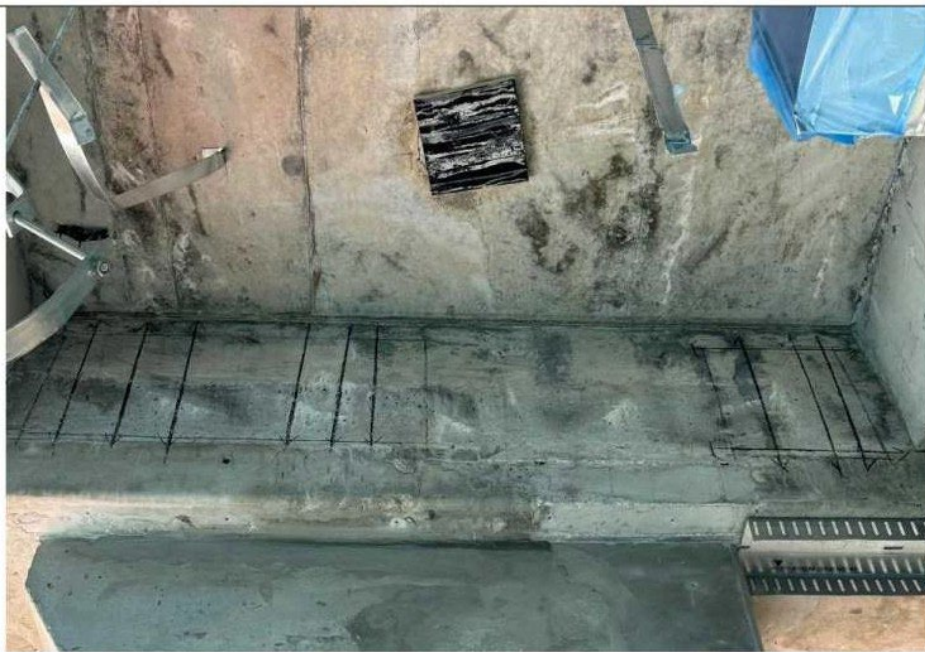
**Location:** Column 3, 3<sup>rd</sup> Floor

**Comments:** The beam above column 2 was about 24" thick. The Mini XT was about to see about 10" deep. Vertical rebar was recorded to 6"-7" deep

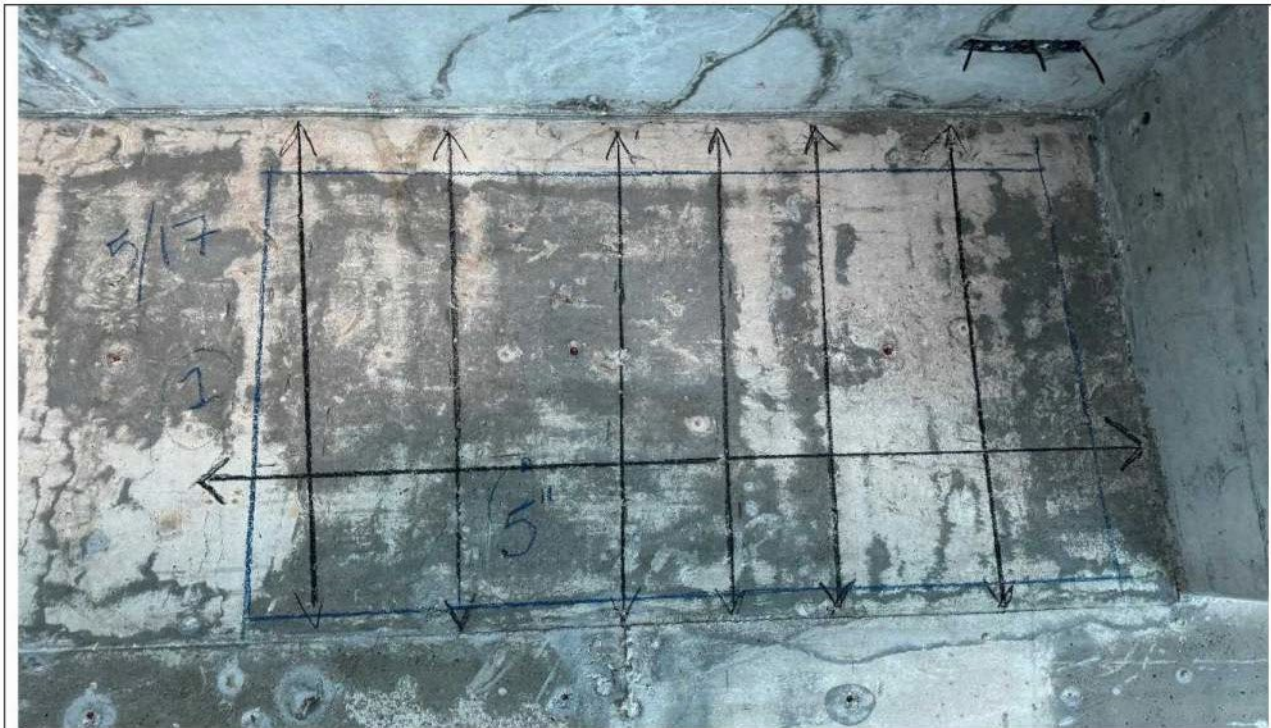
<b>Location:</b>	Column 4 3 <sup>rd</sup> Floor
<b>Comments:</b>	The beam above column 2 was about 24" thick. The Mini XT was about to see about 10" deep. Vertical rebar was recorded to 6"-7" deep. A horizontal rebar was found about 5" deep. More rebars may be present at the depth of 10"

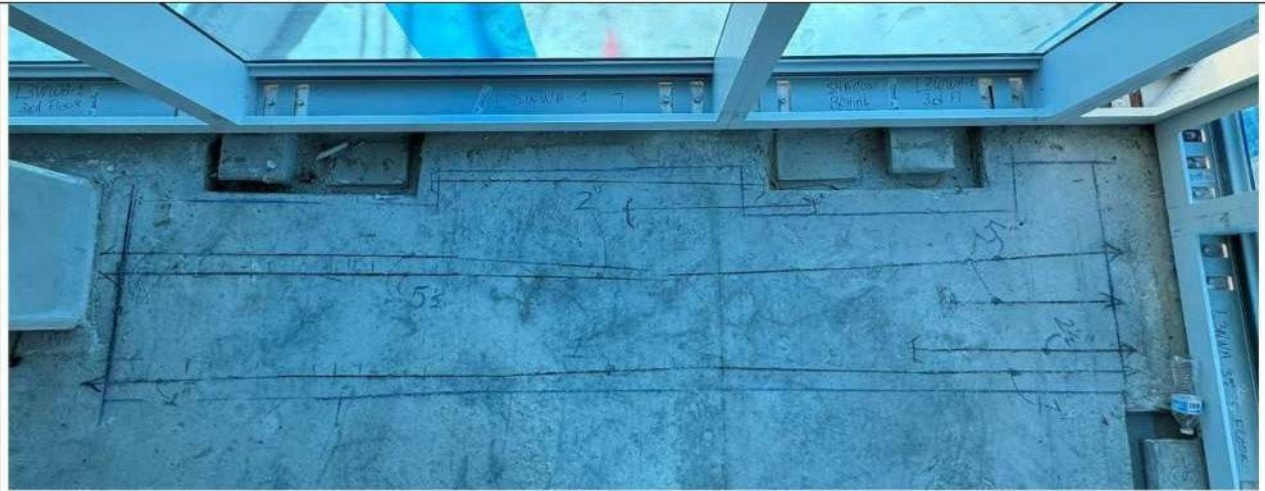
**Location:** In front of colLtmn 4, 3<sup>rd</sup> Floor

**Comments:** About 5 horizontal rebars can be seen ranging at depths of 1" to 5.5" deep.

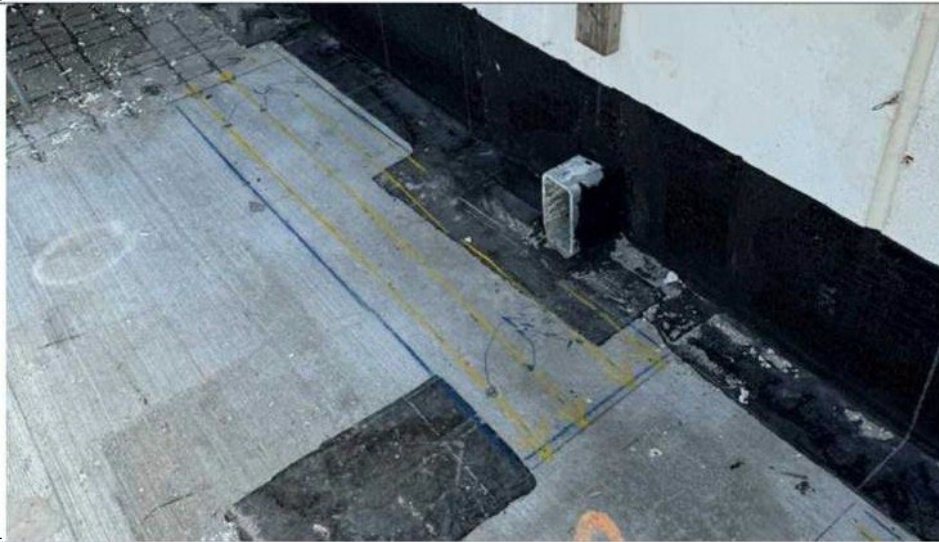
**Location:** Roof area over column 1 in front of column.

**Comments:** 4 horizontal rebars can be seen ranging at depths of 2.5"-3" deep.

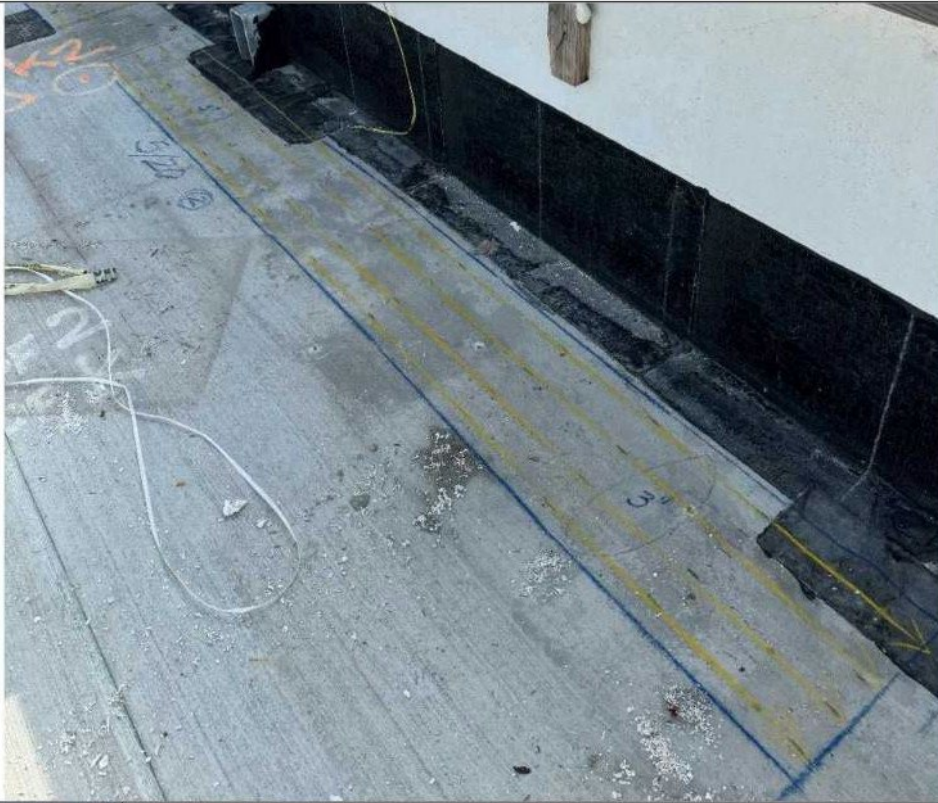
<b>Location:</b>	Roof area over column 1 behind column
<b>Comments:</b>	4 horizontal rebar can be seen ranging in depth of 3"

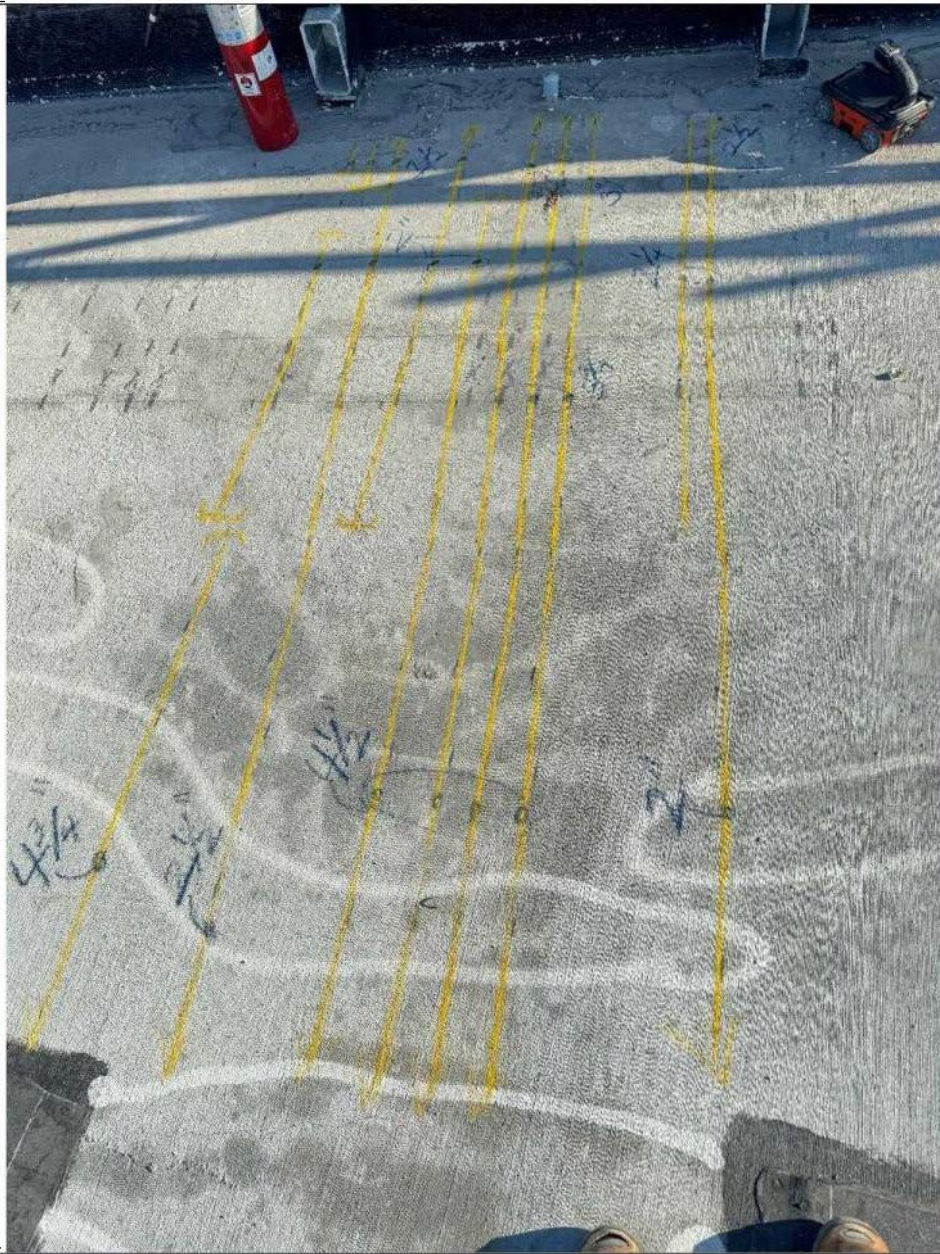
<b>Location:</b>	Roof area over column 2, behind column
<b>Comments:</b>	6 horizontal rebar can be seen ranging at depths of 2.5" to 5" deep.
