## Fort Lauderdale Police Headquarters

WJE Peer Review, Phase 1 - North Elevation Evaluation

1300 West Broward Boulevard  
Fort Lauderdale, Florida 33312

December 31, 2024  
WJE No. 2024.4855.0

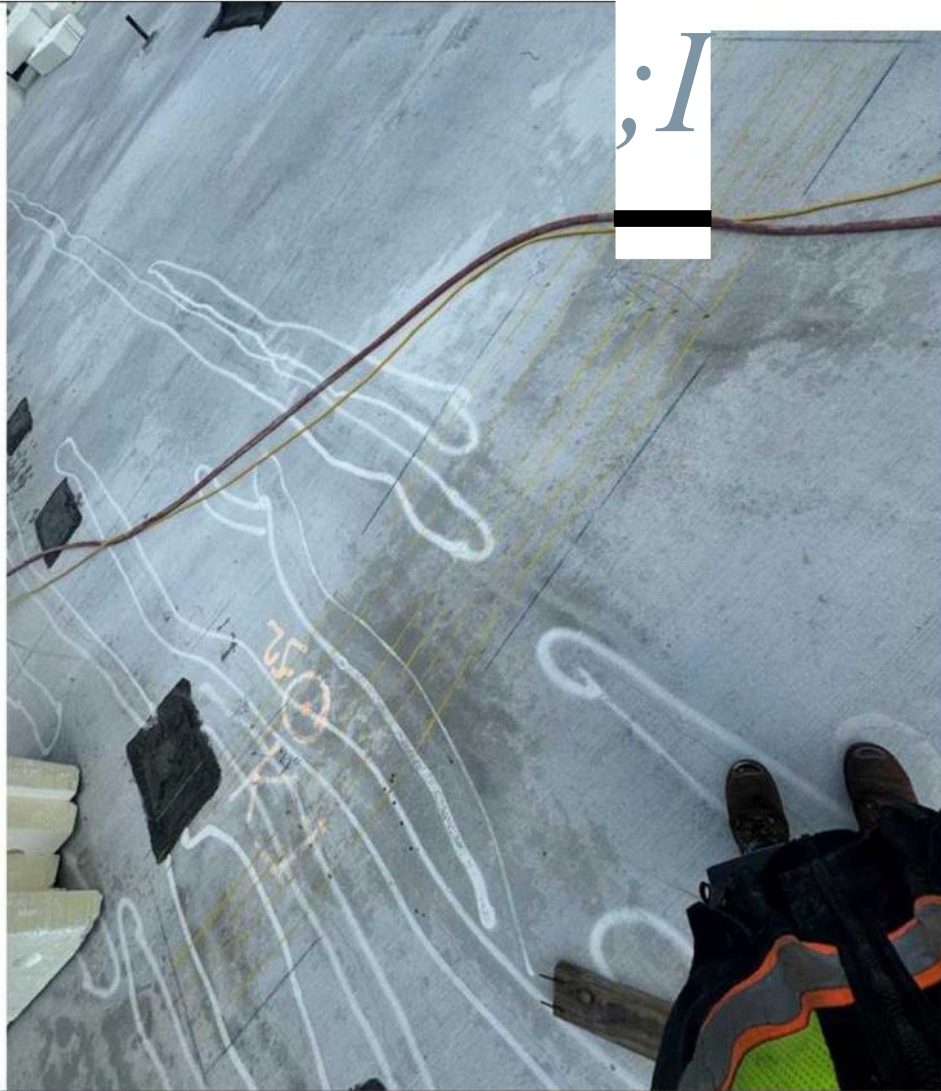
<b>Location:</b>	Roof area over column 2, in front of column
<b>Comments:</b>	About 7 horizontal rebars can be seen ran in at de Jtbs of 2.5" to 4.75" dee

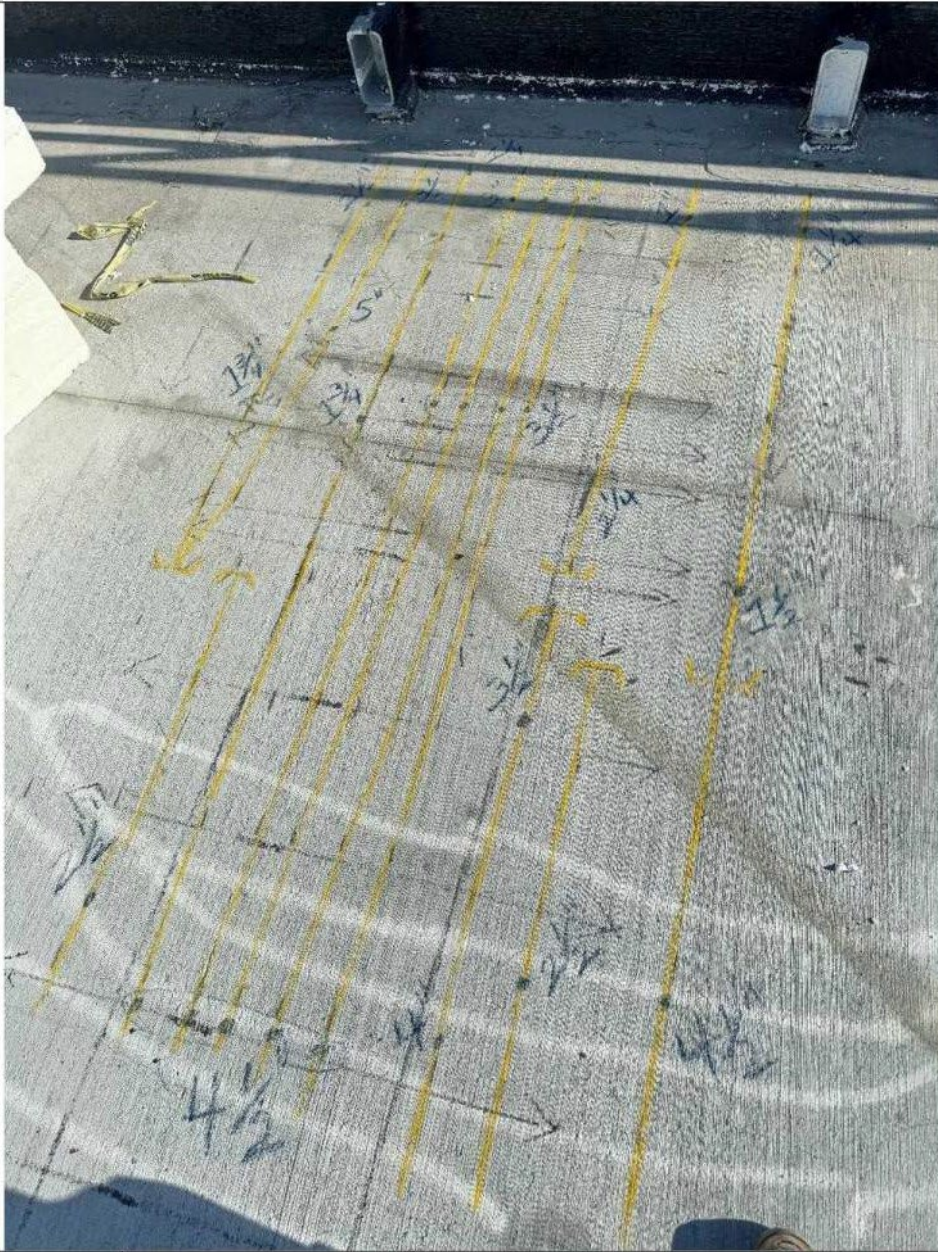
<b>Location:</b>	Roof area over column 3, behind column
<b>Comments:</b>	6 horizontal rebars can be seen ranging at depths of 2.5 to 4" deep .

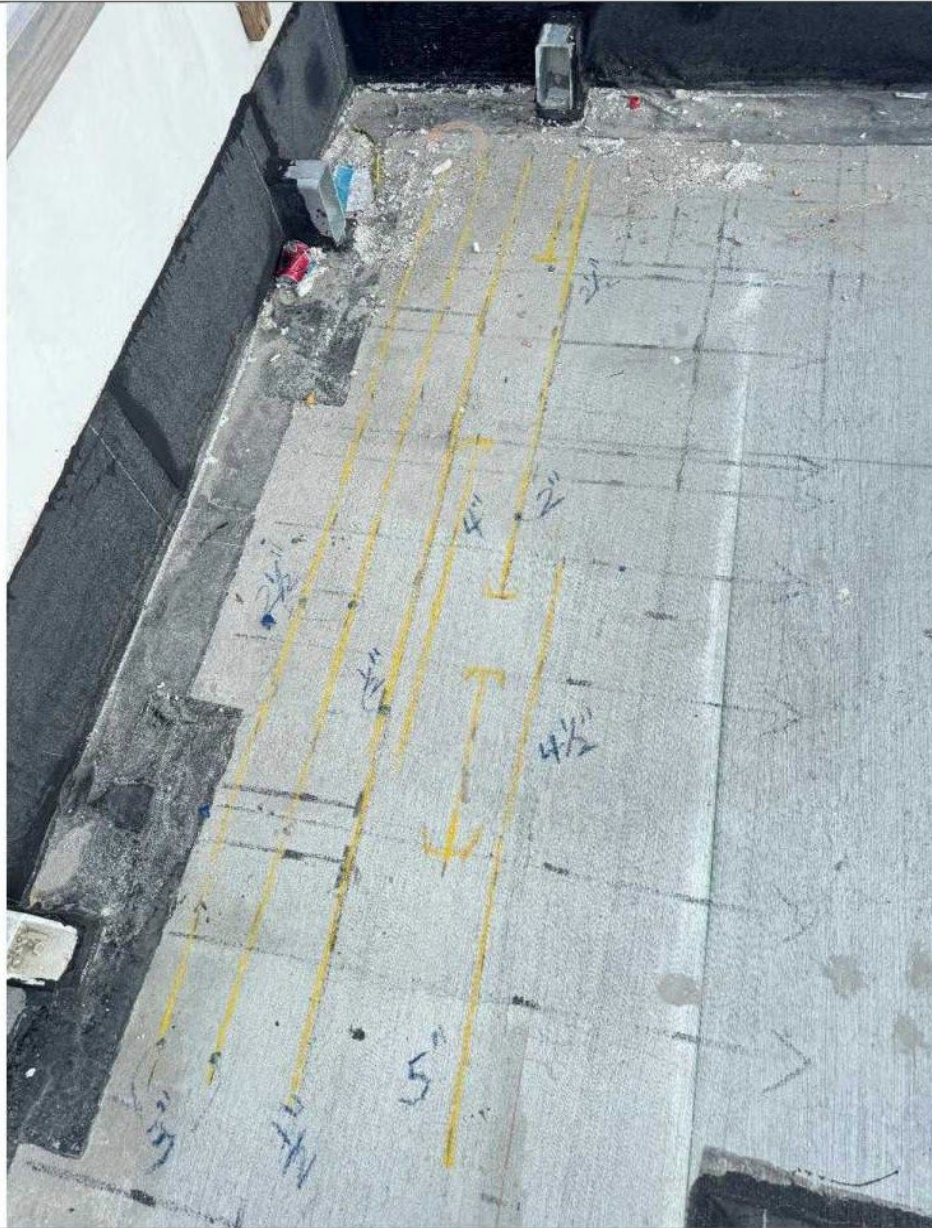
<b>Location:</b>	Roof area over column 3, in front of column 11
<b>Comments:</b>	About 10 horizontal rebars can be seen running in at depths of 1.25" to 4.5" deep
