Fort Lauderdale Police Headquarters

WJE Peer Review, Phase 2 – Building Structural Design Peer Review

Draft Report

April 22, 2025
WJE No. 2024.4855.0

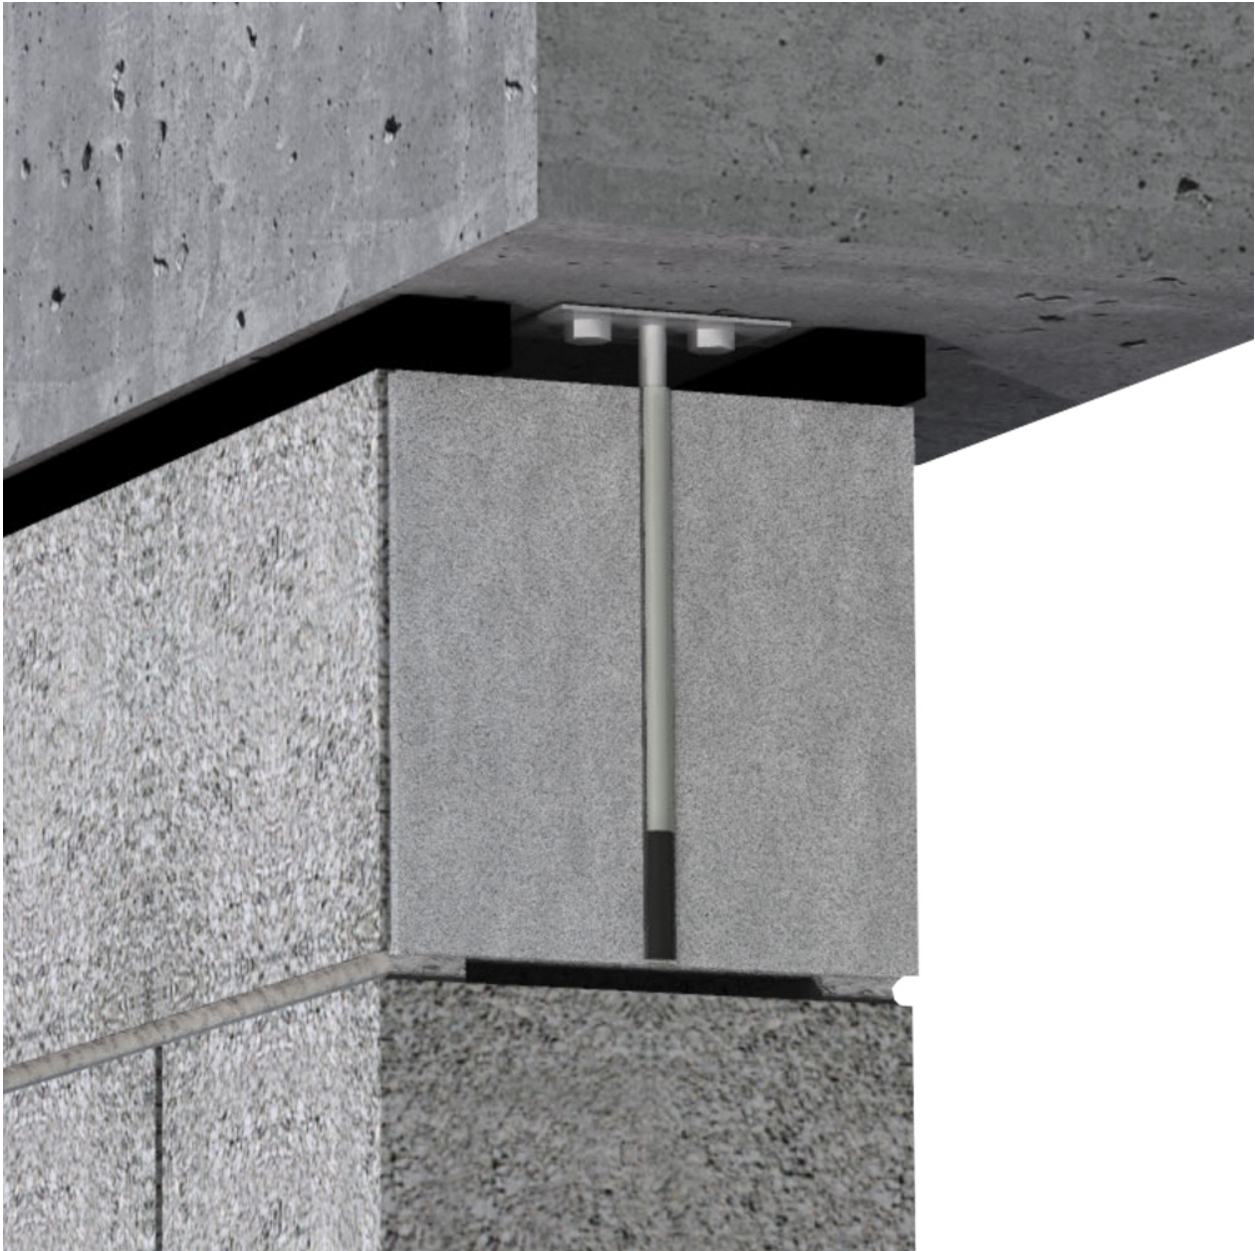
- **Report No. 123, Dated March 4, 2024:** The TI notes that “Anchors to attach the vertical reinforcement of CMU walls to soffit beams were placed with one tapcon screw instead of two how it's specified on the product specs.” Photographs of this condition are shown in Figure 26. The length of plate at the top of the PTA anchors is aligned parallel with the length of the CMU wall in contrast with the rendering shown on the manufacturer's website (Figure 10). No comments were made by the TI regarding the orientation of the anchor plate relative to the wall.

Figure 10. Rendering of installed PTA 420 HS anchor from Hohmann and Barnard. Image taken from <https://www.h-b.com/products/pta-series-anchors-pta-420-hs> (accessed on April 13, 2025). Note that the length of the top plate of the anchor is oriented transverse to the length of the wall
