TO: Honorable Mayor and Members of the Fort Lauderdale City Commission
FROM: Rickelle Williams, City Manager *RW*
DATE: May 5, 2025
SUBJECT: New Police Headquarters — Phase 2 Peer Review

Draft Report

April 22, 2025
WJE No. 2024.4855.0

Fort Lauderdale Police Headquarters
WJE Peer Review, Phase 2 – Building Structural Design Peer Review

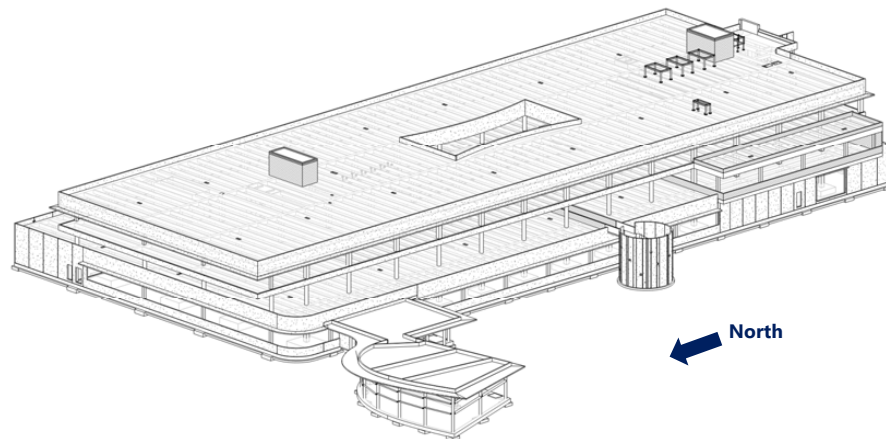
The main portion of the building is rectangular in plan, with the length of the building oriented on a north-south axis. The north elevation of the building has a step at the third floor and roof, forming a cantilevered projection at these floors. An isometric view of the building is shown in Figure 1. The facade of the building is clad with a combination of precast concrete fascia and full-height glass fenestration systems. An overall plan view of the foundation level of the building and the gridlines is shown in Figure 2.

Figure 1. Isometric view of the Fort Lauderdale Police Headquarters building from Sheet HQ-S0-1-00 (dated June 10, 2022) of the structural design drawings. Annotations in blue by WJE

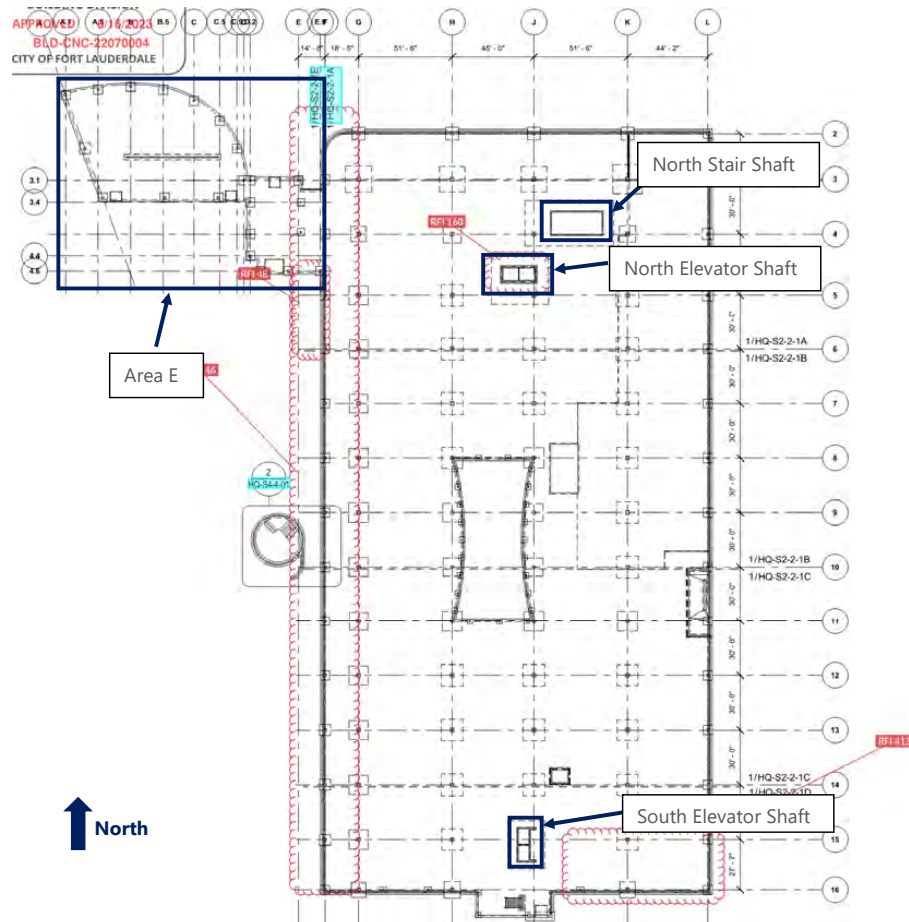
The lateral force-resisting system for the building is composed of cast-in-place reinforced concrete shear walls. See Figure 2 for the locations (on plan) of these walls.

Figure 2. Plan view of the foundation level of the FLPHQ from Sheet HQ-S2-2-01 (dated June 10, 2022) of the structural design drawings with gridlines and shear wall locations shown. Annotations in blue by WJE
