Fort Lauderdale Police Headquarters

WJE Peer Review, Phase 1 - North Elevation Evaluation

1300 West Broward Boulevard
Fort Lauderdale, Florida 33312

December 31, 2024
WJE No. 2024.4855.0

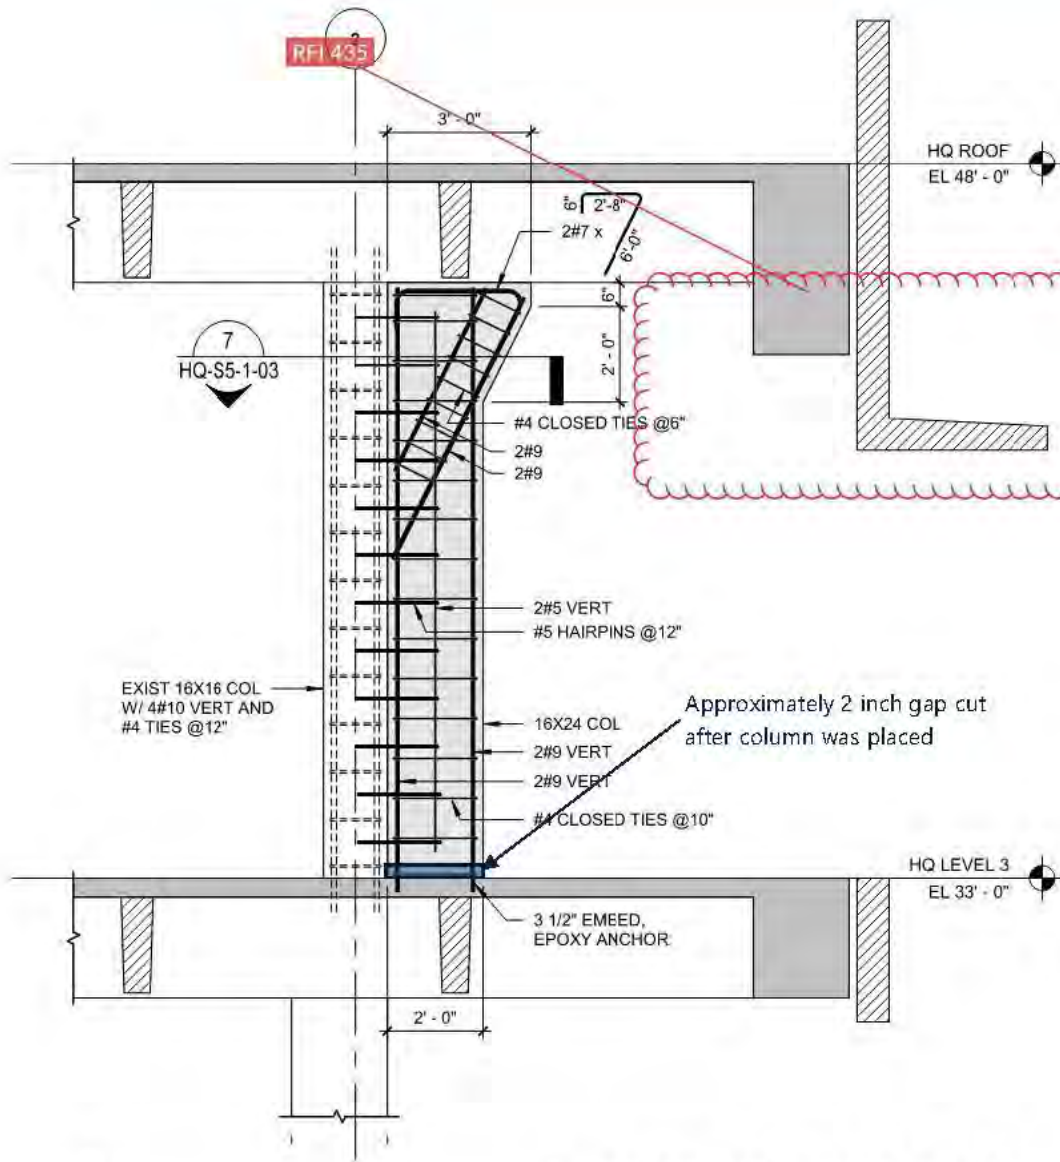
The column enlargement and corbel at the top of the enlarged column are connected to the original column with "U"-shaped No. 5 bar stirrups at 12 inches on center (see Figure 12 and Figure 13). While this distributed connection "stitches" the two columns together, it is our opinion that these "U"-shaped stirrups do not sufficiently resolve the horizontal force that is developed as a result of the inclined "strut" in the corbel. To sufficiently resolve the horizontal force, a tie that spans from the north side of the corbel to the south side of the original column is appropriate. Lakdas also suggested such a tie in their report (Figure 87). This tie should be designed for the horizontal component of the maximum diagonal strut force that is determined through staged-construction analysis. Long-term load-transfer effects due to creep should be considered in the design.

Figure 12. Detail 6 from Sheet HQ-S5-1-03 dated May 24, 2024, showing rectifications details for third story columns at gridlines H-2 and J-2. Annotations in blue by WJE. Note that later the rectifications were modified so an approximately 2 inch gap was cut between the bottom of the column enlargement and the third floor slab.

The rectification measure designed by the SEOR for third story columns is shown in Figure 12 and Figure 13. It consists of a supplemental structural element with a corbel-like section sistered onto and integrated with the existing column, functionally enlarging it. The new element is reinforced with four No. 9 vertical reinforcing bars and No. 4 closed ties spaced at 10 inches on center. The "corbel" is reinforced with four inclined No. 9 longitudinal bars enclosed with No. 4 ties at 6 inches on center. The ends of the longitudinal bars are not hooked and do not extend into the existing column. Two bent No. 7 bars are present at the top of the new "corbel". These No. 7 bars do not extend into the existing column. The supplemental element is integrated with the existing column using No. 5 "U"-bars placed at 12 inches on center. The legs of these "U"-bars are embedded 8 inches into the existing column and anchored using epoxy adhesive. Later, after the supplemental element was constructed, approximately the bottom 2 inches of the new column were cut at the interface between the column and the existing third floor. We understand through verbal correspondence with various parties that this modification was made at the suggestion of Lakdas and that the SEOR accepted this change. We do not, however, have written documentation of how this modification came to pass.

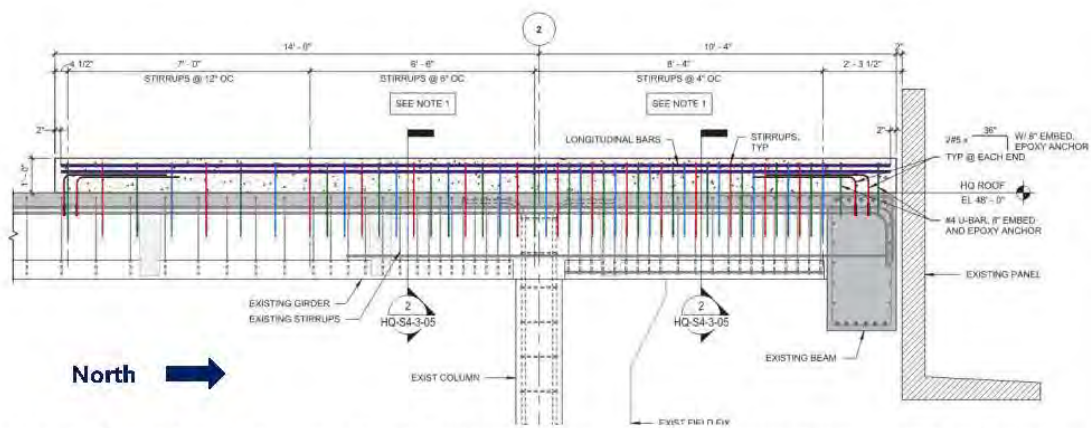
Figure 14. Section from "Rebar Installation Color Sheet.pdf" showing upturned beam at roof. Annotations in blue by WJE.

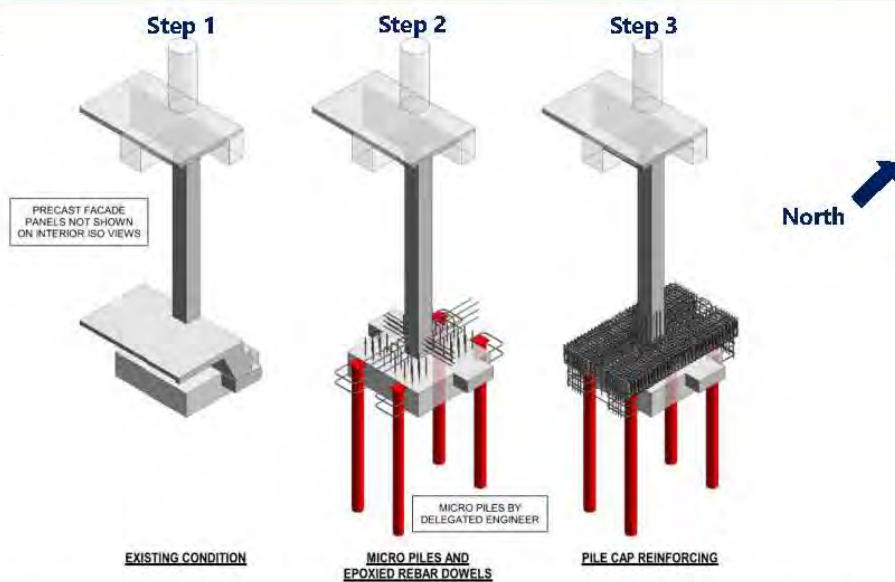
Figure 15. Installation sequence of new micropile and first story column jacket at gridline 2 from detail 2 of Sheet HQ-S6-1-04 dated September 12, 2024. Annotations in blue by WJE. See Figure 16 for subsequent steps.

The design of the column jackets in the first story at gridline 2, the added micropile, and the associated pile cap is found on Sheets HQ-S6-1-04 and HQ-S6-1-05, both dated September 12, 2024. The installation sequence for these elements was set forth diagrammatically in six steps on Sheet HQ-S6-1-04, as shown in Figure 15 (steps 1 through 3) and Figure 16 (steps 4 through 6). The details of the supplemental elements, including structural member sizes and reinforcement, are found on Sheet HQ-S6-1-05 and are shown in Figure 17 and Figure 18.

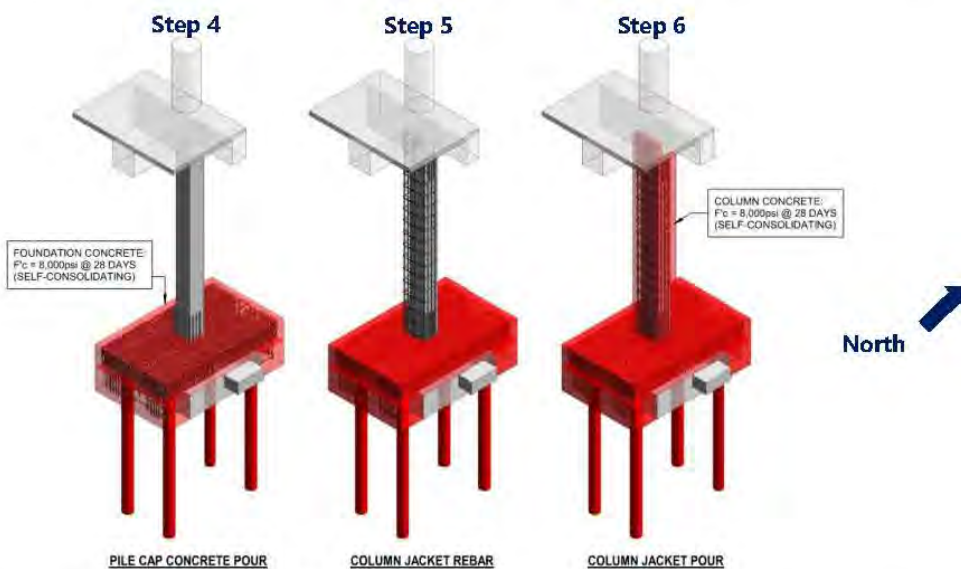
Figure 16. Installation sequence of new micropile and first story column jacket at gridline 2 from detail 2 of Sheet HQ-S6-1-04 dated September 12, 2024. Annotations in blue by WJE. See Figure 15 for preceding steps.

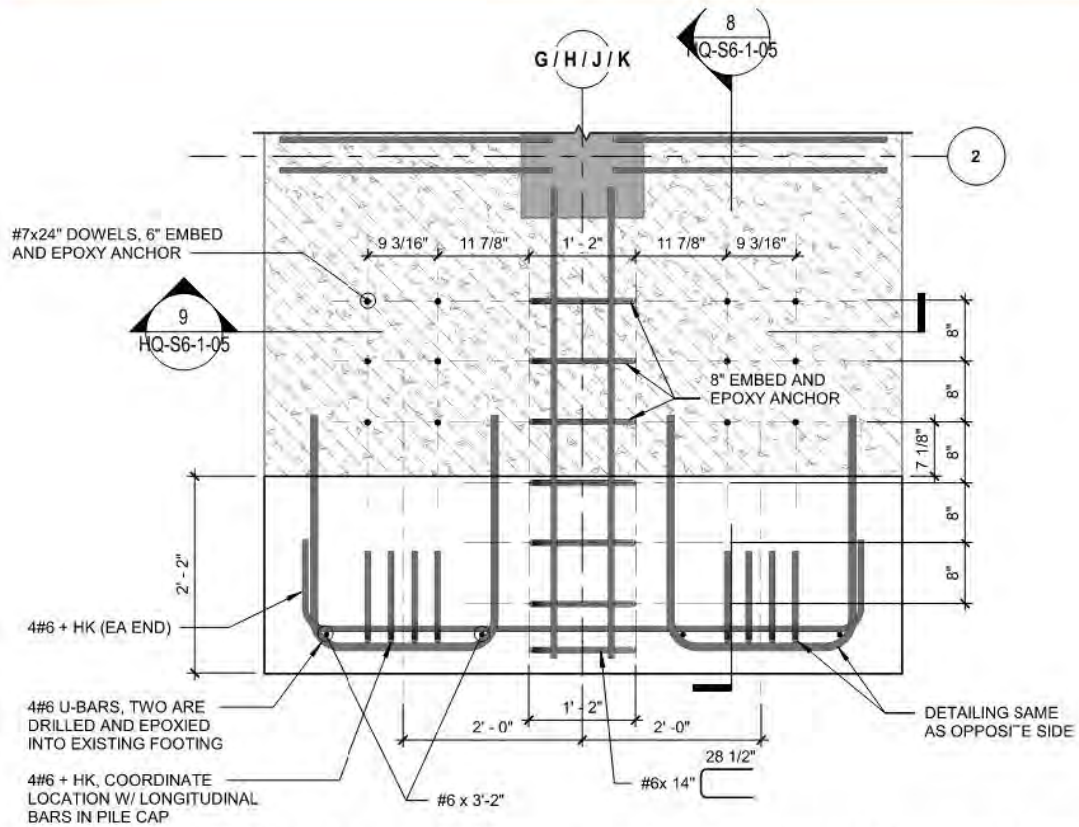
Figure 20. Detail 5 of Sheet HQ-S6-1-05 (dated September 12, 2024) showing partial plan detail view of new pile cap at columns at gridline 2.

The new pile caps are shown in plan in Figure 19 and Figure 20. Pile cap reinforcing information is shown in Figure 20 through Figure 24. The micropiles, four per column, are shown as being designed by a delegated design engineer. Micropiles are spaced at 4 feet from the center of the existing column in the east-west direction and 2 feet on center from the existing column in the north-south direction. The piles bypass the original footing and the new pile cap is largely positioned on top of the existing footing, extending over and engaging with the new micropiles. Twelve No. 7 and six No. 6 inverted "U"-shaped dowels are embedded using epoxy adhesive into the top of the existing footing to tie the new pile cap and existing concrete footings together (Figure 19 and Figure 20). Twenty-four No. 6 dowels are embedded into the sides of the existing column at the base (Figure 20, Figure 23, and Figure 24). Longitudinal reinforcement spans between the east and west micropiles on the north and south sides of the column. This reinforcement consists (per side) of nine No. 8 straight bars on top, nine No. 8 straight bars on bottom, and nine No. 8 bars with hooks at each end at the bottom. The bottom reinforcement is to be in two layers. No. 5 stirrups with four legs are placed at 4 inches on center (Figure 22). As of the date of this report, the micropiles and pile cap have not been installed.

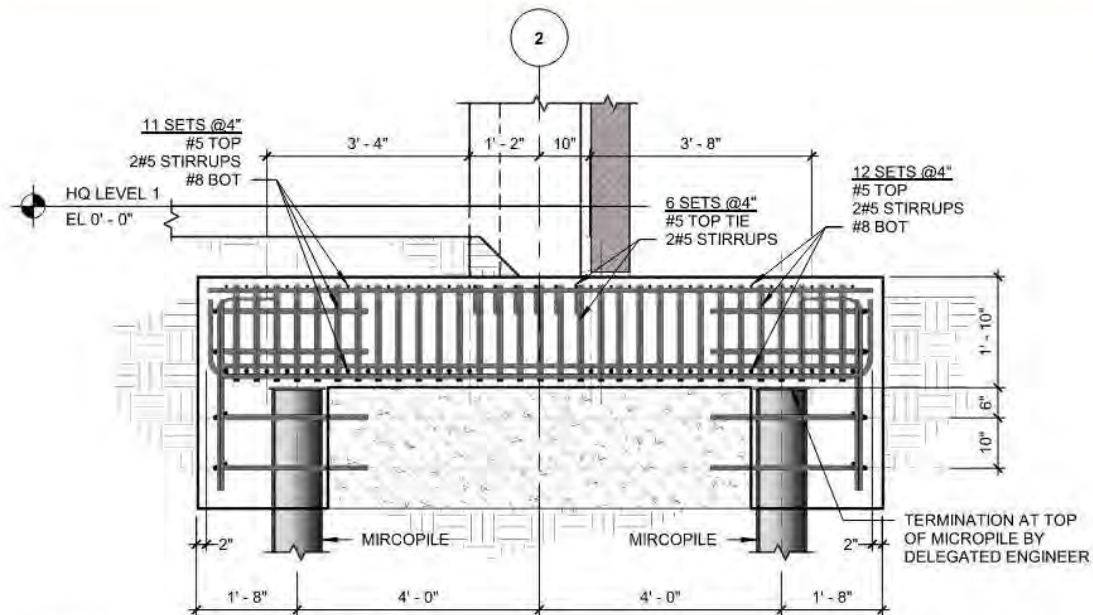
Figure 21. Detail 4 of Sheet HQ-S6-1-05 (dated September 12, 2024) showing section view of pile cap and micropiles at gridline 2.

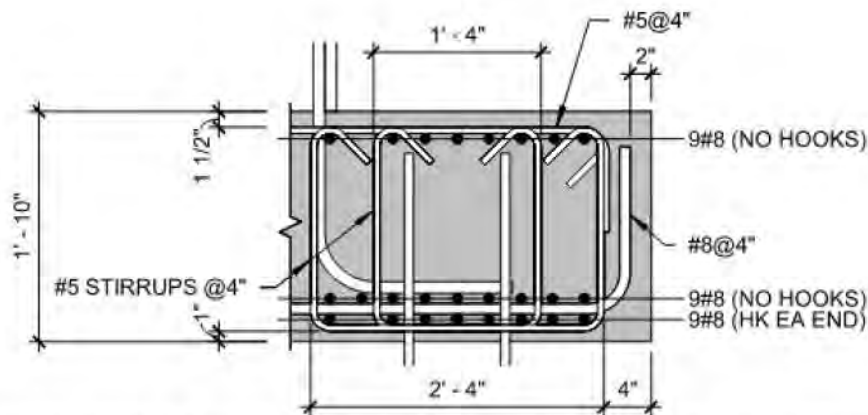
Figure 22. Detail 6 of Sheet HQ-S6-1-05 (dated September 12, 2024) with section view of pile cap showing reinforcement of pile cap.

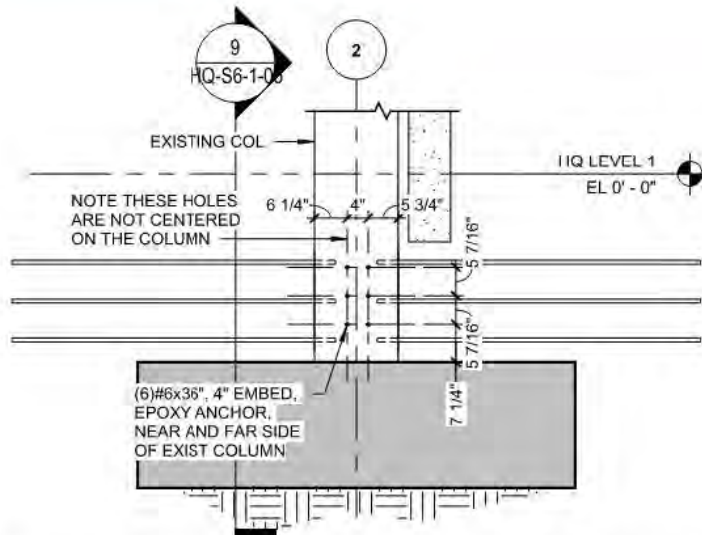
Figure 23. Detail 8 of Sheet HQ-S6-1-05 (dated September 12, 2024) showing section view of dowel reinforcement into existing column.

- We concur with the findings by others that additional rectification measures beyond the enlarged footings are necessary and we find that the proposed micropiles and pile caps are a reasonable rectification measure.
- Comments on the micropile and pile cap design were provided in letter dated November 6, 2024. In addition to our comments in that letter, we recommend that additional dowels be added between the existing footing and the new pile cap.

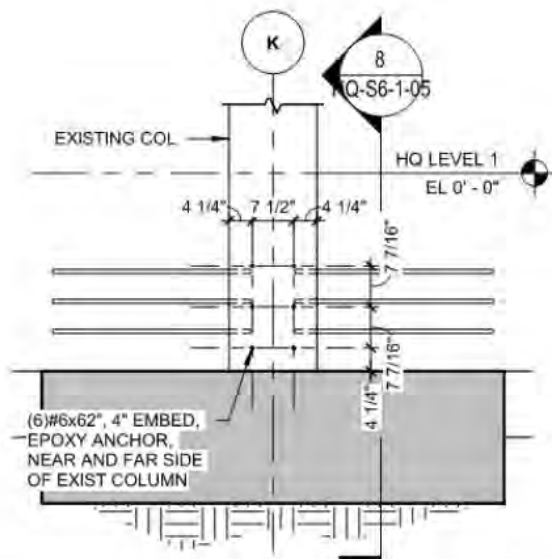
Figure 24. Detail 9 of Sheet HQ-S6-1-05 (dated September 12, 2024) showing section view of dowel reinforcement into existing column.

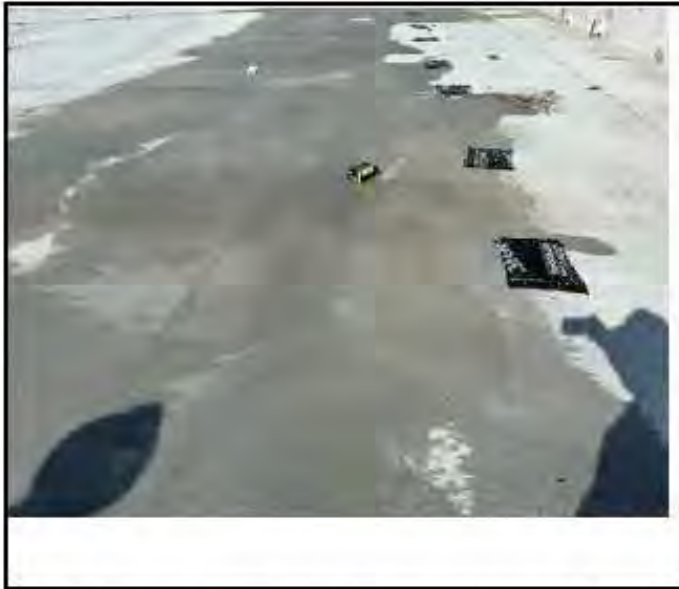
Additional documentation and observations were summarized in Threshold Inspection Report No. 127, dated March 13, 2024. Water was sprayed onto the top of the roof slab (Figure 29 and Figure 30) and it was observed that some water infiltrated through the cracks in the slab and was evident on the underside of the slab (Figure 31 through Figure 34), indicating that the cracks extended through the entire thickness of the slab.

Figure 29. Photograph from Threshold Inspection Report No. 127 showing water which was sprayed onto the top of the roof slab at the north end of building.

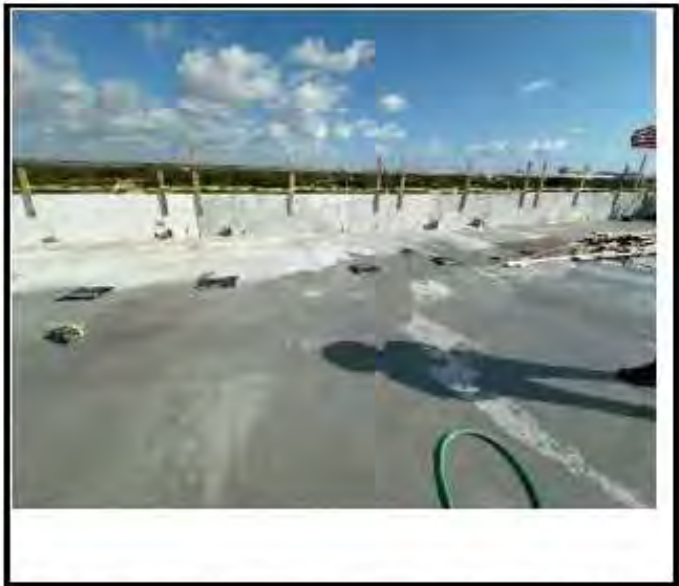
Figure 30. Photograph from Threshold Inspection Report No. 127 showing water which was sprayed onto the top of the roof slab at the north end of building.

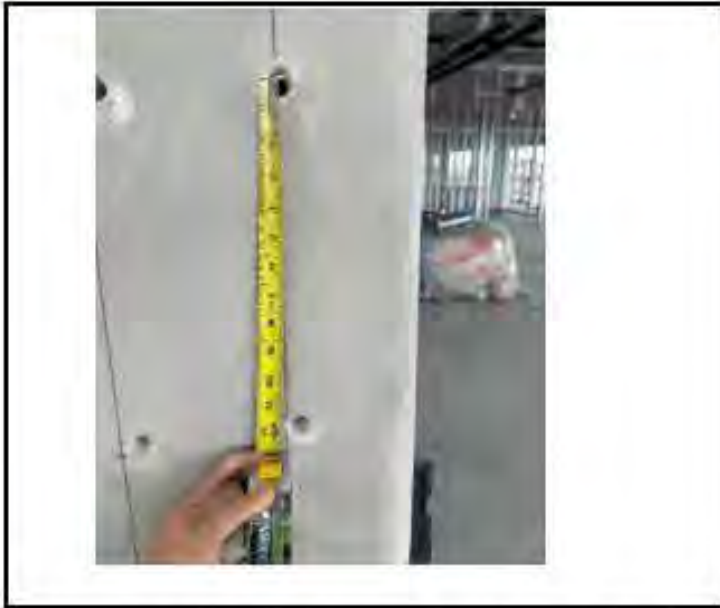
Remedial work to columns H-2 and J-2 (column enlargement) was first documented in Threshold Inspection Report No. 137, dated March 28, 2024. In this report, photographs are provided (e.g., Figure 35) showing holes drilled into the north face of the column to receive epoxy adhesive installed dowels as part of the rectification of the column and roof structure. Documentation of that work continues in Threshold Inspection Report No. 138 (dated March 29, 2024) with installation of the rebar dowels into the north face of columns H-2 and J-2 (Figure 36 through Figure 38) and in Threshold Inspection Report No. 139 (dated April 1, 2024) with installation of the vertical reinforcement and ties (Figure 39). Documentation of the beginning of footing enlargement at the base of columns H-2 and J-2 is also recorded in this report (Figure 40) and documentation of the work on the third story column enlargement (Figure 41 and Figure 42) and footing enlargement (Figure 43 and Figure 44) continued in Threshold Inspection Report No. 140, dated April 2, 2024. In report No. 140, it was noted that the form on the column enlargement was moved 2 inches to the north to provide adequate cover on the reinforcement and this change was approved by the SEOR. Photographs of the completed third story column enlargement (Figure 45 and Figure 46) were provided in Threshold Inspection Report No. 141 (dated April 3, 2024), and continued work on the footing enlargements was documented (Figure 47 and Figure 48). Threshold Inspection Report No. 142 (dated April 4, 2024) stated that the column footing enlargements were completed (Figure 49 and Figure 50).

Figure 35. Photograph from Threshold Inspection Report No. 137 showing holes drilled in the north side of column H-2 to receive rebar dowels as part of the rectification of the column and roof structure.

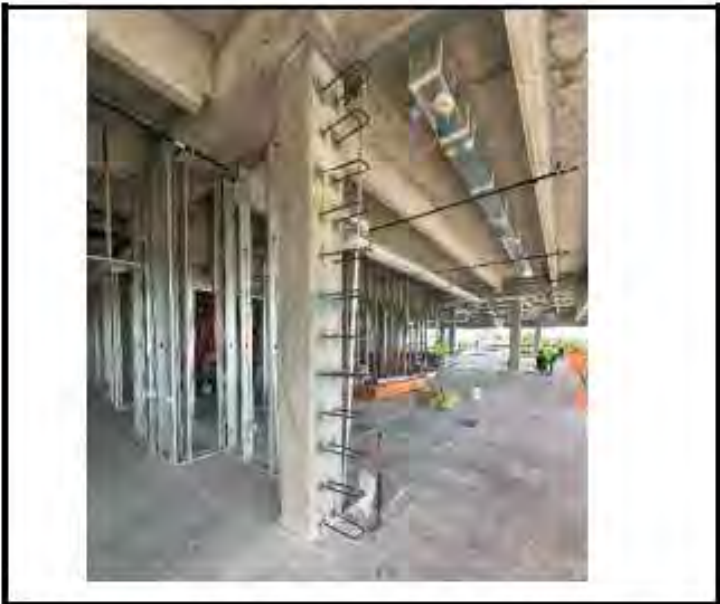
Figure 36. Photograph from Threshold Inspection Report No. 138 showing installed dowels on the north side of column I-2 part of the rectification of the column and roof structure.

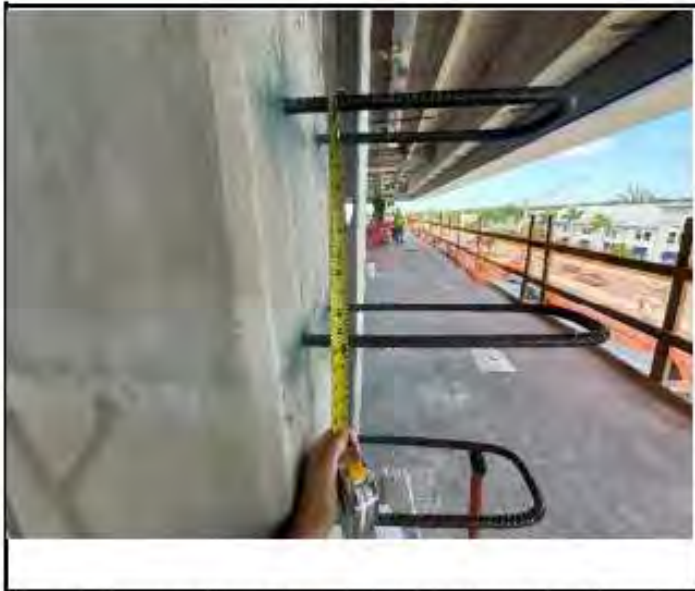
Figure 37. Photograph from Threshold Inspection Report No. 138 showing installed dowels on the north side of column J-2 part of the rectification of the column and roof structure.

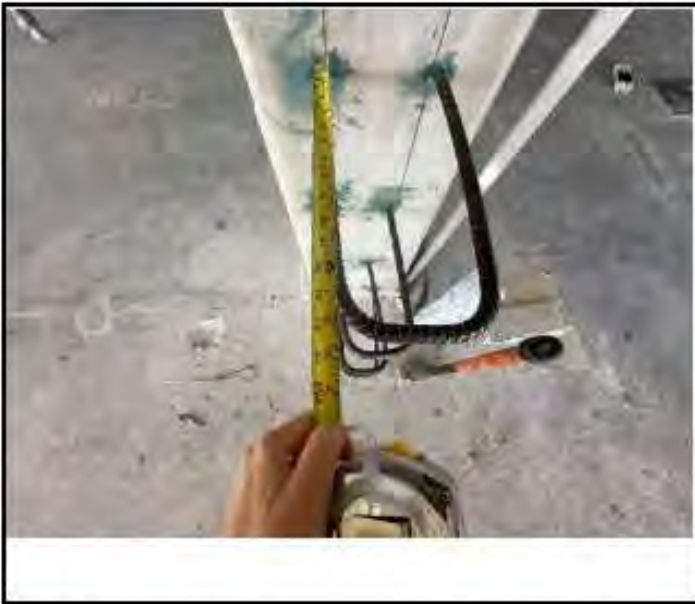
Figure 38. Photograph from Threshold Inspection Report No. 138 showing installed dowels on the north side of column J-2 part of the rectification of the column and roof structure.

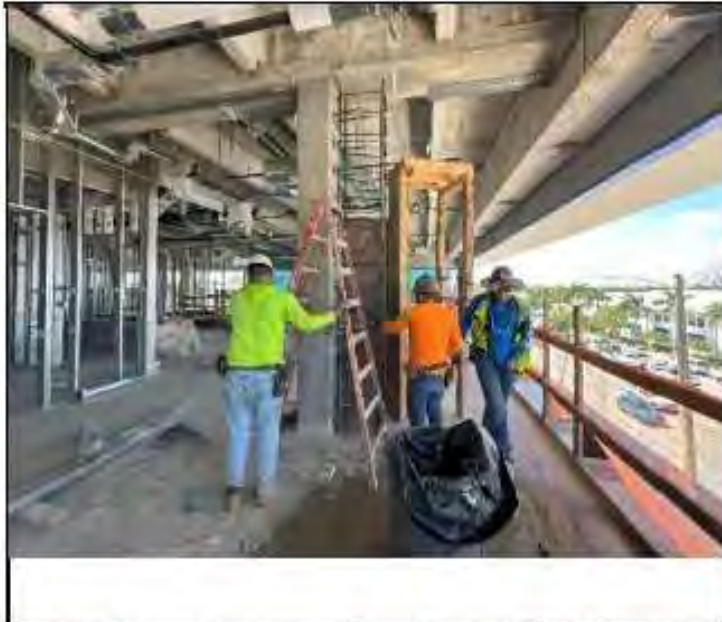
Figure 39. Photograph from Threshold Inspection Report No. 139 showing installed vertical reinforcement and horizontal ties at third story column enlargement.

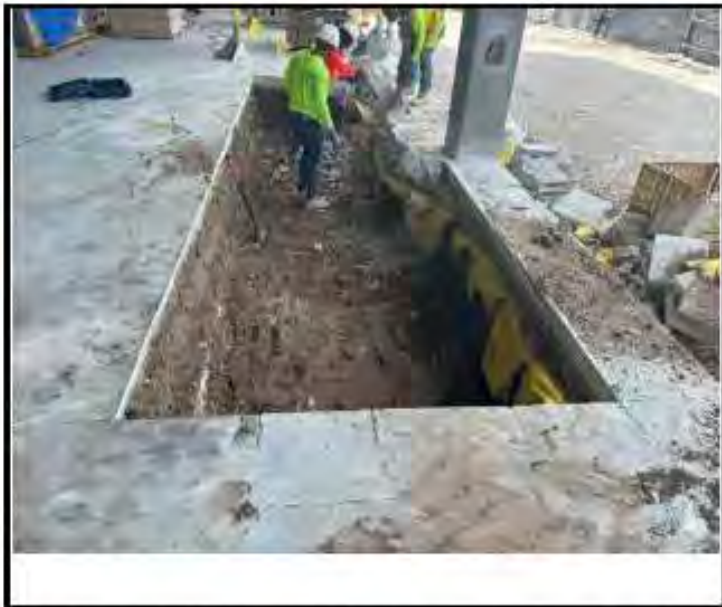
Figure 40. Photograph from Threshold Inspection Report No. 139 showing work to enlarge the footing at the base of either column H-2 or J-2.

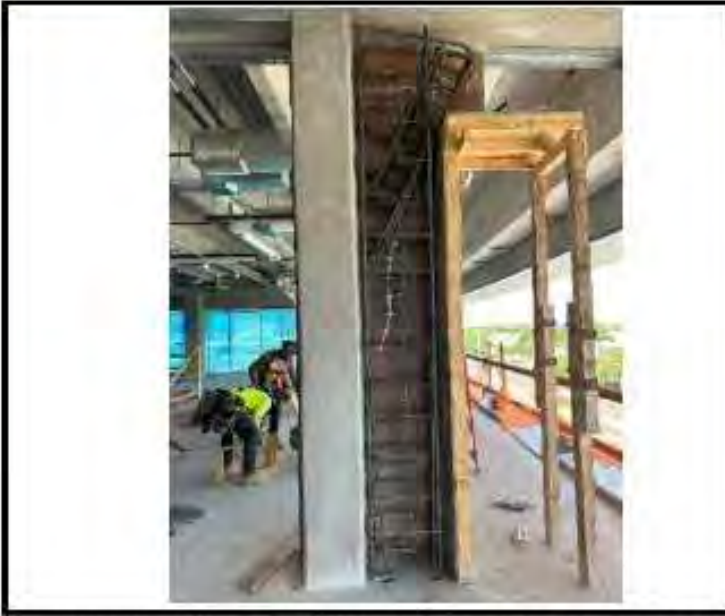
Figure 41. Photograph from Threshold Inspection Report No. 140 showing completed reinforcement installation at third story column enlargement.

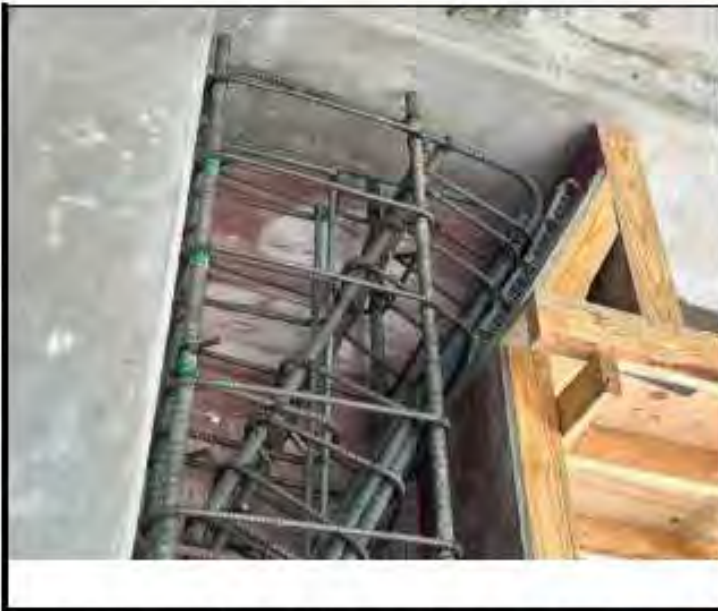
Figure 42. Photograph from Threshold Inspection Report No. 140 showing completed reinforcement installation at third story column enlargement.

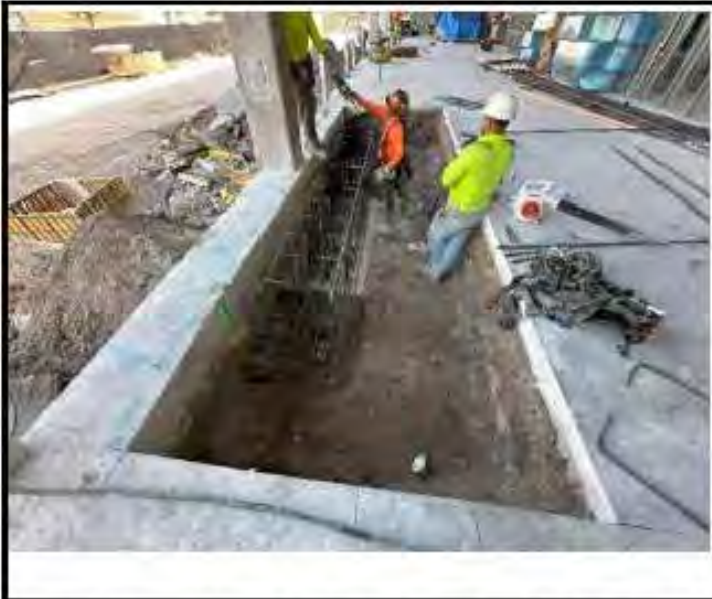
Figure 43. Photograph from Threshold Inspection Report No. 140 showing continuing work on column footing enlargement.

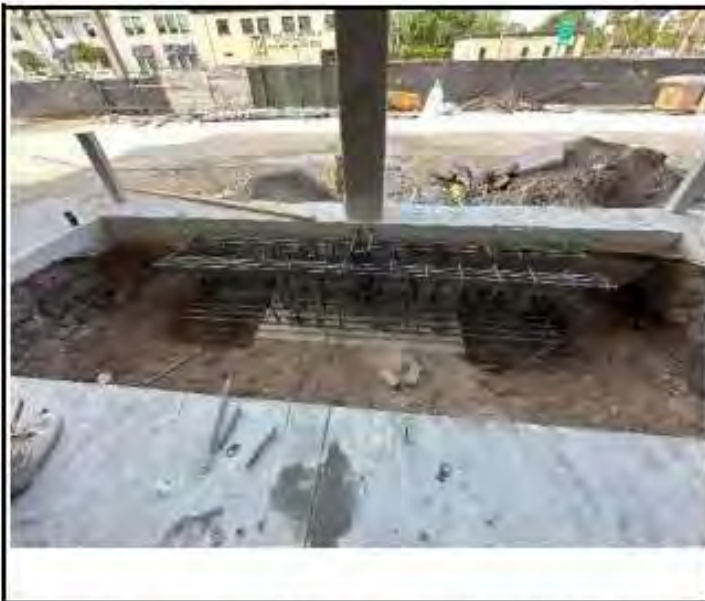
Figure 44. Photograph from Threshold Inspection Report No. 140 showing continuing work on column footing enlargement.

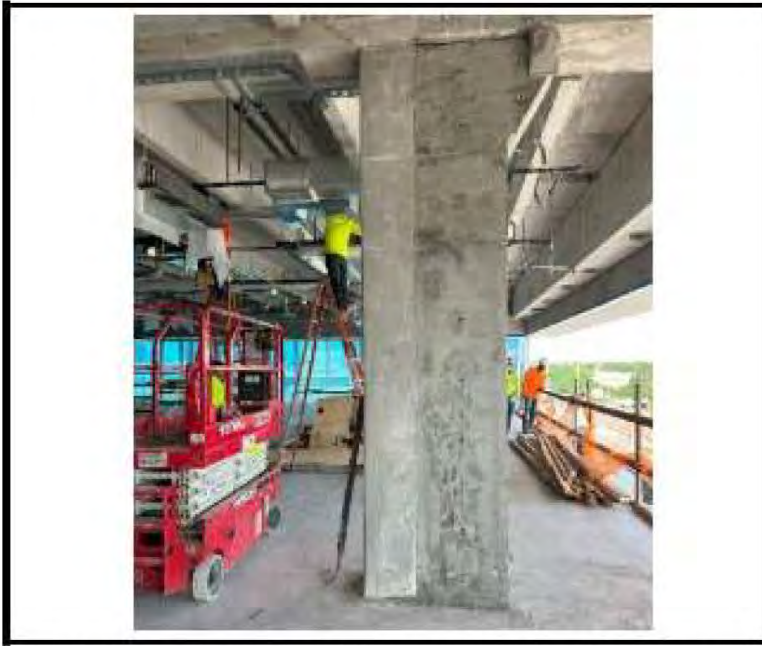
Figure 45. Photograph from Threshold Inspection Report No. 141 showing completed column enlargement.

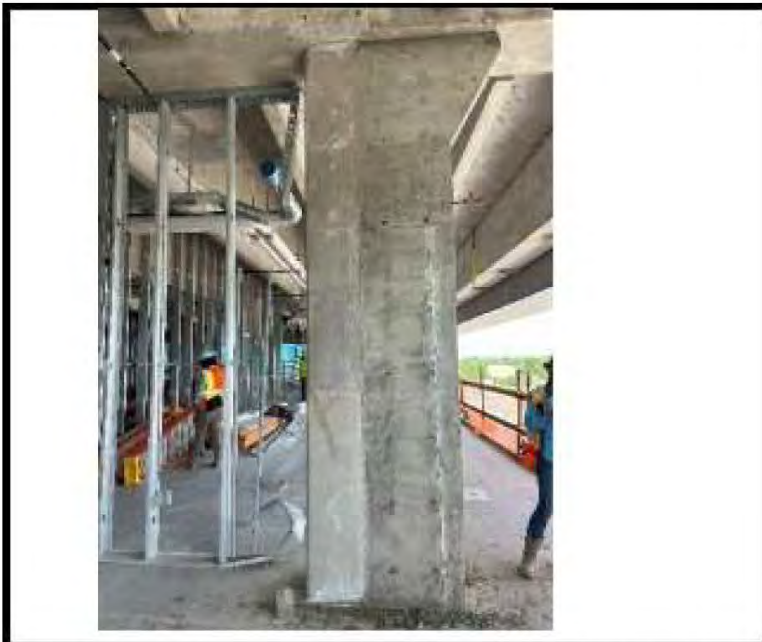
Figure 46. Photograph from Threshold Inspection Report No. 141 showing completed column enlargement.

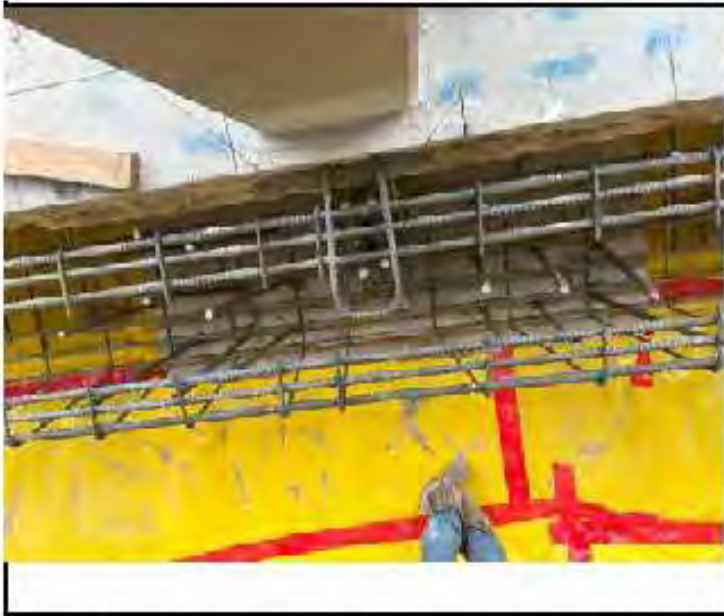
Figure 47. Photograph from Threshold Inspection Report No. 141 showing continuing work on column footing enlargement.

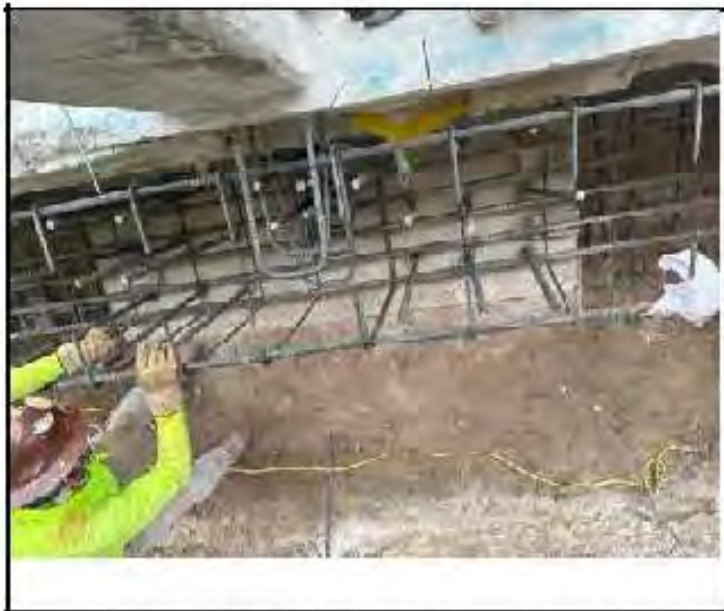
Figure 48. Photograph from Threshold Inspection Report No. 141 showing continuing work on column footing enlargement.

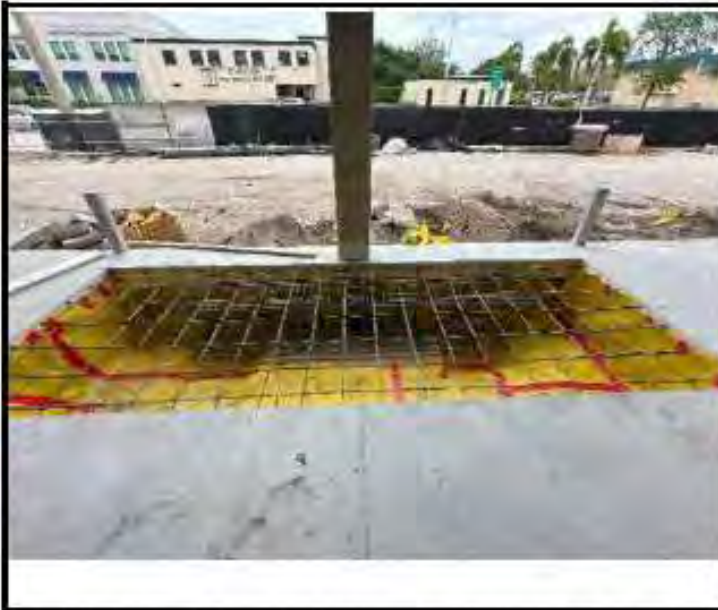
Figure 49. Photograph from Threshold Inspection Report No. 142 showing completed reinforcement placement at column footing enlargement.

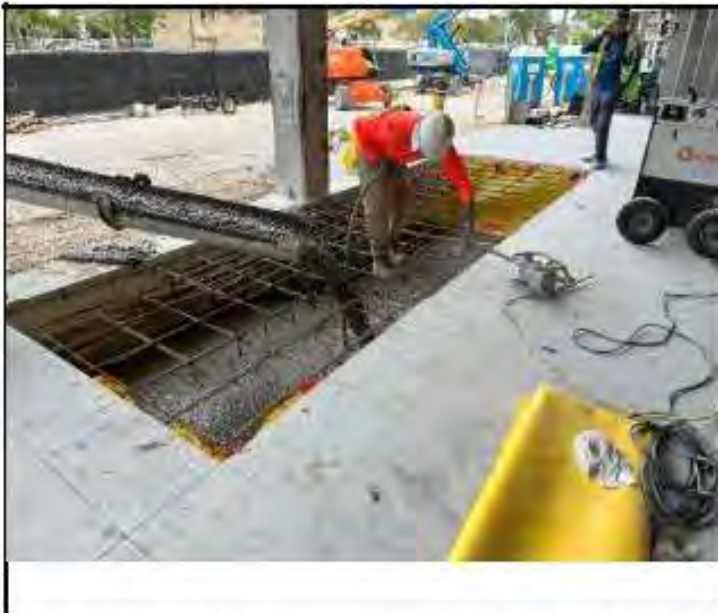
Figure 50. Photograph from Threshold Inspection Report No. 142 showing concrete placement at column footing enlargement.

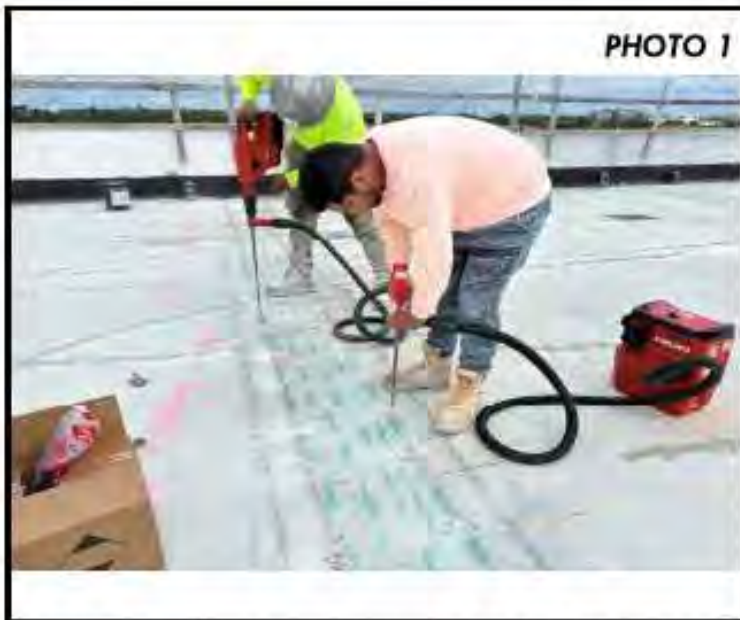
Epoxy injection of cracks in the roof slab at the north end of the building and work on installing the upturned beam projections were first documented in Threshold Inspection Report No. 200, dated August 30, 2024. In this report it was noted that holes were drilled for the inverted "U"-shaped stirrups (Figure 51), roof cracks were cleaned, and injection ports were installed in preparation for epoxy-injection (Figure 52). This work continued in Threshold Inspection Report No. 201, dated August 31, 2024. Some stirrup installation (Figure 53) and epoxy injection (Figure 54) occurred on September 3, 2024 (Threshold Inspection Report No. 202). Documentation of this work continued in Threshold Inspection Report No. 203, dated September 4, 2024 (Figure 55 and Figure 56). Similar work continued in Threshold Inspection Report No. 204, dated September 5, 2024, and No. 205, dated September 6, 2024. Threshold Inspection

Figure 51. Photograph from Threshold Inspection Report No. 200 showing drilling of holes for inverted "U" shaped stirrups in upturned beams.

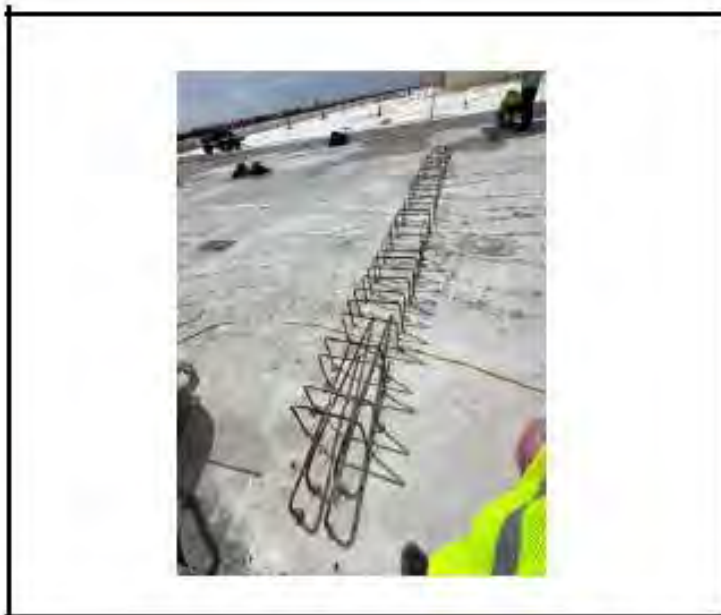
Figure 56. Photograph from Threshold Inspection Report No. 202 showing installed inverted "U" shaped stirrups and end "L" bars in upturned beams.

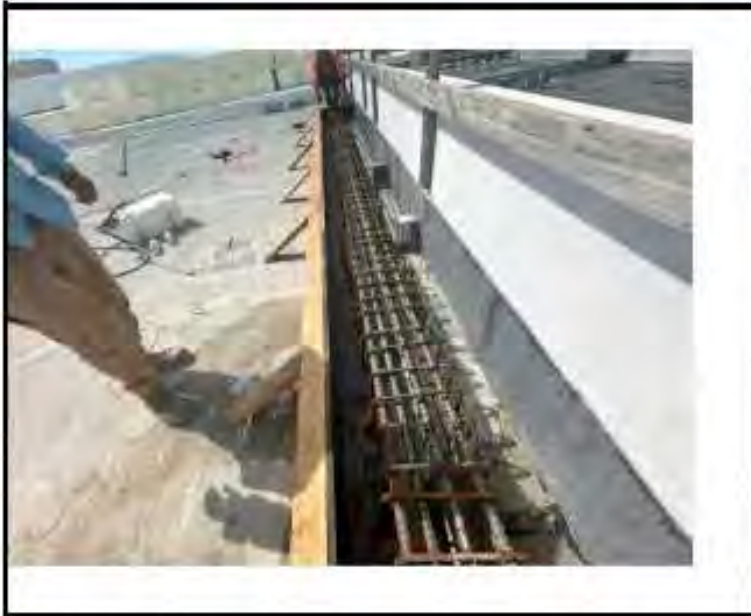
Figure 57. Photograph from Threshold Inspection Report No. 207 showing completed installation of reinforcement in in upturned beam.

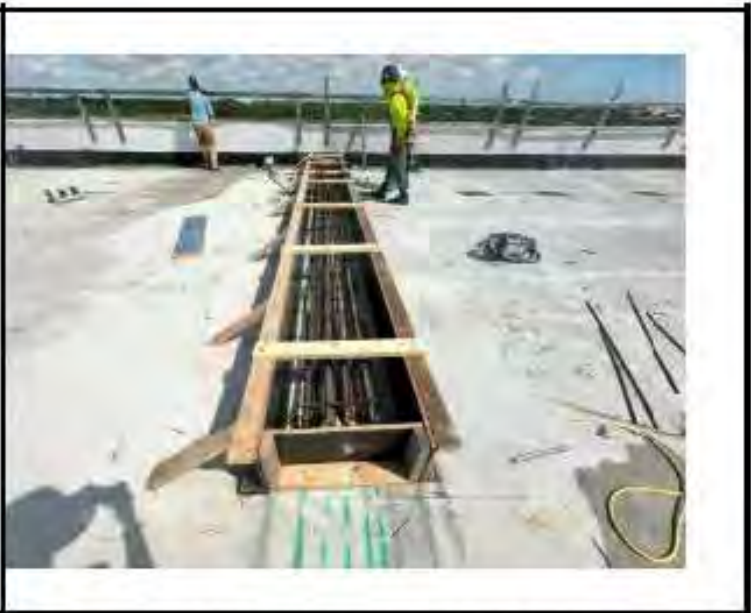
Figure 58. Photograph from Threshold Inspection Report No. 207 showing completed installation of reinforcement in in upturned beam.

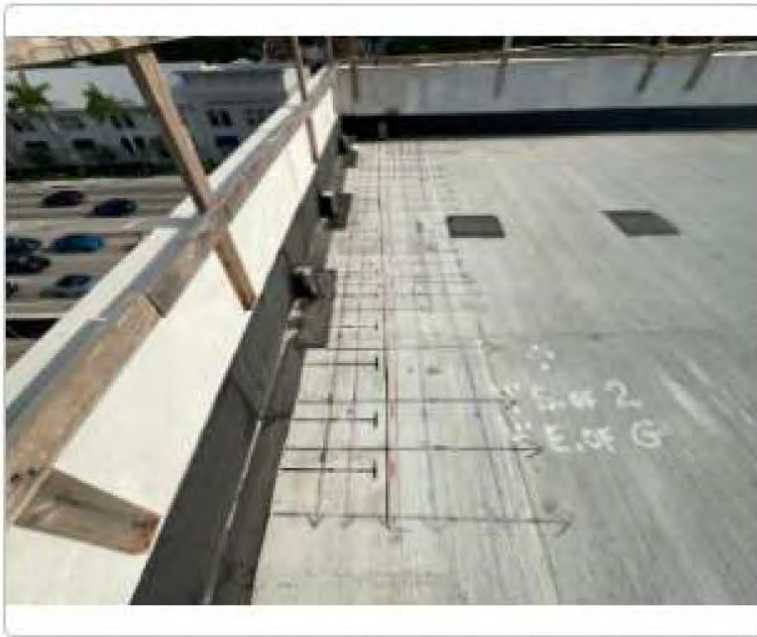
Figure 59. Photograph from ScanTek GPR report at Spot 1 (beams RSB-72 and RSB-73).

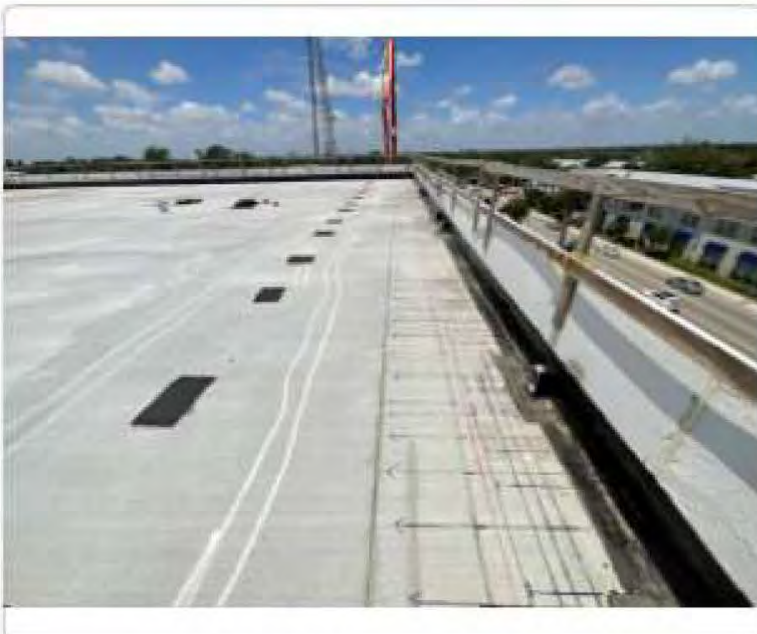
Figure 60. Photograph from ScanTek GPR report at Spot 2 (beam RB-97).

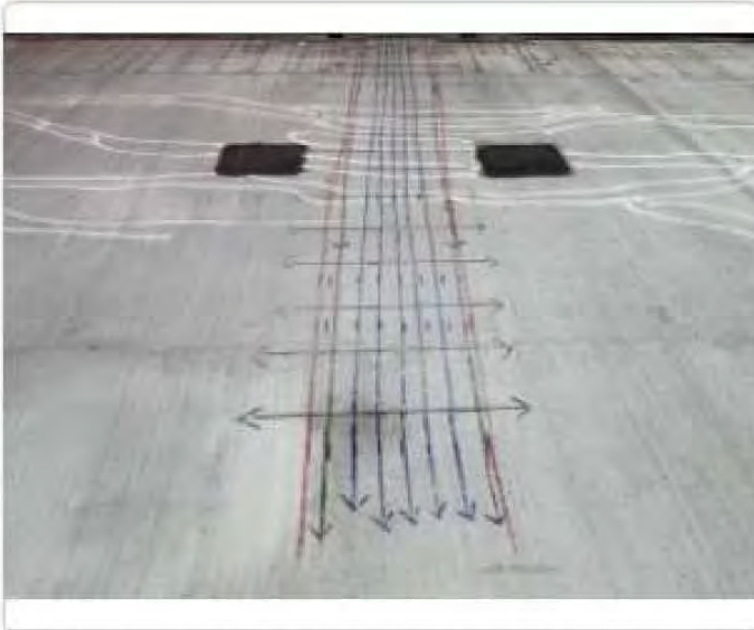
Figure 61. Photograph from ScanTek GPR report at Spot 3 (beams RSB-75 and RSB-76).

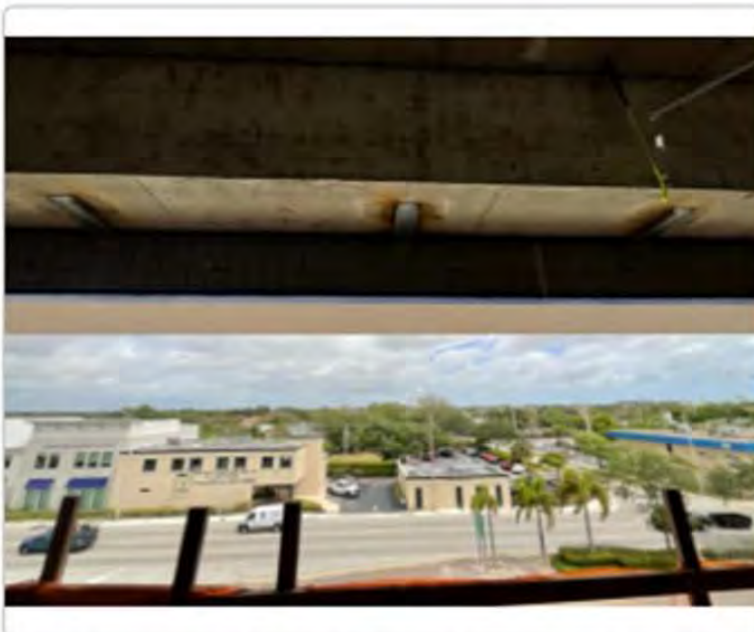
Figure 62. Photograph from ScanTek GPR report at Spot 4 (precast facade panel at roof).

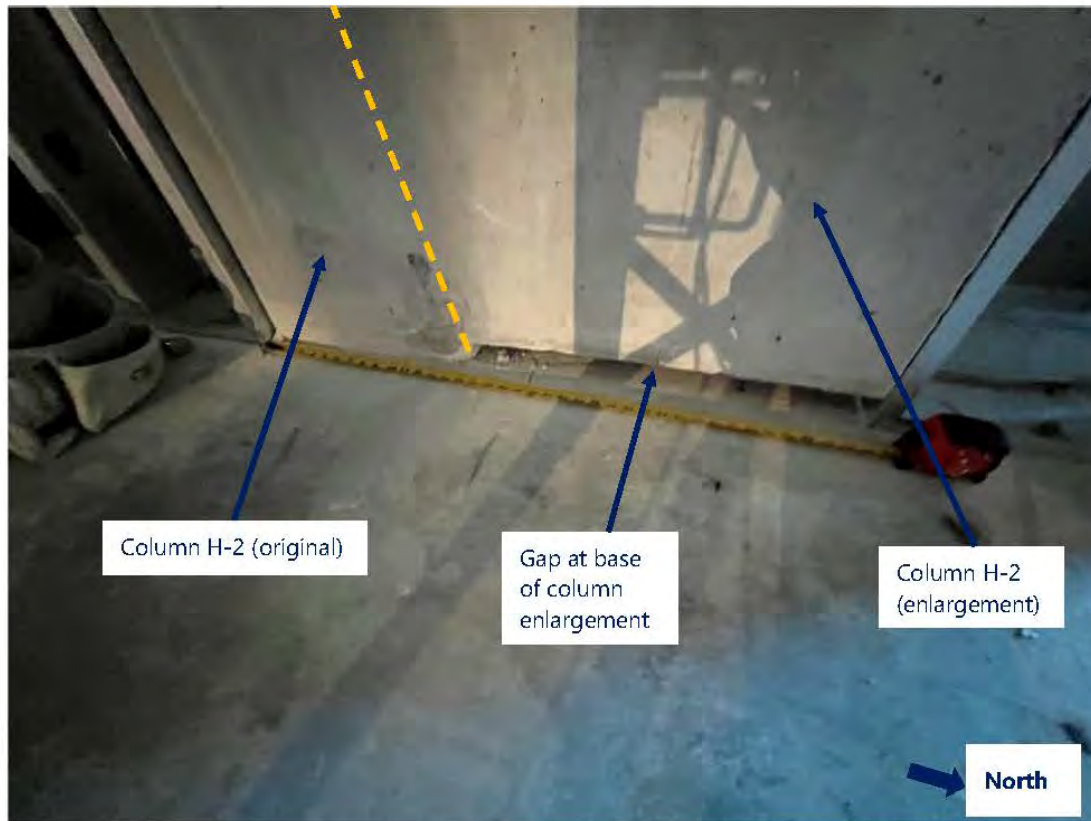
Figure 72. Base of third story column at H-2 showing gap after bottom of column enlargement was cut.

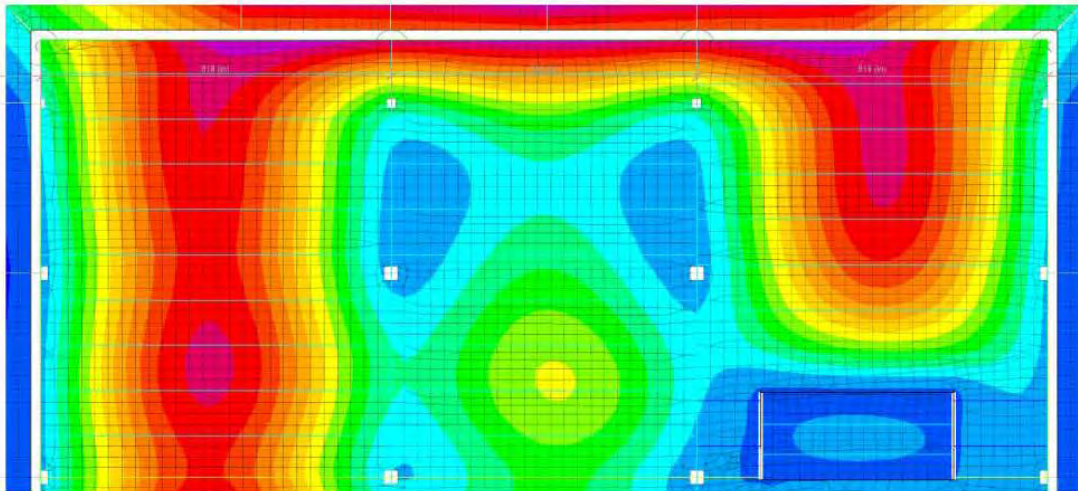
Figure 76. Roof-level deflected shape prediction by ETABS after 10 years of service; as-designed building configuration; purple corresponds with 4 inches of deflection.

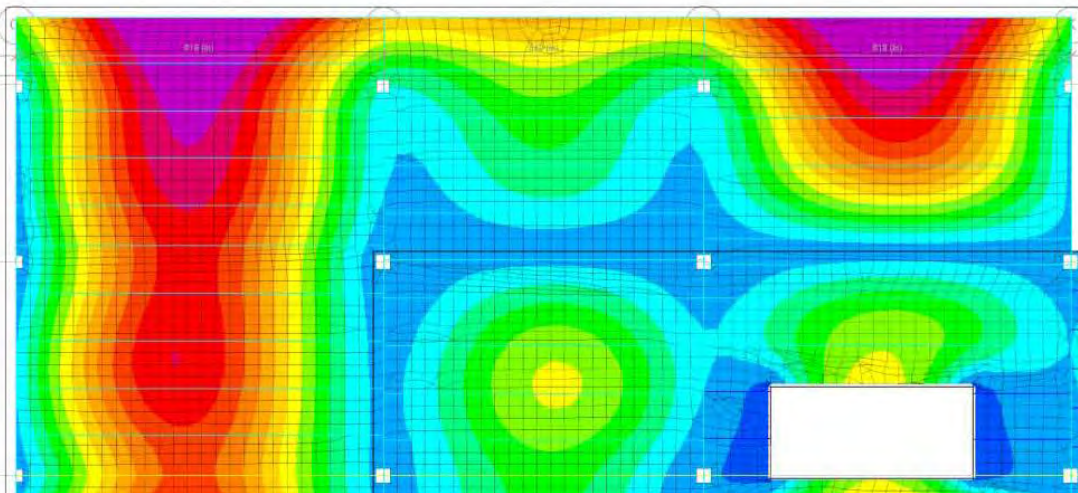
Figure 77. Level 3 deflected shape prediction by ETABS after 10 years of service; as-designed building configuration; purple corresponds with 4 inches of deflection.
