Fort Lauderdale Police Headquarters

WJE Peer Review, Phase 1 - North Elevation Evaluation

1300 West Broward Boulevard
Fort Lauderdale, Florida 33312

December 31, 2024
WJE No. 2024.4855.0

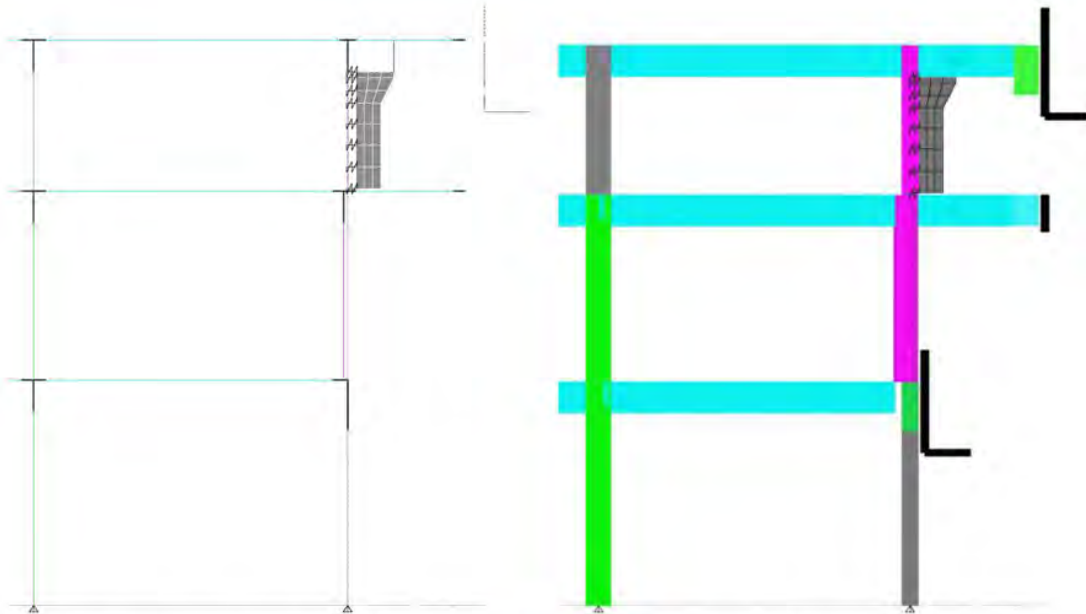
To evaluate the installed and recommended rectification measures, WJE modified the ETABS model described in the preceding section to incorporate the rectification measures into our staged construction analysis. Specifically, the following modifications were made to the model (Figure 78):

Figure 78. Cross section of analysis model in as-rectified configuration (unextruded left, extruded right).

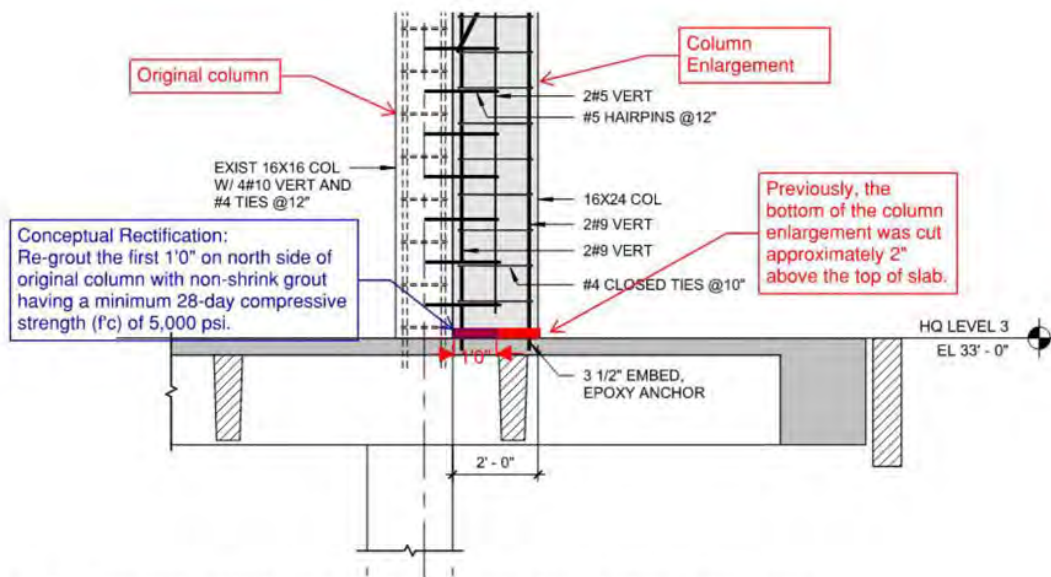
- This result is due to the condition at the base of the column where the column enlargement was demolished in combination with the biaxial bending in the column. If 12 inches of the column enlargement are grouted (see Figure 79) with non-shrink grout having a minimum 28-day compressive strength of 5,000 psi, then the column would be code-compliant for strength for axial plus biaxial bending.

Figure 79. Conceptual rectification for partial re-grouting of base of column enlargement

must be resisted by the original column. We determined that once the enlargement was added and then the lower portion removed, the remaining original column cross-section is no longer code-compliant for axial plus biaxial bending due to the cut but could be brought back into compliance if 12 inches of the base of the column are regouted (see Figure 79).

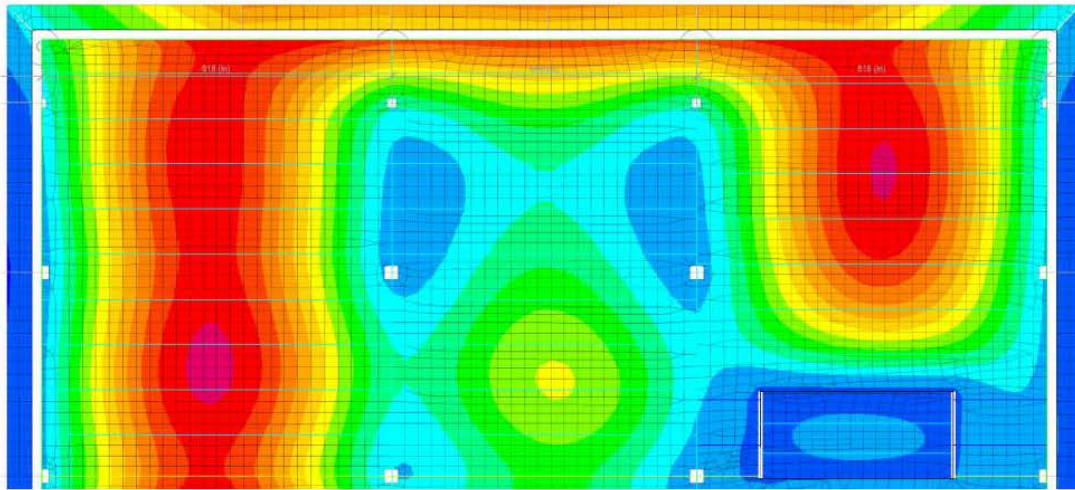
Figure 80. Roof-level deflected shape prediction by ETABS after 10 years of service; rectified building configuration; purple corresponds with 4 inches of deflection.

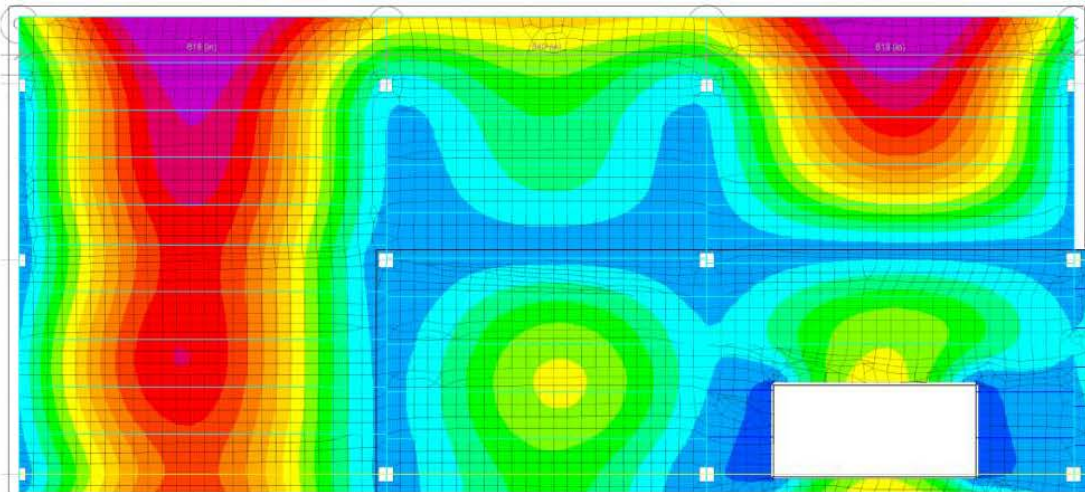
Figure 81. Level 3 deflected shape prediction by ETABS after 10 years of service; rectified building configuration; purple corresponds with 4 inches of deflection.

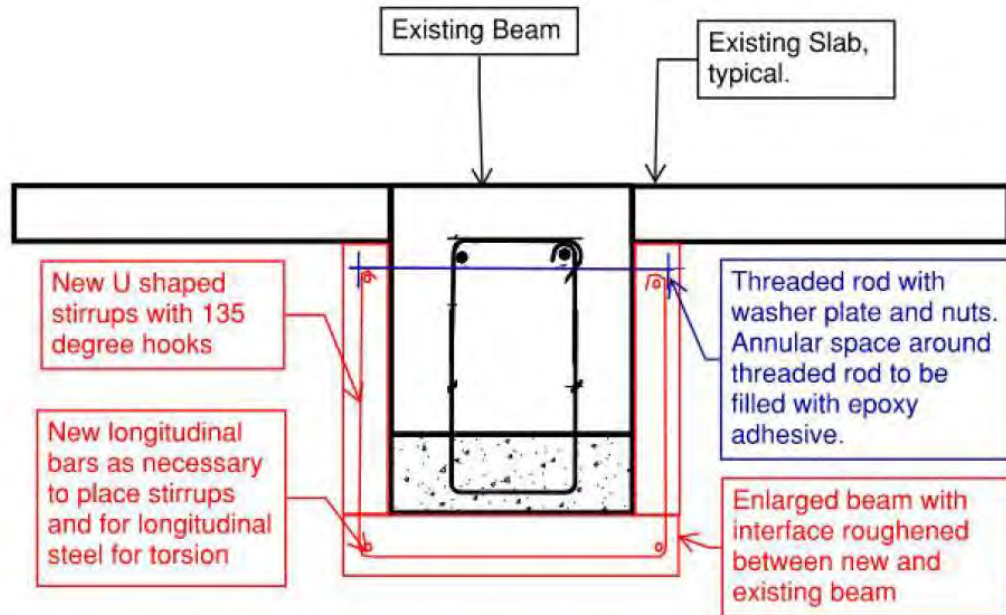
Figure 83. Conceptual solution for strengthening of cantilever roof beams.

In our opinion the beam sections north of the column enlargement (i.e., along gridlines H-2 and J-2), need to be strengthened. Strengthening could be accomplished through the addition of a beam jacket with closed stirrups (e.g. Figure 83).

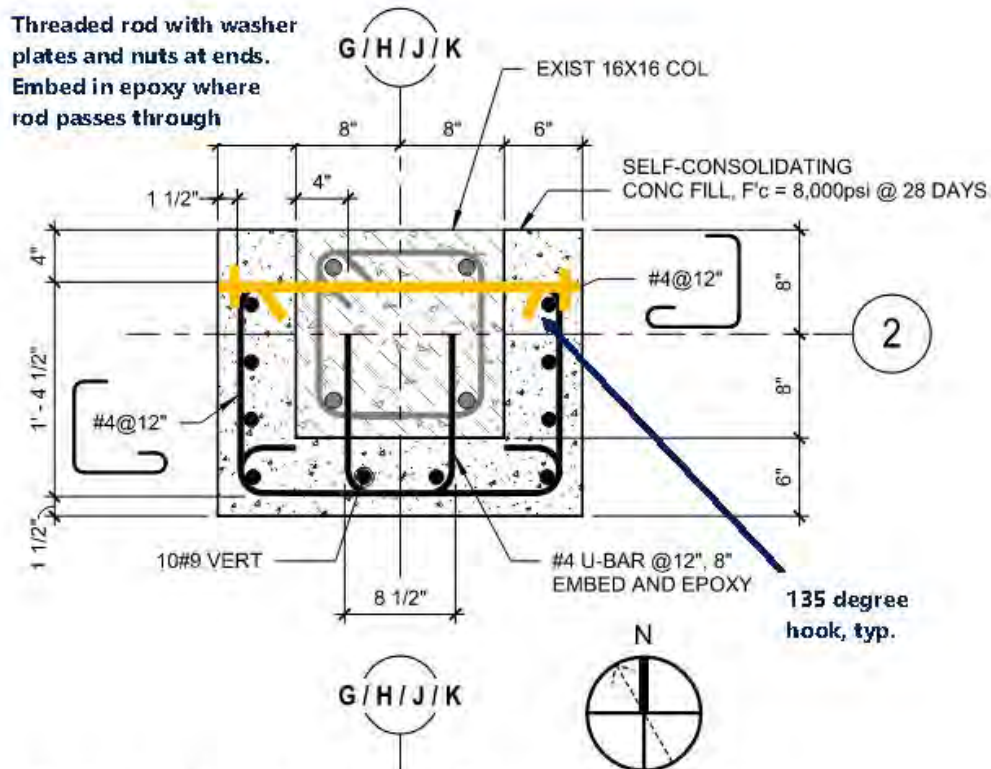
Figure 85: Schematic of alternate tie configuration. WJE annotations in orange and blue.

provide a closed tie. Closed ties will provide a more reliable means of restraining and bracing the flanges of the column bracket and will also serve to provide additional confinement to the original column. We recommend that the tie detail be modified such that a closed tie can be provided. One possible option to achieve a closed tie is shown conceptually in Figure 85.

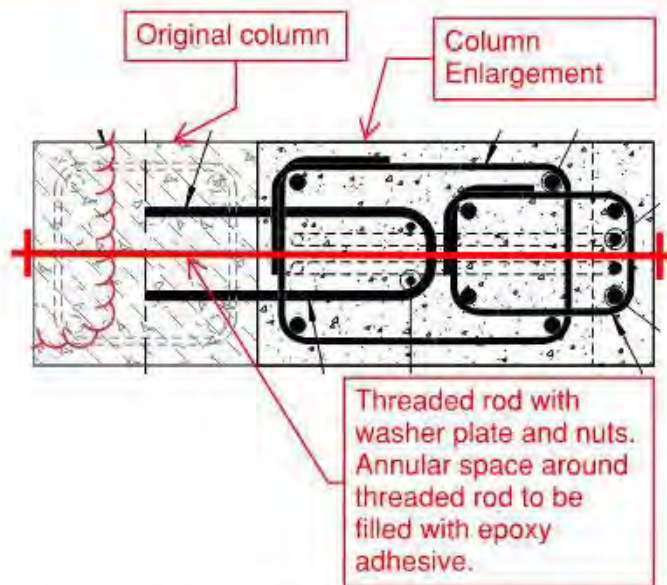
Moreover, these columns were not code-compliant for shear as originally designed. In the as-rectified configuration (with the enlargement), there is additional shear demand on the column as the result of the column enlargement and corbel acting as a strut to transfer some of the bending moment demand from the beam above. The column enlargement does provide some additional shear capacity, but the actual distribution and load sharing of shear demand between the original column and the column enlargement is difficult to ascertain. Further, the total shear demand on the total cross section (original plus column enlargement) is large enough in magnitude that ACI 318-14 Section 10.6.2 requires that minimum shear reinforcement be installed, and currently no shear reinforcement extending the full depth of the combined cross section is provided. As such, it is our opinion that these columns require additional measures to increase the shear capacity to a level sufficient for the demand. We believe a reasonable rectification is to wrap the columns with fiber reinforced polymers (if allowed by code provisions, see preceding section) or to jacket the columns and add closely spaced ties as discussed for columns G-2 and K-2 above. Alternatively, threaded rods with washer plates and nuts could be used to tie the two columns together as shown conceptually in Figure 86.

Figure 86. Conceptual rectification to tie original column and column enlargement together for shear strengthening

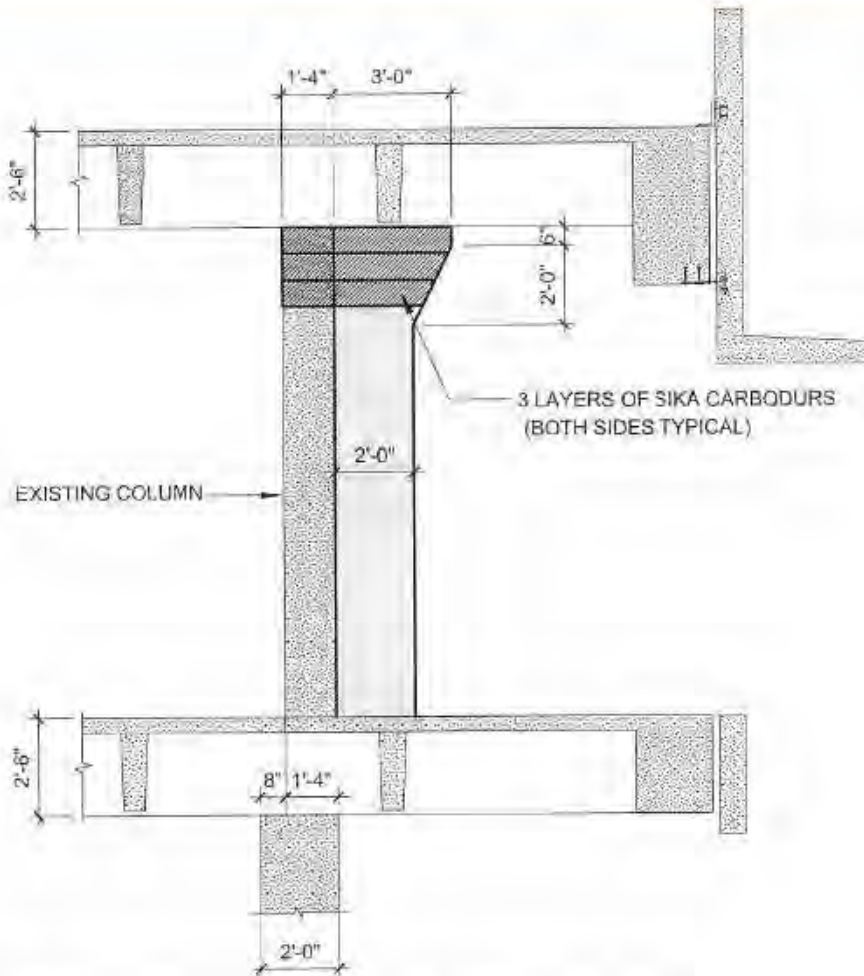
Figure 87. Conceptual rectification proposed by Lakdas to provide tie at corbel

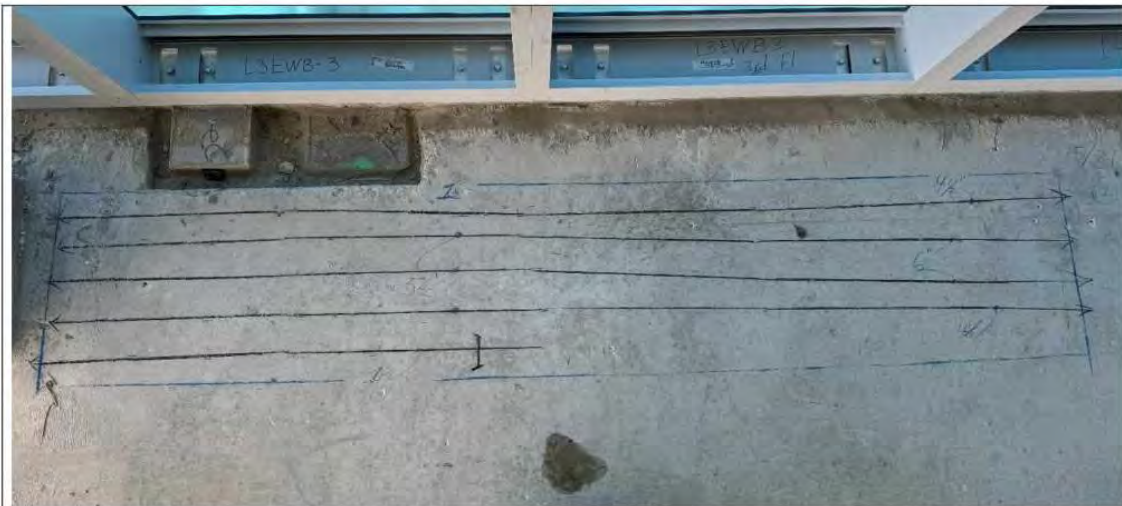
Location:	Behind column 1, 3 rd Floor
Comments:	5 rebars were spotted. Depths ranging from 1" to 6".

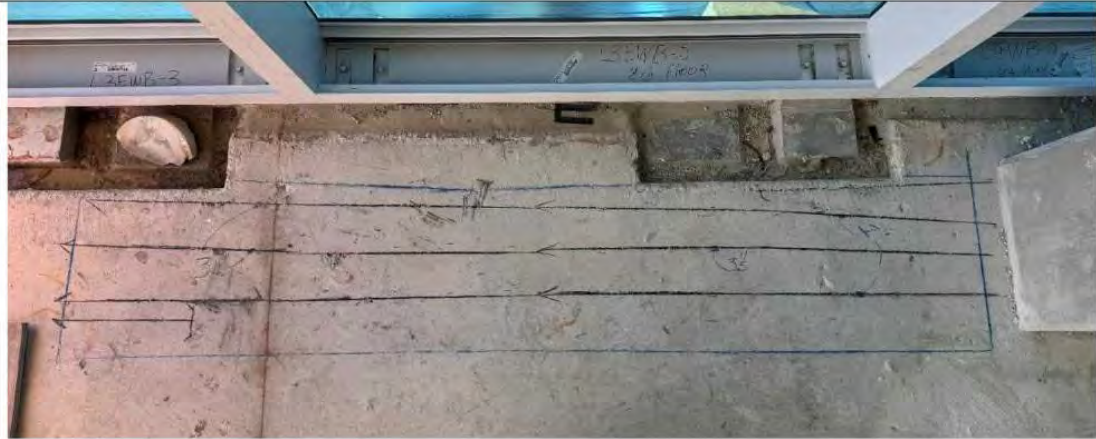
Location:	Front of column 1, 3 rd Floor
Comments:	Briefly 5 rebars were spotted horizontally. Depths ranging 1"-3.5"

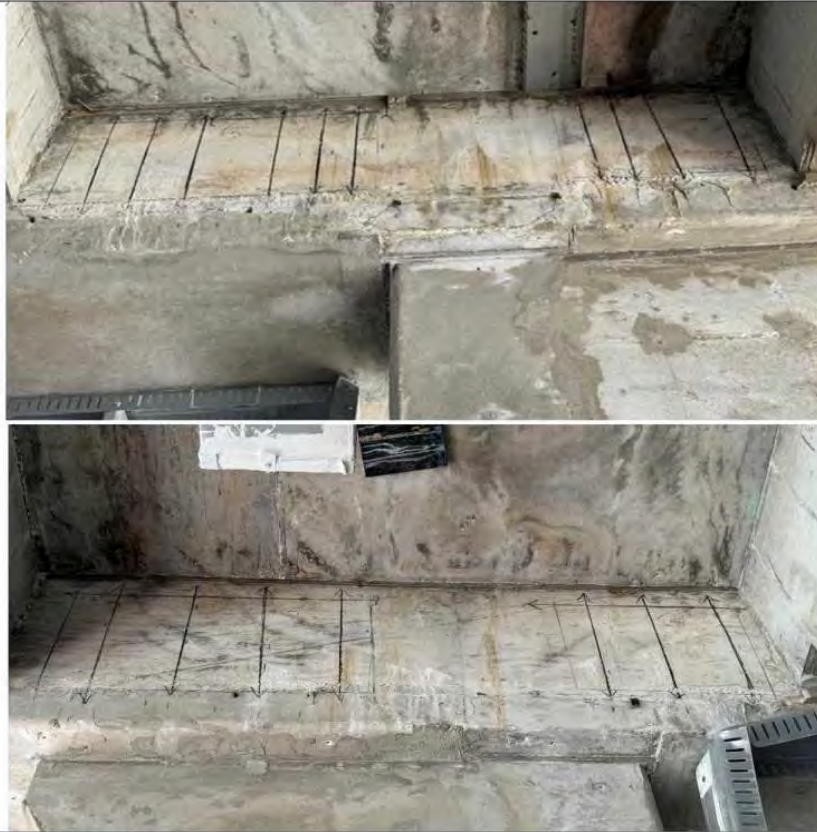
Location:	Column 2, beam, 3 rd Floor
Comments:	The beam above column 2 was about 24" thick. The Mini XT was about to see about 10" deep. Vertical rebar was recorded to 7"-8" deep

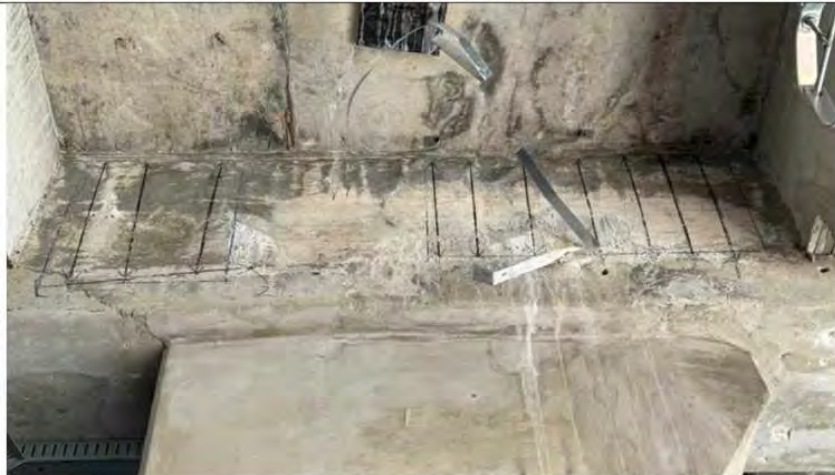
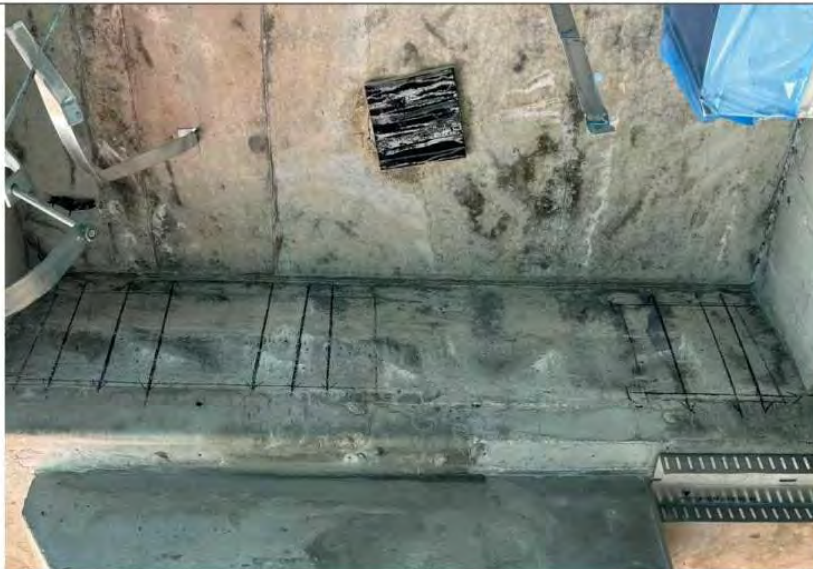
Location:	Column 3, 3 rd Floor
Comments:	The beam above column 2 was about 24" thick. The Mini XT was about to see about 10" deep. Vertical rebar was recorded to 6"-7 deep

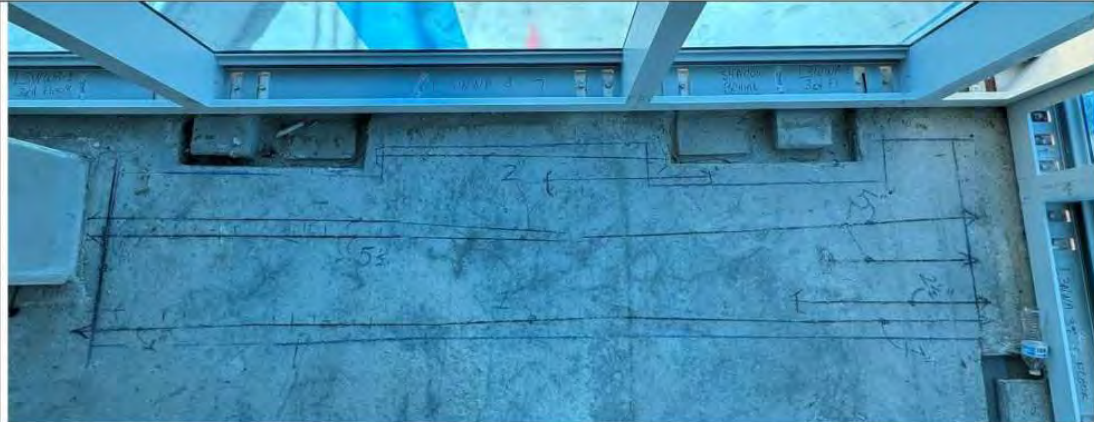
Location:	In front of column 4, 3 rd Floor
Comments:	About 5 horizontal rebars can be seen ranging at depths of 1" to 5.5" deep.

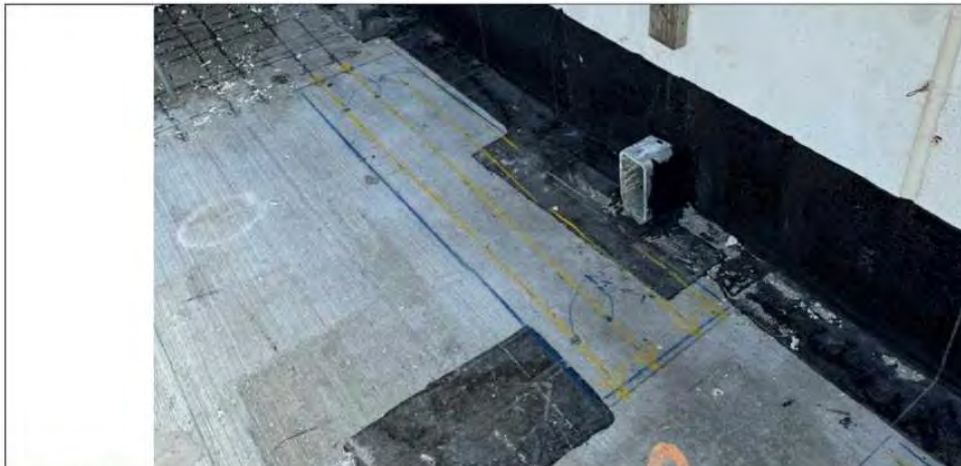
Location:	Roof area over column 1 in front of column
Comments:	4 horizontal rebars can be seen ranging at depths of 2.5"-3" deep.

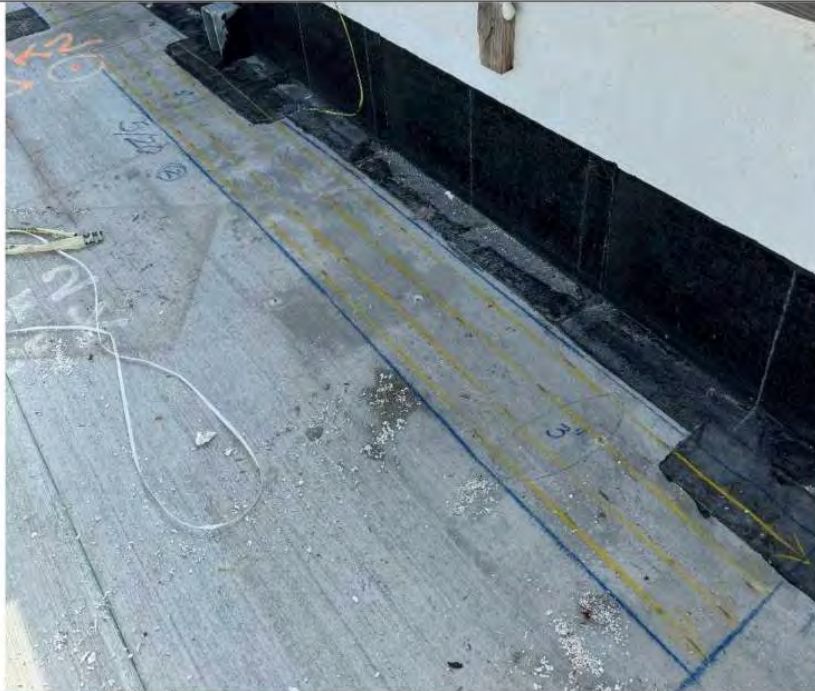
Location:	Roof area over column 1, behind column
Comments:	4 horizontal rebars can be seen ranging at depths of 3"

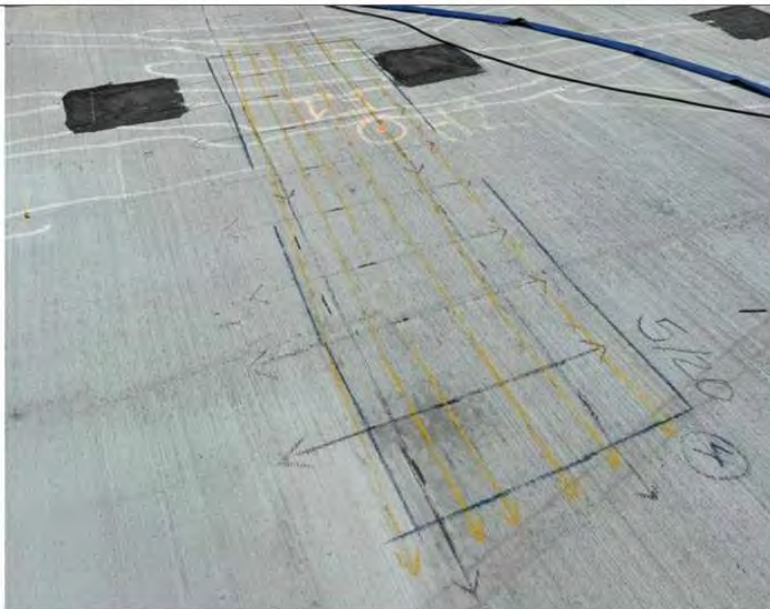
Location:	Roof area over column 2, behind column
Comments:	6 horizontal rebars can be seen ranging at depths of 2.5" to 5" deep.

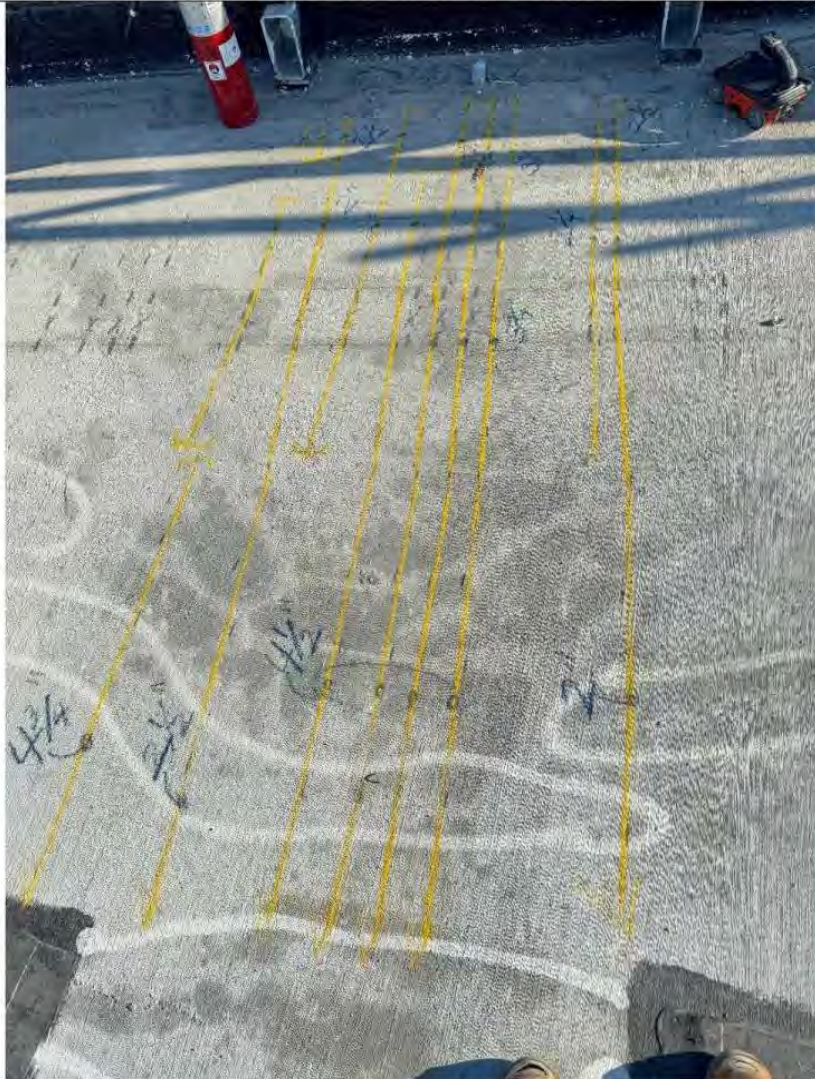
Location:	Roof area over column 2, in front of column
Comments:	About 7 horizontal rebars can be seen ranging at depths of 2.5" to 4.75" deep.

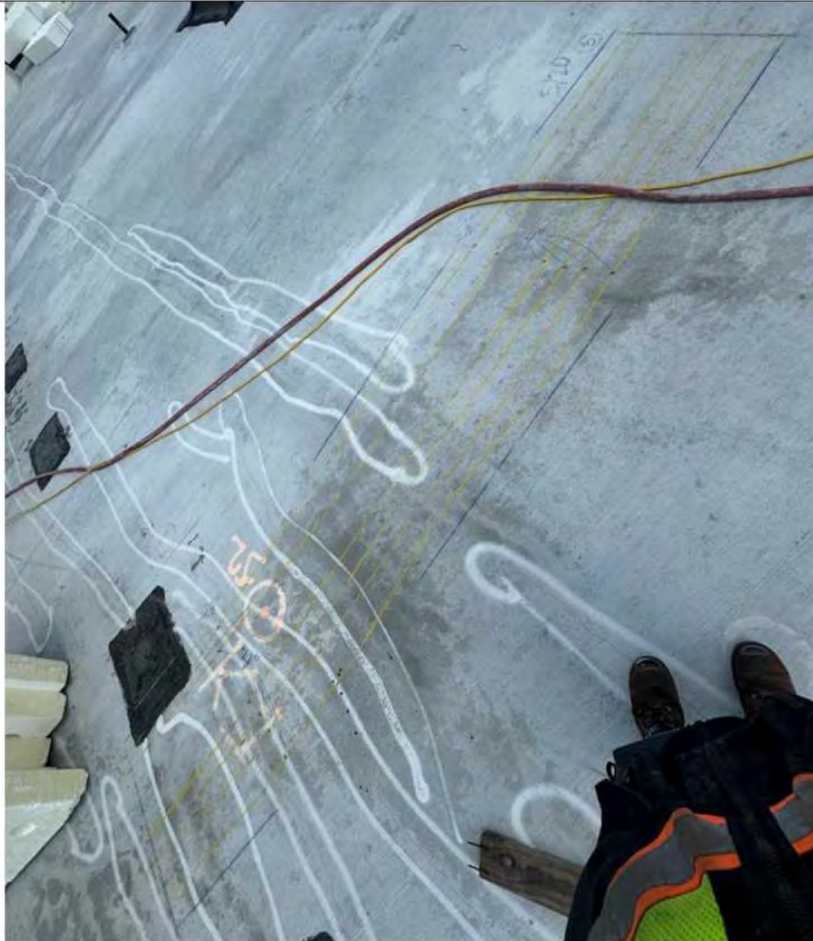
Location:	Roof area over column 3, behind column
Comments:	6 horizontal rebars can be seen ranging at depths of 2.5 to 4" deep.

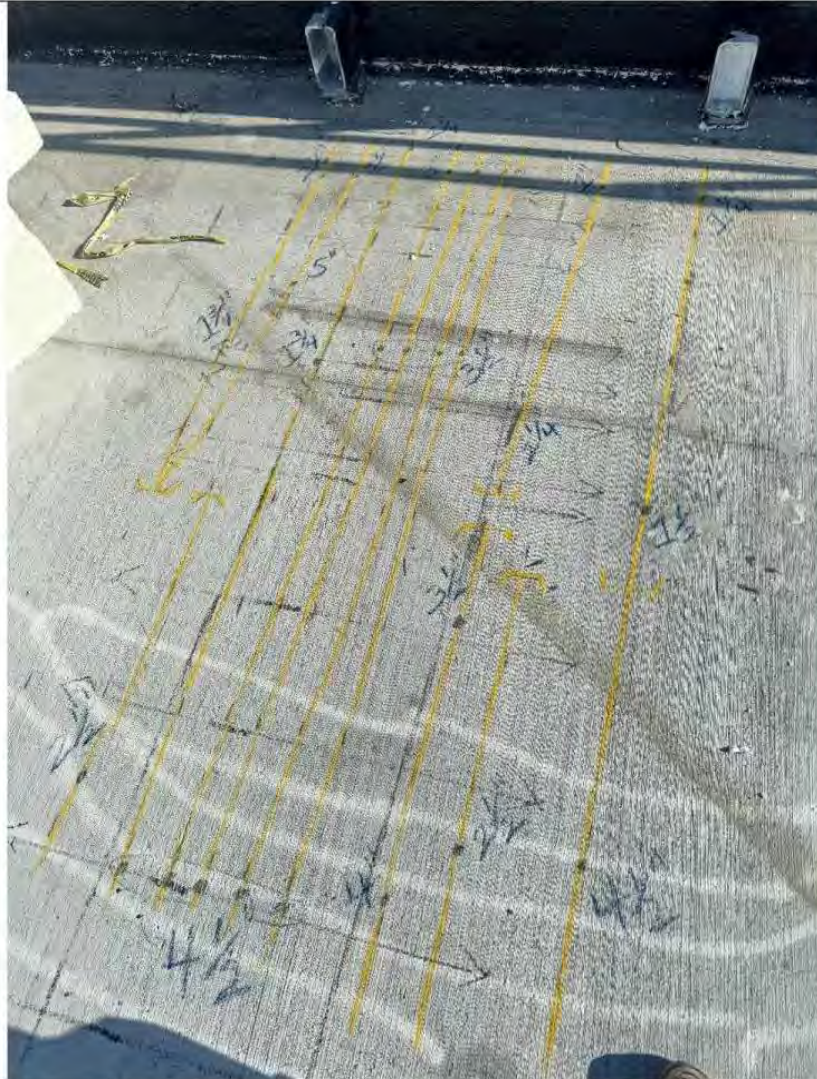
Location:	Roof area over column 3, in front of column
Comments:	About 10 horizontal rebars can be seen ranging at depths of 1.25" to 4.5" deep.

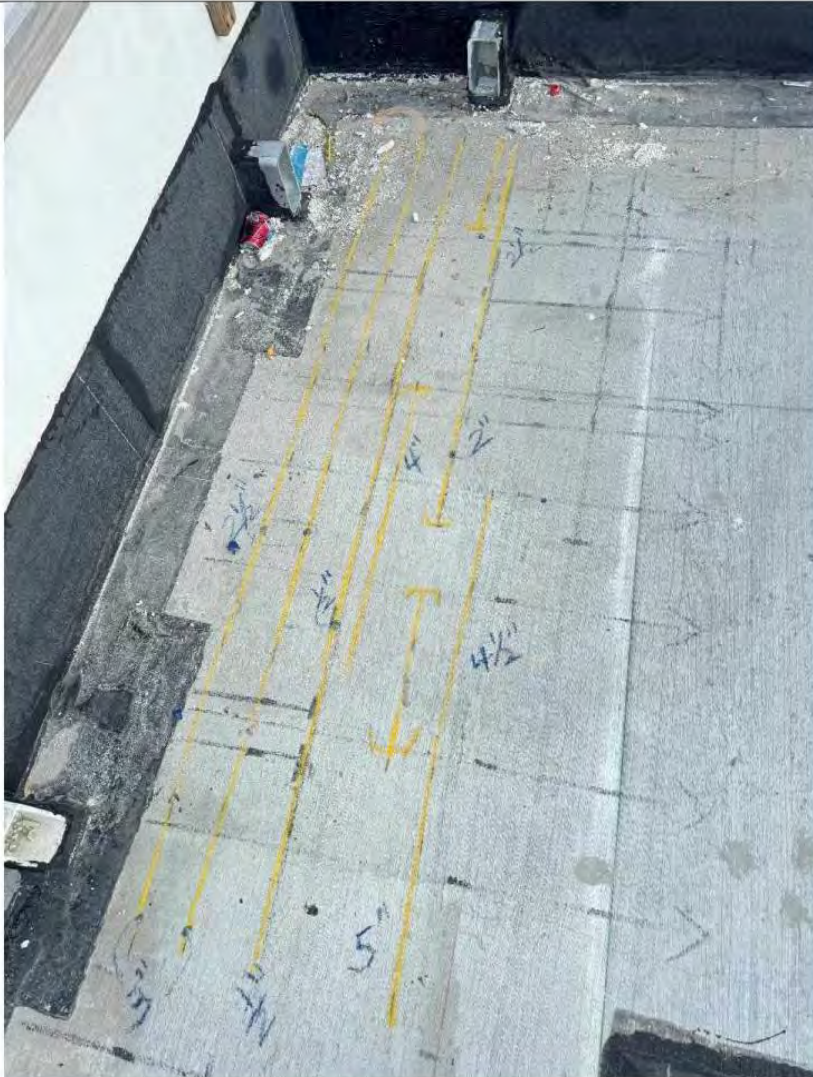
Location:	Roof area over column 4, in front of column
Comments:	About 6 horizontal rebars can be seen ranging at depths of 2.5" to 5" deep.
