CITY OF FORT LAUDERDALE AQUATIC CENTER

FACILITY ASSESSMENT REPORT

March 28, 2016

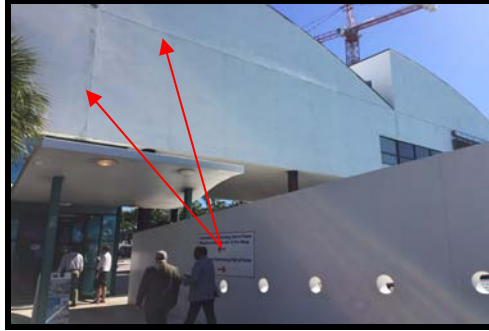
On the exterior second floor, the stucco is not smooth at the seams. This suggests some water intrusion has taken place. The exterior needs repainting. On the interior, there are signs of water intrusion at the window on the west wall.

Figure 7 Building 1, west elevation, buckling at the seams in the stucco

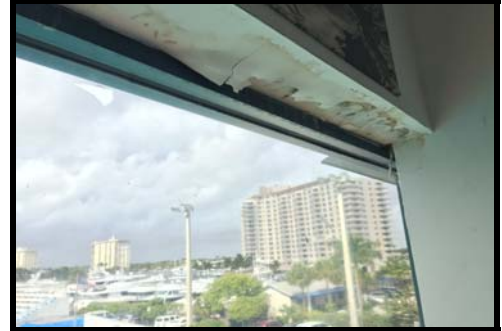
Figure 8 Building 1, second floor interior looking west. Water intrusion around window and possible mold underneath.

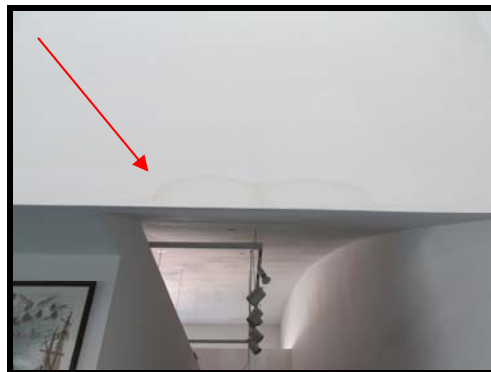
The majority of the ceilings and walls directly below the roof appear to be in good condition. There are no visible cracks or buckling at joints indicating any major defects in the structure. There are some water stains at the intersection points of the curved roof which indicates the roof drain on the exterior of the intersection is leaking.

Figure 9 Building 1, water stain on interior intersection of curved roof.

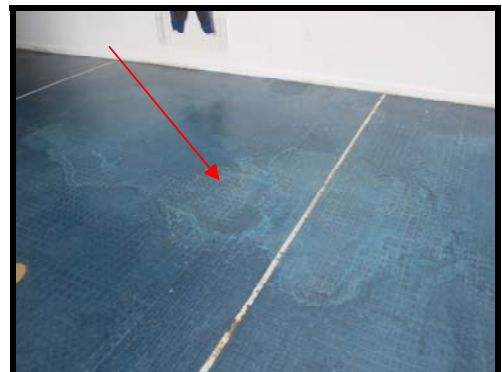
Figure 10 Previous leaks from the roof and walls causing water damage on the floor finish

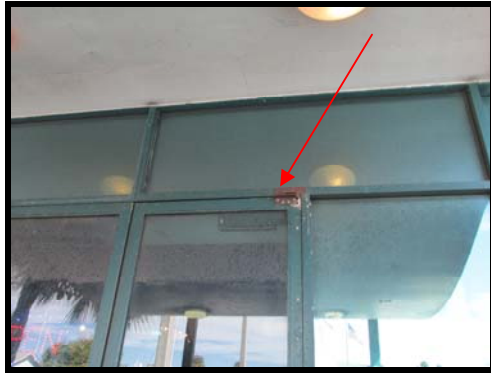
The entry to the gift shop has storefront aluminum doors which are in poor condition, due to age and proximity to the ocean environment. The aluminum appears rusted at corners. Existing door hardware is also in poor condition. The hinges have been replaced but have since rusted. There are holes in the frame where the previous hinges were installed.

Figure 11 Building 1, exterior storefront door entering gift shop, rusted door hardware

The aluminum needs to be refinished, holes patched and painted. Hardware needs to be replaced.

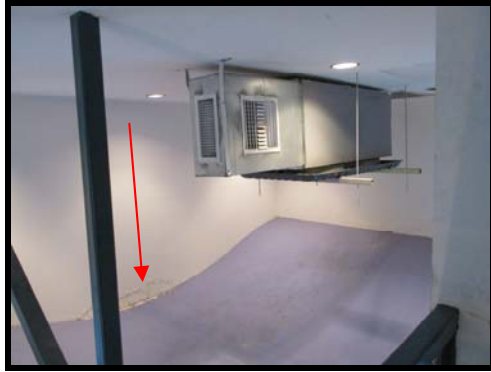
Interior ceilings are gypsum wall board and appear to be in good condition with the exception of some water stains as mentioned above.

Figure 13 Interior gift shop, water damage at wall and ceiling corner

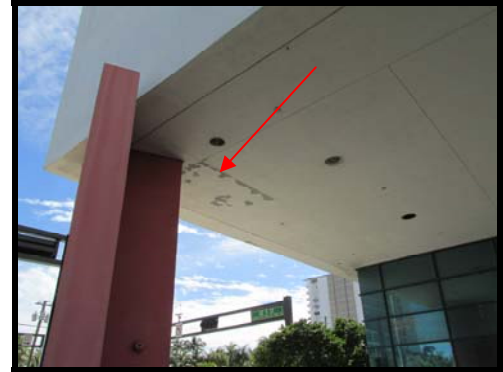
Exterior ceilings appear to be in good condition with the exception of peeling paint. Ceilings need to be pressure washed and repainted.

Figure 14 ceiling of drive through entry,

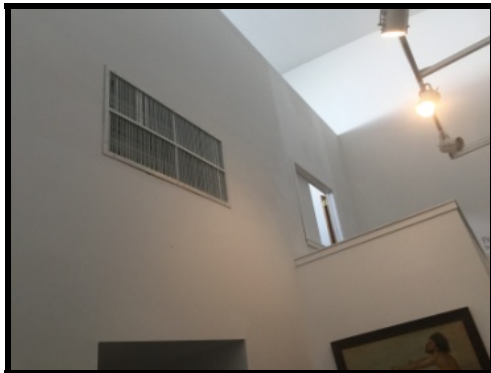
- a. Air Handling Units are inaccessible for maintenance purposes. Due to location and inaccessibility of unit, it is apparent that the equipment has not been well maintained. The photographs below demonstrate the locations of the equipment and its inaccessibility.

Figure 15 opening above restrooms to mechanical area, inaccessible

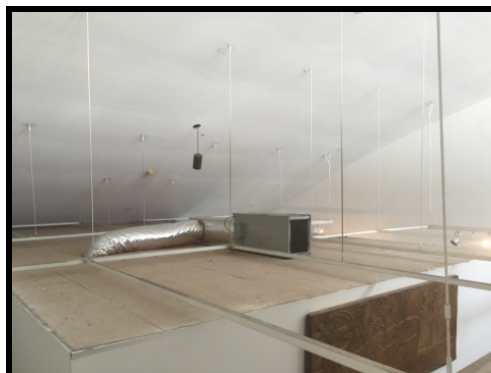
Figure 17 mechanical unit above ceiling space

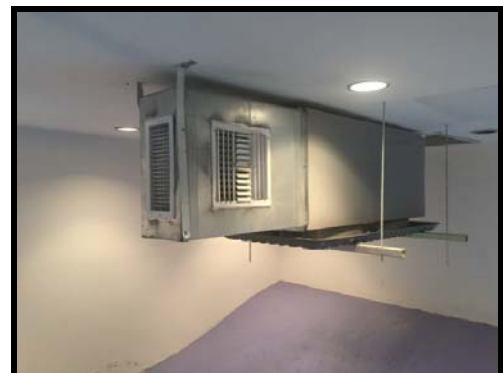
Figure 18 mechanical unit in Proshop stair up to second floor, not easily accessible

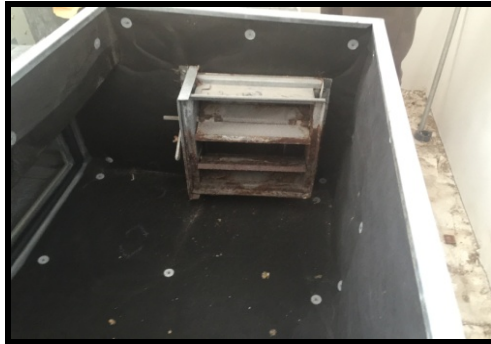
- b. The outside air intake damper is rusted and locked in place. Rusted louvered door, prohibiting ventilation. No ventilation or air conditioning for telecom closet. Photographs below show the rusted damper, the damaged door and the non-ventilated telecom closet.

Figure 19 Outside air intake damper

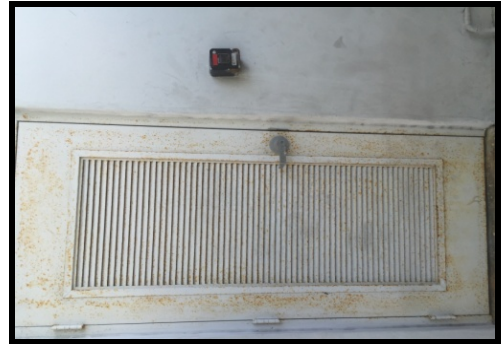
Figure 20 Damaged (rusted) door

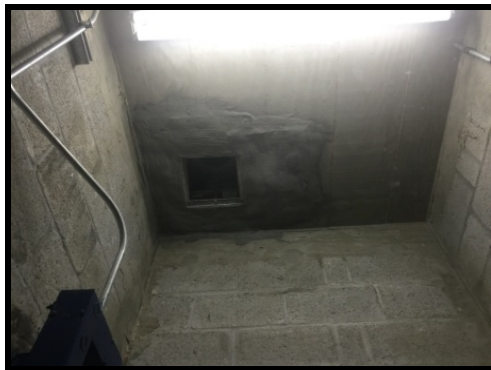
Figure 21 Non-ventilated telecom closet

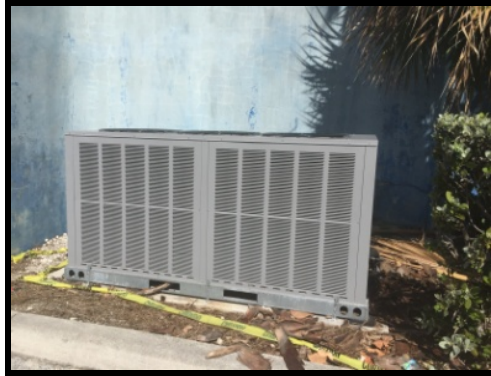
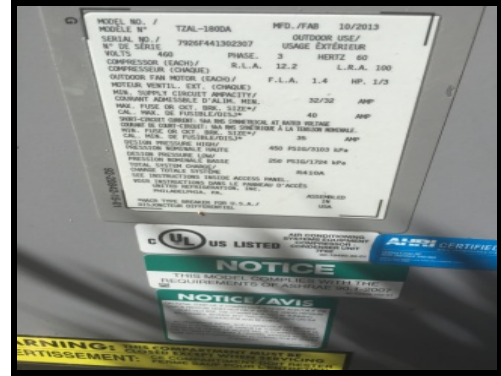
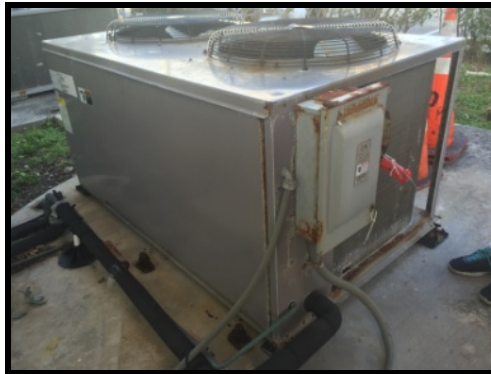
- c. 15 Ton Condensing Unit on the South Side of Building 1 appears to be in fair condition. It was installed in October 2013. While the equipment is in acceptable condition, the refrigerant piping is missing insulation. Remaining useful life for the equipment is approximately 10 years.

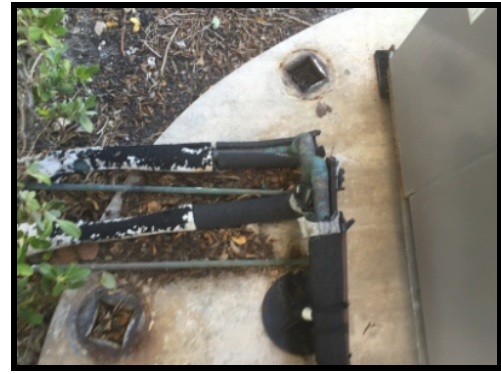
Figure 25 refrigerant piping missing insulation

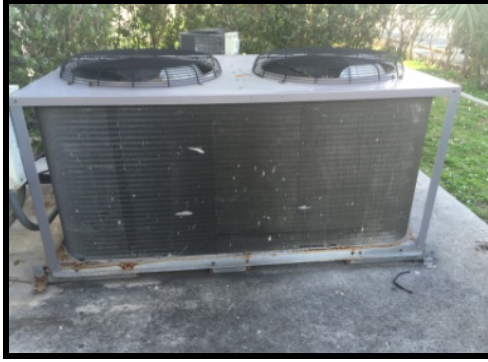
- 1) Location: Ground Level, Exterior South Side
 - 2) Criteria: Industry Standard.
- d. There are three existing condensing units located on the north side of the building. One of the units is a residential type condensing unit in the 2-5 ton range and the other two condensing units vary from 10 to 15 tons (nameplate data is either missing or weathered and not legible). Visually, the equipment appears to be in poor condition due to age and weathering. Refrigerant piping insulation is missing as well. Remaining useful life for these condensing units is approximately one to two years.

Figure 26 15 ton condensing unit, rusted

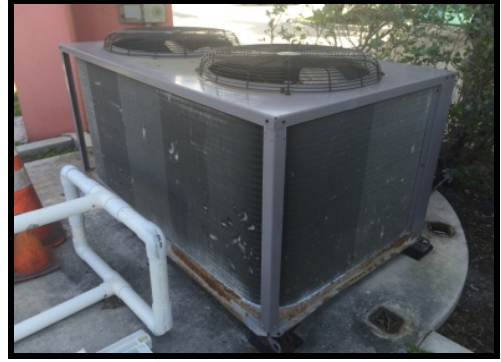
Figure 27 10-15 ton condensing unit, rusted

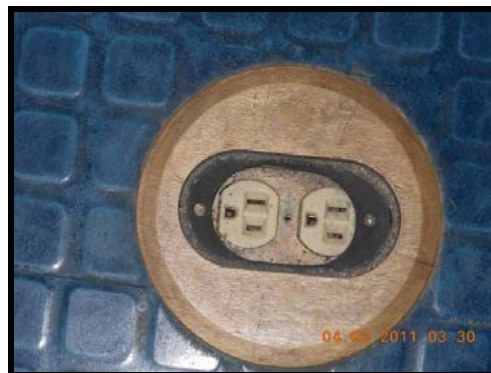
- 1) Location: Ground Level, Exterior North Side
 - 2) Criteria: Industry Standard.
6. Electrical Evaluation:
- a. Floor outlets unprotected from water infiltration.

Figure 30 uncovered floor outlet

- 1) Location: 2nd floor.
- 2) Criteria: Code Violation and safety hazard.

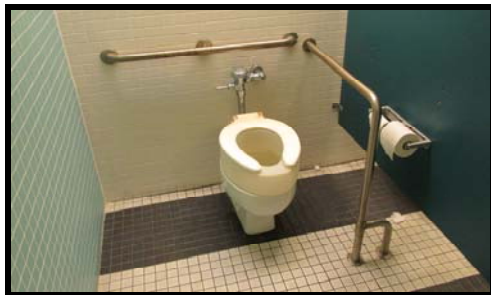
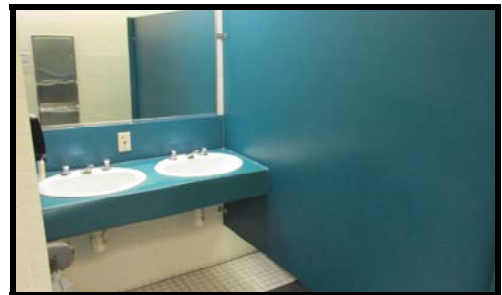
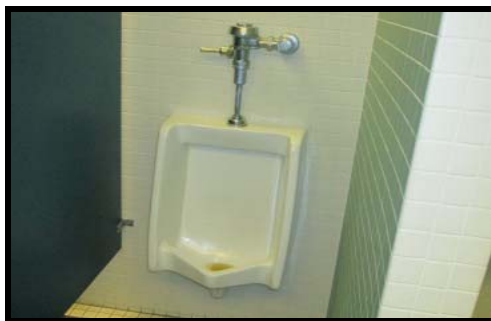
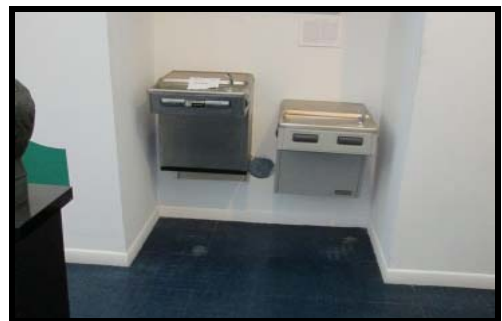
- a. Public Bathrooms (Men's and Women's): Toilets, lavatories, urinals and electric water cooler are showing signs of age and are not water efficient by current standards. Photographs below show current condition of plumbing fixtures (piping is not accessible).

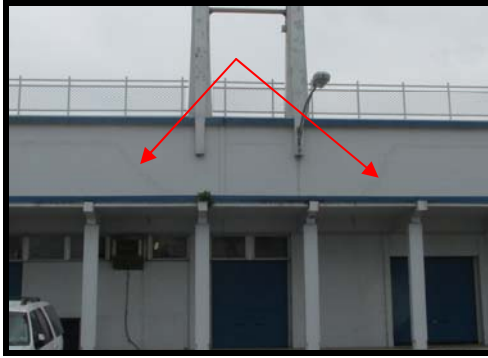
The masonry walls and concrete tie beams are in fair condition and require some maintenance. On the exterior there are several cracks in the stucco. This could be due to settlement or structural fatigue. Destructive testing and analysis would be required to gather more definite information for each component. Without this in-depth investigation, it is difficult to determine what exactly is causing the cracks.

Figure 36 Exterior showing cracks in stucco

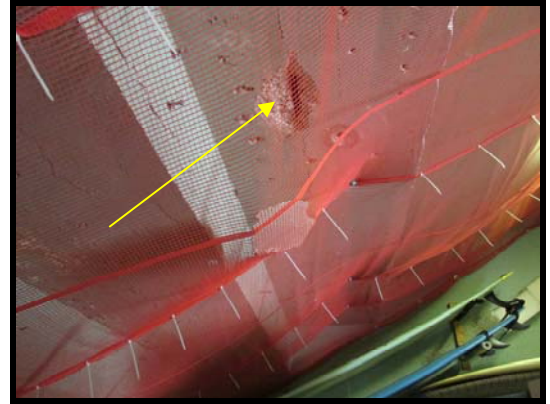
- g. Ceilings: Interior ceilings are plaster in some areas which appear to be in good condition. There are no cracks or water stains. In the areas where the ceiling is exposed to the concrete slab above, the concrete is spalling, cracked, chipped and falling off revealing rusted rebar underneath. It is the poor condition of this structural roof that has caused the building to be condemned by the city.

Figure 39 Interior ceiling of maintenance/storage area, showing chipped concrete and exposed rebar

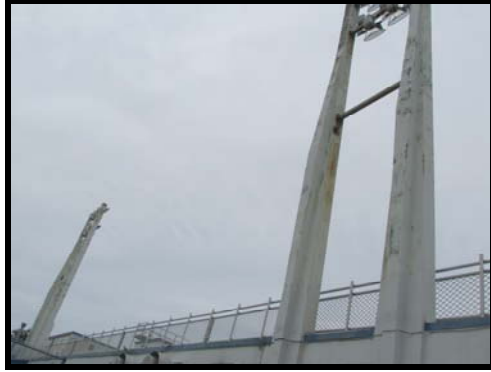
- 2) Restrooms: Currently the restrooms do not provide ADA access. The restrooms will need to be renovated to provide adequate facilities.
- 3) Event/sports lighting: The current event lighting system is antiquated. Since the complex renovation in 1990, Florida has adopted energy codes promoting energy efficiency as well as the Sea Turtle Protection Code. Without significant testing of the lighting system, it is difficult to determine if these lights meet the energy and turtle codes. Most likely they do not. It has also been noted by staff that the surrounding neighbors have complained of excessive light overspill. It doesn't appear that these light fixtures can be adjusted easily. From a visual inspection, there is some rusting on the structural steel members between the posts to which the light fixtures are mounted. Further inspection is needed to determine if the steel members are safe or if they need to be replaced.

Figure 40 Exterior event lighting, showing rust stains and peeling paint

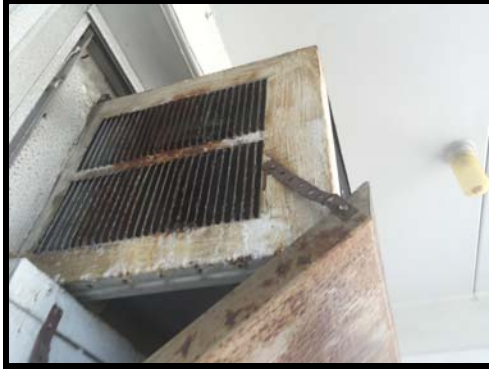
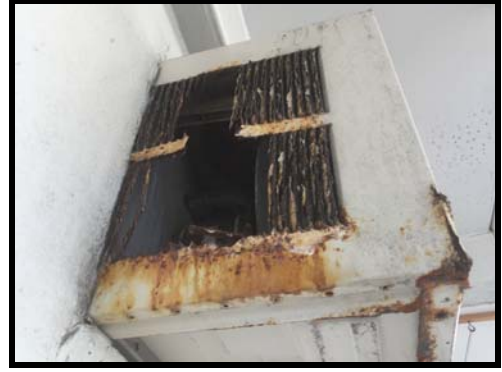
- b. Wall air conditioning units and condensate drain pans are in poor condition.

Figure 44 rusted wall air conditioning units

Figure 45 rusted wall air conditioning units

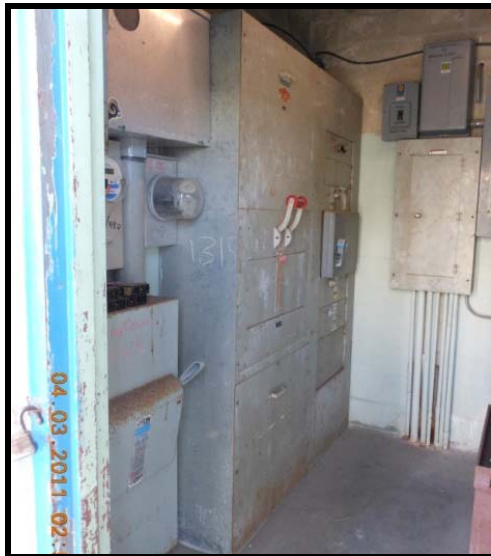
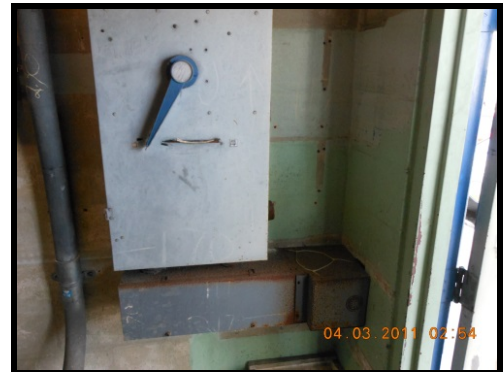
- 1) Location: 1st and only floor.
 - 2) Criteria: Code violation and industry standard
- c. The existing electrical service distribution includes three services (800A, 400A and 600A, 480V). Some of this service equipment is approximately 25 years old. The main electrical service serves building 2, pool equipment and building 5.

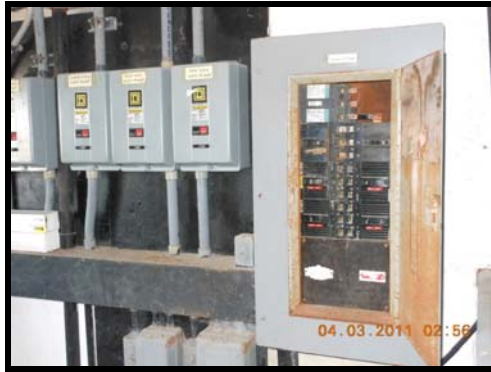
Figure 49

- 1) Location: 1st floor
 - 2) Criteria: Industry standard.
- d. Main pool equipment panel in pool equipment room is in poor condition.

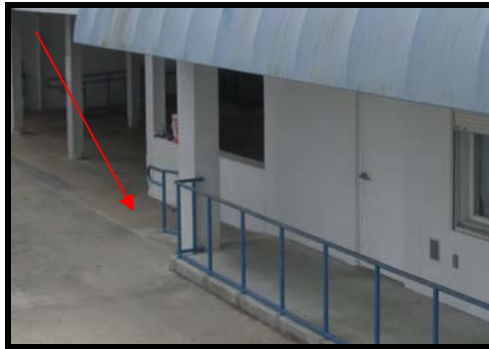
- g. Floor: exposed concrete, VCT, tile, carpet
 - h. Ceilings: gypsum, acoustical tiles
 - i. Stair: interior with carpet finish, exterior concrete
2. Building Access:
- a. The existing concrete pavement around the outside is in fair condition. There are a few cracks which need patching to maintain a smooth surface. The sidewalks and steps need to be pressure washed.
 - b. The ramps appear to be in good condition and compliant with Florida Building Codes, with the exception of the ramp from the weight room at building 4, which is too steep of a slope, the ramp should be longer.
 - c. There is no elevator to the second floor of buildings 3 or 4, only stairs which are not ADA accessible.
 - d. The railings on the exterior stairs are not compliant. Railings need to have a guard rail as well as a hand rail, each at required heights per Florida Building Code (FBC)

Figure 53 Ramp on north side of Building 4, ramp not long enough, slope too steep

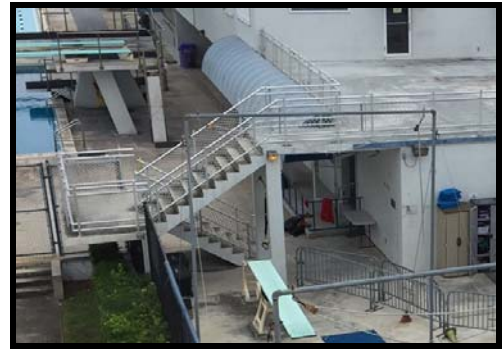
Figure 54 Northwest stair of Building 4, showing railings down stairs

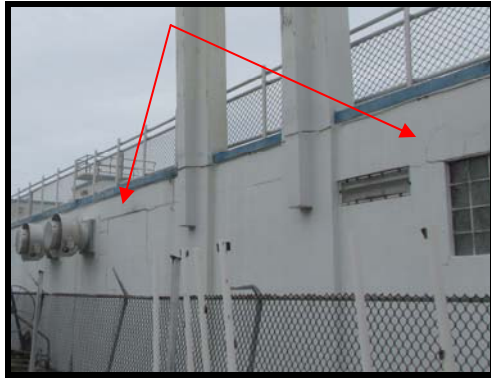
The masonry walls and concrete tie beams are in fair condition and require some maintenance. On the exterior there are several cracks on all sides of the buildings. The larger cracks appear on the south wall of Building 3. This could be due to settlement or structural fatigue. Destructive testing and analysis would be required to gather more definite information for each component. Without this in-depth investigation, it is difficult to determine what exactly is causing the cracks.

Figure 55 Building 3, south wall cracks along entire wall

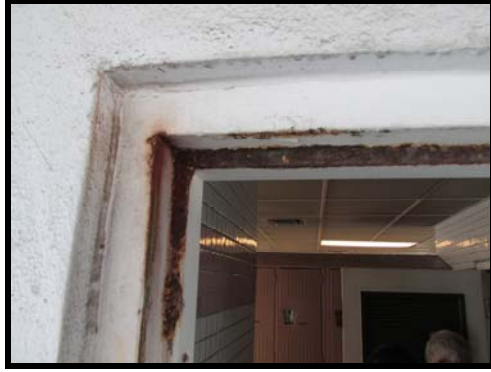
Flush metal doors are typical for exterior swing doors and some interior swing doors. Based on visual inspection, the metal doors and frames are in poor condition on exterior and interior due to age and exposure to the ocean environment. Existing exterior door hardware is also in poor condition due age and rust. Doors and hardware should be replaced.

Figure 59 Exterior door on west side of Building 3 going into women's locker room, showing rusted door frame

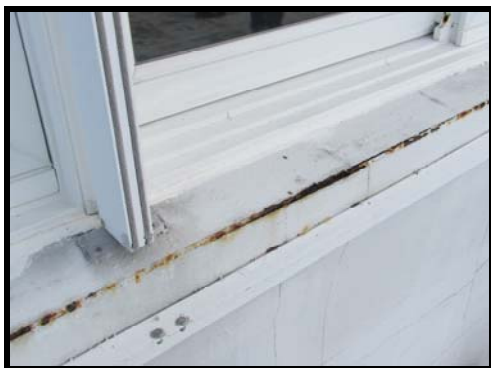
- e. **Windows:** There are several types of existing windows. The second floor additions to the building have 7/32" clear tempered glass horizontal roller and single hung windows with crank roll down shade-shutters on the exterior. It's been noted by staff that many of the windows do not work, and a majority of the shutters are not operable. Codes have been updated since these were installed, so they are not compliant with the current building code. Many of the windows leak damaging the surrounding walls and carpet.

Figure 61 Window on Building 3 showing rust, peeling paint and cracks in the wall below

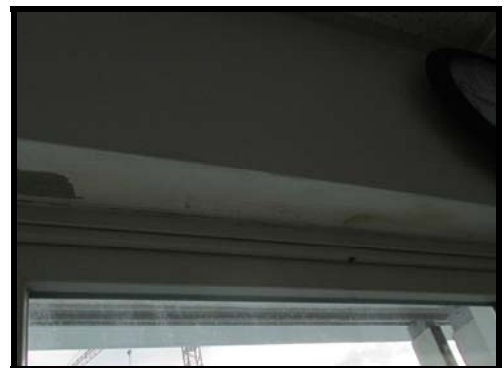
Figure 62 Window on second floor of Building 3 at top of stairs, showing water damage

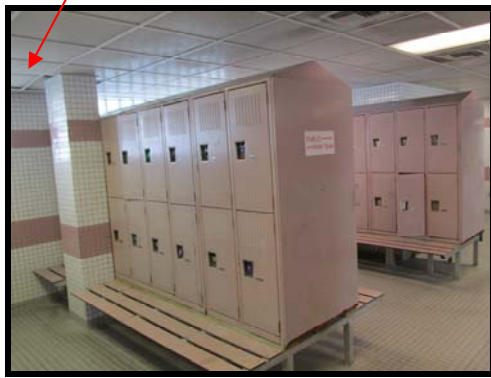
The bath/locker room ceiling grid is rusting in some places and some tiles are broken. In some places the grid is uneven indicating that the grid is not being held up properly due to the grid itself failing or the support wire above failing.

Figure 67 Building 3 women's locker room, showing uneven grid

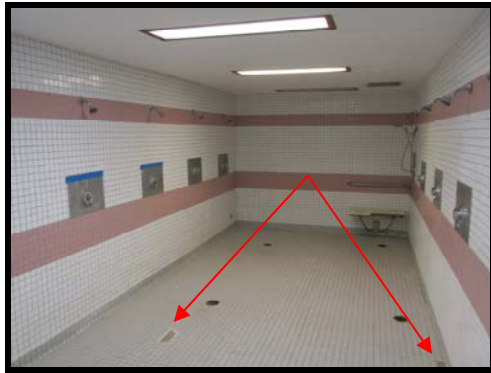
- 5) Locker rooms: the restrooms, locker rooms and shower areas have tile floors and walls. Several areas of the tiles are broken and the sealant is deteriorating. The metal lockers are rusted as well as some of the restroom accessories. The lockers and accessories should be replaced with new rust resistant fixtures.

Figure 69 Building 3, women's shower, broken floor tile

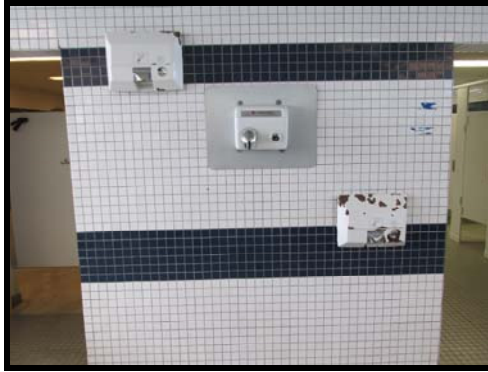
Figure 73 Building 3, men's restrooms dryers

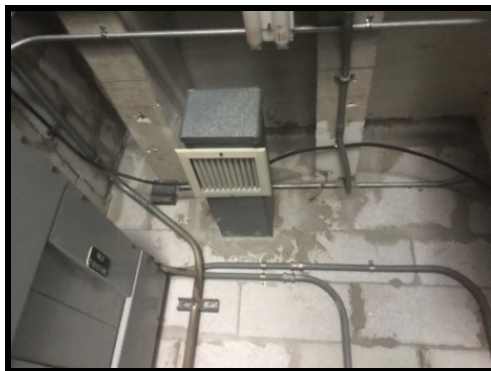
- a. Exhaust was not operational in the electrical room on the first floor. The Telecom closet on the first floor does not have ventilation or air conditioning.

Figure 75 electrical room, exhaust inoperable

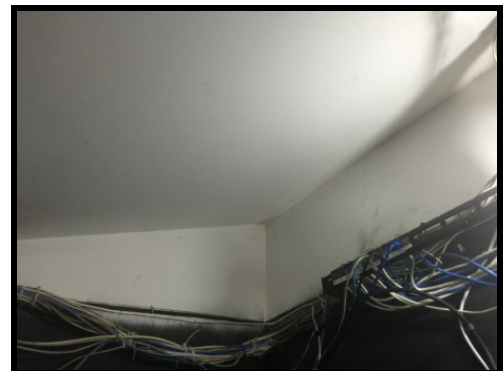
Figure 76 telecom room, no exhaust

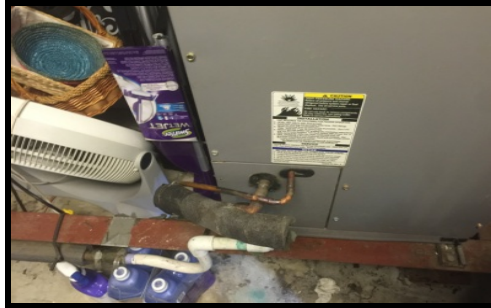
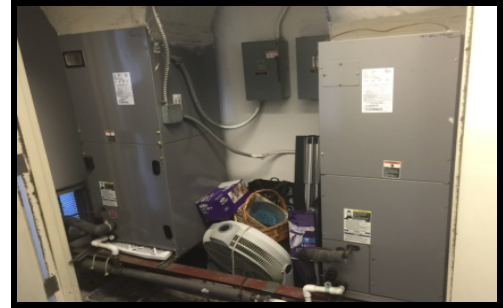
- b. There are two residential type air handling units on the second floor in the east area of the building (approximately 2 to 5 tons each). The units appear to have experienced condensate backups. Based on the visible aging of the equipment, installed in 2012, the anticipated remaining useful life of the air handlers is between 5 and 10 years, with maintenance. On the second floor in the offices areas, there is no ventilation or air conditioning in the electrical room.

Figure 77 air handling unit

Figure 78 air handling unit

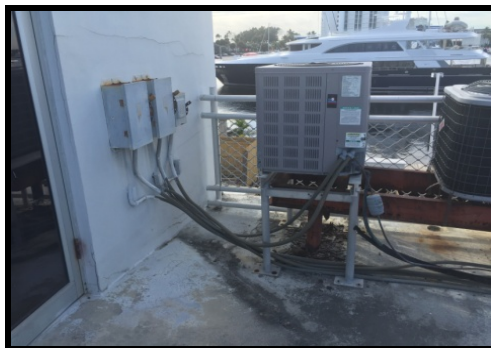
c. Rooftop condensing units and the condensing unit stands show serious deterioration. Rust is visible throughout and the coil fins appear to be flaking off.

Figure 79 visible rust throughout unit

- 3) Recommendation: (Options 1, 2 and 3) Replace condensing units and condensing unit stands with new. This replacement will require replacement of the associated air handlers notes previously.
- d. Timing/storage Room on roof has a wall air conditioner that is not in working condition.

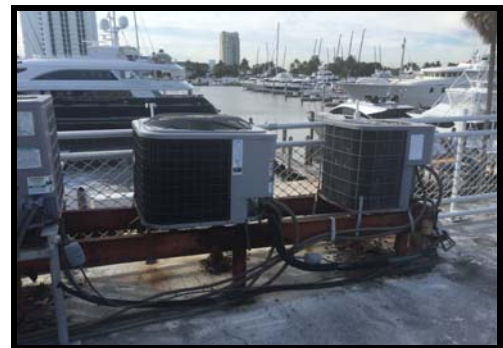
Figure 80 unit stand in poor condition

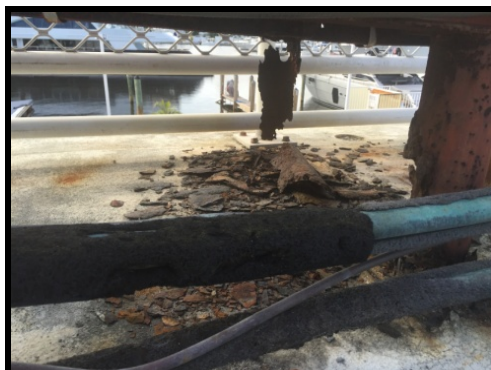
Figure 81 serious deterioration of the coil fins

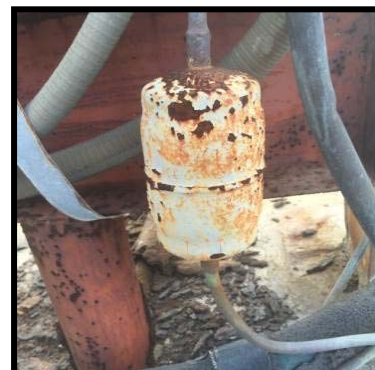
Figure 82 rusted connections

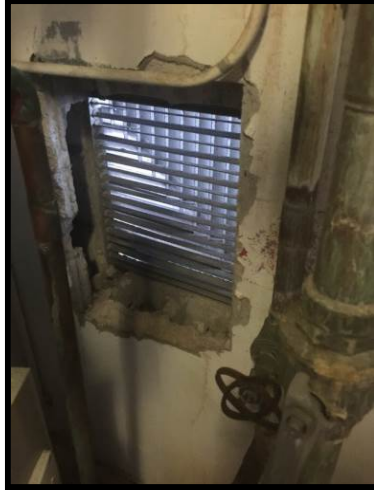
- 1) Location: Roof
- 2) Criteria: Industry Standard
- e. Boiler Room louvered door is rusted preventing required ventilation and preventing combustion air from flowing through louver. Boiler Room make-up air louver and boiler flue is missing sealant and water proofing. These areas are showing signs of water infiltration.

Figure 85 make-up air louver, missing sealant and water proofing

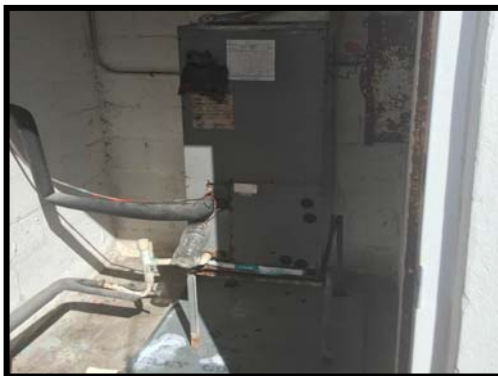
- 1) Location: First floor women's locker room.
 - 2) Criteria: Code Violation.
- f. The air handling units that serve the Men's and Women's Locker Rooms appear to be 10-15 tons each. The units require maintenance but appear to be in reasonable operating condition. The air handling unit that serves the office next to the electrical room appears to be a 2-5 ton residential unit and also requires maintenance. The anticipated remaining useful life of these units is approximately 4-5 years.

Figure 87 air handler unit serving electrical room

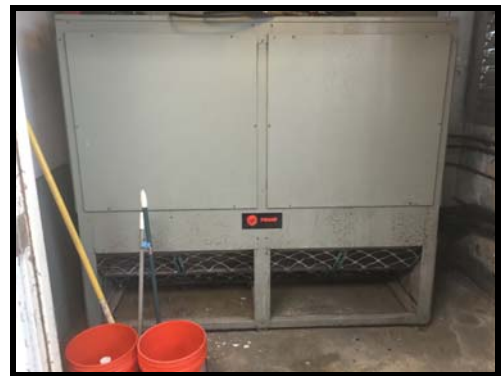
Figure 88 air handler unit serving locker room

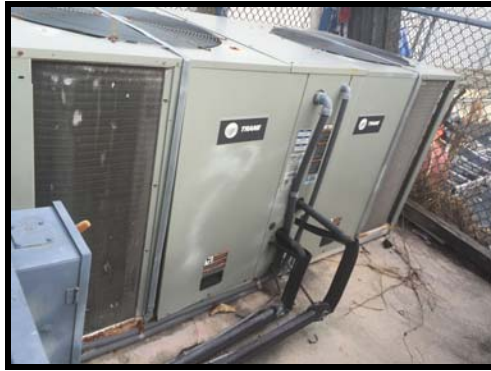
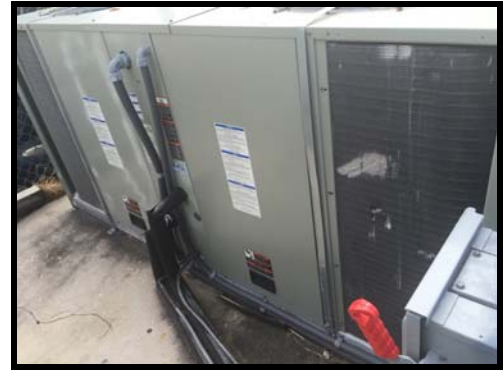
- g. The condensing units associated with the Men's and Women's Locker Room air handling units are also 10-15 tons each. These units appear to be in operating condition but require maintenance. Refrigerant pipe insulation is missing or damaged. The remaining useful life of the equipment is estimated 2-5 years.

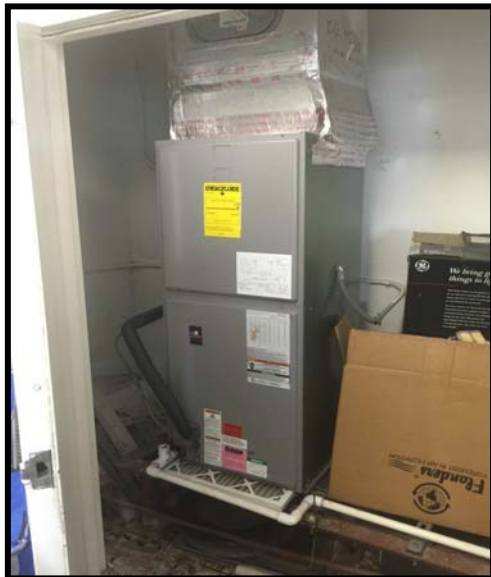
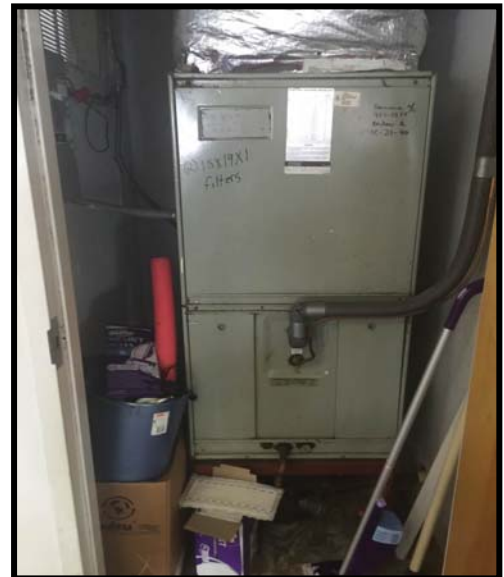
- h. The air handling units that serve the Gym and the Meet Room require maintenance only. Both units are residential type units between 2 and 5 tons each. The estimated remaining useful life of the equipment is between 2-5 years.

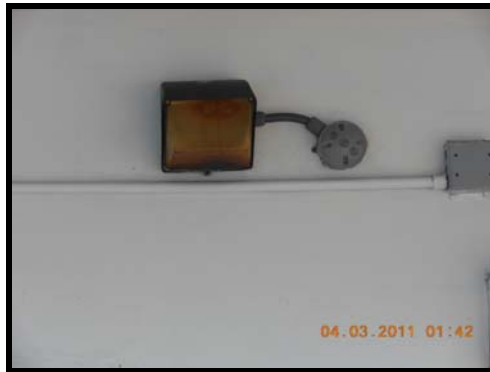
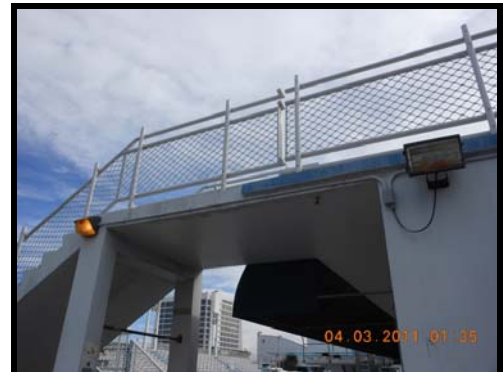
- a. Exterior light fixtures are in poor condition.

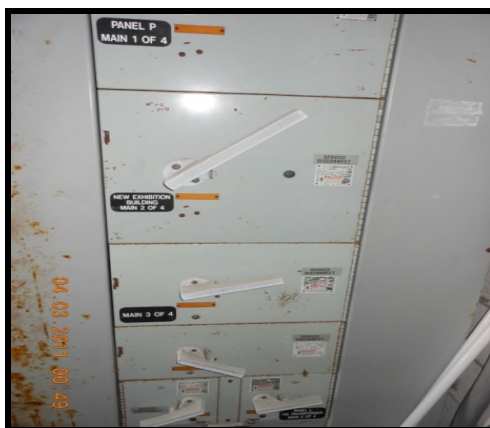
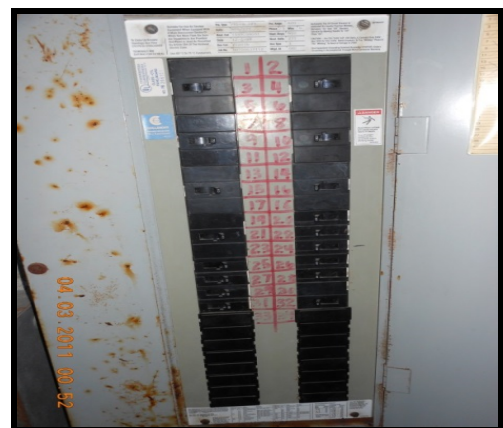
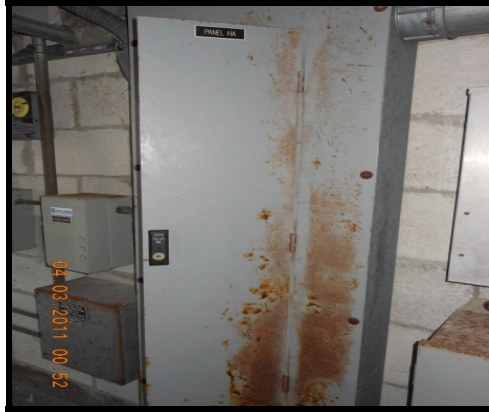
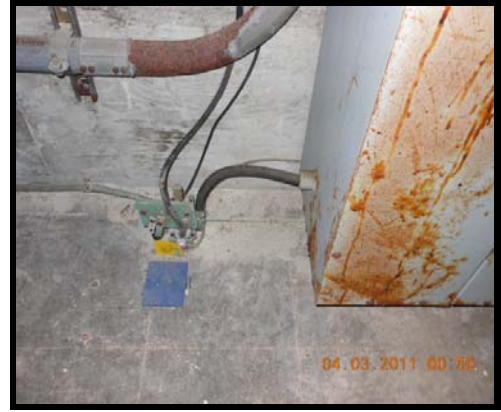
- 1) Location: 1st floor
 - 2) Criteria: Industry standard
- b. The existing electrical service distribution includes services of 800A and 400A, 480V pieces of equipment. Some of this service equipment is approximately 25 years old. However, the equipment enclosures show signs of corrosion. These services serve building 3, building 4, the small building between buildings 3 and 4, and building 1. A few metal conduits also show corrosion. Special coordination shall be made as to maintain power to other buildings while any construction takes place.

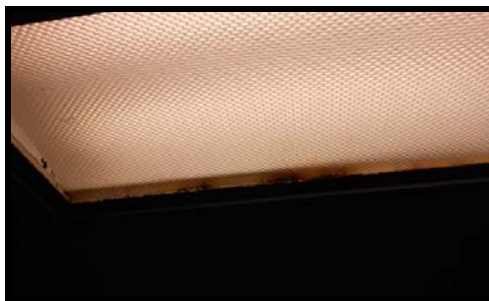
Figure 99

- 1) Location: 1st floor
 - 2) Criteria: Industry standard
- c. An FPL vault is inside this building and should be kept whether the building is renovated or rebuilt. Provisions shall be made to maintain the FPL vault.
- 1) Location: 1st floor
 - 2) Criteria: Industry standard.
- d. Shower lights are in poor condition.

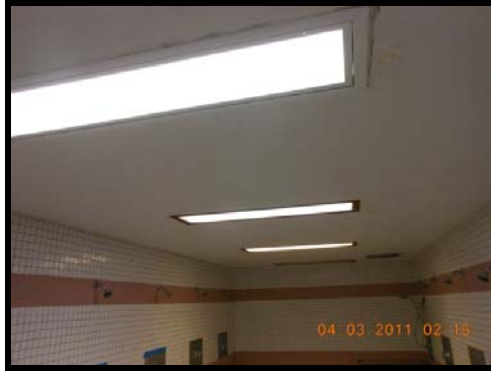
- 1) Location: Shower areas
 - 2) Criteria: Industry standard
- e. Shower areas do not have emergency lights.

Figure 100 lights in women's shower

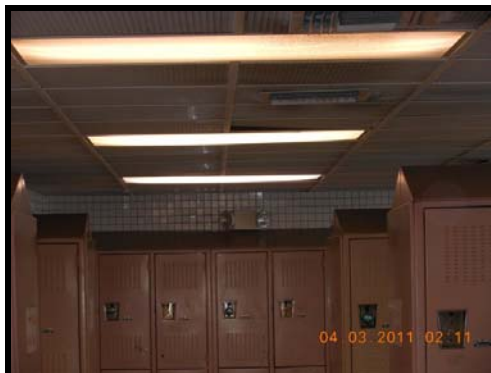
- 1) Location: 1st floor
 - 2) Criteria: Code violation. Safety hazard.
- f. Locker room lights seem to have some light bulbs that use low color temperature and have low color rendering capability.

Figure 101 lights in women's locker room, yellowish color

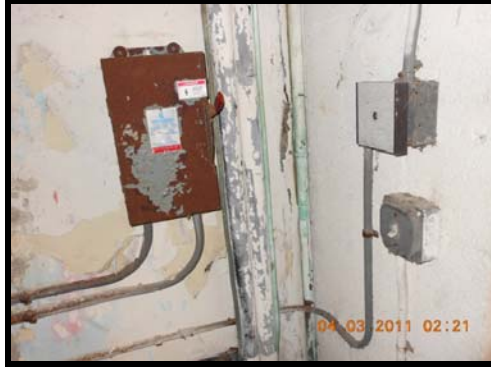
- 1) Location: 1st floor
 - 2) Criteria: Industry standard
- g. Mechanical room electrical conduits, J-boxes and disconnect switches are corroded. This situation weakens the protection of the wiring which can become a hazard for personnel or a fire hazard.

Figure 102 disconnect switch and junction box

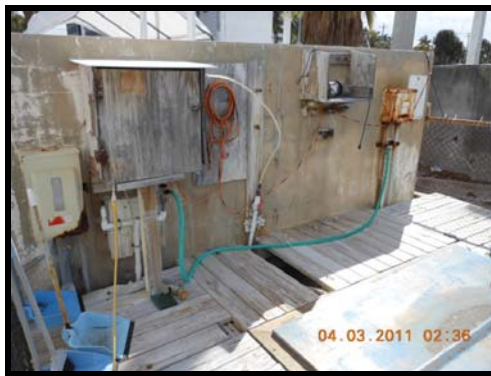
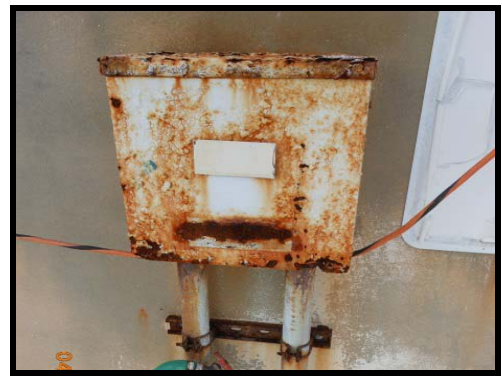
Figure 103

h. Outside pool equipment disconnects, conduits and supports are in poor condition.

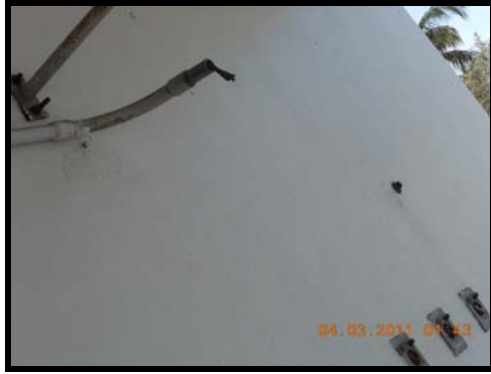
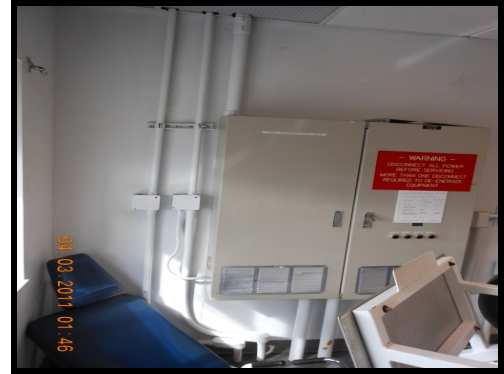
Figure 105

i. Unused conduits, wiring, J-Boxes and equipment outside and inside building.

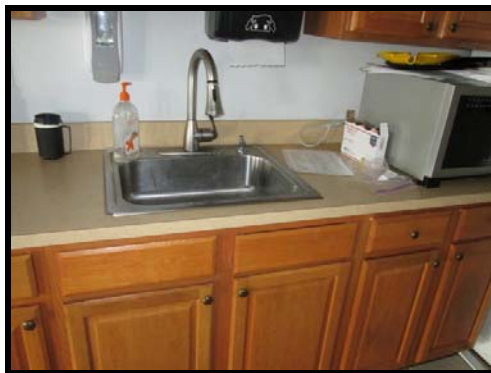
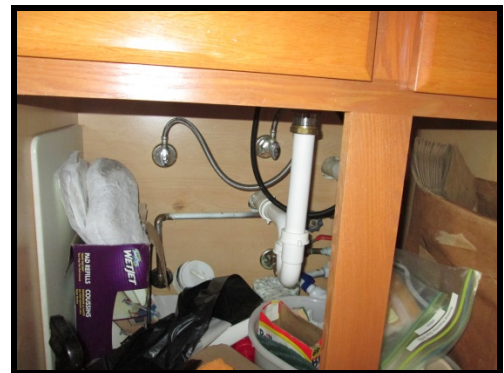
Figure 107

- a. Kitchen Sinks are not provided with hot water connection.

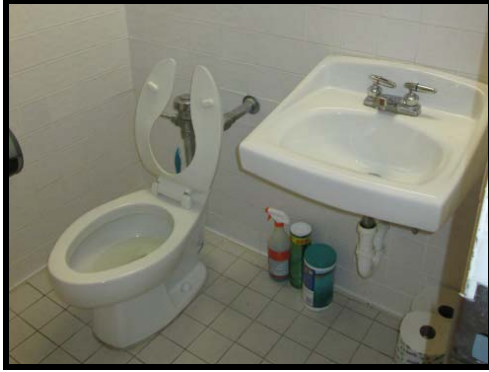
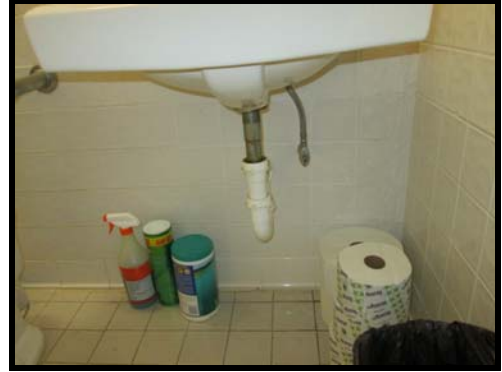
Figure 109

- b. All restroom lavatories are not provided with hot water. Lavatories are also missing ADA shield protection.

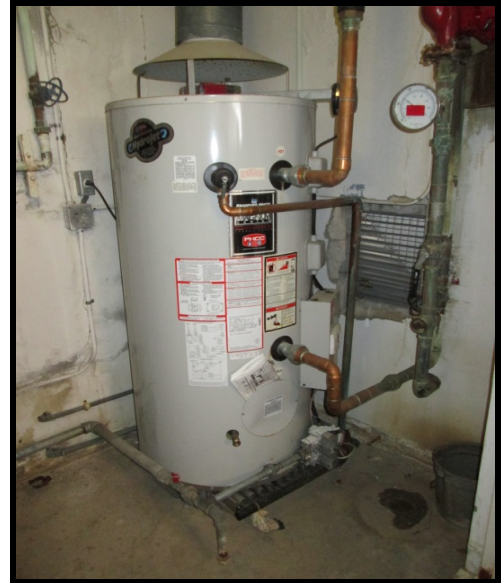
Figure 114

d. Men and Women's Bathrooms and Shower: Gas Water Heater (Bradford White Magnum model # D65T3703N, 1965), water closets, showers and floor drains are showing signs of age and are deteriorated. See photographs below.

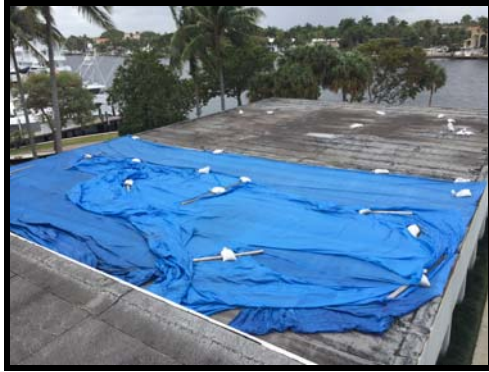
All roofs, except elevator tower, are built-up roofing systems over 1 ½" rigid insulation board on precast concrete slabs. The roof membrane is in poor condition and the sealants and membrane is cracking. There are areas where water pools and penetrates the roof membrane causing it to bubble. All of the drains and metal penetrations are rusted. The roof is original to the building which was built in 1965.

Figure 120 Roof top of banquet hall, damaged, causing major leakage on the interior

Although general maintenance has been on going throughout the years, there are several roof leaks throughout the building, specifically in the banquet hall/auditorium. Staff has indicated that, due to the roof leaks, the banquet hall has been ordered closed in the past year to the public and is no longer able to be rented for events. All roof assemblies need to be replaced as they are beyond their lifecycle.

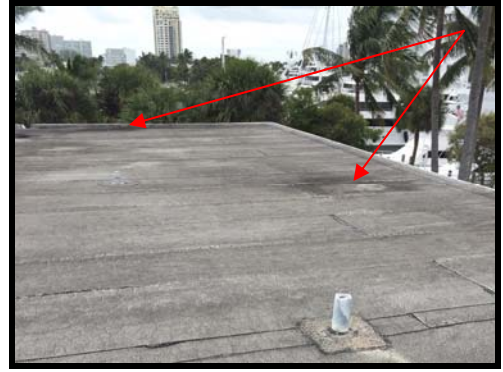
Figure 121 Roof over main exhibit space, dark spots indicate standing water causing the membrane to detach and bubble

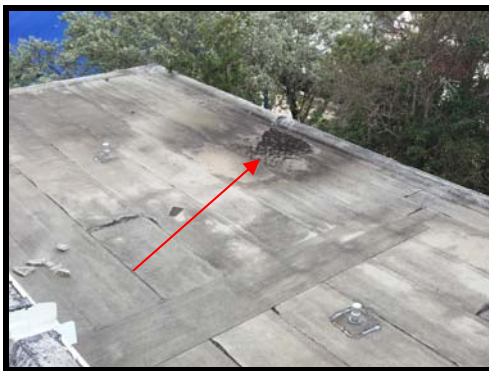
Figure 122 Roof over library, dark spot indicates pooling water damaging the roof membrane

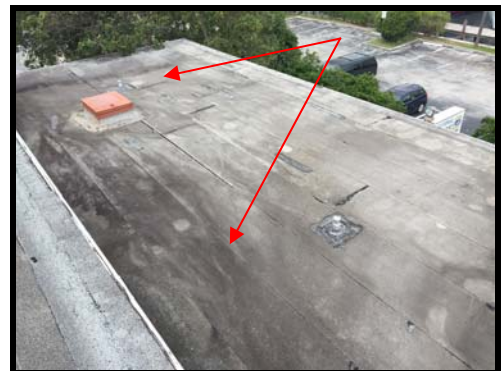
Figure 123 Roof over lobby area, showing the standing water patterns

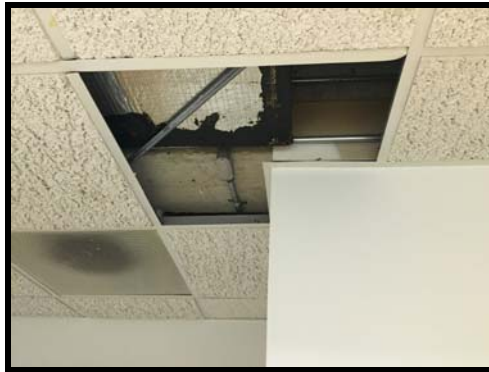
Most of the ceilings are drop down ceiling grid with acoustical tiles. There is evidence of water damage on the ceilings in the conference room and in the banquet hall. The leak in the conference room could be from the air conditioning unit. A more intrusive investigation will be required to determine the cause of the leak.

Figure 124 Ceiling in conference room, first floor

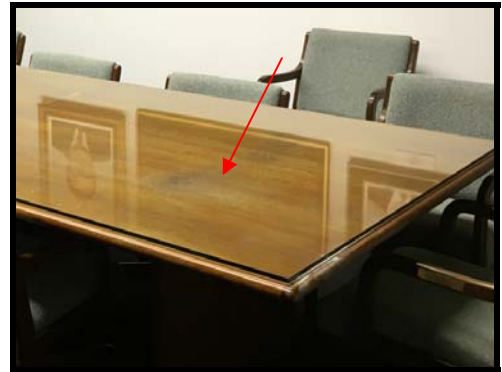
Figure 125 Conference room table, damaged from water leak

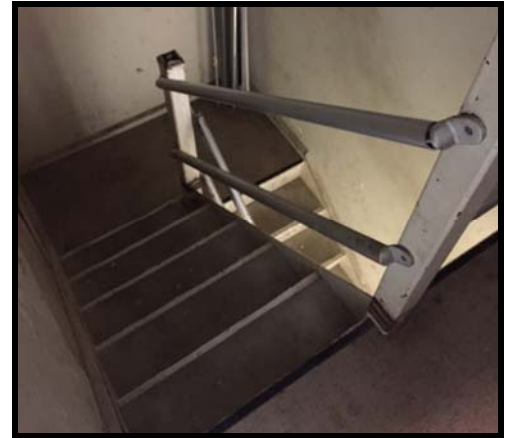
- 1) Stair railings: Several stairs throughout the building do not comply with the Florida Building Code, such as the height, width between rails and extension beyond the landing. The railings should be replaced with new that meet required codes.

Figure 129 Stairs from mechanical room next to banquet hall. Stairs do not comply with Florida Building Code

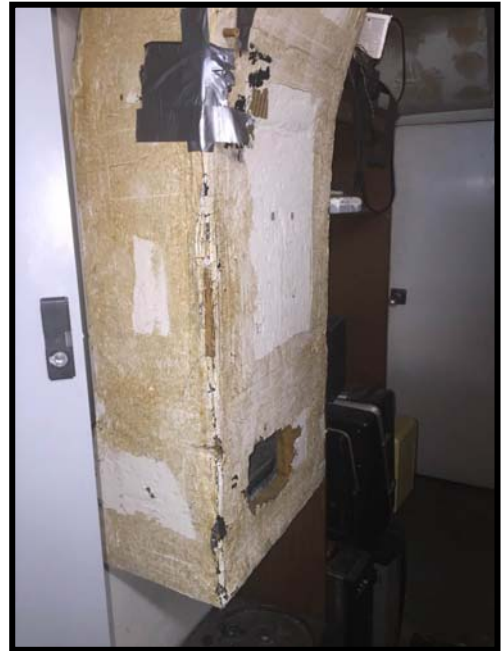
- a. Existing exposed ductwork in mechanical above banquet hall restrooms is leaking, damaged and uninsulated. Some of the ductwork is below the code required height.

Figure 131 low ductwork in mechanical space above restrooms in banquet area

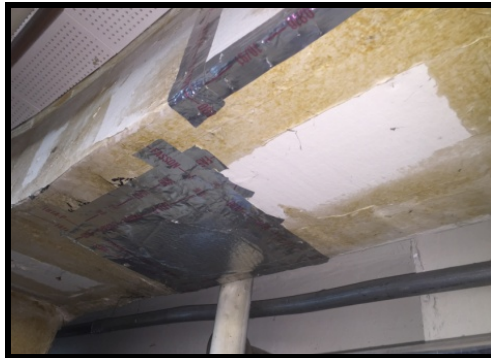
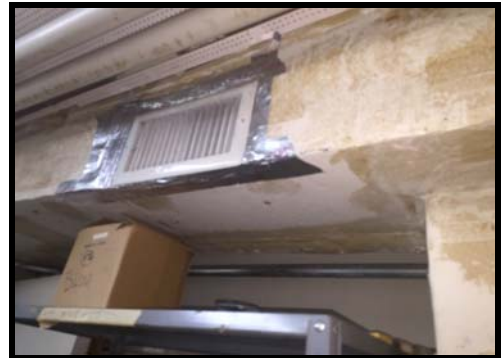
Figure 132 ductwork in mechanical space above restrooms in banquet area

Figure 133 ductwork in mechanical space above restrooms in banquet area

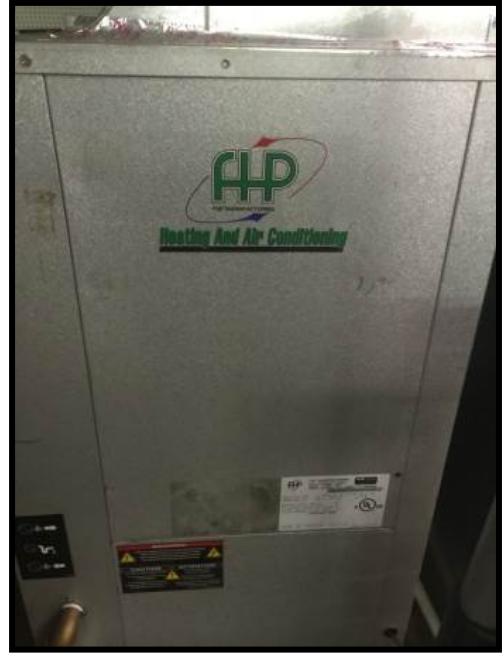
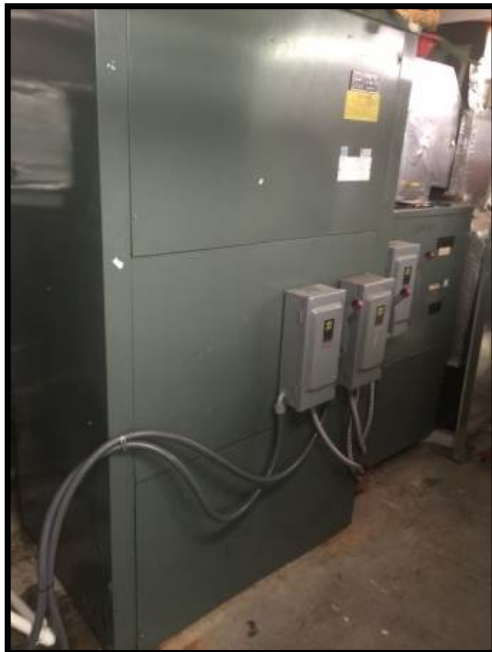
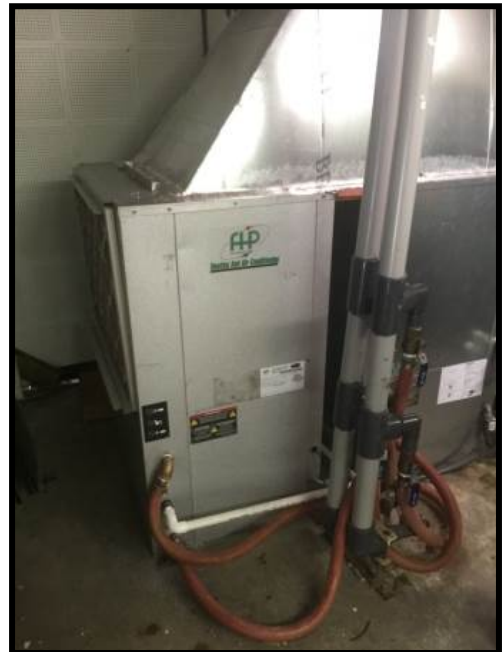
Figure 137

- 1) Location: 2nd Floor
 - 2) Criteria: Code Violation and industry standard.
- c. Remaining heat pumps on the 2nd floor: Maintenance clearance for existing heat pump units is minimal. Heat pump units shall be provided with maintenance. The existing units vary in capacity from 5-10 tons. The remaining useful life expectancy is 2-3 years.

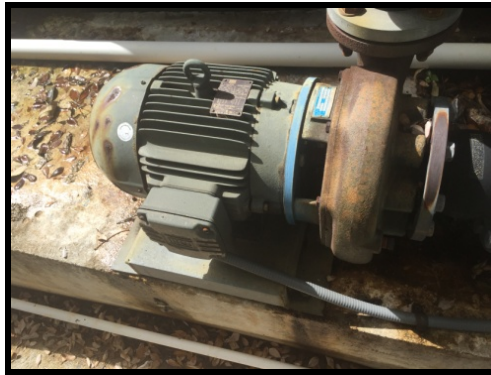
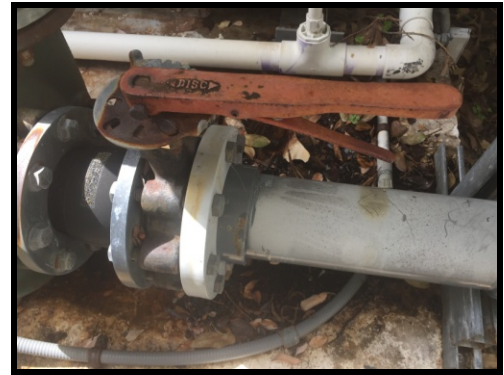
Figure 140

d. Cooling Tower and pumps are in fair condition and require maintenance. Many components of the condenser water system (fittings, pumps, Cooling Tower) are

showing signs of age and deterioration. The condenser water pipe penetration through the exterior wall of building needs to be sealed and caulked. Life expectancy of equipment is approximately 8-10 years.

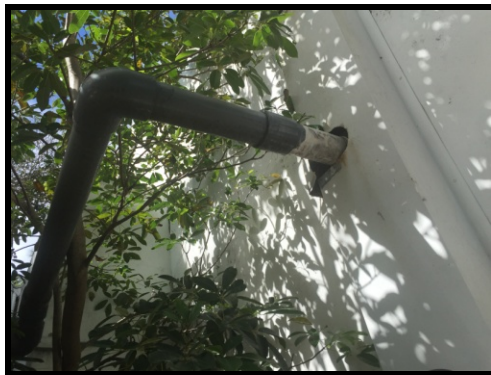
Figure 142 condenser water pipe through building needs sealant/caulk
