CITY OF FORT LAUDERDALE AQUATIC CENTER

FACILITY ASSESSMENT REPORT

March 28, 2016

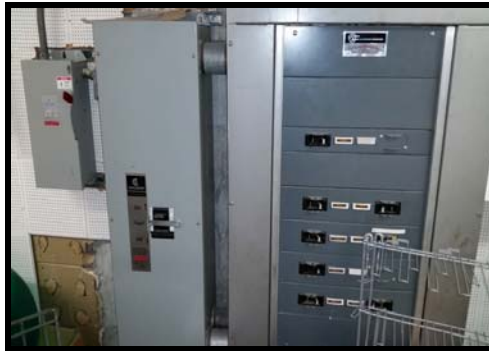
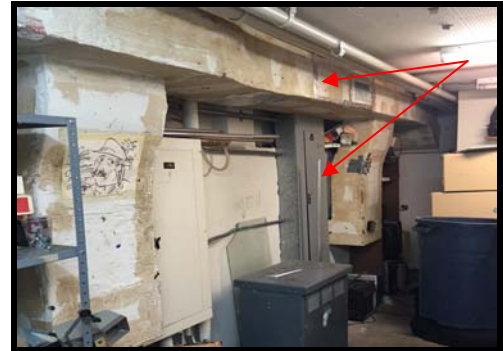
Figure 144

- a. Exit signs currently not illuminated.
 - 1) Location: 1st floor.
 - 2) Criteria: Code violation. Safety hazard.
- b. This building has a 600A, 480V electric service and panel boards in good condition. Some relocation may be needed to avoid conflict with mechanical ductwork above panels/transformer at second floor. Two panels and one transformer have ductwork

routed above which is a code violation and a safety hazard for maintenance personnel.

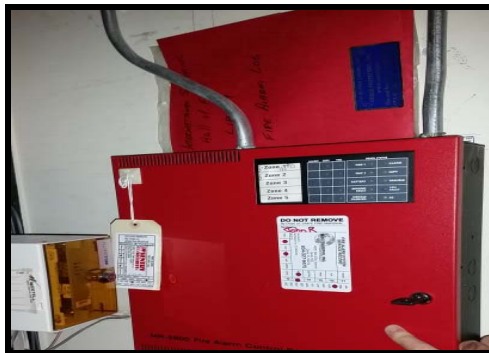
Figure 146

- 1) Location: 1st and 2nd floors
 - 2) Criteria: Code Violation.
- c. Emergency lights not accessible for regular testing. Additional fixtures needed to cover all means of egress.
- 1) Location: 1st and 2nd floors
 - 2) Criteria: Code violation. Safety hazard.
- d. Fire alarm devices not present on second floor.

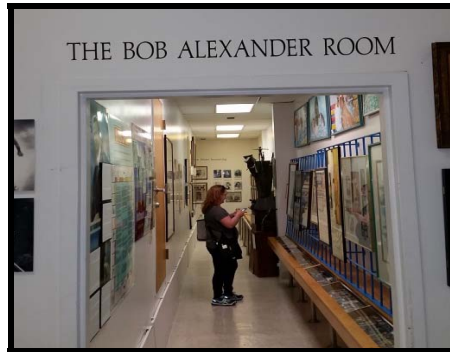
Figure 147

- e. “The Bob Alexander Room” area has no exit and emergency lighting.

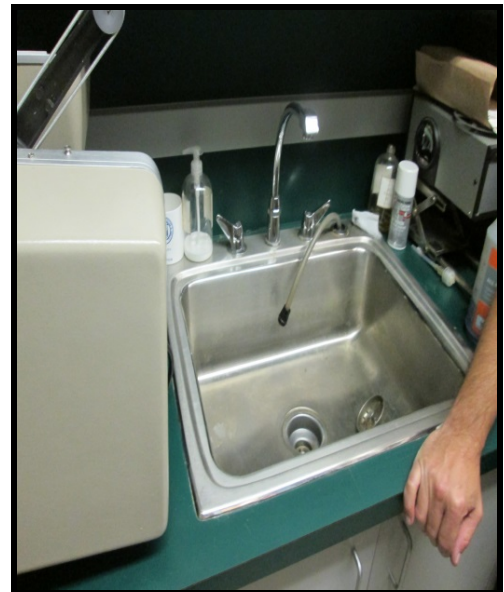
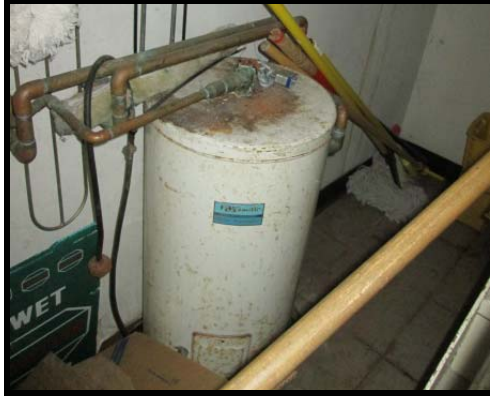
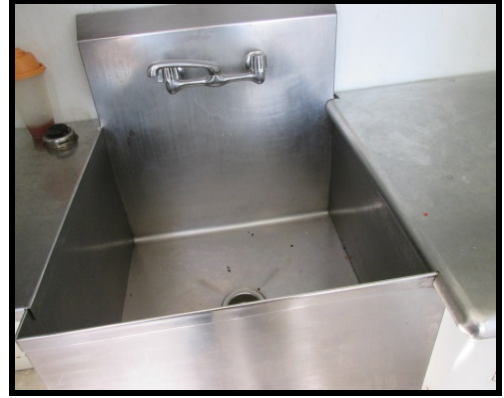
Figure 149

- a. Public Bathrooms (Men’s and Women’s): Toilets, lavatories, urinals, the water heater and the electric water cooler are showing signs of age and are not water efficient by current standards. Photographs below show current condition of plumbing fixtures (piping is not accessible).

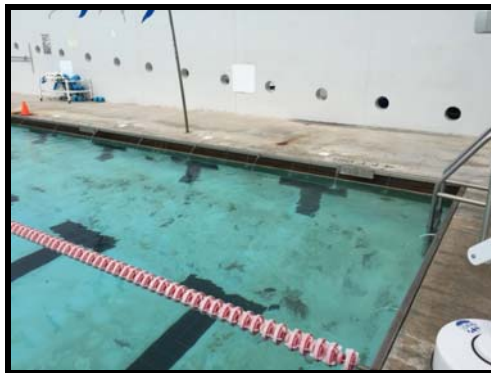
- a. Pool Structure: The pool shell is piling supported and appears to be in reasonably good condition. As the pool was filled with water, a more detailed investigation of the walls and floor could not be made.
- b. Interior: The pool surface is comprised of an aggregate finish pool plaster that is in extremely poor condition. The surface has delaminated in many places leaving an unsightly and rough appearance. The grout for the lane lines and wall targets is also badly worn from age and chemical usage in the water. The interior pool plaster and tile must be completely removed to the original concrete surface and a new finish applied.

Figure 153 Interior pool plaster, the pool has never been resurfaced since it was built in 1992

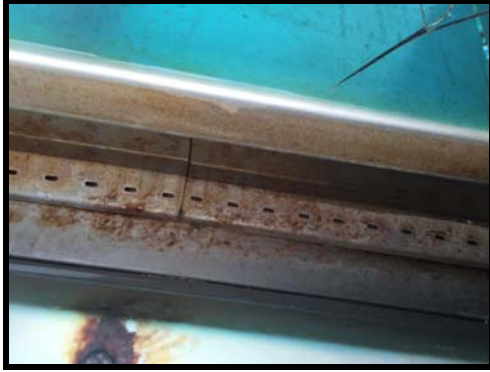
- c. Gutter: The stainless steel gutter is also showing signs of age; the surface is stained and rusting in several areas around the inlet port openings and other areas as well. The rusting has caused pin holes in the surface creating a leaking condition when the cooling/evaporator channel is put in operation. Overall the gutter is 25 years old and not worthy of repair as more than 50% of the component would need replacement.

Figure 155 Stainless steel gutter, view taken from the deck above shows inside of the gutter rusting and corroding at joints and anchor points

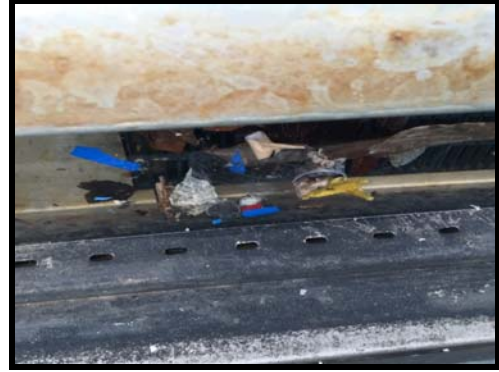
Figure 156 Stainless steel gutter

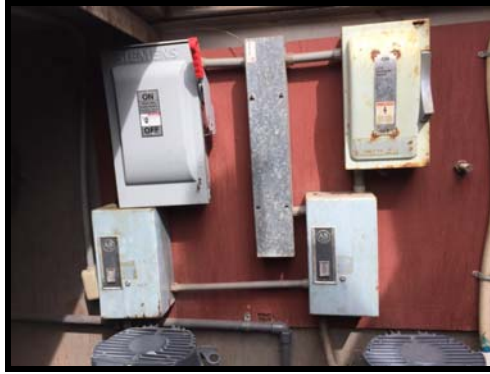
Figure 159 Starters in enclosed space can be located above grade and connected to the BECSys5/7L for direct control of pool circulation and proof of DOH flow compliance

- 2) Recommendations: Replace with BECSys5 or 7L to provide accurate control of chemistry with enhanced safety and efficiency features, and expansion capabilities to handle future energy conservation or regulatory needs:
 - a) ORP, pH, and Direct Reading PPM
 - b) Control of water level, monitoring of water consumption
 - c) Direct Control of PPM
 - d) Monitoring of Filter Soiling, automated filters
 - e) Remote Control, Electronic log keeping and Alert Notification
 - f) Direct control of GPM
 - g) Disable pump in event of pump pit flooding for operator safety

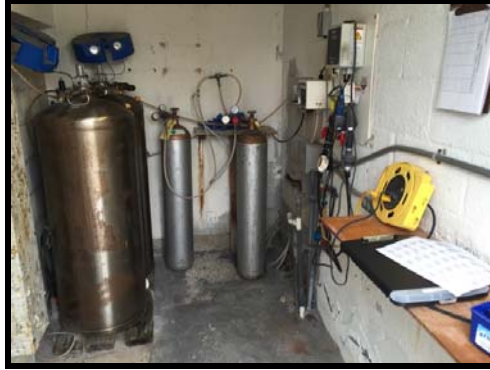
- 1) Existing: Stranco Co2 Feeder circa 2003. Pit is in poor condition and requires near term replacement. Consumption estimated to be high as it utilizes diffuser stone as opposed to more efficient venturi system. Stenner Bleach feed system is undersized and requires near term replacement.

Figure 161 Co2 system, circa 1994 requires repair or replacement, and its inefficient use of Co2 gas is costing the City additional money every month

- 2) Recommendations pH: Replace Co2 Feed System with vacuum venturi based package for safety and efficiency.
- 3) Chlorination: Replace bleach system with NexGen on-site electrolytic chlorination to make 95% of all chlorination needs on site, either on capital or on a NexGen Equipment Maintenance Agreement (EMA). Redundant tablet-based Pulsar feeder provides DOH permitting needs in condensed package and is available under a factory EMA program.

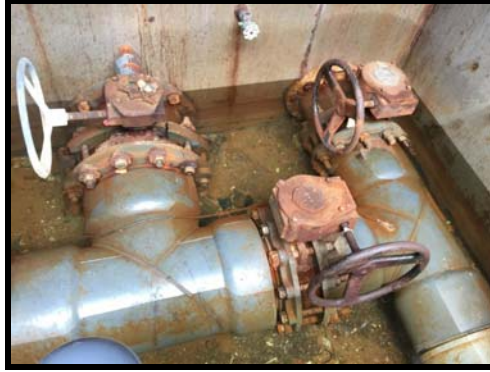
- 1) Existing: Paddock vacuum sand filter, circa 1990, is in operable condition. Media has not been changed in many years and needs replacement; however this is an intricate process and may require specific replacement of laterals and parts. The integrated pump package is prone to flooding, and has tidal standing water issues, as per FLAC staff. The pumps are not capable of achieving required DOH flow standards and should be upgraded to comply with codes. Operating this pool with flooded conditions poses certain safety considerations for FLAC staff.

Figure 162 Standing water in vault poses safety concern, and fluctuated with the tide per FLAC staff. BECSys5 flood sensor will disable power to the circulation pumps in the event of an unsafe level of water in the tank.

- a) This system could continue to operate as is. If flow issue is to be addressed, new in-line pumps could be provided to meet DOH flow, and to fit within the existing configuration. External MCC-VFD could be added to replace the existing starters and disconnects to remove this hazardous electric from the subterranean vault. (Flood sensors to deactivate pump power is part of recommended controls package), or
- b) Entire system could be replaced with a fully automatic permanent media hi-rate granular filtration system equipped with water saving air scour system. Composite strainers would be added to pump package to complete conversion to pressure-side filtration.

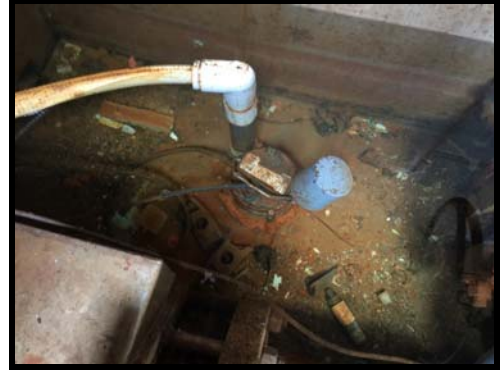
- f. **Paddock Vacuum Sand Filter Tank:** The subterranean vault is partially filled with sea water resulting from a corroding floor. The floor has been repaired several times only to leak again from ground water pressure created at high tides. Many fittings in

Figure 163 Subterranean vault filled with sea water

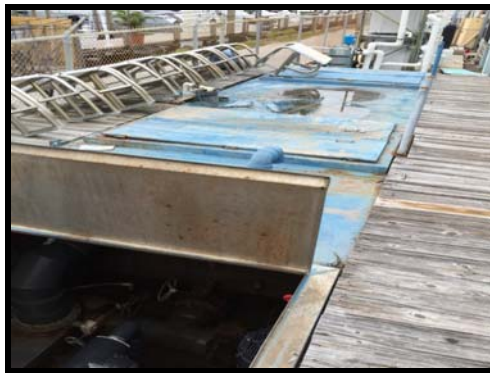
the vault are also corroded from sea water, as well as some valves that are inoperable due to rust and corrosion. The pump motors are fairly new and operational, but impeller casing, valves, and flanges are badly rusted and require replacement. Pump motor starters and disconnect switches are poorly mounted to a plywood board secured to the housing with stainless bolts. The plywood is warped and swollen from the wet environment and not suitable for mounting electrical components. Although the sand media is operational, it is the original media provided by the manufacturer when the pool was built in 1990. The media can continue to be used until it no longer can provide long filter runs. The overall condition of the equipment vault is poor and worthy of replacement. It can however continue to be used and patched as needed. Replacement of the filter plant without major renovation to pool makes no sense.

Figure 164 Paddock Vacuum Sand Filter and Pump Vault is submerged and subjected to sea water

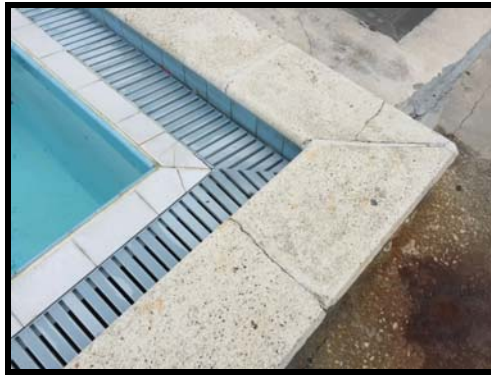
- a. The Gutter: The gutter at the perimeter of the pool has been modified from its original concept. It now mimics a more conventional "Rim Flow" Gutter with a fiberglass grate that covers a concealed trough beneath it. In order to accomplish this modification, the pool's edge has been raised several inches, presenting a positive posture with a high curb around the pool. The piping system is conventional with both wall return fittings and gutter drain fittings piped to a loop that runs continuously around the perimeter. The loop is connected to the filter tank and pumps, which is located in an equipment room beneath the pool deck on the

north side of the facility. The piping system is old and leaks water, hence requiring replacement. Continued repairs are made by staff as needed to keep the pool operational.

Figure 167 Gutter at perimeter of pool

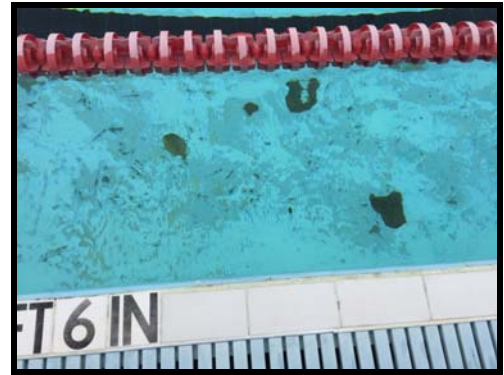
Figure 168 Pool interior, exposed aggregate plaster

- b. Interior: The pool interior is an exposed aggregate plaster that was last installed in 1991. Under the best conditions, plaster finishes may last only 5-7 years before requiring replacement. It is evident that the surface is quite old, since many areas of the floor and walls show signs of delamination leaving an unsightly appearance. DOH has allowed operation of the pool under current circumstances, due to exceptional management of water chemistry by FLAC staff. DOH has previously closed other facilities with similar interior surface issues, so a remediation program should be undertaken as soon as possible.

7. Recommendations: As mentioned earlier in this evaluation, the pool is 50+ years old and has certainly surpassed the customary 25-year life expectancy for consideration for pools of this type. If the pool is to remain operational, it is imperative that the interior tile be repaired and/or replaced along with a completely new exposed aggregate surface finish. Any loose or broken tile on the lane line markers and wall targets should also be replaced. The markers should get new grout. It may be necessary to remove and completely replace all markers. Any unsafe start blocks should be replaced. The gutter grates should be replaced in areas that need it and any broken or chipped pieces of coping should be replaced. Areas of the deck, where rusting is occurring, should be exposed and assessed in more detail to initiate a repair plan.

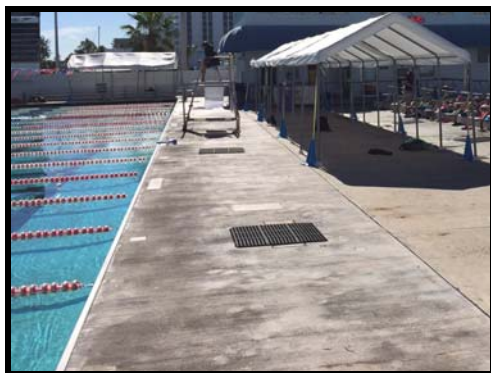
- c. The pool deck is surrounded by metal 3'x 3' grates approximately 15' on center that allow access to a continuous +/-3' deep trench that runs tight around the perimeter of the pool wall. This is used by staff to repair leaks in the pool wall and filtration system and to troubleshoot pool issues.

Figure 169 Access panels along pool side to drainage pipes below

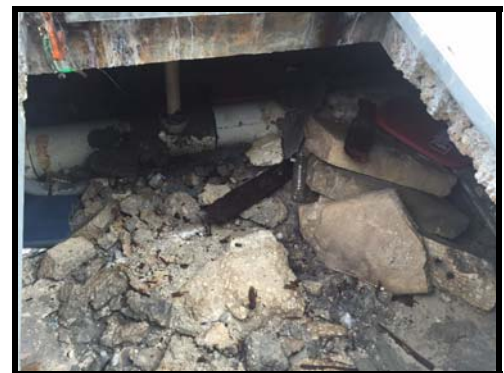
Figure 170 Underground access view of drain pipes that run parallel to pool

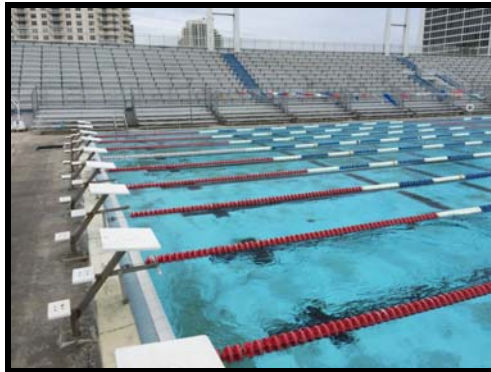
Additionally, the current starting blocks are old and outdated, and some have failing platforms, anchor and grips.

Figure 171 Starting blocks are old and broken in various degrees, such as platforms, grips, and Anchors. The blocks are vastly outdated and lag far behind current models in use at other facilities

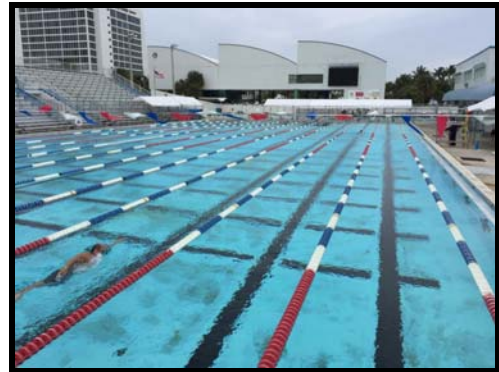
Figure 172 7'-0" wide lane width does not meet national standard lane width of 8'-2"

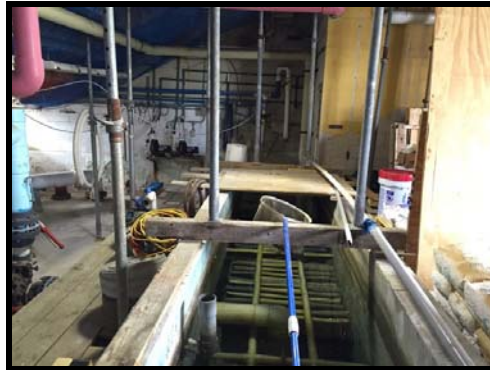
Figure 173 DE system is functional and could be utilized in Option 1, but is very labor intensive and created additional demands for storage, use, and disposal of potentially carcinogenic DE powder

- 1) Existing: VacDE Filters, circa 1965, is in operable condition. Filter cleaning is labor intensive, and requires handling and disposal of DE powder. The pumps appear to be capable of achieving DOH flow standards.
- 2) Recommendations:
 - a) This system could continue to operate as is. External MCC-VFD could be added to replace the existing starters and provide energy savings, or

- b) Entire system could be replaced with a fully automatic permanent media hi-rate granular filtration system equipped with water saving air scour system. Composite strainers would be added to pump package to complete conversion to pressure-side filtration.

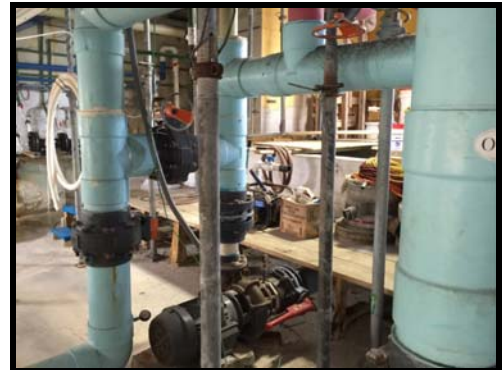
Figure 174 The pool equipment "face piping" is in excellent condition and there are no signs of leaking pipes in the room

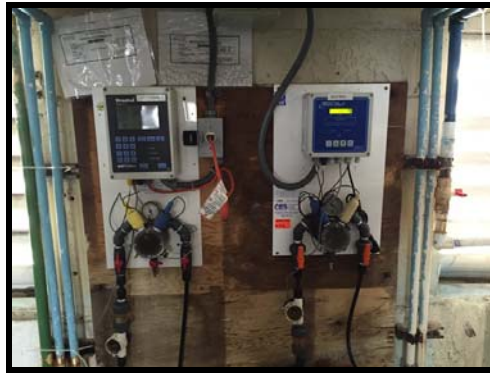
8. Additional items that apply: Both Systems for Pools #2 and #3 share treatment strategies and thus have similar recommendations.
 - a. Controls:
 - 1) Existing: Budget chemistry control systems, circa 1994-1998, lacks desired features found in similar facilities. Mediocre face panel display is inoperative. Sensors are old and require near term replacement. It controls ORP & pH only. It monitors temperature. It has no interactive or expansion capabilities.

Figure 175 Competition pool and Dive Well controllers, CES circa 1990's are in need of repair or replacement

- 2) Recommendations: Replace with BECSys5 or 7L to provide accurate control of chemistry with enhanced safety and efficiency features, and expansion capabilities to handle future energy conservation or regulatory needs:

- a) ORP, pH, and Direct Reading PPM,
 - b) Control of water level, monitoring of water consumption
 - c) Direct Control of PPM
 - d) Monitoring of Filter Soiling, automated filters

- e) Remote Control, Electronic log keeping and Alert Notification
- f) Direct control of GPM
- g) Disable pump in event of pump pit flooding for operator safety

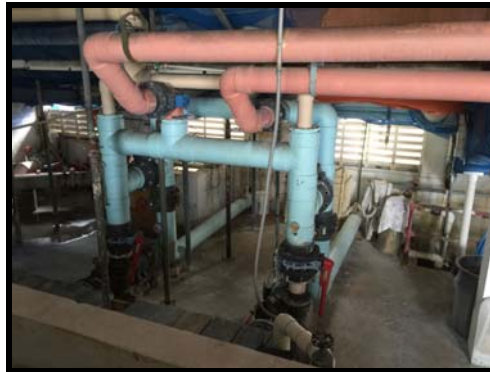
Figure 177 The pool pumps (2) and vacuum D.E filter system is currently operational and performing well. The geothermal heat pump units are also in good condition and performing well. The room lighting is inadequate. It is required by code to have 30 Fc of illumination at the floor level

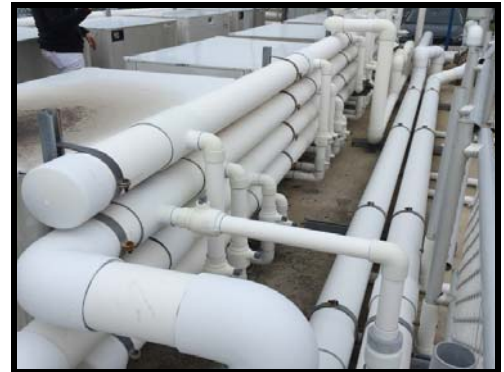
Figure 178 geothermal units are located outside the room west of the pool in a separate fenced area.

- a) Provide in-line booster pump to supply filter water to heater loop from recirculation line. This will allow proper flow through the heaters, while allowing independent turndown of main circulation loop for energy savings.

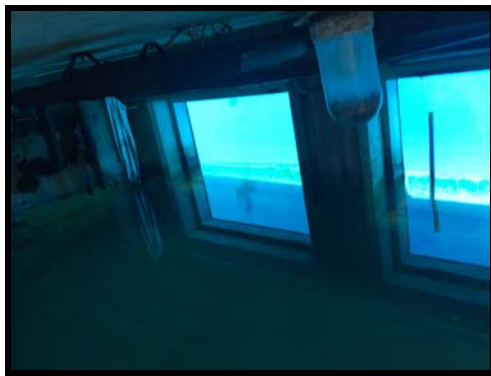
Figure 180 Underground view of dive pool

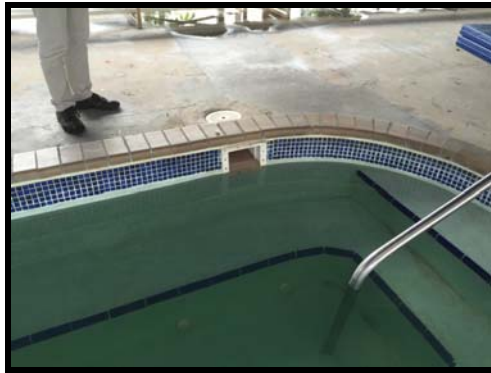
- a. Pool Structure: the condition of the pool is useable although one could clearly tell this was not an originally designed concrete pool. There are some features of the make shift pool that are not code compliant, such as the handrail anchor, and the skimmer suction grate cover; however, DOH is aware of these issues and allows operation without penalty. The pool interior is conventional pool plaster with glazed waterline tile of which both are in poor condition. The vessel is repaired regularly by staff, but is not worthy of any major cosmetic renovation investment. The pool should remain in use until such time that a new vessel can be built in its place.

Figure 184 Skimmer section grate cover and handrail anchor, non-compliant, but allowed

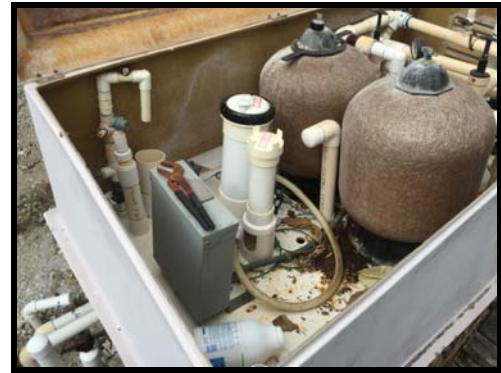
Figure 185 Diver Warmup Spa is in disrepair and can be replaced by either a pre-plumbed pack, or the components can be site assembled and a prepared slab

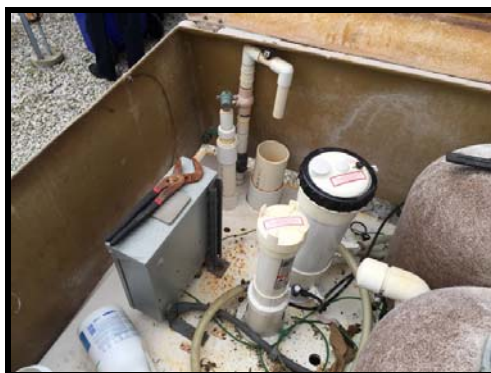
Figure 186 Manual pH feed, lack of chemistry control, and use of Bromine are a major cause for concern in a small body of water.

- 2) Recommendations
 - a) pH: Replace with UDA (Ultra Dilute Acid Feed System).
 - b) Chlorination: Replace with Pulsar all-in-one tablet feed system which will provide all the chlorine, calcium, bicarbonate, and stain prevention requirements while using 1/10 the acid of traditional bleach systems.

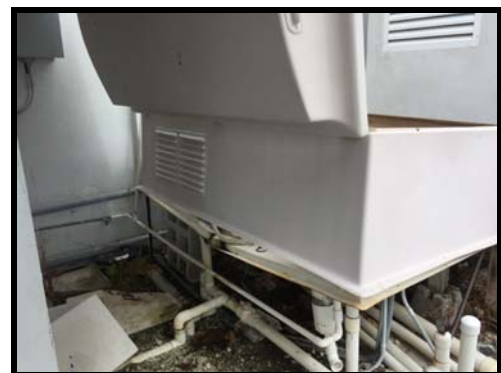
- b. **Equipment:** the pool equipment is located on the south side of Building #3 in a prefabricated equipment pit. The pit is in very poor condition structurally as the cabinet is virtually falling apart. The equipment (pump, filter, and sanitation equipment) inside the cabinet is operational but barely code compliant. The internal piping and some components have been replaced and/or repaired previously to keep the pool in operation and compliant with yearly DOH inspections. Some of the units have been retrofitted to comply with recent Federal Guidelines such as the direct suction line which now includes the use of a “Vac-Alert” anti-entrapment device. The return line from the pump is connected with a natural gas heater located alongside the cabinet on a concrete base. The heater is in fairly good condition and is currently operational.

Figure 187 Equipment cabinet and equipment

5. Recommendations: overall the pool and equipment is barely useable, and can continue to remain so, as long as the current "Patch and Repair" process is allowed to continue. The equipment cabinet and equipment can fail at any time. Attempts to fix the collapsing floor base continue, but soon this will prove to be a waste of time and money. The cabinet and equipment need to be replaced soon even before the realization of any new pool vessel. The cabinet can be replaced with a new prefabricated cartridge filter pack similar to a "Compact Filtration Inc." Model SPH1500 unit customized to suit the current pool vessel. The pack should be complete with pump, filter, water chemistry unit, and electrical panel. The cabinet should also contain provisions for connecting with the existing gas heater as well as connecting with the "Vac-Alert" anti-entrapment manifold.

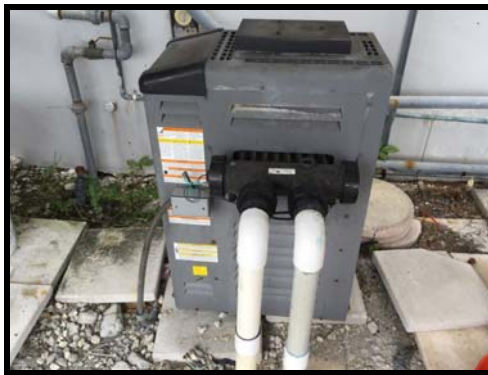
- 1) Existing: Existing Gas Heater appears to be operative, although it is fair condition.

Figure 188 The existing gas heater is in fairly good condition. It can continue in operation regular maintenance by FLAC Staff

- 2) Recommendations:
 - a) Maintain existing heating system and tie into new mechanical system, or
 - b) Replace heater with high efficiency LoNOx heater

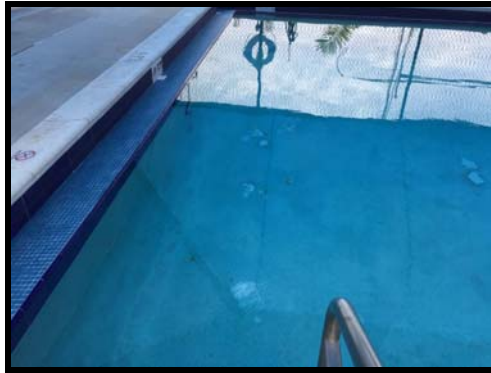
1. Size: 40' x 24' x 4'
2. Capacity: 21,141 Gallons
3. Filtration: 59 GPM
4. Overview: Pool #5 is located west of building #4 on the south side of the site. The pool is approximately 24'-0"x40'-0" and has a maximum depth of 4'-0". The edge condition consists of a 12" wide tiled ledge with a gutter fitting equally spaced and resting 6' below a conventional precast coping. The center is commonly referred to as "Roll Out Gutter". The interior surface is an exposed aggregate plaster with dark contrasting tile at the edge of the pool steps.
 - a. Pool Structure: The condition of the pool is poor, as evidenced by the many modifications and repairs made to the vessel to comply with DOH code and to keep the pool operational. The interior finish is rough and stained, and some areas that are beginning to delaminate from the surface. The tile grout has worn away in

several places and needs replacement. The tile markers are stained, as are the grabrails and the handrail posts. The riser at the backside of the pool coping is unfinished and is missing grout in some areas, with the coping cap revealing the crack that separates the coping from the top of the pool beam.

Figure 191 Interior finish is rough and stained

- b. Interior: The interior pool finish should also be replaced with a product similar to “SGM Diamond Brite” exposed aggregate pool plaster. A complete removal of all prior interior pool surfaces may be required to install the new finish. Any new finish should only be installed by licensed individuals that provide a warranty on the product. At the same time the interior and all remaining tile should be re-grouted and sealed.

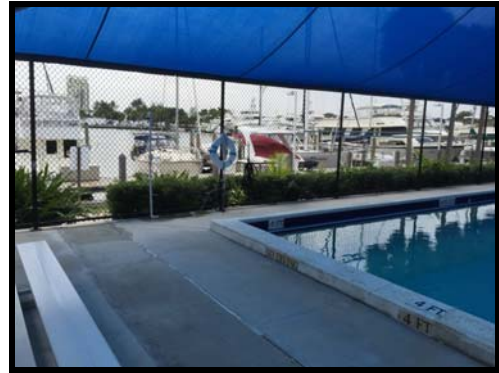
Figure 192 Slab shows evidence that many modifications and repairs made to keep pool operational

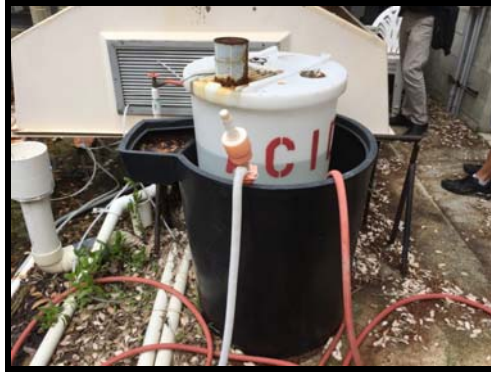
Figure 193

- c. Equipment: The pool equipment is located inside a prefabricated cabinet in a walled area west of the Teaching Pool. The cabinet is in poor condition showing signs of the many repairs and retrofits needed to keep the pool going. There are broken parts from past repairs and other debris on the floor of the equipment platform inside the cabinet. There are also signs of water damage from excessive rains that washed the unit, while the cover remained open. A gas heater sits at the edge of the yard against the enclosure wall and appears to be in good condition. Overall the equipment cabinet, equipment, and associated piping and components are kept running by aquatics staff to a bare minimum core standard for operation.

As a bare minimum, the pool equipment cabinet issue and equipment components need to be replaced with a new prefabricated cabinet. A similar cabinet complete with cartridge filter units, filter pump, water sanitation equipment, electrical panel, and associated plumbing pipes, to connect with the existing pool piping components should also be included. A salt/chlorine generator, to replace the current package unit from autopilot, should be considered as a supplemental means of sanitation that will save on chemical costs from the supplies.

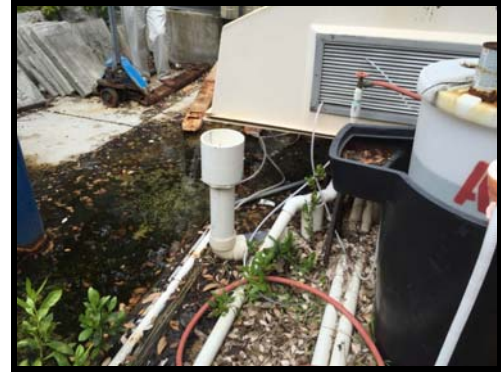
Figure 194 Equipment Vault Piping and other components have been retrofitted to relate top site conditions. The pool drain line is no longer connected to the Atmospheric Gap Funnel Drain and is routed to site drainage elsewhere beyond the perimeter wall.

- 1) Existing: Entire equipment skid is in mediocre to poor condition and has undergone many modifications over the years. The twin cartridge filters are in fair shape and could easily be replaced. Replacement for this feature could be accomplished with either with an integrated replacement pack or a site-built on grade slab package consisting of new pumps, filters, etc.
- 2) Recommendations: Entire system could be replaced with a new automatic permanent media hi-rate granular filtration system equipped with water saving air scour system.

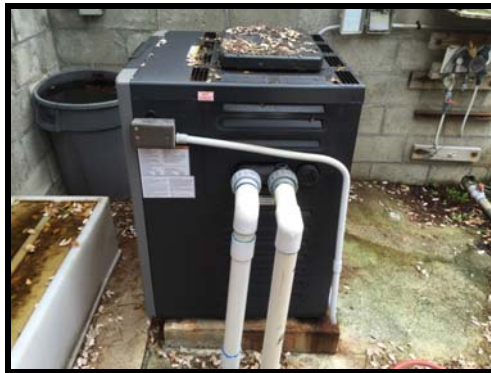
Figure 195 Gas heater

- 1) Existing: Existing Gas Heater appears to be operative, although it is fair condition.

- a) Maintain existing heating system and tie into new mechanical system, or
- b) Replace heater with high efficiency loNOx heater

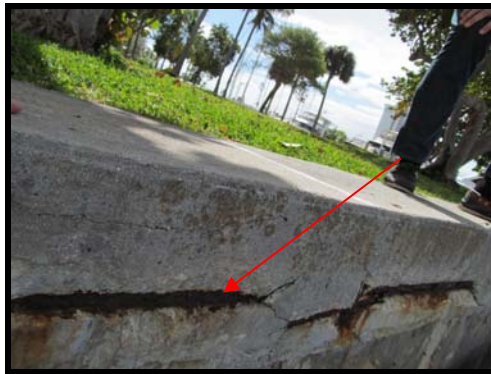
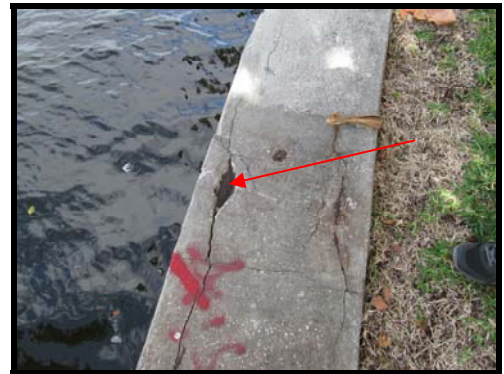
- 2) Seawall Cap: The seawall cap is in good condition around most of the seawall. There is local spalling due to corrosion of the reinforcing steel within the cap. We estimate 100 lineal feet of cap repair.

Seawall cap will need to be repaired in spalled areas. Existing concrete will need to be chipped away and the reinforcing steel exposed. Steel shall be cleaned and coated. New repair mortar shall be used to renovate the cap.

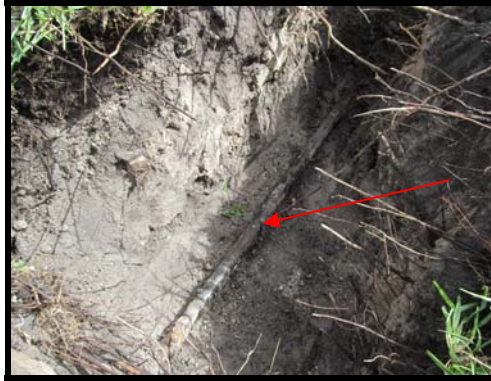
- 3) Tie-Backs: The tie-backs are solid steel rods. Five rods were exposed from the seawall cap back approx. 5' since this is the most exposed area. The rods are originally wrapped with a protection material. The Rods are in good condition. There was minor rust closer to the seawall cap on one of the tie-backs. No additional work is required on the caps.

Figure 199 Tie back: exposed section of seawall tieback, condition of steel is very good
