# City of Fort Lauderdale Comparative Facility Analysis Report

*An Assessment of Three Existing Buildings for Potential  
Conversion to a New City Hall*

City of Fort Lauderdale, Florida

June 18, 2026

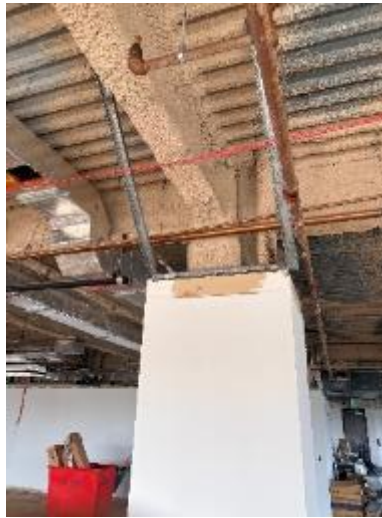
Figure 2A.2.1 Underside of floor framing

2A.2.1 Underside of floor framing is typically covered with spray-applied fireproofing

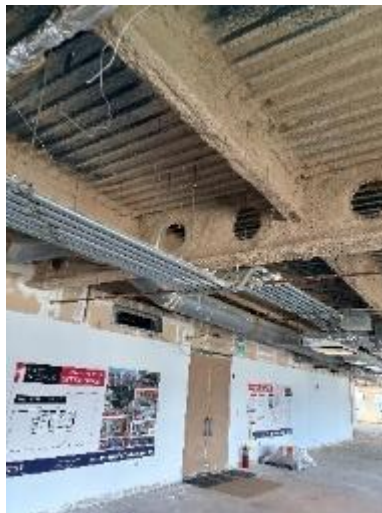
Figure 2A.2.2 Mechanical penetrations at girders

2A.2.2 Mechanical penetrations at girders are typically pre-formed

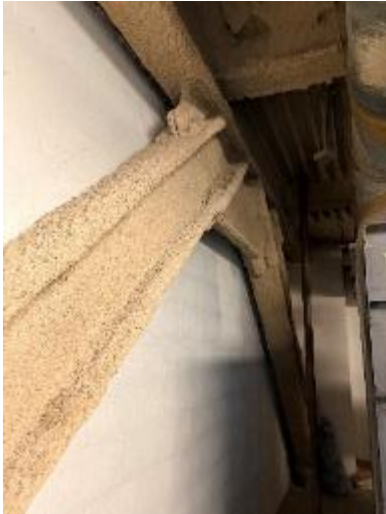
Figure 2A.2.3 Typical main wind-force resisting system

2A.2.3 Main wind-force resisting system wide-flange braced beams

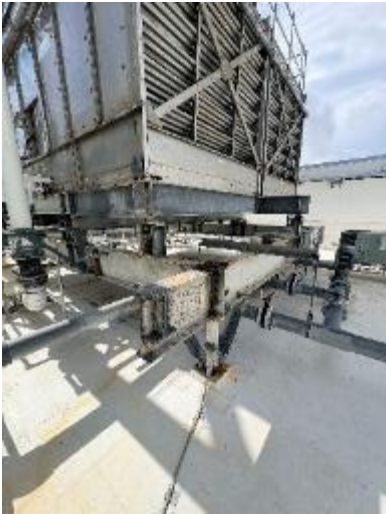
Figure 2A.2.4 Cooling tower framing

2A.2.4 Visible corrosion on cooling tower framing, no section loss observed

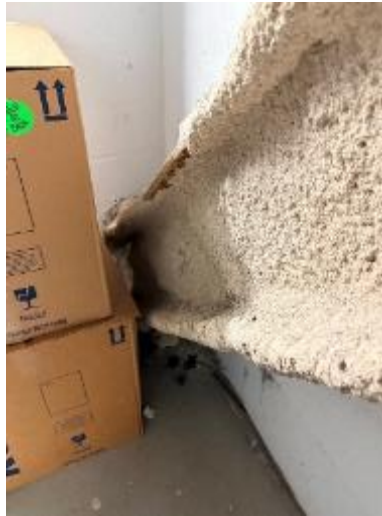
Figure 2A.2.5 Spray-applied fire proofing damage

2A.2.5 Spray-applied fire proofing damage at brace and various members throughout should be surveyed and repaired.

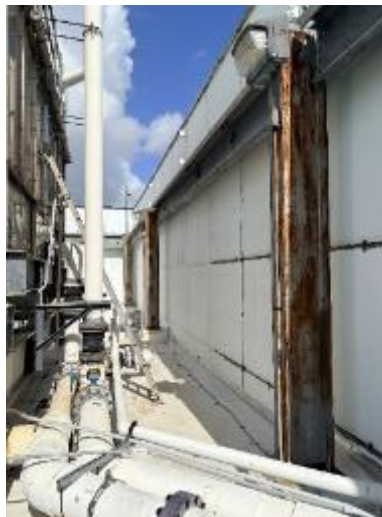
Figure 2A.2.6 Rooftop screen wall framing

2A.2.6 Rooftop screen wall framing visible corrosion to be repaired but section loss not observed.

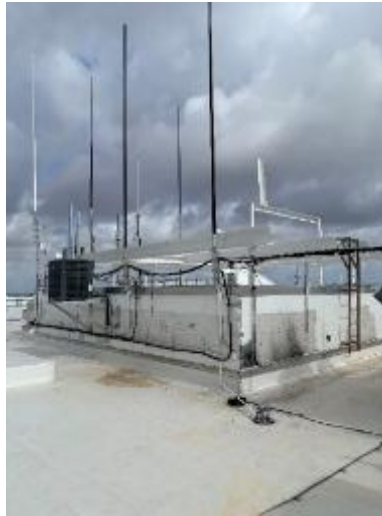
**Figure 2A.2.7 Antenna farm frame**

2A.2.7 Antenna farm frame at rooftop appears in good condition, some minor corrosion visible to be prepped and recoated.

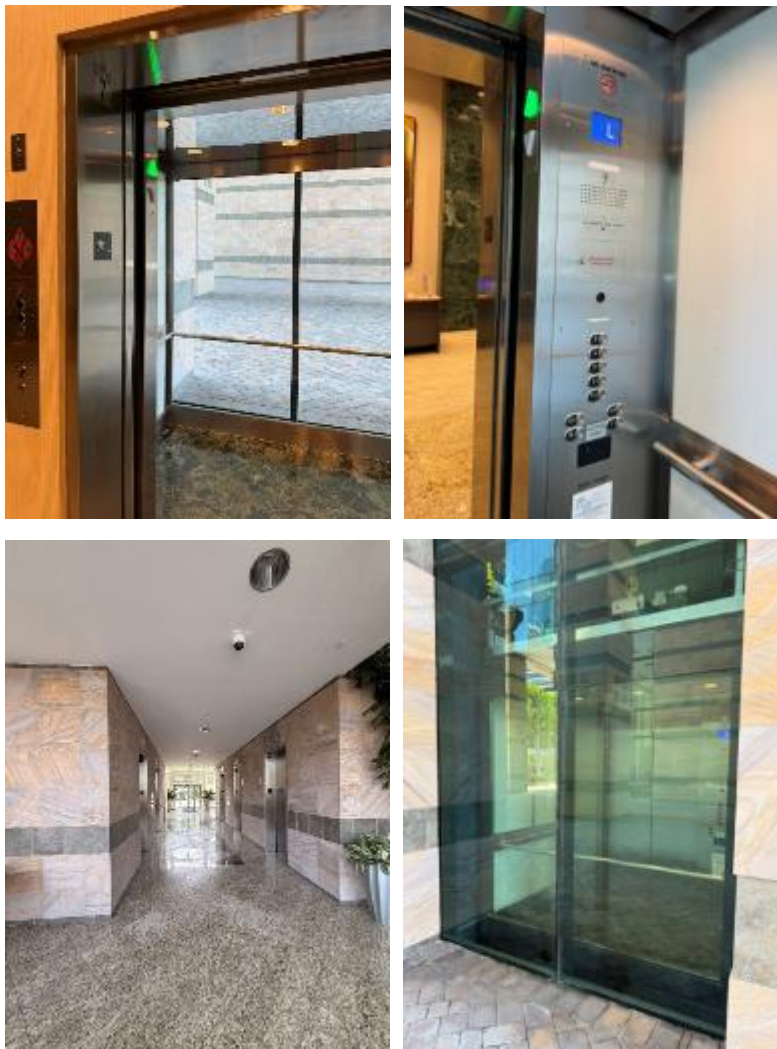
**Figure 2A.3.1 Elevator Lobby and Elevator**

2A.3.1. Elevators interior cab dimensions are 63x81 inches at the main tower, and 49x 61 inches at the two-story East building.

2A.3.2. The elevators can accommodate an ambulance stretcher 76 inches long by 24 inches wide in the horizontal position, as required by FBC.

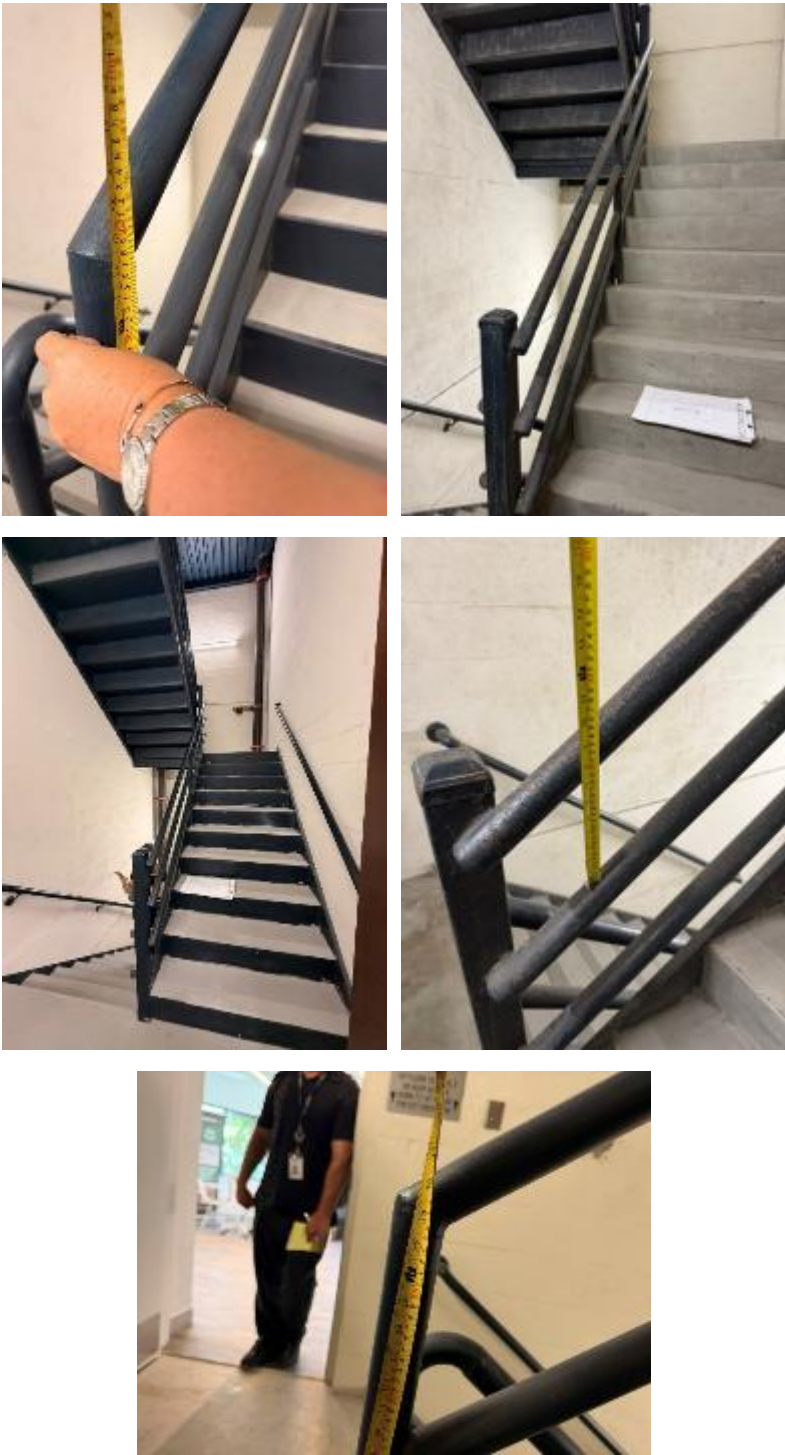
Figure 2A.3.3 Stairs

2A.3.3. Stairwells have no guardrail (required at 42" by current FBC) and handrails are of varying heights (32"/too low, to 39"/too high). Most handrail extensions do not comply with current building code.

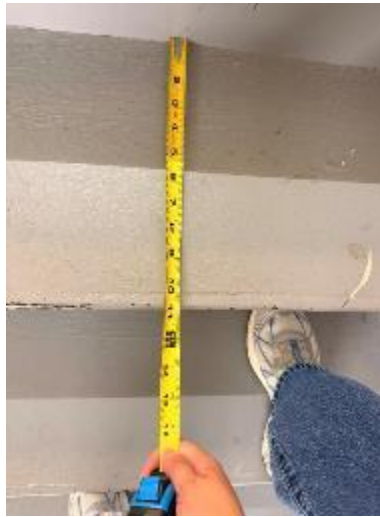
Figure 2A.3.4 Treads

2A.3.4. Stair treads and risers vary within flights, which is not permitted by FBC. A variance would be required to potentially avoid such modifications.

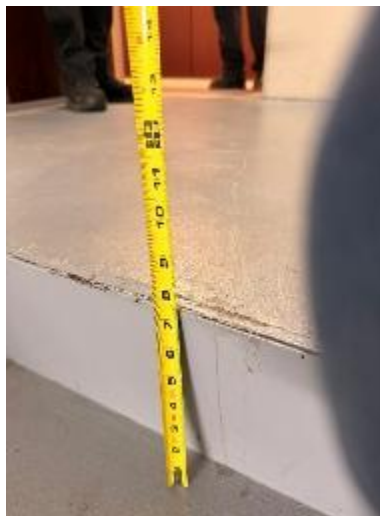
Figure 2A.1.5 Risers

2A.3.5. Most stair risers 7 to 8 inches high (max 7 code required); original construction drawings show risers at 7+ inches. This is a code correction that cannot be addressed without complete modification of stair shafts. A variance would be required to potentially avoid such modifications.

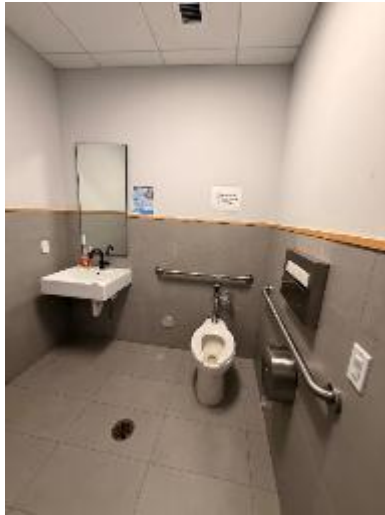
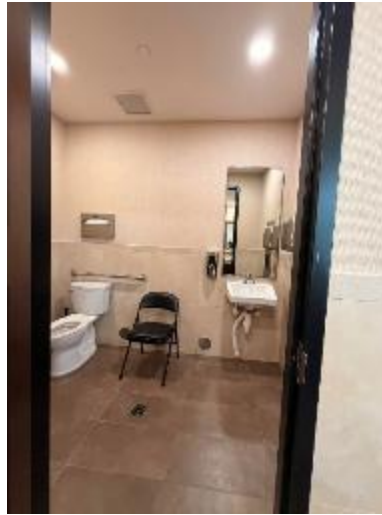
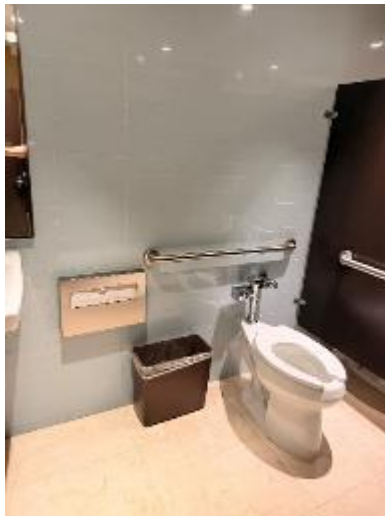
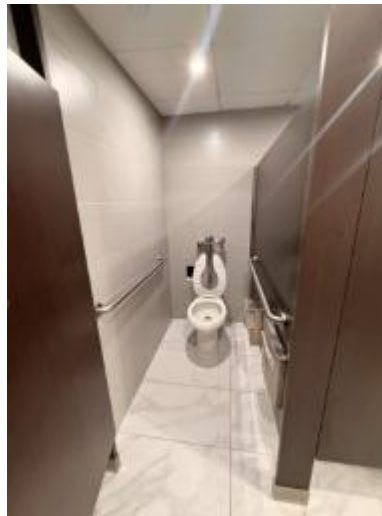
Figure 2A.3.6 Toilets

2A.3.6. Accessible toilet rooms are provided per floor, some of them are not fully compliant with the code requirements of fixtures overlap space or water closet clearance. Ambulatory accessible compartments are provided on some floors in lieu of accessible toilet compartments. Some stall doors are smaller than the required 36 inches. All bathrooms will require significant rework and reconfiguration to be code complaint. Due to occupancy modifications, plumbing fixture counts will need to be assessed and toilet stalls or rooms added if required.

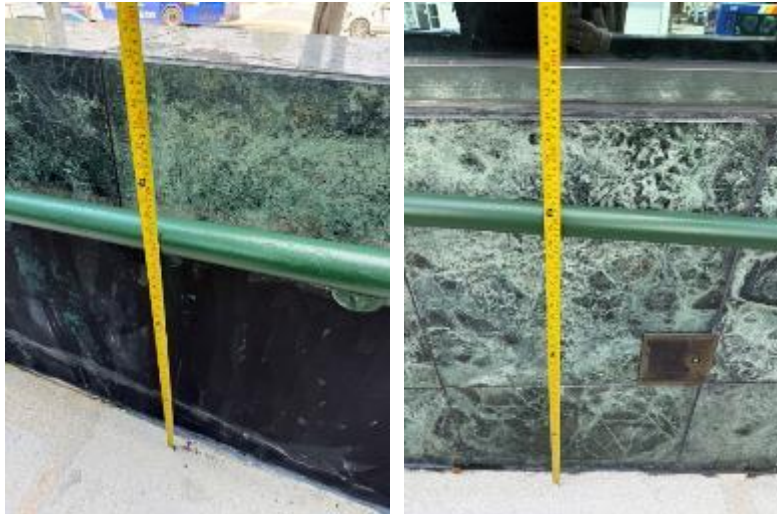
Figure 2A.3.8 Ramp Handrails

2A.3.8. The ramp handrails vary in height from 34 inches to 38 inches and handrails do not extend 12 inches as per code requirements.

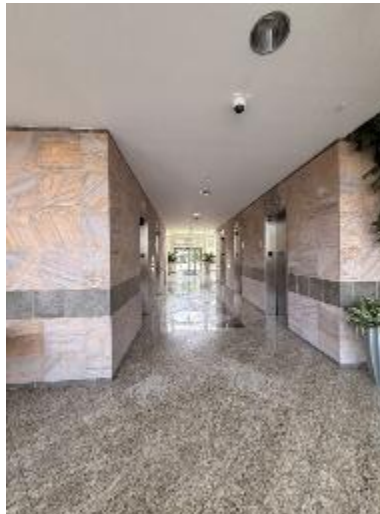
Figure 2A.3.10 Elevator Lobby

2A.3.10. Most of the elevator lobby areas have been renovated with new carpets and finishes. There is no evidence of loose carpeting or missing floor tiles.

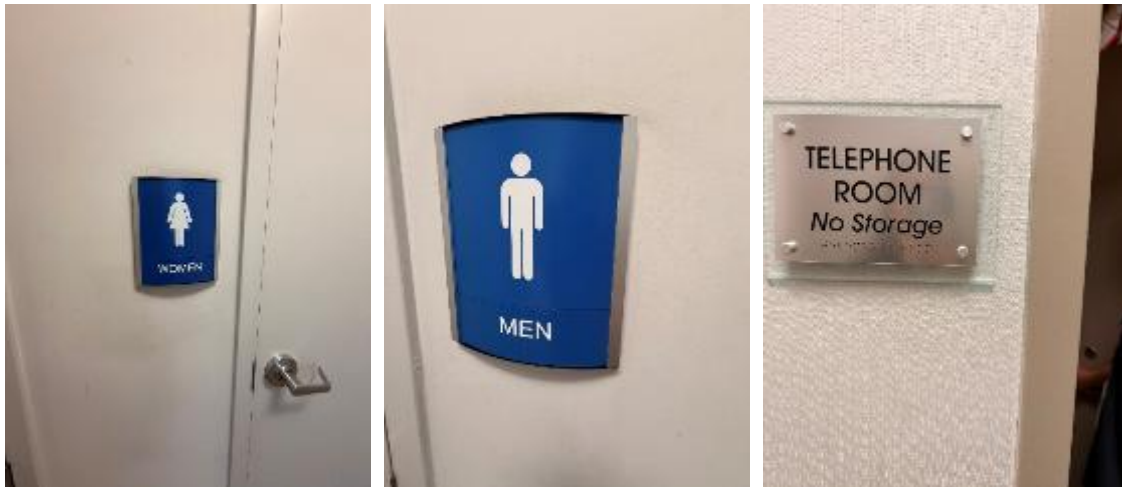
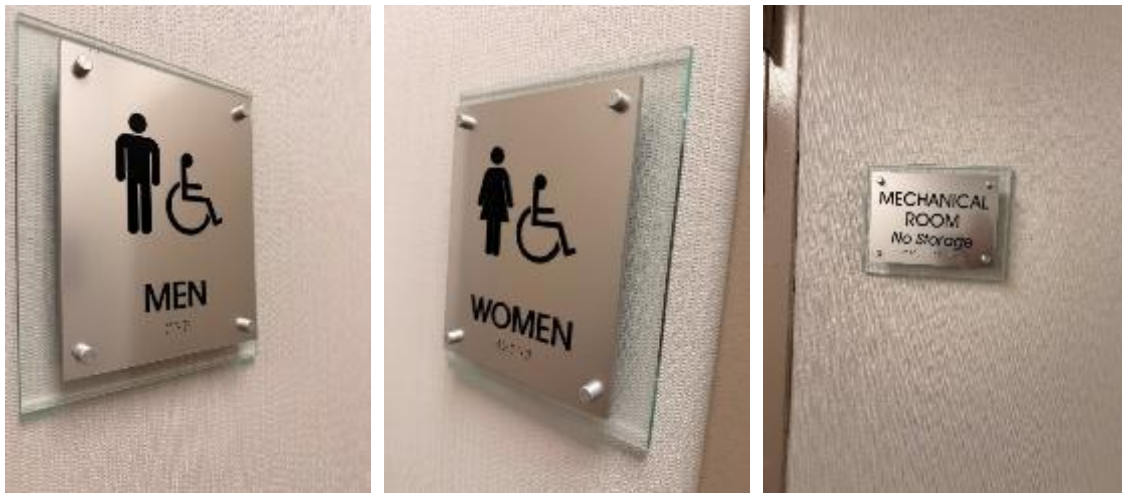
Figure 2A.3.12 Room Identification Signage

2A.3.12. Signage was renovated throughout the building and includes accessible features.

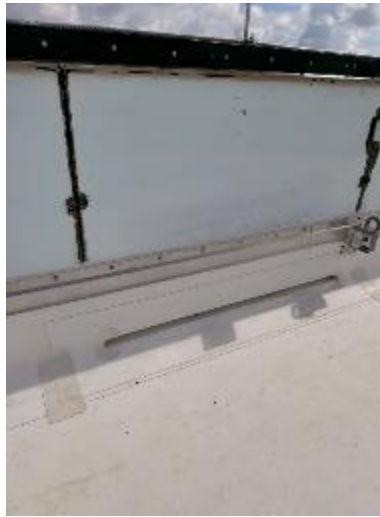
**Figure 2A.3.17 Roof**

- 2A.3.16. There is a flat skylight on the roof that, due to age, is assumed to be non-impact resistant.
- 2A.3.17. There are no overflow drains and only one scupper provided on the main roof at 19<sup>th</sup> level appears to be insufficient.

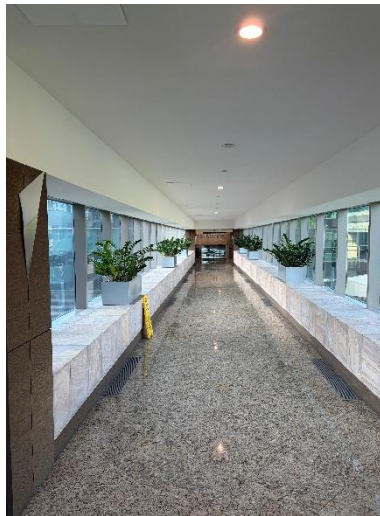
**Figure 2A.3.20 Pedestrian bridge**

- 2A.3.18. Curtainwall glazing is likely not impact-resistant, therefore not meeting current building codes.
- 2A.3.19. Routine maintenance of the glass sealant provides a tight enclosure with no visible leaks throughout.
- 2A.3.20. The pedestrian bridge connecting the building to the City-owned parking garage to the north appears to be in good condition, with the exception of the roof, as noted previously. The bridge has no fire sprinklers nor fire rated separation from the building; sprinklers would need to be added.

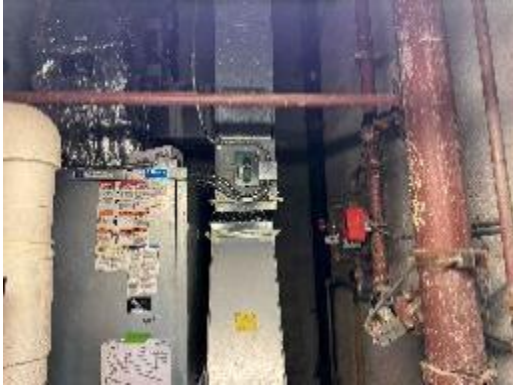
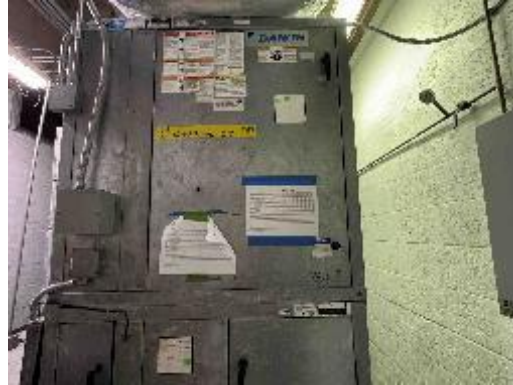
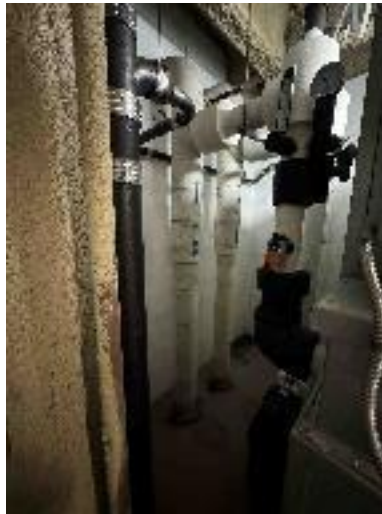
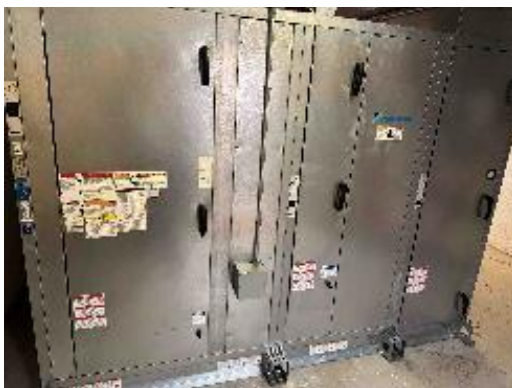
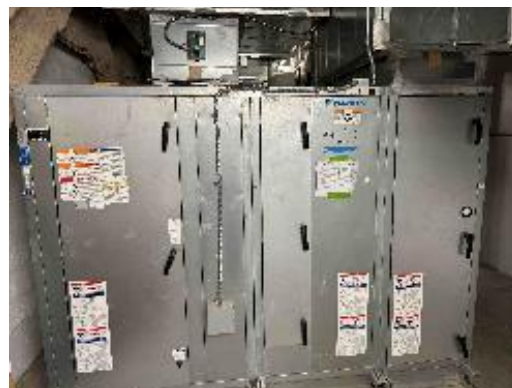
**Figure 2A.4.3 AHUs in good condition**

2A.4.1. Of the 21 air handling units (AHUs) observed during the site visit, 9 units have been replaced since the original construction and are currently in good condition; these units are not expected to require replacement within the next five years. Eight of these units are Daikin units (AHU-5, AHU-7, AHU-11, AHU-13D, AHU-14D, AHU-16, AHU-18, and AHU-23), and one unit (AHU-3) is a Trane unit. Continued preventive maintenance is recommended to sustain performance.

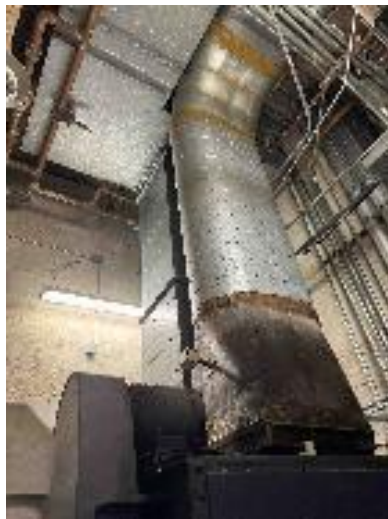
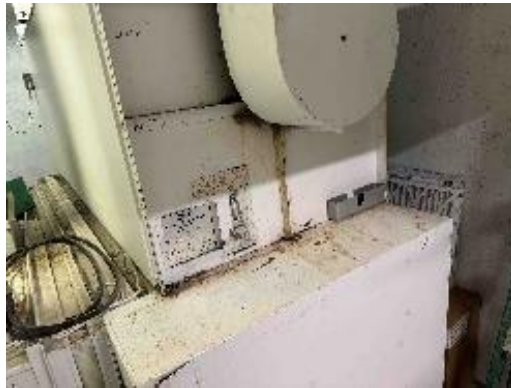
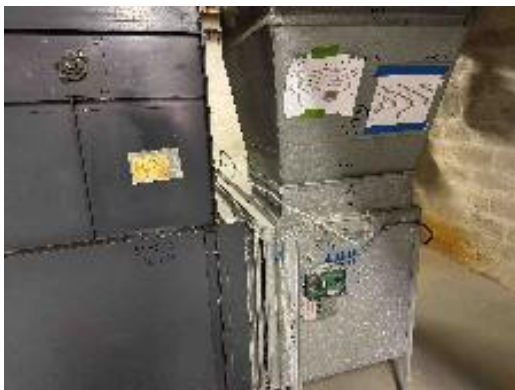
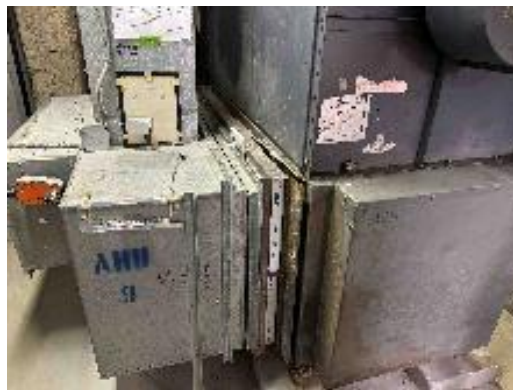
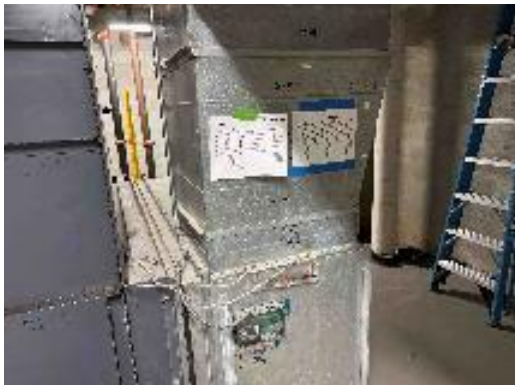
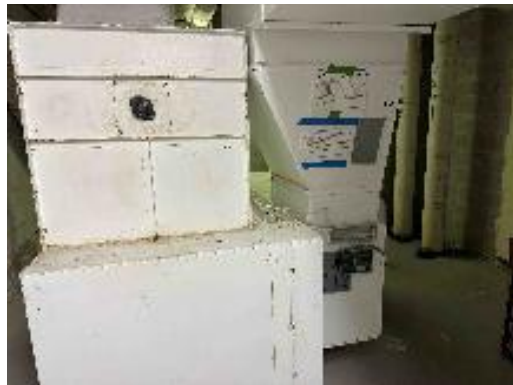
Figure 2A.4.2 AHUs requiring replacement

2A.4.2. The remaining 12 AHUs are original to the facility, appear to date back to the 1980s, and are in poor condition. These units include AHU-4, AHU-6, AHU-8, AHU-9, AHU-10, AHU-12, AHU-13T, AHU-14T, AHU-15, AHU-17, AHU-19, and AHU-22. Based on their age and observed condition, immediate replacement is recommended. ASHRAE equipment life expectancy guidelines indicate a typical service life of approximately 15 years for commercial air handling units, which has been significantly exceeded for these systems.

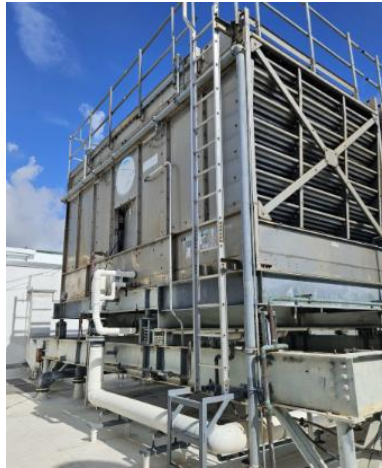
Figure 2A.4.3 Cooling Tower

2A.4.3. HVAC – The cooling tower was observed to be in working condition and well maintained. The age of the cooling tower could not be confirmed. There is some evidence of corrosion on the frame.

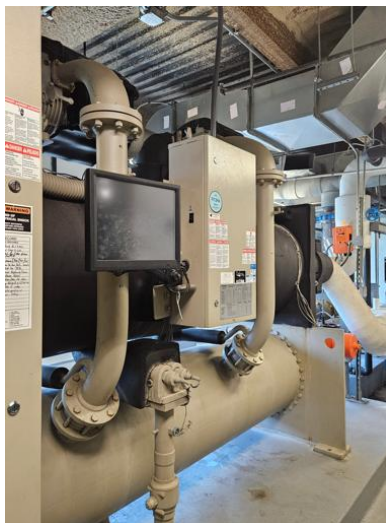
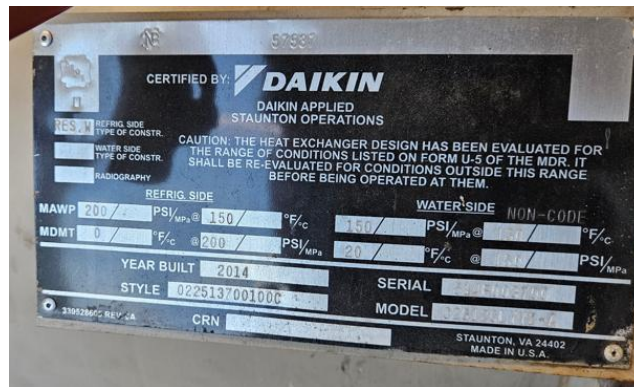
Figure 2A.4.4 Chiller & CHW 2014 Tag

2A.4.4. HVAC – The chillers, as indicated by plans in the room, were replaced sometime close to 2014 which would make them 12 years old. They were observed to be in working condition and well maintained. They are not advised for replacement as centrifugal chillers have expected life of 23 years per ASHRAE.

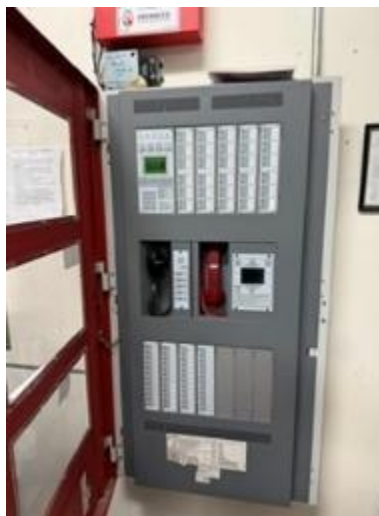
Figure 2A.5.2 Panel

- 2A.5.2 Fire Alarm – Existing EST manufactured system. Fire alarm panels (annunciators, NAC booster, main) are new and are in good condition. The existing Simplex smoke evacuation/stair pressurization panel is original and should be replaced.

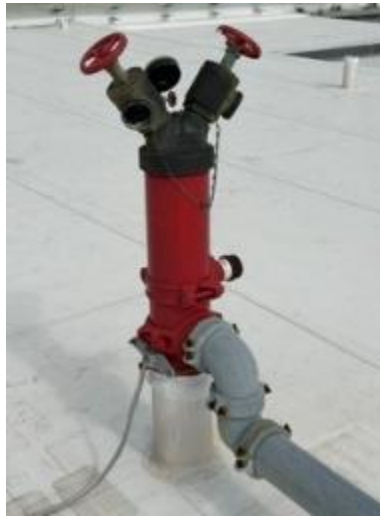
**Figure 2A.5.3 Roof Manifold**

- 2A.5.3 Standpipe Roof Manifolds – found several hose valves missing caps. Hose valve handles were broken on two valves.

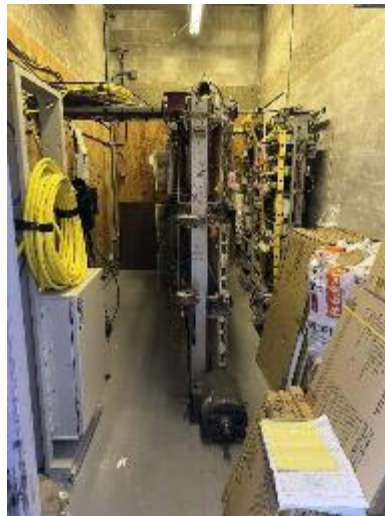
Figure 2A.7.3 TS-1E-001 First Floor Telephone Room

- 2A.7.1. The main building telephone room is located on the first floor, near the loading dock. The room is long and narrow and is the entrance facility for leased telecommunications services from providers such as AT&T, FPL, and Comcast. Various fiber optic cables pass through this room up to intermediate rooms located on floors above. Legacy copper riser cables and terminations that serve the floors are also located here.
- 2A.7.2. As currently configured, the room does not meet National Electric Code (NFPA70) and ANSI/BICSI 009-2024 working clearances of 36" on each side of the equipment racks and cabinets.
- 2A.7.3. Unused cables and equipment should be removed, and remaining equipment should be reconfigured to meet current standards. An uninterruptible power supply (UPS) should be provided, powered from an emergency circuit off the generator, to maintain communications services.

- 2A.7.4. The closet is warm and doesn't appear to meet ANSI/BICSI standards of 64°F to 75°F, and as such additional HVAC will have to be provided along with a hung ceiling to help maintain constant temperature.
- 2A.7.5. There did not appear to be a Telecommunication Main Grounding Busbar. If that is the case, one should be provided, bonded to the building's electrical service ground, to properly ground equipment, racks, cabinets, and cable trays.
- 2A.7.6. The room has fluorescent light fixtures that should be upgraded to LED fixtures.
- 2A.7.7. The room door is secured with a manual key lock. Electronic access control and a video surveillance camera to view the door should be added as a matter of best practices.

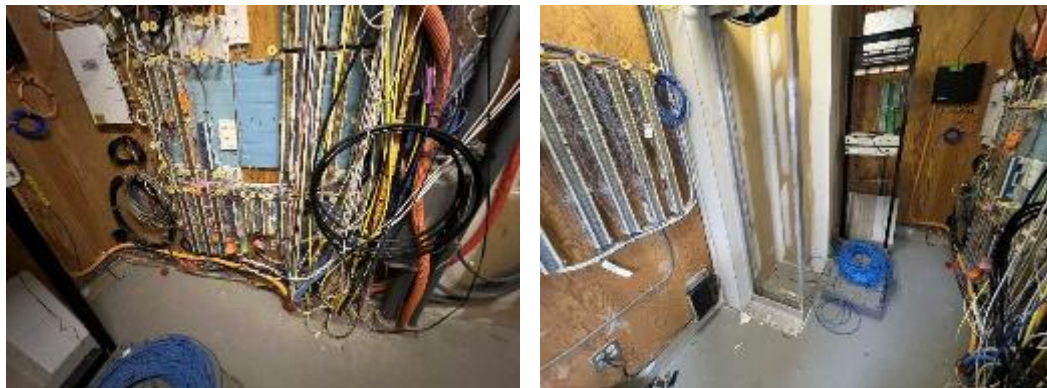
Figure 2A.7.13 TS-1E-009 Ninth Floor Telephone Closet

- 2A.7.11. Some rooms do not meet code for working clearances as currently configured (e.g., 9th floor).
- 2A.7.12. Similar to the first floor main telephone closet, these closets have a fluorescent light fixture, manual key lock (a couple of exceptions with combination lock hardware), utilize building HVAC (again a couple of exceptions such as the seventh floor), have unused cables and equipment, are warm, have no video surveillance camera nor electronic access control.

- 2A.7.13. Upgrades proposed for the first floor main telephone room should be implemented for these rooms as well, i.e. to Category 6 cable and fiber optic cable to support current technology.

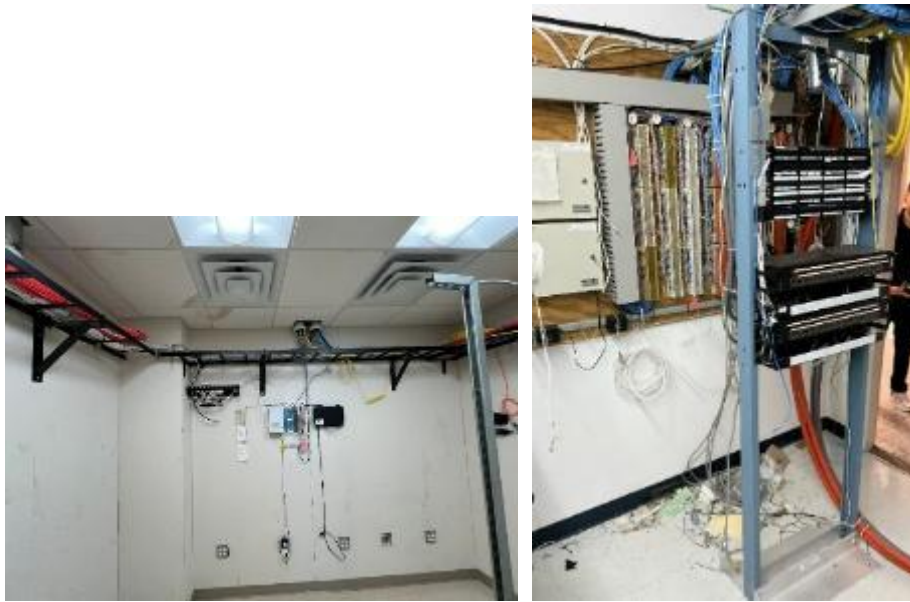
**Figure 2A.7.17 Tenant Owned Telephone Closets  
(TS 1E-009, 9<sup>th</sup> Floor & TS 1E-017, 17<sup>th</sup> Floor)**

- 2A.7.14. Some floors included Telephone Rooms owned by the various tenants in the building. The rooms that were operational were not surveyed, except for a room on the ninth floor and an out-of-service room on the seventeenth floor was accessible.
- 2A.7.15. The ninth-floor room houses racks of communications equipment (not ideally located), cables (installed across the floor in front of the door, and the tenant's electronic access control system.
- 2A.7.16. In the seventeenth-floor room, the network equipment and patch panels were removed, and cables were cut back. For this area we would need to confirm if they are long enough to be re-terminated, and if so, then they would need to be tested and certified.

- 2A.7.17. In general, if any office areas are to be reconfigured, then new horizontal cabling, patch panels, telecommunications outlets, racks, and network data switches will need to be added on each floor occupied by the City. New telephones will be required for all City occupied spaces.

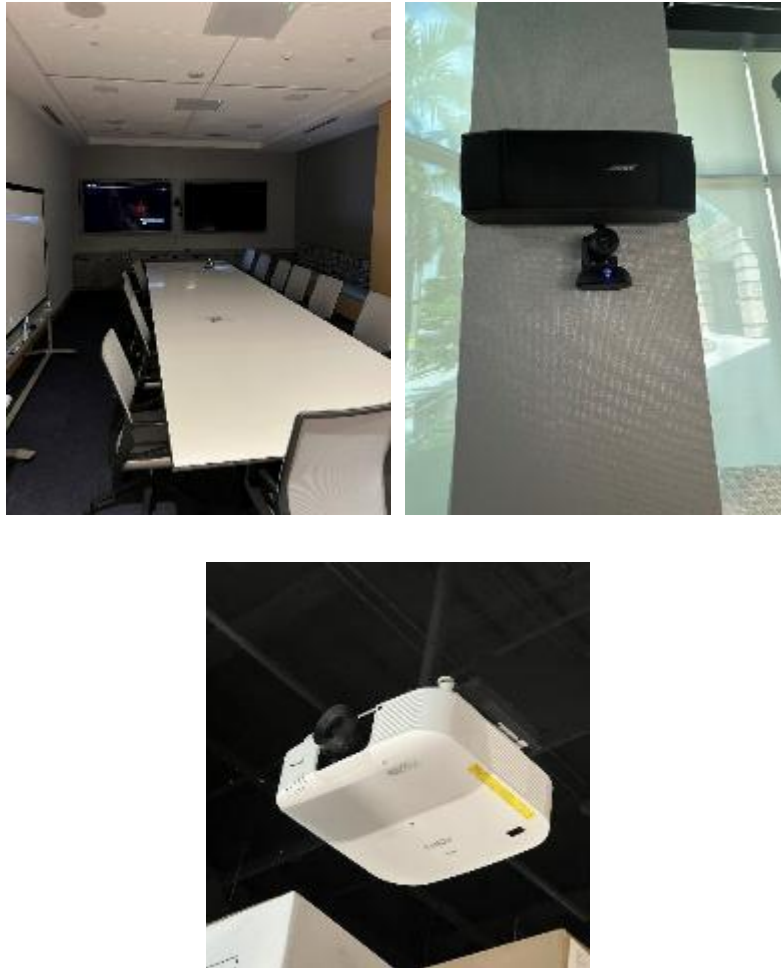
2A.7.19. The conference room has amenities such as two large screen monitors, video conference camera, ceiling mounted loudspeakers, and Crestron A/V control panels (desk and wall mounted). There are dual data jacks on each of the long side walls. The auditorium area has two ceiling mounted Epson projectors, two roll down projection screens, a sound system with multiple Bose loudspeakers, and Aruba wireless access points.

Figure 2A.7.19 Conference Room and Auditorium Area

2A.7.20. If this area is repurposed for the City Hall Commission Chambers, then this equipment can likely be reconfigured to suit the City's needs. Additional equipment, such as additional data jacks, walk-through metal detectors and bag-check stations may be provided during the build out. The building does not have a dedicated public address system, but the fire alarm system has mass notification capabilities.

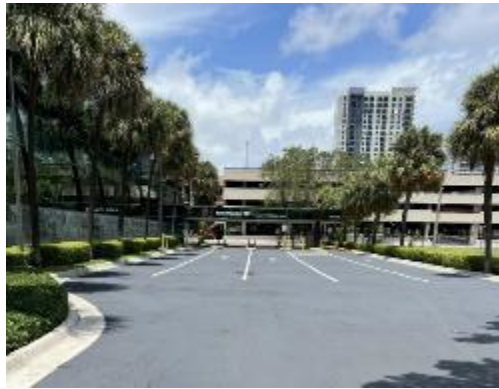
- 2A.7.22. On the east side of the building there is a former bank drive through area. If this area is used in the future for media vehicles, dedicated communications pylons could be proposed to provide each vehicle with direct data connections to systems in the building.

Figure 2A.7.2 Bank Drive Through Area

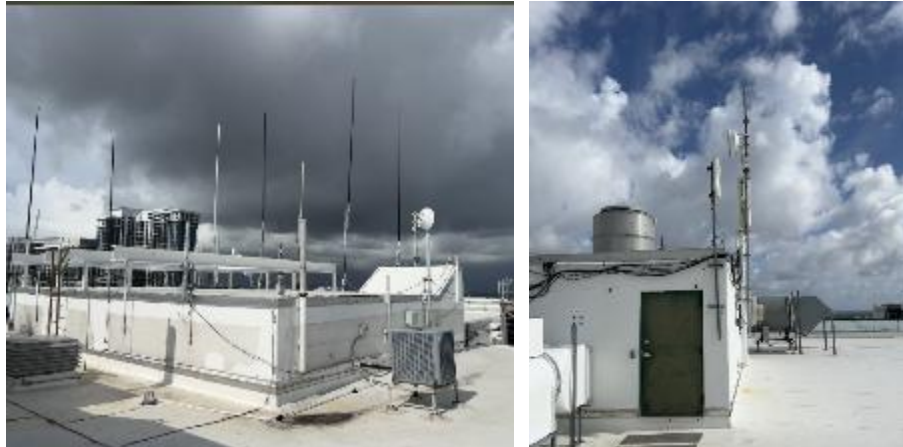
- 2A.7.29. There are multiple omni and directional antennas on the roof. These antennas appear to connect to radio equipment in the radio equipment room on the roof. The room is owned by the City of Fort Lauderdale; during the site visit, access could not be obtained.

**Figure 2A.7.29 Antennas on the Roof**

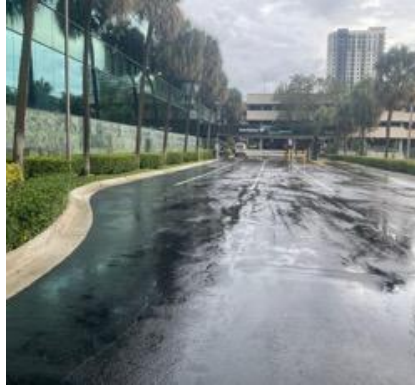
2A.8.1 Concrete sidewalks exist along East Broward Boulevard, SW Andrews Avenue, and NE 1st Street. These streets are designated public roadways and are maintained by the City of Fort Lauderdale. There are existing drive-thru lanes (from a previous financial institution) along the east side of the building. Although this area is paved and can be accessed by pedestrians, there are no accessibility accommodations or dedicated marked walkways.

Figure 2A.8.1 Drive-thru lanes

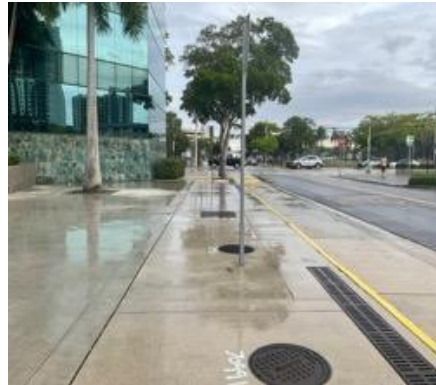
2A.8.3 The only existing on-street parking associated with the building is located on the north side of the building along NE 1st Street. There are accommodations for 4 parking spaces; however, none of these are accessible (ADA) spaces.

Figure 2A.8.3 On-street parking (NE 1st St)

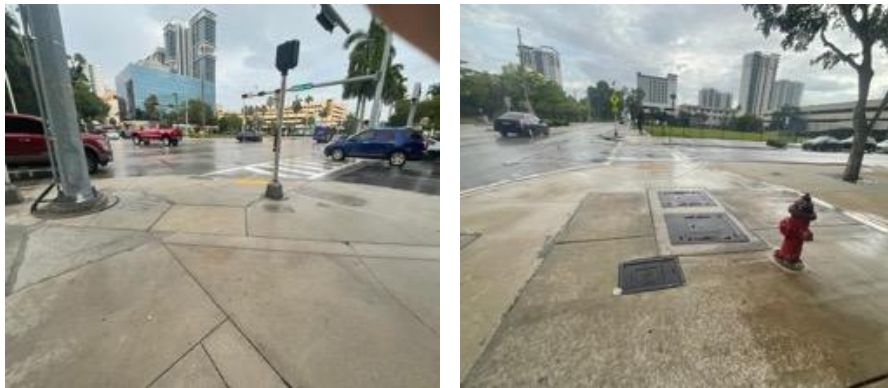
2A.8.4 ADA compliant curb ramps exist at the intersections adjacent to the building. These ramps are located within the public right-of-way and are maintained by the City of Fort Lauderdale. Figures below depict E. Broward/N. Andrews and N. Andrews/NE 1st St, respectively.

Figure 2A.8.4 Curb ramps

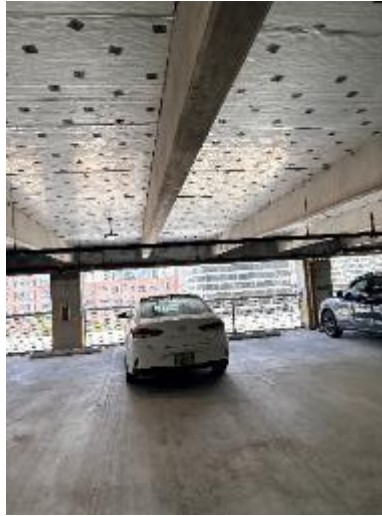
2B.2.1 Under slab garage insulation in high-rise building appears in good condition.

**Figure 2B.2.1 Under slab insulation**

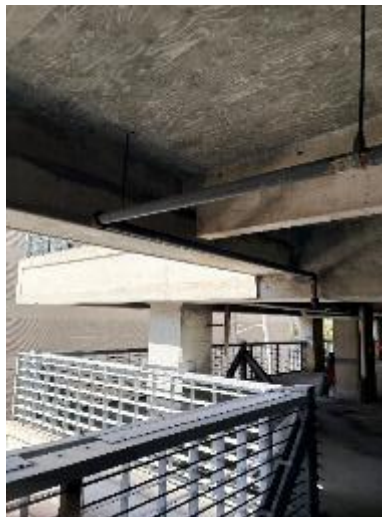
2B.2.2 Railings throughout garage of high-rise building show corrosion due to dissimilar metals with architectural cladding at intermediate verticals. The main supports with diagonal bracing appear in good condition.

**Figure 2B.2.2 Garage railings**

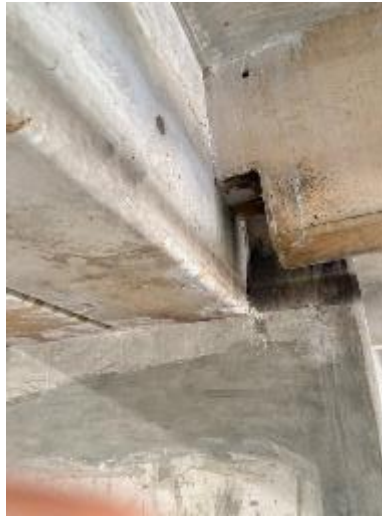
2B.2.3 Typical dapped ends of precast joists in garage at high-rise building, no deficiencies observed.

Figure 2B.2.3 Precast joists

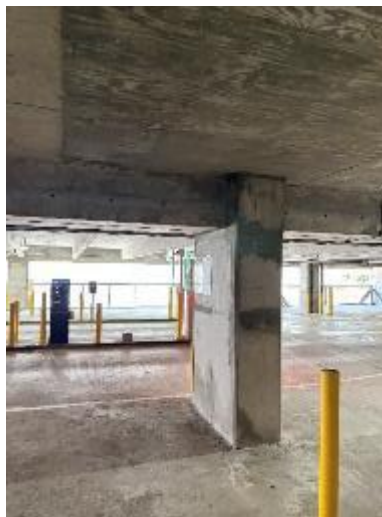
2B.2.4 Typical slab, beam, and girder areas at garage in high-rise building, no deficiencies observed.

Figure 2B.2.4 Garage structure

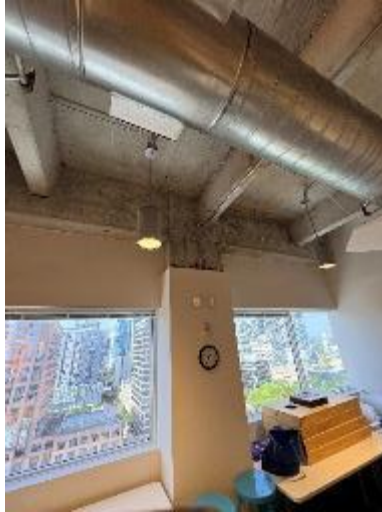
2B.2.5 Interior office framing at high-rise office building, no deficiencies observed.

Figure 2B.2.5 Interior framing

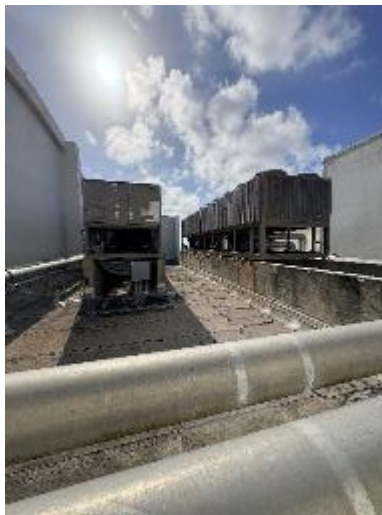
2B.2.6 Rooftop mechanical equipment bases at high-rise building, some exhibiting normal corrosion and should be repaired as needed.

Figure 2B.2.6 Rooftop equipment

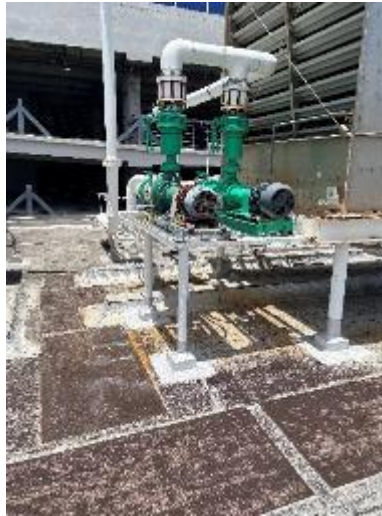
2B.2.7 Chiller frame and pump bases on low-rise building exhibiting corrosion and some section loss will need structural repair.

Figure 2B.2.7 Corrosion at chiller frame/pump bases

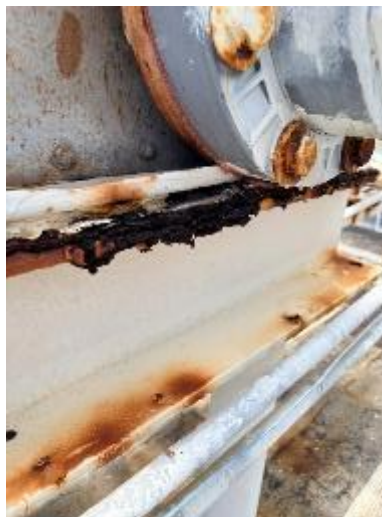
2B.2.8 Chiller frame and pump bases on low-rise building exhibiting corrosion and some section loss will need structural repair.

Figure 2B.2.8 Corrosion at chiller frame/pump bases

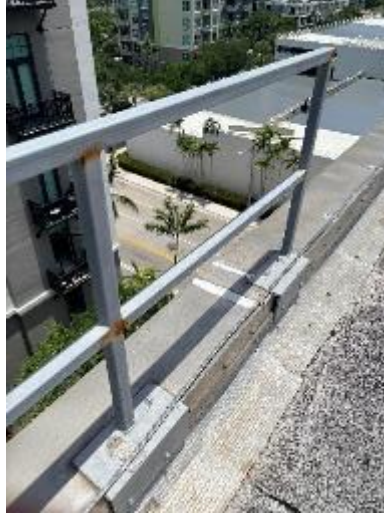
2B.2.9 Some mild corrosion at railing welds need to be scrubbed and recoated.

Figure 2B.2.9 Corrosion at railing welds

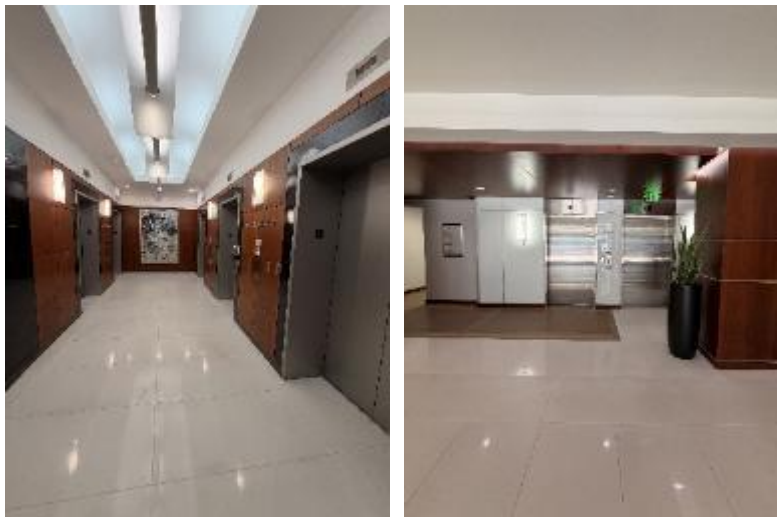
2B.3.1. Elevators interior cab dimensions are 65x80 inches at the main tower, and 50x79 inches at the Center building.

Figure 2B.3.1 Elevator Lobby

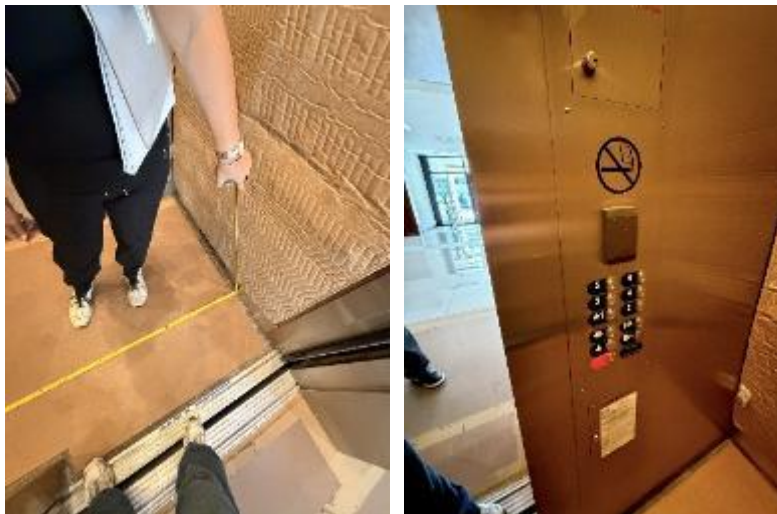
2B.3.2. The elevators can accommodate an ambulance stretcher 76 inches long by 24 inches wide in the horizontal position, as required by Florida building code.

Figure 2B.3.2 Elevator

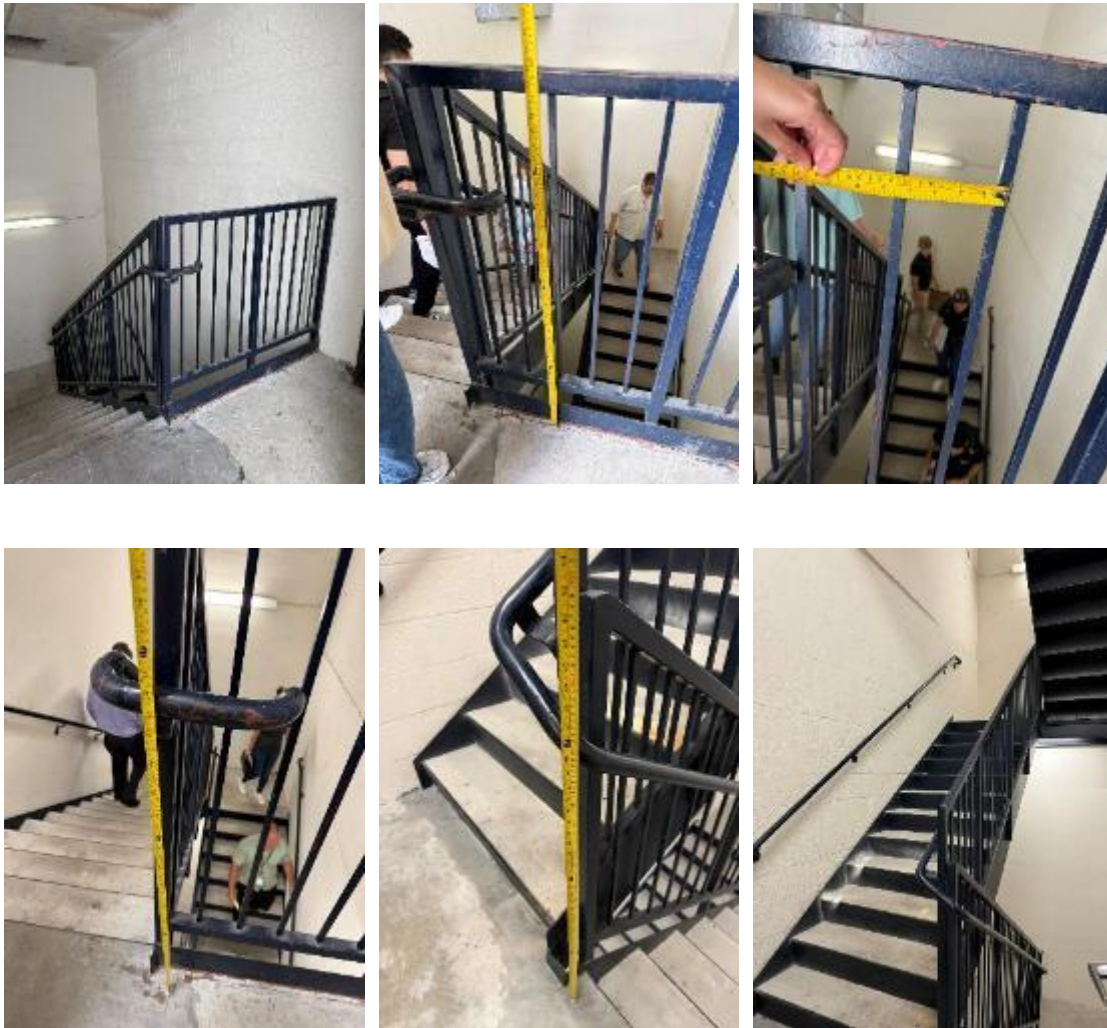
2B.3.3. Stairwells have guardrails at 42" A.F.F. and handrails are of varying heights. Most handrail extensions do not comply (too short in height or length) with current building code.

Figure 2B.3.3 Stair Guardrails & Handrails

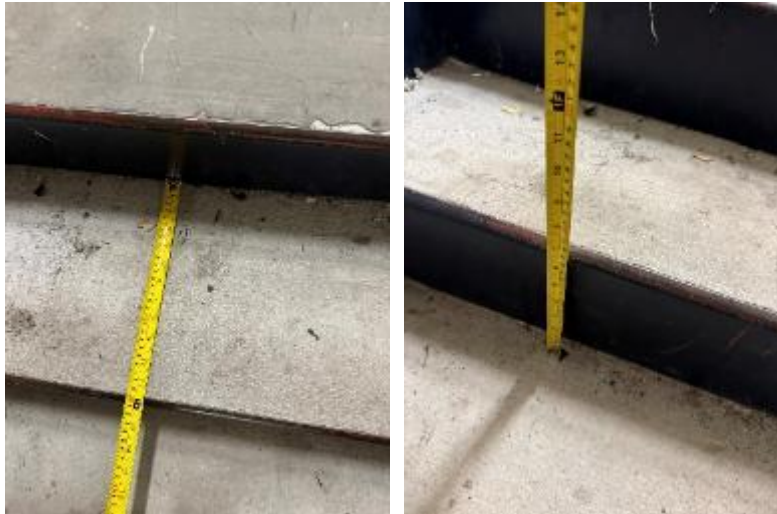
2B.3.4. Stair treads are 12" and risers are 7" complying with current building code.

Figure 2B.3.4 Stair Guardrails & Handrails

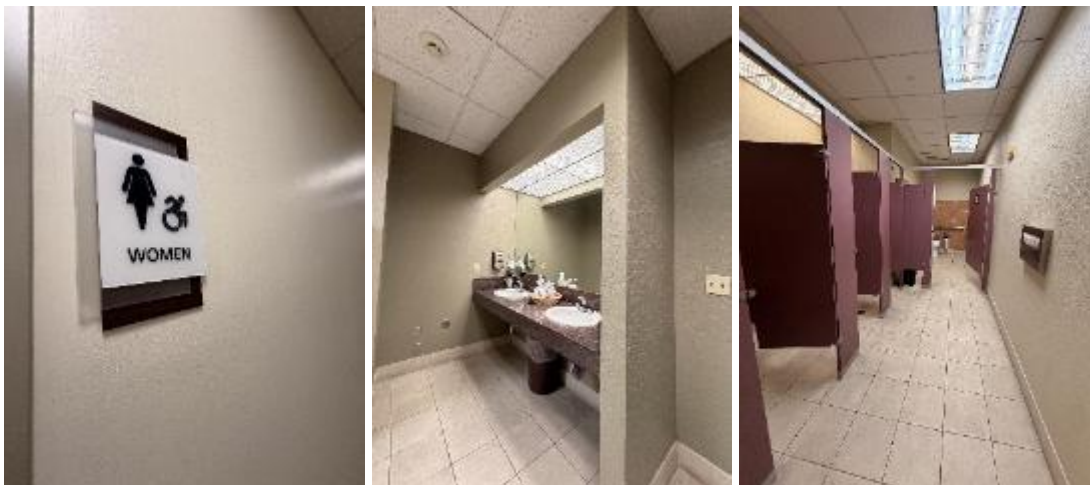
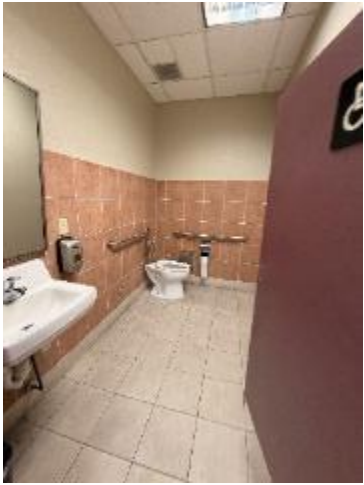
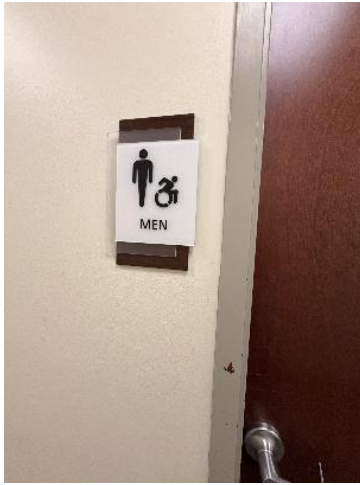
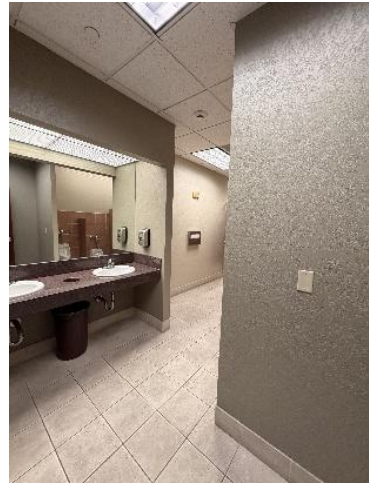
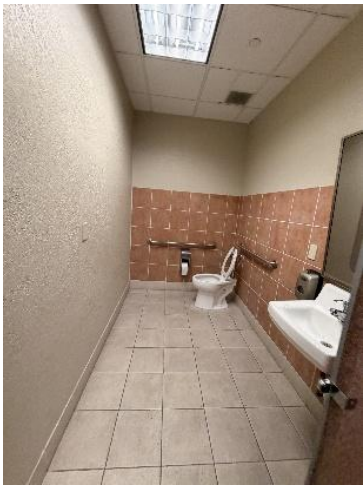
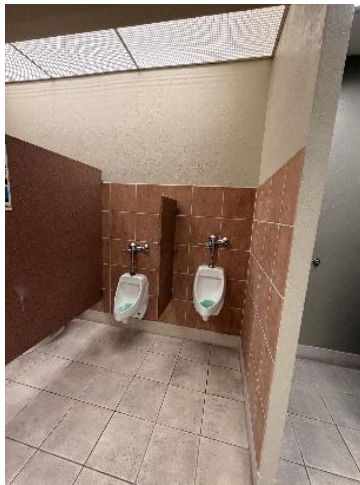
2B.3.5. All floors have accessible toilets and Hi-lo water fountains in the corridor complying with ADA requirements. However, some accessories at the ADA toilet compartments are mounted at incorrect / different heights. General observation of the restrooms indicate that renovations are not uniform, and some restrooms have not undergone any renovation. If a cohesive appearance is desired, new finishes and accessories, including flooring, tile, toilet partitions and vanities, would be necessary. No plumbing rework would be required unless the plumbing count is insufficient due to the new occupancy count.

Figure 2B.3.4 Restrooms (Women; Men next page)

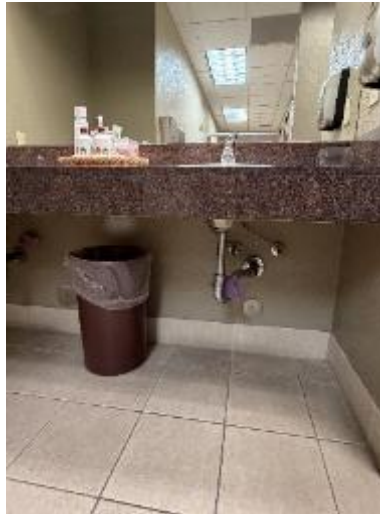
2B.3.6. Some vanities are missing ADA-required pipe protection underneath the sink.

Figure 2B.3.6 No pipe protection
