# City of Fort Lauderdale Comparative Facility Analysis Report

*An Assessment of Three Existing Buildings for Potential  
Conversion to a New City Hall*

City of Fort Lauderdale, Florida

June 18, 2026

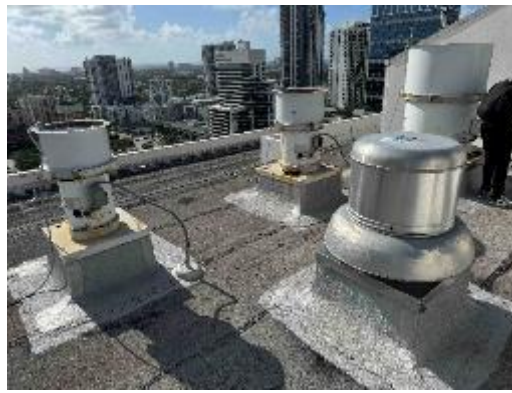
2B.4.6 Exhaust Fans (EFs): EF-7 manufactured in 2023, in very good condition, no action required at this time.

**Figure 2B.4.6 Exhaust fans**

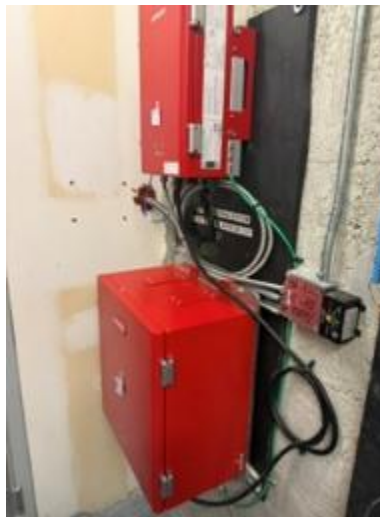
2B.5.2 New Bi-directional amplifier is installed throughout the building, however some initiating devices were not included.

**Figure 2B.5.2 Bi-directional amplifier**

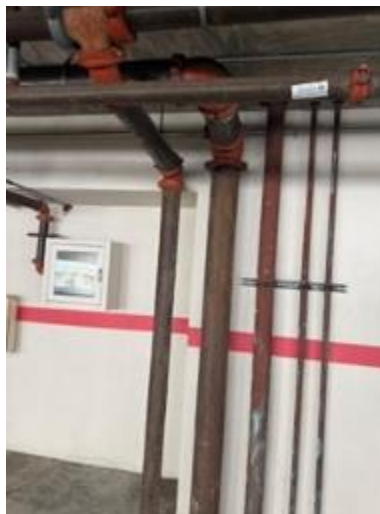
- 2B.5.3 Fire sprinkler and standpipe systems overall in good condition with exception of parking garage. Original fire sprinkler system installed in 1986 with multiple zoned upgrades over time.
- 2B.5.4 Parking Garage – Surface rust was observed on piping risers and mains. Galvanized branch lines and sprinkler heads have minor oxidation. Limited sections of pipe and fitting show pitting from oxidation. Replacement of pitted components is recommended.
- 2B.5.5 Chiller Pump Room – Sprinkler piping is corroded and needs to be replaced (2 branch lines, 2 cross mains)

**Figure 2B.5.5 Corroded Piping**

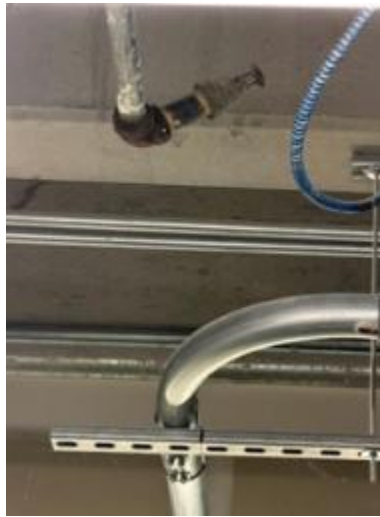
- 2B.5.6 17<sup>th</sup> Floor Electrical – Sprinkler is misaligned. Needs piping repair.

**Figure 2B.5.6 Misaligned Sprinkler**

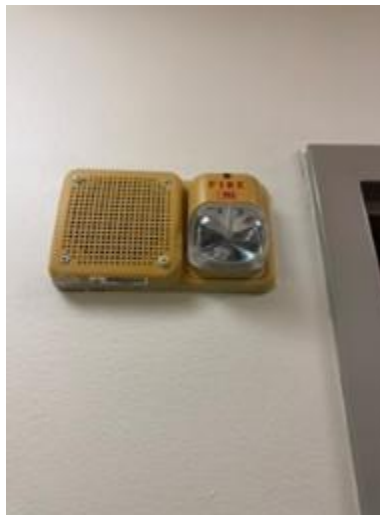
- 2B.5.7 14<sup>th</sup> Floor Electrical – Four fire stopping issues within room
- 2B.5.8 14<sup>th</sup> Floor South Stair – Broken door closer.
- 2B.5.9 14<sup>th</sup> Floor – Replace old speaker strobes on floor

**Figure 2B.5.9 Old NAC**

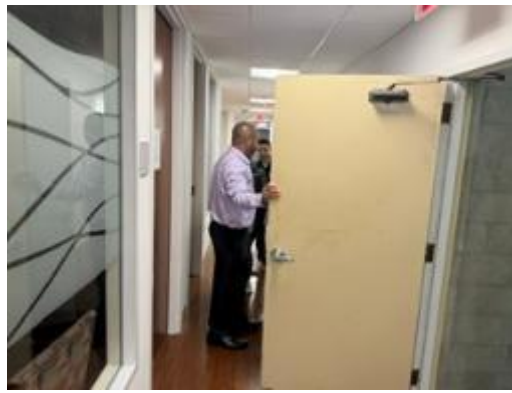
- 2B.5.10 7<sup>th</sup> Floor Parking Garage – Clearance height issue with sprinkler piping across drive.
- 2B.5.11 1<sup>st</sup> Floor Drawing Room – Room is partially sprinklered.
- 2B.5.12 Generator Room – Sprinklers are over-spaced.
- 2B.5.13 Loading Area – Remote inspectors test connection has been painted over.
- 2B.5.14 South Stair – No sprinklers at top of stair shaft. Stair signage missing, all floors.
- 2B.5.15 6<sup>th</sup> Floor Sprinkler FCA – pressure gauge missing, old/poor condition butterball control valve needs to be replaced.
- 2B.5.16 North Stair – Top of stair shaft is partially sprinklered. Stair signage missing, all floors.
- 2B.5.17 5<sup>th</sup> Floor Mechanical – Large holes found in fire wall
- 2B.5.18 4<sup>th</sup> Floor Core – Found 2 doors swing greater than 50% open to the egress corridor.

**Figure 2B.5.18 Egress Door**

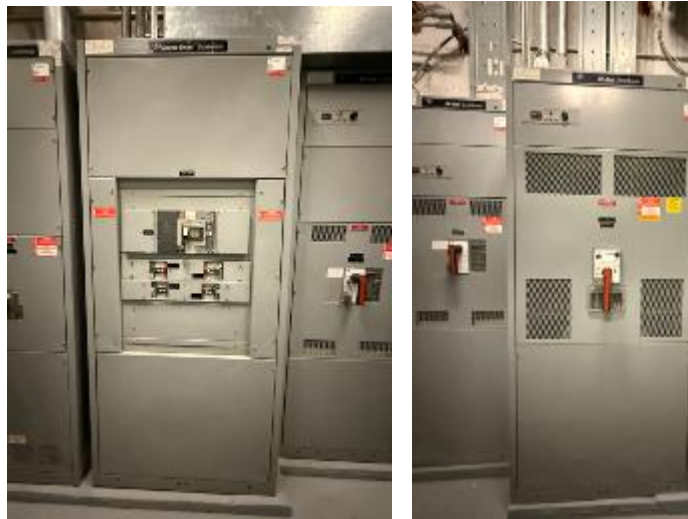
2B.6.1. The primary electrical distribution equipment serving the Tower appears generally well maintained and operational.

**Figure 2B.6.1 Electrical distribution equipment (Tower)**

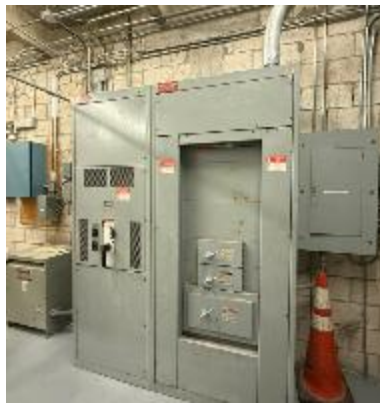
2B.6.2. The electrical distribution equipment serving the Center appears older than the equipment serving the Tower but generally remains operational and functional.

**Figure 2B.6.2 Electrical distribution equipment (Center)**

2B.6.3. Due to the age of the Center electrical infrastructure and anticipated future municipal occupancy requirements, replacement of major portions of electrical distribution infrastructure should be considered as part of future modernization efforts.

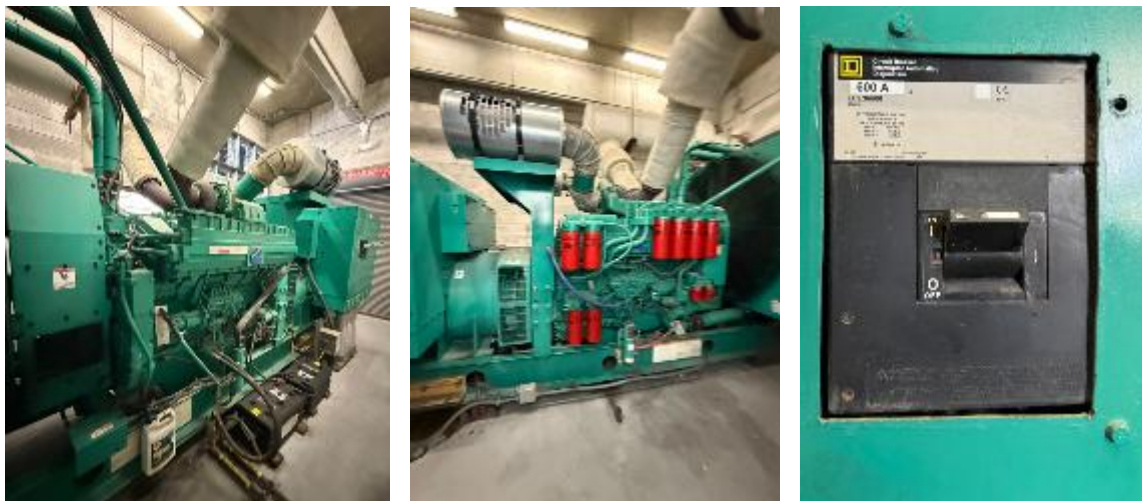
- 2B.6.13. The 900 kW emergency generator serving the Tower appears operational and generally well maintained based on available information and visual observations.

Figure 2B.6.13 Emergency generator serving the primary tower

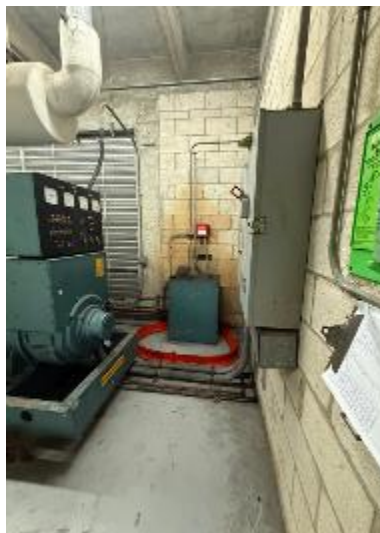
2B.6.15. A working clearance deficiency was observed within the Center's generator room where the main disconnect appears to have reduced clearance in front of the equipment.

**Figure 2B.6.15 Emergency generator working clearance (Center)**

2B.6.16. Due to the age of the equipment, limited remaining useful life, and future municipal occupancy requirements, replacement of the Center's generator and associated emergency power distribution infrastructure should be considered as part of future modernization efforts.

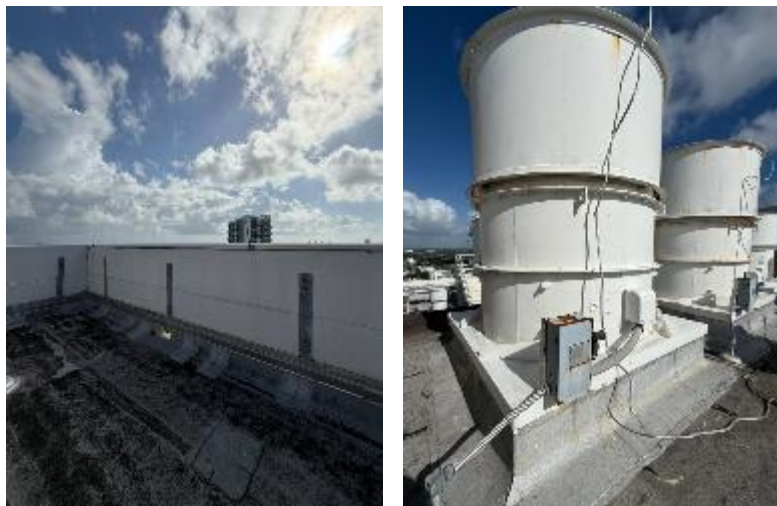
2B.6.18. The existing lightning protection system appears functional and generally serviceable based on visual observations.

**Figure 2B.6.21 Existing lightning protection on the roof**

2B.6.19. Portions of the system exhibit signs of age and weather exposure consistent with the age of the facility.

2B.6.21. Testing and verification of the lightning protection system are recommended to confirm continuity, grounding performance, and overall operational effectiveness.

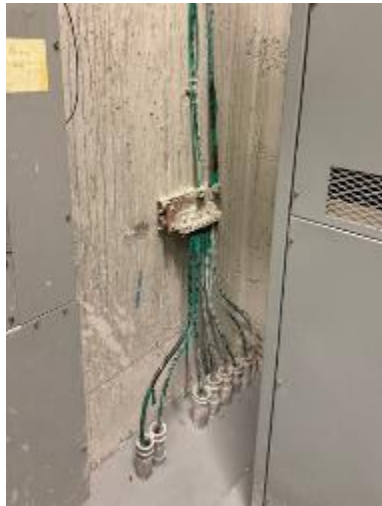
2B.6.20. Grounding bars were not visibly identified in all electrical and telecommunications rooms and should be verified during future renovations.

**Figure 2B.6.21 Grounding bar located in the main electrical room**

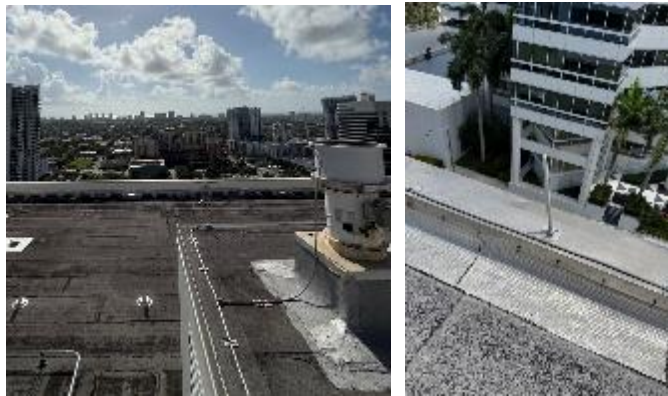
**Figure 2B.6.21 Existing Lightning Protection System**

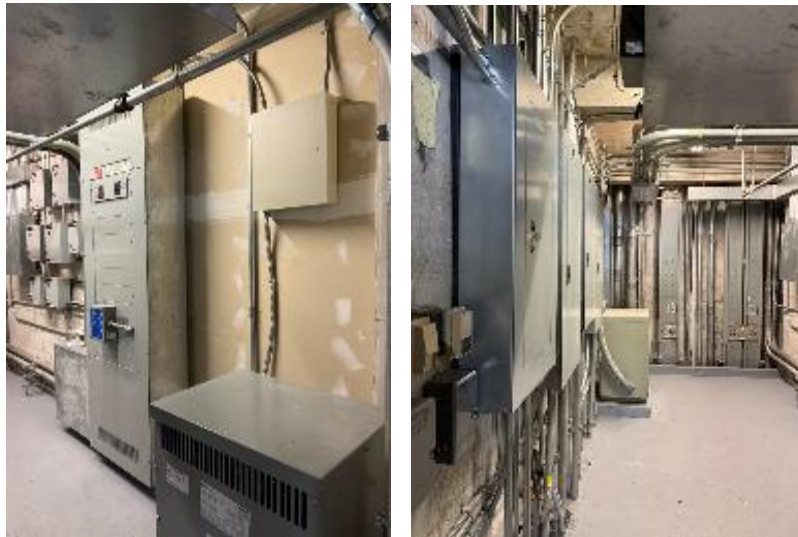
**Figure 2B.6.30 Electrical room in the Parking Garage**

- 2B.6.30. Future EV charging implementation will likely require construction of a new dedicated electrical room, or expansion of existing electrical rooms, to accommodate new EV charging infrastructure and associated electrical distribution equipment.

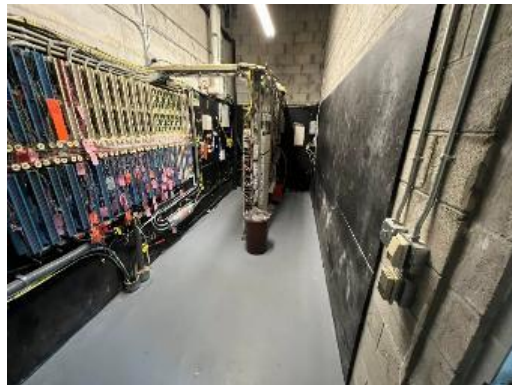
Figure 2B.7.6 Main telephone room

- 2B.7.5. The room has fluorescent light fixtures that should be upgraded to LED fixtures.
- 2B.7.6. The room door is secured with a manual key lock. Electronic access control and a video surveillance camera to view the door should be added.

- 2B.7.4. There did not appear to be a Telecommunication Main Grounding Busbar. If that is the case, one should be provided, bonded to the building's electrical service ground, to properly ground equipment, racks, cabinets, and cable trays.

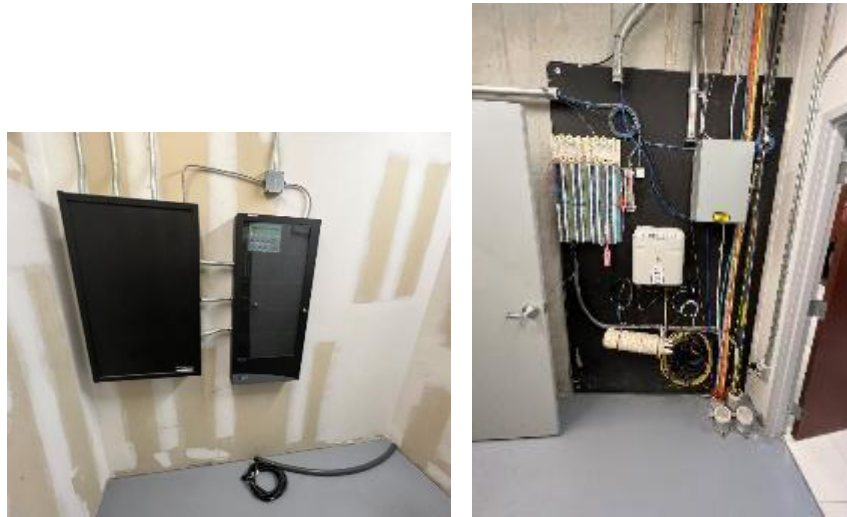
Figure 2B.7.7 Intermediate telephone rooms

- 2B.7.7. Each office floor has at least one Intermediate Telephone Room. These rooms house legacy copper riser cables, and leased service provider equipment and fiber optic cables.

- 2B.7.8. Fire alarm system panels are also located in some of these closets (i.e., 18th floor). These telephone rooms have plywood on the walls for mounting equipment, riser cores through the floors and ceilings, and additional penetrations for horizontal cables. All of the closets were warm, with no HVAC. Similar to the first floor main telephone closet, these closets have a fluorescent light fixture, manual key lock, have unused cables and equipment, have no video surveillance camera nor electronic access control. Upgrades proposed for the first floor main telephone closet should be implemented for these closets as well.

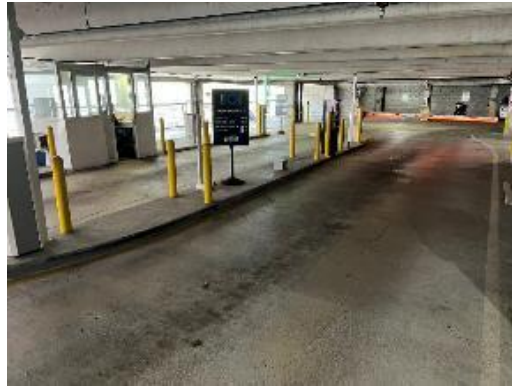
Figure 2B.7.12 Parking garage

- 2B.7.11. There is a security desk located on the first floor Visitors check in, provide their license, and are added to a visitors list.
- 2B.7.12. The parking garage has license plate recognition cameras at the lift arm gates, monitoring vehicles entering and existing the garage. The system appears to be operational and in a state of good repair.

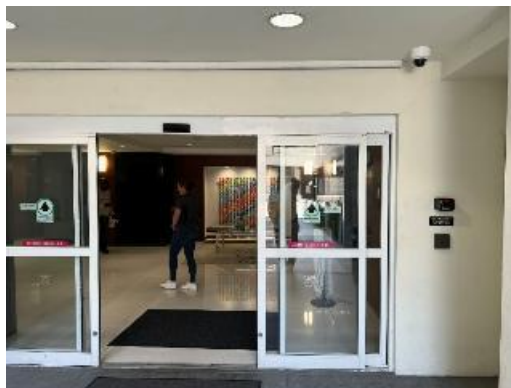
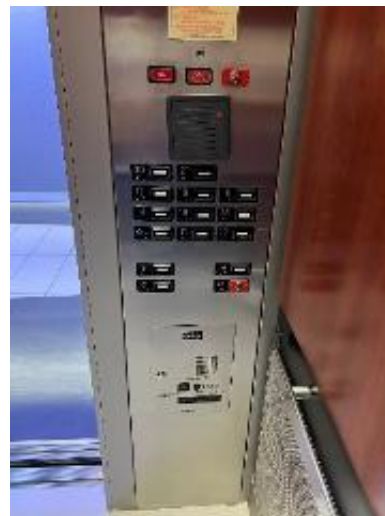
Figure 2B.7.14 Front Entrance & Elevator cab

- 2B.7.13. The Building Management company has video surveillance cameras on the exterior and interior of the building. The cameras are connected to a local video management system (VMS) and network video recorder (NVR). The video surveillance system is manufactured by Hikvision, a Chinese company, and is generally not allowed for use in federal and state government locations, and most likely will need to be replaced. There is a dedicated viewing station at the security desk. The VMS provides the viewing of live and recorded video streams.
- 2B.7.14. The Building Management company has electronic access control (card readers) on the exterior perimeter doors that lead into the lobby and within the elevator cabs.

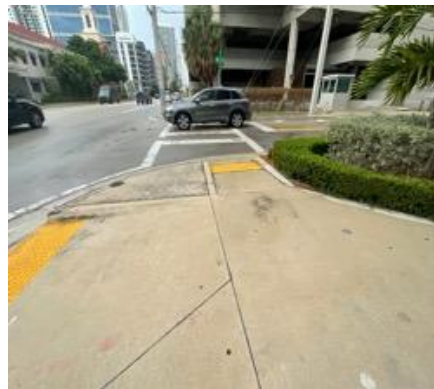
Figure 2B.8.3 Curb ramp

2B.8.2 ADA compliant curb ramps exist at the intersection adjacent to the building, at NE 1st St/NE 3rd Av. This ramp is located within the public right-of-way and is maintained by the City of Fort Lauderdale.

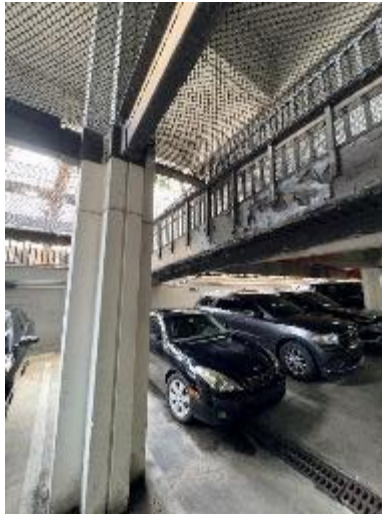
2C.2.1. Bridge paint peeling and sooty appearance in garage may indicate previous small fire.

Figure 2C.2.1 Bridge surface appearance

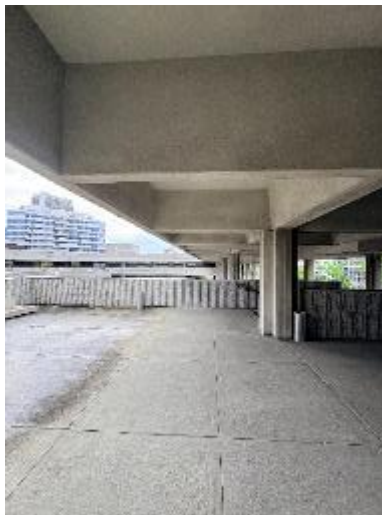
2C.2.2. Typical exterior precast soffits appear to be in good condition.

Figure 2C.2.2 Typical exterior precast soffits

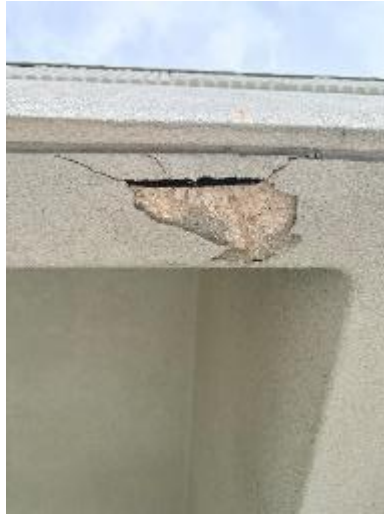
2C.2.3. Spalling observed at exterior framing edges.

**Figure 2C.2.3 Spalling at exterior framing edges**

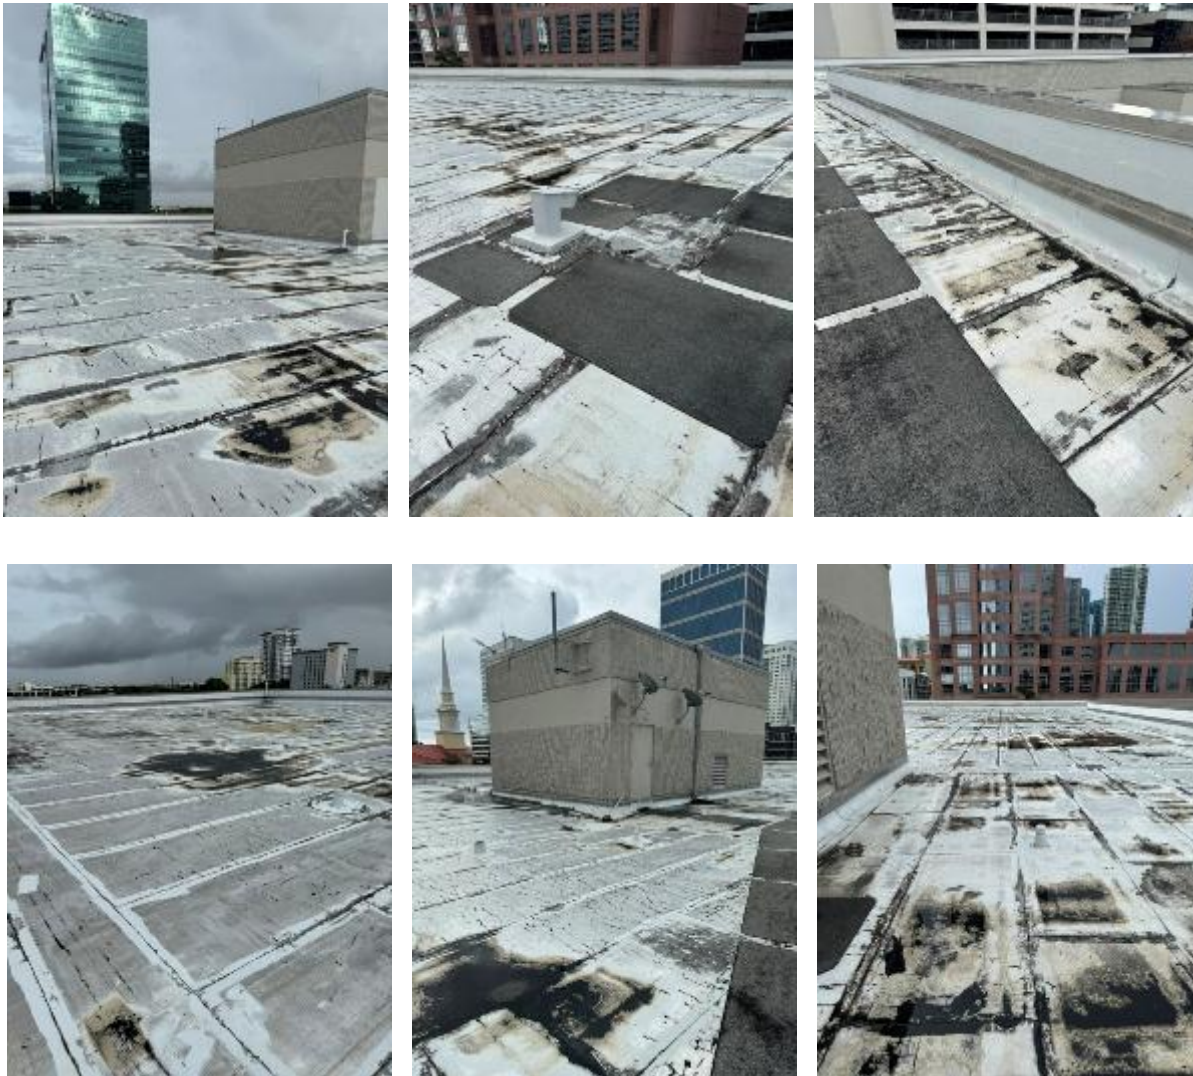
**Figure 2C.3.6 Roof**

The roof was replaced in approximately 2014, however flashing was replaced more recently and is in good condition. The roof membrane (unknown type) is presently in poor condition. While no active leaks or evidence of leaks were observed, maintenance personnel stated that there have been leaks within the last year that have been repaired, near an expansion joint on the north side of the building.

2C.3.6. Roof membrane in poor condition, several tears and areas of ponding observed; ample roof drains visible. Visible lower-level roofs appear to be in same condition.

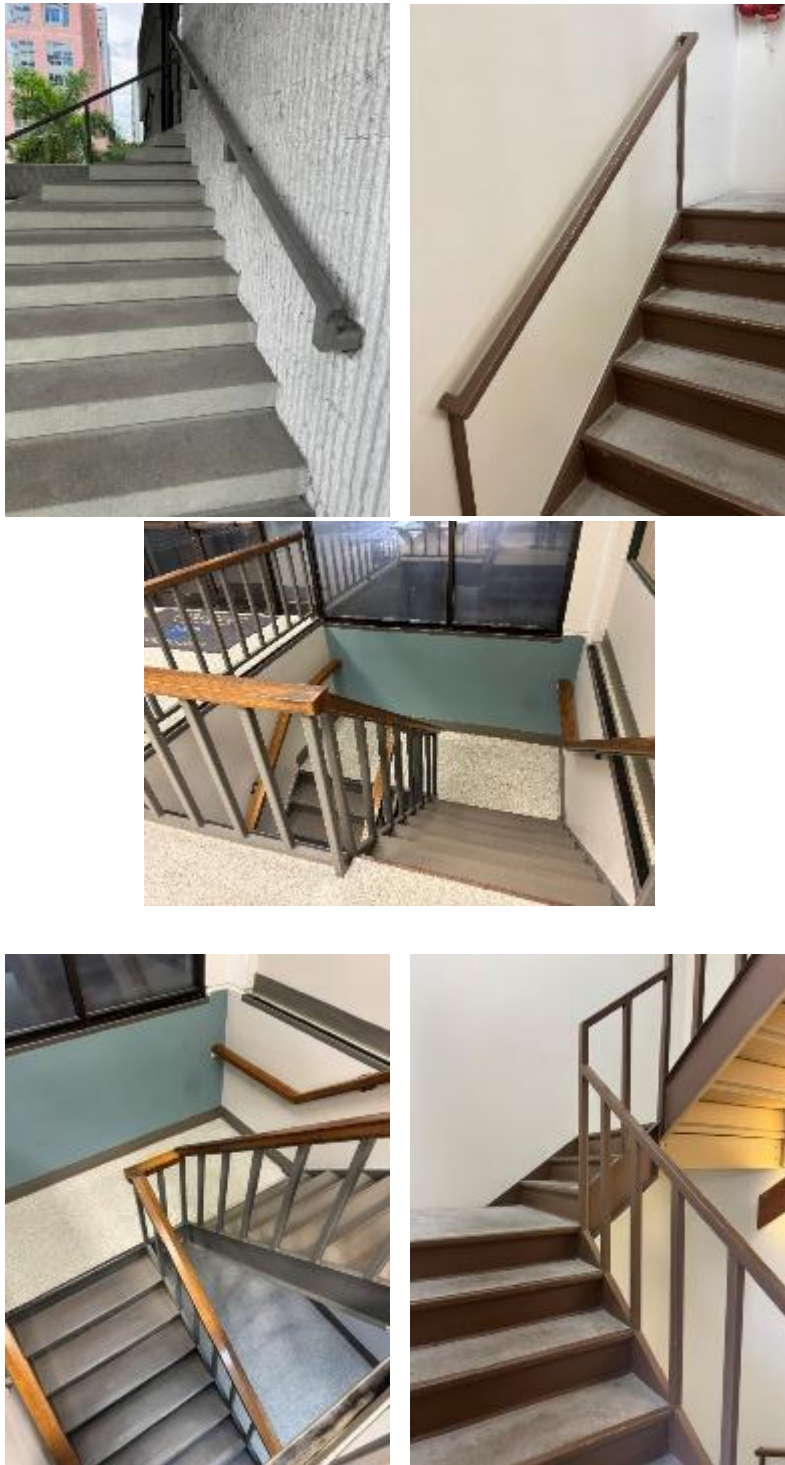
Figure 2C.3.9 Stairs

2C.3.8. Stair risers are 8", exceeding building code required 7" maximum.

2C.3.9. Stairs do not have code-compliant guardrail/handrail systems; guards are not present along flights and are too low around open stairs (36" where 42" is required), most handrails do not have required extensions and are of varying heights.

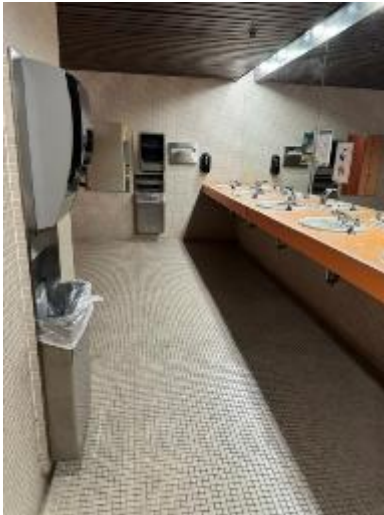
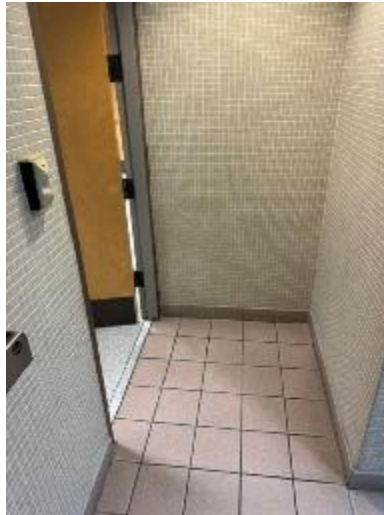
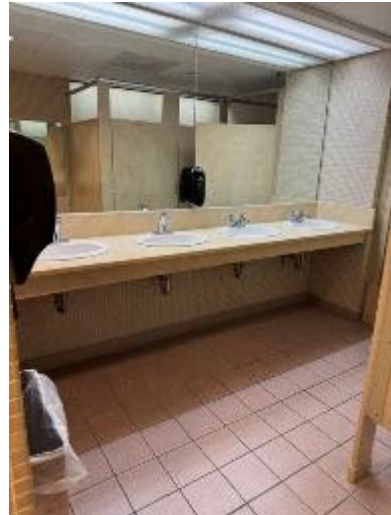
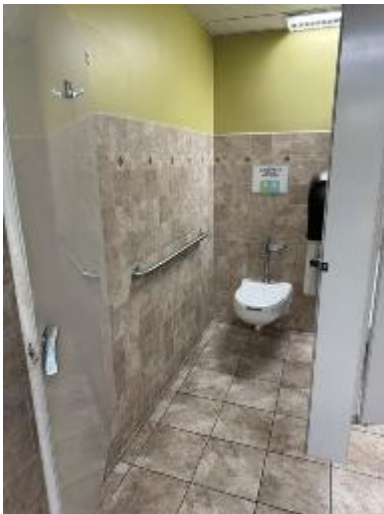
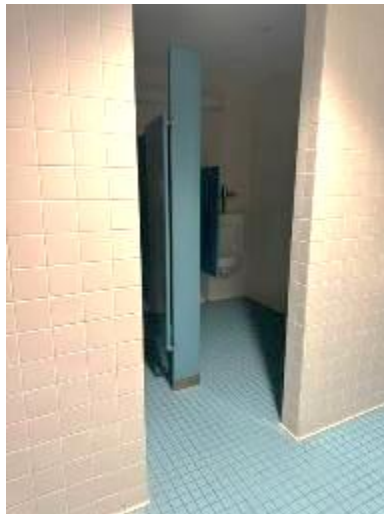
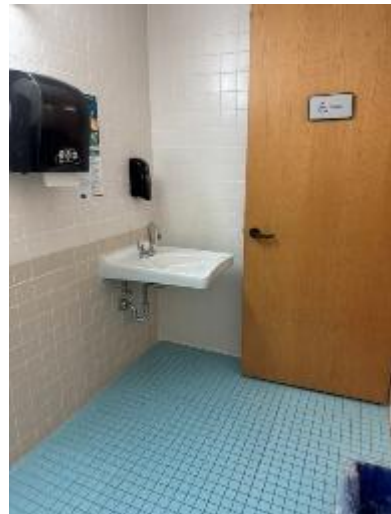
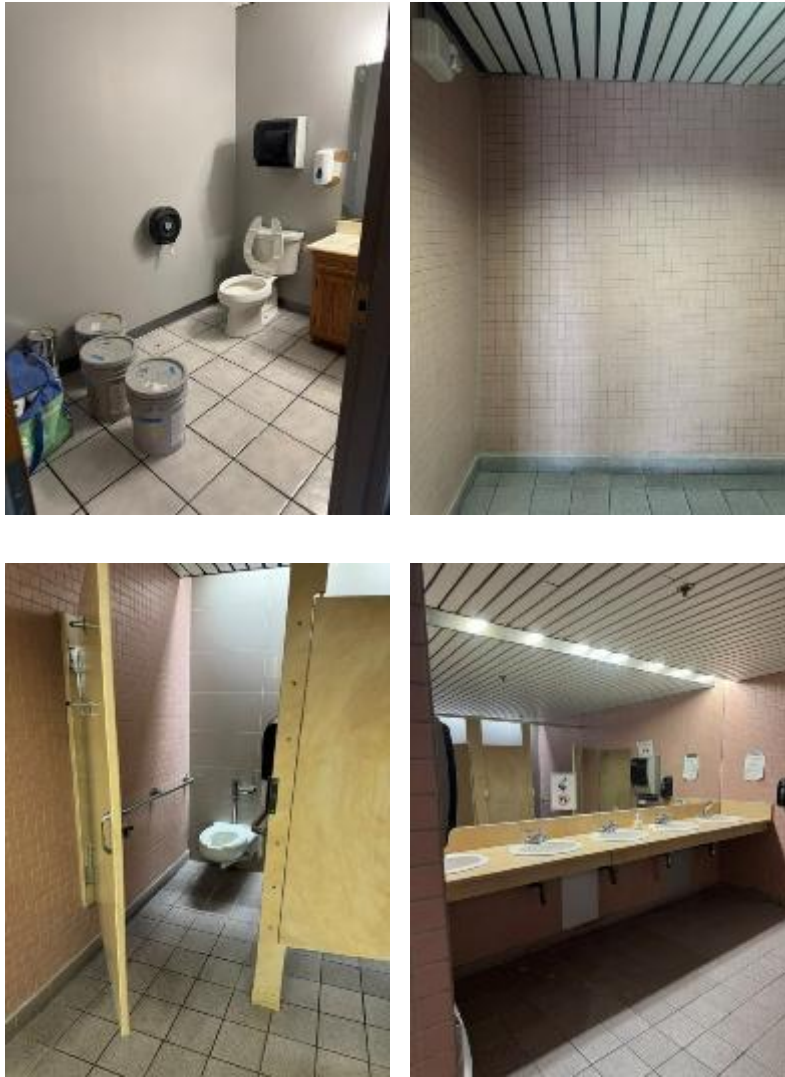
Figure 2C.3.14 Restrooms

- 2C.3.10. Restrooms: most are not fully compliant with ADA, with no wheelchair accessible stalls in any of the public restrooms, several had no under sink pipe protection; most do have an ambulatory stall.
- 2C.3.11. First floor multi-user restrooms do not have adequate maneuvering clearance at entry.
- 2C.3.12. Single-user toilet rooms scattered throughout with varying levels of ADA-compliance, e.g. grab bars too high at 40" to top, door swing almost hitting sink.
- 2C.3.13. Jury room multi-user restroom does not have required clearances (single-user provided nearby but not fully compliant).
- 2C.3.14. Restroom finishes are dated and, in most cases, in subpar condition; aluminum slat ceilings sagging in several areas.

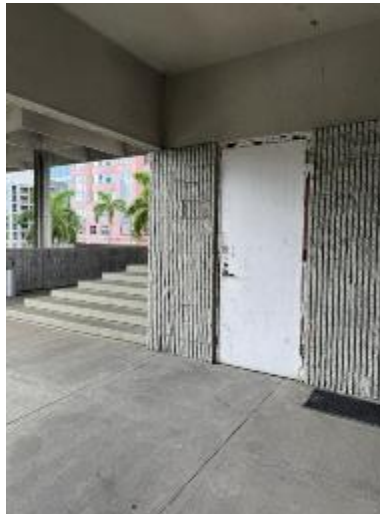
2C.3.15. Exterior flush doors exhibit visible rust and peeling paint and corrosion on hardware.

**Figure 2C.3.15 Typical Exterior Door**

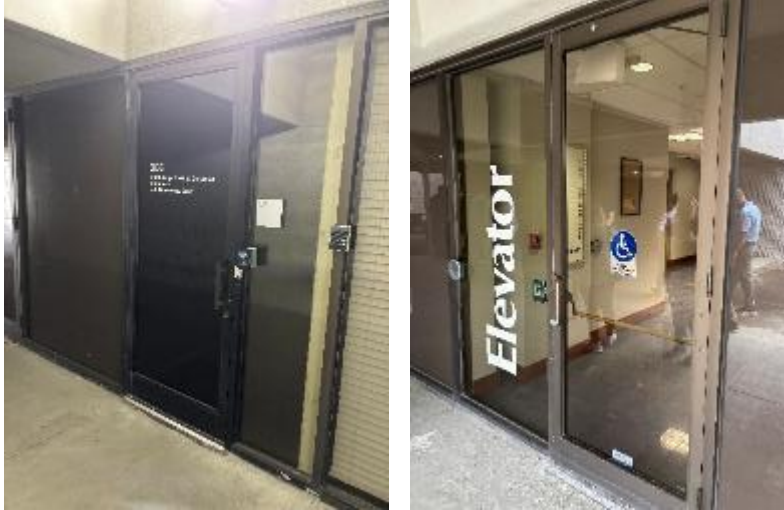
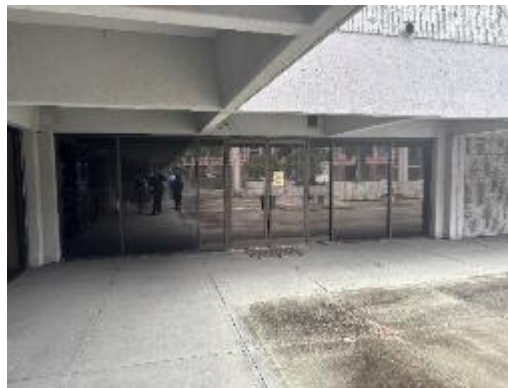
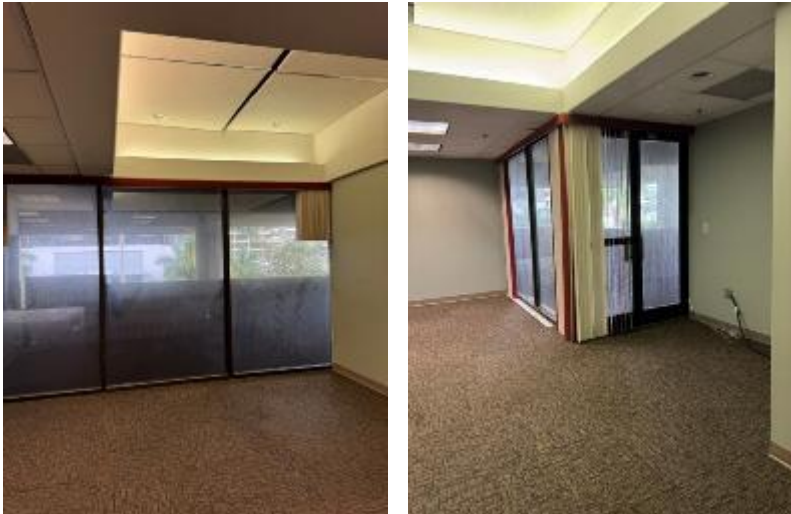
**Figure 2C.3.18 Storefront Systems and Doors**

- 2C.3.16. Doors leading to interior spaces from the exterior terraces are heavy, not ADA-compliant, but necessary for exterior security and weather resistance.
- 2C.3.17. Doors in exterior facing storefront are generally not air-tight and allow noticeable noise intrusion.
- 2C.3.18. Storefront window/door systems appear to be original to building, in good condition overall, but likely not impact resistant nor energy efficient.

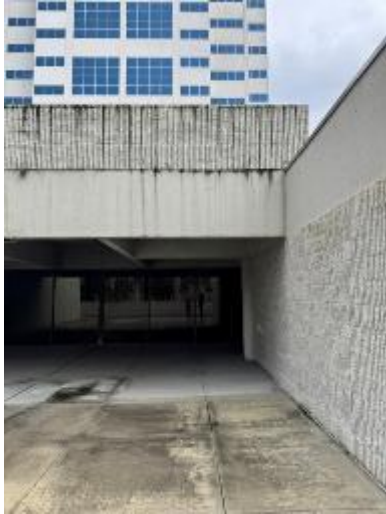
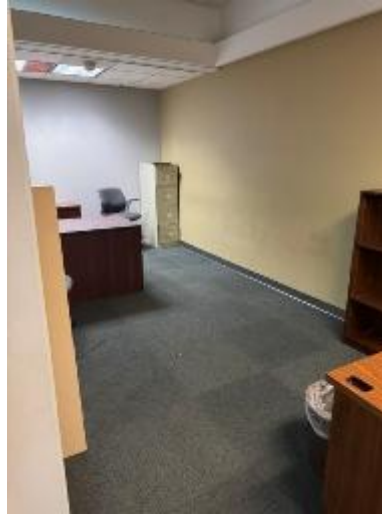
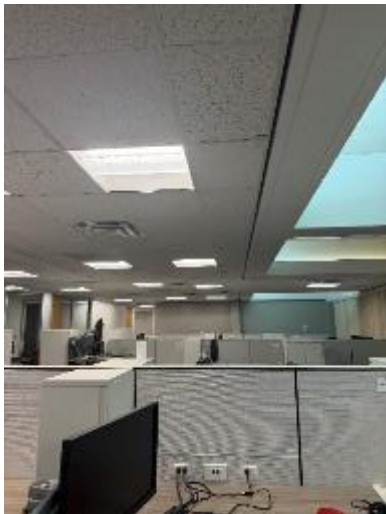
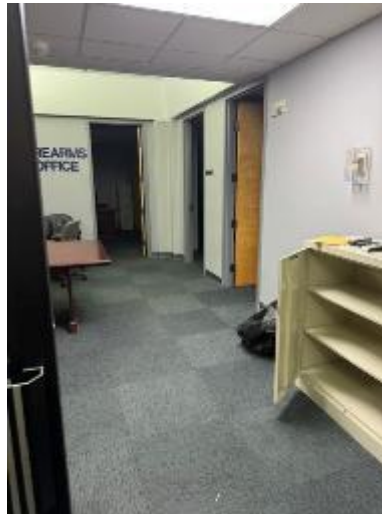
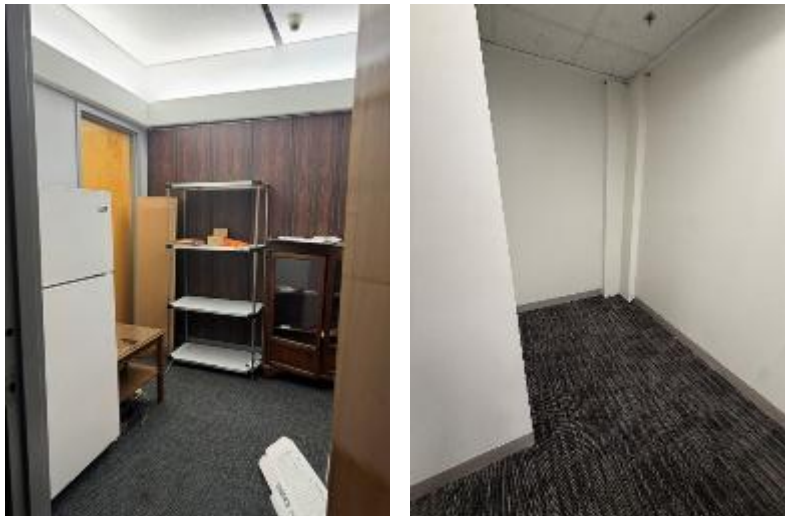
Figure 2C.3.21 Interior Spaces

- 2C.3.19. Some interior spaces have strong musty odor indicating presence of mold; none observed.
- 2C.3.20. Interior spaces are dark due to deep overhangs at storefronts and no other windows.
- 2C.3.21. Interior spaces are not configured well for flexibility or adaptation of space to other uses; many rooms require egress through adjacent rooms to reach the exterior.

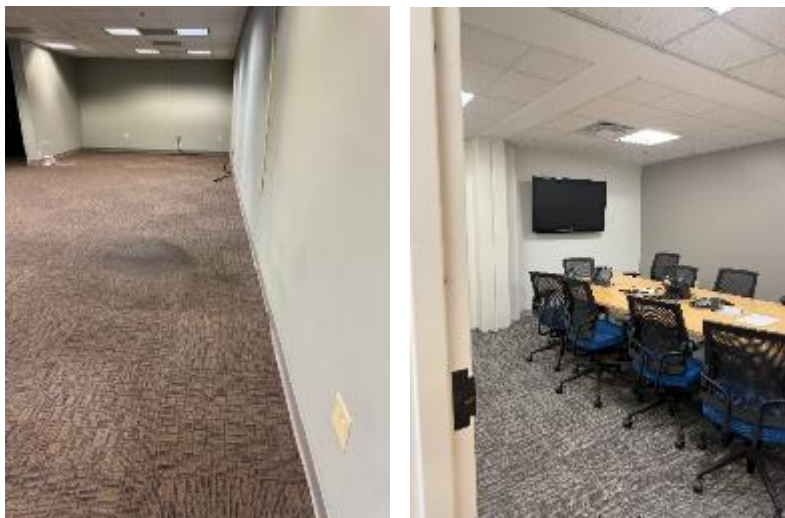
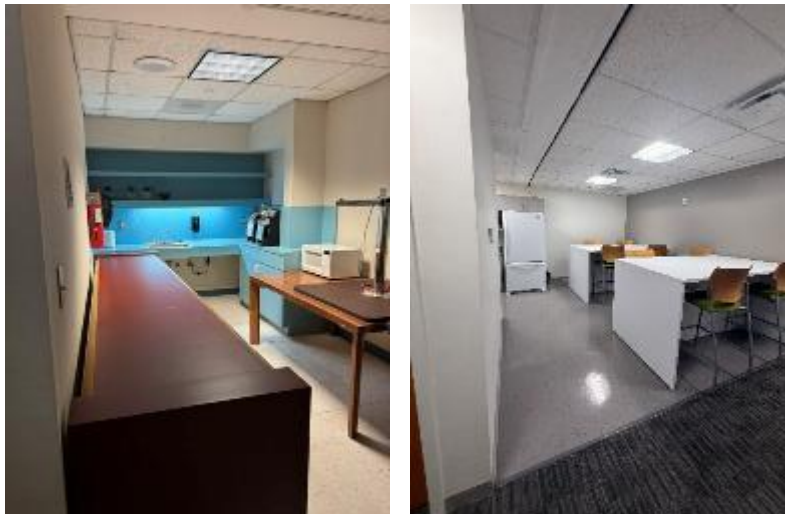
Figure 2C.3.23 Interior Finishes

- 2C.3.22. Security-hardened areas used by US Marshals would require significant, challenging renovation; includes vault, several holding cells, secure elevator (original to building), sally port.
- 2C.3.23. Interior finishes in most spaces are dated, in varying condition from poor to fair. A notable exception is the wood slat wall finish (in several courtrooms) is in very good condition, although with spaces reconfigured for different use, the wood slat walls would likely require removal.

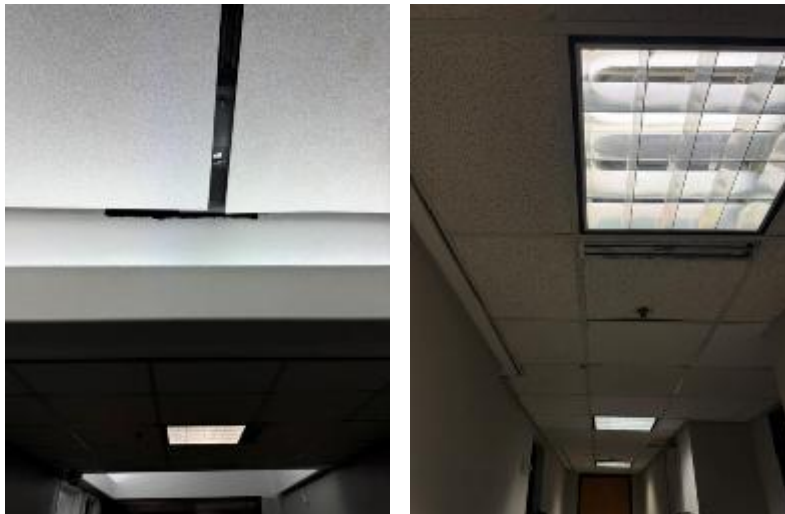
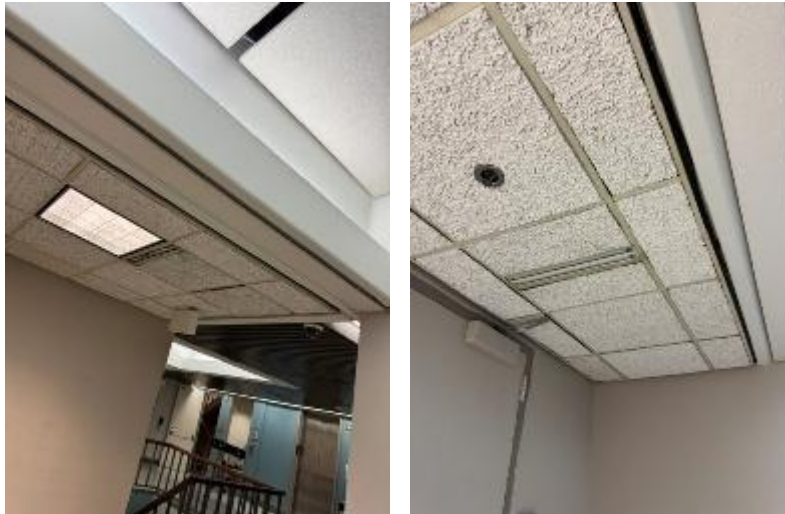
Figure 2C.3.25 Ceilings

- 2C.3.24. Interior doors vary in material and condition, ranging from poor to good; many have non-ADA compliant hardware.
- 2C.3.25. Ceilings are mostly suspended grid systems, with aluminum slat or acoustic ceiling tiles, in varying condition, from poor to good.

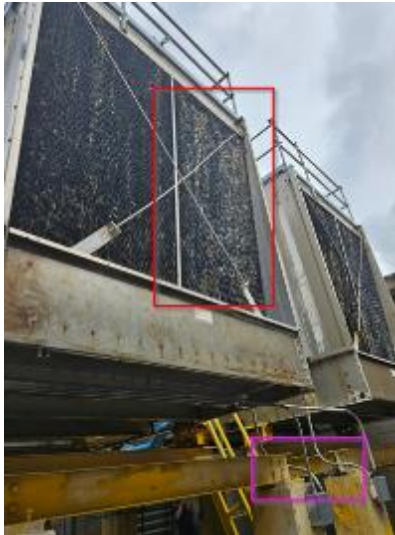
- 2C.4.1. Most of the air handling units (approx. 2 per floor), though they are well maintained, are advised for replacement. One Trane unit was dated to a manufactured year of 1995. This would suggest a 31 year old unit which is well beyond the equipment life expectancy (ASHRAE).
- 2C.4.2. The two cooling towers are in need of major repair or possible full replacement.

Figure 2C.4.2 Cooling tower fouling (red) and rusted framing (magenta)

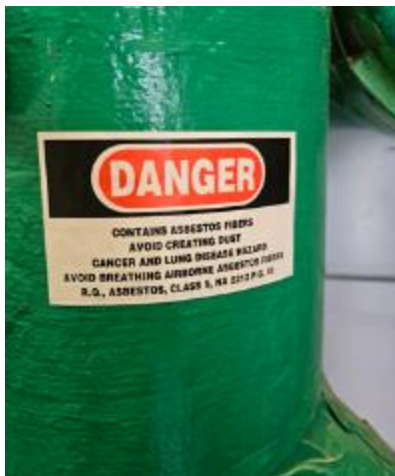
- 2C.4.3. Most of the insulation is indicated to have asbestos fibers and is recommended for replacement.

Figure 2C.4.3 Sample label on insulation

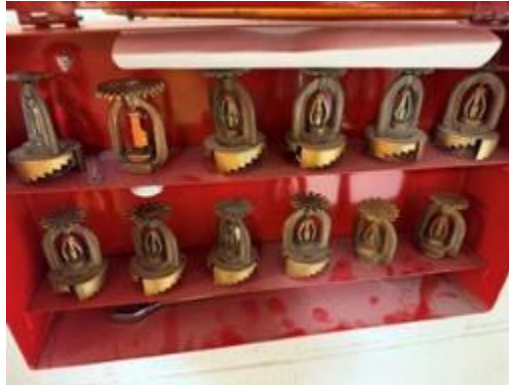
Figure 4.1- Sprinkler head cabinet

- 2C.5.1. General Comment – Original fire sprinkler piping is coated with lead paint. Replacing existing system may need lead abatement.
- 2C.5.2. General Comment – Many original fire sprinklers (solder link type) installed in the existing system are old and is nearing replacement. Per NFPA 25 Standard response, standard coverage type sprinklers should be replaced 50 years.

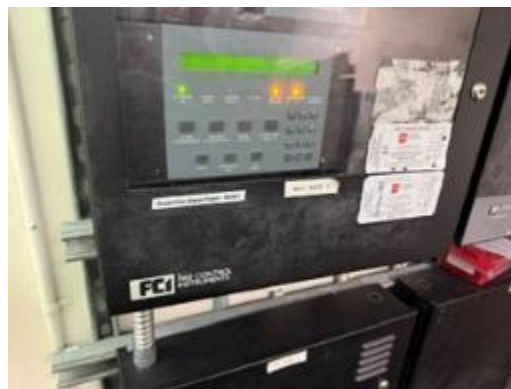
Figure 4.3.2- Fire Alarm Control Panel

- 2C.5.3. General Comment – Significant fire stopping issues (floor and fire wall) throughout the building.
- 2C.5.4. General Comment - Due to the age of the existing fire alarm/voice evacuation system recommend replacing the fire alarm control panel. NAC booster panels and transceiver has been recently replaced and is in good condition.

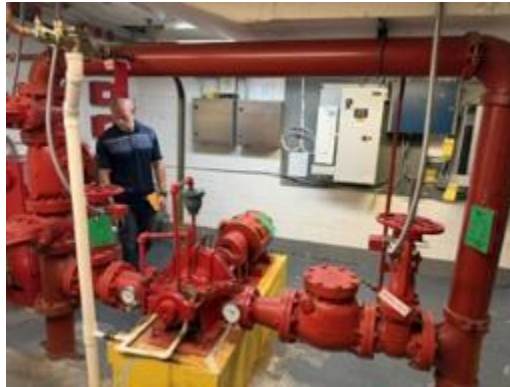
**Figure 4.3.3- Fire Pump Room**

2C.5.13. Fire Pump Room – No jockey pump provided for fire pump. Makeup pressure connection is tapped on the bypass line with a domestic water connection.

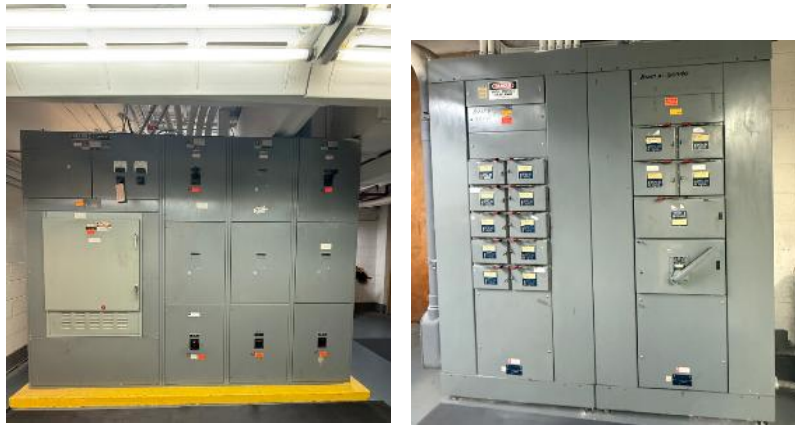
Figure 2C.6.1 Electrical distribution equipment

The overall condition of the electrical infrastructure is considered poor when compared to modern facilities. Significant portions of the electrical distribution system appear to be approaching or exceeding their anticipated service life.

- 2C.6.1. The existing electrical distribution system appears significantly aged and exhibits signs of long-term service.
- 2C.6.2. Multiple panelboards appear outdated and contain incomplete or missing panel schedules and circuit identification.
- 2C.6.3. Due to the age of the infrastructure and anticipated future municipal occupancy requirements, replacement of major portions of the electrical distribution system should be anticipated.
- 2C.6.4. Existing switchgear, panelboards, transformers, and associated distribution equipment appear to be approaching the end of their useful life.
- 2C.6.5. Surge Protective Devices (SPD) were not visibly identified on major distribution equipment and are recommended as part of future modernization efforts

Approximately 75% to 90% of the electrical infrastructure should be assumed to require replacement, major modification, or modernization as part of future municipal occupancy improvements.

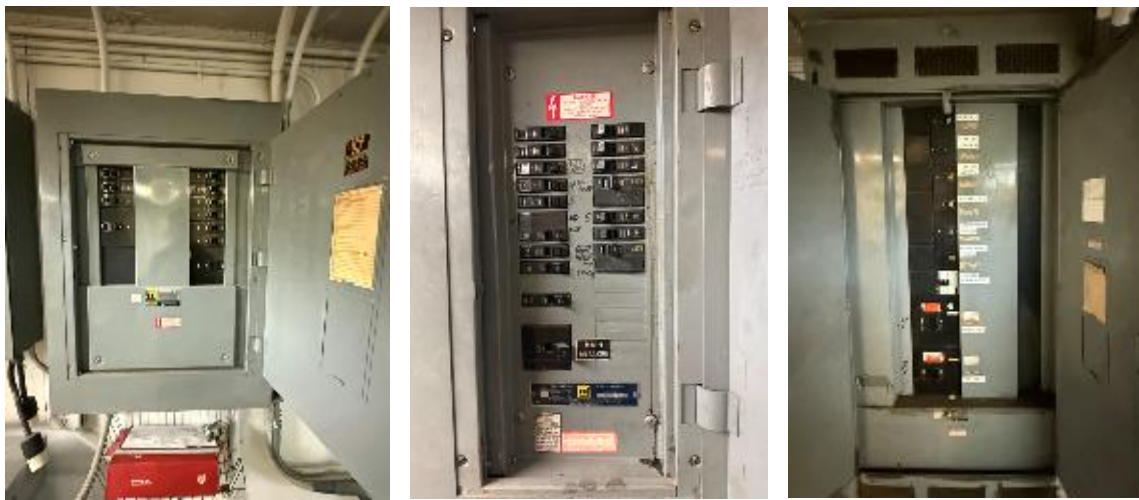
Figure 2C.6.2 Condition of existing electrical panels

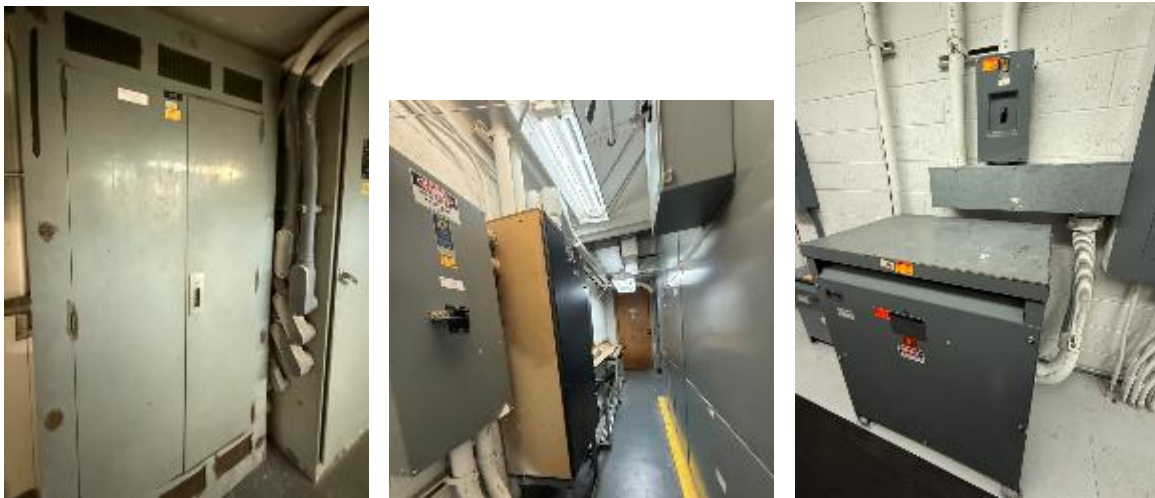
Figure 2C.6.4 Examples of existing electrical panels and transformer conditions

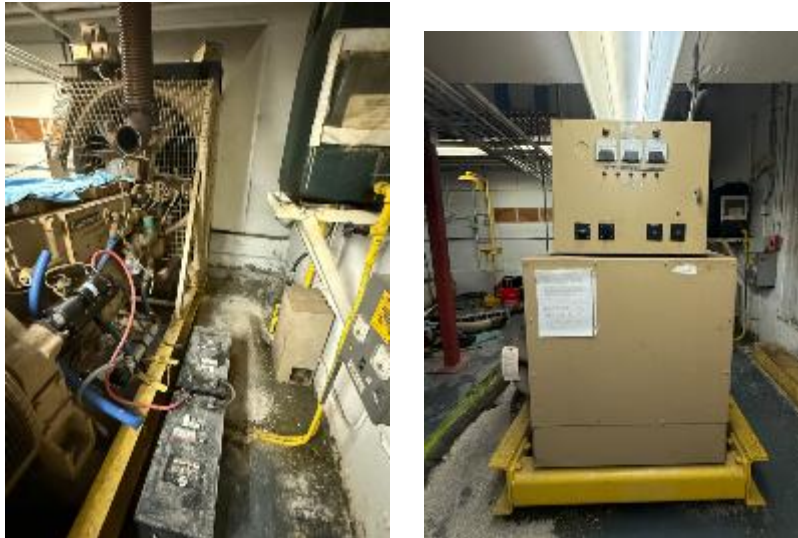
Figure 2C.6.16 Existing electrical generator

2C.6.17. Based on visual observations and available information, the remaining useful life of the existing generator is estimated to be approximately five years.

2C.6.18. Replacement of the existing generator and associated emergency power distribution equipment should be anticipated as part of future modernization efforts.

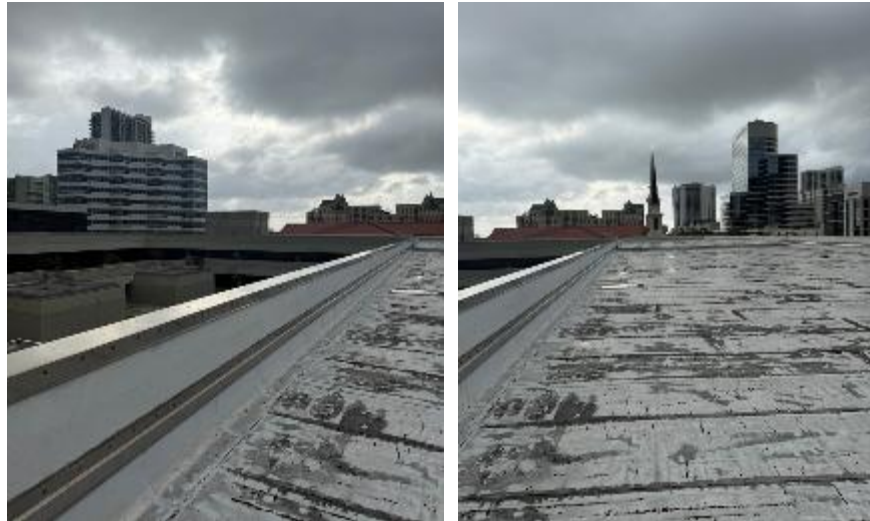
2C.6.21. Existing lightning protection infrastructure could not be fully verified and should be evaluated during future renovations.

Figure 2C.6.21 Existing roof - no lightning protection system

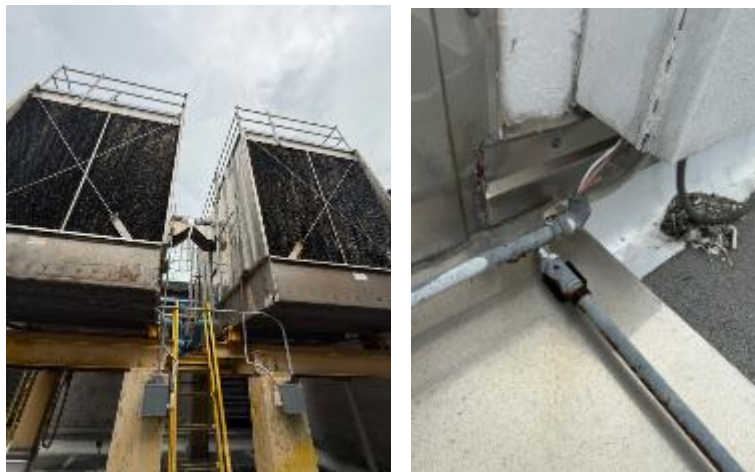
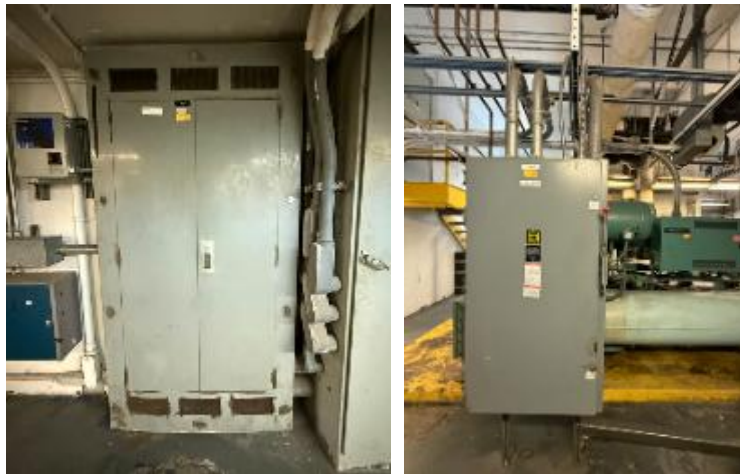
- 2C.6.22. Rooftop electrical equipment exhibits age-related deterioration and weather exposure.
- 2C.6.23. Existing rooftop disconnect switches and associated electrical equipment should be evaluated for replacement during future modernization efforts.

Figure 2C.6.23 Existing electrical equipment
