# City of Fort Lauderdale Comparative Facility Analysis Report

*An Assessment of Three Existing Buildings for Potential  
Conversion to a New City Hall*

City of Fort Lauderdale, Florida

June 18, 2026

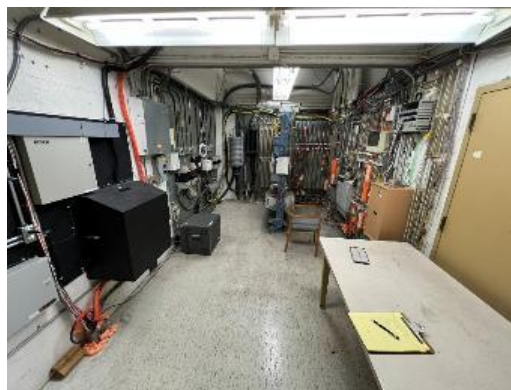
2C.7.1. The main building telephone room is located on the first floor. The room is the entrance facility for leased telecommunications services from providers such as AT&T. Various fiber optic cables pass through this room up to intermediate telephone rooms throughout the building. Legacy copper riser cables and terminations that serve the floors are also located here. There are two telecommunications equipment racks in the rear center of the room. As currently configured, the closet appears meets National Electric Code (NFPA70) and ANSI/BICSI 009-2024 working clearances of 36" on each side of the equipment racks. There are three telephone systems in the room, their operational status could not be determined. Unused cables and equipment should be removed, and remaining equipment should be reconfigured to meet current standards. The room has a 100 amp rated electrical panel that provide electrical power to some of the equipment located in the room. The panel may be served by an emergency circuit. An uninterruptable power supply (UPS) should be provided, powered from an emergency circuit off the generator, to maintain communications services. The room also houses equipment for the electronic access control system. The room didn't appear to have HVAC, but it was cool at the time of the visit. There is a Telecommunication Main Grounding Busbar. The room has fluorescent light fixtures that should be upgraded to LED fixtures. The closet door is secured with a manual key lock. Electronic access control and a video surveillance camera to view the door should be added.

Figure 2C.7.1 Main telephone room

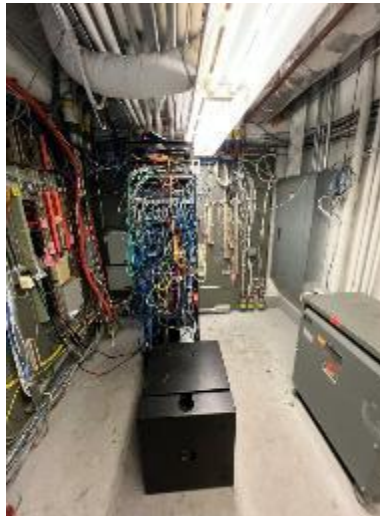
2C.7.2. Each floor has Intermediate Telephone Rooms. These rooms house legacy copper riser cables, and leased service provider equipment and fiber optic cables. Electronic access control system panels are also collocated in these rooms. These telephone rooms have plywood on the walls for mounting equipment, riser cores through the floors and ceilings, and additional penetrations for horizontal cables. All the closets were warm, with no HVAC. Similar to the first floor main telephone closet, these closets have

fluorescent light fixtures, manual key lock, have unused cables and equipment, and have no electronic access control. Some intermediate rooms had video surveillance cameras on the inside viewing the room door. Upgrades proposed for the first floor main telephone room should be implemented for these closets as well. In general, if any office areas are to be reconfigured, then new horizontal cabling, patch panels, and telecommunications outlets will need to be added. Racks and network data switches will need to be added in each telephone room to provide service to offices occupied by the City. Essentially, the entire building needs to be rewired.

**Figure 2C.7.2 Intermediate telephone room**

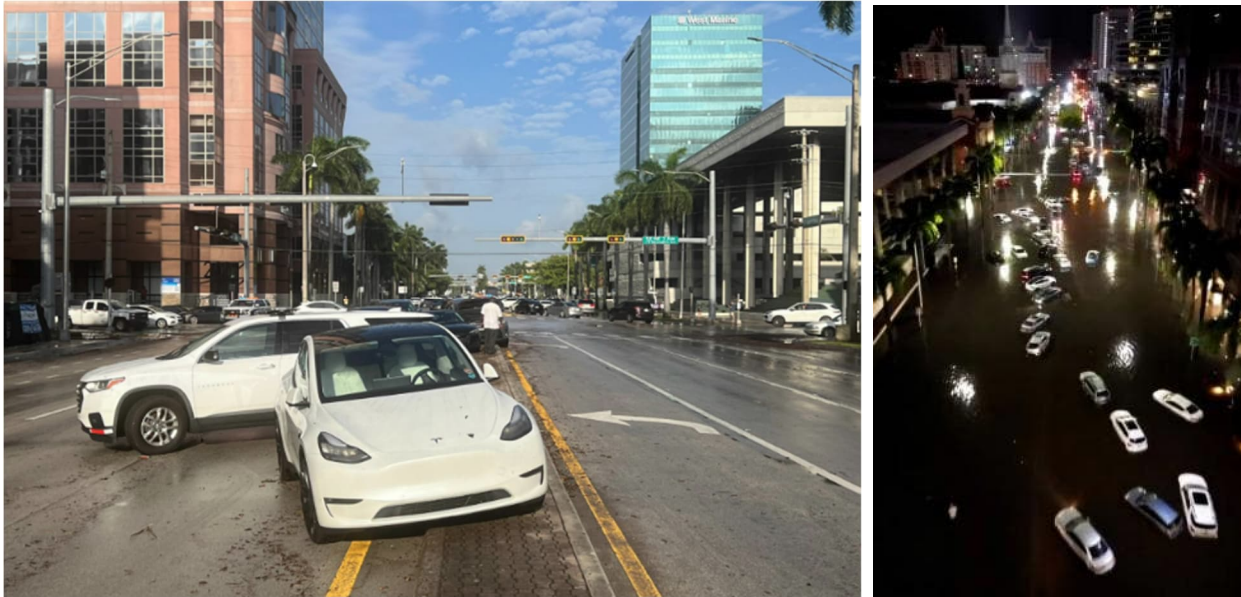
**Figure 2. E Broward Ave After Extreme Rainfall Event on April 12<sup>th</sup> 2023, 1 East Broward Blvd Building and 299 East Broward Blvd Building (top right of photo on left; left side of photo on the right)**

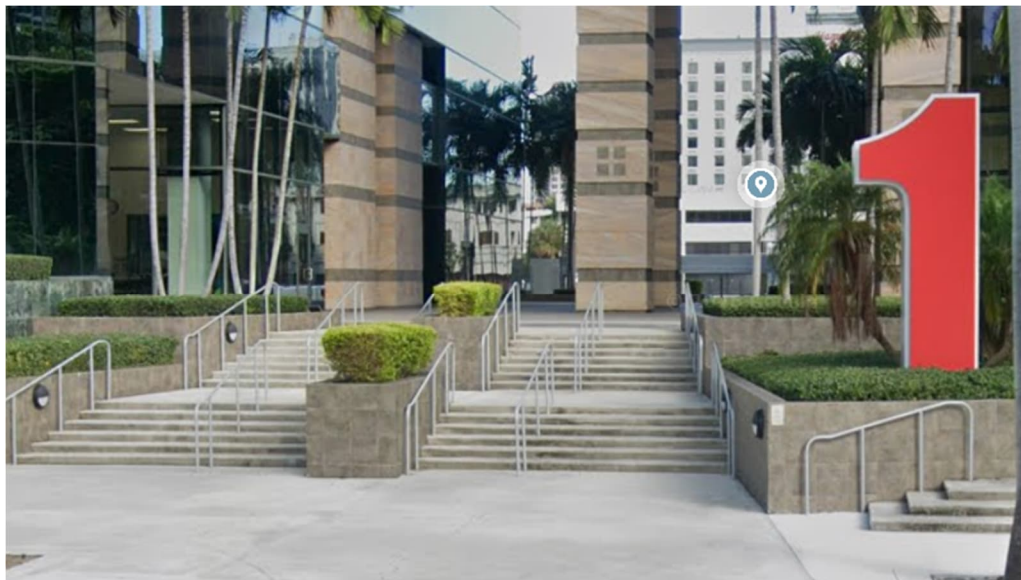
South side. Primary building entrance is about 5' above grade.

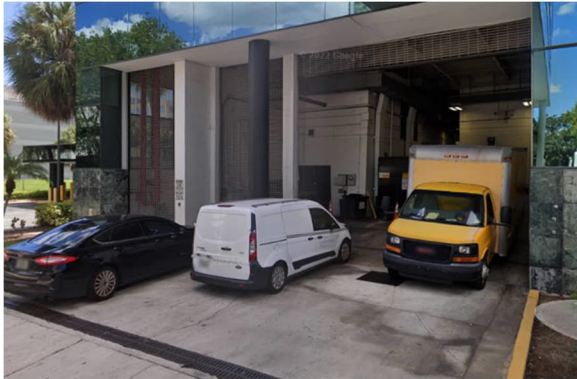
Loading dock area (back of house). FPL Vault is at grade in loading dock area. This would need flood panels. Louver at lower elevation extends up to the Mezzanine above.

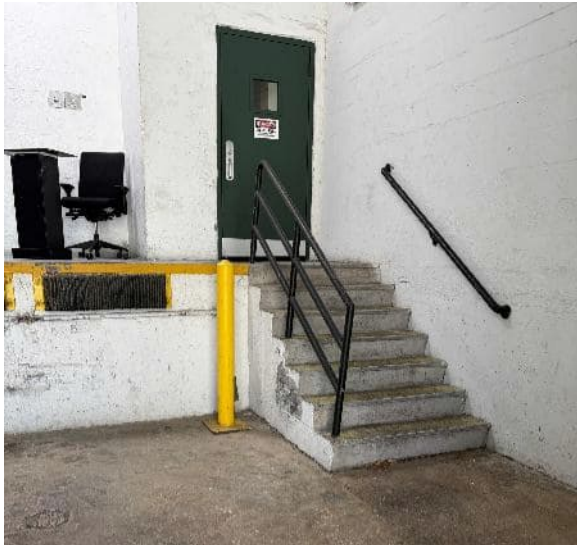
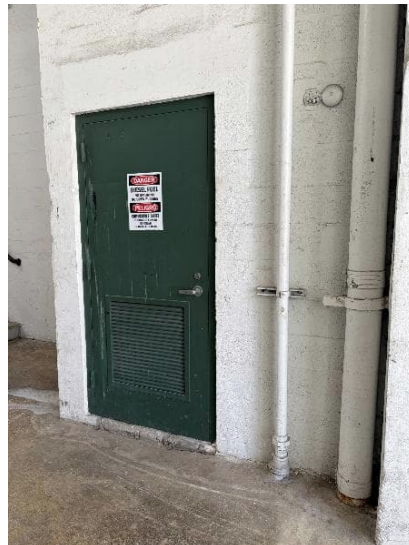
Loading dock is approx. 4' above grade. There is no change in elevation between loading dock and lobby within building. Road on south side of building may be 1' lower than roadway on North side.

Right photo appears to be a storage room, located under an egress stair.

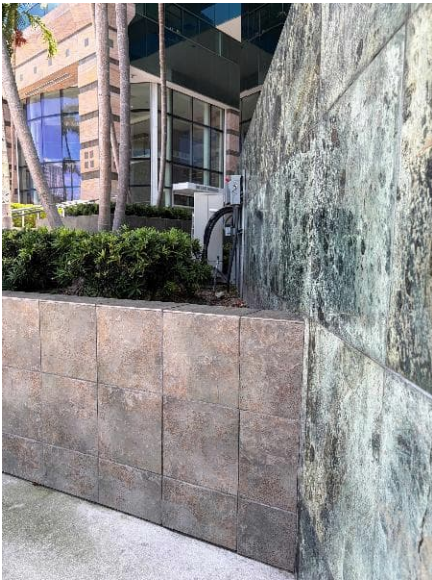
North side. This mini split AC unit sits at approx. 32" above grade.

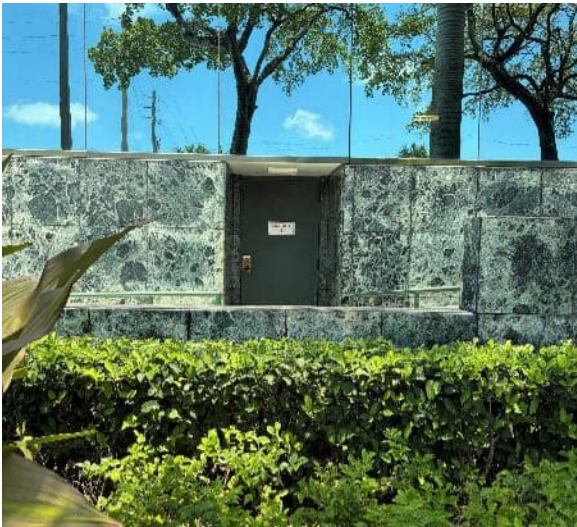
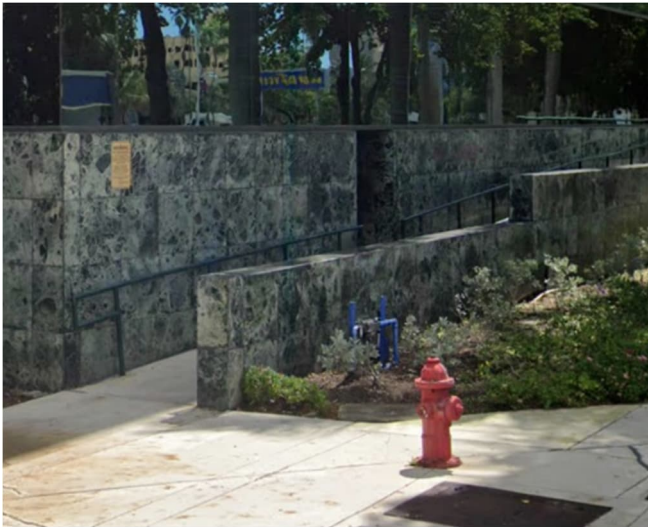
West side of building. Egress stair. Approx 2' above grade. Stairwell will take on water.

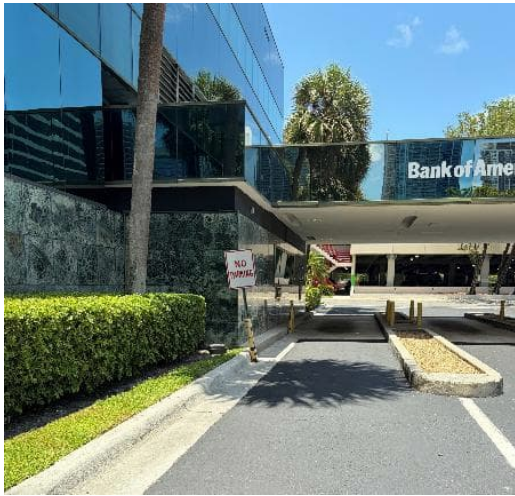
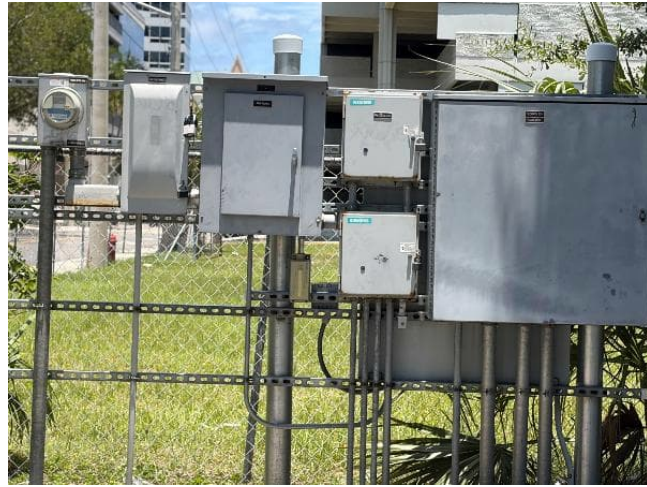
East side of building. Unless the City wants a drive through to process utility payments, this will likely be removed. Room, equipment and existing electrical service are all at grade.

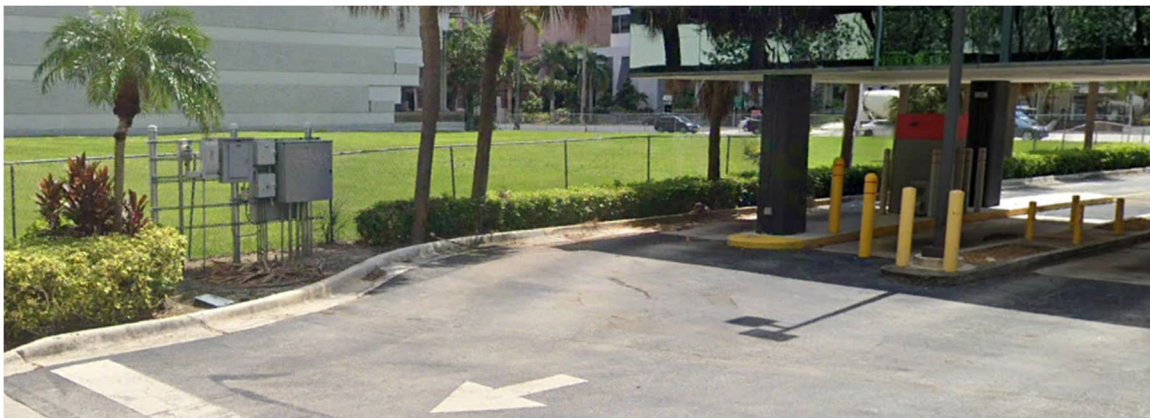
Electrical service for drive through. (low point of equipment est. 24-30 inches above grade)

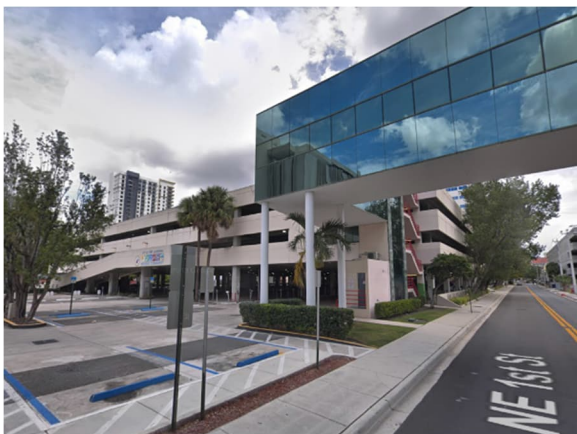
Access door to elevator shaft mech. equipment (approx. 18 inches above grade)  
Elevator shaft access doors (assumed to be close to grade)
