CITY'S POLICE DEPARTMENT BUILDING INFRASTRUCTURE OBSERVATIONS

By Ralph Zeltman Date: 9 April 2018

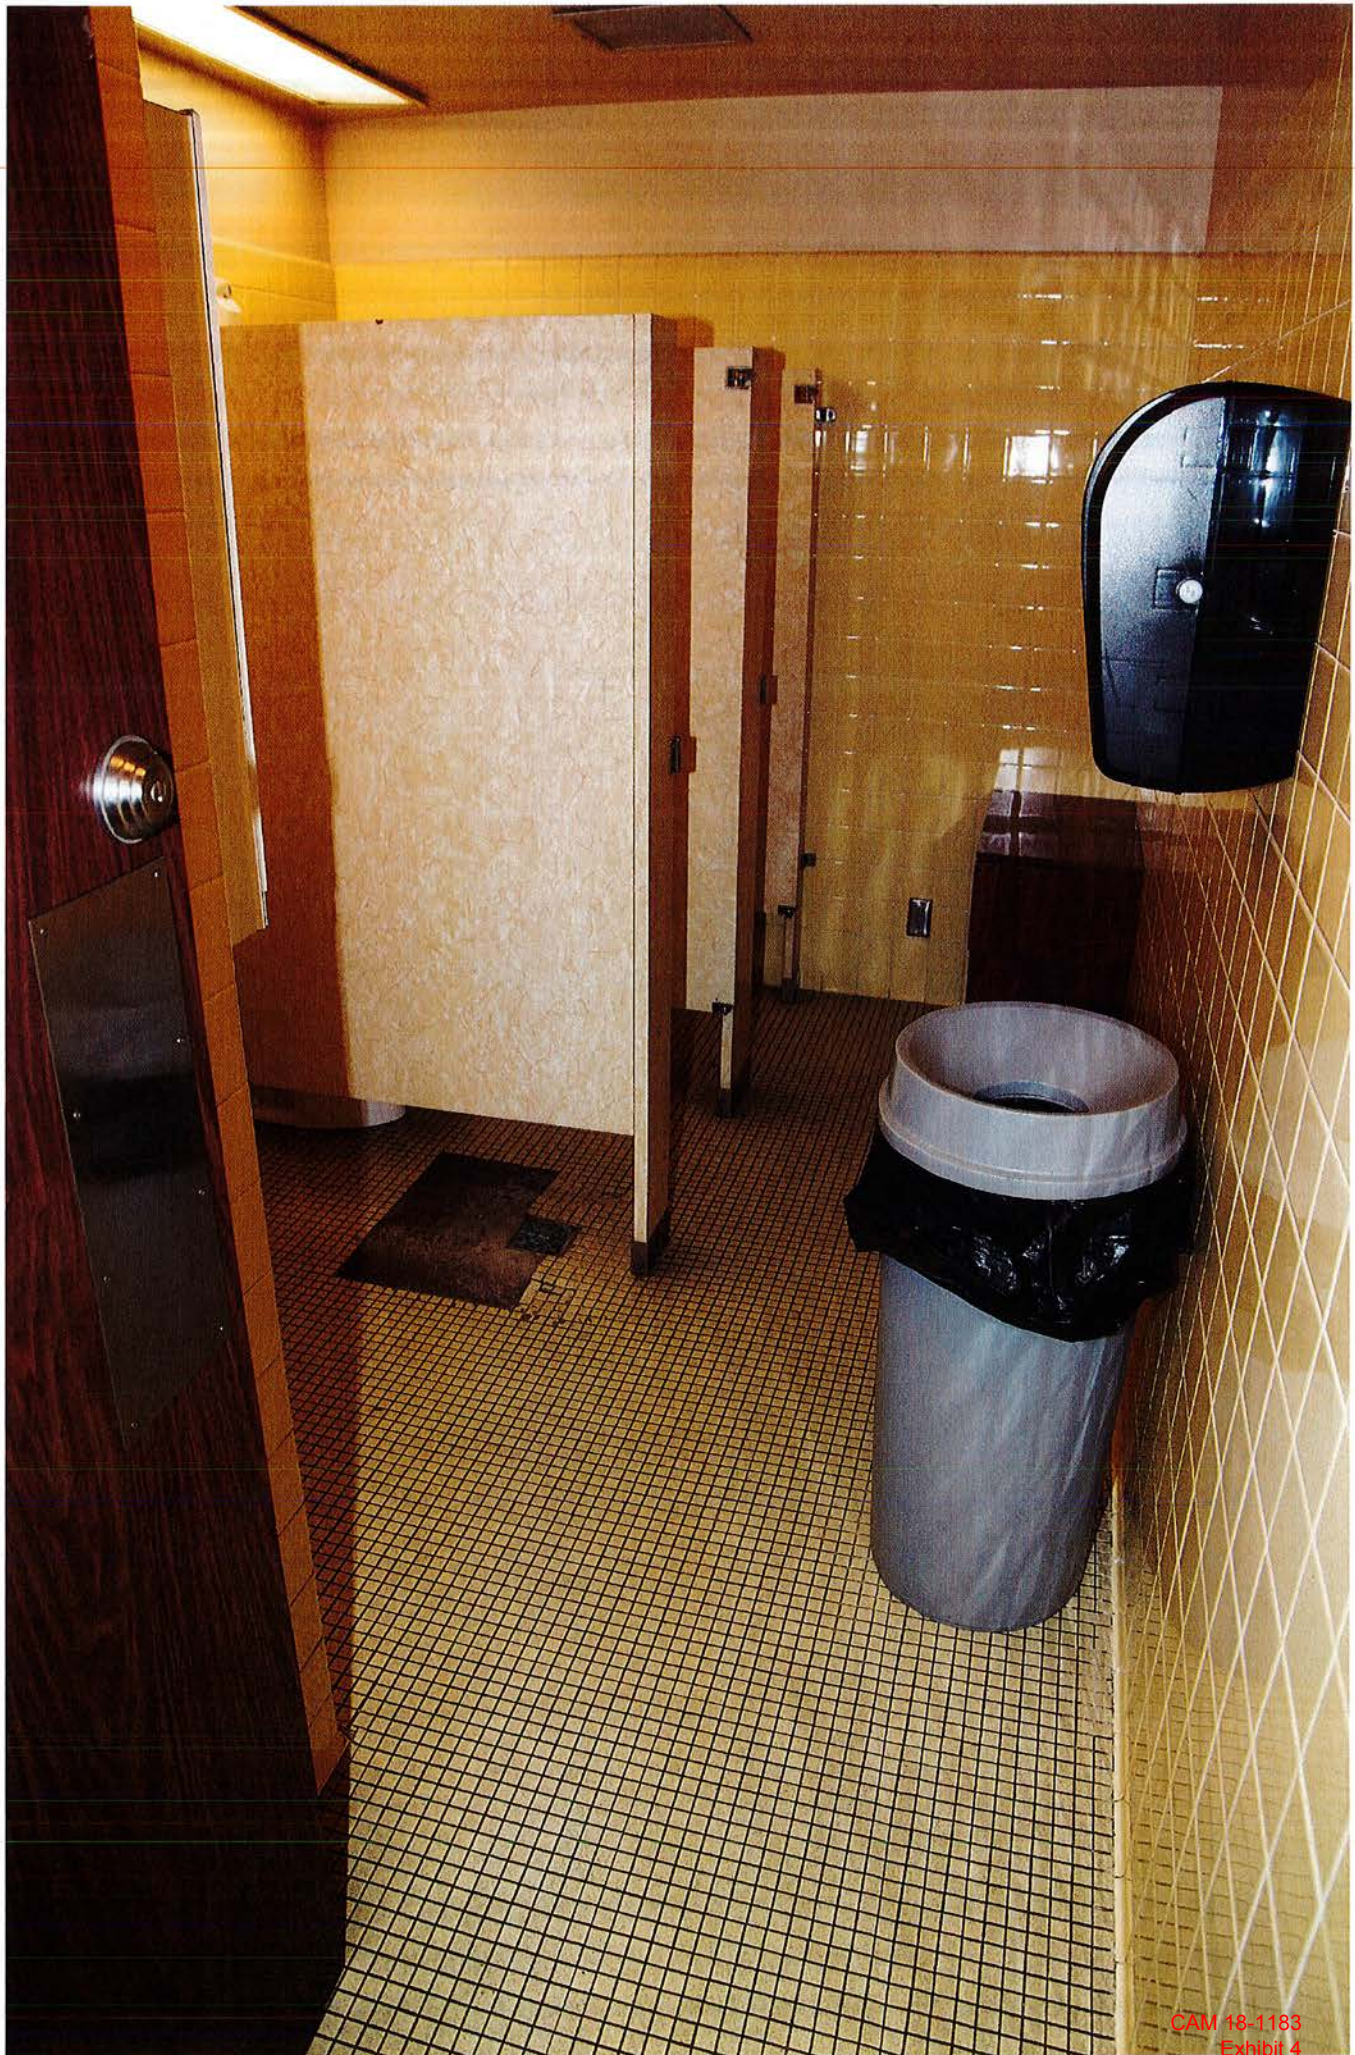
Panel B

PNL B

OFF: FOR INJURY TO PERSONS HAS
TRIPPED AUTOMATICALLY TO REPAIR
MOVE HANDLE TO "OFF" POSITION

South Hill
Water Office

Coffee & Juice Machine

- 10.) Outdated electrical breaker systems throughout the building not having replaceable parts readily available and apparently exceeds the amperage ratings.
