CITY OF FORT LAUDERDALE

RIVERWALK CENTER PARKING GARAGE

Structural Condition Assessment – Final Report

May 12, 2021

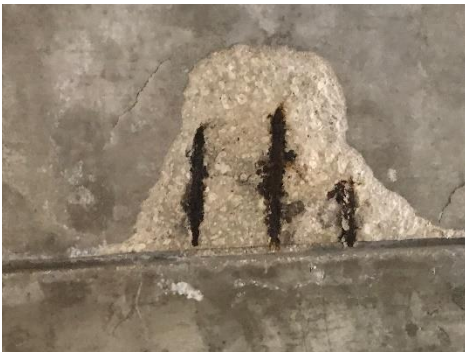
Several quantities of cracking, delamination and spalling with exposed reinforcement were observed on the elevated floor slabs. Previous floor cracks, overhead floor cracks, and concrete spalls were observed to be repaired. Several of the previous repairs were observed to be in poor conditions. Pourstrip areas were also observed to have many structural deficiencies. Additional cracks not observed may be present upon removal of dirt and debris from powerwashing the floor surface.

Exposed Rebar

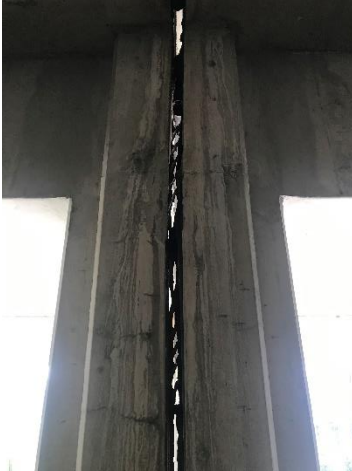
The expansion joints running east to west through the garage was observed to be in fair conditions. Some expansion joints were observed to be deteriorating. Additionally, areas of large water ponding were observed near the expansion joints, causing debris build up and deterioration of joints. Few plate covers installed over the expansion joint on the interior bays were observed to be detached. Vertical Joint on the exterior face of the building were observed to be in poor conditions, due to direction sun exposure.

Vertical Expansion Joint

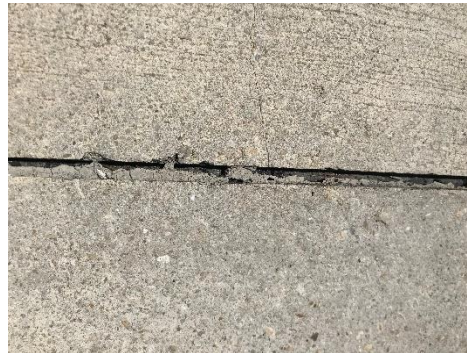
Various areas of deteriorated or missing sealant were observed, most significantly on the top level due to direct exposure to the elements. Horizontal sealants were observed on all floors at the pour strips, joints, topping areas, and planter covers and were found to be in fair conditions. Cove sealant was observed on the top floor around the barrier wall and concrete curb and was found to be in poor condition, due to direct exposure to the elements.

Horizontal Sealant

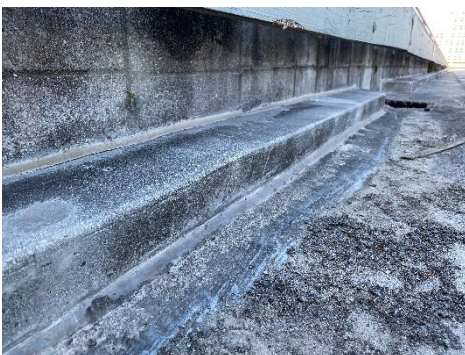
Cove Sealant

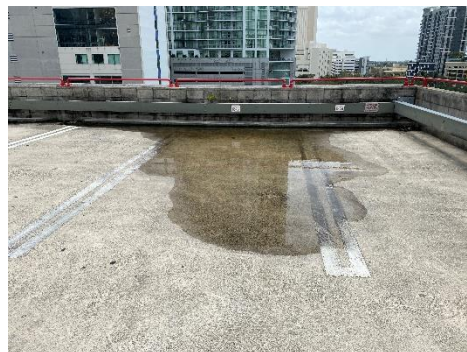
Water Ponding

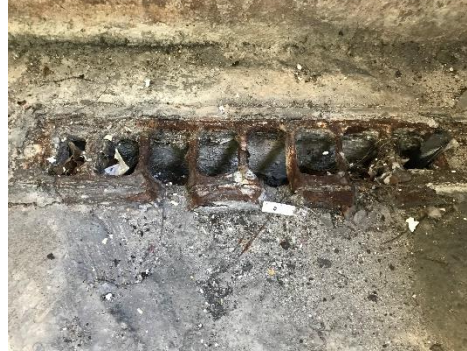
Drain Grate

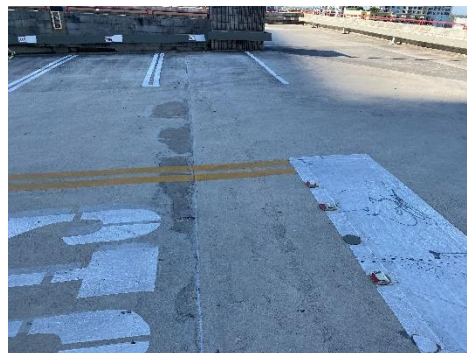
Striping

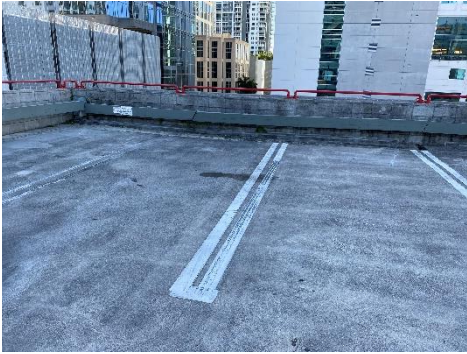
Striping

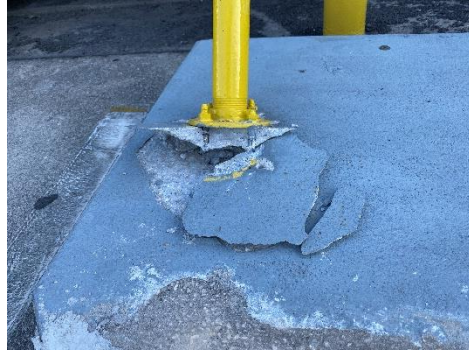
Pipe Support
